UPPER MISSISSIPPI RIVER SYSTEM
ENVIRONMENTAL MANAGEMENT PROGRAM
DEFINITE PROJECT REPORT/ENVIRONMENTAL ASSESSMENT (SP-17)

MISSISSIPPI RIVER BANK STABILIZATION
HABITAT REHABILITATION AND ENHANCEMENT PROJECT
POOLS 5-10, UPPER MISSISSIPPI RIVER
MINNESOTA, WISCONSIN, AND IOWA

ST. PAUL DISTRICT, CORPS OF ENGINEERS
ARMY CORPS OF ENGINEERS CENTRE
190 FIFTH STREET EAST
ST. PAUL, MINNESOTA 55101-1638
AUGUST 1995

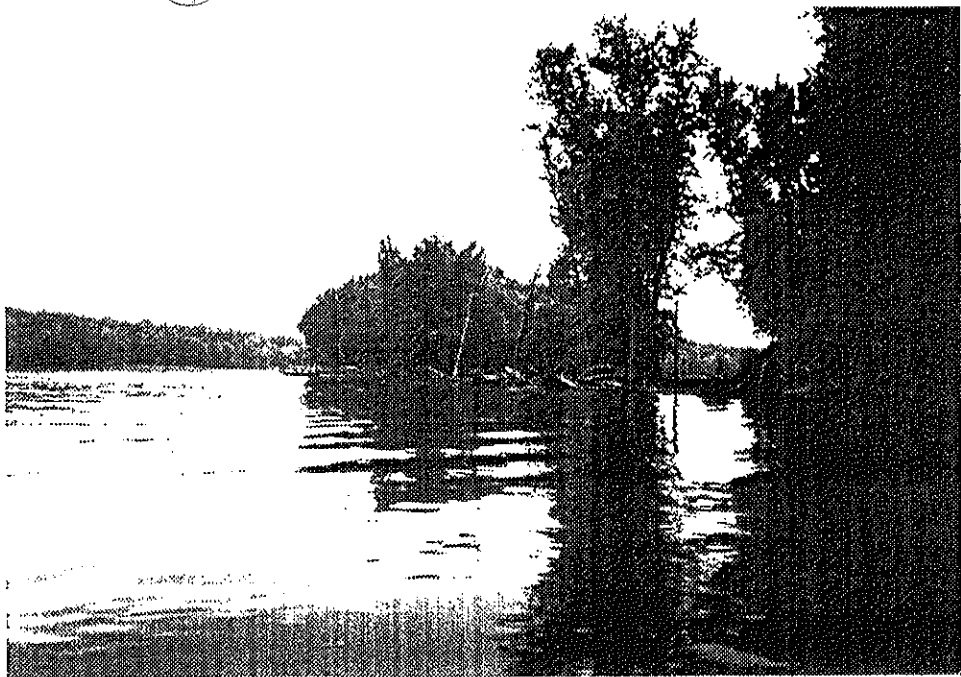
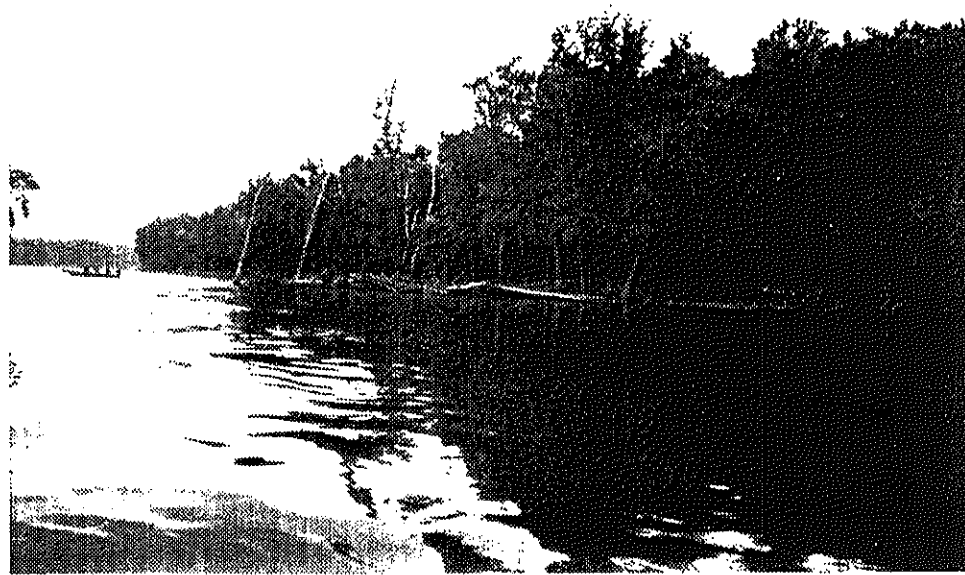
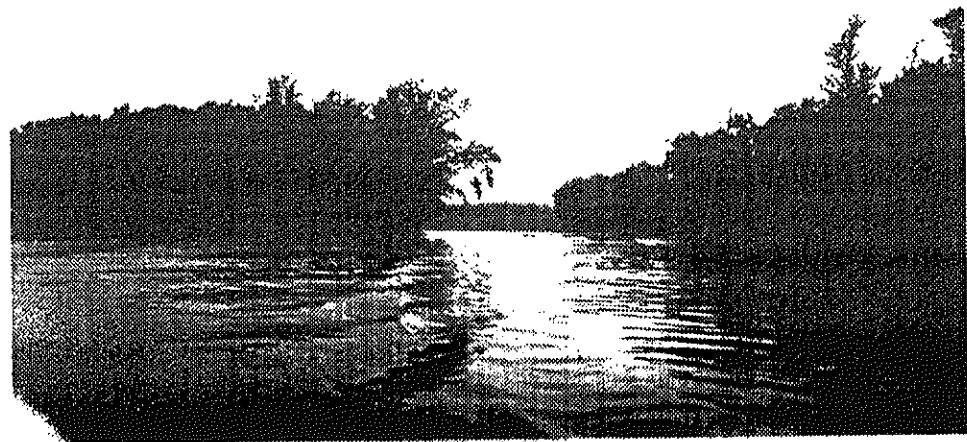
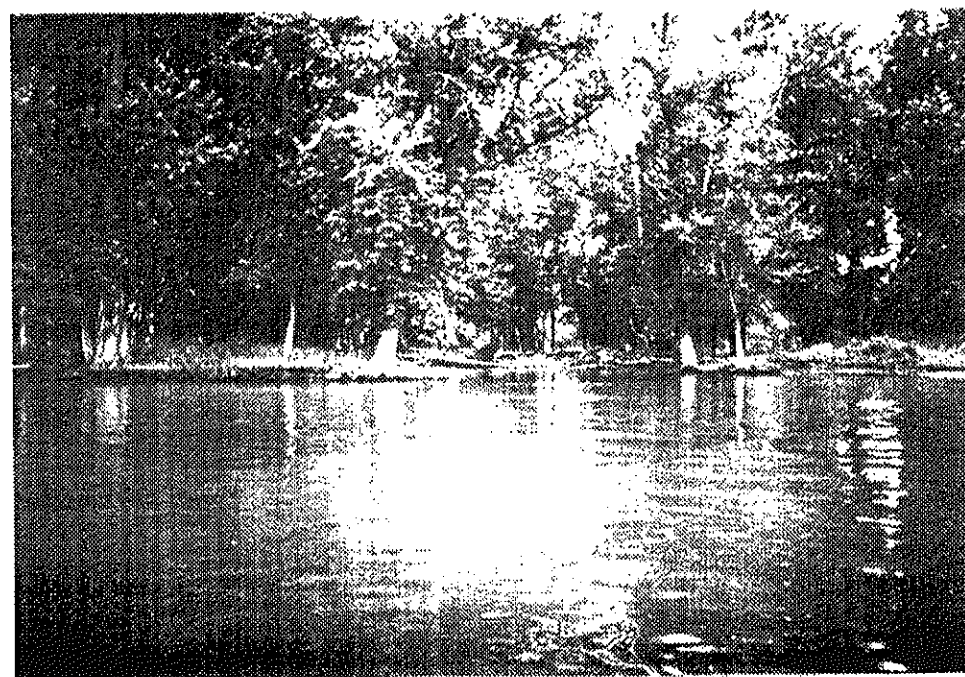
10-646.4

(f) (m) (c) gravel <input type="checkbox"/> cobbles <input type="checkbox"/> other info: _____		
Existing bank protection? <input type="checkbox"/>		
Apparent causes of erosion: river flows <input type="checkbox"/> wind waves <input type="checkbox"/> boat waves <input type="checkbox"/>		
(number in order of cause) prop wash <input type="checkbox"/> ice action <input type="checkbox"/>		
Estimated rate of erosion or erodibility (low, moderate, <u>high</u>) (future rate)		
Source of local sediment transport (upstream, none)		
Bottom material		
Existing vegetation: nearshore - _____		
(density, type)	shoreline - _____	
	bank - _____	
	top of bank - _____	
Trees (fallen, species, size range, average size, location, number)		
Habitat type and species impacted by continued erosion <i>Harpers Slough is currently being impacted by the erosion of this site and the introduction of bed load. Important habitat includes diverse mussel beds and nursery areas for the fishery.</i>

Quality of affected habitat (low, medium, <u>high</u>) <i>again important fish nursery and v. important mussel habitat (large 5-16) wash</i>		
Area protected by island (shadow zone) <i>important backwater areas</i>		
Other impacts of erosion (future conditions) <i>increased sedimentation by movement of bedload</i>		
Type(s) of stabilization proposed <i>rock protection across the face</i>		
Other type(s) of stabilization possible <i>just upstream of the main blow-out, there is another erosion site where action may be warranted.</i>		
Fill required?	Source?	
Bank shaping required?		
Construction access considerations or problems?		
Cultural resources?		
Other information

Typical bank cross-section

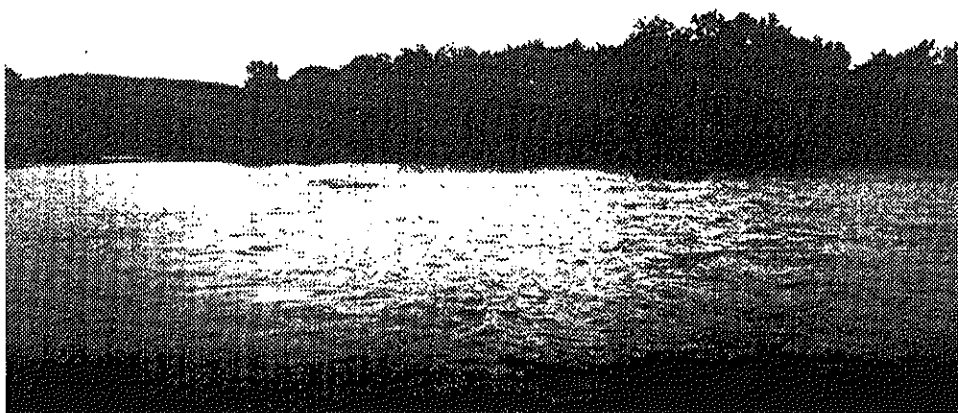
Typical bank cross-section

Rec.
Minimal habitat prot.
