**Peterson Lake  
Pool 4 Mississippi River  
Habitat Rehabilitation and Enhancement Project  
Project Evaluation Report**

**Environmental Management Program for the  
Upper Mississippi River System**

December 2011

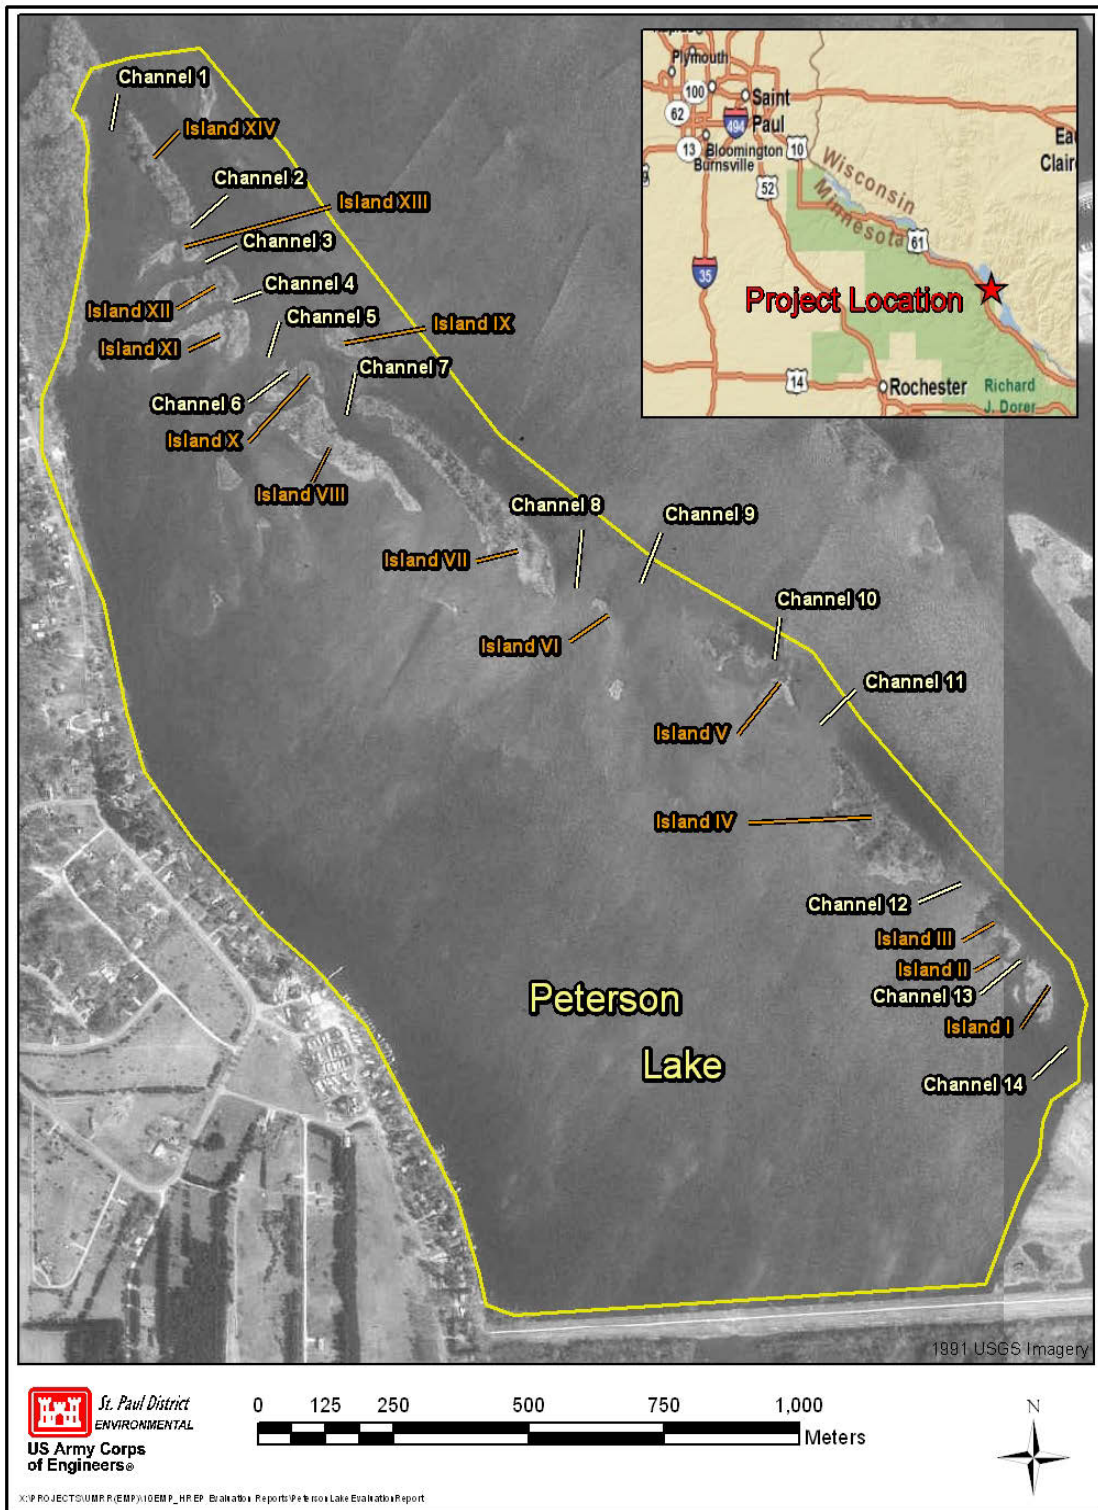
Figure 1. Peterson Lake HREP location, channels, and islands.

Peterson Lake is a 500-acre backwater lake located in Upper Mississippi River Pool 4 between a string of main channel border islands and the Minnesota shoreline (Figure 1 on next page). There are 13 inflow channels (#1-13) to the lake along its northeast perimeter and one outflow channel (#14) located to the southeast. The lake is triangular in shape and is located immediately north of the earthen dike at Lock and Dam 4. Peterson Lake lies between river miles 753.0 and 754.8 of the Upper Mississippi River. The project area is defined as Peterson Lake, including the Lock and Dam 4 dike, the Minnesota shoreline, and the islands separating Peterson Lake from the main channel. Towns nearest to Peterson Lake include Alma, Wisconsin (approximately 1 mile SE) and Kellogg, MN (approximately 3 miles SW). Peterson Lake lies within the Upper Mississippi River National Wildlife and Fish Refuge. Peterson Lake is closed to the use of motors from October 15 to the end of the MN duck hunting season, with the exception of a travel corridor to the main channel.

The numbered channels and islands in the following descriptions can be found in Figure 1. The labeled project features can be found in Figure 2.

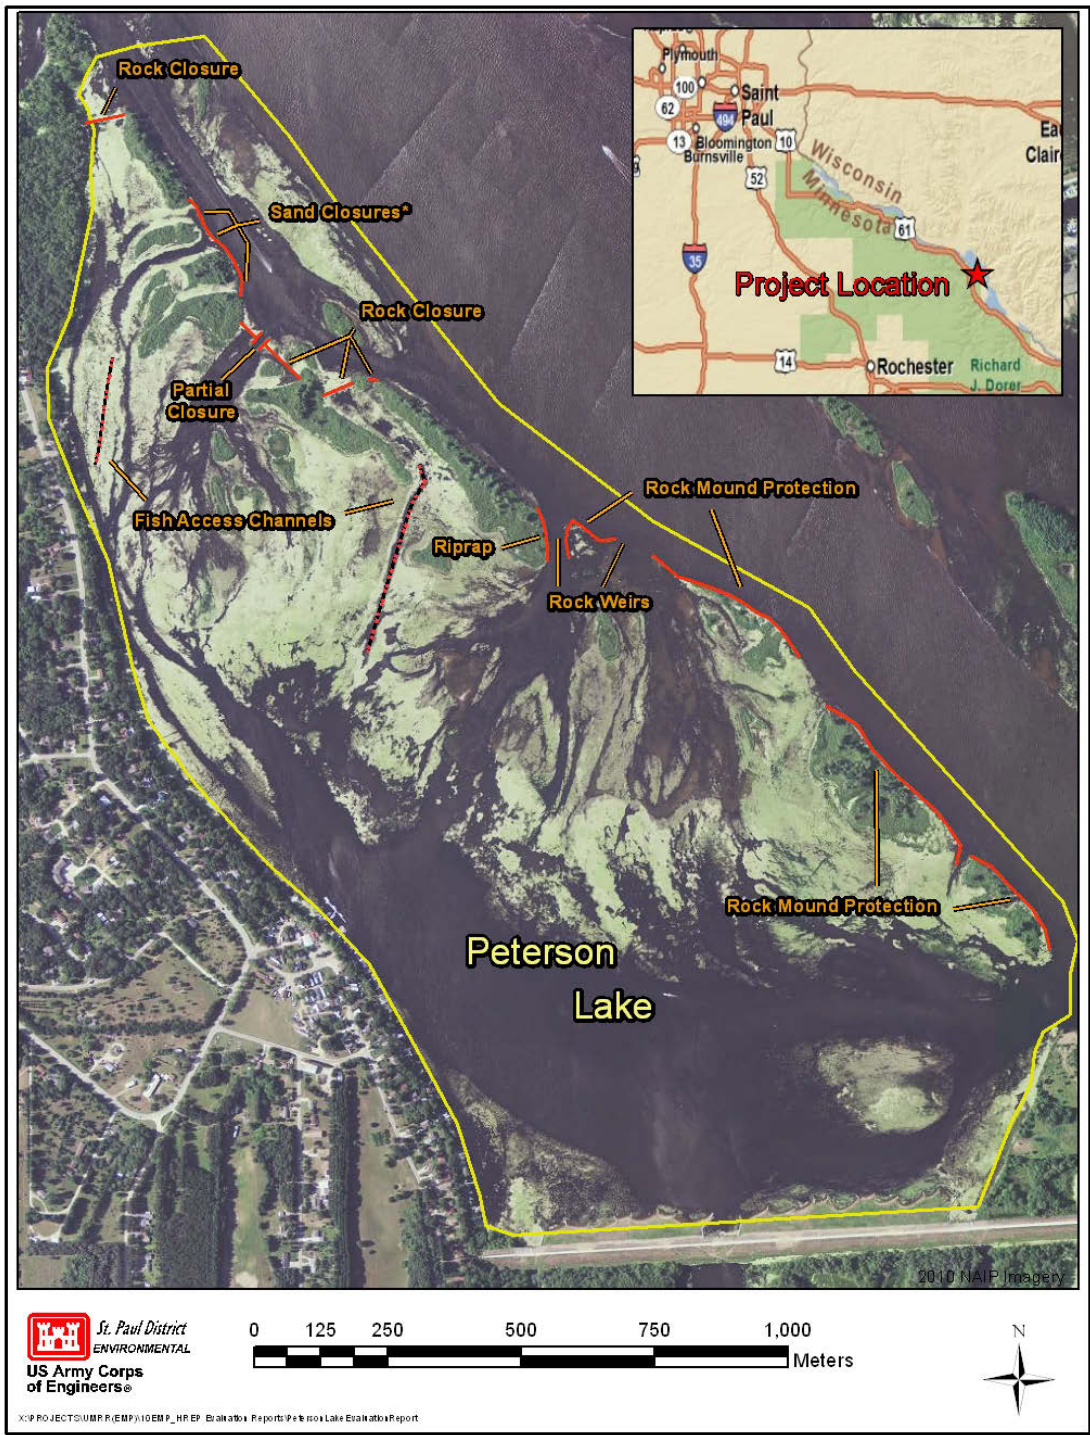
Figure 2. Peterson Lake project features.

\*Sand closures were washed out and replaced with rock.

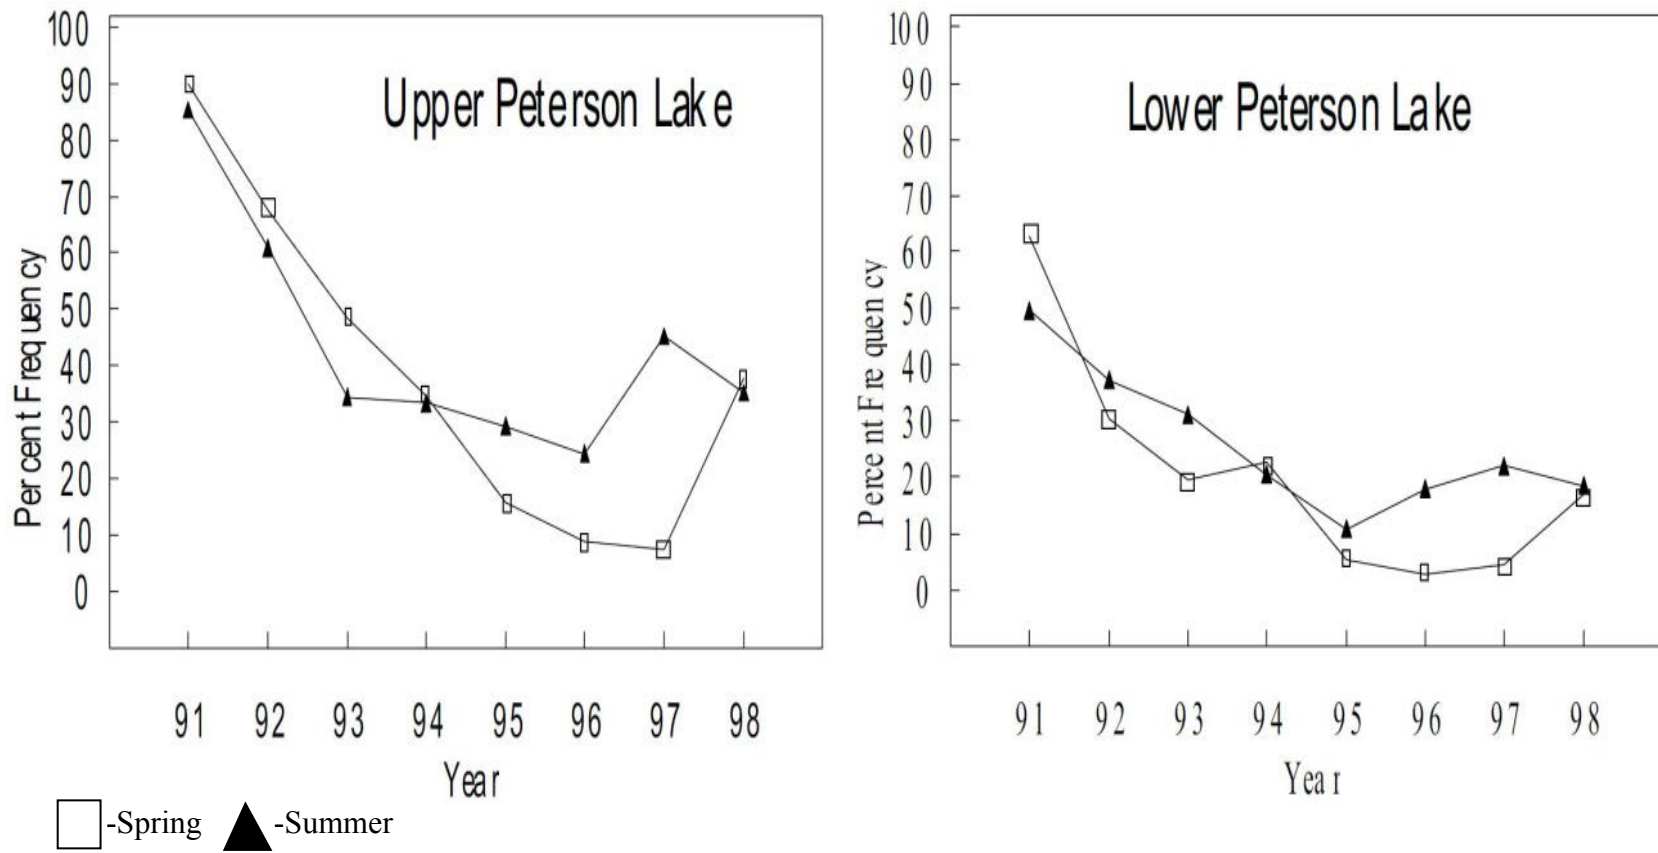
whole and in Peterson Lake specifically. Figure 7 displays this trend in Upper and Lower Peterson Lake.

**Figure 7.** Percent frequency of aquatic vegetation sampled along transects in Peterson Lake from 1991-1998 (Yin et al. 2000).
