**UPPER MISSISSIPPI RIVER SYSTEM
ENVIRONMENTAL MANAGEMENT PROGRAM
POST CONSTRUCTION PERFORMANCE EVALUATION REPORT
(10-YRS AFTER CONSTRUCTION)**

**BERTOM AND McCARTNEY LAKES
HABITAT REHABILITATION AND ENHANCEMENT PROJECT**

MAY 2002

**POOL 11
UPPER MISSISSIPPI RIVER MILE 599-603
GRANT COUNTY, WISCONSIN**

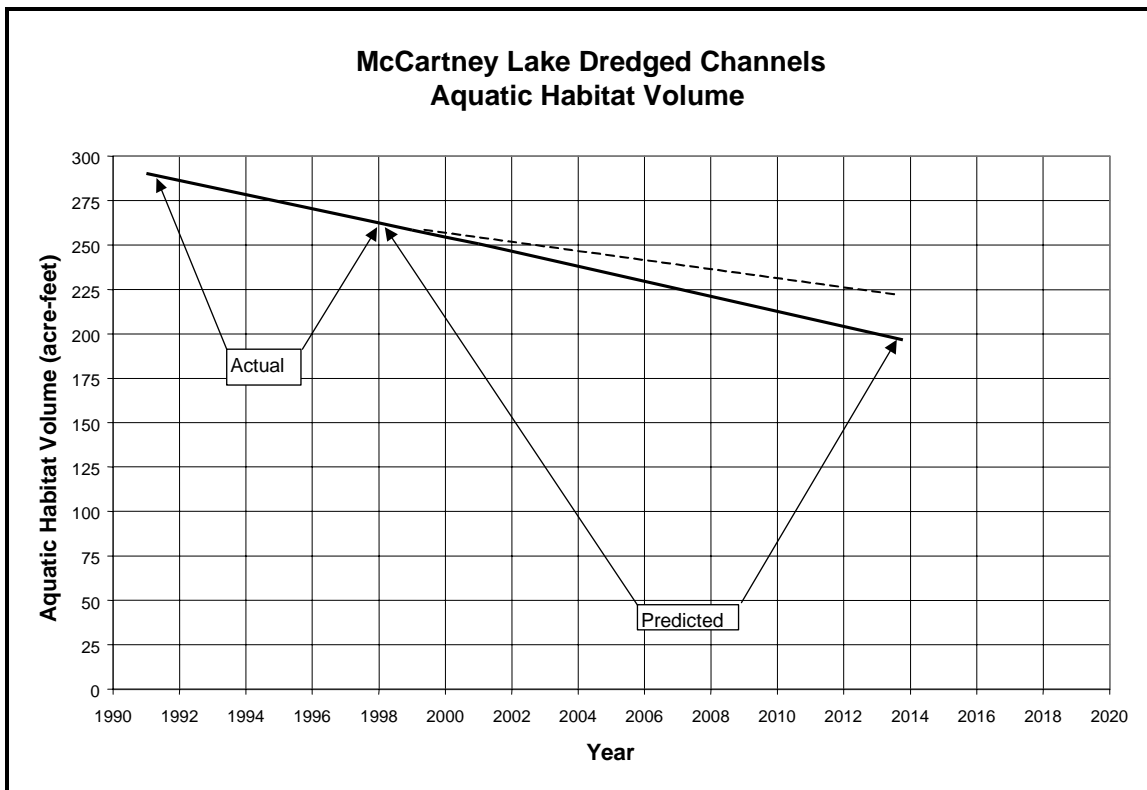
Figure 5 - 3. McCartney Lake Dredged Channels Aquatic Habitat Volume, 1991-2014.

The original plan called for creation of 250 ac-ft of this habitat. It was predicted that, due to sediment accumulation, this would be reduced to 200 ac-ft by the end of the project life, or 50 years. This is an average loss of 1 ac-ft per year. The actual constructed volume was 290 ac-ft, and by year 7 (1998) the volume had been reduced to 263 ac-ft, or a loss of 3.9 ac-ft per year. At the current rate, deep aquatic habitat volume would be reduced to 200 ac-ft by the year 2014. A graph of past and predicted dredged channel deep aquatic habitat volume is shown below. It is noted that this assumes that the rate of sediment accumulation will be constant. From experience on other EMP projects, it appears that the rate of sediment accumulation in dredged channels is faster initially after construction and

slows gradually. With the assumption of a slowing rate of sediment accumulation, a better prediction of aquatic habit volume would be a reduction to 225 ac-ft by the year 2014.

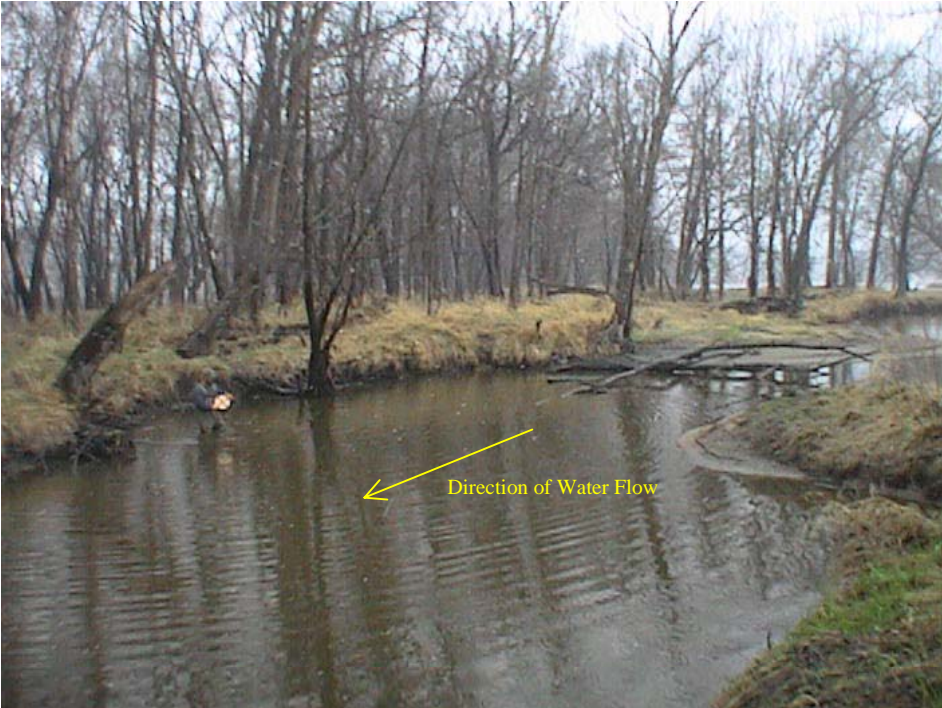
Figure 5 - 4. Enlarged Channel at RM 601.5, taken April 2000.

investigations. No hydrographic soundings have been performed at the access areas where the dredged channels merge with the deeper, main open water channel. However, field observations by the USFWS (Mr. Clyde Male) noted that there has been no littoral zone development for the project area since construction ended in 1992. Also a channel leading to Area A has enlarged during post-construction, probably due to high flows in 1993 and 1997. The photos below show these observations.

The channel size increase is suspected of increasing flow and affecting overwintering habitat, thus impacting Areas A and C. The Corps completed two surveys of the enlarged channel to investigate potential for riprap and a notched closing structure that would be used to stabilize the bankline along the enlarged channel entrance and to slow down the flow velocities through the channel. The one survey was completed before and the second was completed after the 2001 flood. Drawings C15-C18 of Appendix G shows the results of these surveys.

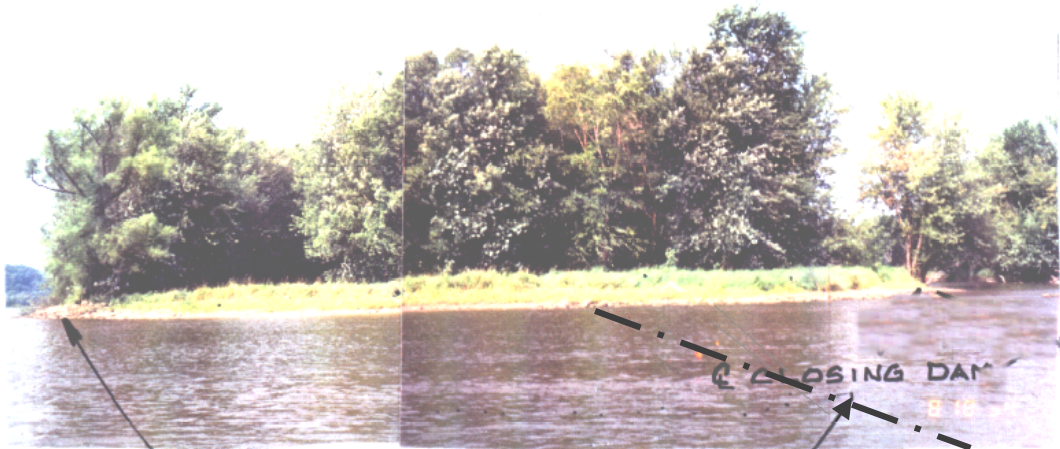
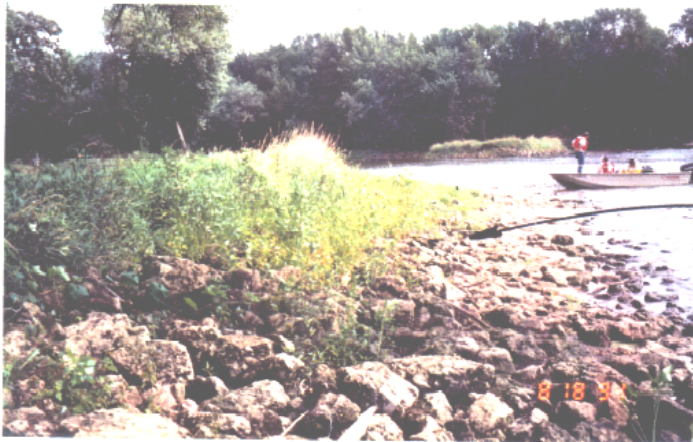
MISSISSIPPI RIVER
POOL 11
MILE 602.0
PHOTOGRAPHS

(1) Monitoring Results. The Flood of 1993 washed away approximately 300 feet of the riprap protection wing that tied the closing structure into the bank on the upstream end of the partial closing structure. Scour of the rock-lined channel was also noted as damage from the flood. The repair of the damage to the partial closing structure was completed in 1995. This repair included replacing the riprap on the upstream riprap protection wings to the bottom toe elevation of 602.0 or to a maximum of 25 feet from the top of the bank. The location and photos of the damage and repair for partial rock structure are given below in Figures 5-6 and 5-7, Plates 1 and 2 of the Site Investigation Report; Bertom & McCartney Lakes Partial Closing Structure dated February 1, 1995.

AREA TO BE REPAIRED

The 400-pound stone riprap protection was placed approximately 300 feet in length with a thickness of two feet. The 1993 and 1998 cross-section transects for the rock habitat channel and the submerged partial closing structure show evidence of scour in the rock lined channel as seen in Appendix G on plates 3 & 4. This scour may be the carry over from the Flood of 1993, and any subsequent repair of this damage is still under review.

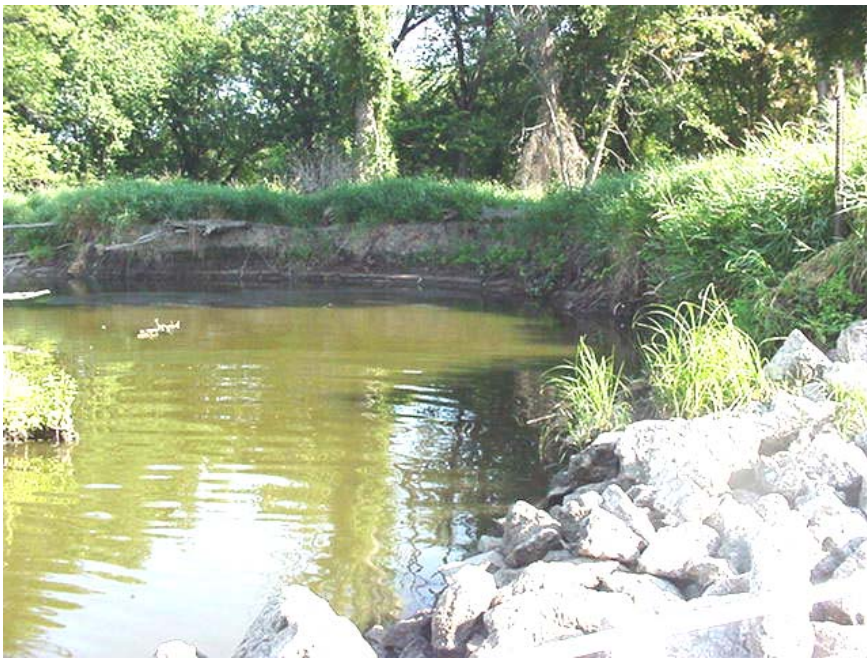
After a more recent event, the flood of 2001, the USFWS Site Manager and representatives from the Corps inspected the project area to identify locations of physical damage that may have been the result of this flood. Excessive sedimentation, bank erosion, and scour were noted at several locations during the inspection and are shown in the photos below. Figure 5-13 identifies the locations the primary damage was found. General conditions for the channel, lunkers, and logjam were checked and preliminary discussions were made with the USFWS Site Manager and WDNR to determine the scope for further investigation and potential repair of damaged areas. The need to further evaluate the cost and feasibility of repair of the identified areas requires a follow-up discussion between the project sponsors, so these details will be covered in the next post-construction performance evaluation report.

Figure 5 - 8. Bank scour behind left bank of riprap of rock habitat channel, dated 14 August 2001.

(2) Conclusions. The primary damage caused by the Flood of 1993 to the riprap protection wing for the partial closure structure was repaired in 1995. The USFWS Site Manager and representatives from the Corps visually checked the evidence of scour damage in the rock channel and new damage to the partial closing structure during a joint site inspection after the Flood of 2001. The requirements for repair are currently being developed. Factors such as feasible equipment access and availability of funds are instrumental to whether the repair work can be done. Cross-sections and surveys of the damaged areas are planned for the 2002 evaluation year to help detail the proposed repair. Further feature assessment requires a follow-up meeting and discussion with the project sponsors that will be scheduled during the next year once the survey of the damaged areas are complete. The results of this discussion will be provided in the next post-construction performance evaluation report. Damage from high flows/flood events will continue to be a challenge for the success of these features.

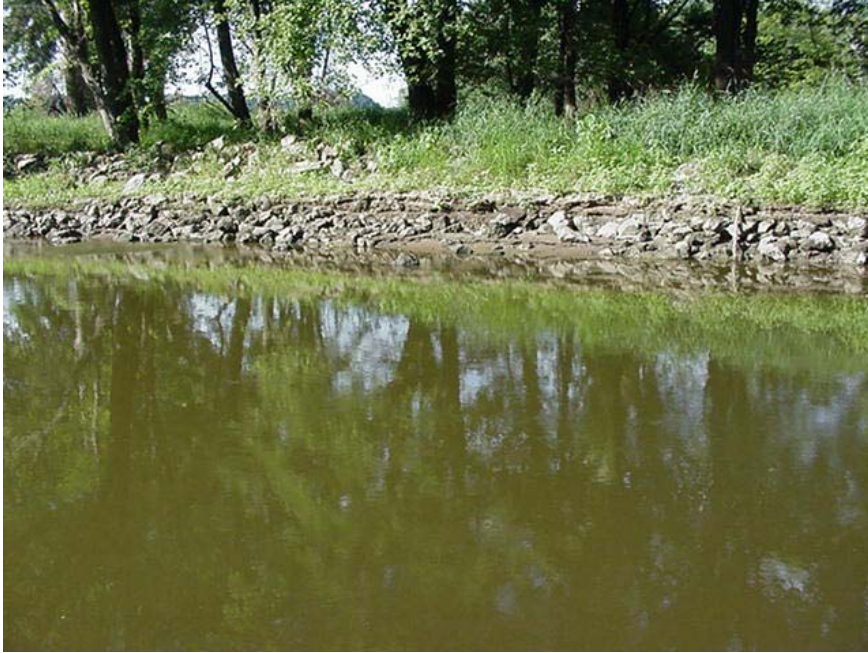
Figure 5 - 9. Sedimentation and scour of rock lined channel, dated 14 August 2001.

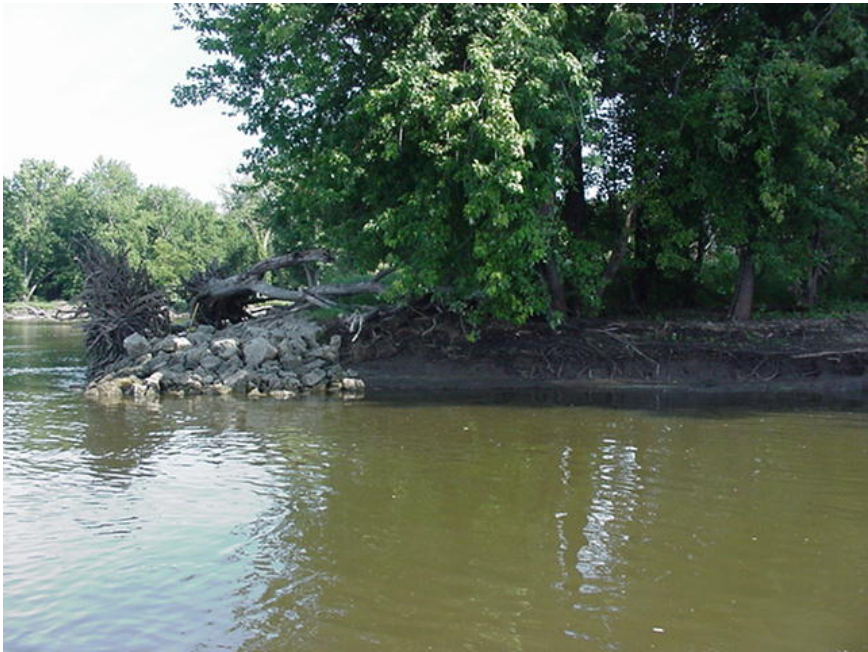
Figure 5 - 10. Bank scour behind downstream riprap protection wing of partial rock closure structure, dated 14 August 2001.

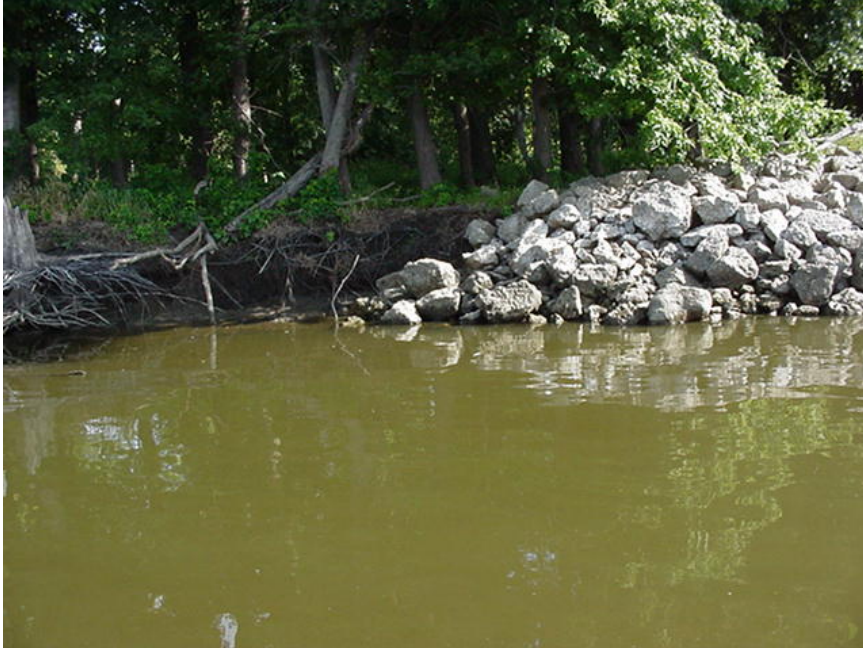
Figure 5 - 11. Bank scour behind upstream riprap protection wing of partial rock closure structure, dated 14 August 2001.

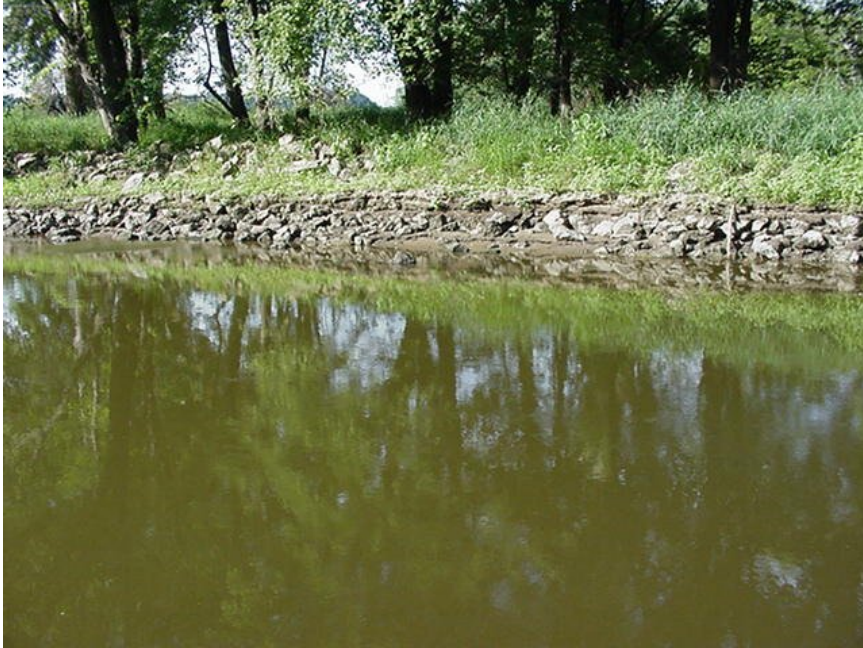
As noted in section 5.c., after the flood of 2001, the USFWS Site Manger and representatives from the Corps inspected the project area to identify locations of physical damage that may have been the result of the 2001 flood. Excessive sedimentation was noted at several locations during the inspection and is shown in the photos below (See Figure 5-13 to identify the locations the primary damage was found).

Figure 5 - 12. Sedimentation and loss of riprap to rock habitat embankment, dated 14 August 2001.

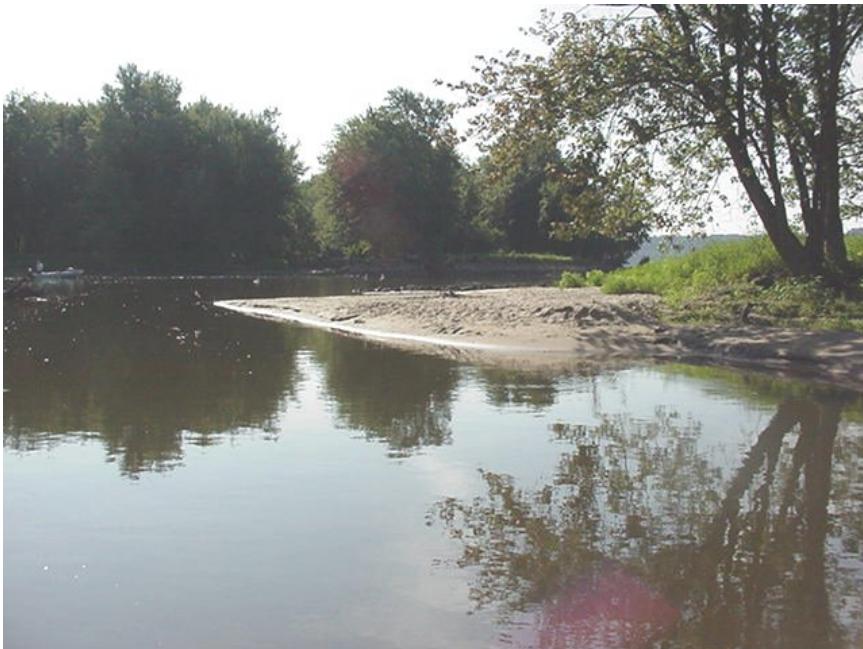
Figure 5 - 13. Excessive sedimentation behind upstream protection wing of partial rock closure structure, dated 14 August 2001.

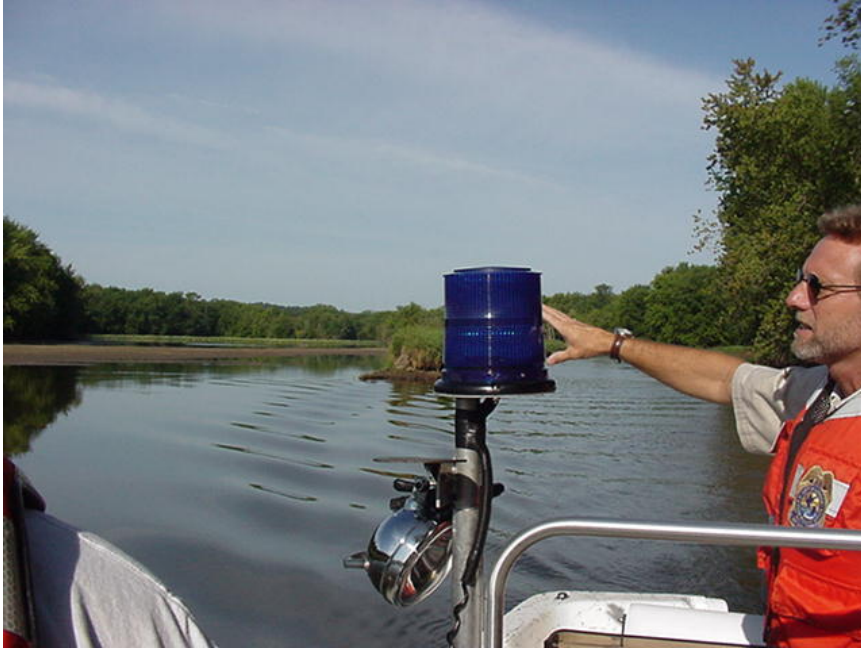
Figure 5 - 14. Excessive sedimentation in northern back channel leading to Bertom Lake from closure structure dated 14 August 2001.

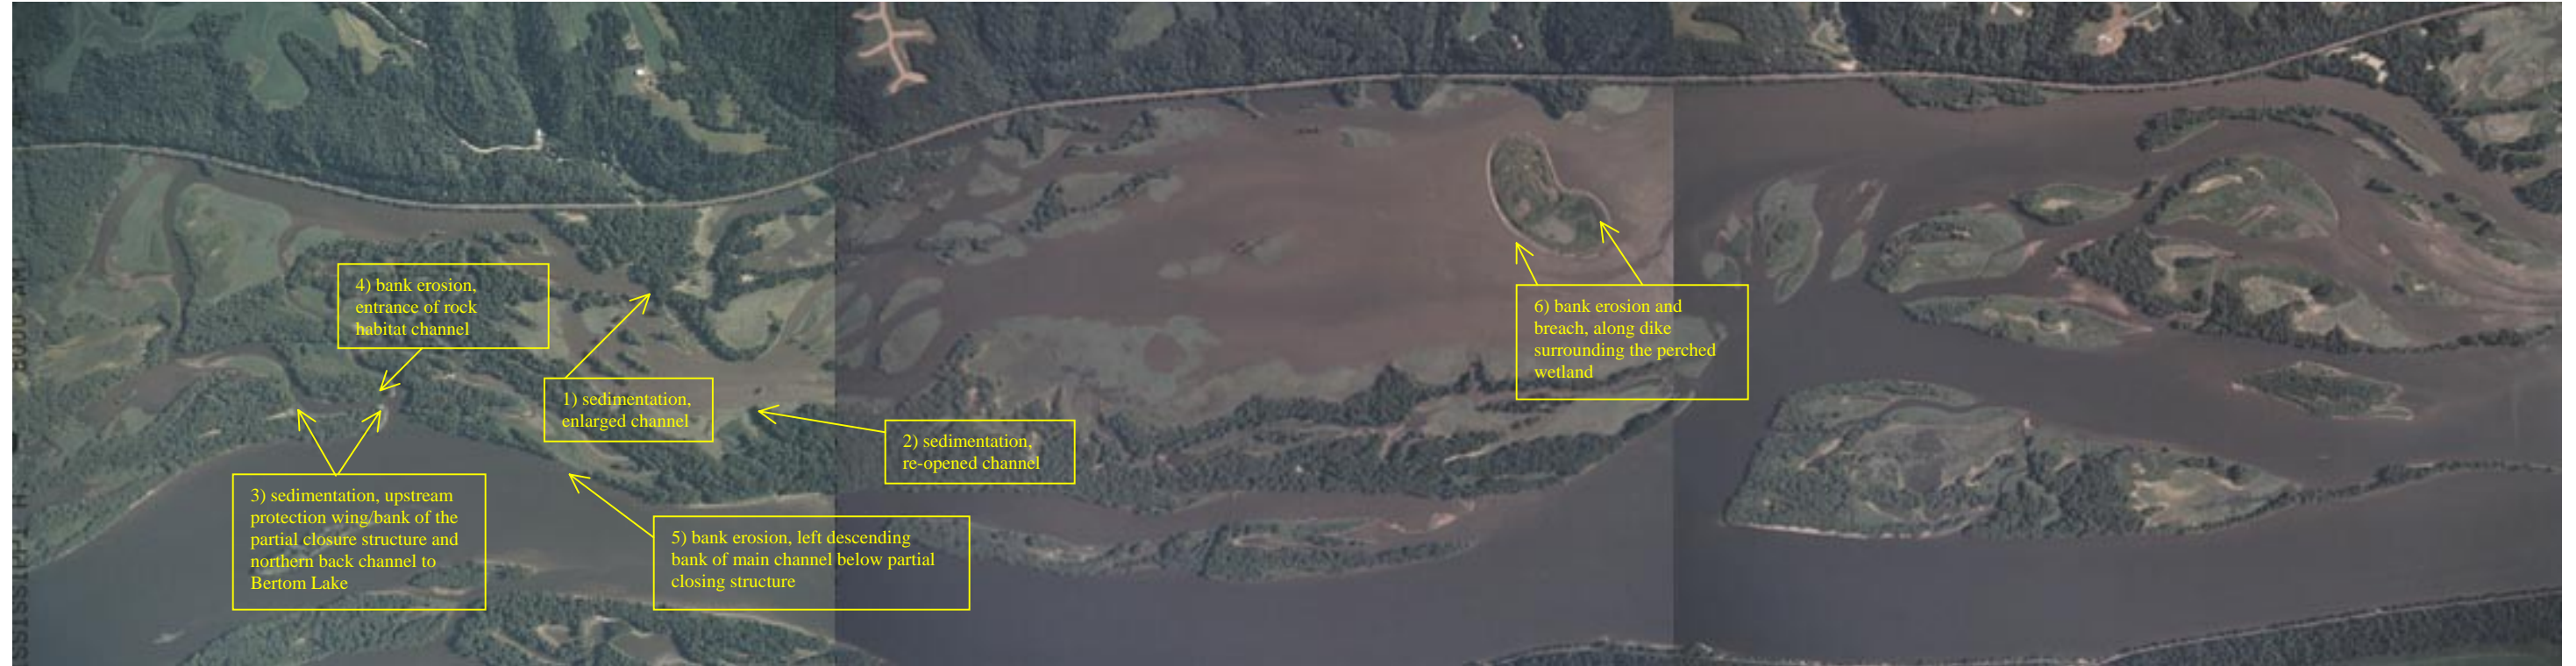
Figure 5 - 15. 2001 Flood Inspection, Areas of Noted Damage noted on 14 August 2001.

- 1) Excessive sedimentation at the entrance of a channel that has previously been a concern due to its enlarging and is located just downstream of the Farnuf boat ramp (Drawings C15-C18, App. G, show survey results of this area),
- 2) Excessive sedimentation in a re-opened channel into McCartney Lake from the main channel of the Mississippi River and also just downstream of the Farnuf Boat Ramp,
- 3) Excessive sedimentation at the upstream protection wing / bank of the partial closure and the adjacent northern back channel leading to Bertom Lake,
- 4) Excessive scour at the entrance of rock habitat channel,
- 5) Bank erosion along left descending bank of the Mississippi River main channel below the partial closing structure,
- 6) Bank erosion and breach of the dike surrounding the perched wetland.

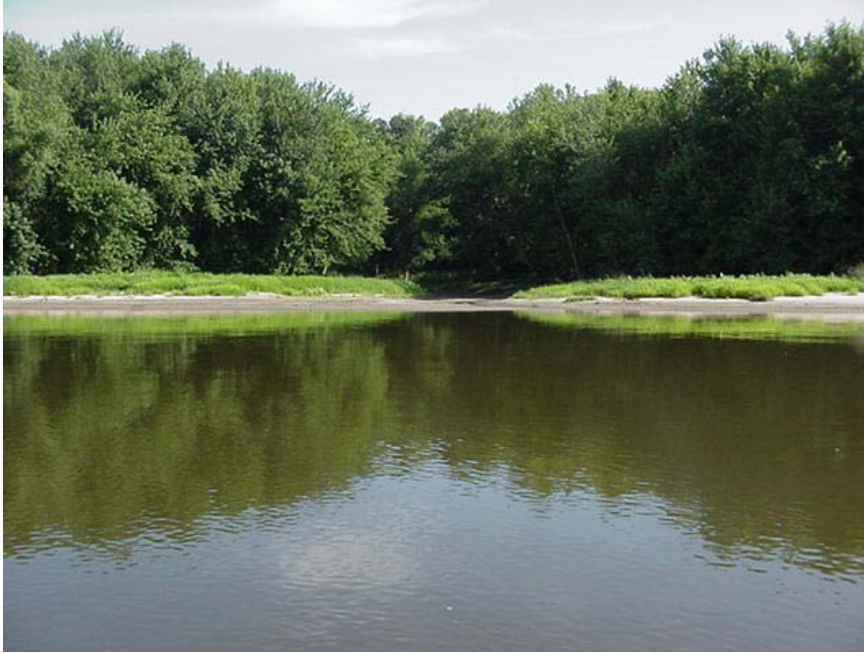
As noted in section 5.c., after the flood of 2001, the USFWS Site Manger and representatives from the Corps inspected the project area to identify locations of physical damage that may have been the result of the 2001 flood. It was observed that a channel connecting the Mississippi River to the McCartney Lake had re-opened and deposited a substantial amount of sediment into McCartney Lake habitat area (See Figures 5-19, 5-20, and 5-21).

Figure 5 - 19. Re-opened channel from Mississippi River to McCartney Lake habitat area, dated 14 August 2001.

(2) Conclusions. As stated in previous sections, details of proposed actions in light of the joint inspection results require further feature assessment and a follow-up discussion with the project sponsors. The results of this discussion will be provided in the next post-construction performance evaluation report.

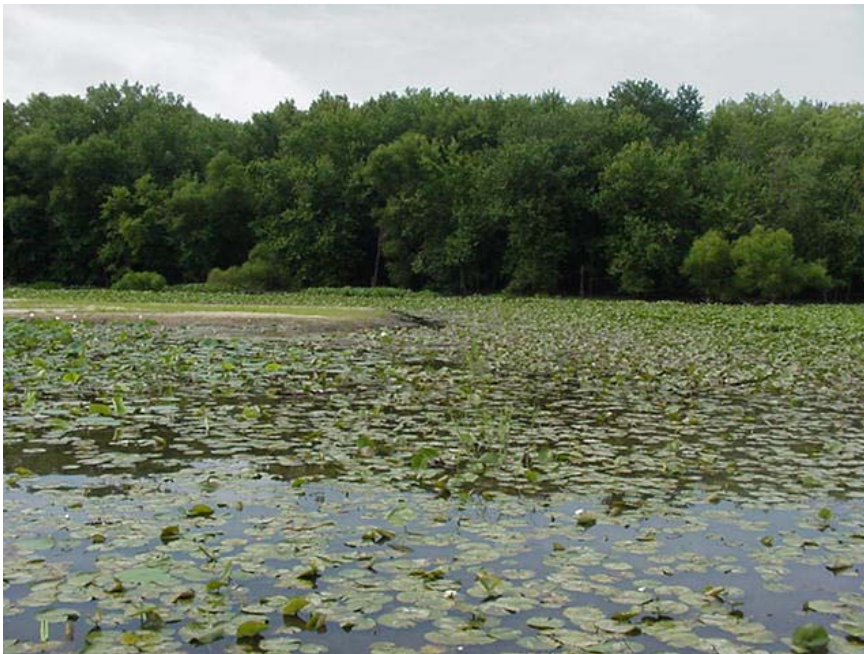
Figure 5 - 20. Edge of sediment deposits left in McCartney Lake habitat areas by the re-opened channel from Mississippi River, dated 14 August 2001.

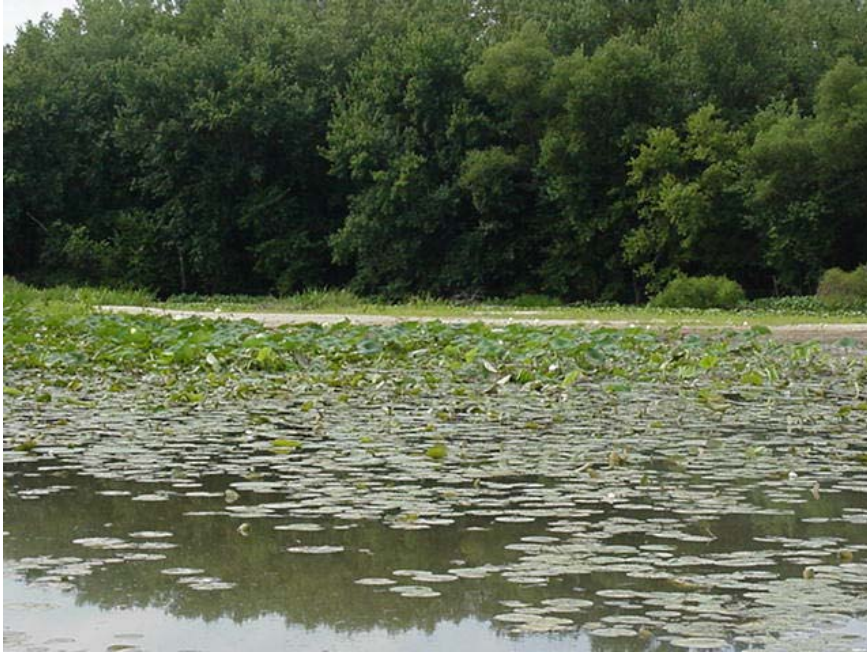
Figure 5 - 21. Line of sediment deposits left in McCartney Lake habitat area by the re-opened channel to the Mississippi River, dated 14 August 2001.

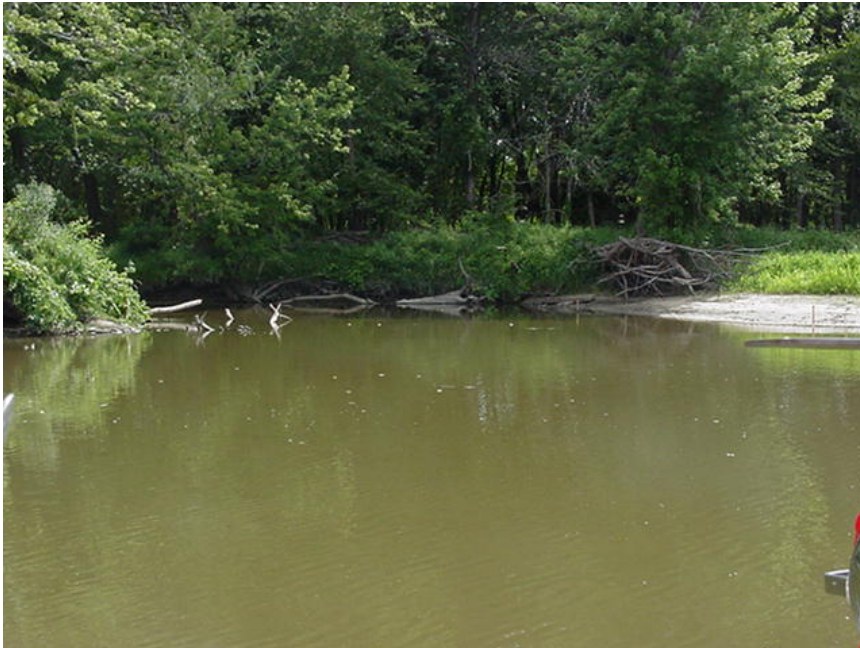
Additionally, the channel below the Bertom Lake Boat Ramp that had previously been noted for enlarging also was subjected to excessive sedimentation (See Figure 5-22). The channel was resurveyed on 14 August 2001 and the results were plotted against the previous survey completed on 26 September 2000 and 18 November 2000 (See Appendix G, Plates 10 and 11). The typical sections of the left descending bankline below the Bertom Lake Boat Ramp and the mouth of the enlarged channel showed changes due to the sedimentation, but the bankline's profile showed very little change. The thalweg survey of the enlarged channel also did not show very much change in elevation with the predominant sedimentation noted only at the channel's entrance.

Figure 5 - 22. Excessive sedimentation at the entrance of a channel that has been a concern due to its enlarging and is located immediately downstream of the Farnuf boat ramp, dated 14 August 2001.

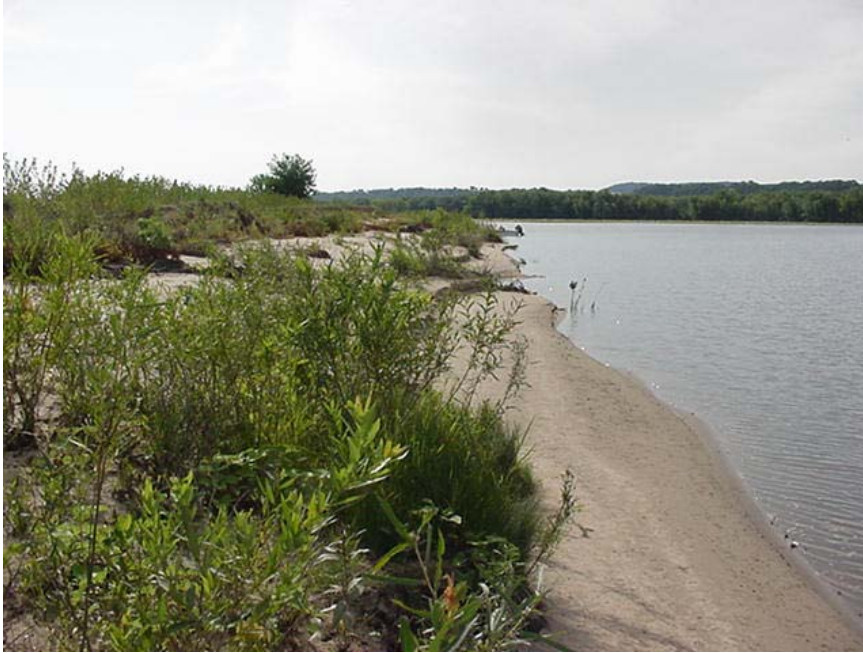
Figure 5 - 23. Bank erosion of berm surrounding perched wetland, dated 14 August 2001.

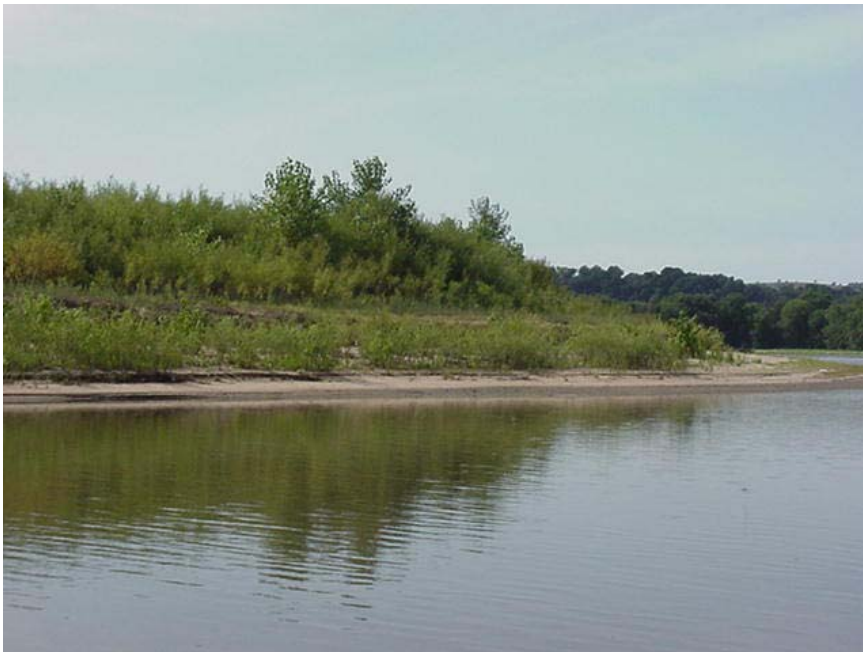
Figure 5 - 24. Bank erosion of berm surrounding perched wetland, dated 14 August 2001.

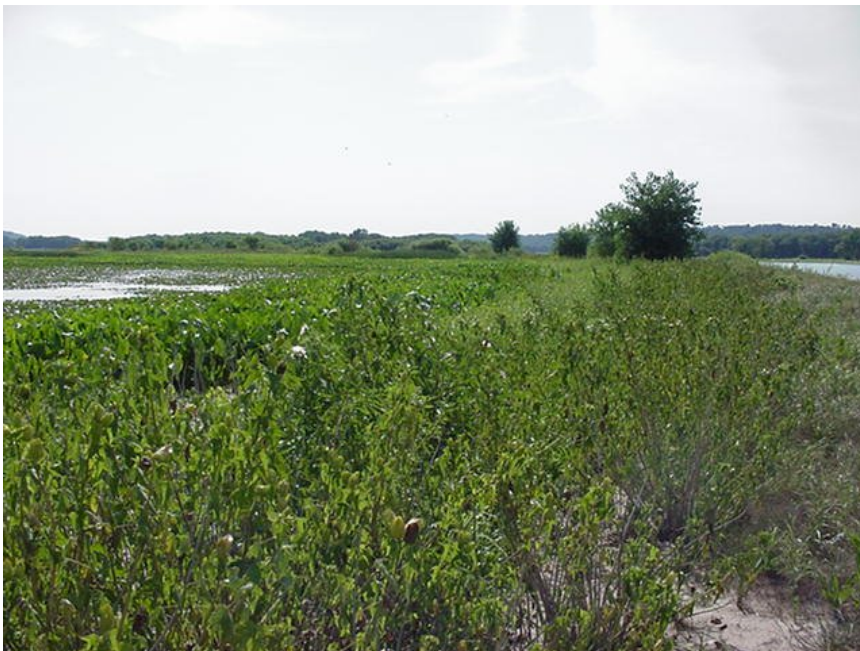
The establishment of a vegetative bed within the perched wetland is considered voluntary. “The vegetation on the berm was seeded but the remaining area has come back naturally. The aquatic vegetation within the perched wetland is some of the best on the Refuge and is attributed to the initial rich seed bank and stable clear water (see Figure 6-1).

Figure 6 - 1. Abundant aquatic vegetation within the perched wetland, dated 14 August 2001.

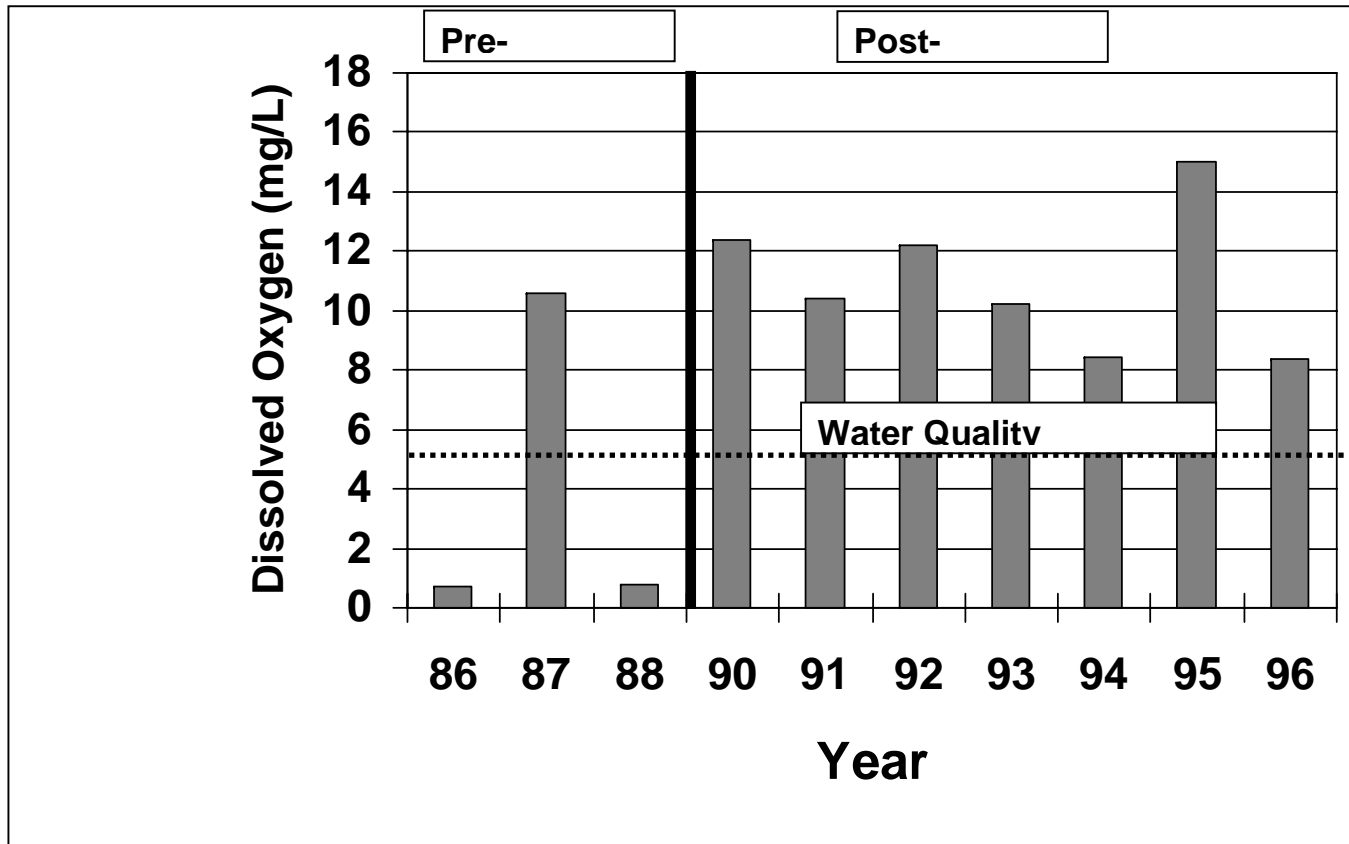
Figure D1-1. Onalaska - Average surface dissolved oxygen for sites 4 & 5 combined, during late January and February

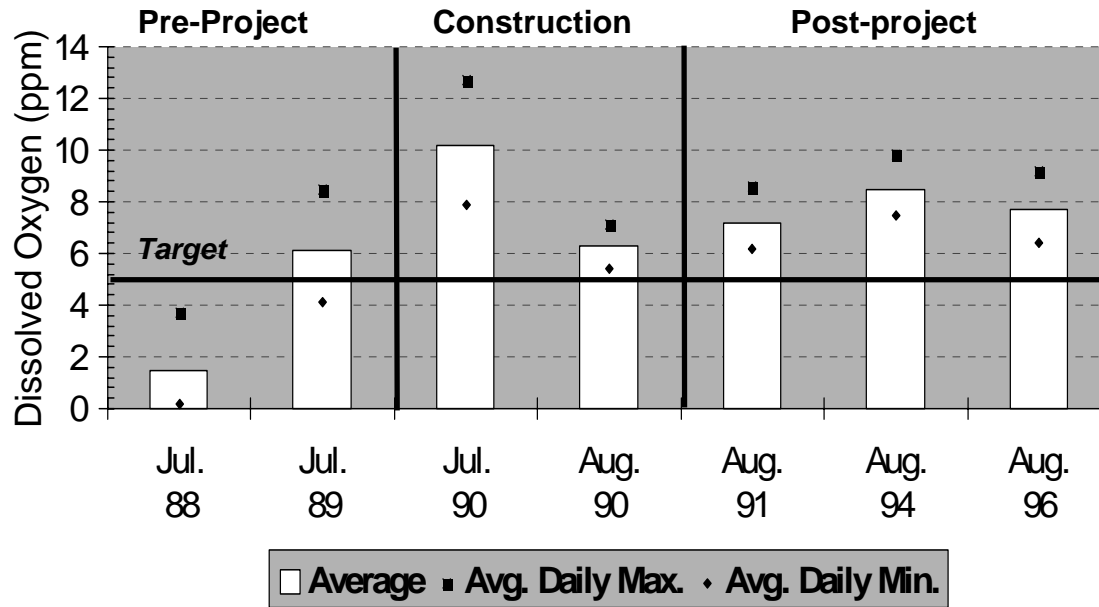
Figure D1-3. Pre- and Post-Project Continuous Water Quality Monitoring,
During summer at “The Rock”
