**UPPER MISSISSIPPI RIVER RESTORATION  
ENVIRONMENTAL MANAGEMENT PROGRAM  
POST-CONSTRUCTION  
PERFORMANCE EVALUATION REPORT  
2013  
FOR  
BIG TIMBER REFUGE  
HABITAT REHABILITATION AND ENHANCEMENT PROJECT**

**POOL 17  
RIVER MILES 443.5 – 445.0  
LOUISA COUNTY, IOWA**

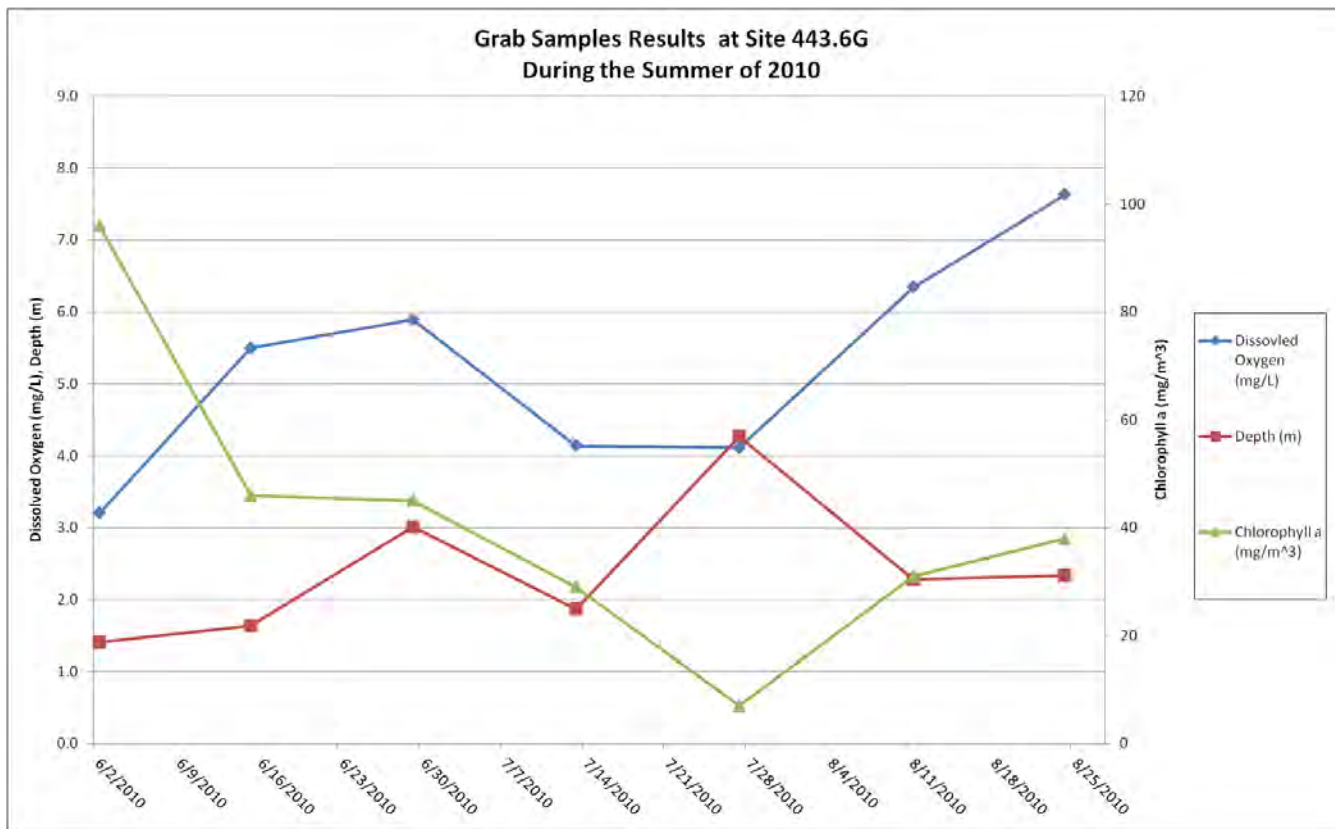
The pre-construction average DO concentration for site W-M443.6G was 10.5 mg/L, which only represents the summer sampling season since no winter sampling was performed. Pre-construction DO concentrations ranged from 0.6 mg/L to 19.7 mg/L, with 2 grab samples below the target DO value of 5.0 mg/L. During the current monitoring period of May 31<sup>st</sup> 2006 to September 8<sup>th</sup> 2010, the average DO concentrations at site W-M443.6G were 7.5 mg/L during the summer and 13.0 mg/L during the winter sampling season. Additionally, 4 of the 31 summer sampling results were below the DO target and 1 of 6 winter sampling events yielded a concentration below 5.0 mg/L. There are limited results from in-situ continuous monitoring to confirm or further investigate some of the low DO events. Typically, summer DO concentrations fluctuate daily, with daytime highs commonly above the 5.0 mg/L target and nighttime lows typically below the target. Photosynthetic activity primarily accounts for these diurnal fluctuations. Due to the fact that low DO concentrations were measured via grab samples at both sites on July 13<sup>th</sup> and 27<sup>th</sup> of 2010 and by examining continuous monitoring data for that period. Low algal counts and high suspended sediment due to continued high water during the summer of 2010 are likely contributing factors that led to this low DO event that lasted the whole 2 weeks (See graphs 1 and 2 on the following page).

Graph 1 shows DO, depth, and chlorophyll a at site 443.6G from 02 June 2010 to 24 August 2010.

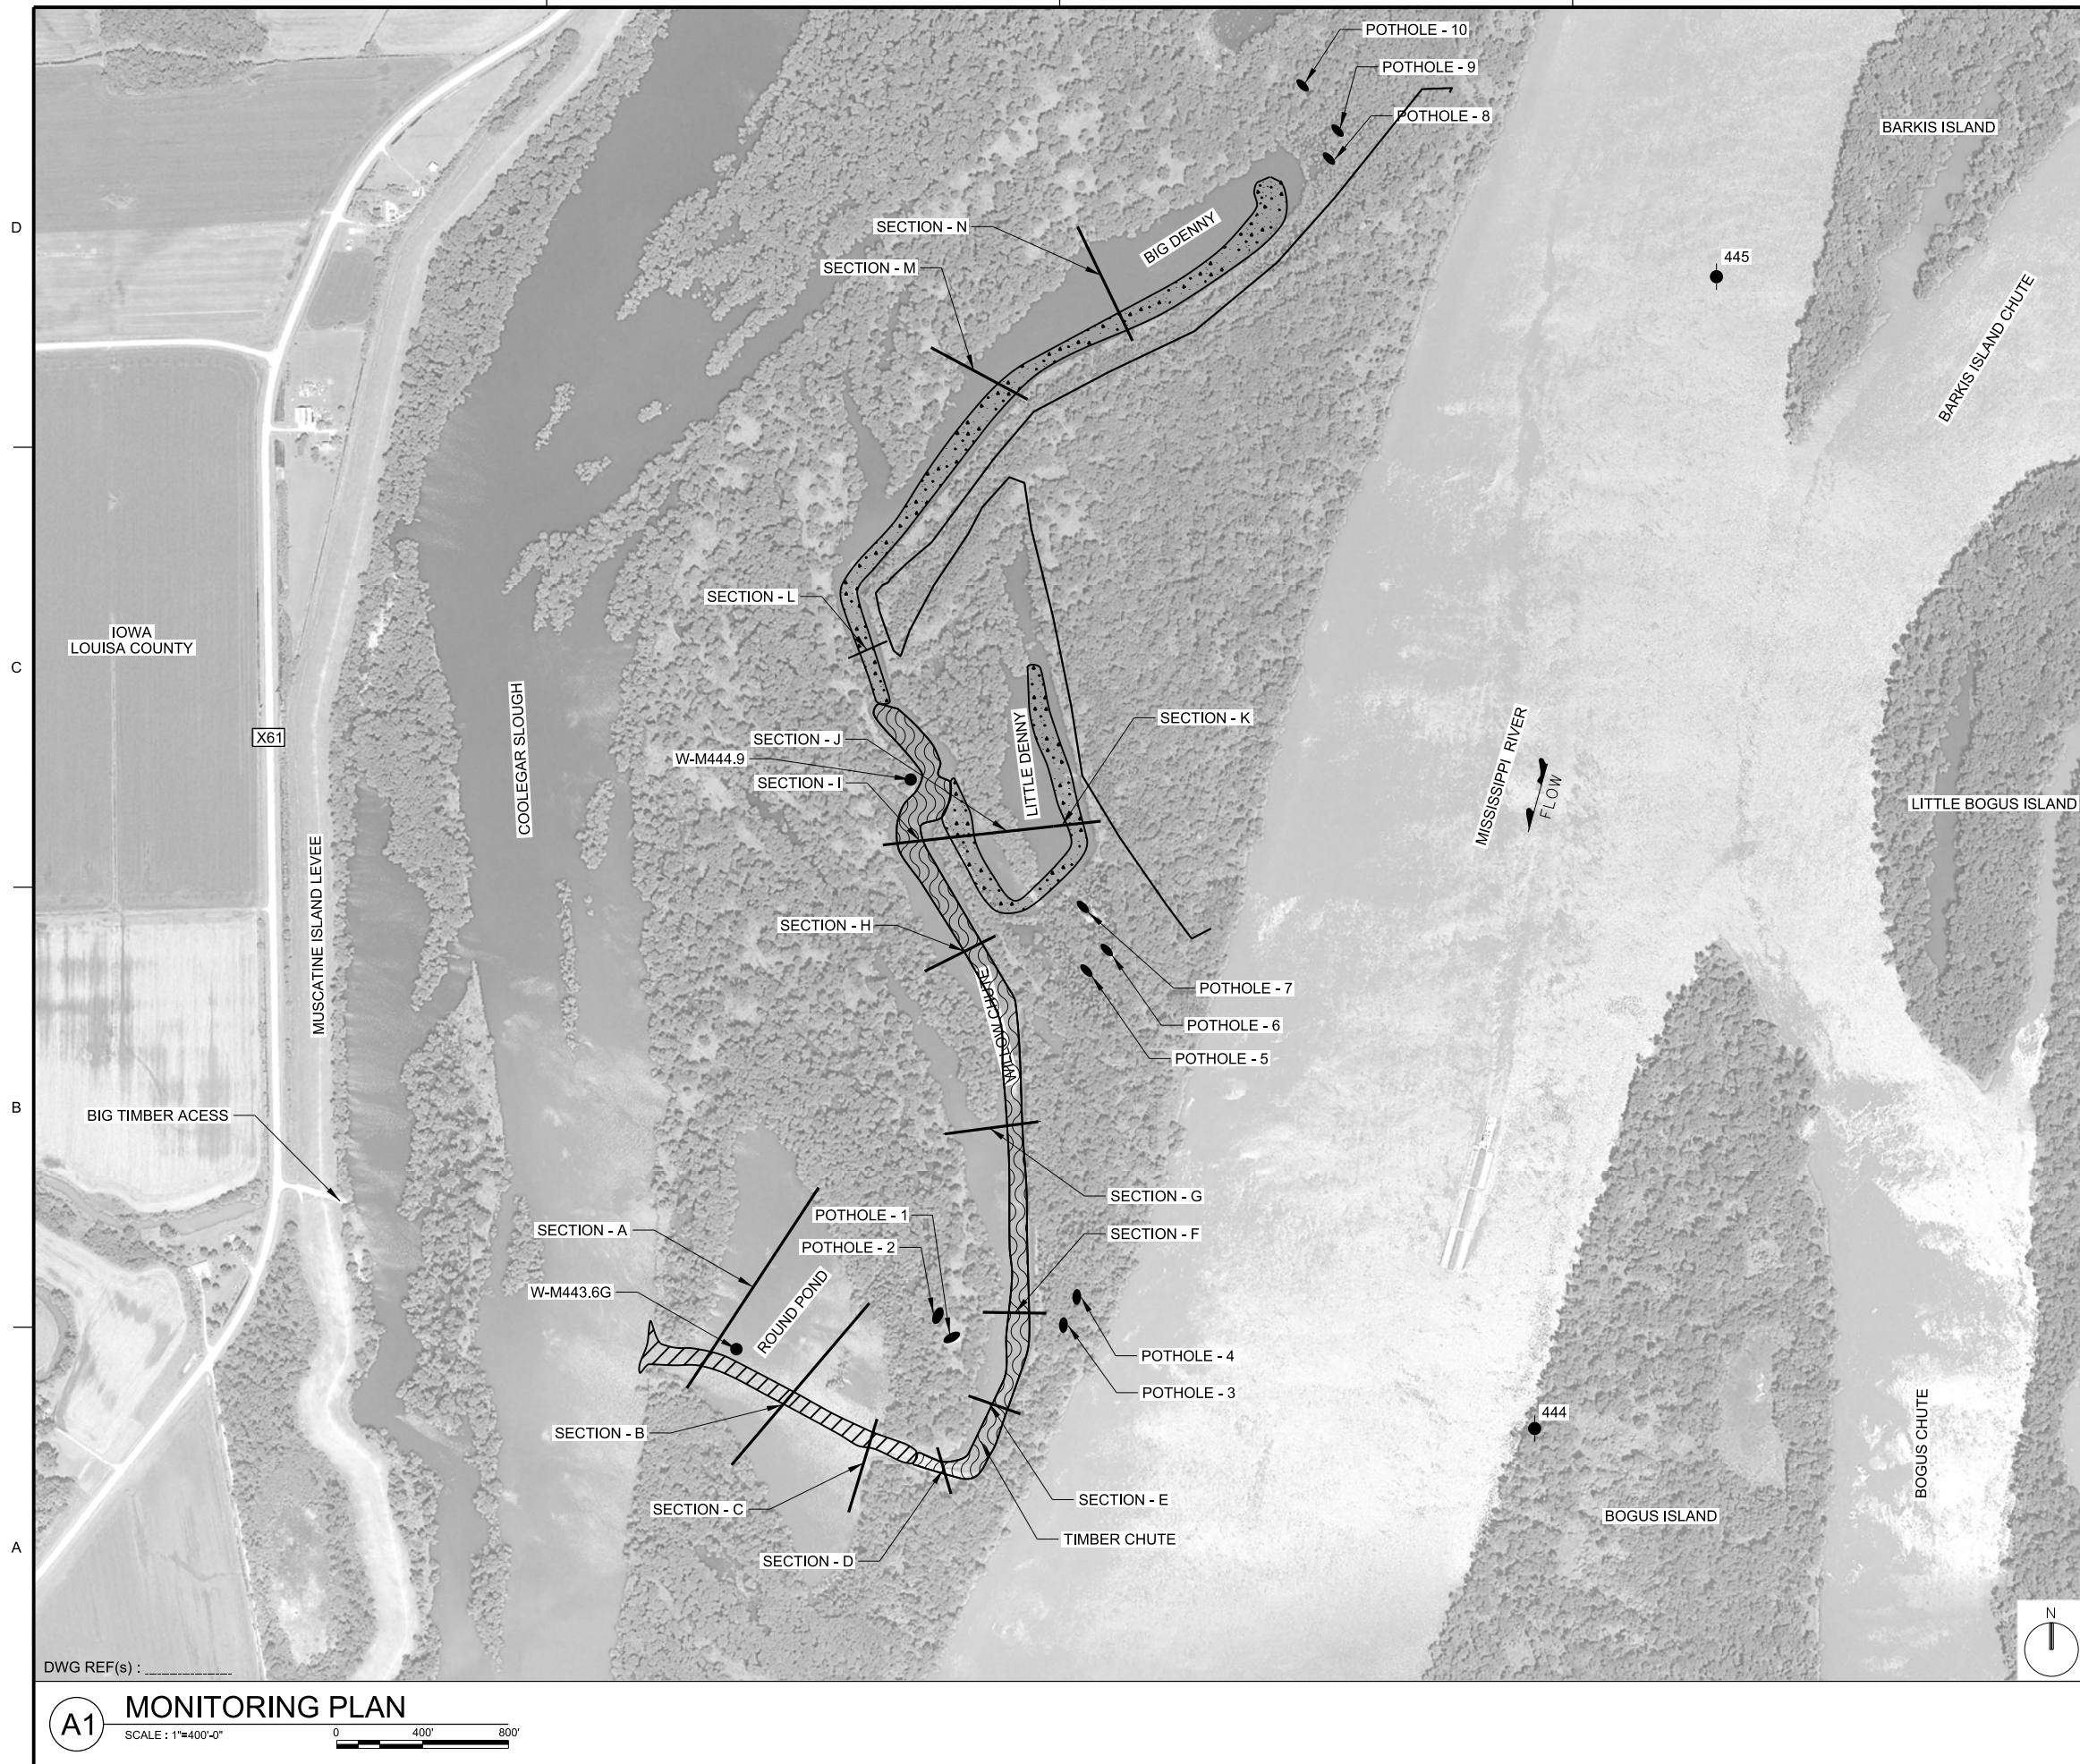
- MAST TREES PLANTED ON CONTAINMENT DIKE.
- DATE OF AERIAL PHOTOGRAPHY 2010
