**BIG TIMBER REFUGE  
HABITAT REHABILITATION  
AND ENHANCEMENT PROJECT**

**POST-CONSTRUCTION PERFORMANCE  
EVALUATION REPORT – YEAR 15 (2006)**

**US Army Corps  
of Engineers**  
Rock Island District

**POOL 17  
MISSISSIPPI RIVER MILES 443.5 – 445.0  
LOUISA COUNTY, IOWA**

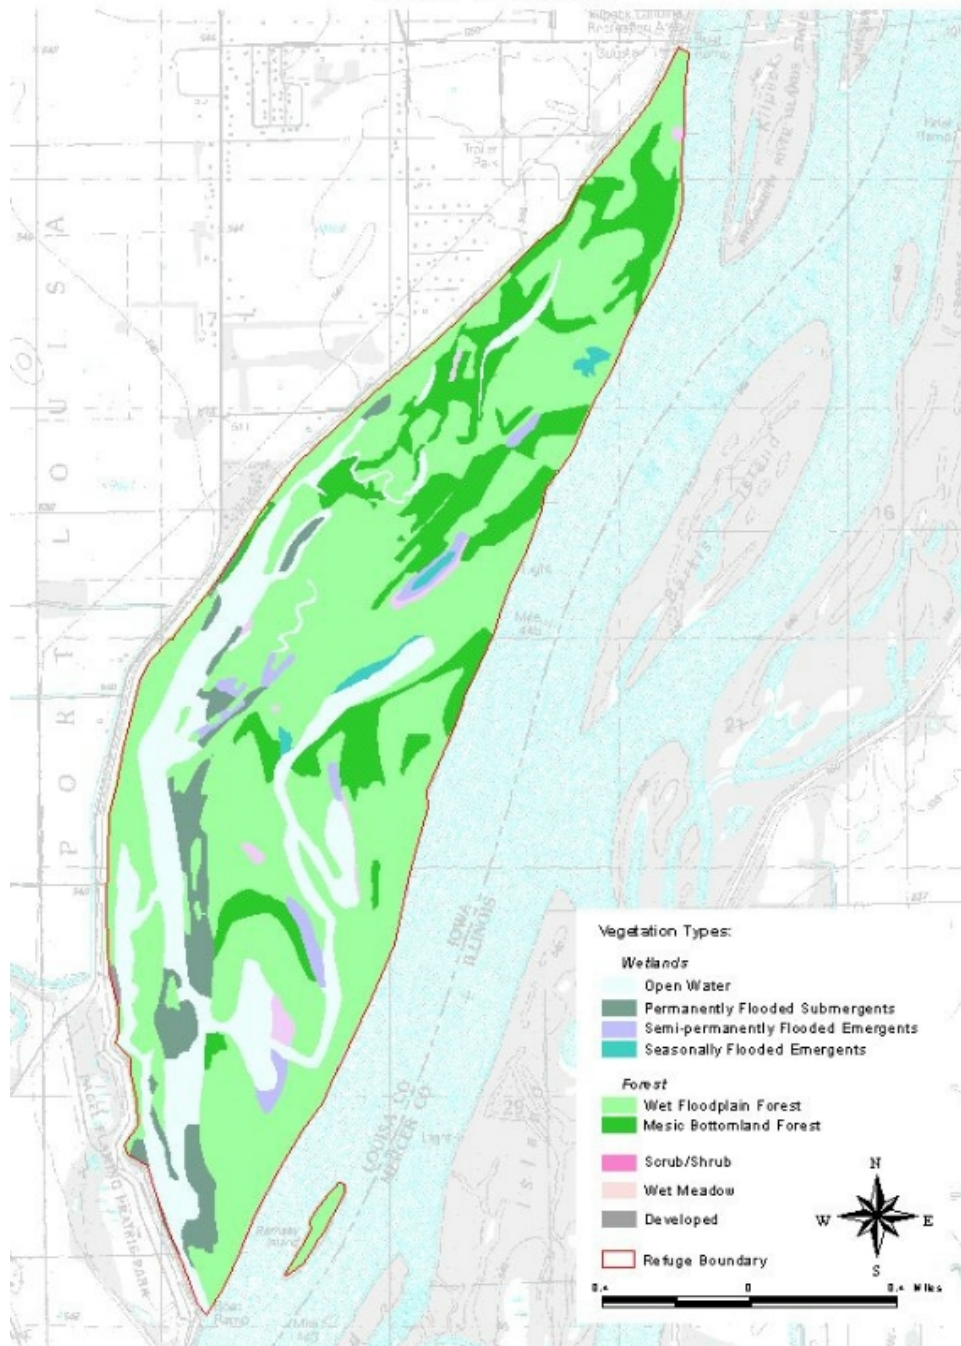
FIGURE 6-1

Port Louisa NWR  
**Upper Big Timber Division**  
2000 Land Cover

(2) Conclusions. It appears that the Big Timber HREP is meeting the objective of providing mast tree dominated areas. The 2000 land cover map illustrated that the majority of the Upper Big Timber Division is wet floodplain forest, with mesic bottomland forest, or mast trees, next in abundance. These forest types are also illustrated in the aerial photos provided by the USFWS (see Figures 6-2 and 6-3). The areas of mesic bottomland forest within the Big Timber HREP are adjacent to Round Pond, near Willow Chute and Little Denny, and to either side of Big Denny. The largest area of mesic bottomland forest lies east of Big Denny and extends to the Mississippi River. The USFWS reports declining quality and composition of the stands but the next land cover map will not be produced for the area until 2010.

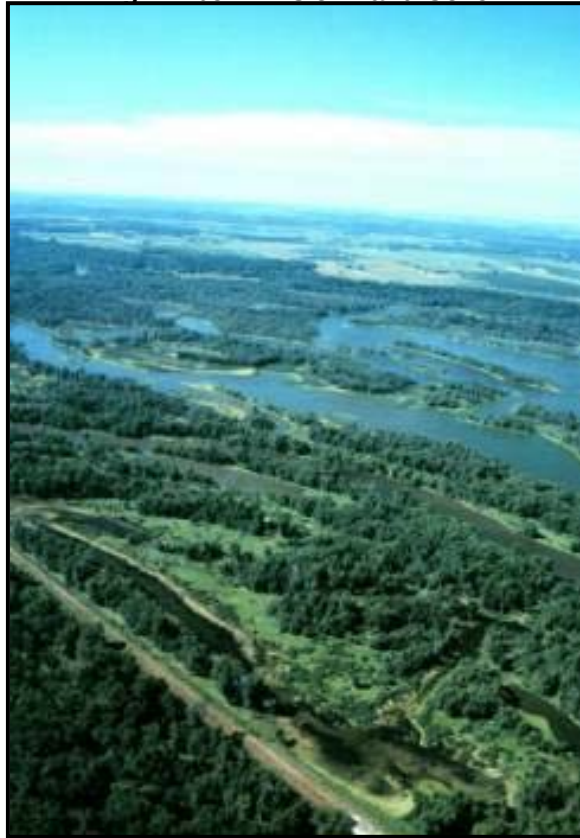
**FIGURE 6-2**  
**Big Timber Division Land Cover**

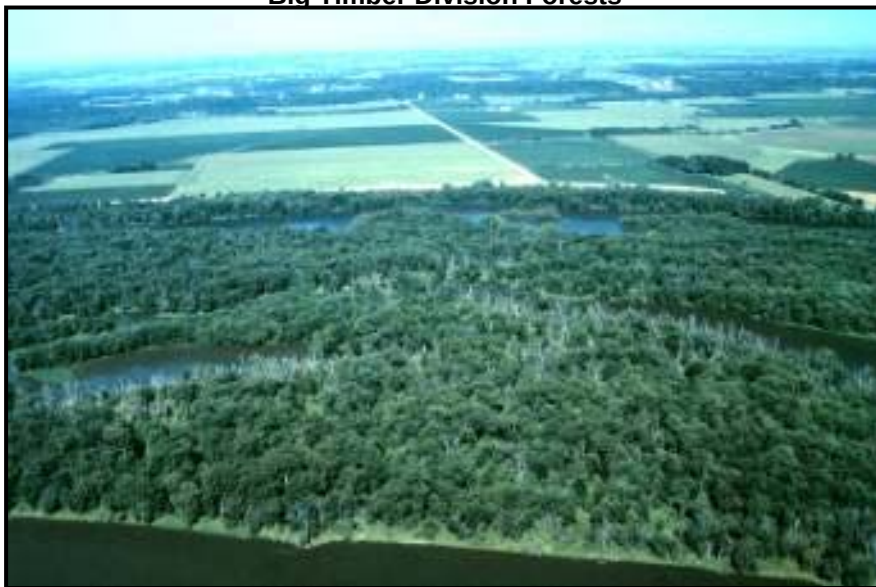
**FIGURE 6-3**  
**Big Timber Division Forests**

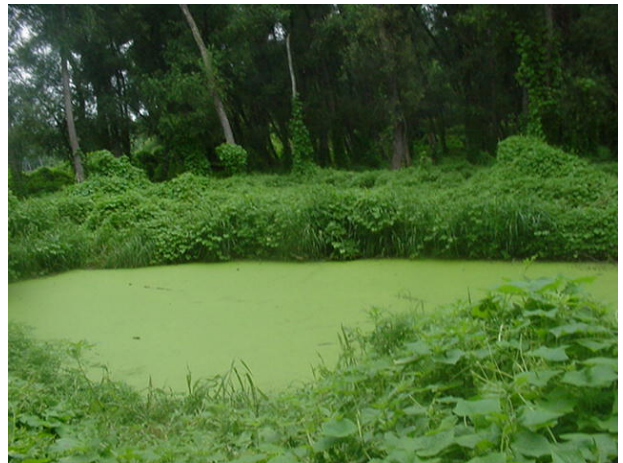
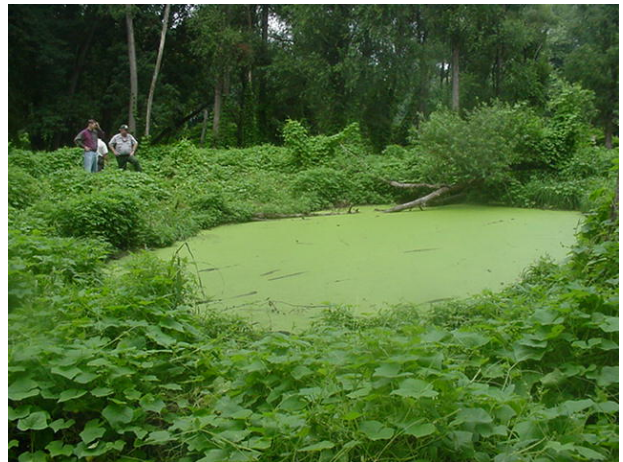
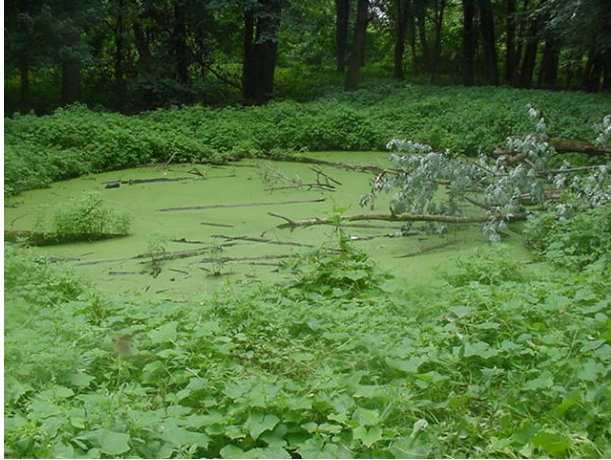
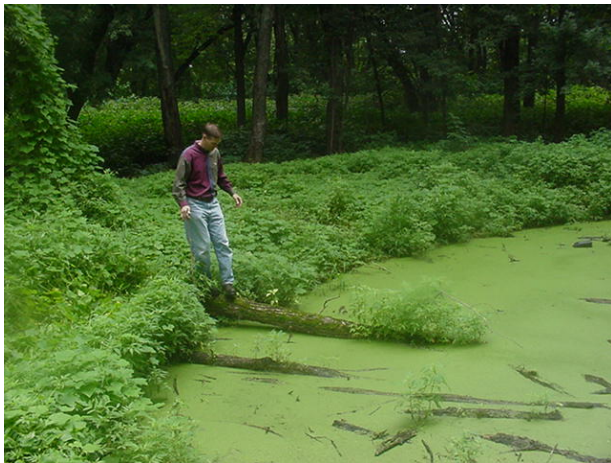
- d. Check Dam: The check dam remains in good condition and is continuing to serve its function of reducing boat access to Little Denny Lake.
- e. Pothole Creation: The potholes have filled in with some sediment, and the slopes have flattened out to a stable slope. There has not been very much waterfowl use of the potholes, possibly because they are not large enough, are too close to trees, or do not have adequate depth of water during the appropriate waterfowl migration seasons.

**Photo 17 Pothole NE End of Big Denny**

**Photo 18 Pothole NE End of Big Denny**

**Photo 19 Pothole NE End of Big Denny**

**Photo 20 Pothole NE End of Big Denny**

According to USFWS reports, the potholes are not being utilized by waterfowl. They report that they do provide excellent habitat for amphibians but the use by waterfowl is limited by inadequate size and depth. The pothole's small size, steep slopes, and surrounding forest make for excellent opportunities for predators. The USFWS staff has recommended future potholes be a minimum of 2 acres and constructed using bulldozers to eliminate steep slopes.
