**UPPER MISSISSIPPI RIVER RESTORATION
ENVIRONMENTAL MANAGEMENT PROGRAM
POST-CONSTRUCTION
INITIAL PERFORMANCE EVALUATION REPORT
2012
FOR
COTTONWOOD ISLAND
HABITAT REHABILITATION AND ENHANCEMENT PROJECT**

**US Army Corps
of Engineers**
St. Louis District

Pool 21

River Mile 328.5 – 331.0

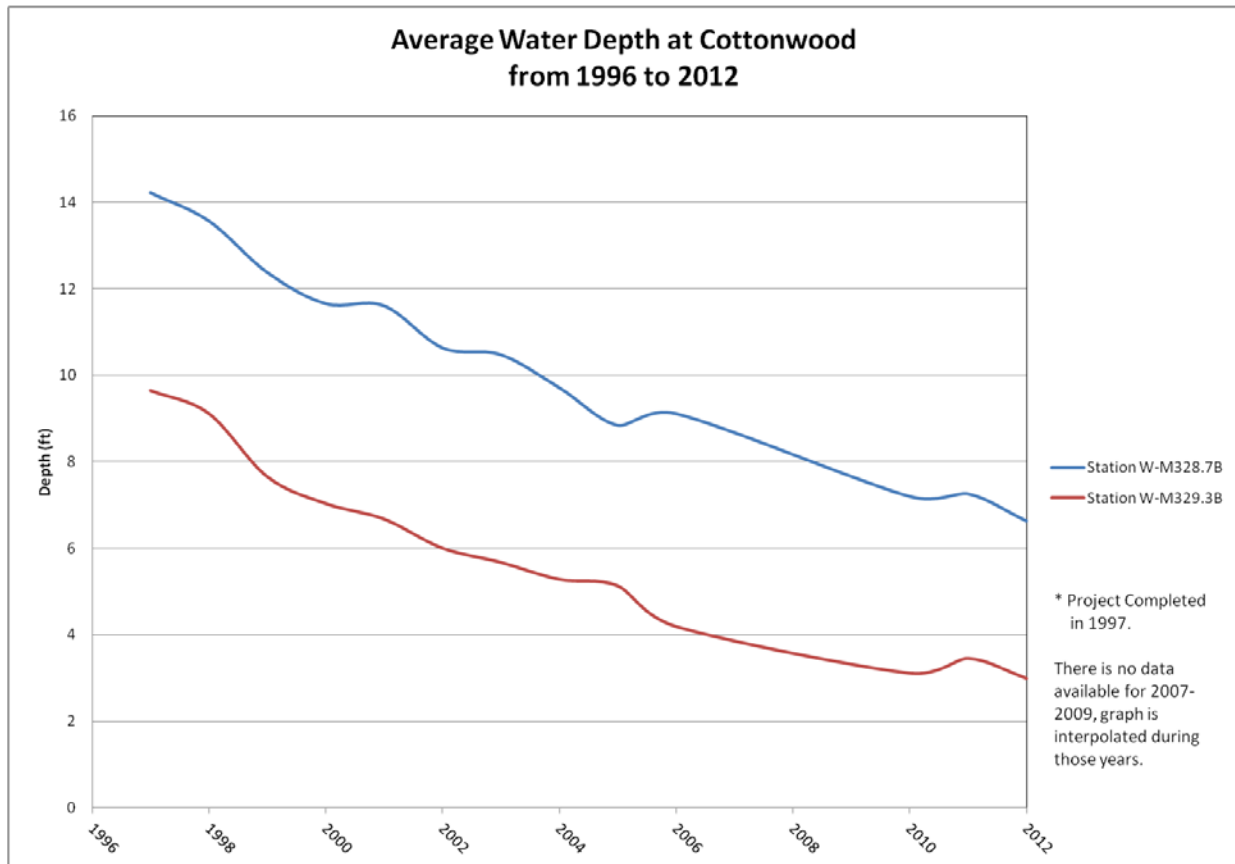
Pool depths values are shown in feet. There are no depth values for 2007 to 2009 due to lack of data, as no water quality monitoring was performed during that time frame.

The steady decline in water depths at both stations is indicative of sedimentation in the dredge channel. The average annual sedimentation rate from 1997 to 2005, the previous monitoring period, was 8.04 in/yr at site W-M328.7B and 6.72 in/yr at site W-M329.3B. During the most recent sampling period, the estimated average sedimentation rate dropped to 6.19 in/yr for site W-M328.7B and 5.84 in/yr at site W-M329.3B. Although the sedimentation rate has decreased over the past two years, these rates are still considerably higher than the estimated sedimentation rates from the 1996 US Army Corps of Engineers DPR of 0.11 in/yr at W-M328.7B and 0.16 in/yr at site W-M329.3B.

Average water depth in feet at sites W-M328.7B and W-M329.3B of the Cottonwood project from years 1997 to 2006 and 2010 to 2012.

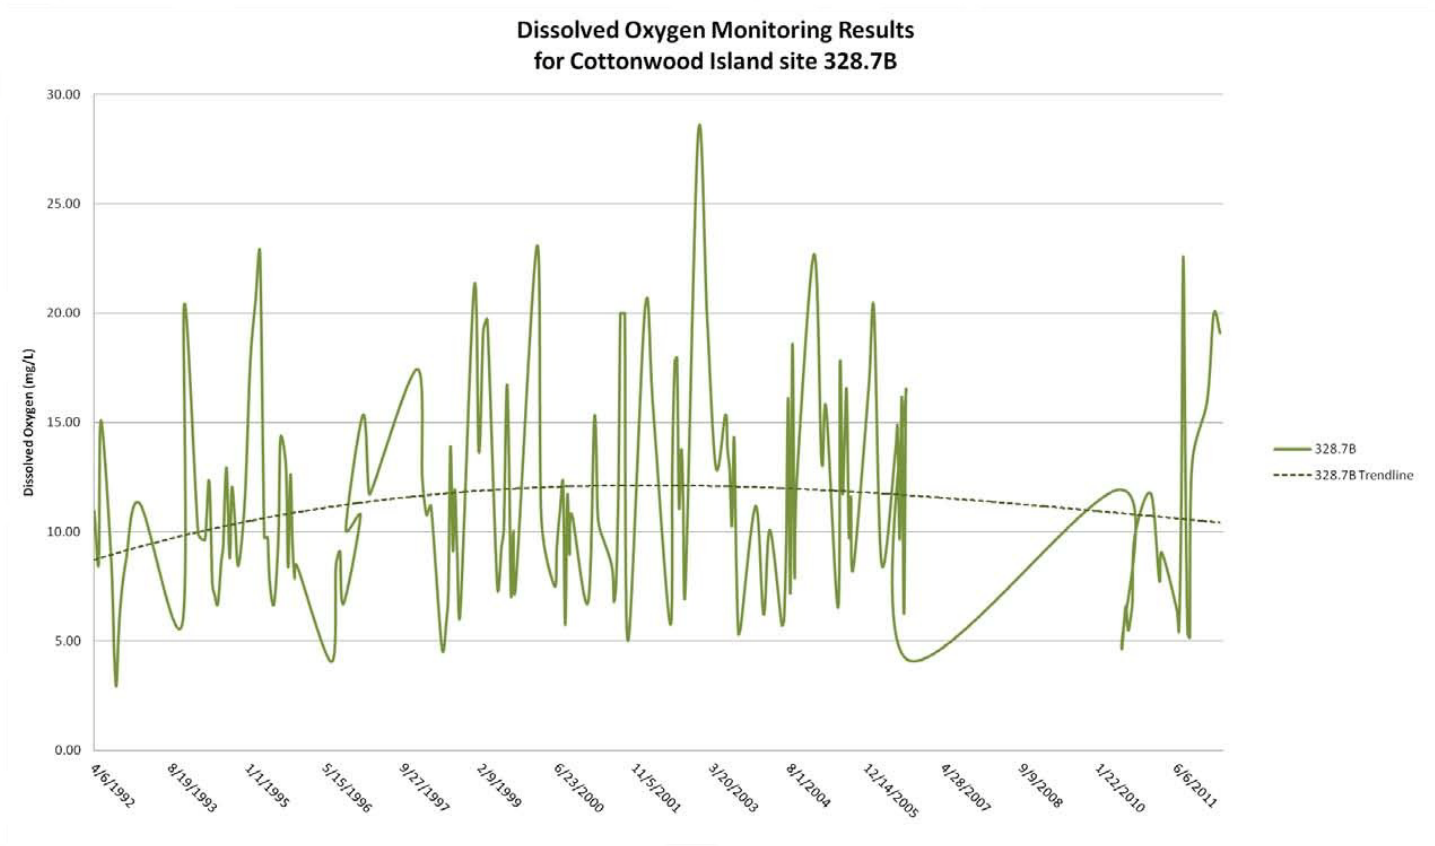
Graph 2 illustrates the dissolved oxygen concentrations (mg/L) at site 328.7B from 7 April 1992 to 13 March 2012. Due to the cyclical nature of EMP water quality monitoring, no data is available from 7 September 2006 to 2 June 2010.
