**UPPER MISSISSIPPI RIVER SYSTEM
ENVIRONMENTAL MANAGEMENT PROGRAM
POST-CONSTRUCTION PERFORMANCE
EVALUATION REPORT – YEAR 3 (2000)**

**COTTONWOOD ISLAND
HABITAT REHABILITATION
AND ENHANCEMENT**

JUNE 2001

**POOL 21
MISSISSIPPI RIVER MILES 328.5 – 331.0
LEWIS AND MARION COUNTIES, MISSOURI**

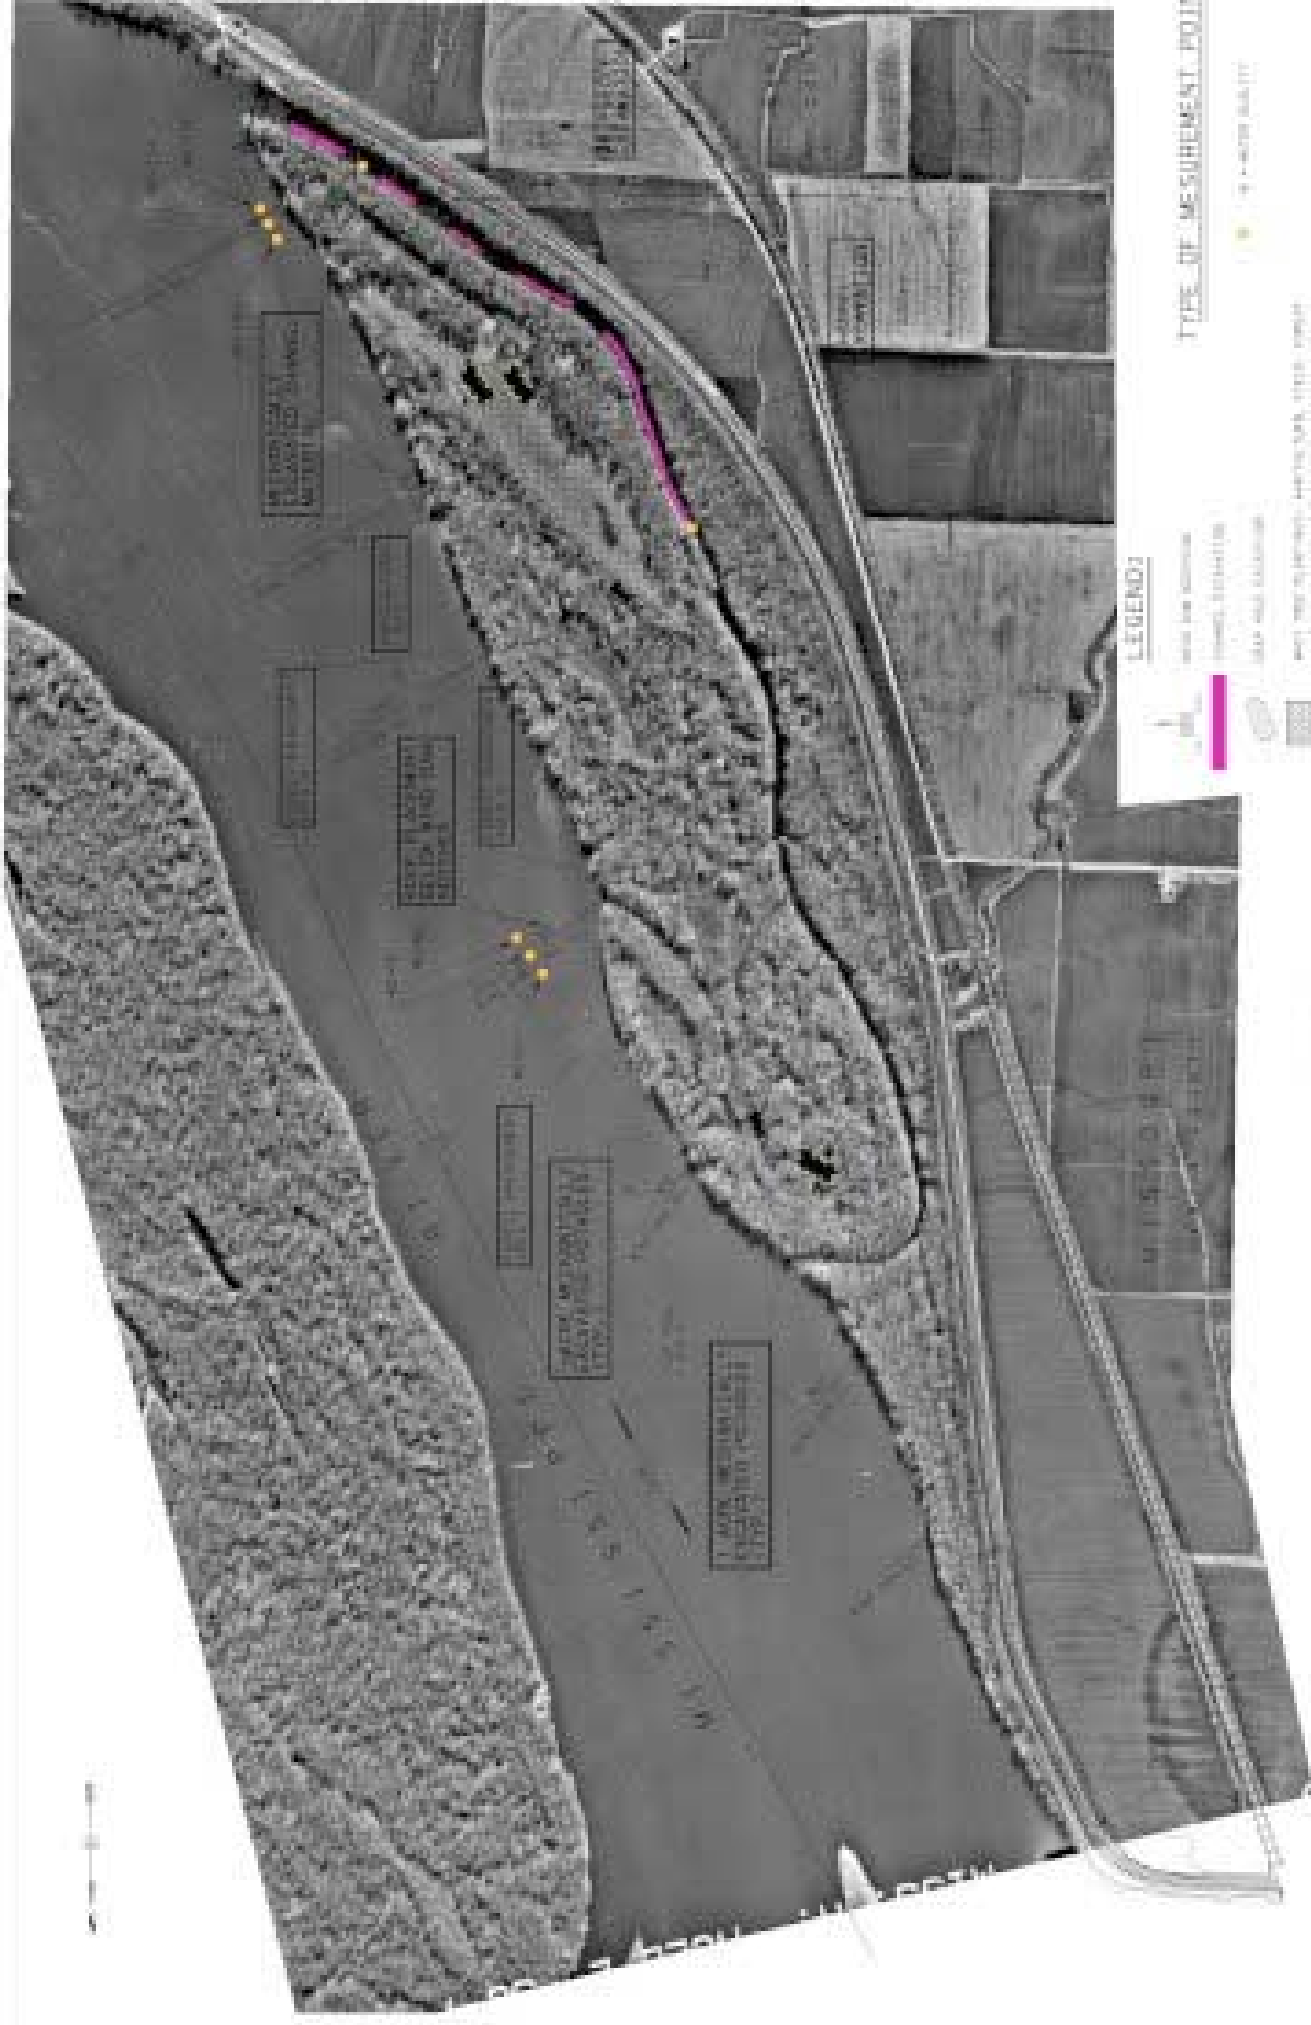
SITE PLAN

a. Project Features. The Cottonwood Island project consists of mechanically excavated side channel and deep holes to restore aquatic overwintering habitat, notched wing dams to restore main channel border habitat, and mechanically excavated potholes and planting mast trees to restore wetland habitat. Plate 2 in Appendix J contains the site plan for the Cottonwood Island project.
