## **POST-CONSTRUCTION 10-YEAR PERFORMANCE EVALUATION REPORT**

### **POOL 11 ISLANDS (MUD AND SUNFISH LAKES) HABITAT REHABILITATION AND ENHANCEMENT PROJECT**

**US Army Corps  
of Engineers** ®  
Rock Island District

**RIVER MILES 583.3-593.0**

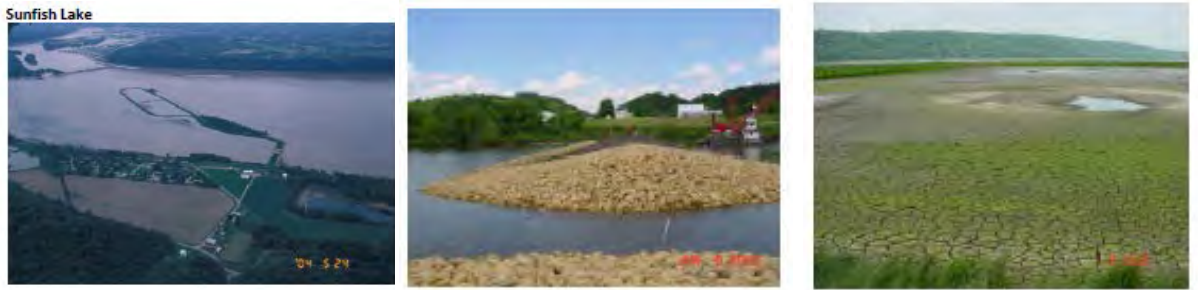
**Figure 2.** Sunfish Lake Aerial Photo At High Water (Left), the Inlet Notch (Center), and Inside the Confined Containment Facility Emergent Marsh During Low Water Condition (Right)

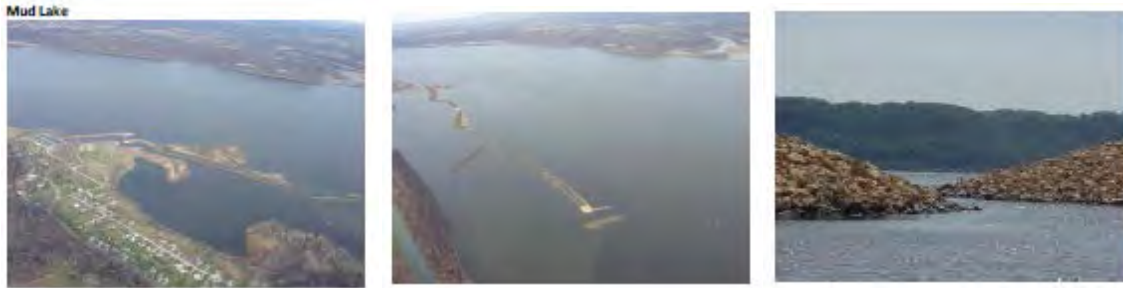
**Figure 3.** LEFT: Mud Lake Aerial Photo, CENTER: Mud Lake (Left), RIGHT: the Lower Part of the Project (Zollicoffer Slough), and Looking Toward The River Through A Notch.

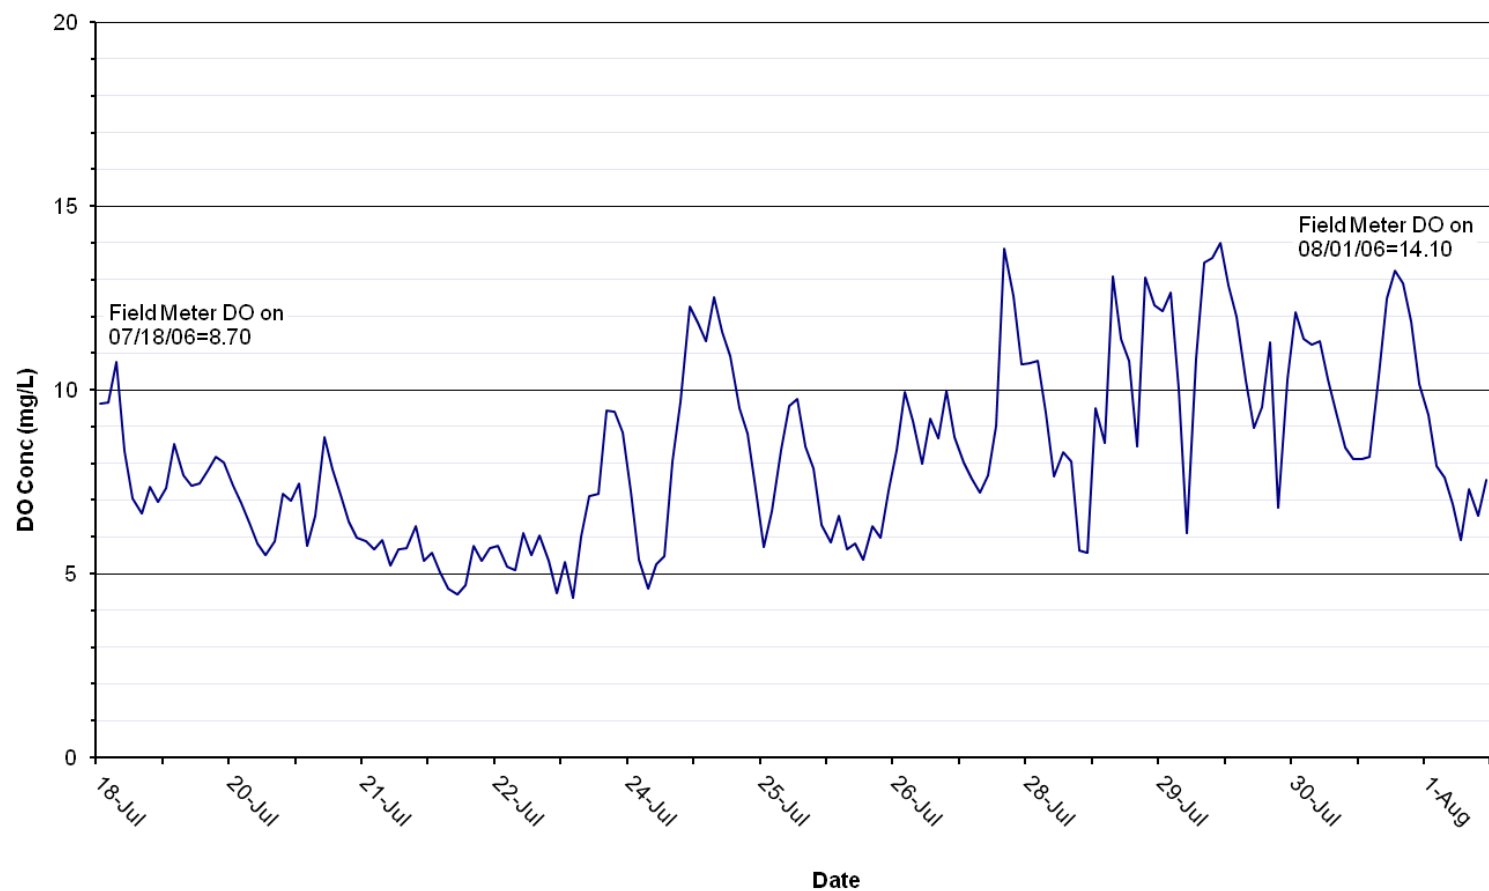
**Graph B-1** illustrates a typical summer continuous data monitoring session for dissolved oxygen at Mud Lake. Field DO concentration grab samples were gathered upon deployment and retrieval of the continuous monitoring sondes.

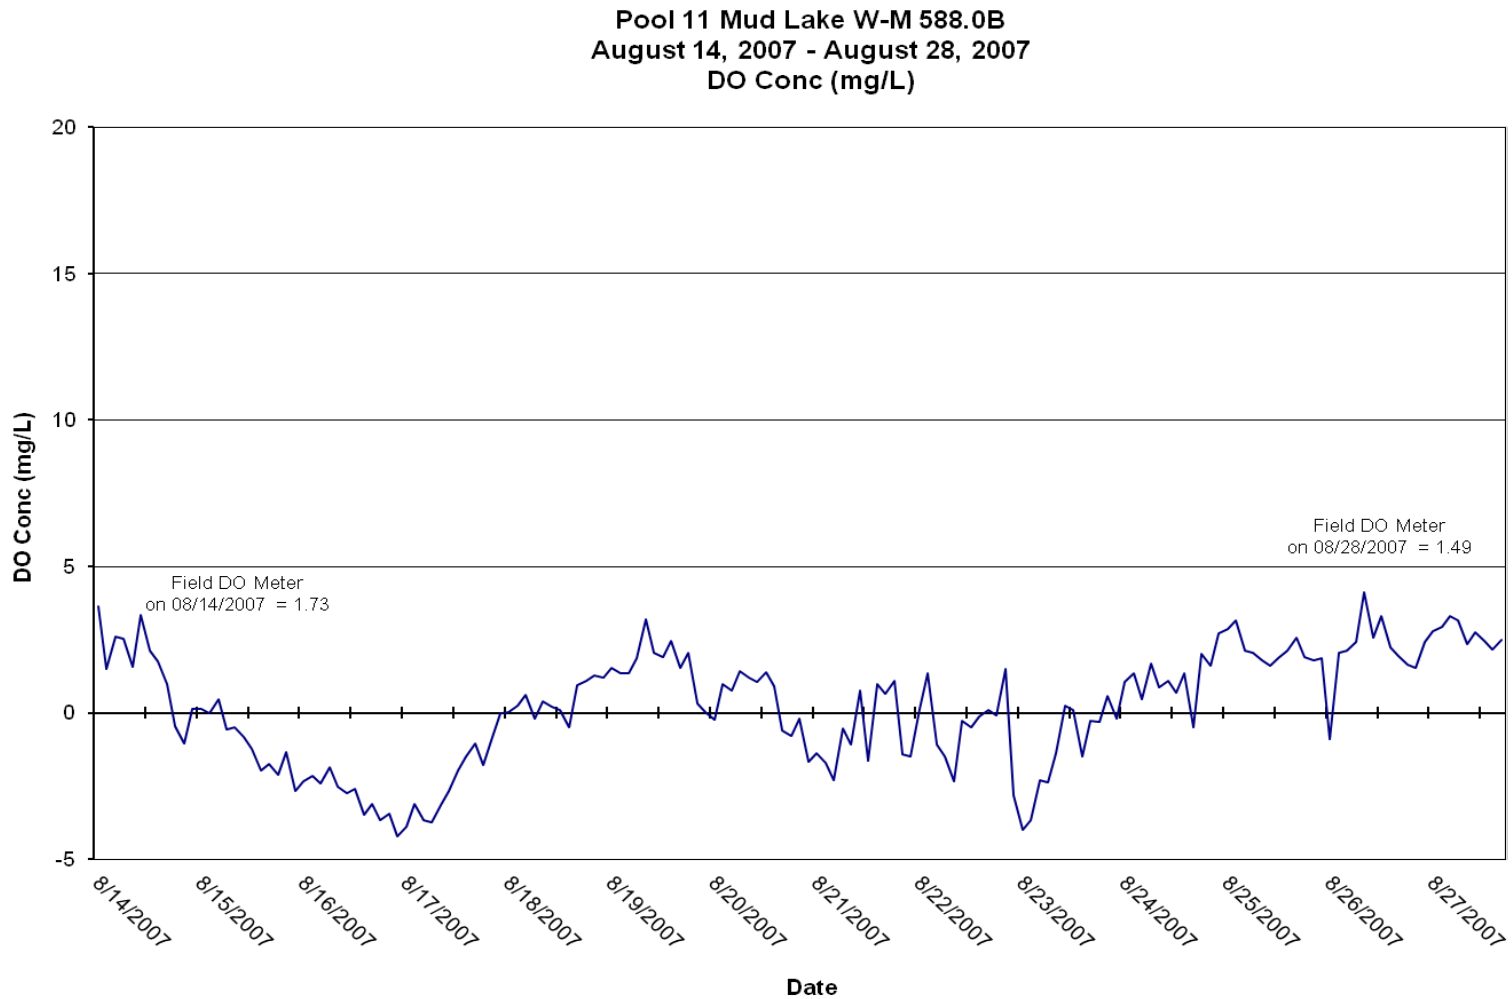
**Graph B-2** demonstrates a worst case scenario for low dissolved oxygen concentrations in Mud Lake. Field DO concentration grab samples were gathered upon deployment and retrieval of the continuous monitoring sondes. Values below 0 mg/L are not valid and should not be taken into consideration, but grab samples collected on August 14<sup>th</sup> and 28<sup>th</sup> provide credibility to the observed trend of continued low DO during the monitoring period.

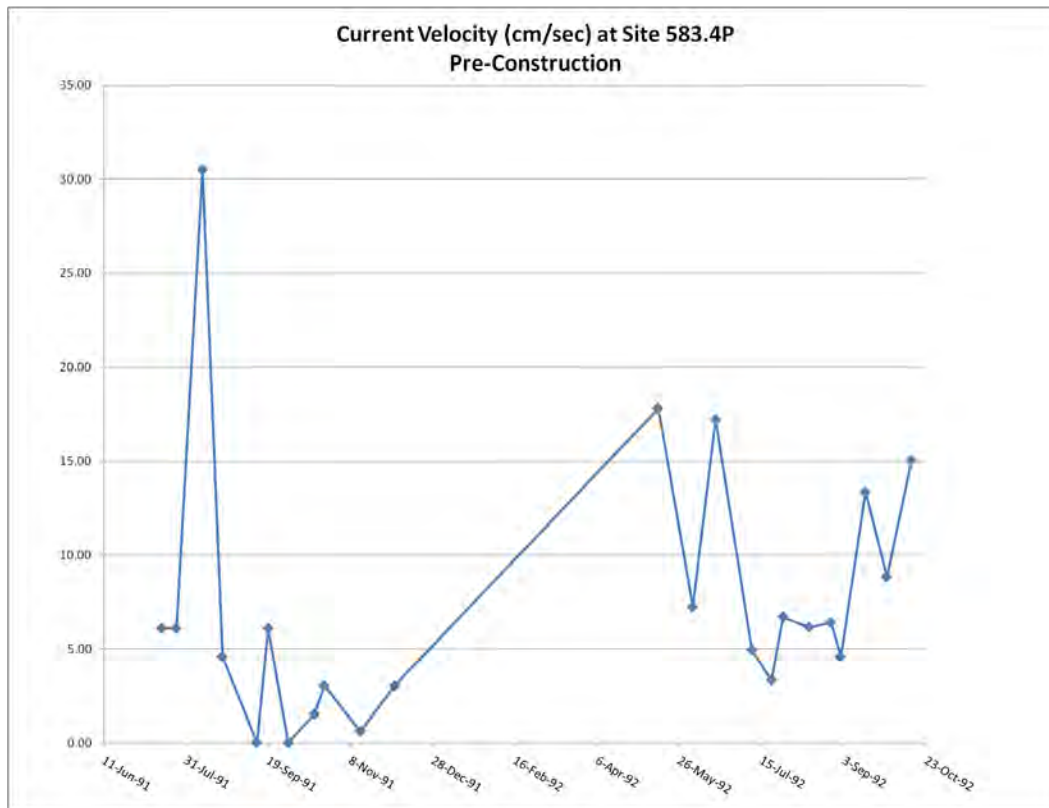
**Graph B-3** shows typical current velocities at Site 583.4P during 2 years of pre-construction monitoring.

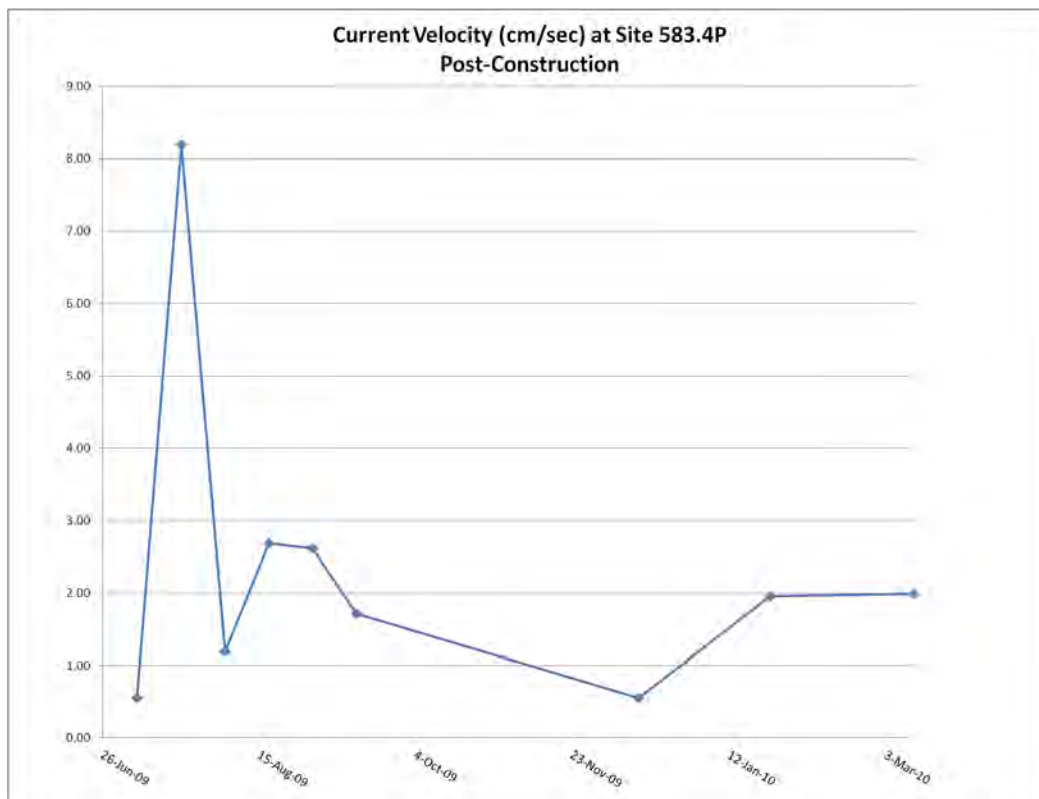
**Graph B-4** shows typical current velocities at Site 583.4P during a year following project construction.

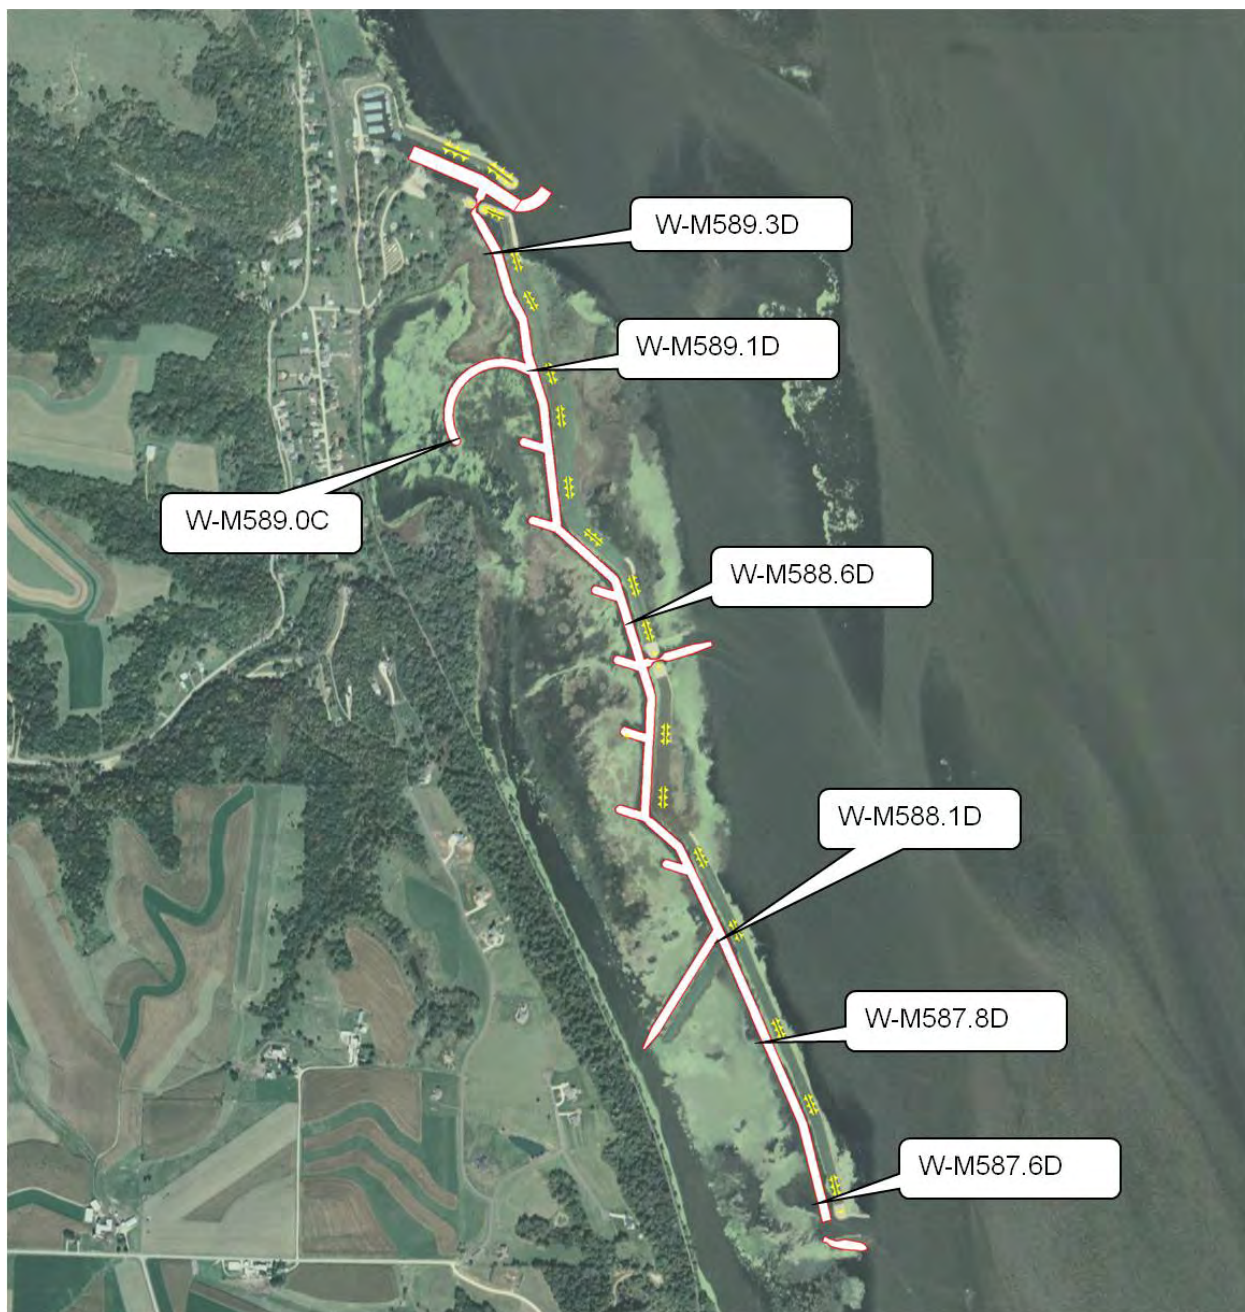
**Figure B-2-1.** Pool 11 Islands Temperature Monitoring Sites in Mud Lake

When comparing temperature values for the site between high spots in Mud Lake versus the Mud Lake off-main dredge channel site and the main channel site in Sunfish Lake that do not have high spots, it appears that being located off the main channel produced a more pronounced water column temperature stratification. The high spots produced only a minimal amount of desired effect, to provide a low area for warmer water to settle. This effect was only realized when river flows were not high. Yet at site 589.0C in Mud Lake, off the main dredge channel, average water temperatures remained warmer at increased depth, regardless of river stage. So, data would indicate that the more important factor in the presence of warmer winter water temperatures is the sites location relative to the main dredge channel and flow path, not the existence of high spots.

The above conclusion was confirmed during a follow up deployment that occurred December 19, 2013 to March 18, 2014. Monitoring was conducted between high spots in the southern end of the main dredged channel of Mud Lake at sites 587.8D and 587.6D. The results were similar to what was previously observed in the main channel sites in that there was little difference between the lower and upper temperature readings. These sites also experienced average temperatures much colder than the other deployments, indicating the likelihood of fresh cold water from the Mississippi River main channel was entering the project area from this location.

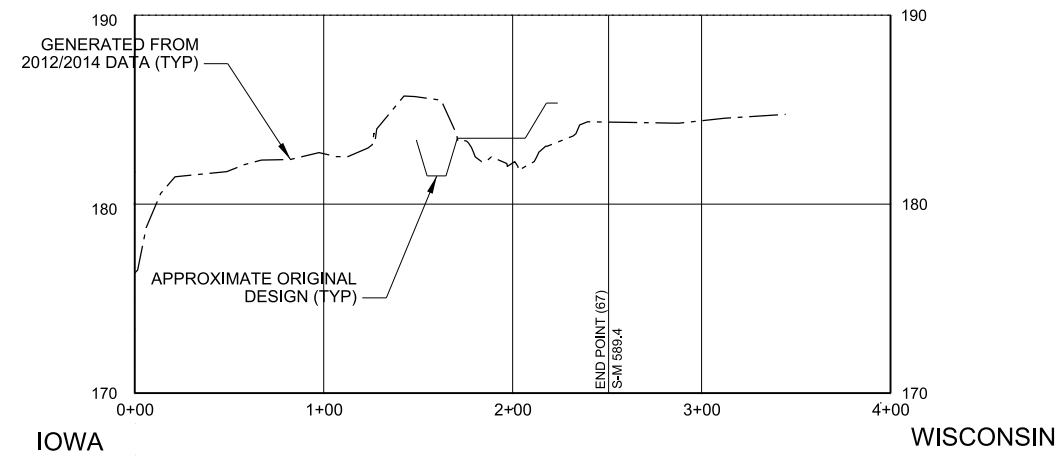
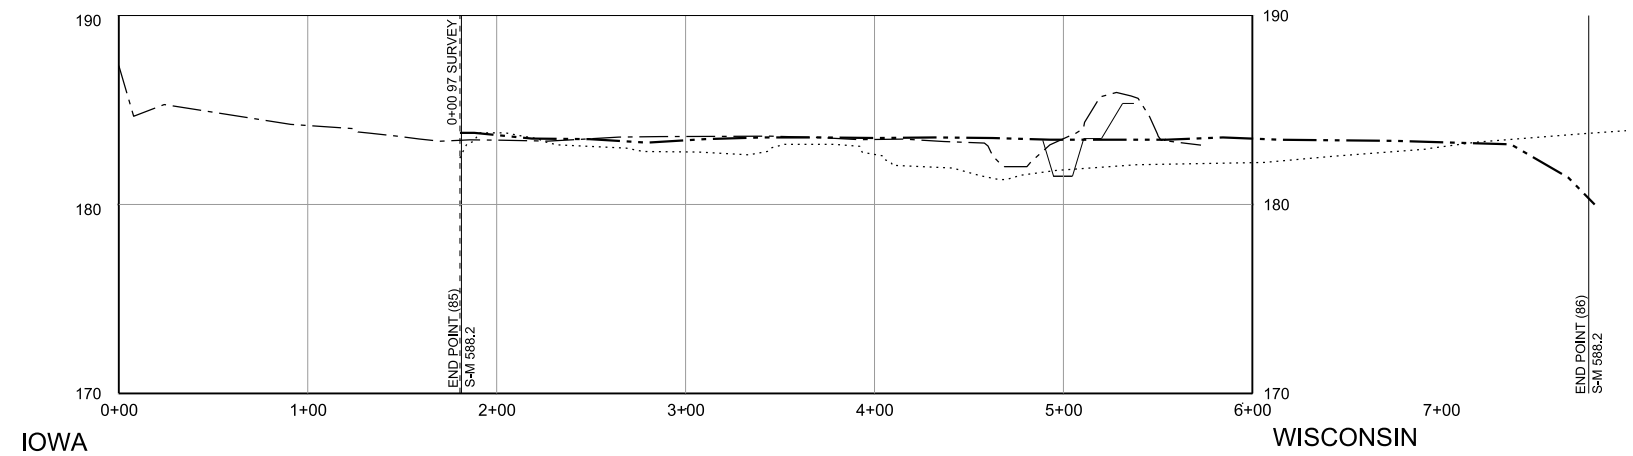
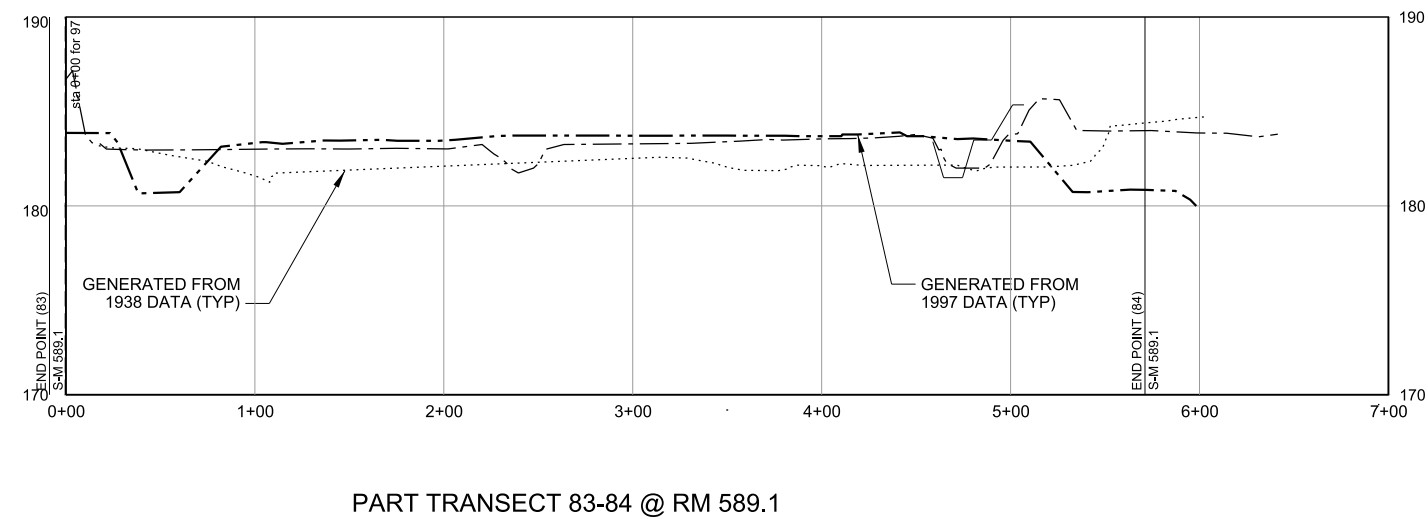
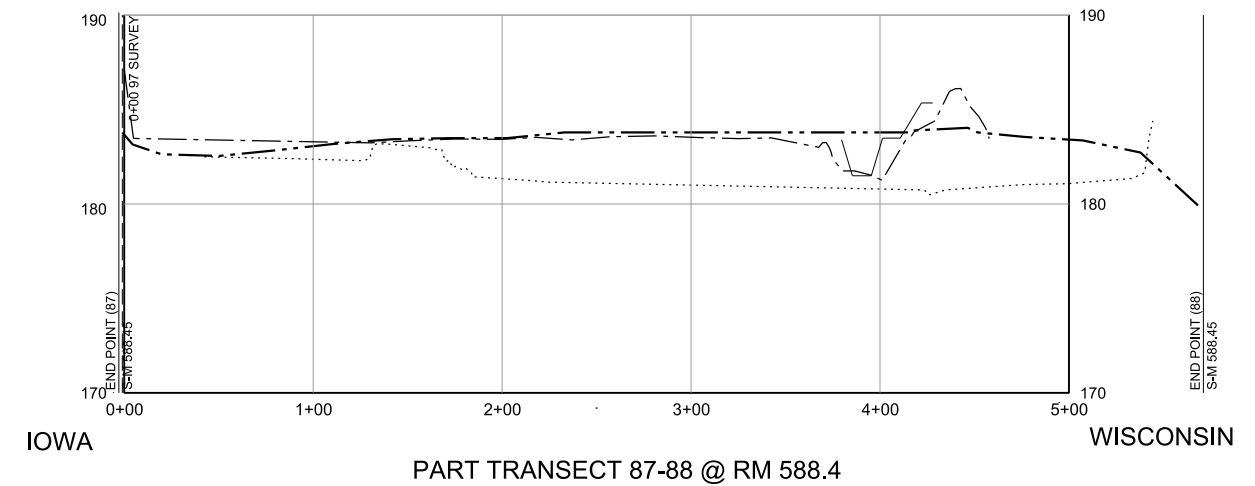
MUD LAKE TRANSECTS

The cross sections are provided in Appendix C. The cross sections indicate relatively uniform sediment deposition; however some areas show signs of possible sloughing. The Year 50 target for deepwater channel habitat is 23.1 hectares (57 acres) which represents the actual as built condition. DPR states the Year 50 target as 24.3 hectares (60 acres), which represents the projected as built condition. Based on the limited bathymetric survey data, and water quality station depth measurements, it appears that the amount of deepwater channel habitat has decreased since HREP construction. Full bathymetric surveys of all deepwater channels will need to be conducted in order to completely determine the amount of habitat reduction.
