**POOL 12 OVERWINTERING HREP
STAGE 1, SUNFISH LAKE
INSPECTION OF COMPLETED WORKS
2021**

Pool 12 Overwintering – Stage 1 – 5-year inspection

Upper Mississippi River Restoration (UMRR)

Pool 12, Mississippi River Miles (RM) 563.5-565.0, Jo Davies County, IL

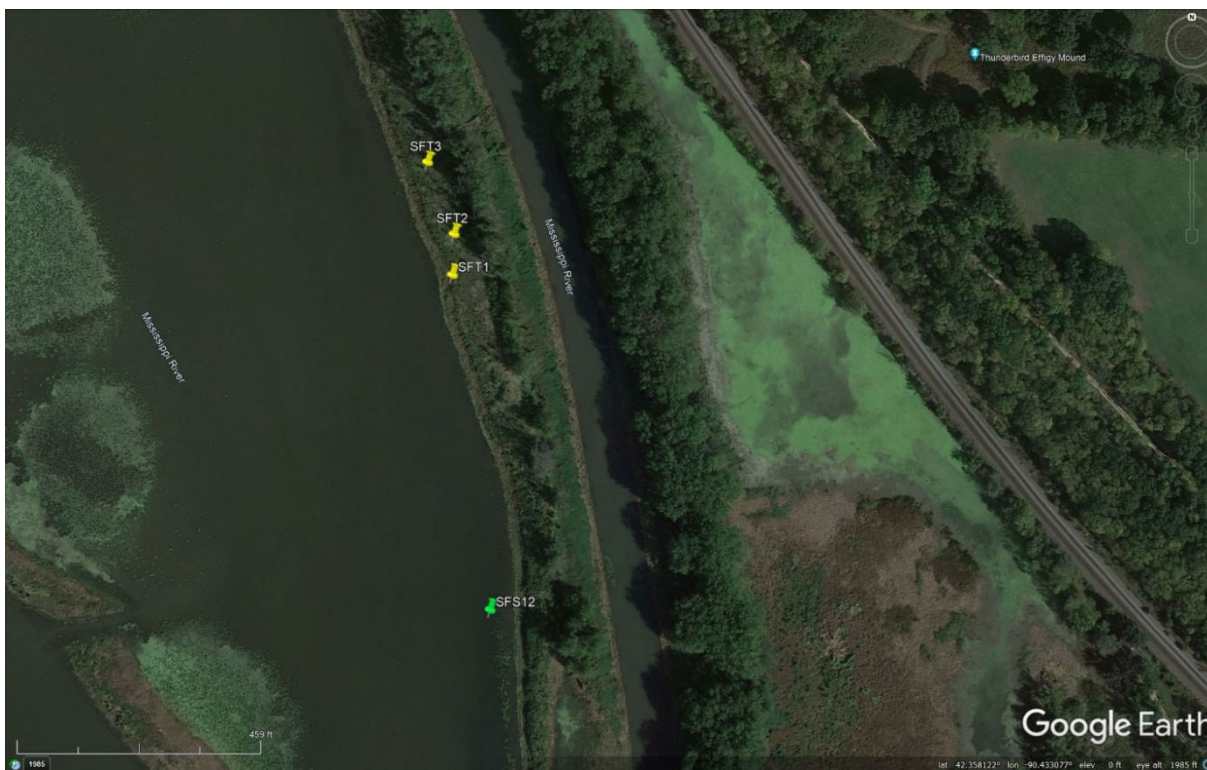
Berm Samples SFT1, SFT2, SFT3, Channel Boring SFS12
 Image Courtesy Google Earth™

Boring SFN12 was hand driven to 3.5 feet below the bed surface. The upper foot of sediment consisted of brown/gray, flocculent silt and clay with very fine sand. From the 1 to 2.5-foot interval sediment consisted of brown, massive, organic silty clay, and in the 2.5-to-3.5-foot interval a brown/gray firm, massive clay was present. No bedding structures were observed. Based on water depth elevations and pool elevations that day, the bed elevation at the boring location was estimated to be at 585 feet.

Samples were taken in two general areas of the Sunfish placement berm as shown on the map in Attachment D. Samples Sunfish Tree 1 (SFT1), Sunfish Tree 2 (SFT2) and Sunfish Tree 3 (SFT3) were collected within 200 feet of each other near the northern portion of the berm. Samples Sunfish Tree 4 (SFT4) and Sunfish Tree 5 (SFT5) were collected within 200 feet of each other in the southern portion of the berm. Miscommunication on sample placement occurred between field personnel, so samples were not distributed as desired, but for the purposes of interpretation, the two separate groupings of samples were compared against recommended standards and each other. A control sample, Stone Control (SC), was collected the same day in a forested area where no placement or construction activities had occurred.

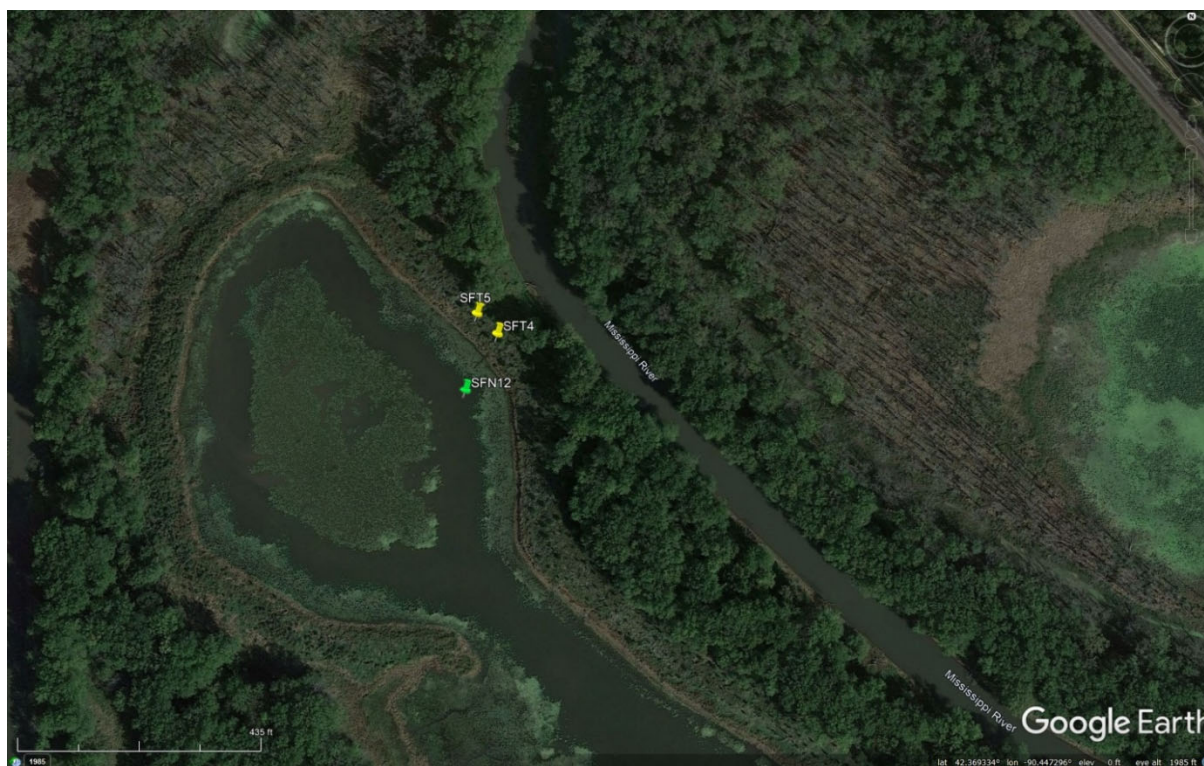
Berm Samples SFT4, SFT5, Channel Boring SFN12
 Image Courtesy Google Earth™

Channel Soil Borings: On August 11, 2021, two borings were driven into sediments within the Sunfish Lake constructed overwintering habitat. These borings, SFN12 and SFS12, were collected to help estimate the type and thickness of materials that have deposited within the overwintering habitat since construction. SFN12 is located at Station 27+00B and SFS12 is located at Station 9+00. A map showing the boring locations is included in Attachment A.

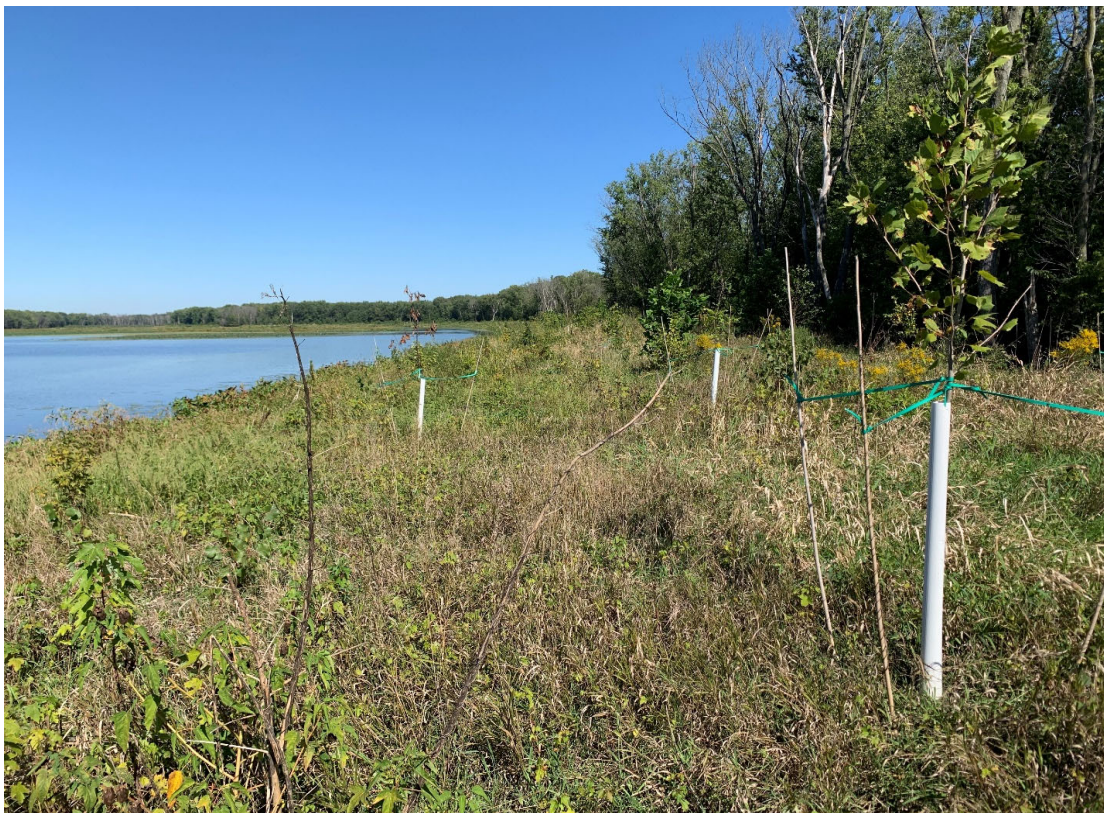
Photograph 2: Recent Tree Plantings

Perimeter Berms: Good vegetation was present and growing on all of the berms during the site visit. (Photographs 2, 5, and 7) There did not appear to be any excessive erosion of the side slopes or settlement of the crown. A large animal hole was observed in the "doughnut" area at the north end of project.

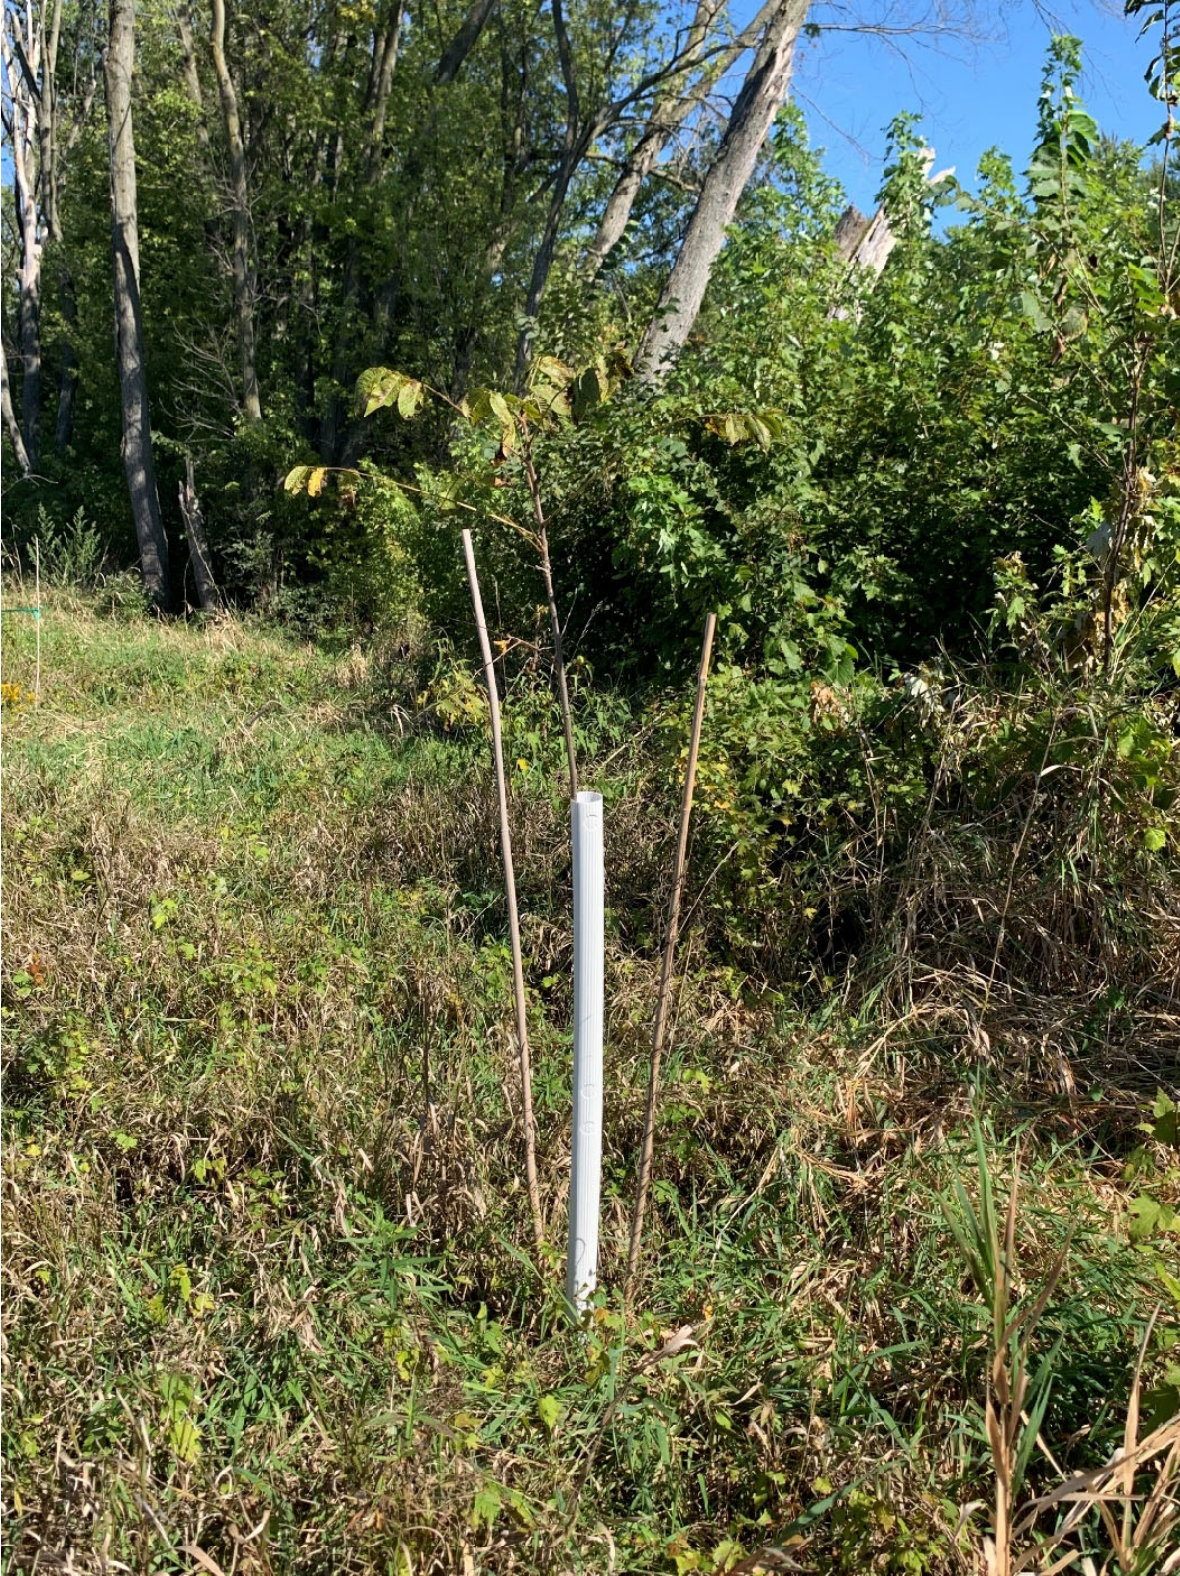
Photograph 5: Plantra Trunk Saver Solid Wall Tree Guard on a Planted Tree

The first plantings were noted to be encased in corrugated plastic drain tile with a slit cut down the center. The forester on the project made note to never use the corrugated plastic drain tile method again as it permanently damages the tree which leads to decay main stem of the tree that will cause mortality over time. (Photographs 9 and 10) The forester recommends Plantra trunk saver solid wall tree guards for several reasons. (Photograph 5) They are twin-walled and porous meaning in high water they will float and can move vertically on the tree so no debris and sediment accumulation occurs at the base of the tree. The type of material the tree guards are created with allows air movement reducing unwanted mold growth on the tree. Plantra tree guards are split full length allowing for easy install and removal; as the tree grows, the tree guard expands without damage to the tree.

Utilize Plantra trunk saver solid wall tree guards in all situations that tree protection is merited. Corrugated drain tile is not a sufficient alternative and detrimental to tree growth. Do not direct seed button bush with dense herbaceous seed, the competition of the herbaceous vegetation will out compete the button bush and prevent establishment. If having a slough that is winding or can keep curving is an option, try to go this route. It might help with bank erosion due to vessel wave wash because the boats move slower.

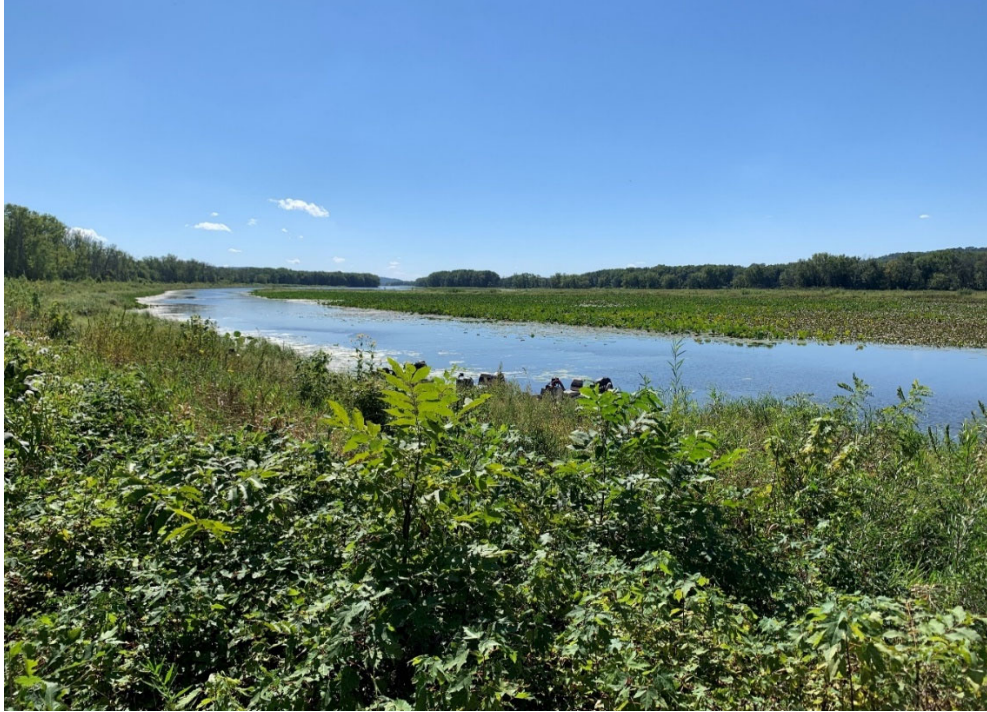
Photograph 8: Sunfish Lake Dredged Area

Channels: During the site visit, the boats used were equipped with depth finders. It was noted by ILDNR that the average depth of the channels appeared to be between 7 and 8 feet. Elevation was 592.1feet (MSL 1912) at this time. Target depth is 6 to 8 feet.

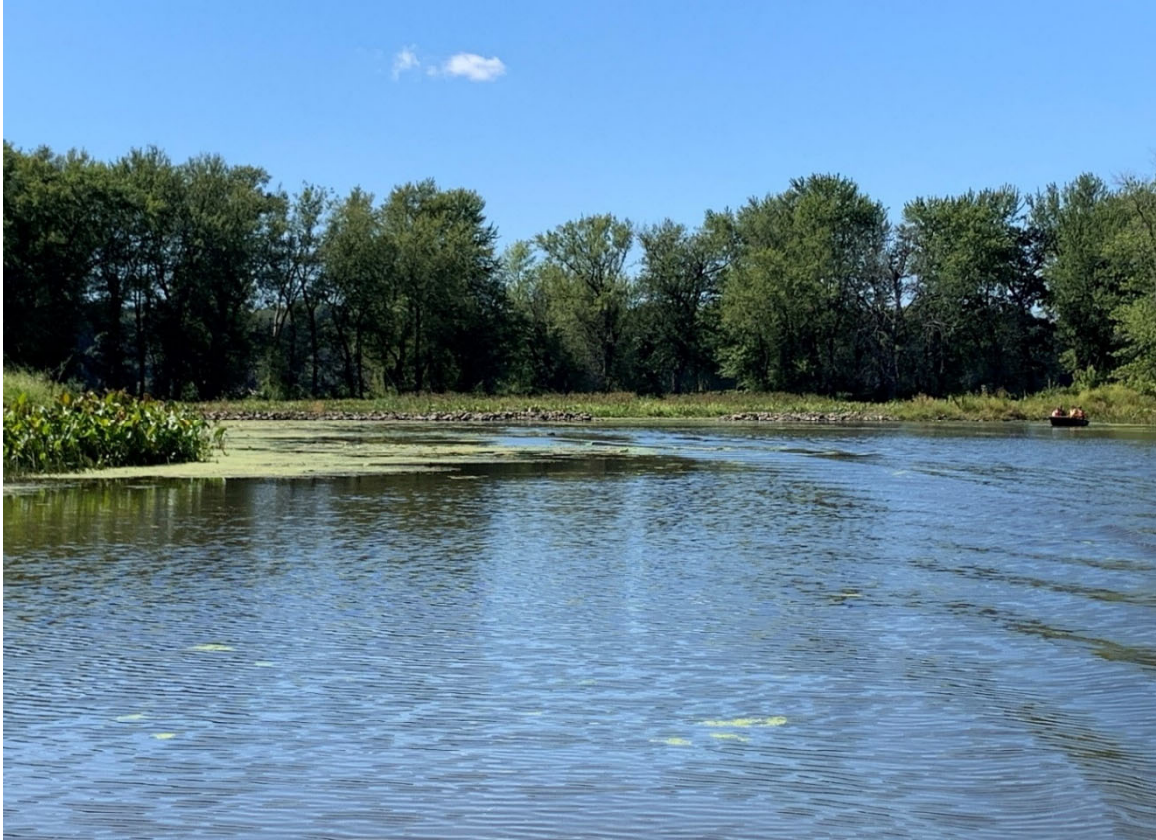
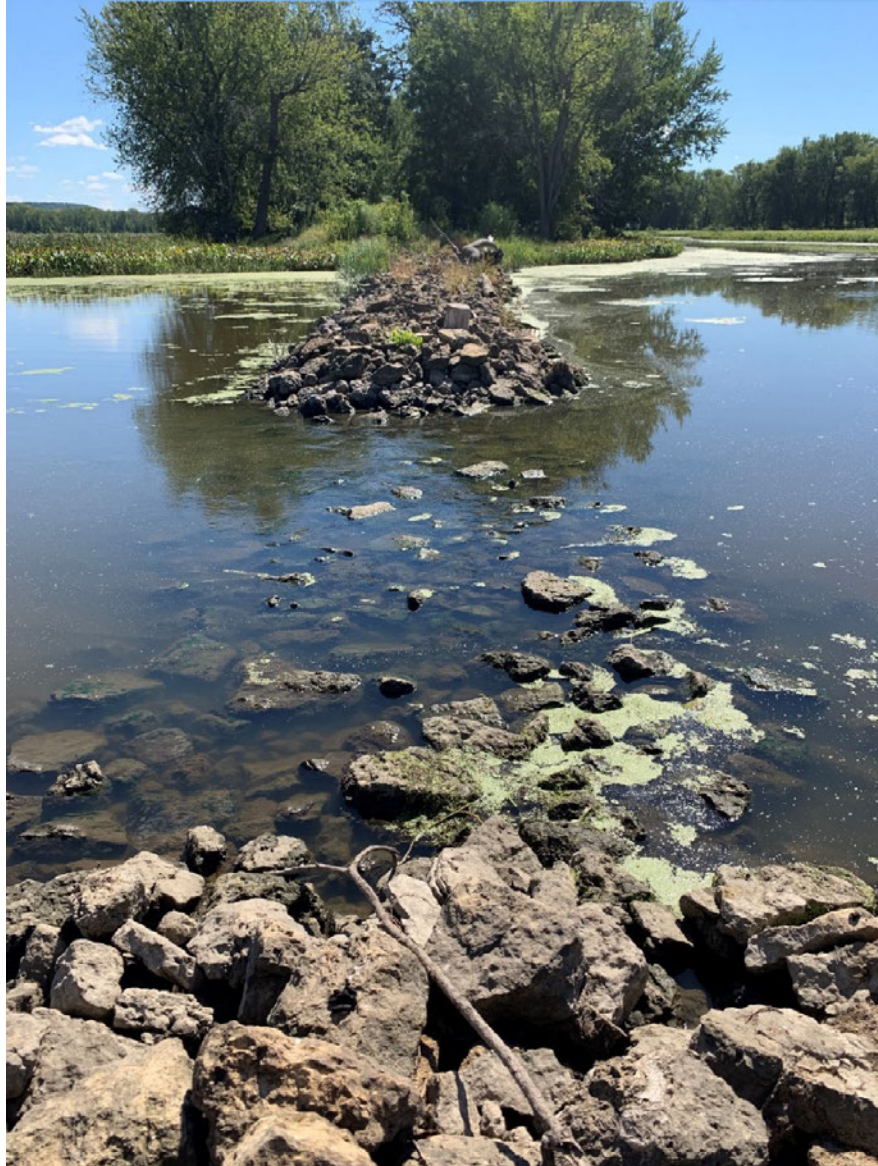
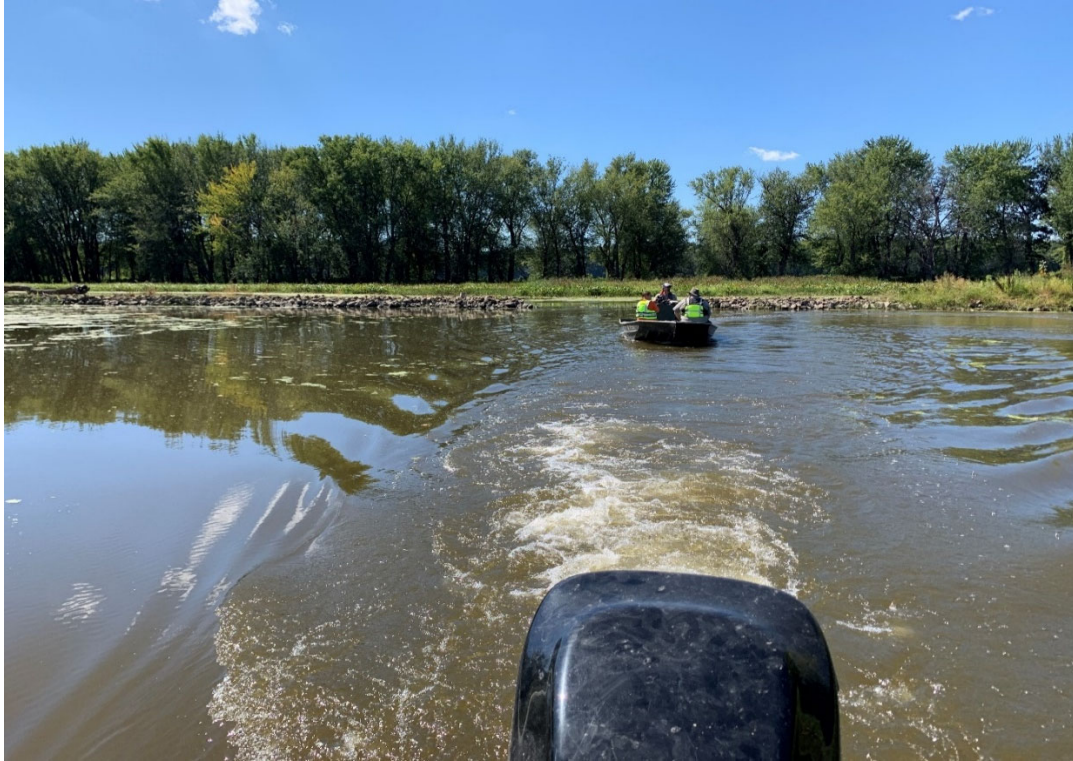
Rock Closure Structure: At the west end of Sunfish Lake, a rock closure structure (Photographs 11, 12, and 13) was constructed to aid in winter freeze kill off. This structure increased water velocity and will oxygenate water during the cold months. While on site, a member of the IL DNR made a verbal note that it is performing spectacularly and will hopefully provide enough velocity and oxygen to assist living conditions in the winter.

Photograph 11: Rock Structure

Photograph 12: Rock Structure

Photograph 13: Rock Structure

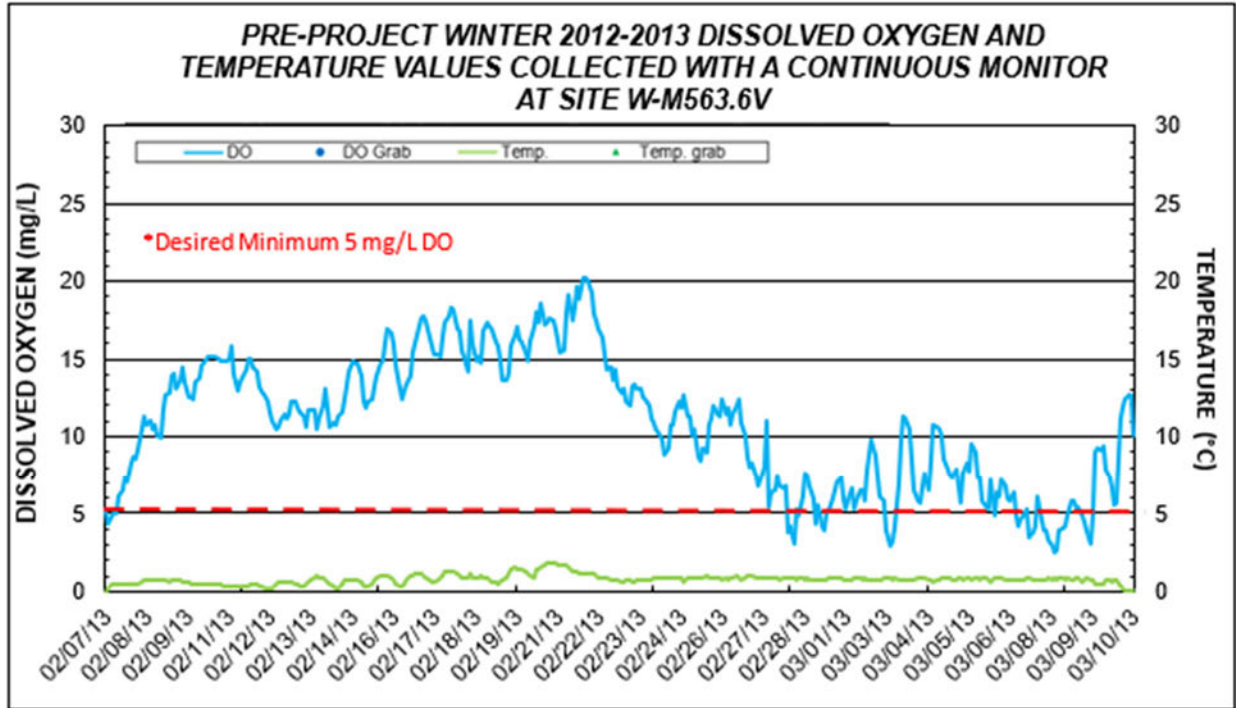
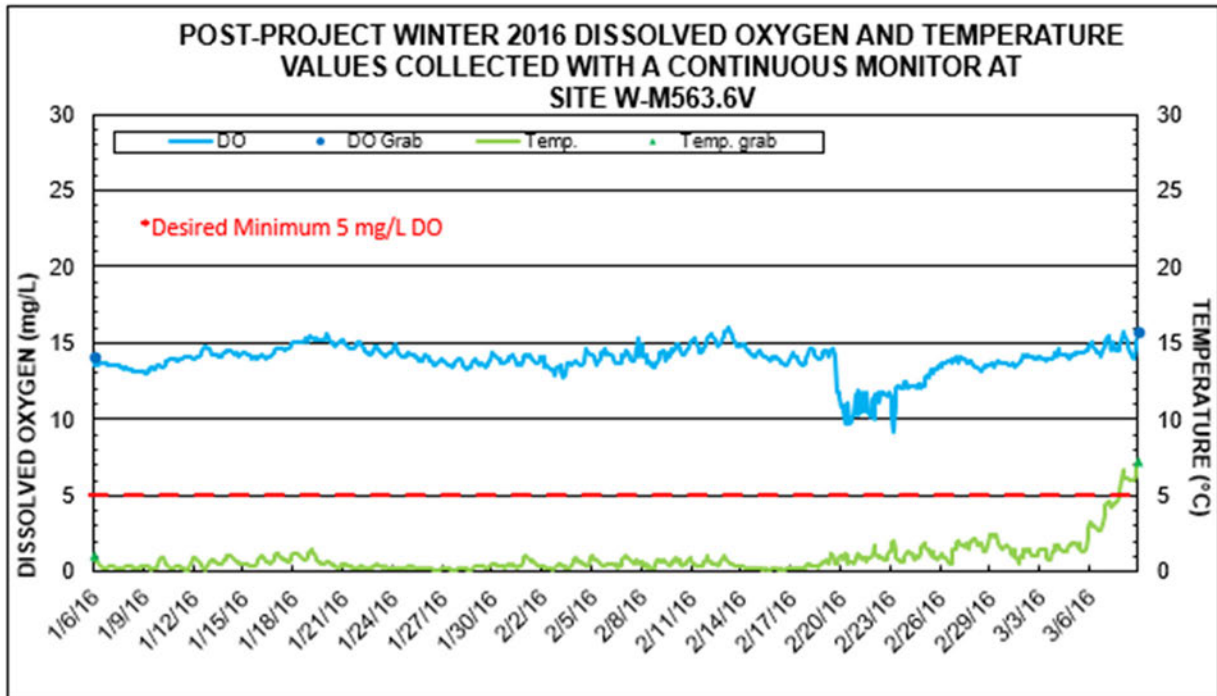
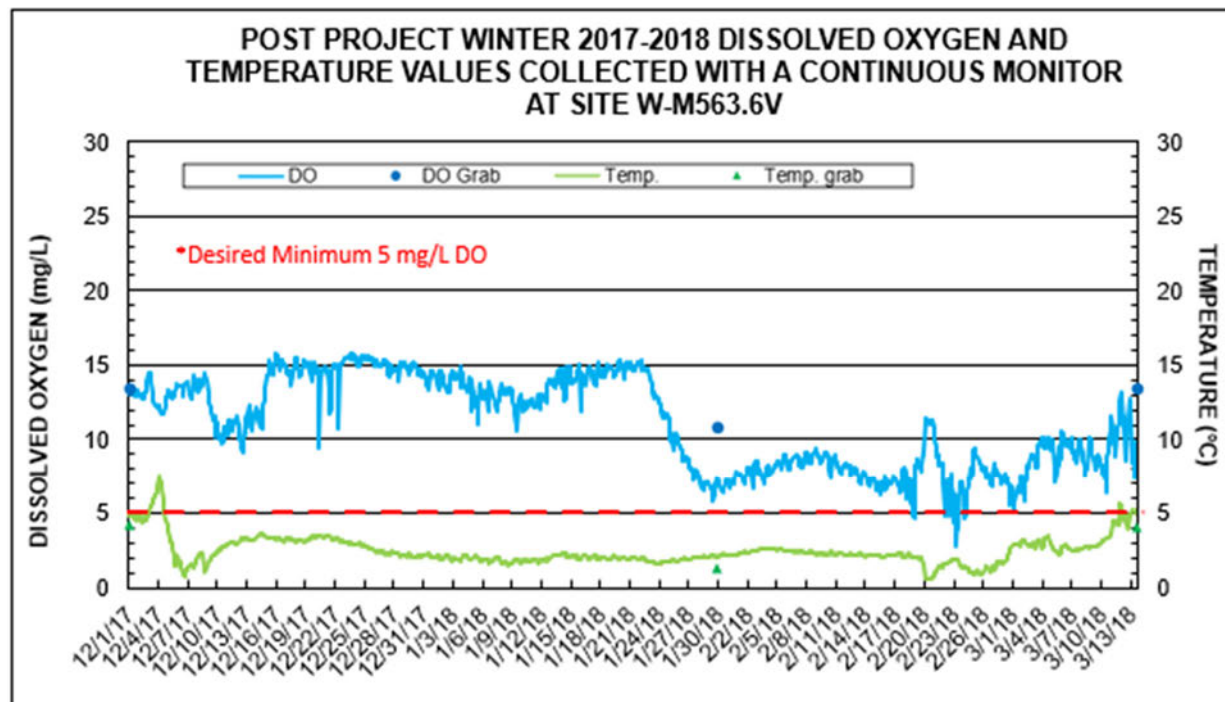
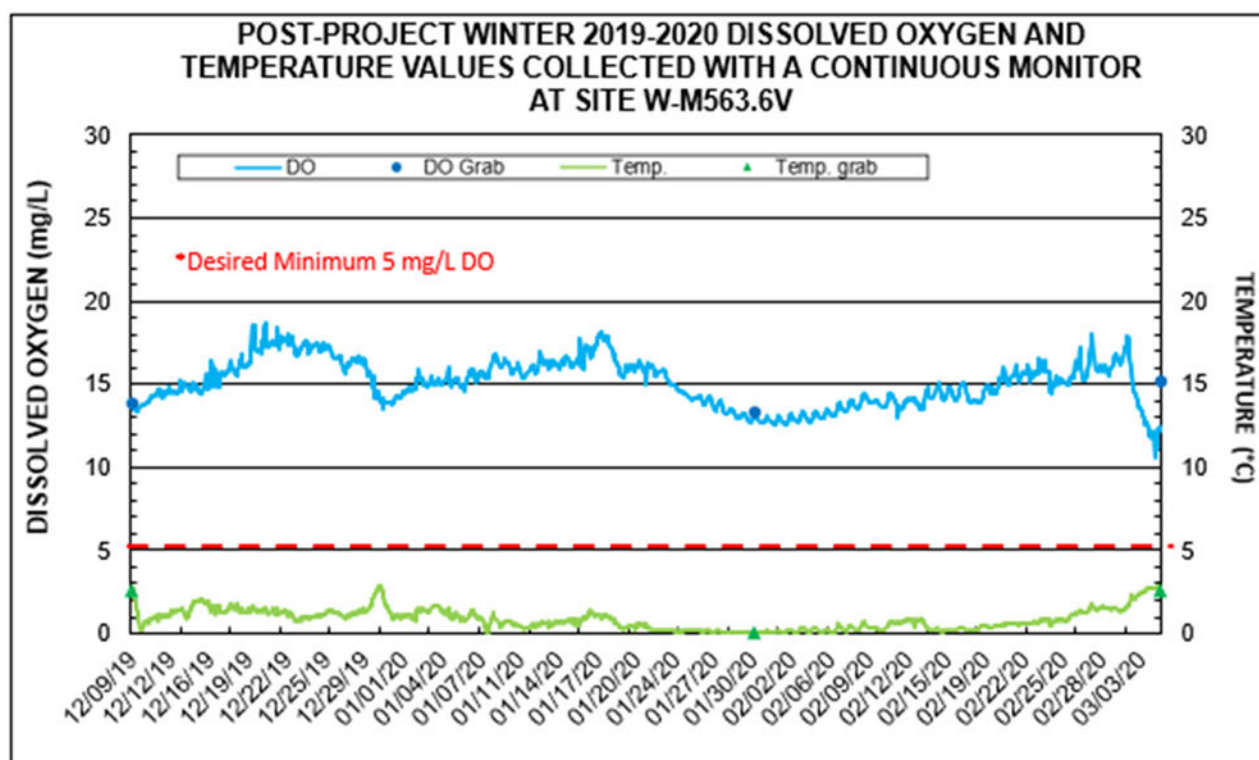
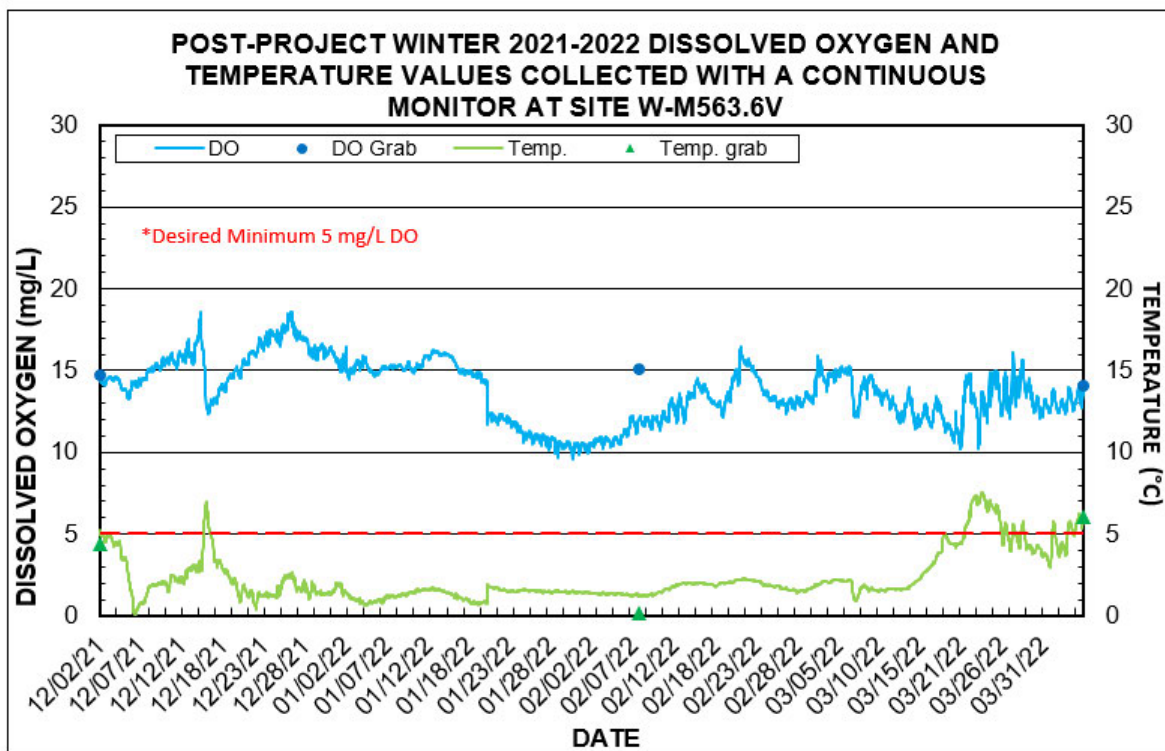
Pre and Post Project Graphical Comparison Site W-M536.6V

When looking at the years of data collected after construction was complete in 2016, dissolved oxygen (DO) levels appear to range between 10-15 mg/L for the majority of the winter seasons with greater consistency as time progressed. It is to be noted, however, that there are some drops in DO below 5 mg/L observed within some post-construction monitoring years for the winter season. Commonly with the post-construction data there are drops in DO as other parameters, most commonly temperature, change as well. These drops are likely due to ice and snow accumulation affecting organisms' ability to produce oxygen within the water column, but more data would be necessary for any confirmed conclusions. Drops in continuous data that do not match grab samples are likely experiencing interference while in the field and are not accurate. Temperatures between the two sites are typically higher at site W-M563.6V in comparison to site W-M564.7R due to closer proximity to main flow of the river. Additionally, water temperatures each monitoring season are going to vary greatly depending on seasonal differences in snow fall, ice formation, and air temperatures. Velocities for both sites average below 4 cm/sec each season and are also dependent on ice formation in terms of accumulations and melts. W-M563.6V more commonly experiences slightly higher velocities due to relative proximity to the main channel.

The most recent monitoring reveals no immediate concerns in terms of dissolved oxygen (DO). When looking at the years of data collected after construction was complete in 2016, DO levels appear to range between 10-15 mg/L for the majority of the winter seasons with greater

consistency as time progressed. It is to be noted, however, that there are some drops in DO below 5 mg/L observed within some post-construction monitoring years for the winter season. Specifically, for the 2019-2020 season, it was observed that DO levels dropped below the threshold within the winter monitoring season for a notable period. During these observed drops in DO, other associated parameters saw similar drops or increases in values lending the reasoning to be more likely from harsh winter conditions and ice and snow accumulations. With this being said, the exact reasoning behind this would need more data to be determined. Additionally, site W-M564.7R observed an extended drop in DO as well, but this is likely due to equipment malfunctions or field interferences due to inconsistency between grab samples and continuous data. In terms of temperatures and velocities, values are found to be typically higher at site W-M563.6V in comparison to site W-M564.7R due to closer proximity to main flow of the river. Additionally, it is to be noted that dissolved oxygen levels, water temperatures, and velocities observed each monitoring season are going to vary greatly depending on seasonal differences in snow fall, ice formation, and air temperatures. Refer to Attachment C for more specific water quality monitoring results.

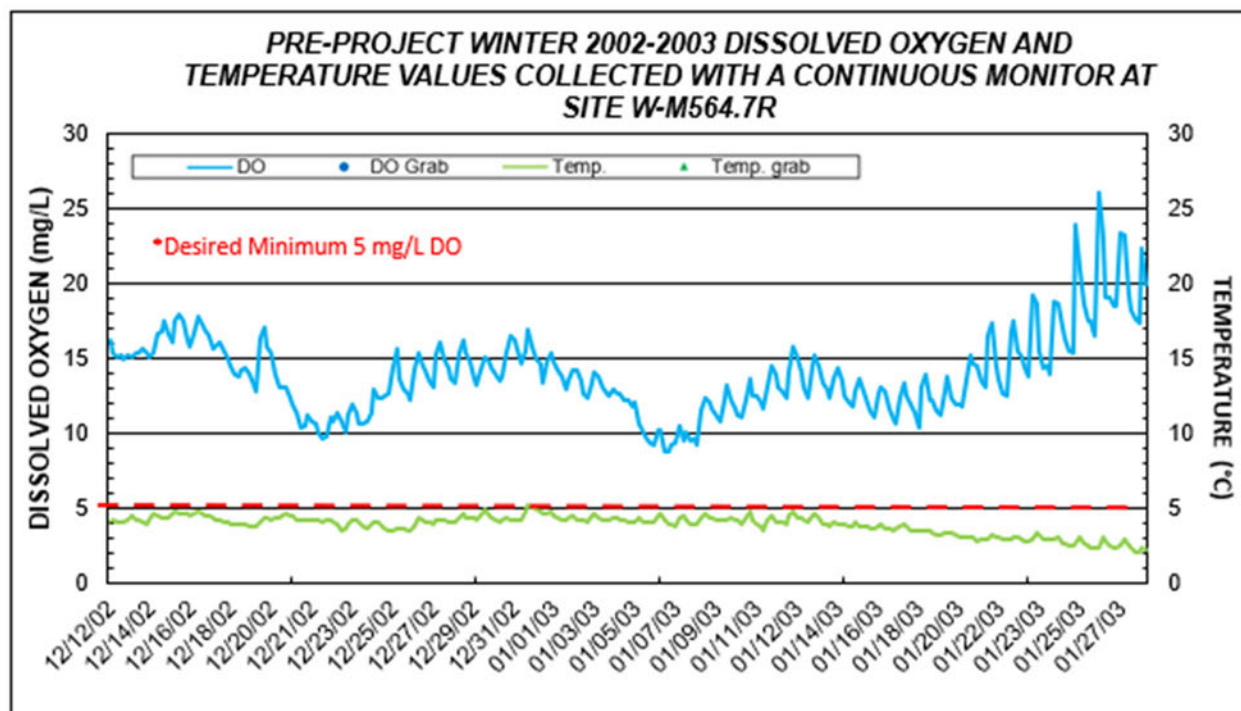
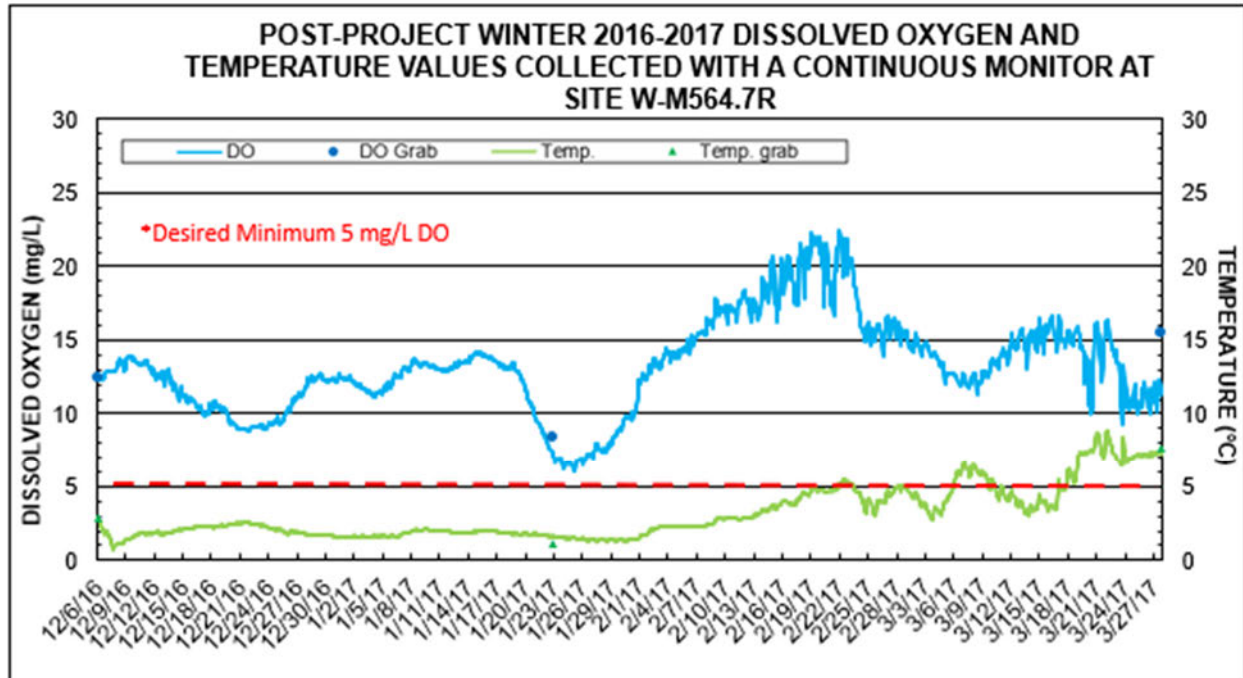
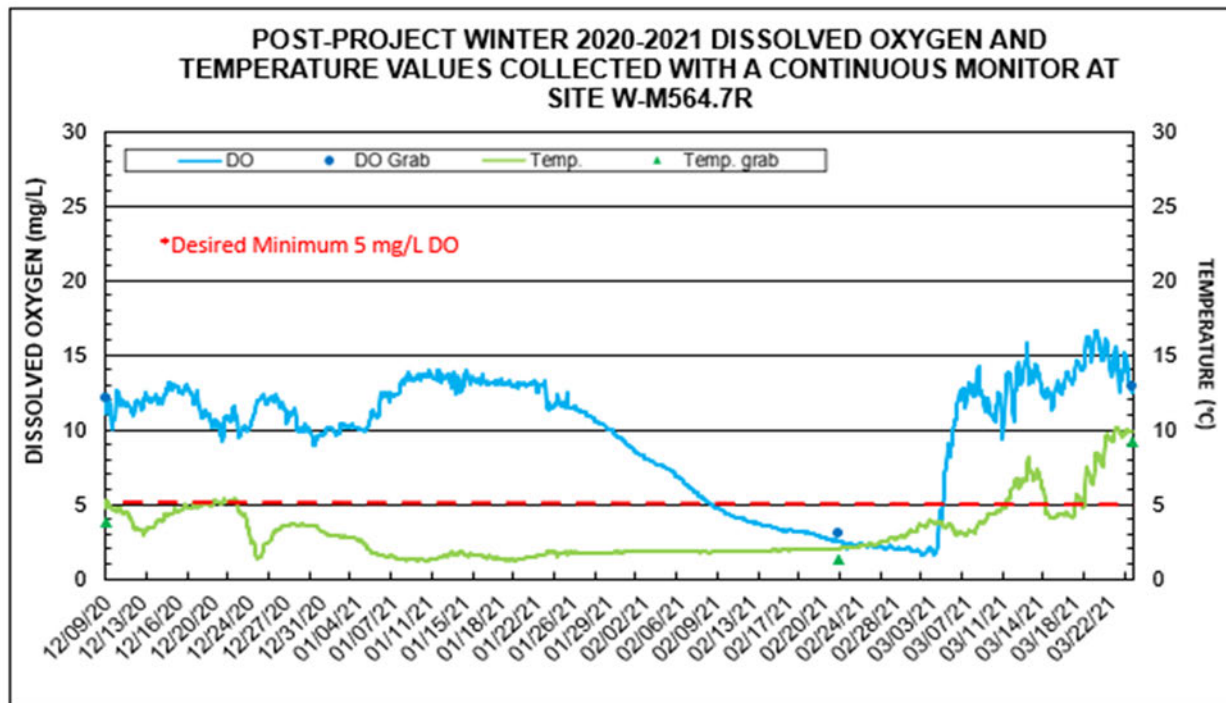
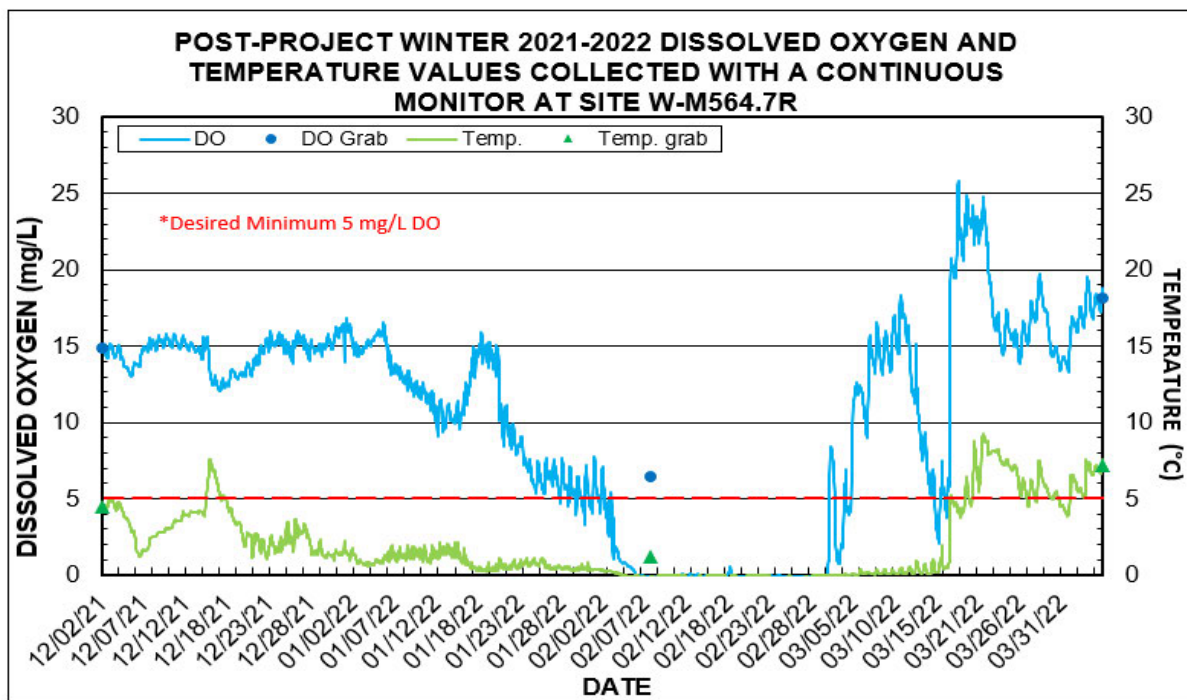
Pre and Post Project Graphical Comparison Site W-M564.7R

*Potential equipment malfunction 2/7/2022-2/28/2022 due to grab samples not matching sonde data
