UPPER MISSISSIPPI RIVER SYSTEM
ENVIRONMENTAL MANAGEMENT PROGRAM
POST-CONSTRUCTION INITIAL PERFORMANCE
EVALUATION REPORT (IPER9F)

POTTERS MARSH REHABILITATION AND ENHANCEMENT

NOVEMBER 1998

POOL 13
MISSISSIPPI RIVER MILES 522.5-526.0
CARROLL AND WHITESIDE COUNTIES, ILLINOIS

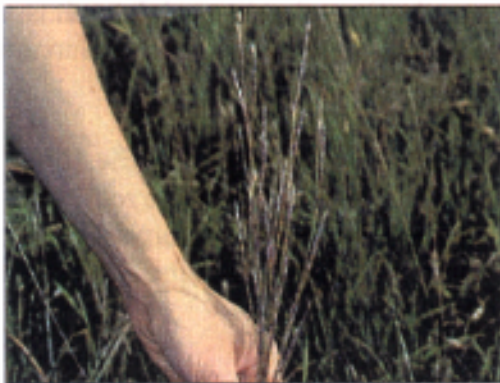
Little Bluestem

A second site visit to inspect vegetation on the CPS was made by Corps staff on July 17, 1997 (Appendix F). The grassland area, crown, and outer slopes of the CPS berm were still dominated by annual and perennial rye. The lower inside slope of the berm was dominated by white sweet clover. Several scattered clumps of little bluestem, possibly

remnants of last year's growth, were noted in the grassland area. A few specimens of purple prairie clover and black-eyed susan were observed in flower on the area. These species were not included in the seed mixture listed in construction specifications. The berm and grassland areas were initially seeded in the spring of 1996 following construction. The USFWS Refuge staff originally planned to conduct a maintenance burn

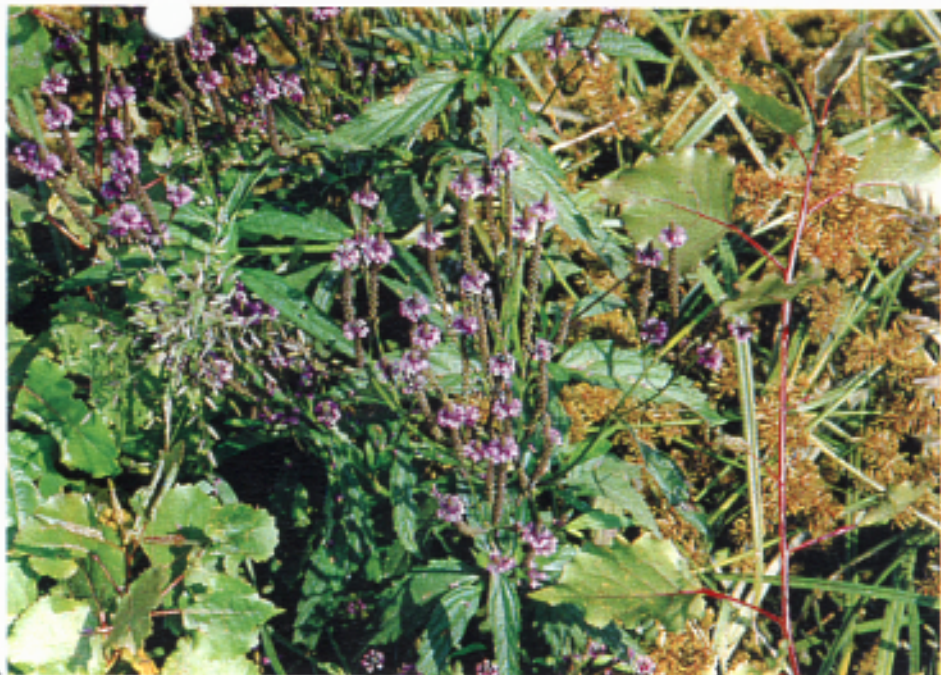
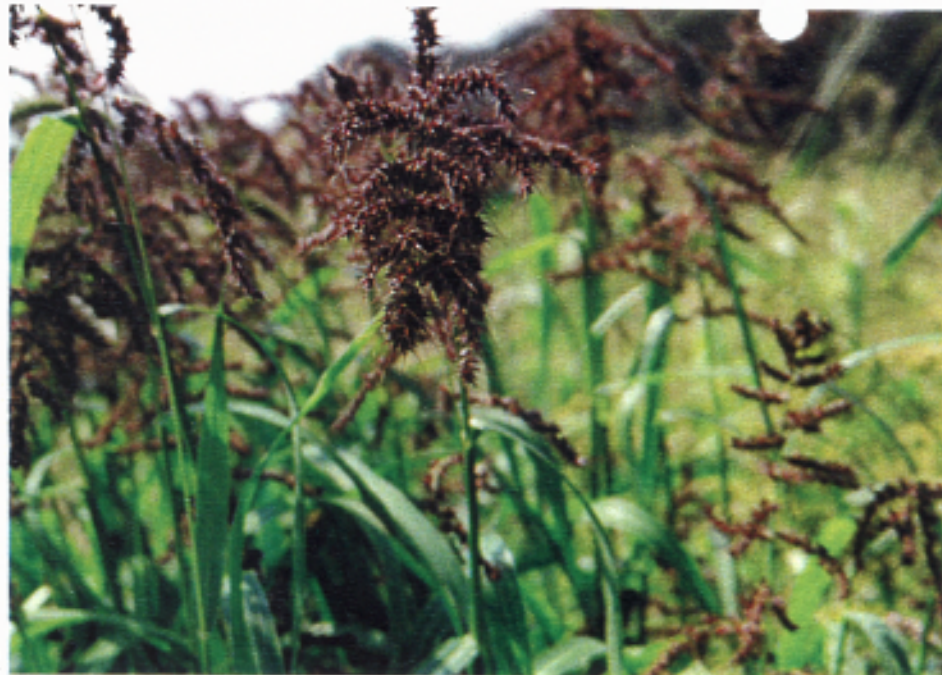
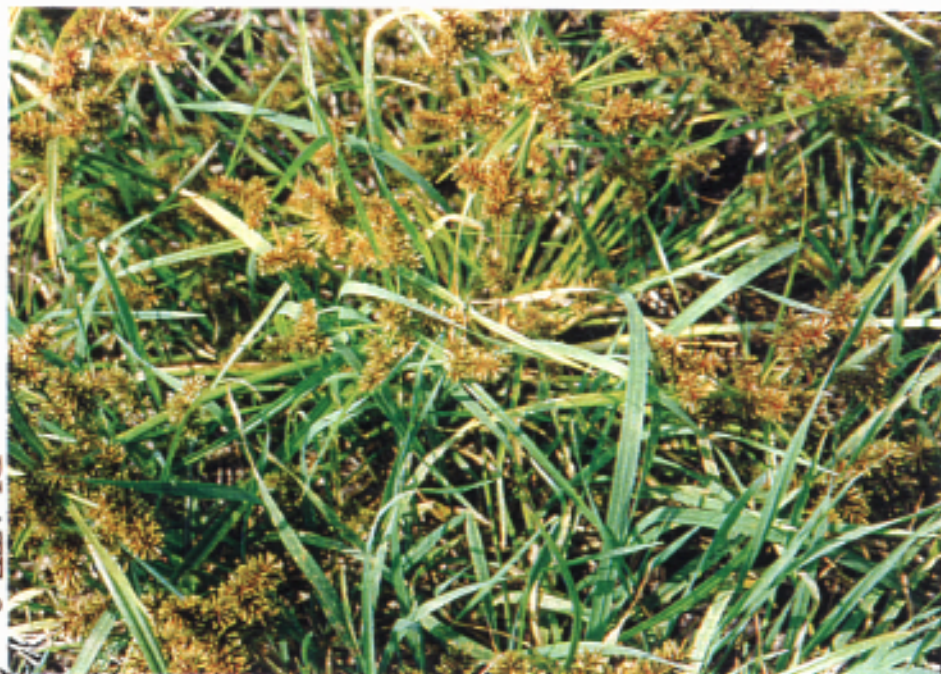
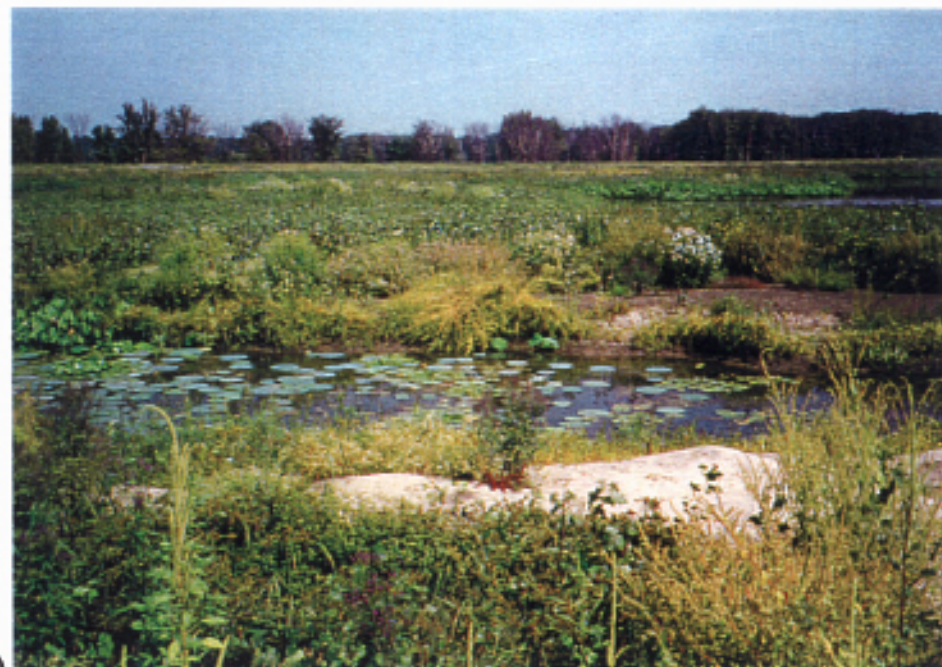
PLATE 3

PLATE 3: These photos were all taken on September 4, 1996, and show examples of naturally occurring vegetation within and adjacent to the CPS. **Photo A** shows a mixture of three species of vegetation naturally colonizing the CPS: blue vervain (*Verbena hastata*), seedling cottonwood (*Populus deltoides*), and straw-colored nutsedge (*Cyperus strigosus*). Blue vervain is a native forb that is a frequent colonizer of wetland sites. Seedling cottonwood is generally considered an undesirable invader of open grasslands and disturbed sites. Straw-colored nutsedge is one of a group of wetland plant species referred to as “moist soil” vegetation. **Photo B** shows a dense growth of straw-colored nutsedge. The seeds and tubers of this species are eaten by wildlife. **Photo C** shows specimens of another “moist soil” plant, commonly called wild millet or barnyard grass (*Echinochloa sp.*). **Photo D** shows a view of the interior of the CPS and the variety of

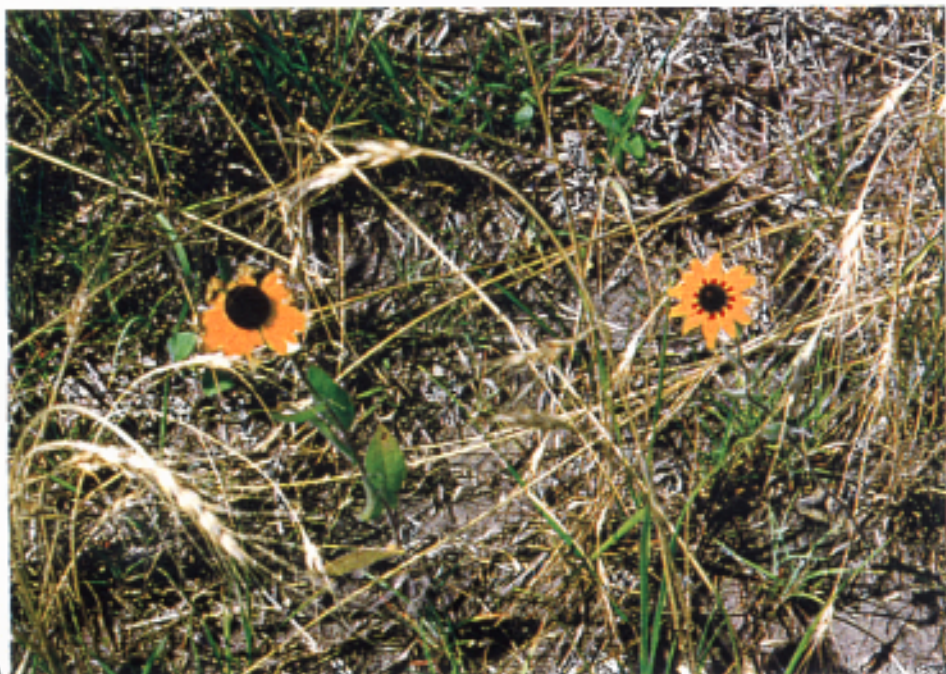
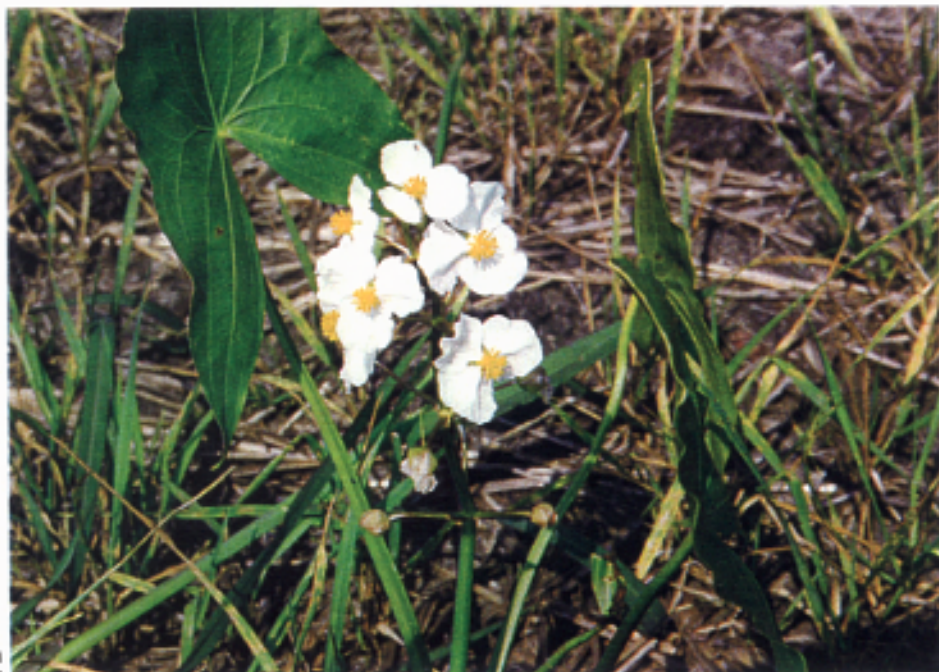
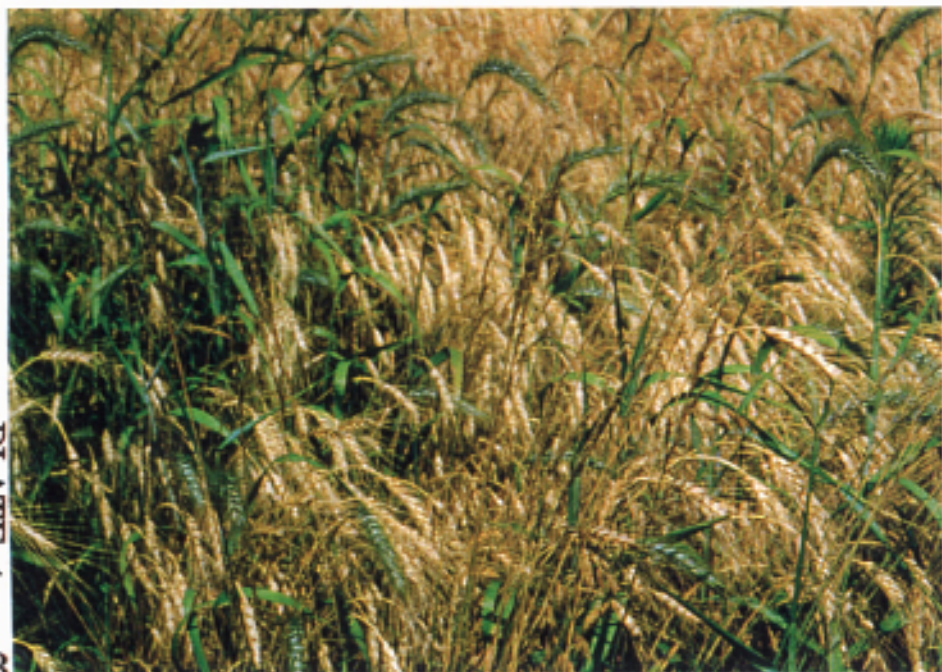
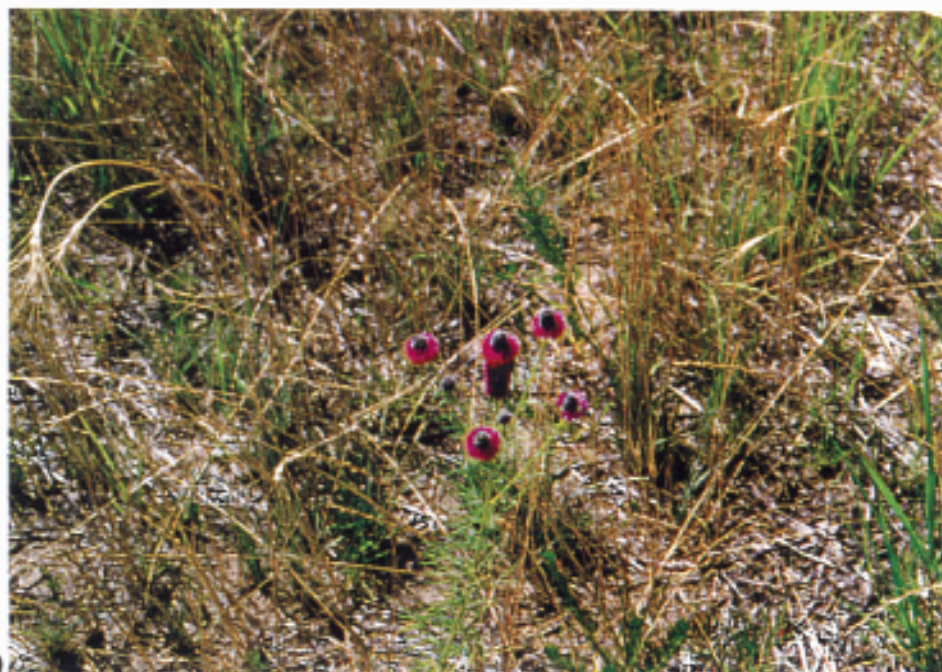
PLATE 4

PLATE 4: These photos all show examples of vegetation found on the berm and grassland areas of the CPS. All were taken on July 17, 1997, except for **Photo C**, which was taken on September 4, 1996, and shows a specimen of arrowhead growing on the crown of the CPS berm. Although normally an obligate wetland species, arrowhead was apparently present in the seed bank of the dredged material used to construct the berm and naturally revegetated the site in the first year following construction. This species was not encountered on top of the CPS berm during the July 1997 site visit. **Photo B** shows some of the grasses that comprise the dominant cover of the berm and grassland areas. **Photo A and Photo D** show two prairie forbs encountered on the berm: black-eyed susan (*Rudbeckia hirta*) in Photo B and purple prairie clover (*Petalostamun purpureum*) in Photo D.
