# **DYE DISPERSION AND FISH MOVEMENT IN RESPONSE TO INCREASED WINTER INFLOW AT SPRING LAKE, A BACKWATER OF THE MISSISSIPPI RIVER NEAR SAVANNA, ILLINOIS**

February 2006

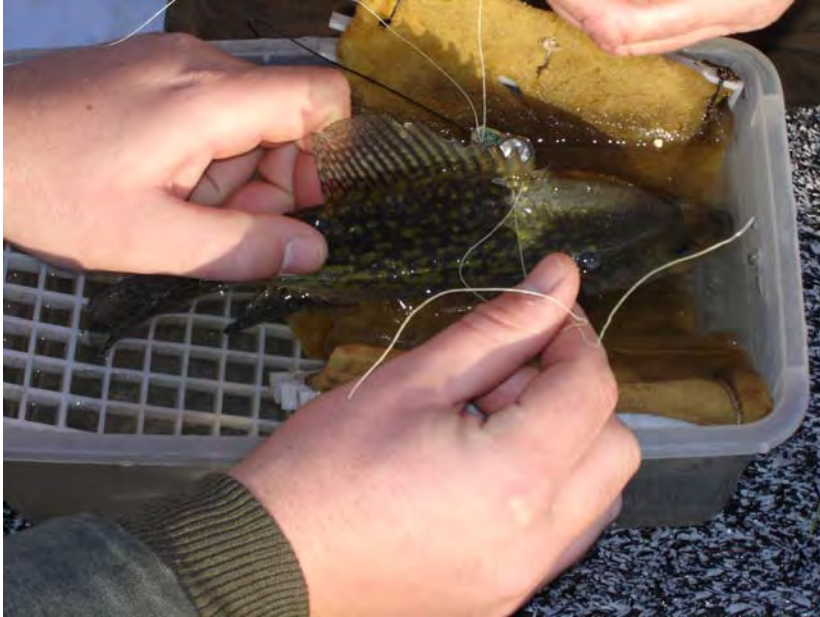
**Figure 2. Attaching transmitter to a black crappie.**

The fish were immediately fitted with externally placed transmitters and released at the capture location. The transmitters were attached at two locations just below the base of the dorsal fin spines (see Figure 2). The transmitters were body implant types that were modified for external placement by tying braided fishing line (Firewire) to the body of the transmitter in two locations and using epoxy to hold it in place. The free ends of the line were drawn with a needle through the musculature at the base of the dorsal fin, one at a point anterior to a spine and the other at a point posterior to the spine. The two lines were then pulled tight around the spine and were tied off. The process was then repeated at a second dorsal fin spine. The

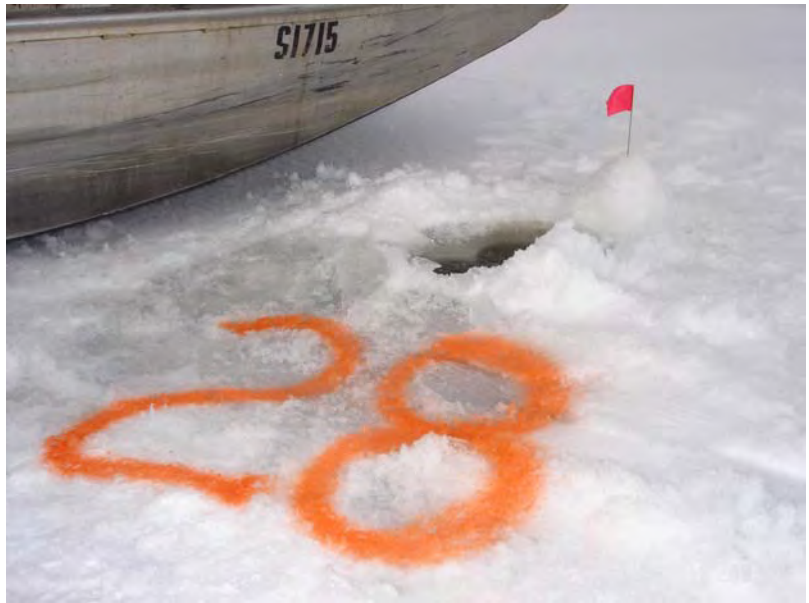
Figure 3. Dye sampling site identifiers.

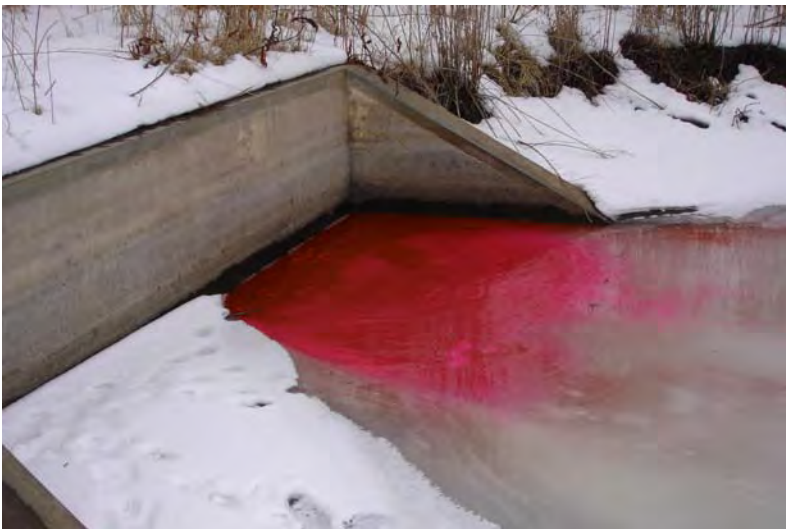
Figure 4. Dye entering Spring Lake at the water control structure.

was positioned at the level of the gate opening. In order to facilitate the assimilation of the dye with the inflowing river water, 7 liters (1.8 gal) of dye was mixed with 90 liters (23.8 gal) of river water in the refuse container. This helped reduce the viscosity of the dye and equilibrate the temperature of the dye with that of the inflowing river water. Dye was immediately visible on the lake side of the water control structure (see Figure 4) following release of the dye, which commenced at 9:16 a.m. By 9:44 a.m., all of the dye had been dispensed. At no time was a dye plume observed on the river side of the perimeter levee.

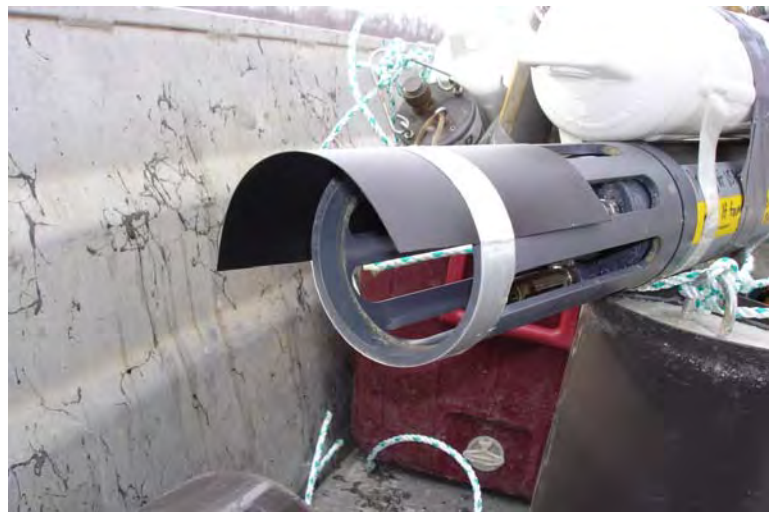
**Figure 5. Sonde fitted with plastic shade to reduce exposure to sunlight.**

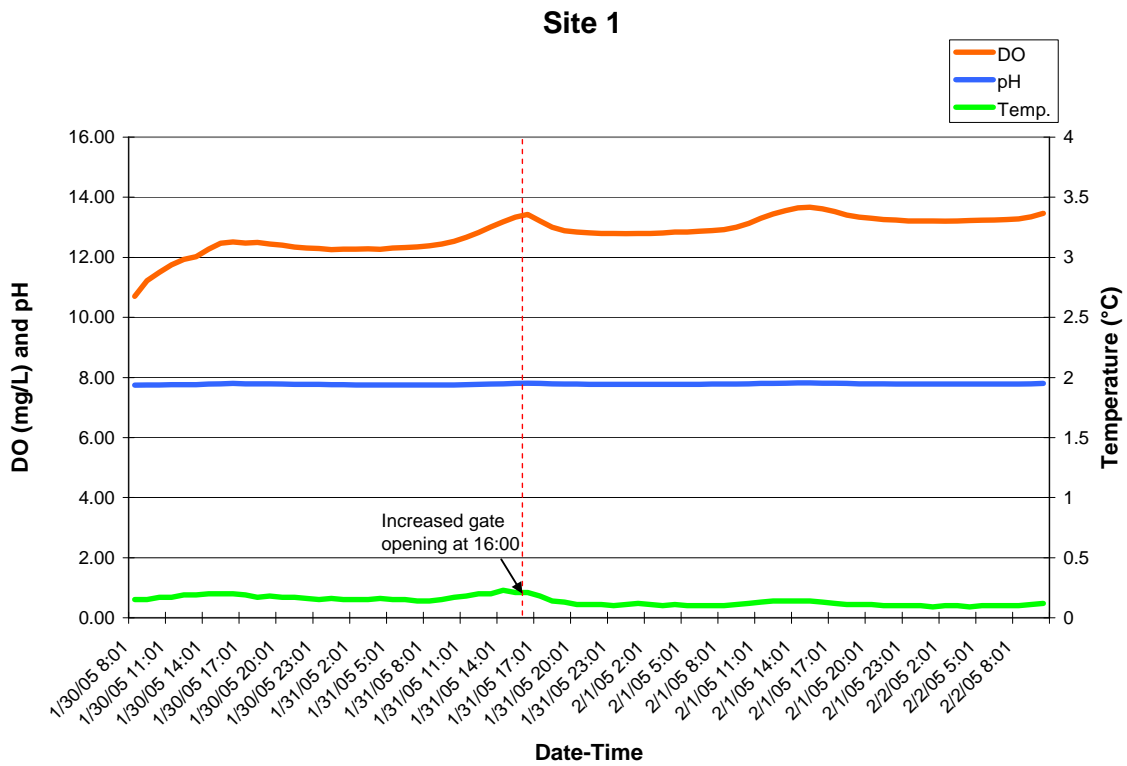
**Figure 6. Multiparameter Sonde Water Quality Data from Site 1.**

At site 1, the monitoring site closest to the inlet structure, the DO and temperature values decreased slightly following the increase in gate opening, whereas pH values remained relatively stable (see Figure 6). Sondes were deployed at points 0.91 m (3.00 ft) and 2.13 m (7.00 ft) from the bottom at Site 5, the deepest site. As seen in Figure 7, stratification was most noticeable with DO. Differences between DO concentrations measured by the upper and lower sondes were generally about 4 mg/L, with the exception of a DO spike near the surface on February 5<sup>th</sup>. The differences in temperature and pH values throughout the deployment were less noticeable. DO concentrations started to increase about the time when the initial impact from the increased gate opening would have reached the site; whereas, temperature and pH values remained relatively constant throughout the deployment. The time window of initial water quality impact from increased gate opening was estimated from the results of the dye analyses. The beginning of the time window coincided with the last sampling time dye was not detected at the site (minus 17 hours to account for the time difference between when the gate opening was increased to the time the dye was injected) and the end of the window coincided with the time dye was first detected at the site (again, minus 17 hours). As displayed in Figure 8, the results from the sonde deployed at site 7 were similar to those seen at site 5, in that the pH remained relatively constant throughout the deployment and a DO spike was observed on February 5<sup>th</sup>. The main difference between the two sites was seen with temperature. The temperature fluctuations at site 7 were noticeably greater than at site 5. This could be explained by the shallower depth, and therefore smaller volume of water at site 7, which would be more susceptible to temperature changes. The site 14 results are shown in Figure 9. DO concentrations were supersaturated and pH values changed little throughout the deployment. A pronounced diurnal pattern was seen in the temperature values at this site. A noticeable diurnal pattern was also seen with temperature at site 16 (see Figure 10). A sharp drop in temperature was noted on February 7<sup>th</sup>. All three parameters began to decline on February 9<sup>th</sup>. The results from site 19 are displayed in Figure 11. The DO concentrations were

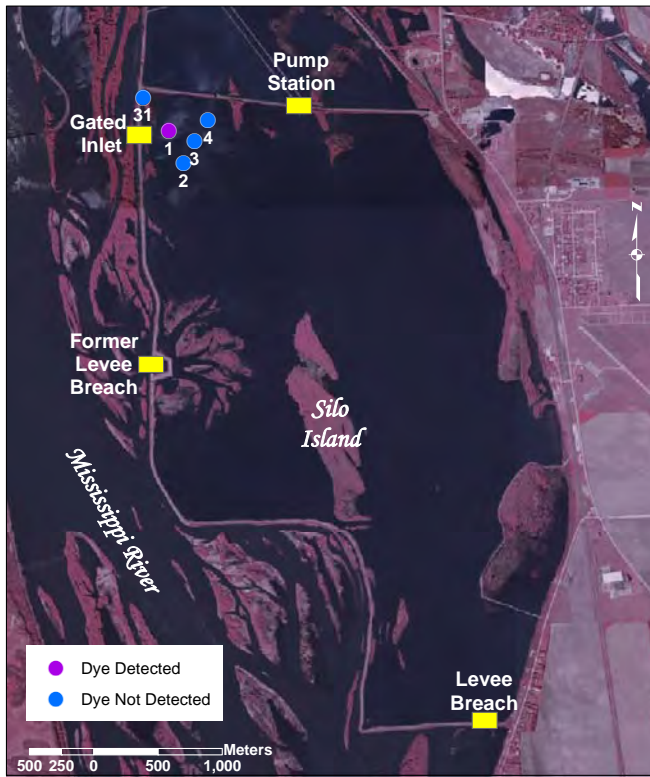
Figure 21. Spring Lake Dye Dispersion, February 1, 2005.

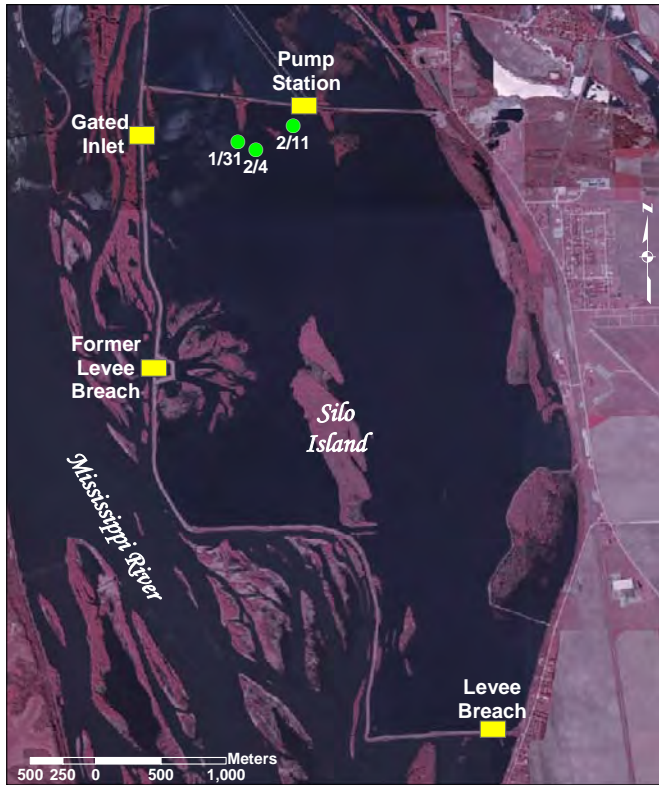
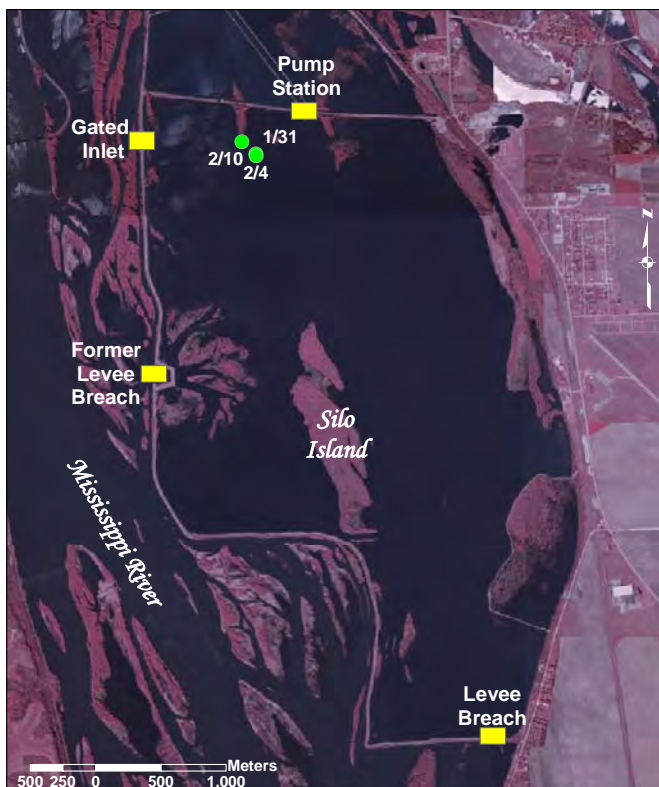
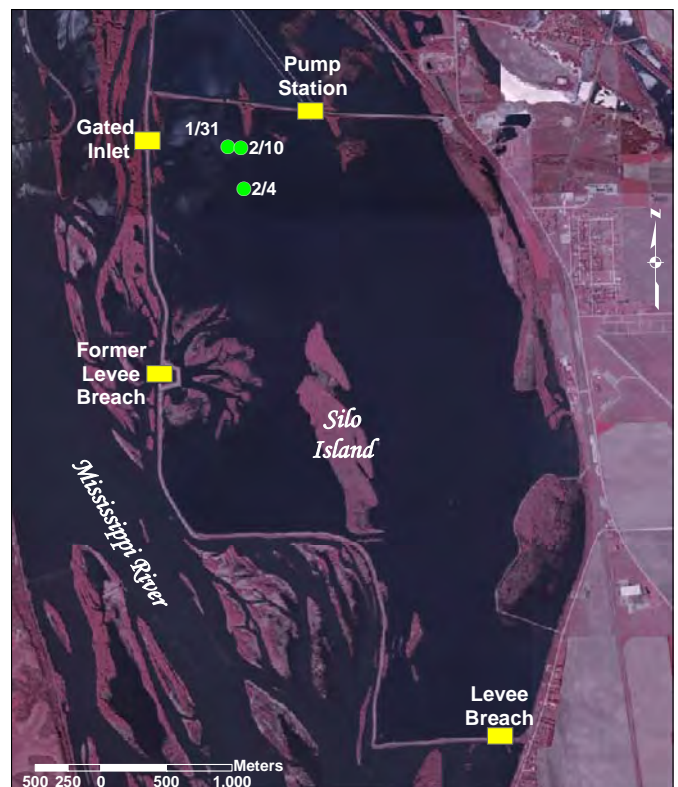
Figure 28. Location of Fish 810C, 831C, 851C and 890C on Specified Dates in 2005.

One objective of the study was to determine if an increase in water velocity caused by a larger gate opening would adversely impact over-wintering centrarchids, which prefer areas with little or no velocity. This objective was accomplished by tracking the movement of centrarchids fitted with radio transmitters to determine if they would leave the area where they were captured/released in response to the increased inflow. Twenty fish were caught and released below the cross dike on January 25<sup>th</sup> and 26<sup>th</sup> (see Figure 24). Fish were identified according to the last three digits of their transmitter frequency and whether they were a black crappie (“C”) or a bluegill (“B”). For example, the fish labeled “164B” was a bluegill fitted with a transmitter emitting a radio signal with a frequency of 49.164 MHz. The fish were monitored during three tracking events: January 31<sup>st</sup>-February 2<sup>nd</sup>; February 4<sup>th</sup>; and February 10<sup>th</sup> - 11<sup>th</sup>. Nineteen of twenty fish were located during each tracking event. Fish 761C was never found. The objective of the first tracking event was to determine initial fish location. The second and third tracking events were performed following the increase in gate opening. Figures 24-28 show the location of the fish during each tracking event by date. During the first tracking event, sixteen fish were located on January 31<sup>st</sup>. The position of some fish on this date was estimated when late in the day the GPS unit lost battery power. Fish 084C and 631C were found on February 1<sup>st</sup> and fish 194C was found on February 2<sup>nd</sup>. Although some fish were located after the increase in gate opening, it is unlikely the area where they were found was yet impacted by the increased inflow, except for perhaps fish 194C. The fish remained relatively close to the area where they were captured/released. The farthest distance traveled was approximately 1,200 m (3,937 ft) by fish 631C (see Figure 26). The second tracking event occurred on the fourth day (February 4<sup>th</sup>) following the increase in gate opening. The fish still remained relatively close to the area of capture/release, except for fish 751C. This black crappie traveled over 1,800 m (5,906 ft) to the east side of the lake; however, by the third tracking event six days later, it had returned to the vicinity where it was originally captured/released (see Figure 27). The third tracking event was performed on the tenth and eleventh days following the increase in gate opening. Again, the fish were located relatively close to the area of capture/release. The farthest distance traveled was approximately 900 m (2,953 ft) by fish 831C (see Figure 28).
