**UPPER MISSISSIPPI RIVER RESTORATION
ENVIRONMENTAL MANAGEMENT PROGRAM
POST-CONSTRUCTION
INITIAL PERFORMANCE EVALUATION REPORT
2012
FOR
SPRING LAKE
HABITAT REHABILITATION AND ENHANCEMENT PROJECT**

**US Army Corps
of Engineers** ®
Rock Island District

POOL 13

CARROLL COUNTY, ILLINOIS

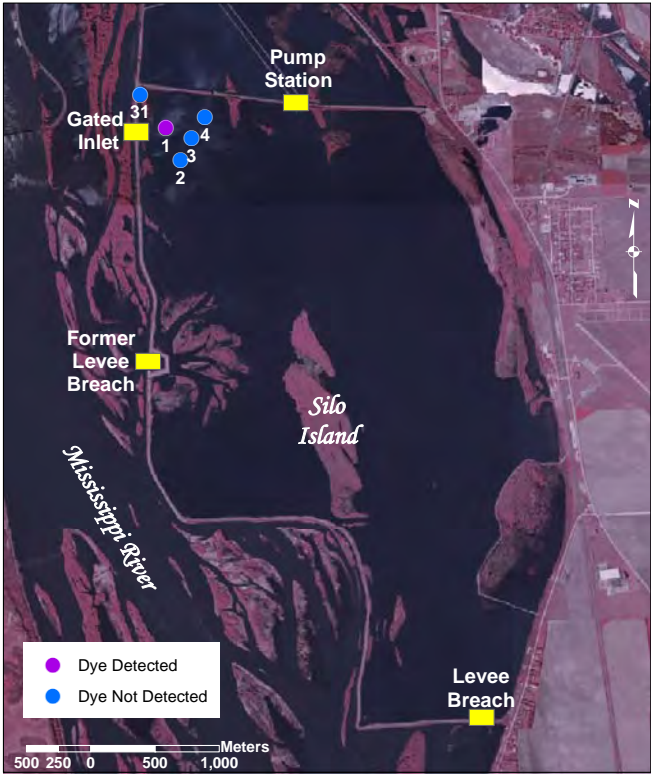
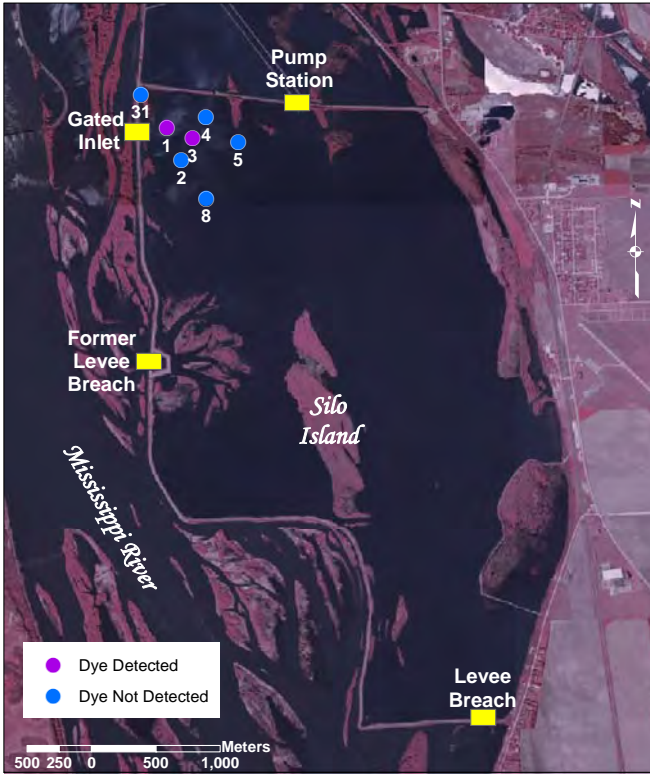
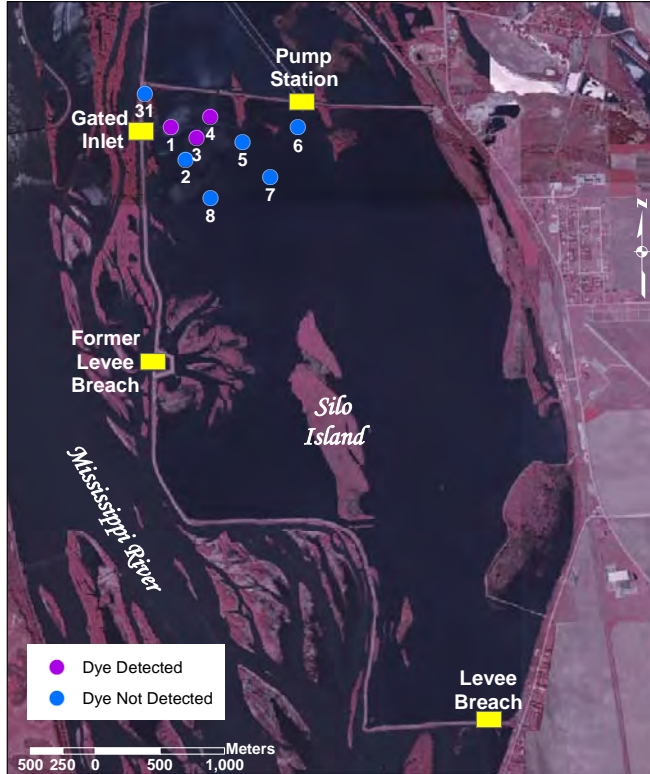
Figure D-7. Spring Lake Dye Dispersion, February 1, 2005.

The locations where dye was detected are shown on orthophotos of Spring Lake in Figures D-7 through D-9. The photos are positioned sequentially for the ten sampling events and include the time elapsed from initial addition of the dye to the beginning of each sampling event. The last photo is a cumulative map, showing all sites where dye was detected. Dye was detected at site 1 during the first six sampling events, was not found here during event seven, and then reappeared during events eight and nine. It is surmised that the reappearance of dye at site 1 may have been due to the rise in water level that occurred between events seven and eight, which may have flushed dye out of a small bay in the lake where site 31 is located. By sampling event two (elapsed time 3 hours), the dye was also detected at site 3. During sampling events three (elapsed time 5½ hours) and four (elapsed time 8½ hours), dye was present at sites 1, 3 and 4. After one day (sampling event five), the dye was detected at sites 1-5 and 31. At this point during the 2002 study the dye was present at only sites 3 and 4. During event six, at the 1¼ day mark, dye was detected at one additional site (7). By day 3 (sampling event seven), dye was not detected at site 1, but was additionally detected at sites 6, 8 and 11. The dye was no longer detected at sites 2, 3 and 4 during sampling event eight (elapsed time 6 days) but it reappeared at site 1 and was detected for the first time at sites 12 and 16. At this point during the 2002 study, site 7 was the farthest point from the injection site where dye was detected. During sampling event nine on day 9, the dye was detected at the most sampling points (sites 1, 5-17, 24-26, 28 and 31). On the final sampling event, day 13, dye was for the first time detected in the sub-basin of the lake west of Silo Island, appearing at sites 22 and 23. Dye was not detected in this area of the lake during the 2002 study. Other sites where dye was detected during event ten include 5, 13-15, 24-26, 28 and 31. The cumulative map indicates that over the course of the study, dye was detected at 23 of the 29 sites. During both the 2002 and present study, samples were collected on the sixth day following dye injection. Comparison of dye analysis results from these sampling events show that the dye traveled more than twice the distance during 2005 compared to that observed in 2002. The dye traveled 1,125 m (3,691 ft) in 2002, for an average velocity of .22 cm/sec while in 2005 it traveled 2,375 m (7,792 ft) for an average velocity of .46 cm/sec.

The middle portion of lower Spring Lake is bisected by Silo Island. As observed in 2002, the primary route of the dye in 2005 was to the east side of Silo Island. However, unlike in 2002, dye was detected in the sub-basin west of Silo Island in 2005, albeit not until the last sampling event. The area west of the upper part of Silo Island is relatively shallow. A significant amount

With a gate opening of 3 feet in 2005, inflowing water dispersed throughout Spring Lake faster and more completely than was observed during a similar study in 2002 when the inlet structure gate was open only 10 inches. With the larger gate opening in 2005, the inflow to the lake was measured at $1.06 \text{ m}^3/\text{s}$ (37.39 cfs), which is comparable to the value predicted ($1.33 \text{ m}^3/\text{s}$ or 47 cfs) prior to construction utilizing a culvert rating program. The dispersal pattern still favored the deeper portions of the lake north and east of Silo Island; however, unlike in 2002, dye was eventually detected in samples collected from the sub-basin of the lake west of Silo Island. A comparison of dye analysis results from samples collected on the sixth day following injection during both studies show that the dye traveled more than twice the distance during 2005 compared to that observed in 2002. The dye traveled 1,125 m (3,691 ft) to site 7 in 2002, for an average velocity of .22 cm/sec while in 2005 it traveled 2,375 m (7,792 ft) to site 16 for an average velocity of .46 cm/sec. In both studies the velocity of the inflow dropped markedly once it exited the dredged channel near site 1 and entered the main basin of the lake. In 2002, the velocity measured at site 1 was 3.353 cm/s, while in 2005 it ranged from 15.18 to 20.97 cm/s. Velocities measured at other sites throughout the lake were nearly all below 1 cm/sec.

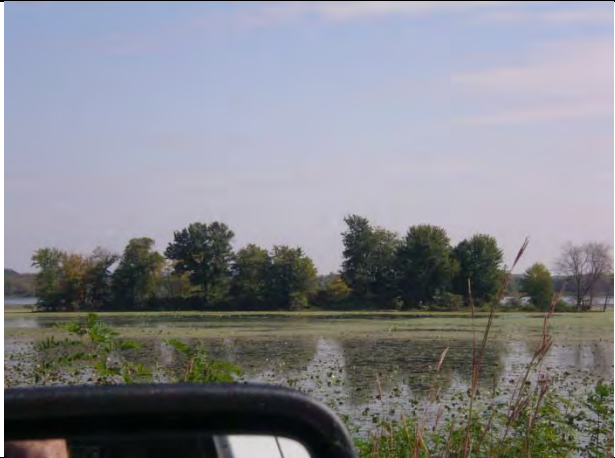
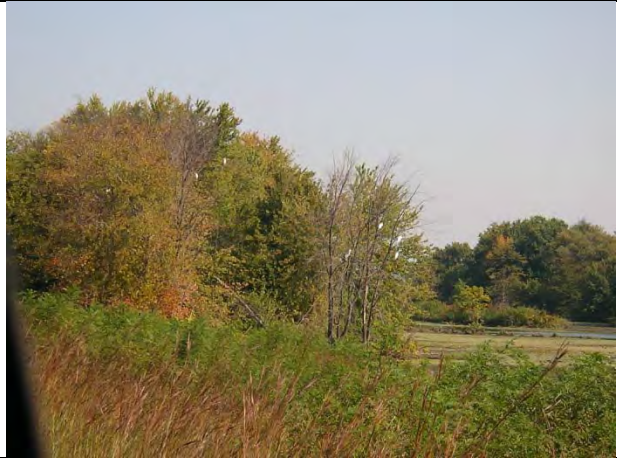
Spring Lake Site Visit 28-SEP-2011 Looking southwest at Mississippi from exterior of containment levee. 2008 flood damage repair.	Spring Lake Site Visit 28-SEP-2011 Interior view looking east from west side

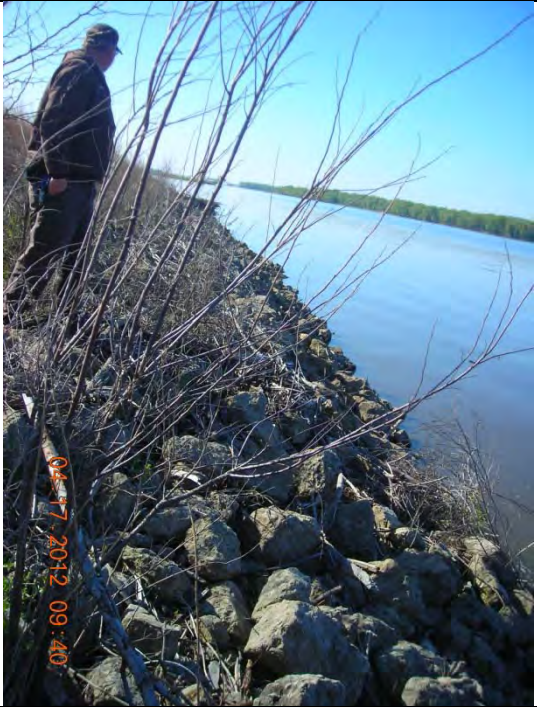
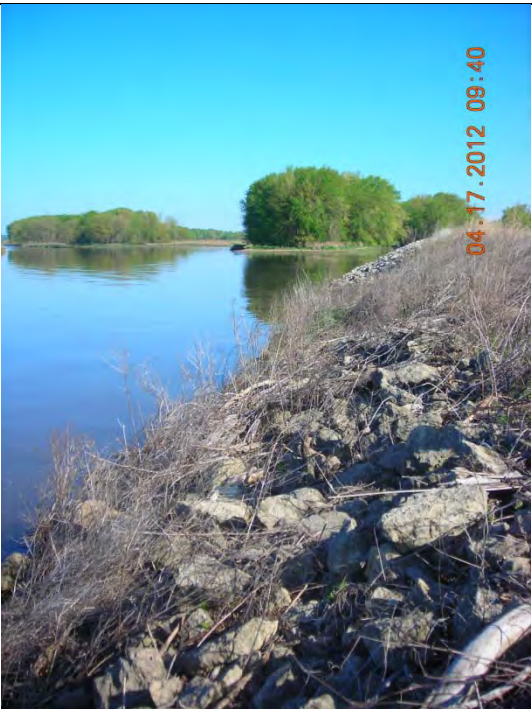
<p>Spring Lake Site Visit 17-APR-2012 West levee.</p>	<p>Spring Lake Site Visit 17-APR-2012 Erosion at base of west levee. The water depth is 20-25' just a few feet offshore with strong currents against the bank. (per Ed Britton)</p>

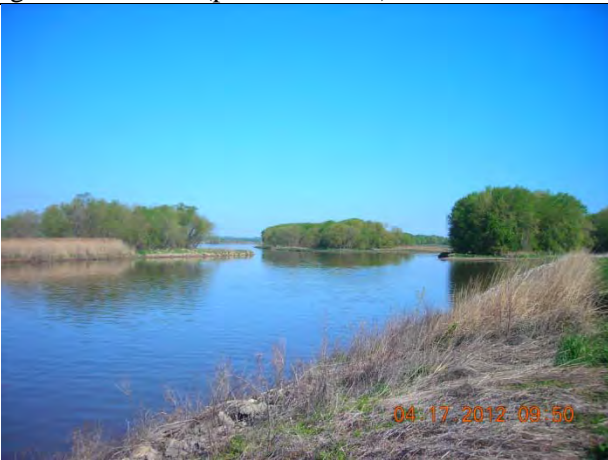
<p>Spring Lake Site Visit 17-APR-2012 Erosion at base of west levee.</p>	<p>Spring Lake Site Visit 17-APR-2012</p>

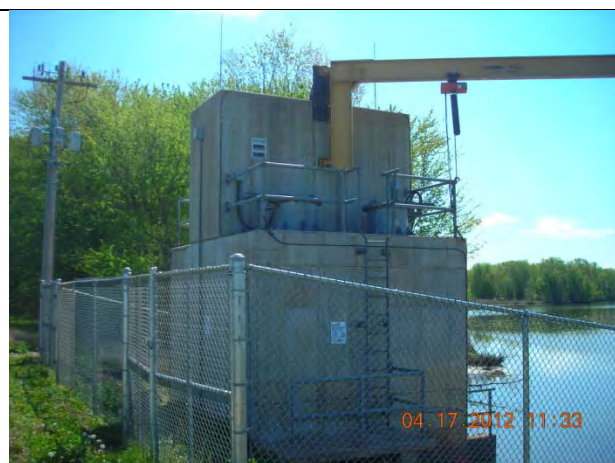
Pump station near main entrance (looking SE)
Spring Lake Site Visit 17-APR-2012

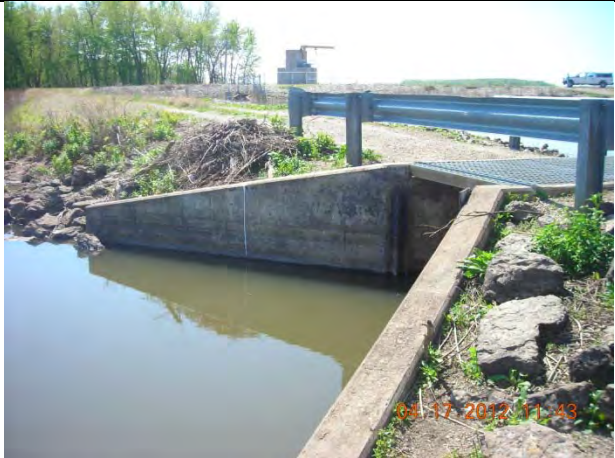
<p>Persistent Beaver Dam Spring Lake Site Visit 17-APR-2012</p>

Obstacles hindering success include determination of best management practices for the gated inlet structure that would allow for greater dissolved oxygen influx and dispersion; the persistent muskrat and beaver populations causing damage to the structures, and erosion/scour control. Efforts by the USFWS have made headway in dealing with the later two issues.
