## **Chapter 2: Shoreline Stabilization**

### Upper Mississippi River Basin EMP Workshop

by Kari Layman

Hydraulic Engineer US Army Corps of Engineers, St. Paul District

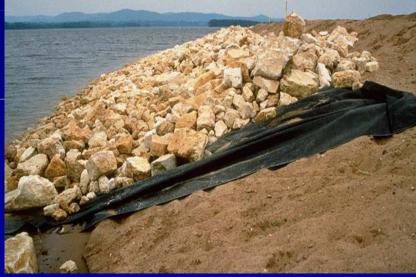
#### Design Criteria

Rock Slope	1V:1.5H – 3H
Height above Average Water Surface Elevation (feet)	1 – 5
Thickness (inches)	18 - 36

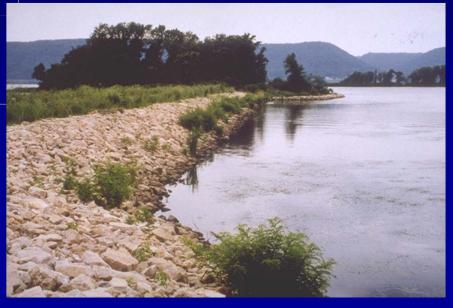
## **Rock Revetments**

Design Criteria

Rock Slope	1V:1.5H – 3H
Height above Average Water Surface Elevation (feet)	1 – 5
Thickness (inches)	18 - 36

- New Construction and Existing Shoreline
- Improves shear strength of shoreline

- 18 inch thickness placed at 1V : 3H is stable
- 1V: 4H should be used if ice action is expected

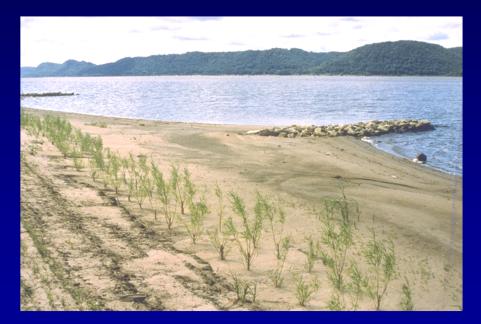
### **Rock Groins**

Design Criteria	
Top Width (feet)	2 – 5
Rock Slope	1V:1.5H – 2H
Height above Average Water Surface Elevation (feet)	1.5 – 2
Groin Length (feet)	30 – 40
Groin Spacing (feet)	120 – 240
Ratio of Groin Spacing to Groin Length	4 – 6
Key-in (feet)	5 – 10

Mainly New Construction

✓ Wave Action and Littoral Drift are the Dominant Processes

- If ice action is anticipated, end slope should be 1V:5H
- If little scalloping observed, vegetation alone could have been used

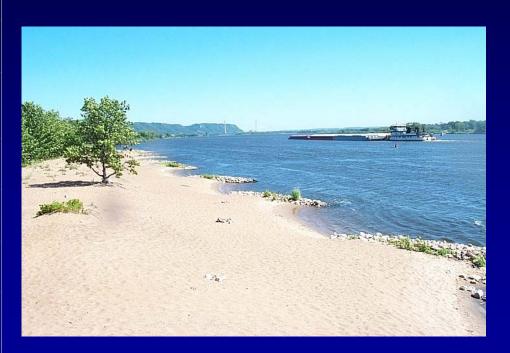
### **Rock Vanes**

#### Design Criteria

Top Width (feet)	3 – 5
Rock Slope	1V:1.5H – 3H
Height above Average WSE (feet)	1.5 – 2
Top Elevation Slope	10 – 12%
Length	30 – 45
Hook Length (J-Hook vanes only)	30 – 45
Angle (θ)	40 – 55
Spacing Ratio (Length to Spacing)	1:3 - 4

- New Construction and Existing Shoreline
  - ✓ Adjacent to moving current
  - ✓ More economical than groins in deeper water

• Stabilized bank, but reshaping is still occurring.

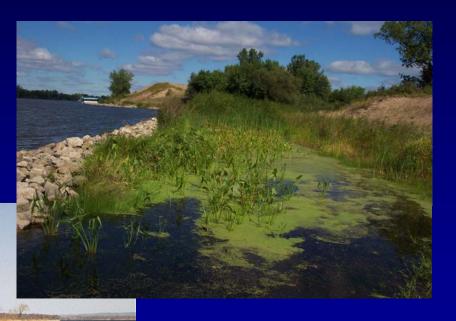
## **Offshore Rock Mounds**

#### Design Criteria

Top Width (feet)	3 – 5
Rock Slope	1V:1.5H – 3H
Height above Average WSE (feet)	1.5 – 2

- Shoreline with shallow nearshore bathymetry
- Low shorelines or marsh area
- Shorelines with heavy wood debris

- Design top elevations need to account for settling
- Settling has continued over time

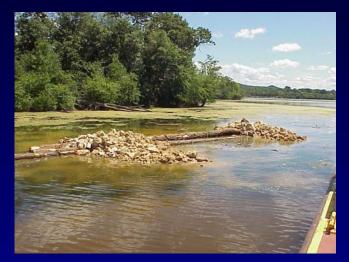
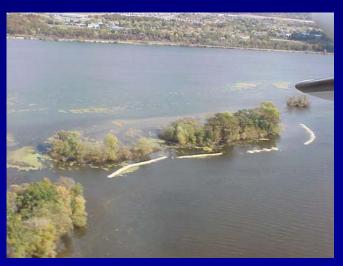
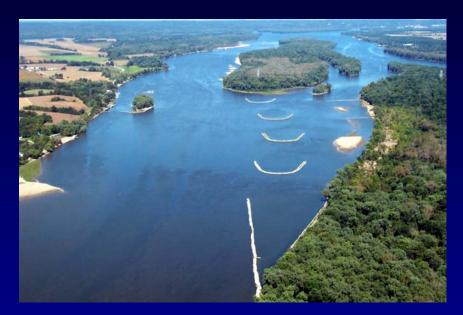
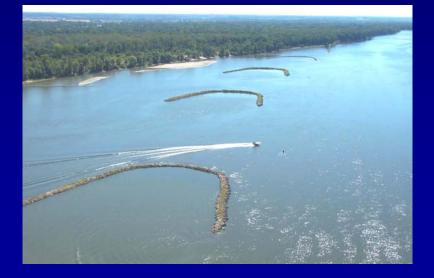
### **Rock-Log Structures**

Minimum Rock Cover Needed (feet)	Typical Bottom Elev Required and Elevation of Tree Trunk
2.0' if 15' of tree is covered by rock 1.5' if 20' of tree is covered by rock	628.0 to 628.5 = Bottom 630.0 to 630.5 = Tree Trunk

- Allow better control of flow splits between the main and side channels
- Scour holes on the downstream side improve habitat diversity
- Wide reaches of the river, where a typical dike is not feasible

- Better if several are used in a series
- Bank revetment is typically needed on the near bank of the structures

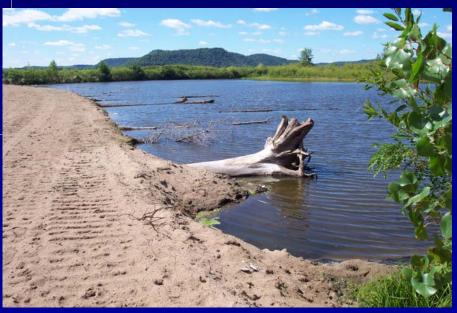
## **Loafing Habitat**

Design Criteria

Height above summer pool (inches)	2 – 12
Length (feet)	25 - 60
Tree Species	Black Locust, White Oak
Location	Sheltered Areas
