Upper Mississippi River Restoration Program

Floods, Rain, Drought and Snakes
(Lake Odessa)

Kara N. Mitvalsky, P.E.
CEMVR-EC-DN

Construction in a Managed Backwater

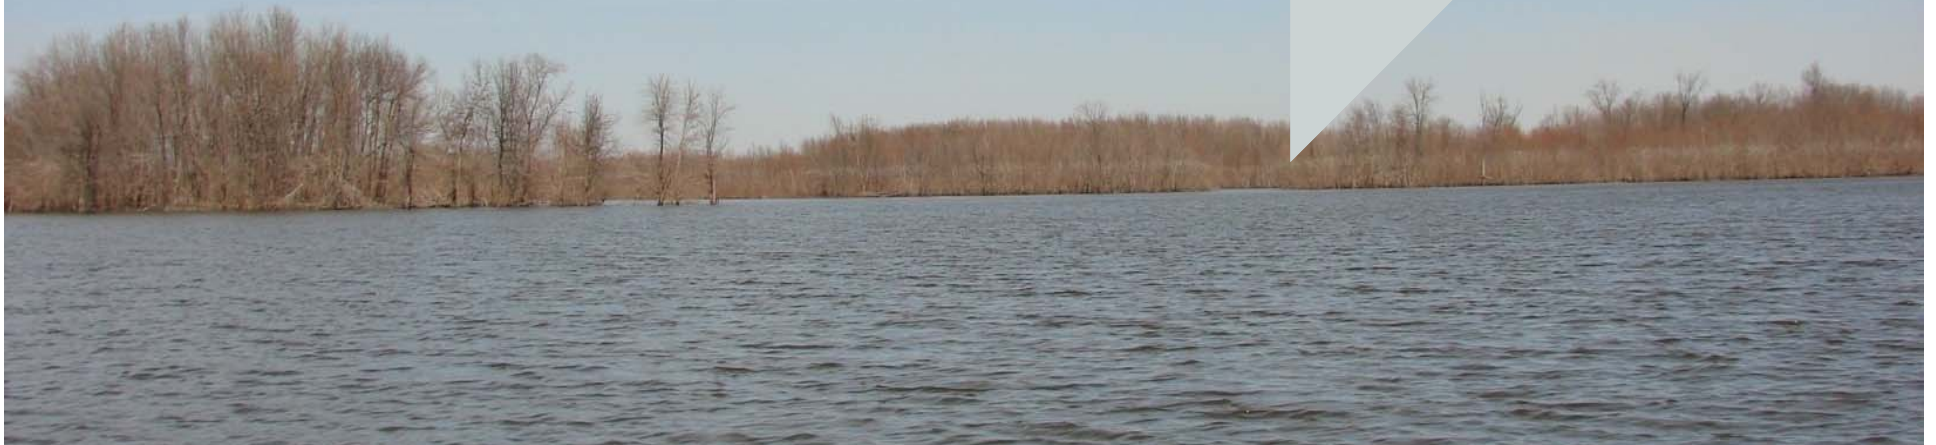
Long
Inundation

Mast Tree
Loss

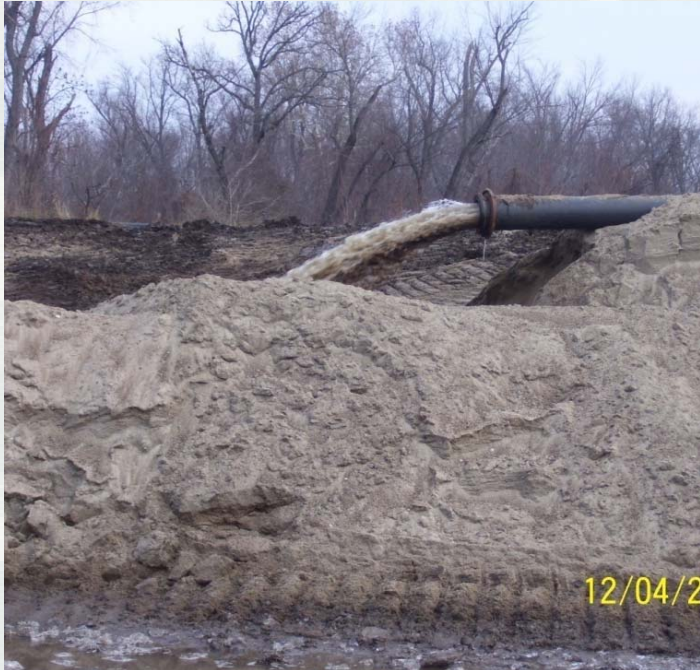
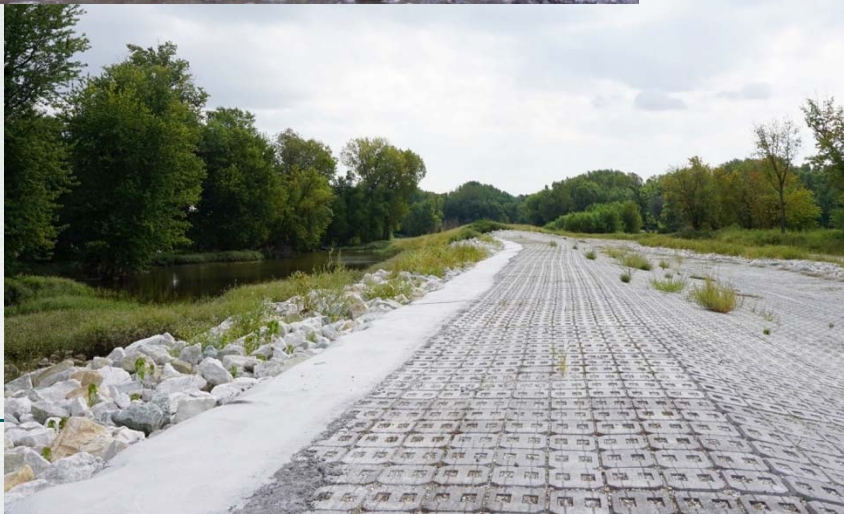
The Fix (Part 1: Protect the Site)

- Allow for interior filling prior to overtopping.
 - ▶ 4 spillways.
 - ▶ Inlet Structure
 - ▶ Outlet Structure
- Ensure embankment top elevation slopes with river elevations uniformly.
- Clay cap for overtopping protection

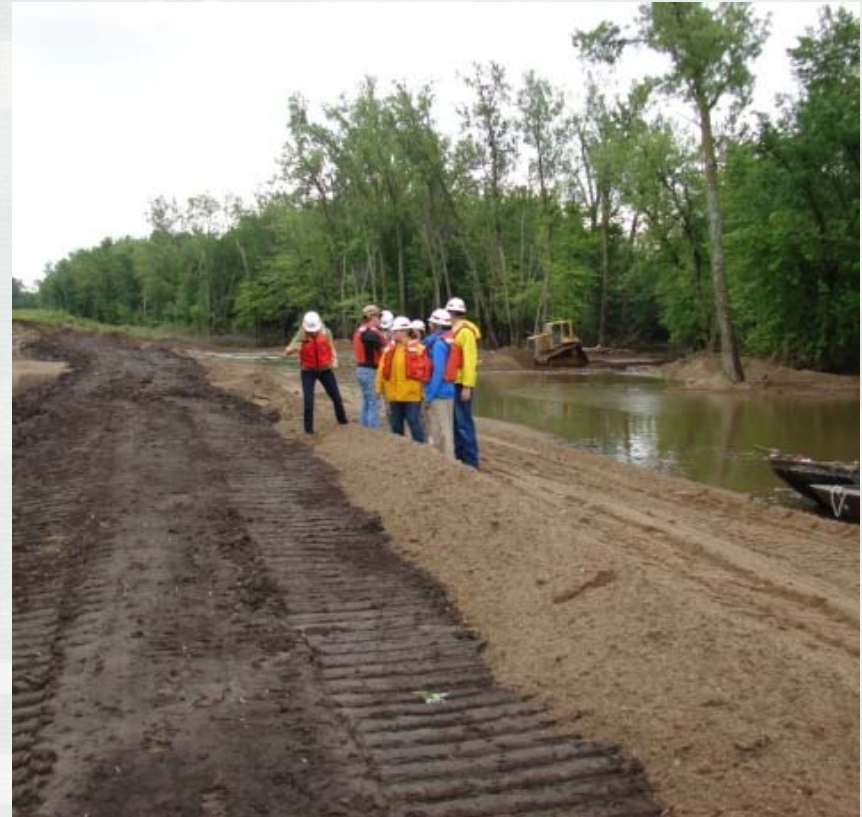
Interior Filling Challenges During Construction

- Levee Design:
 - ▶ DPR: Sand Levee
 - ▶ Reality: Overtopping sand levees does not work. (Damage during Stage I)
 - ▶ Fix: Clay cap so when overtopped levee is protected (Stage IB)

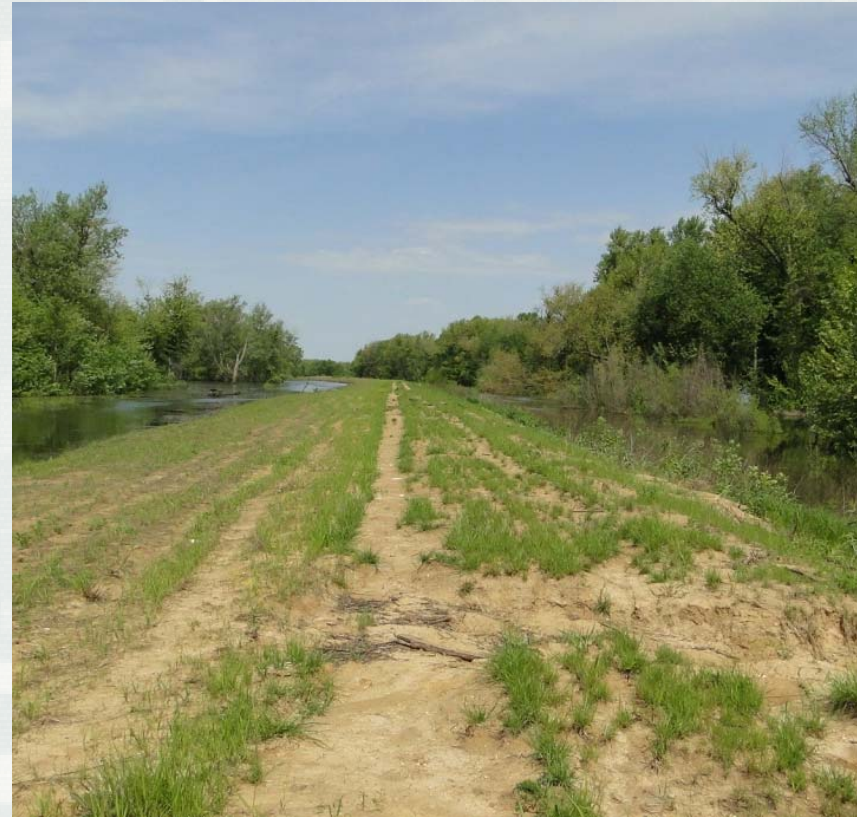
Interior Filling Challenges During Construction

- Levee Design:
 - ▶ Condition: Sand Levee with Clay Cap that is SEEDED
 - ▶ Reality: Seed needs water to grow. There is not much water during a drought year. Following this with a flood year can cause damage.
 - ▶ Fix: Levee breaches repaired, seed reestablished (2013 Flood Recovery Contract). Consider praying for rain, rain dances, or add watering to your contract.

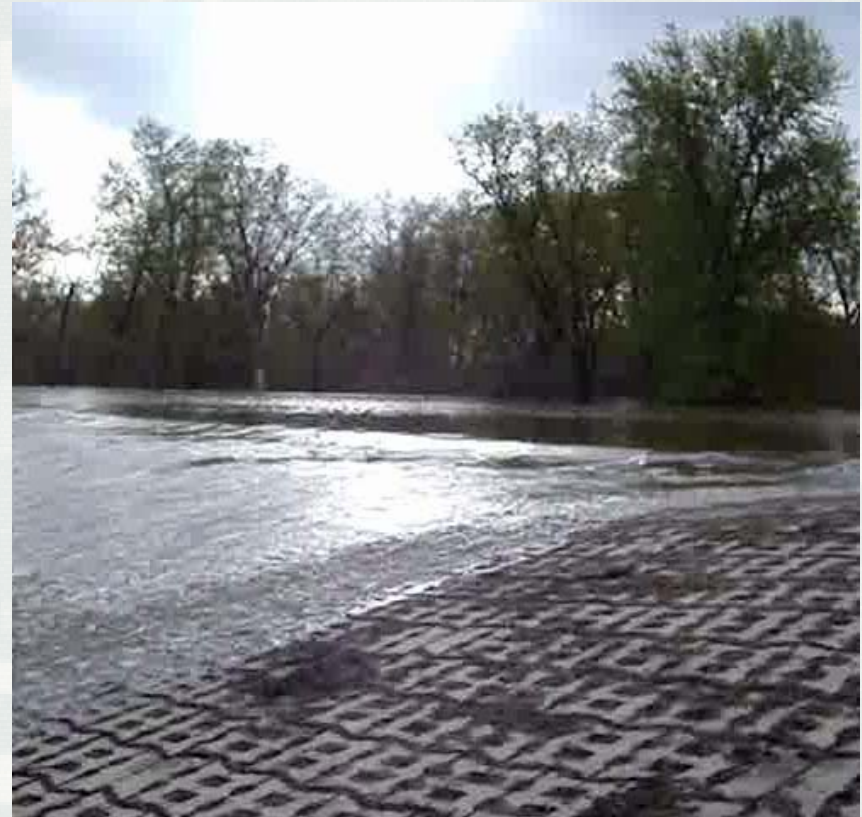
Interior Filling Challenges During Construction

- Spillway Design.
 - ▶ DPR: 2 spillways
 - ▶ Design Change: Spillway moved to protect historic site
 - ▶ Reality: 2013 was fastest river rise on record, exceeding design rise.
 - ▶ Fix: 2 additional Spillways added to allow for interior filling (2013 Flood Recovery)

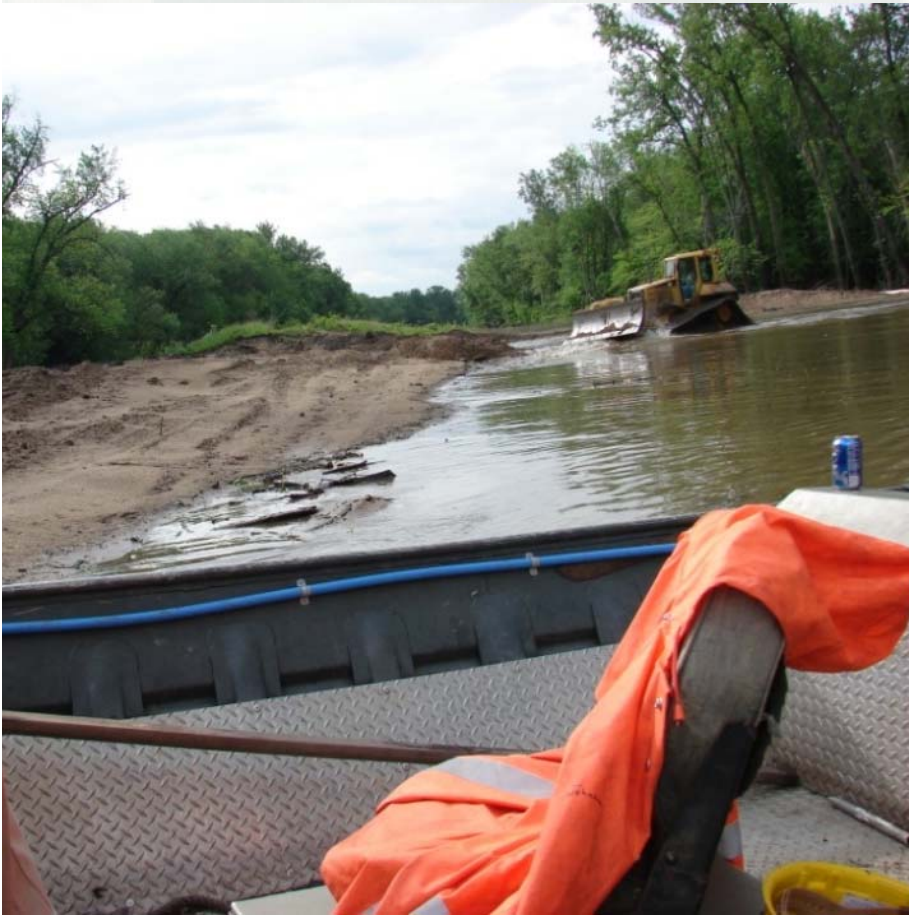
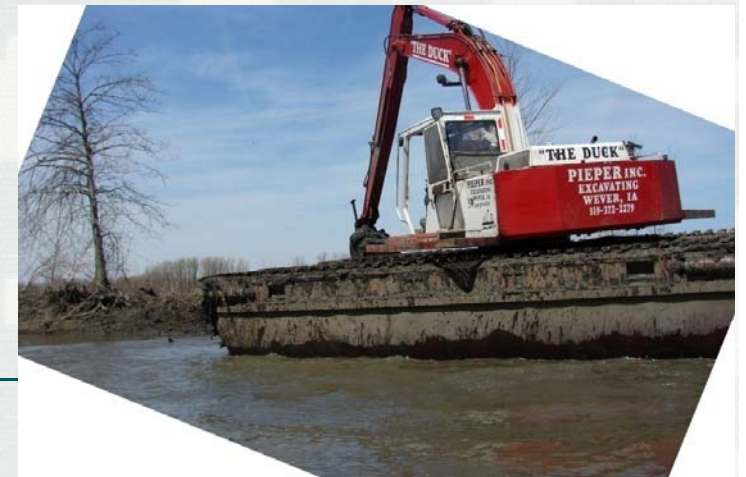
The Fix (Part 2: Save the Fish)

- Remove sediment which has entered system through previous breaches

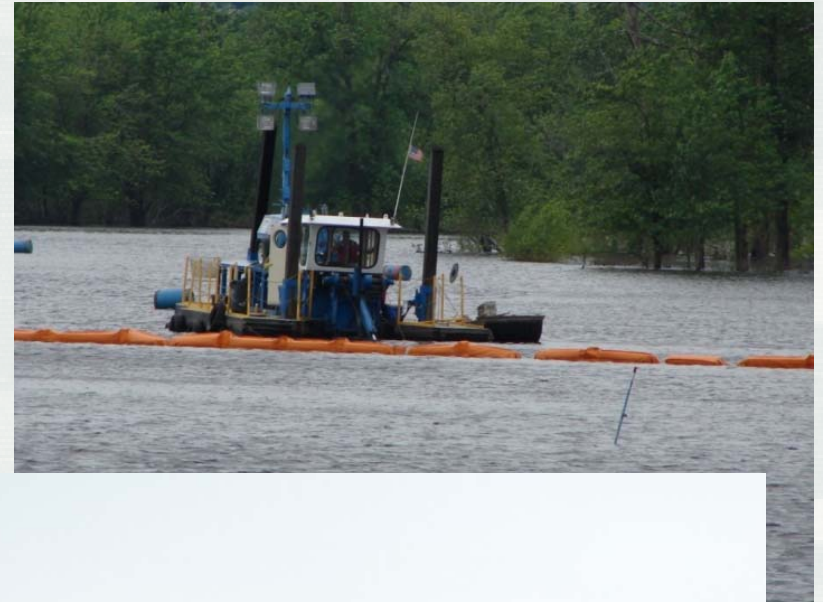
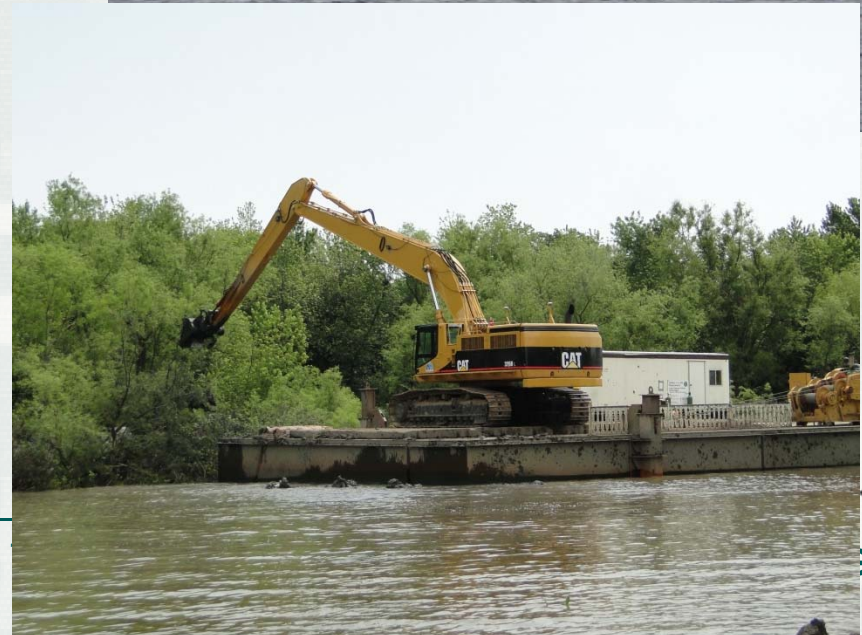
Dredging/Excavation Challenges During Construction

- Drought/Low Water Years made it difficult to access site.
- Flood years made it difficult to access site.
- Limited boring data did not discover clay which could not be hydraulically dredged (removed from Stage IIA and moved to Stage IIB)
- Hydraulically dredged material was to be used to cap a MSU. Without this material, water could not be held. Modification issued to grade MSU to provide clay layer throughout.

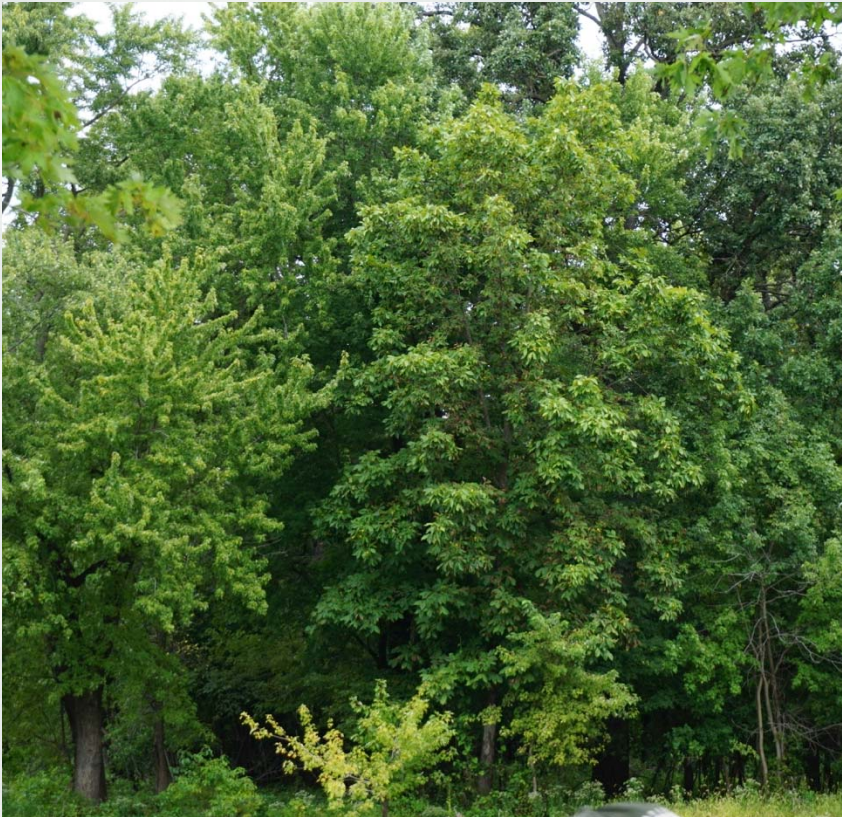
The Fix (Part 3: Save the Trees)

- Timber Stand Improvement to compensate for trees which died from long inundation stress
- Protecting the system will help protect the trees.

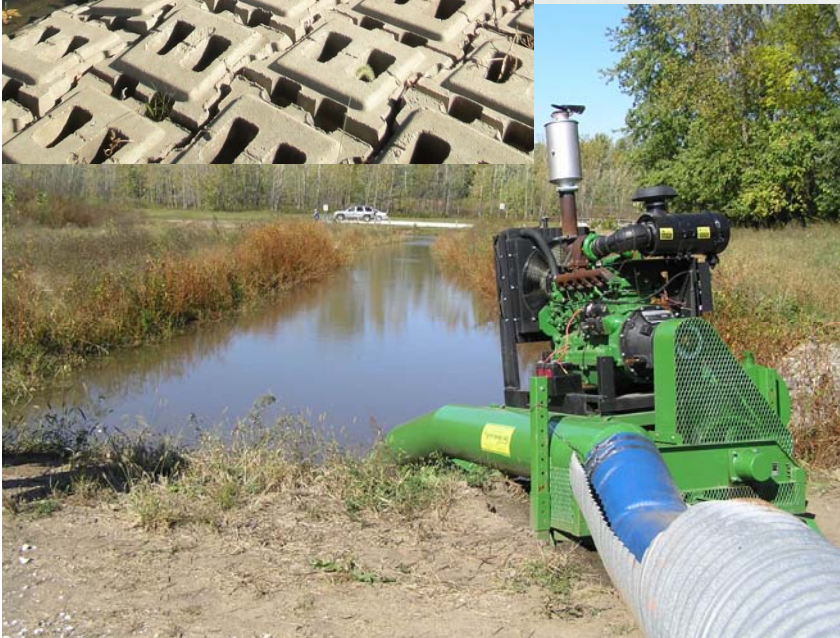
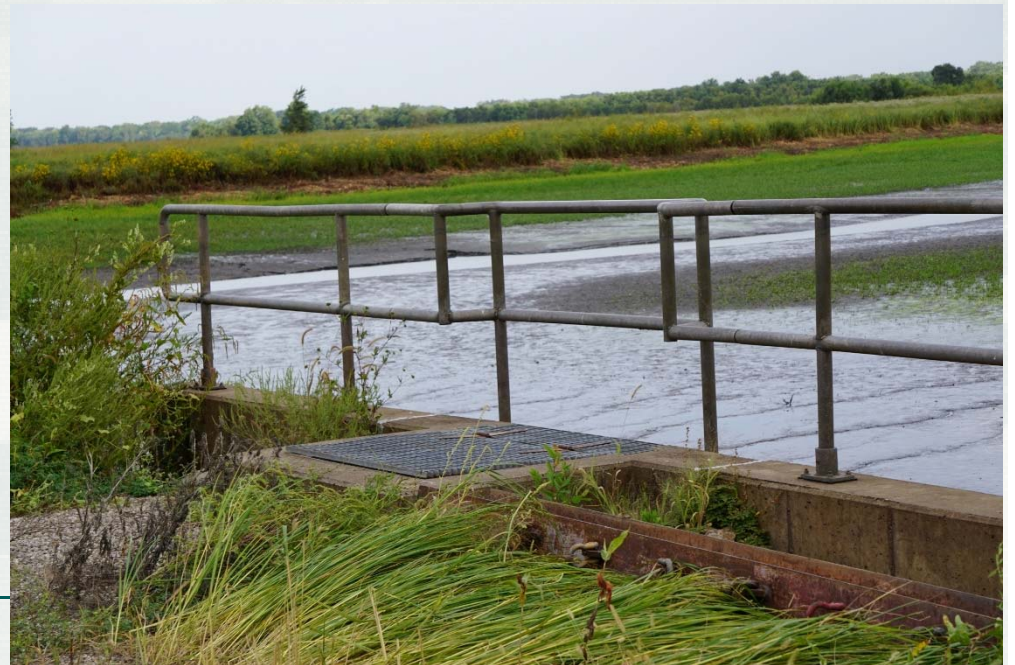
The Fix (Part 4: Backup Plans)

Internal water level
management in smaller
moist soil management
units

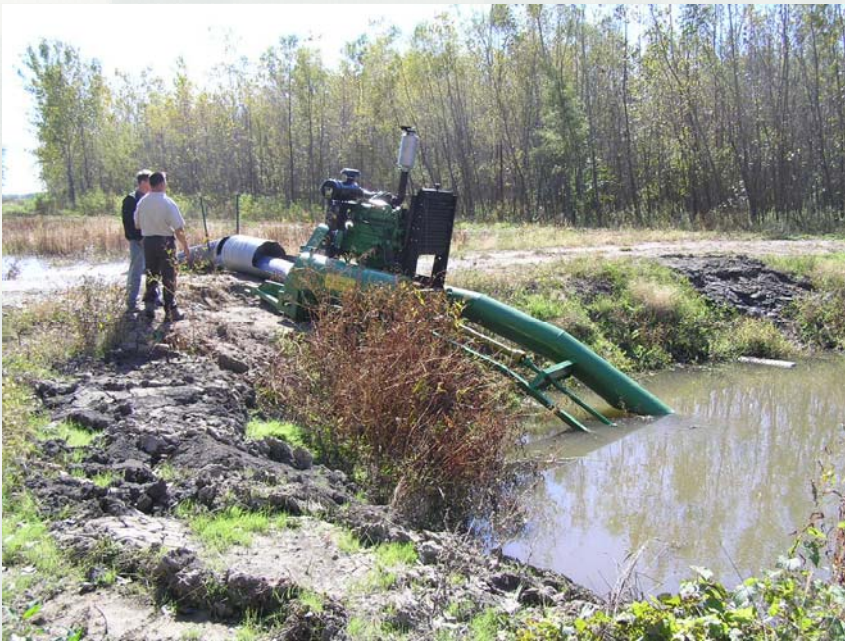
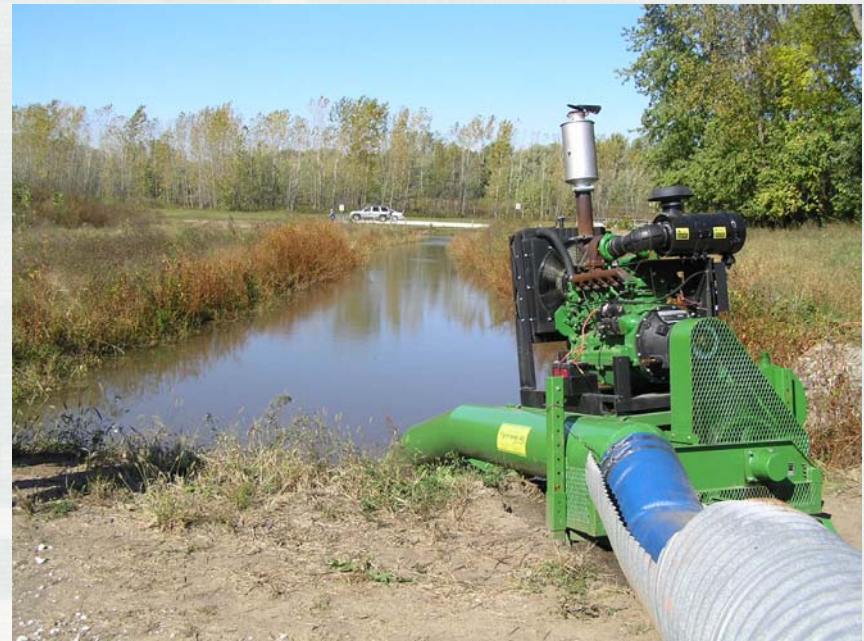
Pumps Purchase (2005) (for wetland water level management)
