POST-CONSTRUCTION PERFORMANCE EVALUATION REPORT – YEAR 10 (2002) FOR

ANDALUSIA REFUGE HABITAT REHABILITATION AND ENHANCEMENT PROJECT

UPPER MISSISSIPPI RIVER SYSTEM ENVIRONMENTAL MANAGEMENT PROGRAM

JULY 2003

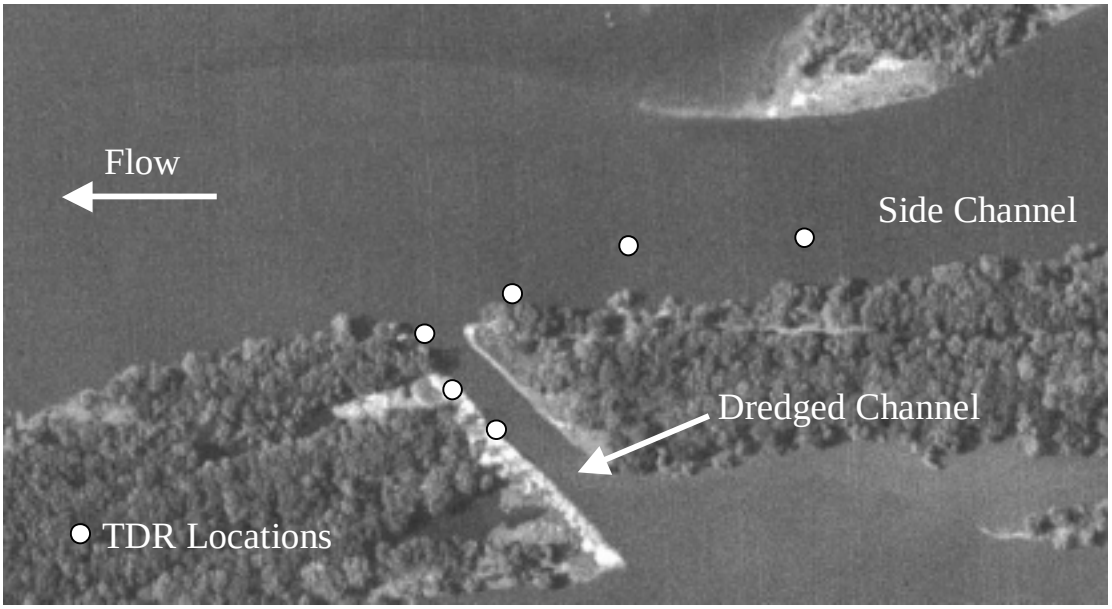
Figure 2. TDR locations, Mississippi River.

Mississippi River, Andalusia, IL. The objective of the study was to document the changes in bed elevation during the winter to calibrate a numerical sediment model. The instrumented site is at the confluence of a dredged channel with a side channel in a navigation pool on the Mississippi River downstream of Rock Island, Illinois. The instrumented site is shown in Figure 2, with the dredged channel (which provides water to a wildlife reserve) on the lower right, the side channel in the middle of the figure, and the navigation channel on the opposite side of the island along the top edge of the figure. Bed elevations were monitored at six locations using the TDR probes during the winters of 1999-2000 and 2000-01 (Zabilansky, in prep.). Probes were installed in the side channel and the dredged channel for the reserve; channel depths were 3 and 1.5 m, respectively. Water velocities within the pool were relatively low, and a thermally grown ice cover formed in place with a relatively smooth bottom surface. Being a regulated pool, the stage was not allowed to increase as the ice cover formed. The maximum ice thickness in the confluence area was on the order of 22 cm, and ice completely covered the width of the river. There was no appreciable change in bed elevation in the side channel during the

winter, but material was deposited in the dredged channel. Ice melted in place starting in the navigation channel. As the ice melted in the navigation channel, material started to deposit in the side channel and continued to deposit in the dredged channel. Deposition continued until the side channel was ice-free.

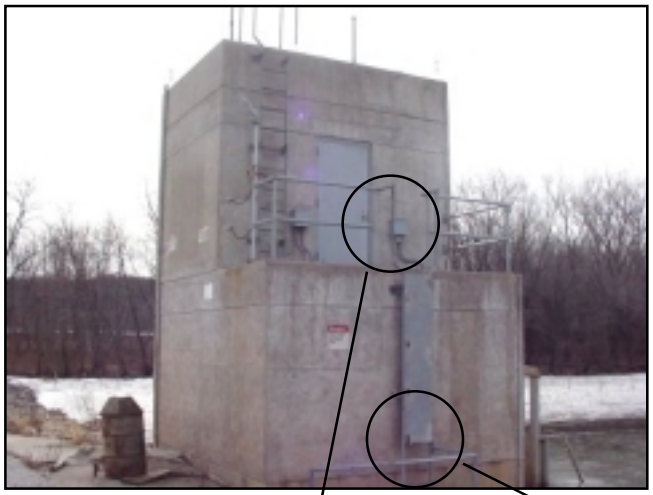
On levee looking at pump station

(f) Pump Station. In 2002, the building, gates, pumps, control panel, and trash racks were reported as being in good condition. In August 2001, the low level float was replaced. It was documented that the rubber edging on the sluice gates will also need to be replaced. Annual maintenance of the fence systems should continue prior to freezing conditions. The pump station water level control form is located in Appendix D.

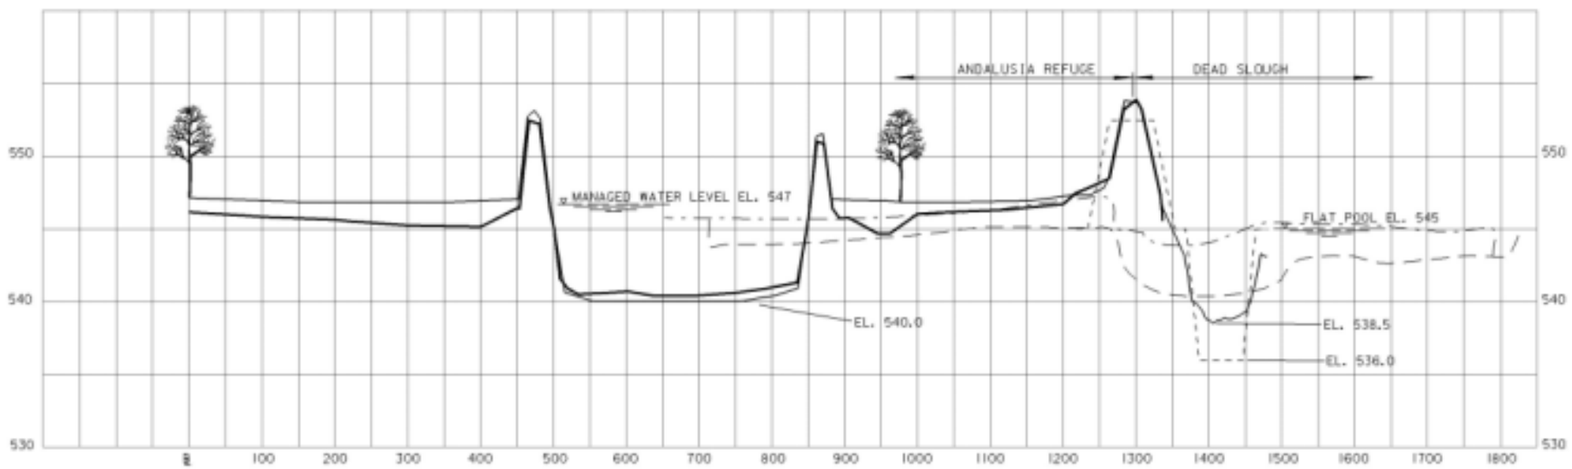
Sheet Reference Number:
PLATE 4

According to Appendix C, Table C-2, hydrographic soundings are required every 5 years by the Corps. Hence, additional soundings were completed in July 2002. Using these data, the average channel width could be calculated by measuring the distances along each transect at the maximum water elevation of 547 feet MSL. The channel length was determined using a distance representative of the average channel width for each individual transect. Once these two values were known, the water surface area could be estimated. The water surface area in 2002 was found to be approximately 99.0 acres, generously exceeding the Year 50 Target of 50 acres. These data are summarized in Table 5-1, while the hydrographic soundings can be seen on Plates 4 and 6 in Appendix M.

A recommendation for the Andalusia HREP is to complete hydrographic soundings within Dead Slough based on the monitoring plan, thus providing more adequate data to better define deep aquatic habitat depths throughout the entire area. Current analysis is based on data collected at the water quality station. It could be assumed that these depths are representative of the entire Dead Slough area but it is not known for sure if this is indeed the case. In addition, the location of the water quality station is determined through use of landmarks rather than coordinates, so channel depths are not necessarily recorded in the exact same spot each time. While the data from the water quality station may provide some idea of deep aquatic habitat depths, this is not its intended purpose.
