UPPER MISSISSIPPI RIVER SYSTEM
ENVIRONMENTAL MANAGEMENT PROGRAM
POST-CONSTRUCTION PERFORMANCE
EVALUATION REPORT – YEAR 4 (2001)

COTTONWOOD ISLAND HABITAT REHABILITATION AND ENHANCEMENT

APRIL 2002

POOL 21
MISSISSIPPI RIVER MILES 328.5 – 331.0
LEWIS AND MARION COUNTIES, MISSOURI

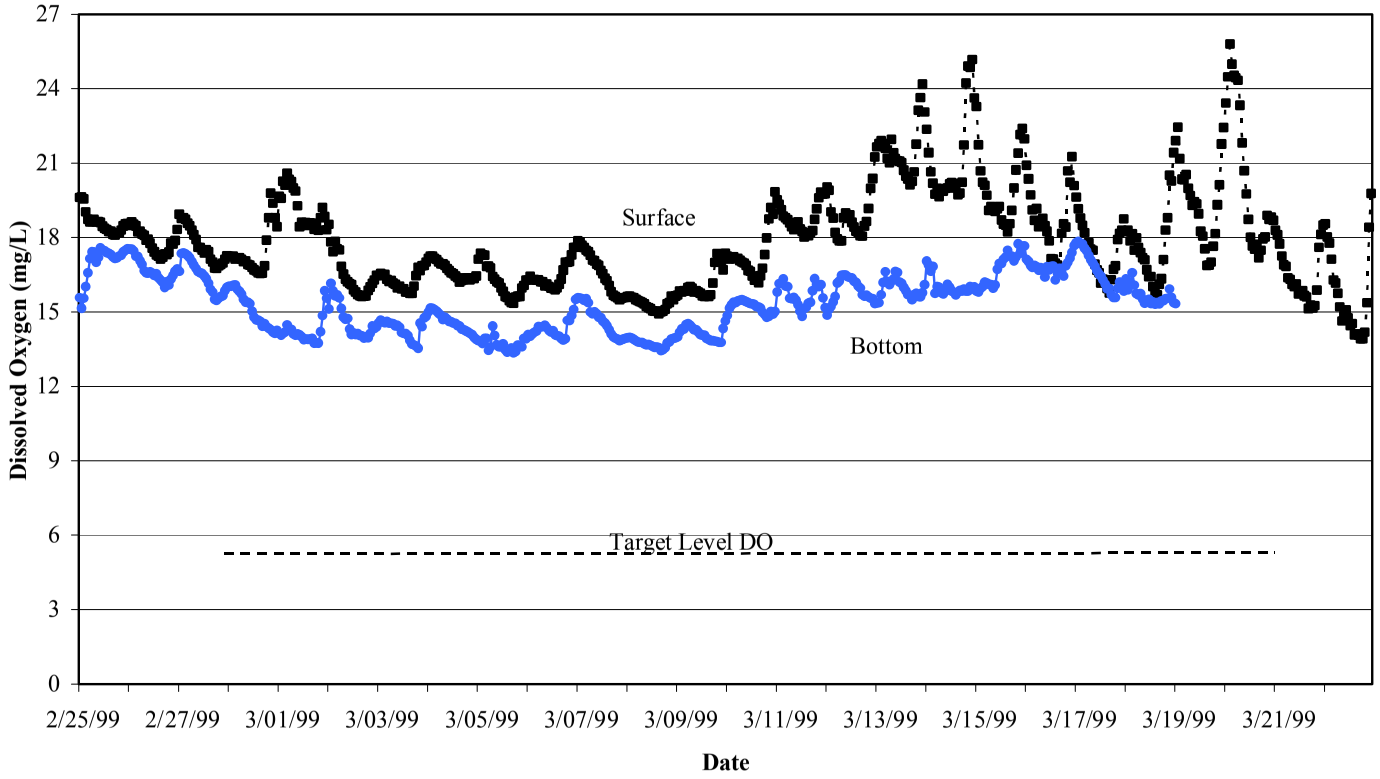
Figure E-1. Monitoring Results at Station W-M328.7B during Winter 1999

In-situ continuous water quality monitors were deployed at Station W-M328.7B on 6 occasions during the winter months. All DO concentrations were greater than the state standard and supersaturated conditions were common. Figure E-1 in Appendix E is an example of DO data collected during the winter with a continuous monitor. The graph depicts DO concentrations during the deployment period of February 25 through March 23, 1999 as measured at points 3 feet (bottom) and 12 feet (surface) from the bottom. Supersaturated conditions existed for most of the deployment. DO concentrations close to the bottom generally paralleled and were almost always lower than those observed near the surface. Data from the bottom sonde only extended to March 19, 2001 due to a loss of battery power. Daily fluctuations in DO concentrations near the surface were greater than those observed near the bottom due to algal photosynthesis.

FIGURE E-1. Post-Project Dissolved Oxygen Concentrations Collected with Continuous Monitors Near the Surface and Bottom at Station W-M328.7B (February 25, 1999 - March 23, 1999)

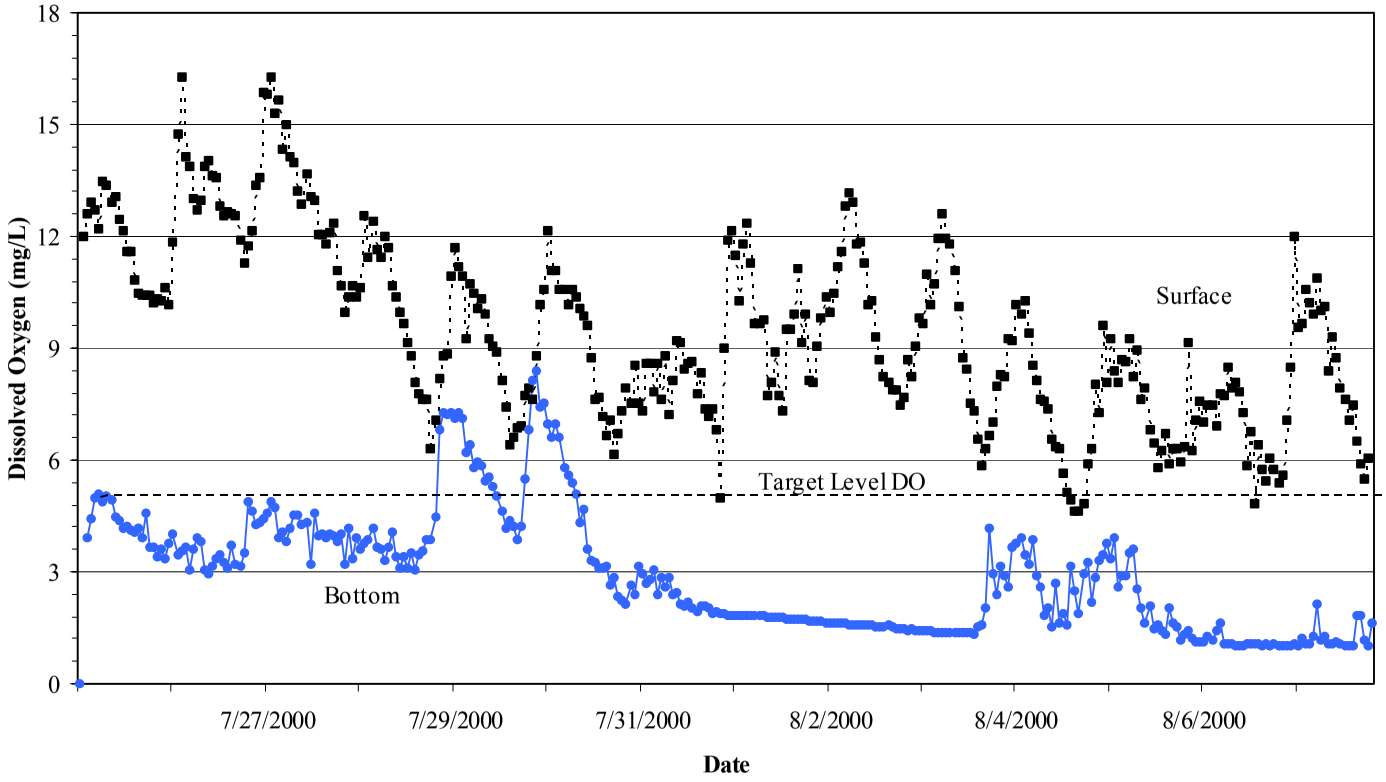
Figure E-2. Monitoring Results at Station W-M328.7B during Summer 2000

In-situ continuous water quality monitors were deployed at Station W-M328.7B on 17 occasions during the summer months. During this period, stratification was more intense. DO concentrations measured 3 feet from the bottom were frequently below the state standard, while those measured near the surface only occasionally fell below the state standard. Figure E-2 in Appendix E is an example of DO data collected during the summer with a continuous monitor. The graph depicts DO concentrations during the deployment period of July 25 through August 8, 2001 as measured at points 3 feet (bottom) and 12 feet (surface) from the bottom. On occasion, the DO concentration at the surface fell below the state standard of 5 mg/L. However, these excursions were short lived. Conversely, the DO concentration near the bottom during this deployment was rarely above the state standard. During two extended periods, the DO concentration near the bottom showed little diurnal variation. A sonde malfunction may have been responsible for these anomalies.

FIGURE E-2. Post-Project Dissolved Oxygen Concentrations Collected with Continuous Monitors Near the Surface and Bottom at Station W-M328.7B (July 25, 2000 - August 8, 2000)

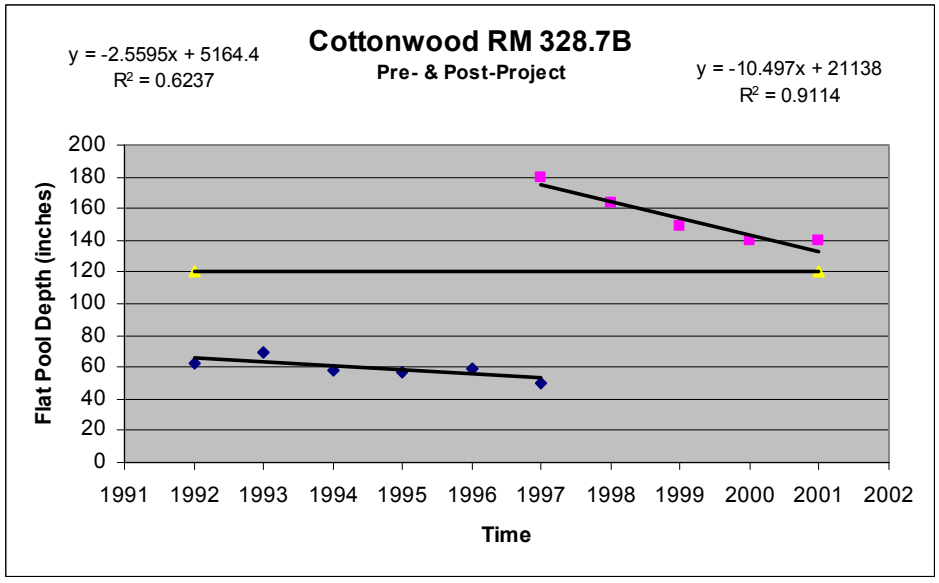
Figure F-1. Sedimentation Rates at Station W-M328.7B

deep aquatic habitat depths in 1997 at project completion averaged 15 feet. In 2001, deep aquatic habitat depths averaged 11.61 feet. This equates to an annual average sedimentation rate of 10.50 inches per year. It should be noted that the average sedimentation rates from 1998 to 2001 steadily decreased from year to year. This may suggest that the slough is approaching a stable condition. From Year 3 to Year 4, the average sedimentation rate was approximately 0.60 inches per year. This rate closely resembles the determined value in the DPR.

A couple of factors may explain why the overall average sedimentation rate of approximately 10.5 inches per year for both transects is higher than the estimated numbers. First, the deep holes were excavated to a depth of approximately 15 feet, as illustrated in the O&M Manual on Plates 11 through 13. In essence, these holes were over-excavated to allow for sloughing of the vertical slopes. Therefore, it appears logical to assume that some of the chute bottom deposits are a result of the deep holes attempting to reach a stable condition or more gradual slope. Another factor that may explain the higher sedimentation rate is the occurrence of spring flood events. At high river levels, the causeway is overtopped, which carries sediment-laden water into the chute. According to the MDOC, the causeway was overtopped three times in the first two years following project completion. Both of these factors allow Cottonwood Chute to be more susceptible to sediment deposition.

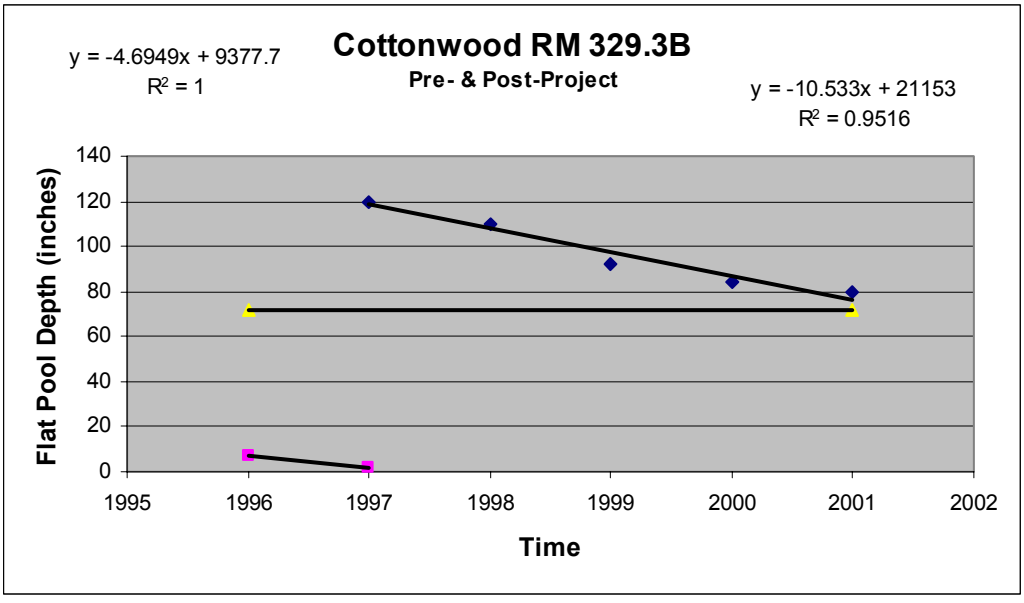
Figure F-2. Sedimentation Rates at Station W-M329.3B

The DPR estimate of the sedimentation rate in the middle portion of Cottonwood Chute, or near Transect J, was also lower than the estimated overall average. This rate was estimated to be approximately 0.16 inches per year. In general, chute excavation depths in 1997 at project completion averaged 10 feet. In 2001, deep aquatic habitat depths averaged 6.68 feet. This equates to an average sedimentation rate of 10.53 inches per year, which is essentially the same as that for Transect C. It should be noted here that the average sedimentation rates from 1998 to 2001 steadily decreased from year to year. From Year 3 to Year 4, the average sedimentation rate was approximately 4.32 inches per year. This value is one-fourth the rate determined only two years before (17.52 inches per year).

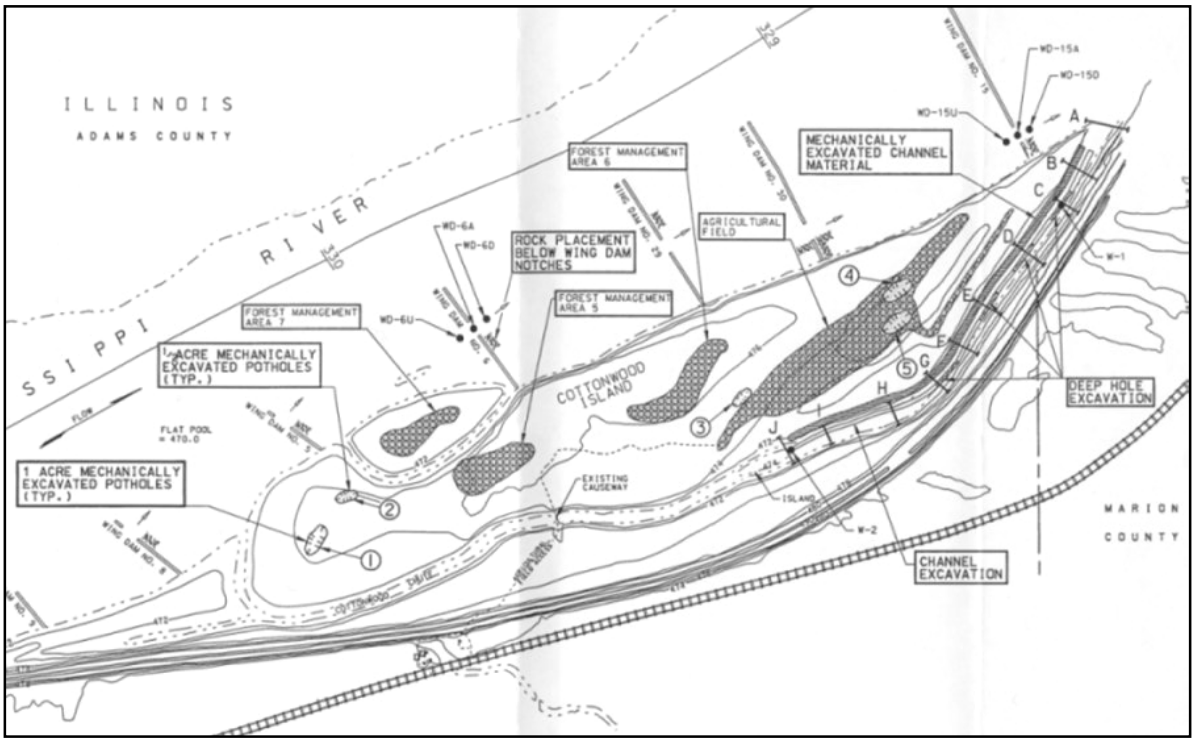
Cottonwood Island HREP Project Features

The MDOC has expressed concerns about the construction of an impermeable causeway road and the effects this may have on fish numbers in Cottonwood Chute. Further monitoring of water quality parameters and fish numbers should determine these effects.

I will reserve judgment of the effects of creating an impermeable channel blockage with the causeway until water quality parameters can be compared to the earlier period when there was minimal flow in the chute. Design of the causeway was not what I had requested.

(1) Causeway. The intent of raising the causeway was to reduce flow through Cottonwood Chute except during high river levels. If the average DO concentration falls below the Year 50 Target and as a result, fish kills are observed, then the option of rehabilitation may be considered. Any decision would be carried forth only upon written mutual agreement between the Corps, USFWS, and MDOC. Included within this agreement would be a description of the agreed-upon course of action and funding responsibilities, if any. The likely course of action would be to replace the existing rock in the causeway with a larger stone.
