Figure 6-35. Bank sections at site UP1 (concluded)

Site UP2, Marseilles Pool, 9/18/95. This site is located on the Left Descending Bank (LDB) at RM 270.8, opposite site UP1. Figure 6-33 shows the position of the site on a GIS-based map of the Illinois navigation chart, and figure 6-36 shows one photograph of the site.

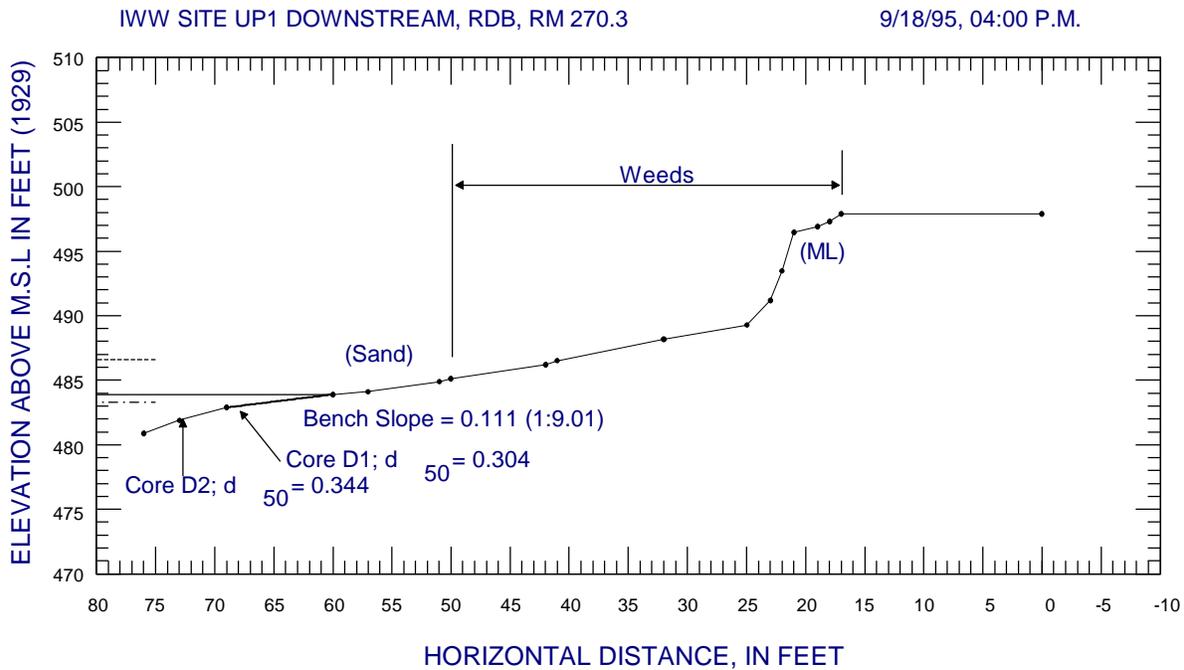
The gradation plots of bank soils and nearshore sediment are presented in appendix F. At the midsection, the d_{50} varies from 0.009 mm at the top surface of the bank to 0.379 mm at the upper part of a core sample at a depth of about 2 feet of water.

The bench slope varied from 1V:6.8H to 1V:9.H. The bank at this site can be classified as a combination of types 1 and 3 (figure 6-18, 6-20, table 6-4). Floods and high water stages could be the major cause of bank erosion. There was a collapsed bank section. Failure could be due to erosional oversteeping. Several holes were observed on bank face indicating that piping could also be a factor in bank failure.

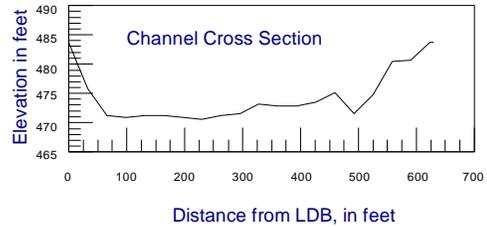
Figure 6-43. Bank sections at site UP4 (concluded)

At the midsection, the d₅₀ varied from 0.035 mm at the top of the bank to 0.185 mm for the top portion of a core sample at a water depth of about 2 feet. The bank scarp consisted of

cohesive materials and the sediments are of fine sand fairly consistently at three sections. Gradation plots of bank soils and nearshore sediment are presented in appendix F. The detailed cross section and coordinates are shown in appendix G.

Bench slopes varied from 1V:12.5H to 1V:7.5H, and the subaqueous bench becomes steeper. Piping holes at the scarp and moist soils on the lower portion of the bank were noted. This site can be classified as a combination of types 2 and 3 (see figures 6-19, 6-20, and table 6-4). The bank soils appeared to be cohesive, but the bench was sandy with several clay outcrops. Seepage could weaken the base support and cause the bank to slip, as shown at the downstream section. Failed soils and/or recently deposited sediment on the bench are reworked and transported by wind or tow-generated waves. The steep dropoff in subaqueous benches is indicative of effects of direct vessel contact or traffic-induced velocities.

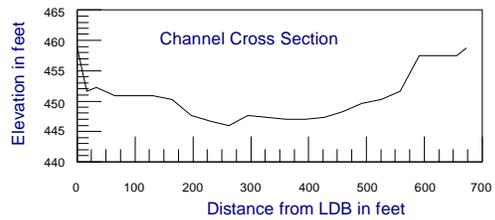
Figure 6-48. Bank sections at site 1

Neither Bhowmik and Schicht (1980) nor Hagerty (1988) observed erosion at this site. Hagerty (1988) noted rock instead. During this survey a near vertical scarp about 8 feet high was encountered. Exposed tree and grass roots covered the top of the scarp, and some leaning tall trees were found on the scarp. Flat slabs or rocks approximately 1 to 2 inches in length and only about quarter inch in thickness were found on the bench at the foot of the scarp. Rocks increased in size to about 4 or 5 inches long near the waters edge. Rock crops out along the Moores Creek. Figure 6-48 shows the two measured bank sections and a reduced cross section. Available stage data from the Marseilles Lock and Dam is used for interpolating stage information at this site (table 6-11). The OHW is at 460 feet and NP is at 458.5 feet above msl. Stages higher than 461.8 feet will submerge the scarp.

At the midsection, the d_{50} varies from 0.010 mm at the surface of the bank to 0.696 mm at the edge of water to 0.025 mm for a core sample at a depth of about 1 foot of water. Gradation plots of bank soils, and nearshore sediment are presented in appendix F. The detailed cross section and coordinates are shown in appendix G.

Bench slopes varied from 1V:6.1H to 1V:17.2H. This site can be classified as type 1 (figure 6-18 and table 6-4). Surficial bank materials slake and are loosened by weathering with subsequent collapse. Reworking and transport of failed materials and recently deposited sediments occurs within bench areas during high flows.

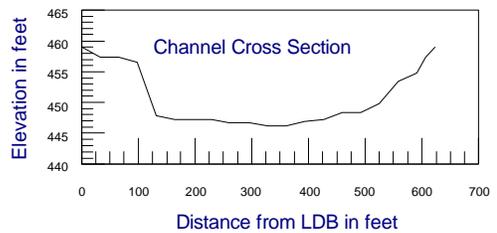
Figure 6-53. Bank sections at site 3 (concluded)

Figure 6-53 shows the three measured bank sections and a reduced cross section. The bank slopes were steeper towards the downstream limit. The OHW is 459.3 feet and NP is 458.5 feet above msl. This range of fluctuation is within the bench area. Ten-year stage data (table 6-13) shows that only stages with less than 10% recurrence frequency can reach the base of the bank face.

At the midsection, the d_{50} varied from 0.193 mm at the upper part of bank surface to 0.206 mm at the base of the bank. A core sample at 2 feet of depth on the upstream section had d_{50} of 0.202 mm. Gradation plots of bank soils and nearshore sediment are presented in appendix F. The detailed cross section and coordinates are shown in appendix G.

Bench slopes varied from 1V:50H at the upstream section to 1V:8H at the midsection. The bank consisted mostly of noncohesive sandy materials. The three sections can be classified as a combination of types 1 and 6 because of the extended subaqueous bench width (figures 6-18 and 6-23, and table 6-4). Rework and transport of failed soils and recently deposited sediment occur during floods. Eddy currents induced by the trees or gravel upstream of concave sections can cause bank failure and eddies are generated at stages when the flows are disturbed by trees or gravel.
