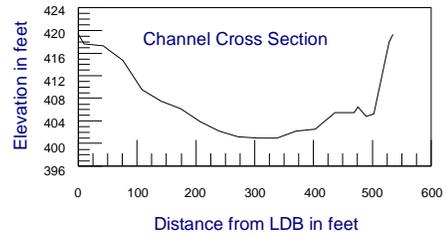
Figure 6-109. Bank sections at site 23

Figure 6-109 shows the three measured bank sections and a reduced cross section. The stage at the time of survey was at about the 90% recurrence frequency stage. Dense seasonal vegetation covered the upper portion of the bank face, and the bank slope was steeper downstream. Bank materials were similar to those at other bank sections in the Alton Pool, with a hard clayey layer at the upper part of the bank, and a lower bank covered by moist, soft clayey soil. Algae were growing near the water's edge. As shown in table 6-33, the bare bank face corresponds well to the stage ranging between 50% and 25% recurrence frequencies. The 50% recurrence stage is about 420.3 feet at the base of the scarp.

At the midsection, the d_{50} varied from 0.016 mm at the surface of the bank to 0.020 mm at the upper part of a core sample at a water depth of about 2 feet. The d_{50} values were very uniform at the midsection. Gradation plots of bank soils and nearshore sediment are presented in appendix F. The detailed river cross section and coordinates are shown in appendix G.

Bench slopes varied from 1V:12.5H at the upstream section to about 1V:5.0H at the midsection and downstream section. The upstream section and midsection are classified as type 4 and the downstream section is classified as type 2 (figures 6-21 and 6-19 and table 6-4). There was erosion due to surface drainage; other apparent causes are seepage, rework, and transport by levees and currents at various stages of pool-level fluctuations.

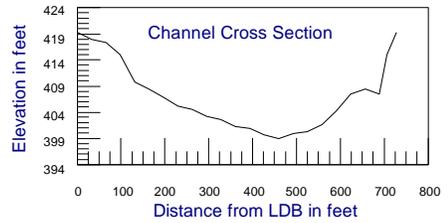
Figure 6-112. Bank sections at site 24

The bank characteristics are similar to those at other sites in the Alton Pool. Figure 6-112 shows the three measured bank sections and a reduced cross section. Land cover on the top and upper portion of the bank was dense seasonal vegetation, mostly above the water line. The sloping bank below the vegetation zone was bare; the base of the bare area was moist and algae was growing near the water's edge. The stage at the time of the survey was at about the 90% recurrence frequency stage. The subaqueous bench at the site was broader and flatter than the bench at site 23. The bench was covered with a layer of thick sediment in the nearshore area, but farther riverward the bench surface was hard. The stage analysis (table 6-34) indicated that the bare bank face was located between the 50% and 25% recurrence stages. The 50% recurrence stage, 420.3 feet, was at the base of the scarp.

At the midsection, the d_{50} varied from 0.019 mm at the surface of the bank to 0.020 mm at the upper portion of a core sample at a water depth of about 2 feet. The d_{50} for the lower core sample is 0.019 mm. A detailed river cross section is shown in appendix G, while gradation plots of bank soils and nearshore sediment are presented in appendix F.

Bench slopes varied slightly from 1V:25.0H to 1V:15.9H in this reach. The bank soils were cohesive. This site can be classified as a combination of types 2 and 5 (figures 6-19, 6-22, and table 6-4). Erosion processes could be traced as initiated by piping; debris-induced local currents and wave wash extend the erosion; rework and transport by waves and currents at various stages of pool-level fluctuation then remove the failed soils or recently deposited sediment.
