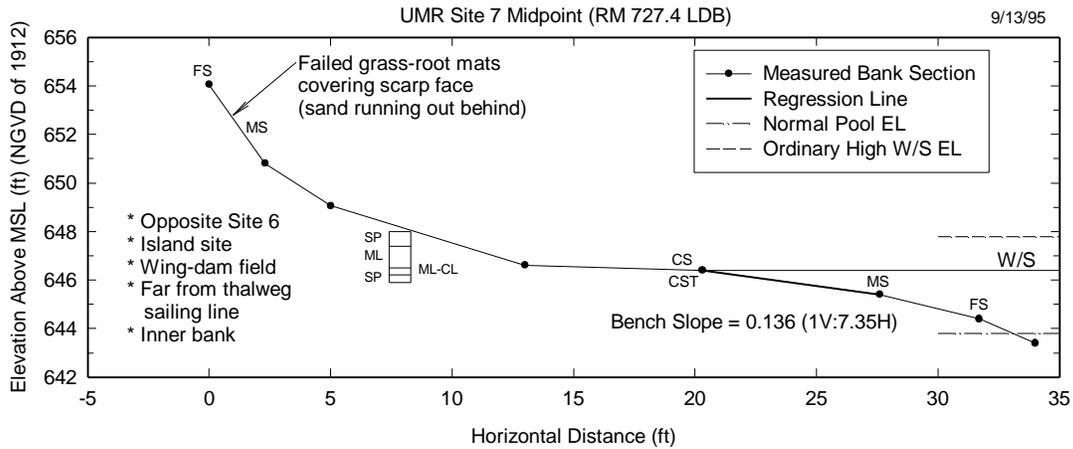
Figure 7-28 Bank section measured at Site 7 midpoint

Primary causative factors for bank retreat at this site include flood erosion, wave and rework-transport within bench and berm areas, and minor piping. Because bench cover is primarily sand, erosion by traffic-induced waves was observed. This site is classified as bank Type E.

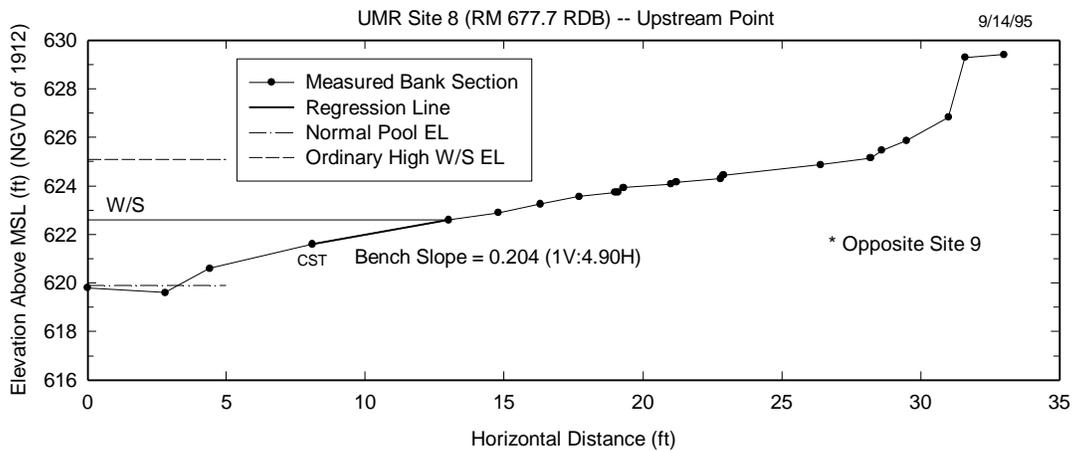
Figure 7-30 Bank section measured at Site 8 upstream point

This right-bank site on the outside of a slight bend, shown in figure 7-29, is located only about 1.7 miles downstream from Lock & Dam No. 8. A downstream view of the site is shown in Photo 7-24. Three bank sections obtained at this site are plotted in figures 7-30 through 7-32. The bank soils are predominantly coarse silt (CST defined in table 7-3), and piping features were observed within the entire bank face. The river cross

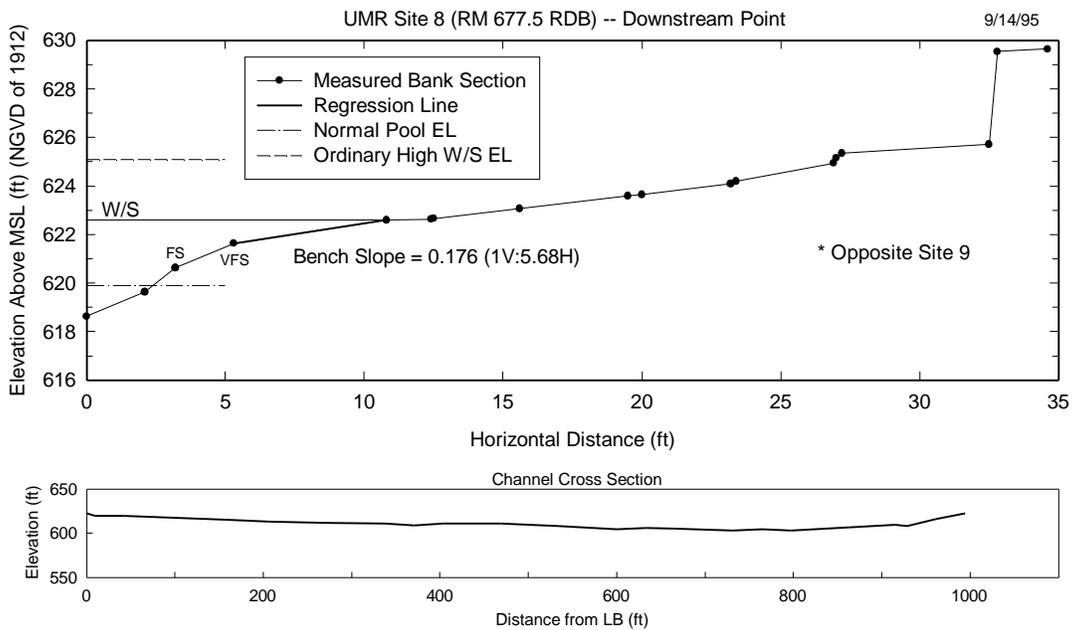
Figure 7-32 Bank section and channel cross section measured at Site 8 downstream point

Causative factors for bank retreat at this site include flood-flow erosion, wave-flow related rework-transport of failed soils and recently deposited sediments, and piping. Potential for wave erosion of bench areas is significant. This site is classified as Type C.

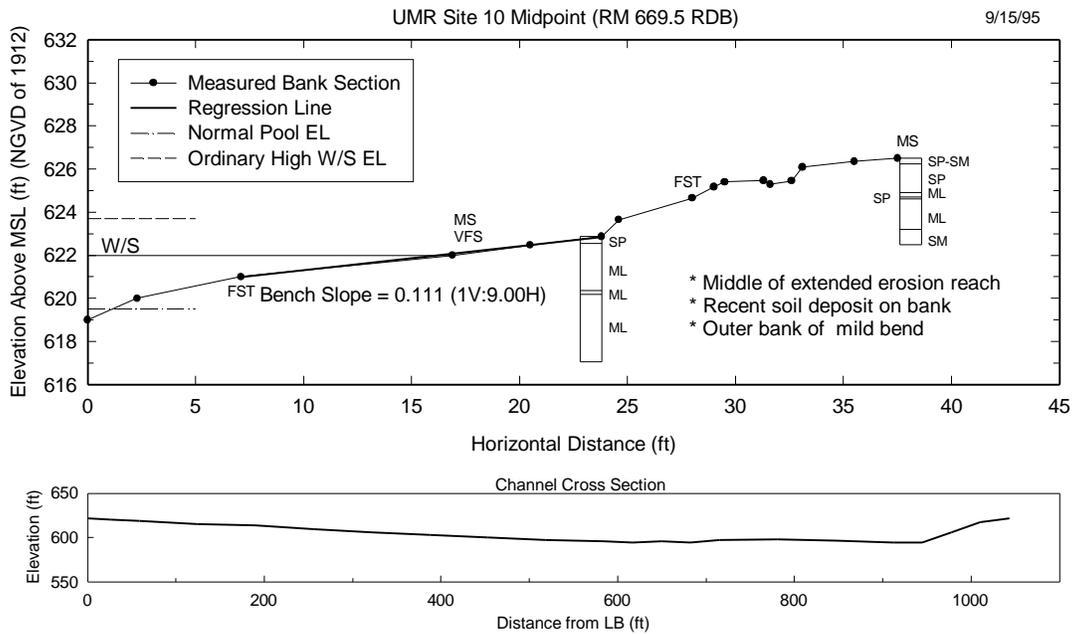
Figure 7-36 Bank section and channel cross section measured at Site 10 midpoint

Causative factors for bank retreat at this site include flood-flow erosion, secondary currents, overland flow, wave and rework-transport of failed soils and recently deposited sediments, and piping. There is potential for wave erosion in bench areas. The bank section at this site is classified as a combination of bank Type D and Type E.

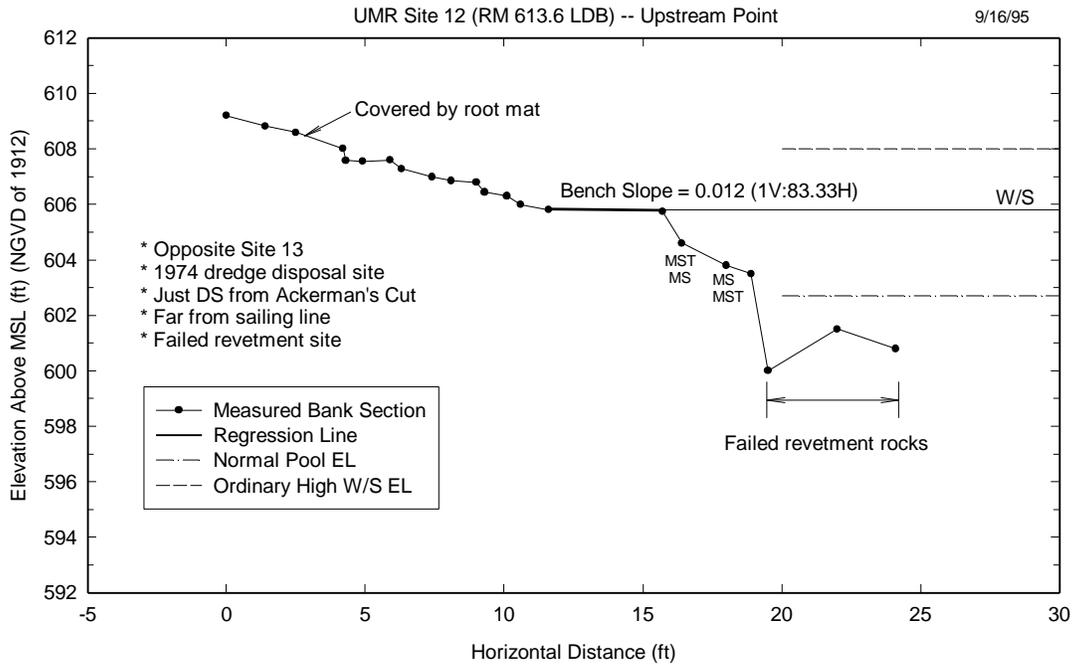
Figure 7-43 Bank section measured at Site 12 upstream point

7-43 through 7-45. Bank retreat at Site 12 since 1984 is apparent in figure 7-42. As can be seen in figure 7-44, the thalweg is very close to this left bank, and evidence of severe channel erosion was observed at the site. This site was a dredged material disposal site. At the upstream section, failed revetment rocks were found adjacent to the water's edge (see figure 7-43). Since the upper end of Cassville Slough (eastern limb of the MR) was closed when Lock & Dam No. 10 was completed in 1938, the new MR channel flow, downstream from the dam spillways located on the west side of the river, had a tendency to return to the old channel slough, resulting in Ackerman's Cut. According to Nakato (1983), as much as 28 percent of the river flow was passing through Ackerman's Cut, causing reduction of sediment-transport capacity of the main channel and transport of sediment into the slough. In order to protect the fishery resources of Cassville Slough and to reduce dredging requirements in the downstream navigation channel, the COE-RID constructed partial closure structures in Ackerman's Cut in 1985. A post-construction study was conducted in 1986 and it was found that the flow diversion rate was reduced to 18 percent from the previous 28 percent (Toda and Nakato 1987). The bank was covered

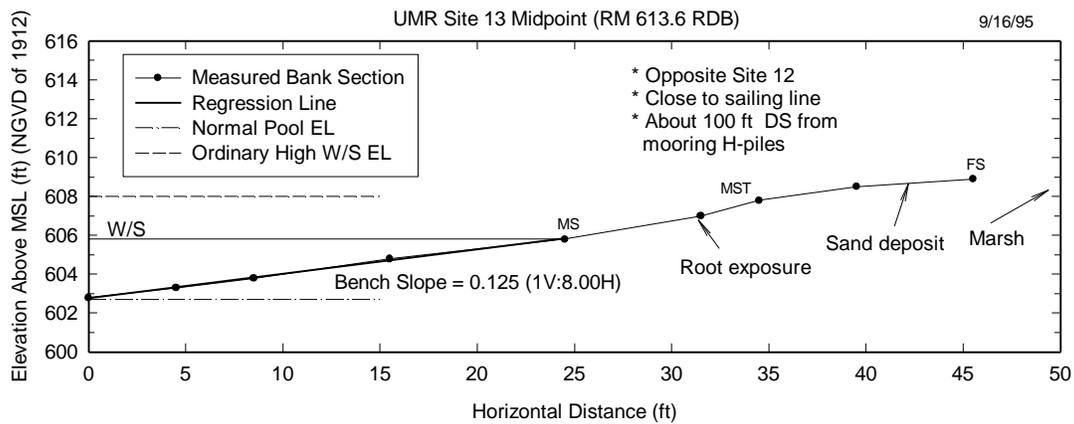
Figure 7-46 Bank section measured at Site 13 midpoint

32 and 7-33, respectively. The bank section is shown in figure 7-46. The site is located within a wing-dam field and the low-lying island is connected to a marsh area. There is a barge-mooring facility located about 100 ft upstream from this site. The bank bench and berm area cover consists of recent silt (MST) and sand (FS-MS) deposits left by floods.

Causative factors for bank retreat at this site include piping failure, and wave and flow rework-transport of recently deposited sediments in bench areas. This site is classified as bank Type E.

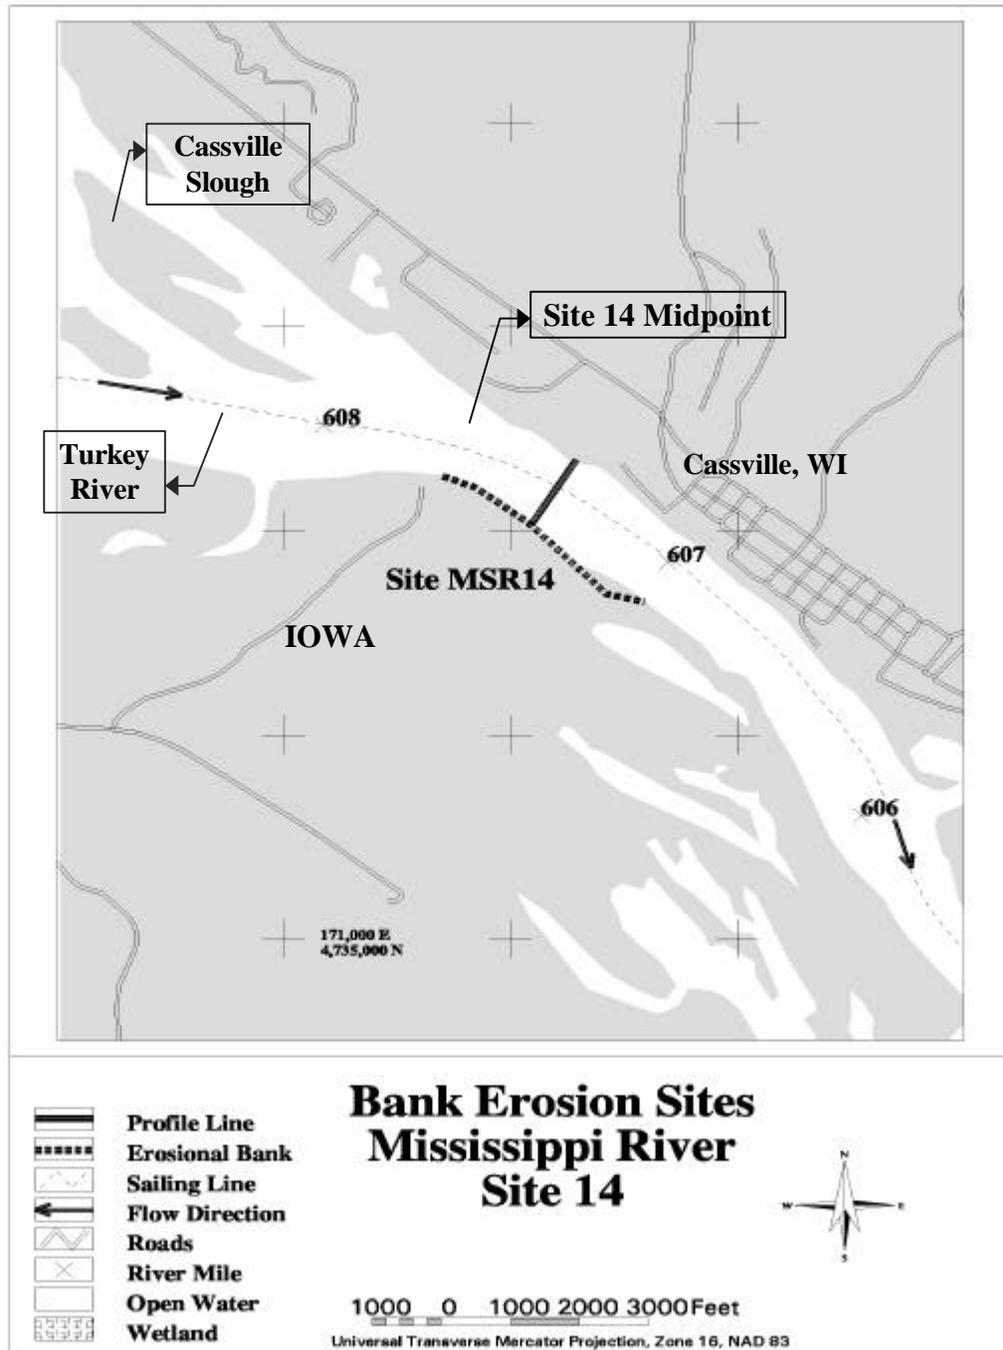
Figure 7-47 A site map showing Mississippi River Site 14

Cassville, Wisconsin. The Turkey River confluence is only 0.5 mile upstream from the site. Upstream and downstream views of the site are shown in Photos 7-34 and 7-35, respectively. Three bank sections taken at this site are plotted in figures 7-48 through 7-

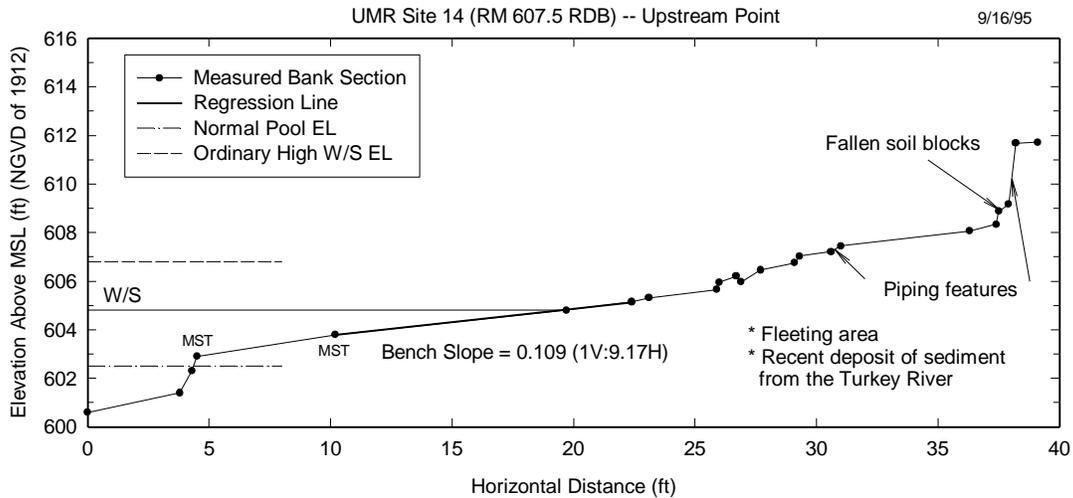
Figure 7-48 Bank section measured at Site 14 upstream point

50. The bank soils consist of fine silt (FST) to coarse silt (CST). Fallen soil blocks were observed at the base of the scarp, and piping features were observed within the bank scarp as well as at minor scarps within the berm and bench rework-transport zones. As can be seen in figure 7-49, the surveyed river cross section is atypical for a river bend because the site is located near the upstream end of the bend.
