**UPPER MISSISSIPPI RIVER RESTORATION
ENVIRONMENTAL MANAGEMENT PROGRAM
POST-CONSTRUCTION
FINAL PERFORMANCE EVALUATION REPORT
2013
POOL 9 ISLAND
HABITAT REHABILITATION AND ENHANCEMENT PROJECT**

POOL 9

RIVER MILE 655 TO 656

CRAWFORD COUNTY, WISCONSIN

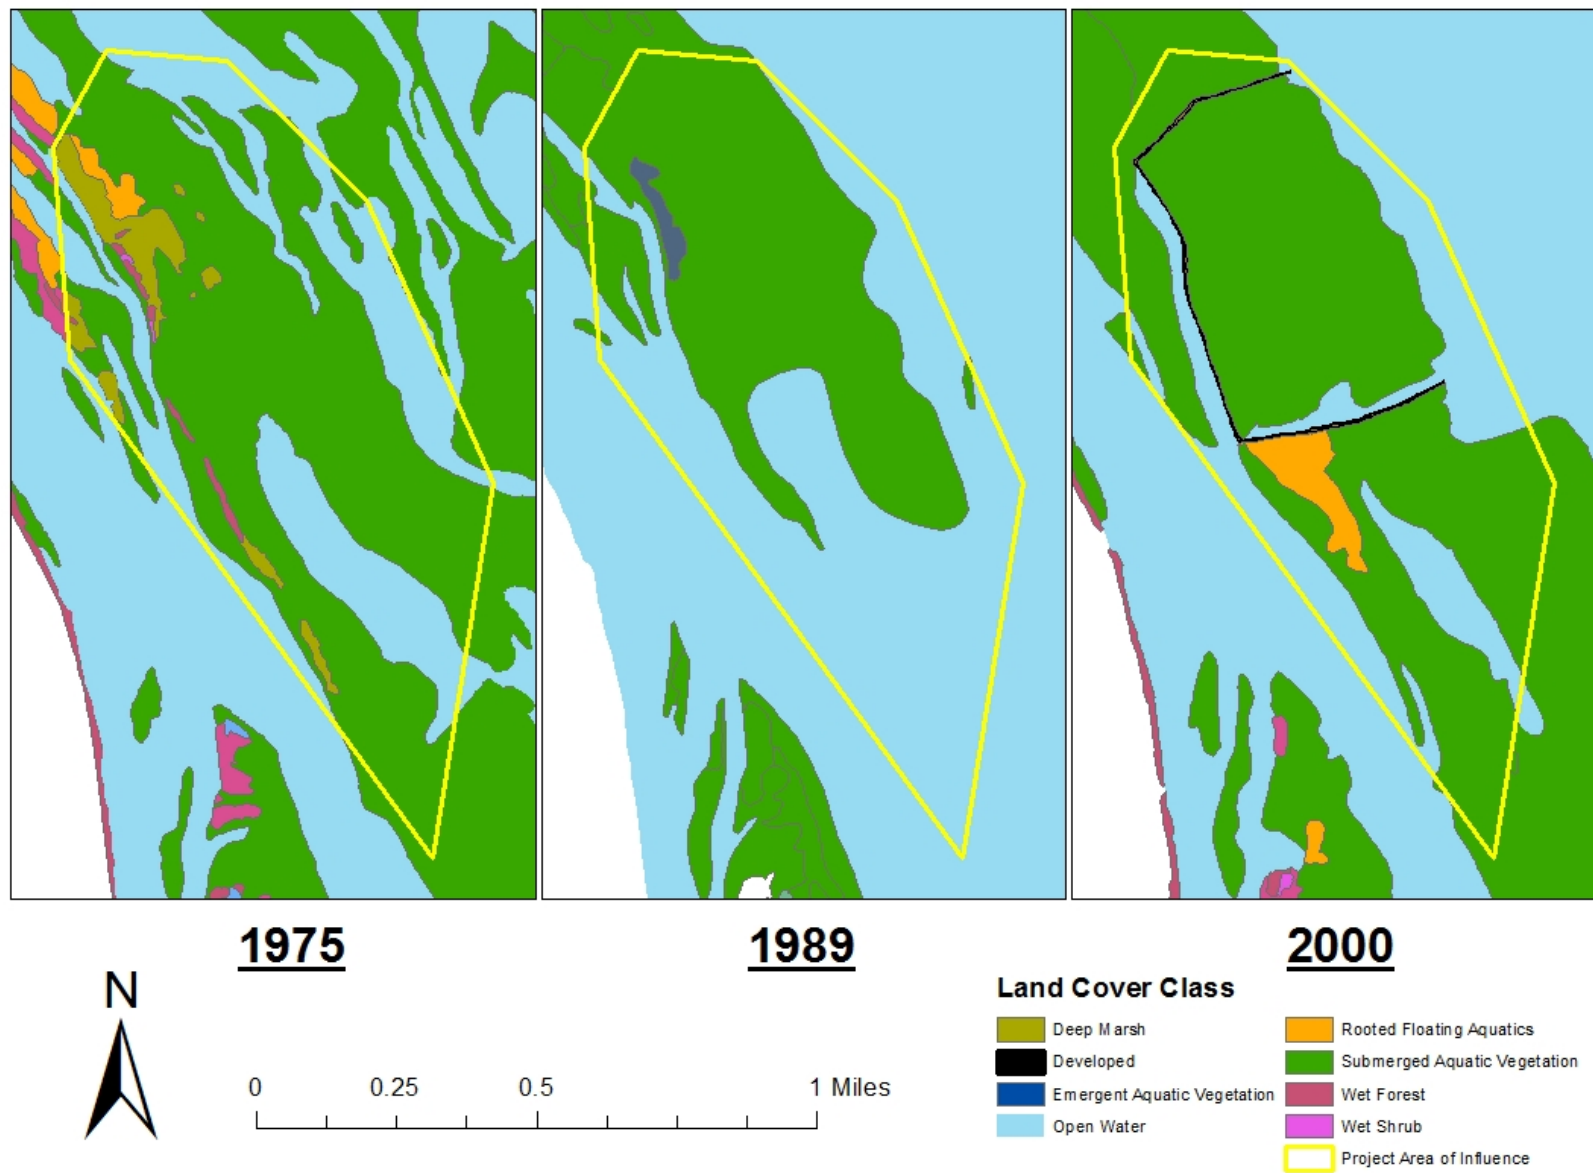
Figure 5. USGS land cover surveys of 1975 (left), 1989 (middle), and 2010 (right)

Based on available land cover survey data and aerial photos of the site, both the protected inner zone of the island as well as the outer zone adjacent to the lower part of the island have seen significant submerged aquatic vegetation growth in the shallow water areas. USGS land cover data from the years 1975, 1989, and 2000 were compared using GIS software in the area influenced by the project (Figure 5 & Table 5). The area of influence was delineated as the general area around the project where there was a noticeable change in wind fetch (Figure 6). From the 2000 data it was calculated that 130 acres of aquatic vegetation exists in the area protected by the 3 islands, as well as over 60 acres of vegetation in the south exterior of the island. A total of approximately 290 acres of vegetation has developed within the project's area of influence. In comparison to the same data from 1989, the vegetation in this area has grown by about 64%, becoming more similar to its condition in 1975. The island has allowed the existing vegetation to develop and grow throughout the project area. The vegetation in this area primarily consists of submerged aquatic vegetation in the inner

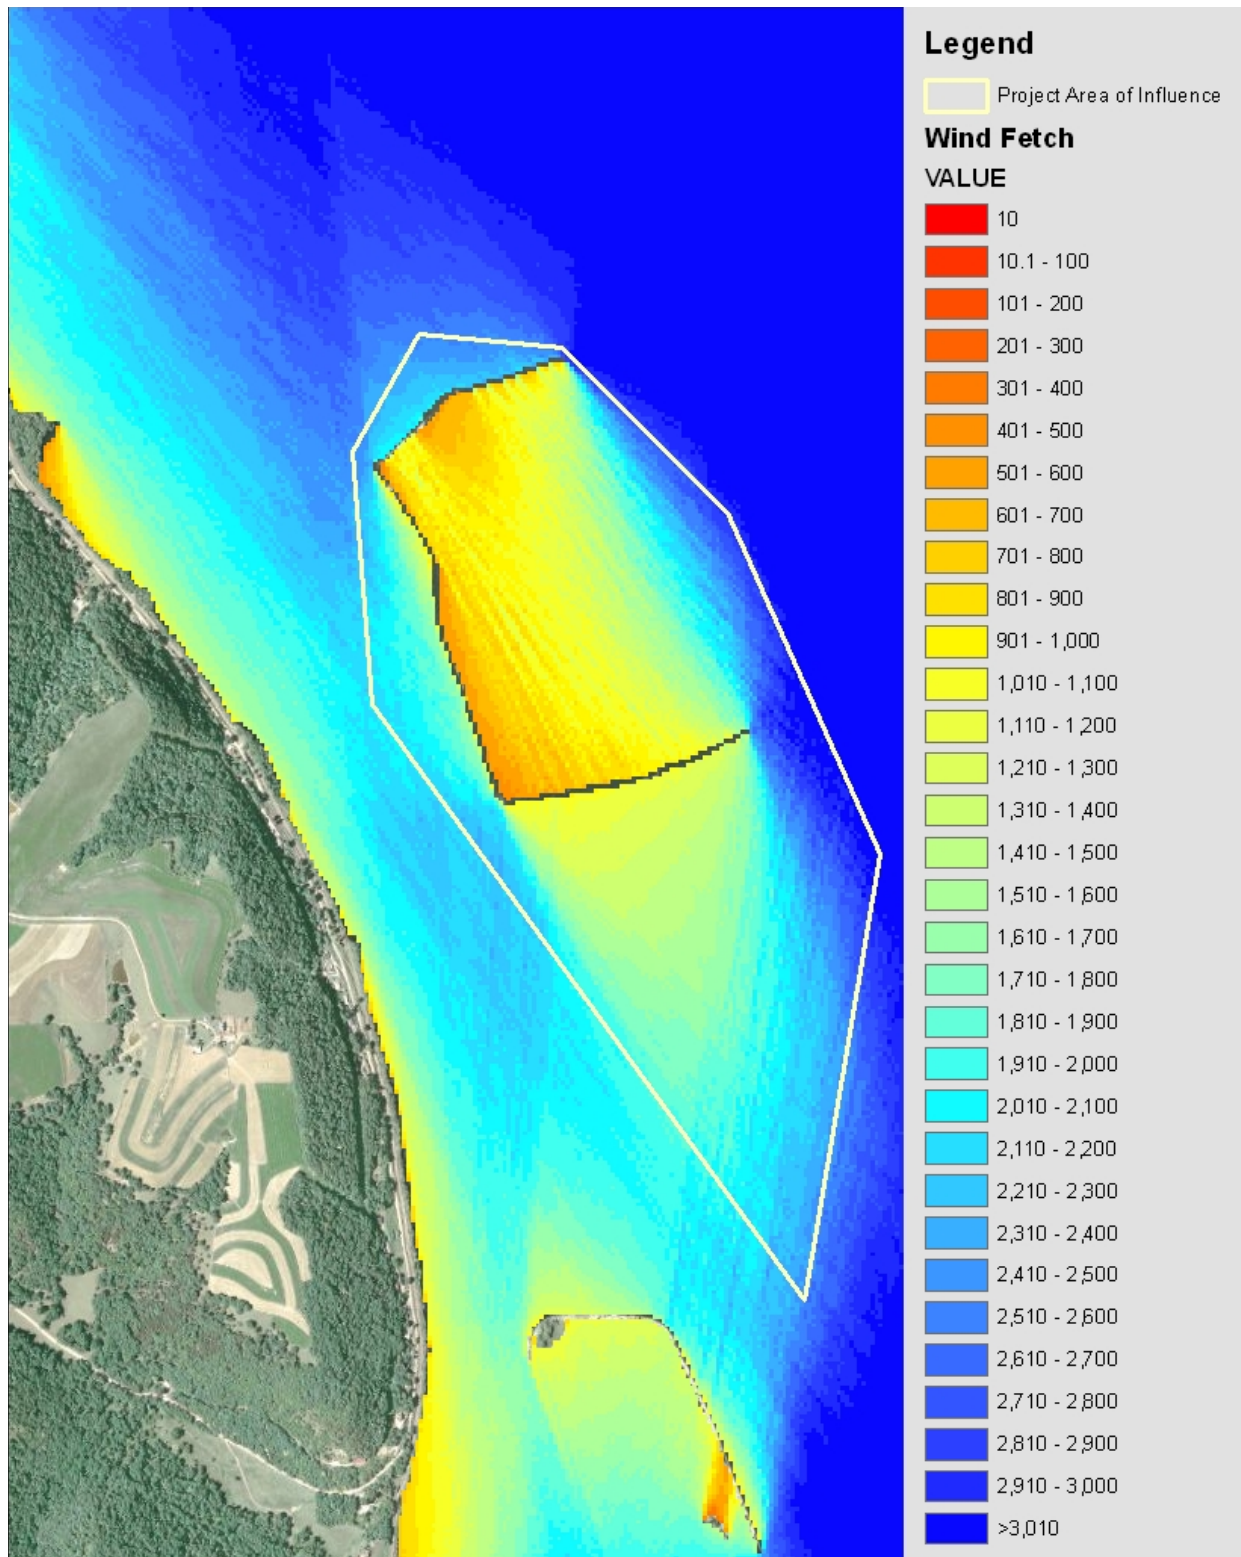
Figure 6. Pool 9 Wind Fetch, 2008

An analysis of wind-driven wave action conducted during project planning indicated that, within the 3 to 5 foot water depths that existed in this area, maximum bottom velocity and bottom shear stress due to wave action ranged from 0.77 to 0.93 fps and from 0.018 to 0.027 psf respectively. In other words, the orbital wave velocity for a 25 mph wind was greater than the measured flow velocities (0.2 to 0.8 fps) due to river currents. Comparing the bottom shear stresses to critical bottom shear stresses for sediment resuspension indicated that the potential for resuspension of bottom sediments was great. More recent wind fetch analysis indicated a significant reduction in wind-induced waves in areas protected by the island. Data from a 2008 Pool 9 wind fetch analysis (Figure 6) show the fetch inside the island complex to be in the range of 656 to 3,600 feet, which is significantly lower than the surrounding area wind fetch of 9,800+ feet. The pre-construction wind fetch in this area had been recorded at 15,840 feet in both north and southeast directions, causing 0.9-1.1 foot high waves. With the island, wind fetch was expected to drop to around 2,000 feet in the project area.
