**Rice Lake  
Habitat Rehabilitation and Enhancement Project  
Project Evaluation Report**

**Environmental Management Program  
for the Upper Mississippi River System**

April 2012

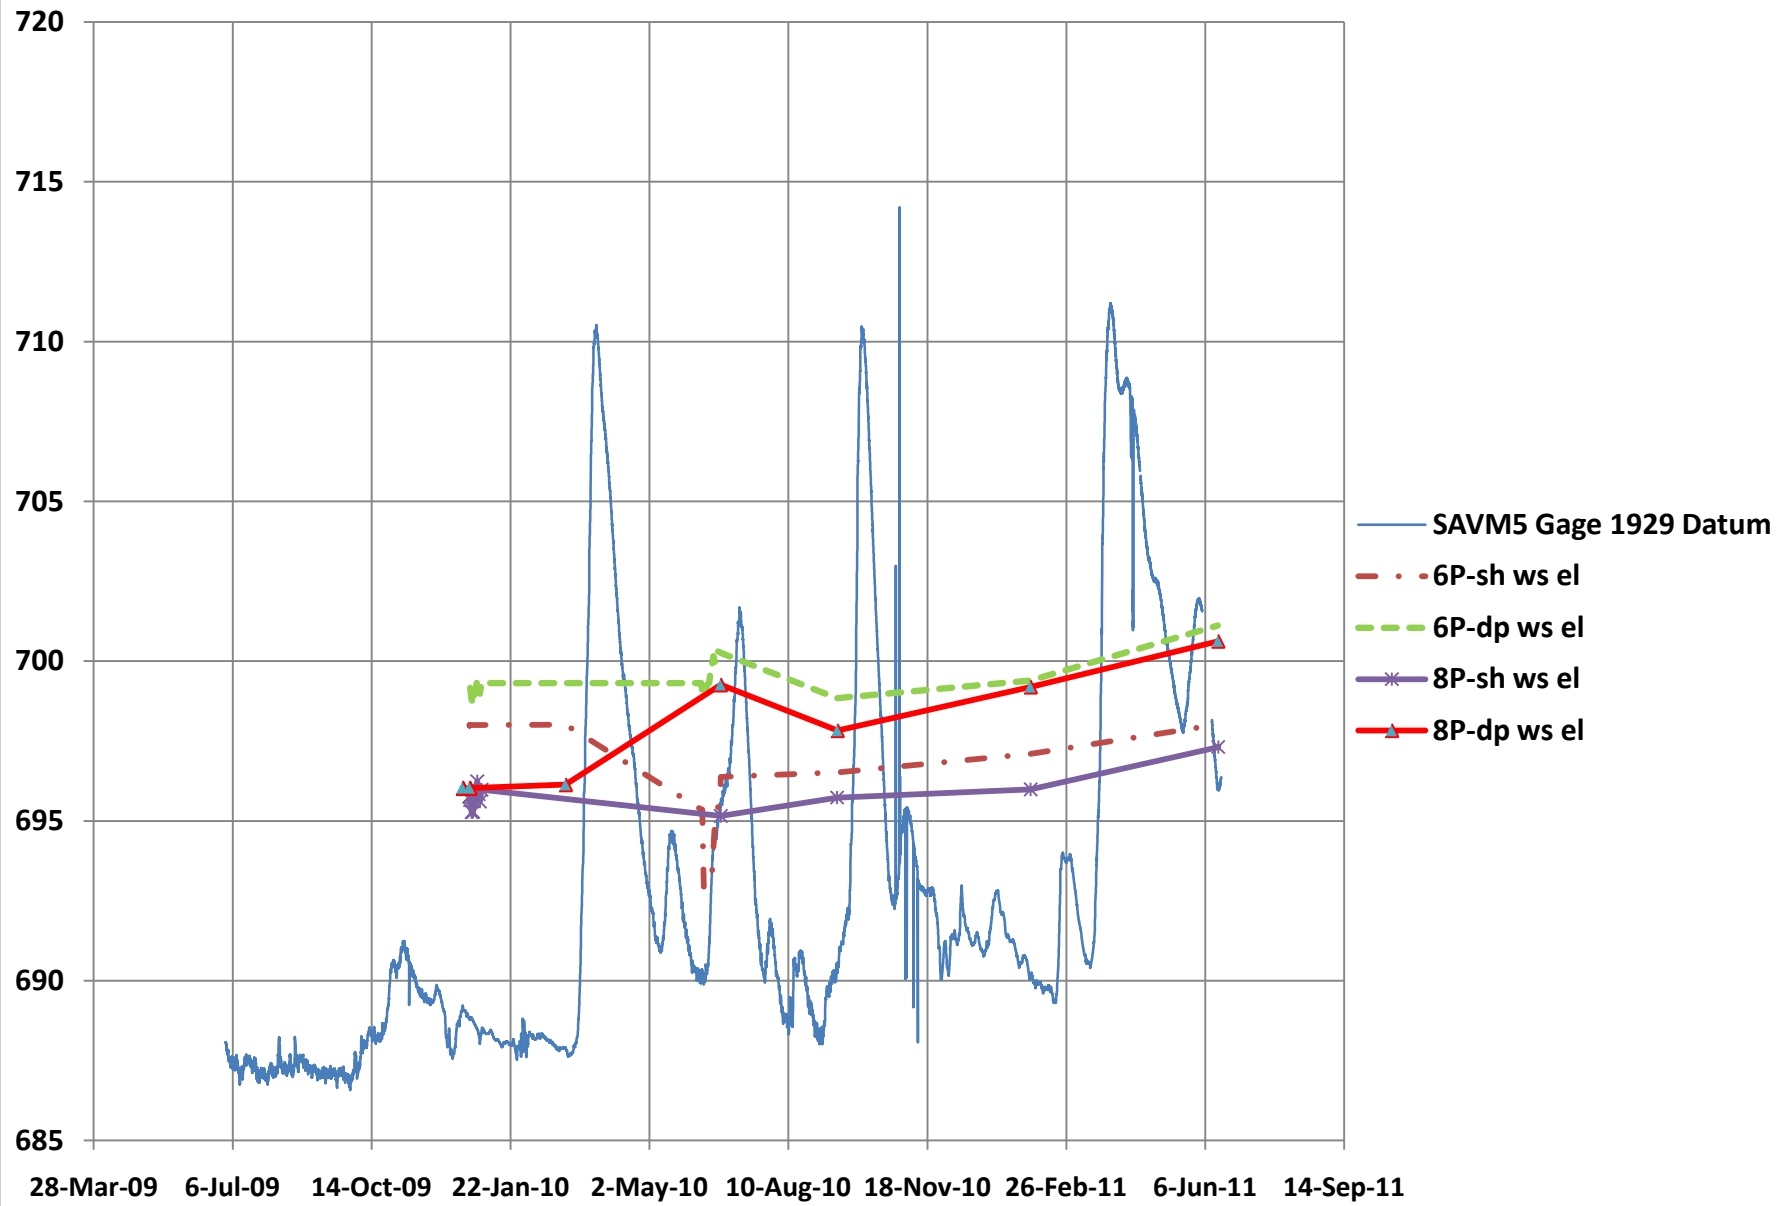
### Rice Lake Berm: Piezometer Data

**2. PIEZOMETERS:** Figure 3 shows plots of the two pairs of piezometers with the Minnesota River levels at the Savage gage, located downstream of the site. Interpreting piezometer data is subjective and should be done with timely field observations; not all

Seeps, bank slumping,  
higher erosion rates
