**UPPER MISSISSIPPI RIVER SYSTEM  
ENVIRONMENTAL MANAGEMENT PROGRAM  
POST-CONSTRUCTION PERFORMANCE  
EVALUATION REPORT – YEAR 8 (2000)**

**ANDALUSIA REFUGE  
HABITAT REHABILITATION  
AND ENHANCEMENT**

**JUNE 2001**

**POOL 16  
MISSISSIPPI RIVER MILES 462.0 – 463.0  
ROCK ISLAND COUNTY, ILLINOIS**

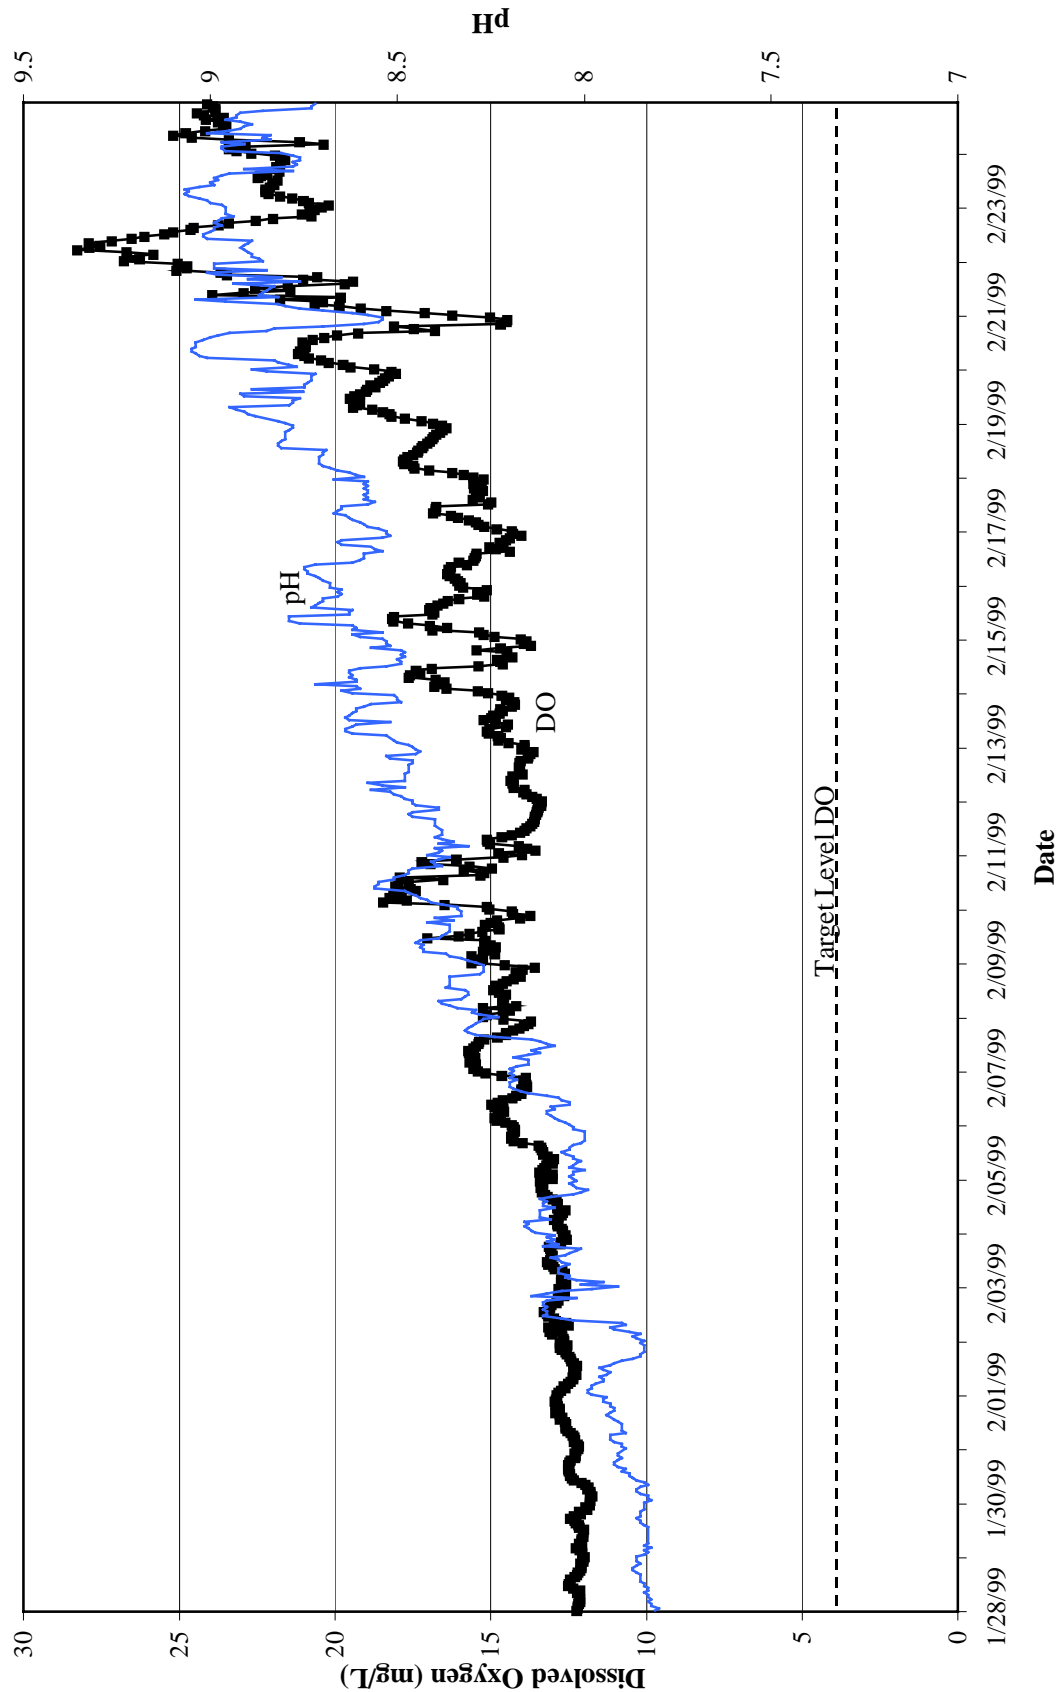
**FIGURE E-1. Post-Project Dissolved Oxygen and pH Values Collected with a Continuous Monitor at Station W-M462.5O**

**Figure E-1. Monitoring Results at Station W-M462.5O during Winter 1999**

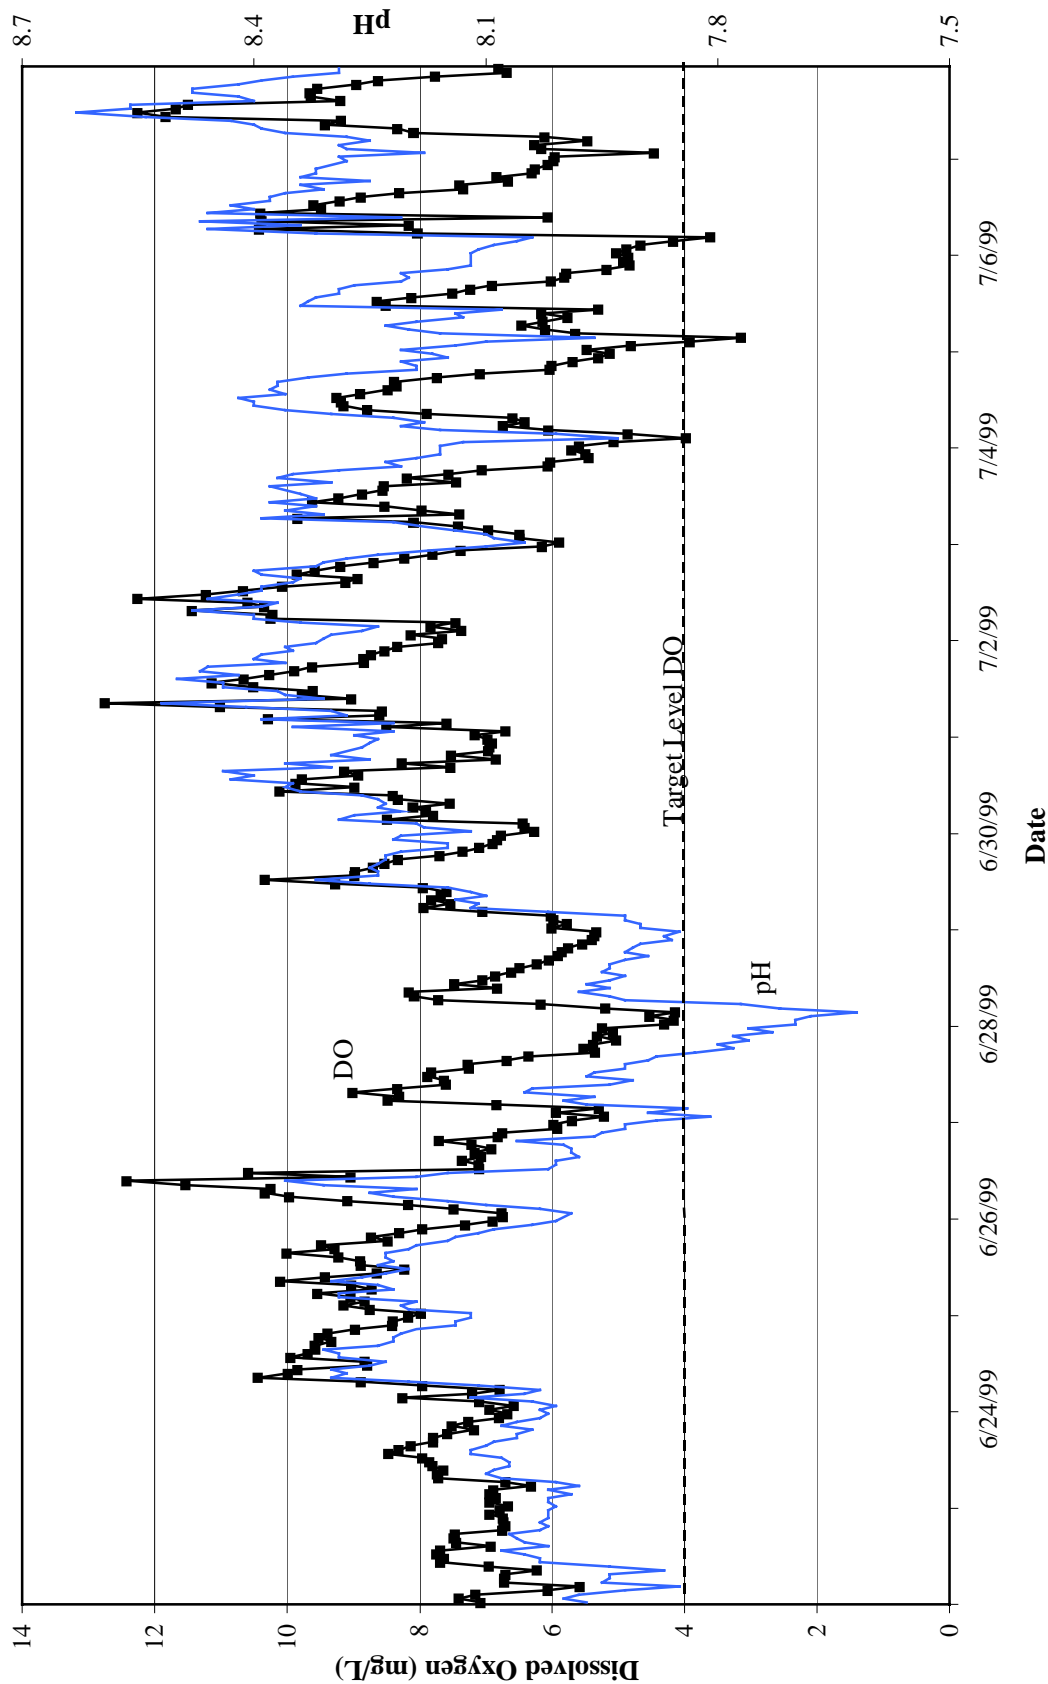
**FIGURE E-2. Post-Project Dissolved Oxygen and pH Values Collected with a Continuous Monitor at Station W-M462.5O**

**Figure E-2. Monitoring Results at Station W-M462.5O during Summer 1999**

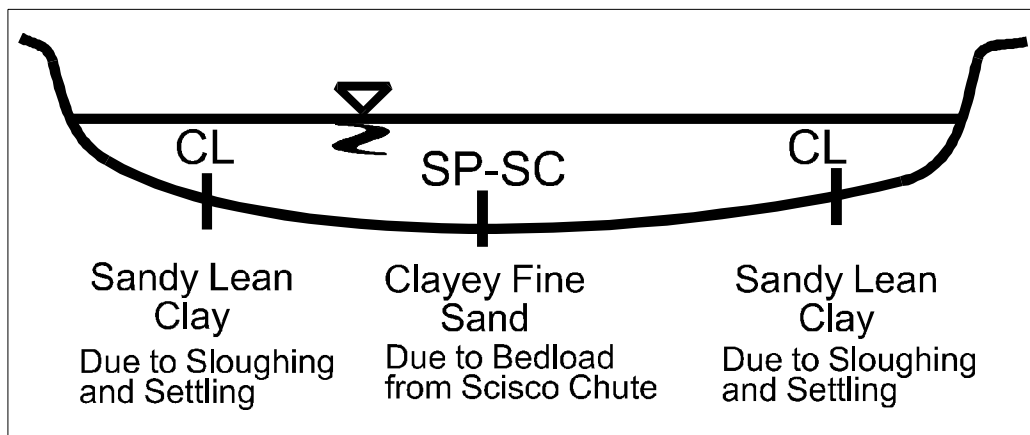
4. The magnitudes of the model velocities were verified by field measurements using an Acoustic Doppler Current Profiler. Changes in velocity distributions predicted by the model were monitored with pool fluctuations, and indicated flow into the dredged channel during rising pool events and flow out of the dredged channel during falling pool events. The model results show velocities of 0.2 ft/s to 0.7 ft/s near the mouth of the dredged channel, and negligible velocities ( $<0.1$  ft/s) within the channel and Dead Slough areas. The channel bottom survey results show that deposition occurs from 200 to 300 feet inland from the mouth of the channel while the model results indicate that deposition should not occur beyond 100 feet. The channel bottom survey is very sparse however, having only three surveyed points between the mouth and 300 feet inland from the mouth. The sediment survey results indicate a high percentage of sand deposited in the middle portions of the dredged channel. The sandy material at the mouth of the dredged channel closely matches that of the bed material of Scisco Chute. The figure below shows the sediment classification and location along a cross-section of the dredged channel near the mouth:

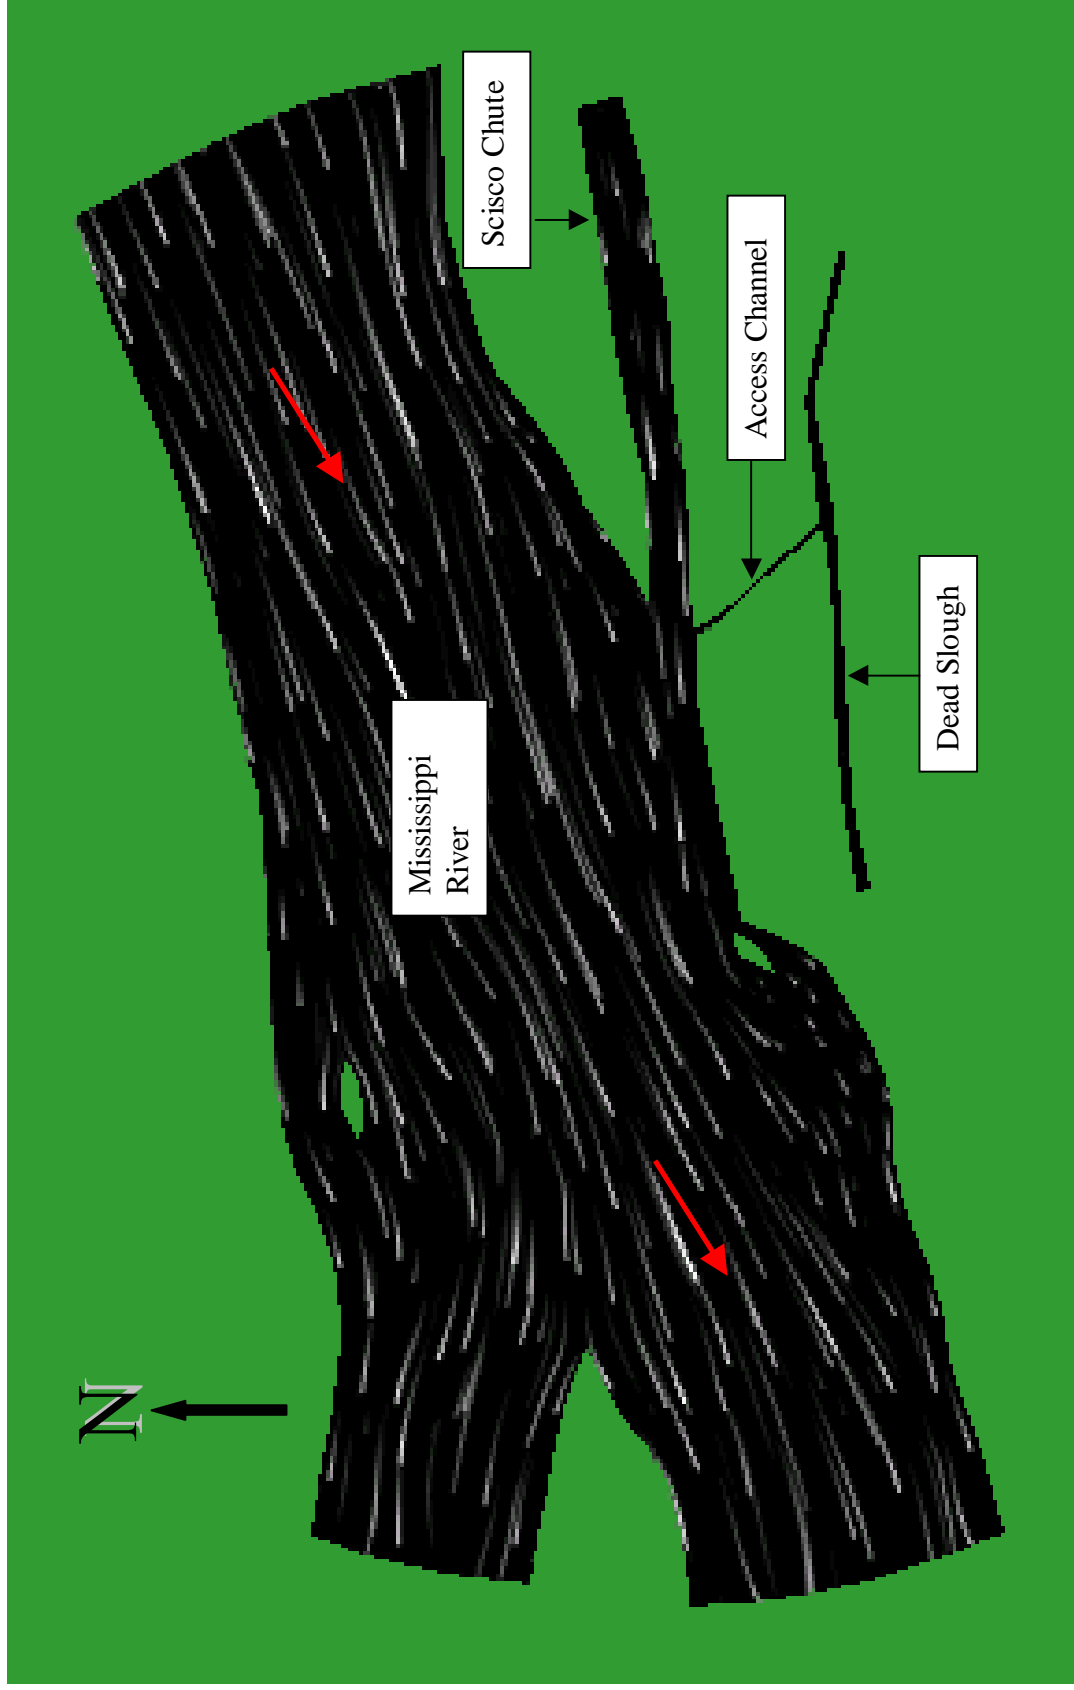
## Andalusia EMP - River Miles 461.6 to 463.3

Pool 16 fluctuates from elev. 545.6 ft to 548.1 ft (Flowrate: 84,000 cfs to 130,000 cfs and back)

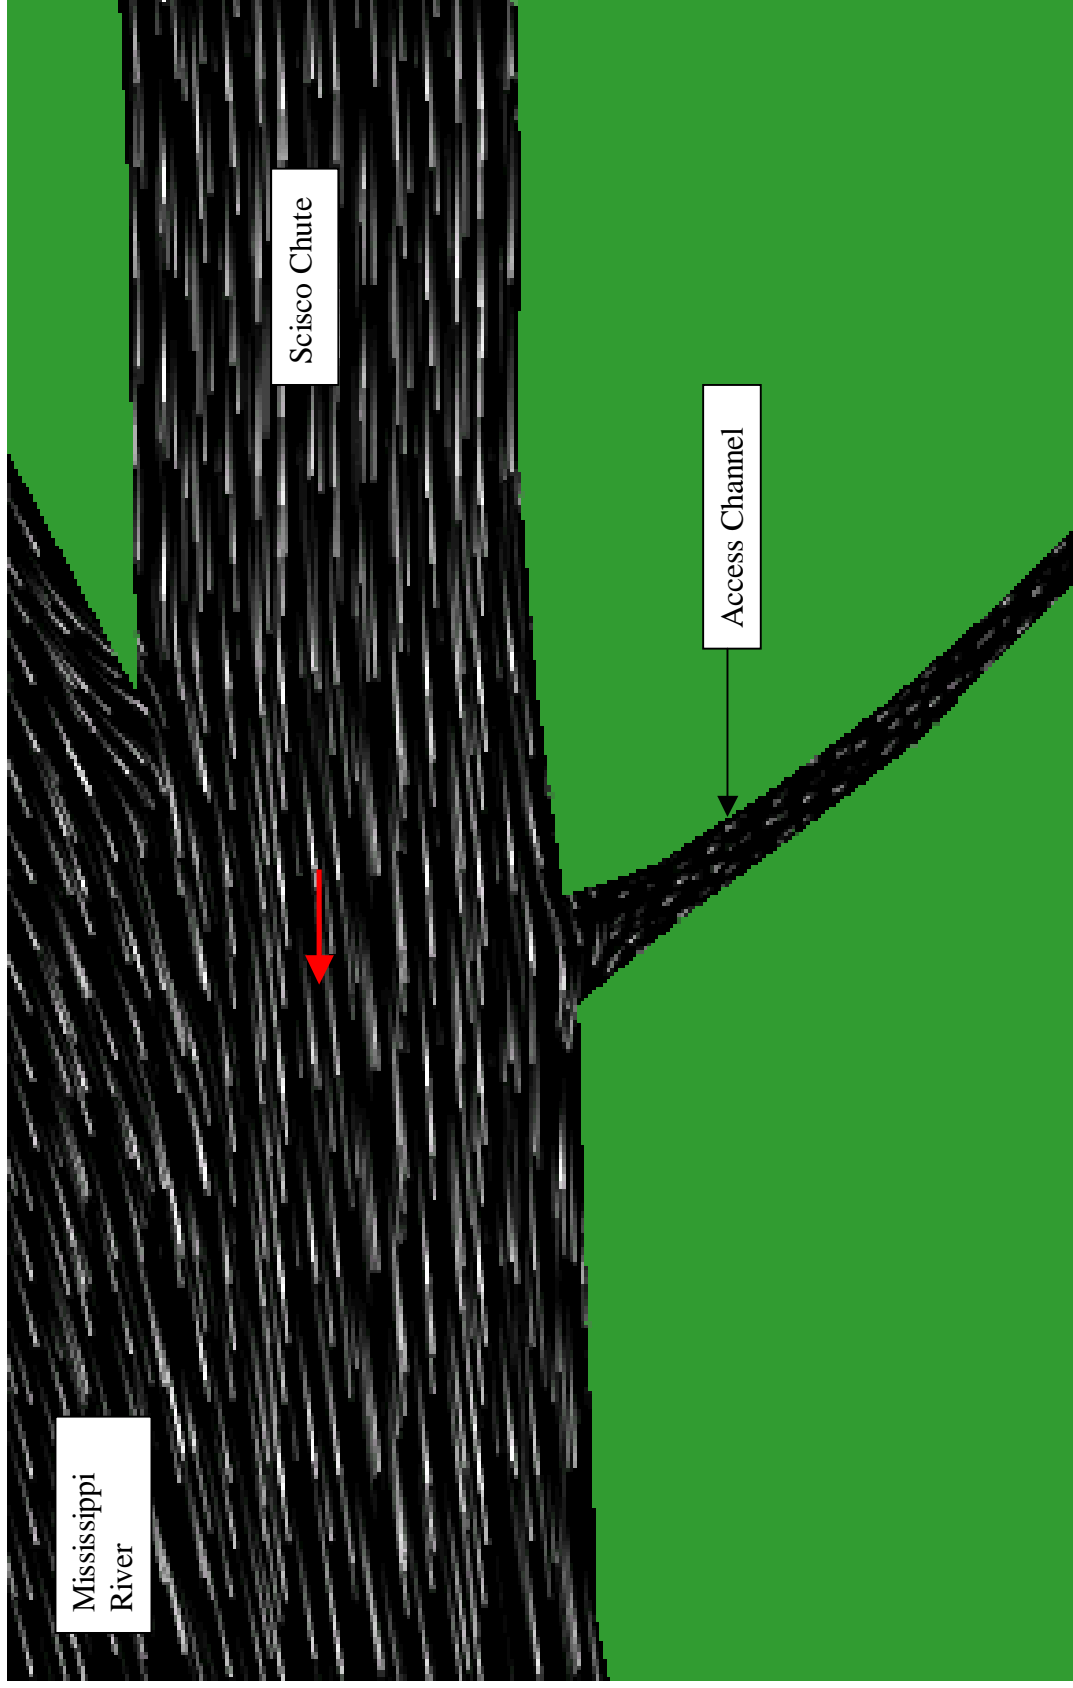
## Andalusia EMP - Near Scisco Chute

Pool 16 fluctuates from elev. 545.6 ft to 548.1 ft (Flowrate: 84,000 cfs to 130,000 cfs and back)
