**POST-CONSTRUCTION
PERFORMANCE EVALUATION REPORT**

**ANDALUSIA REFUGE
HABITAT REHABILITATION AND ENHANCEMENT PROJECT**

**US Army Corps
of Engineers** ®
Rock Island District

**POOL 16
RIVER MILES 462.0-463.0
ROCK ISLAND COUNTY, ILLINOIS**

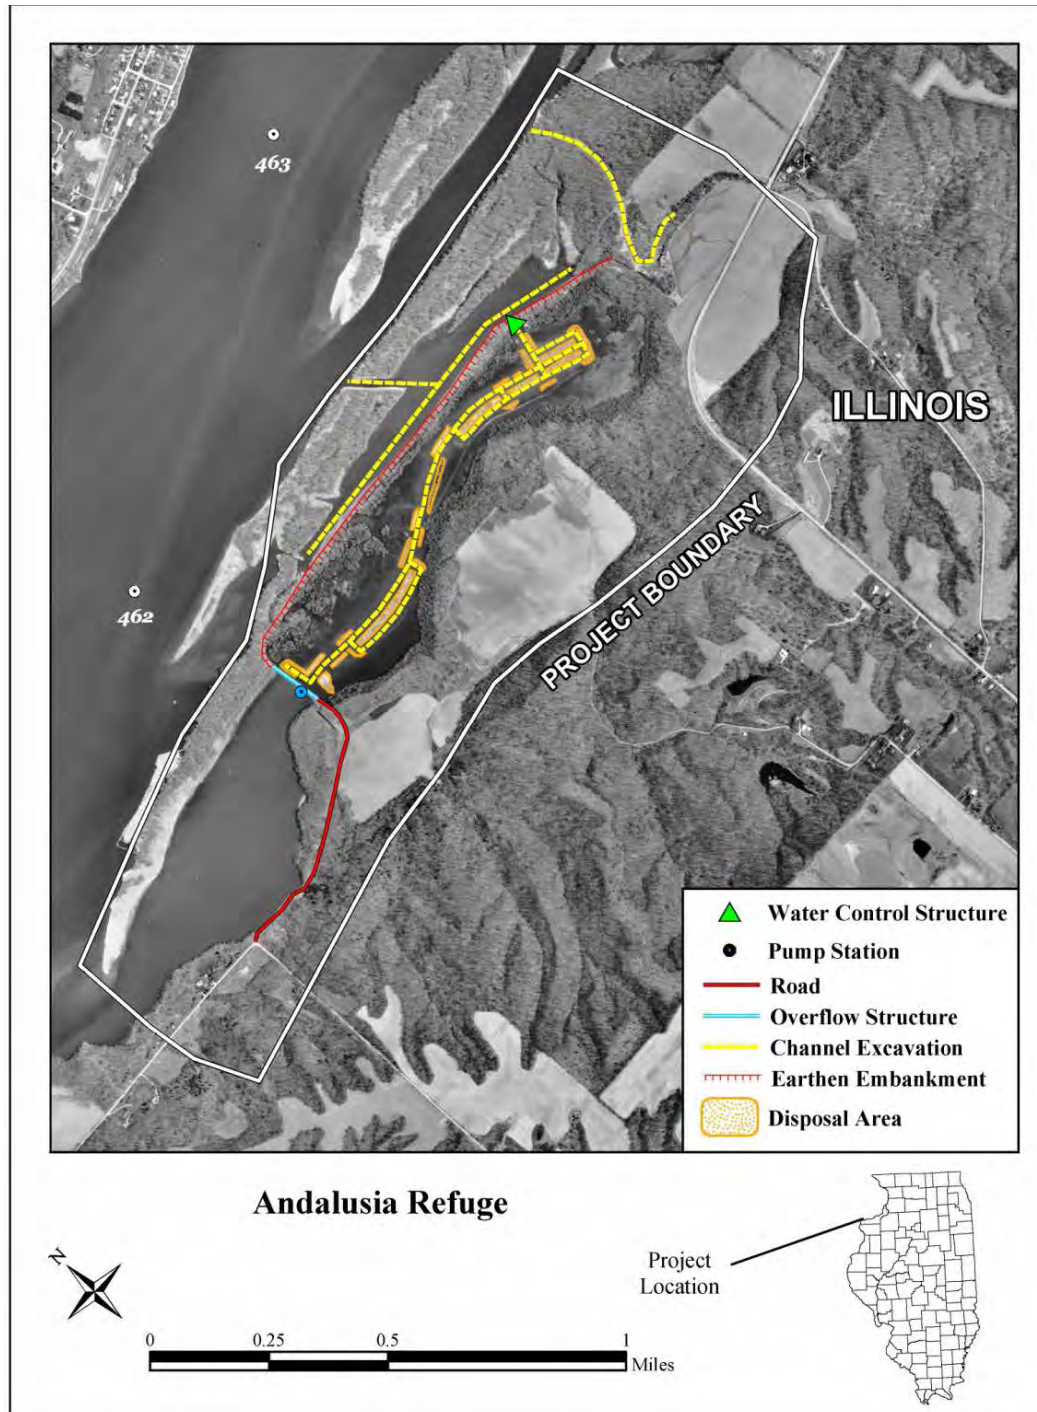
Figure 1. Andalusia Refuge HREP

4. Project Location. The Andalusia Refuge HREP project is located in Rock Island County, IL, on the left descending bank of the Mississippi River, between River Miles 462.0-463.0 (Figure 1). The project is operated by the ILDNR under the terms of a Cooperative Agreement with the USFWS.

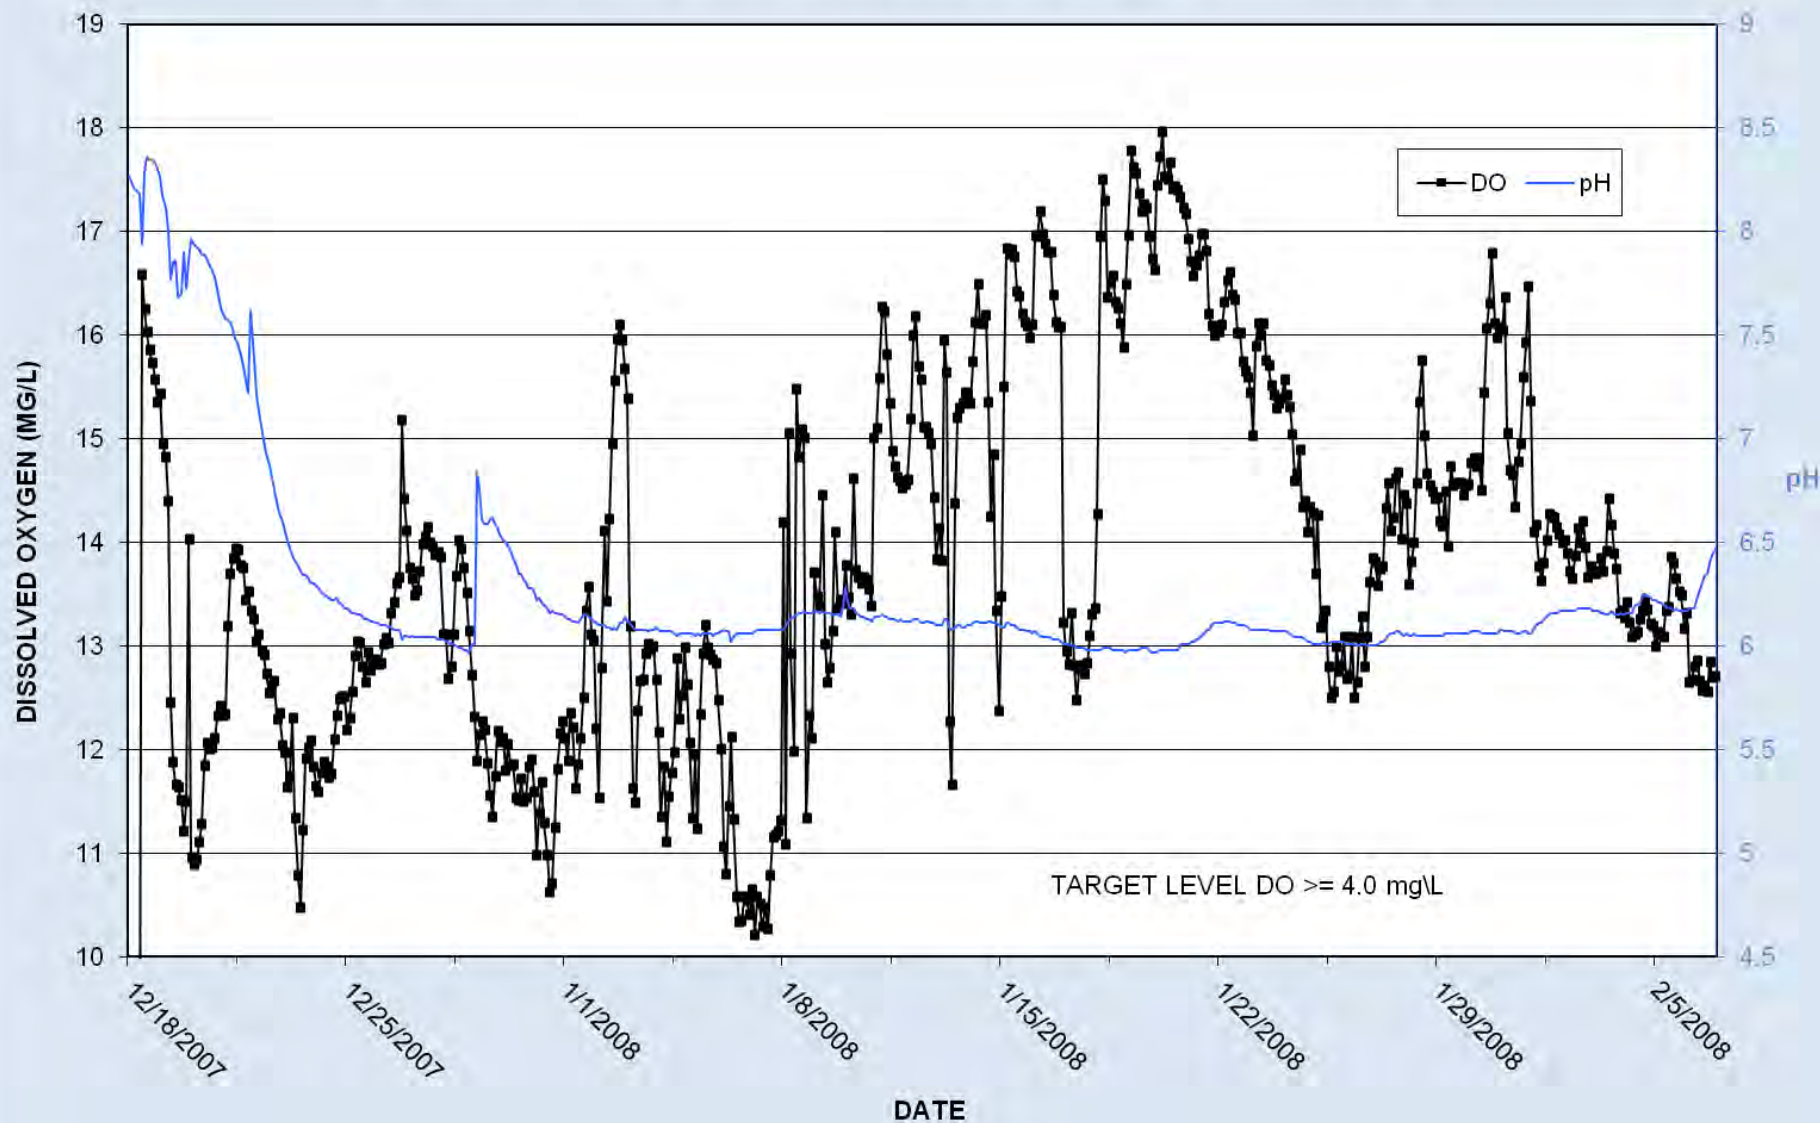
FIGURE 2. POST-PROJECT DISSOLVED OXYGEN AND pH VALUES COLLECTED WITH A CONTINUOUS MONITOR AT SITE W-M462.50 (DECEMBER 20, 2007 - FEBRUARY 7, 2008)

Figure 2. Best Case Deployment during Current Monitoring Period, December 20th, 2007, to February 7th, 2008

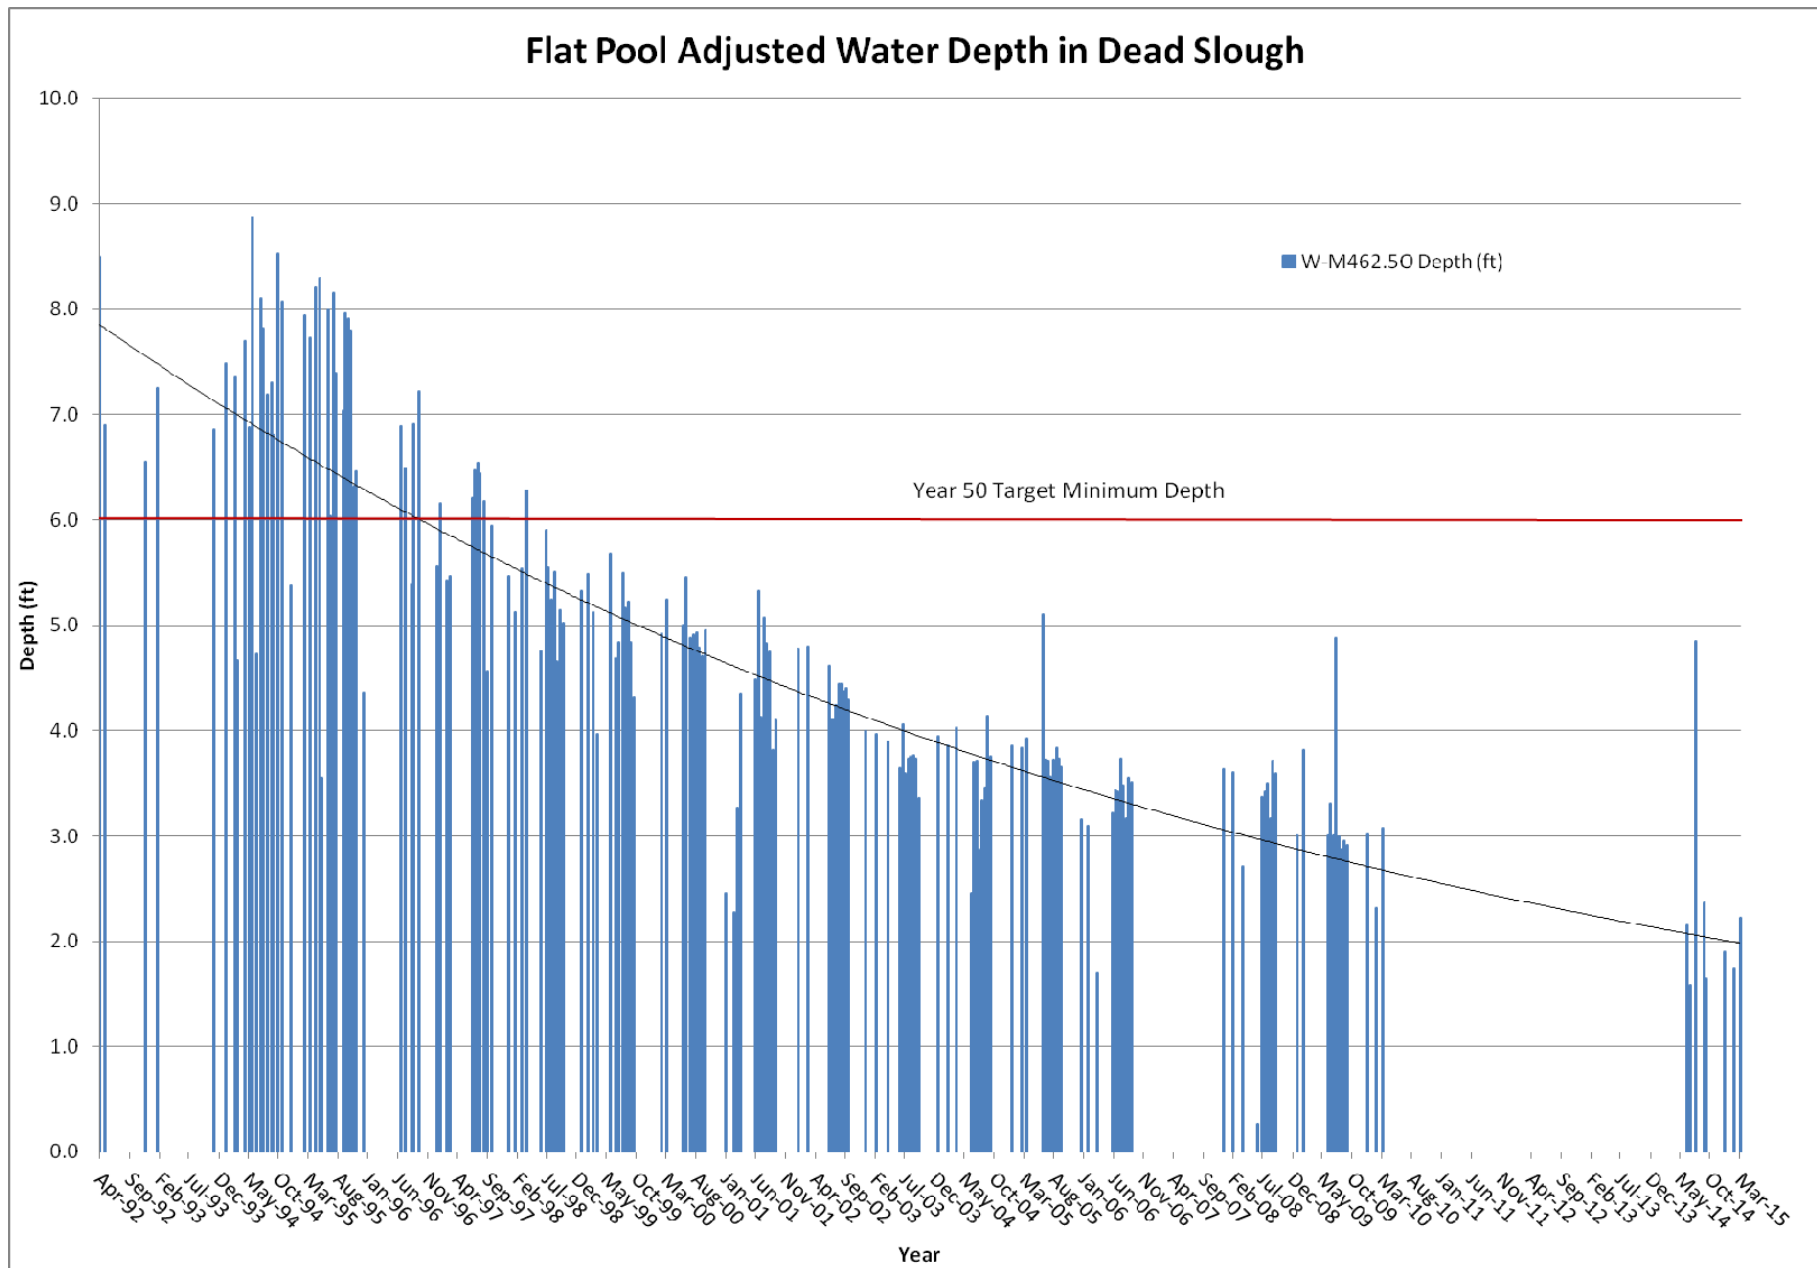
Other important elements under the "Enhance aquatic habitat" project objective in Table 12-1 of the Definite Project Report are the restoration of deep aquatic habitat in Dead Slough and restoration of an access channel to the slough. According to the USACE Andalusia Refuge PER from 2001, the Year 50 Targets are to maintain a flat pool depth > 6' in Dead Slough dredge channels and depth \geq 2' in the slough's access channel. Flat pool adjusted water depth at the Dead Slough sampling site was determined according to the method described in the 2001 Andalusia Refuge PER. Since that report, subsequent reports have used the same methodology to determine flat pool depths at the sampling site. Average annual sediment accumulation was calculated by subtracting average annual water depths from successive years. The loss of water depth at the sampling site from 1992 through 2015 is illustrated in Figure 4. A summary of water depth and sediment accumulation is provided in Table 2. Average sediment accumulation per year at site W-M462.50 since post construction monitoring commenced in 1992 was 3.1 inches, based on water depth measurements taken at the time of water quality monitoring at the sampling site and water surface elevations provided by the Rivergages.com website for the Fairport, IA gage. Gage data at Fairport (RM 463.5) was interpolated to the monitoring site location (RM 462.5) using the average water surface elevation slope for the Mississippi River at this section of Pool 16. The average annual sediment accumulation rate for the current report period is 1.8 in/yr. Due to the lack of data collected between 2010 and 2014, this sedimentation rate is likely under-estimated and should not be used. However, a distinct downward trend in water depth at the sampling site can be seen utilizing the trend line in Figure 3. The sampling site in Dead Slough has not met the Year 50 Target depth of 6' or greater since 1997.

Figure 4. Water Depths Adjusted to Flat Pool at Site W-M462.50 in Dead Slough

Depths were adjusted to flat pool using water depth values observed at the sampling site during a monitoring event and water surface elevations obtained from the Rivergages website at the Fairport, IA gage.

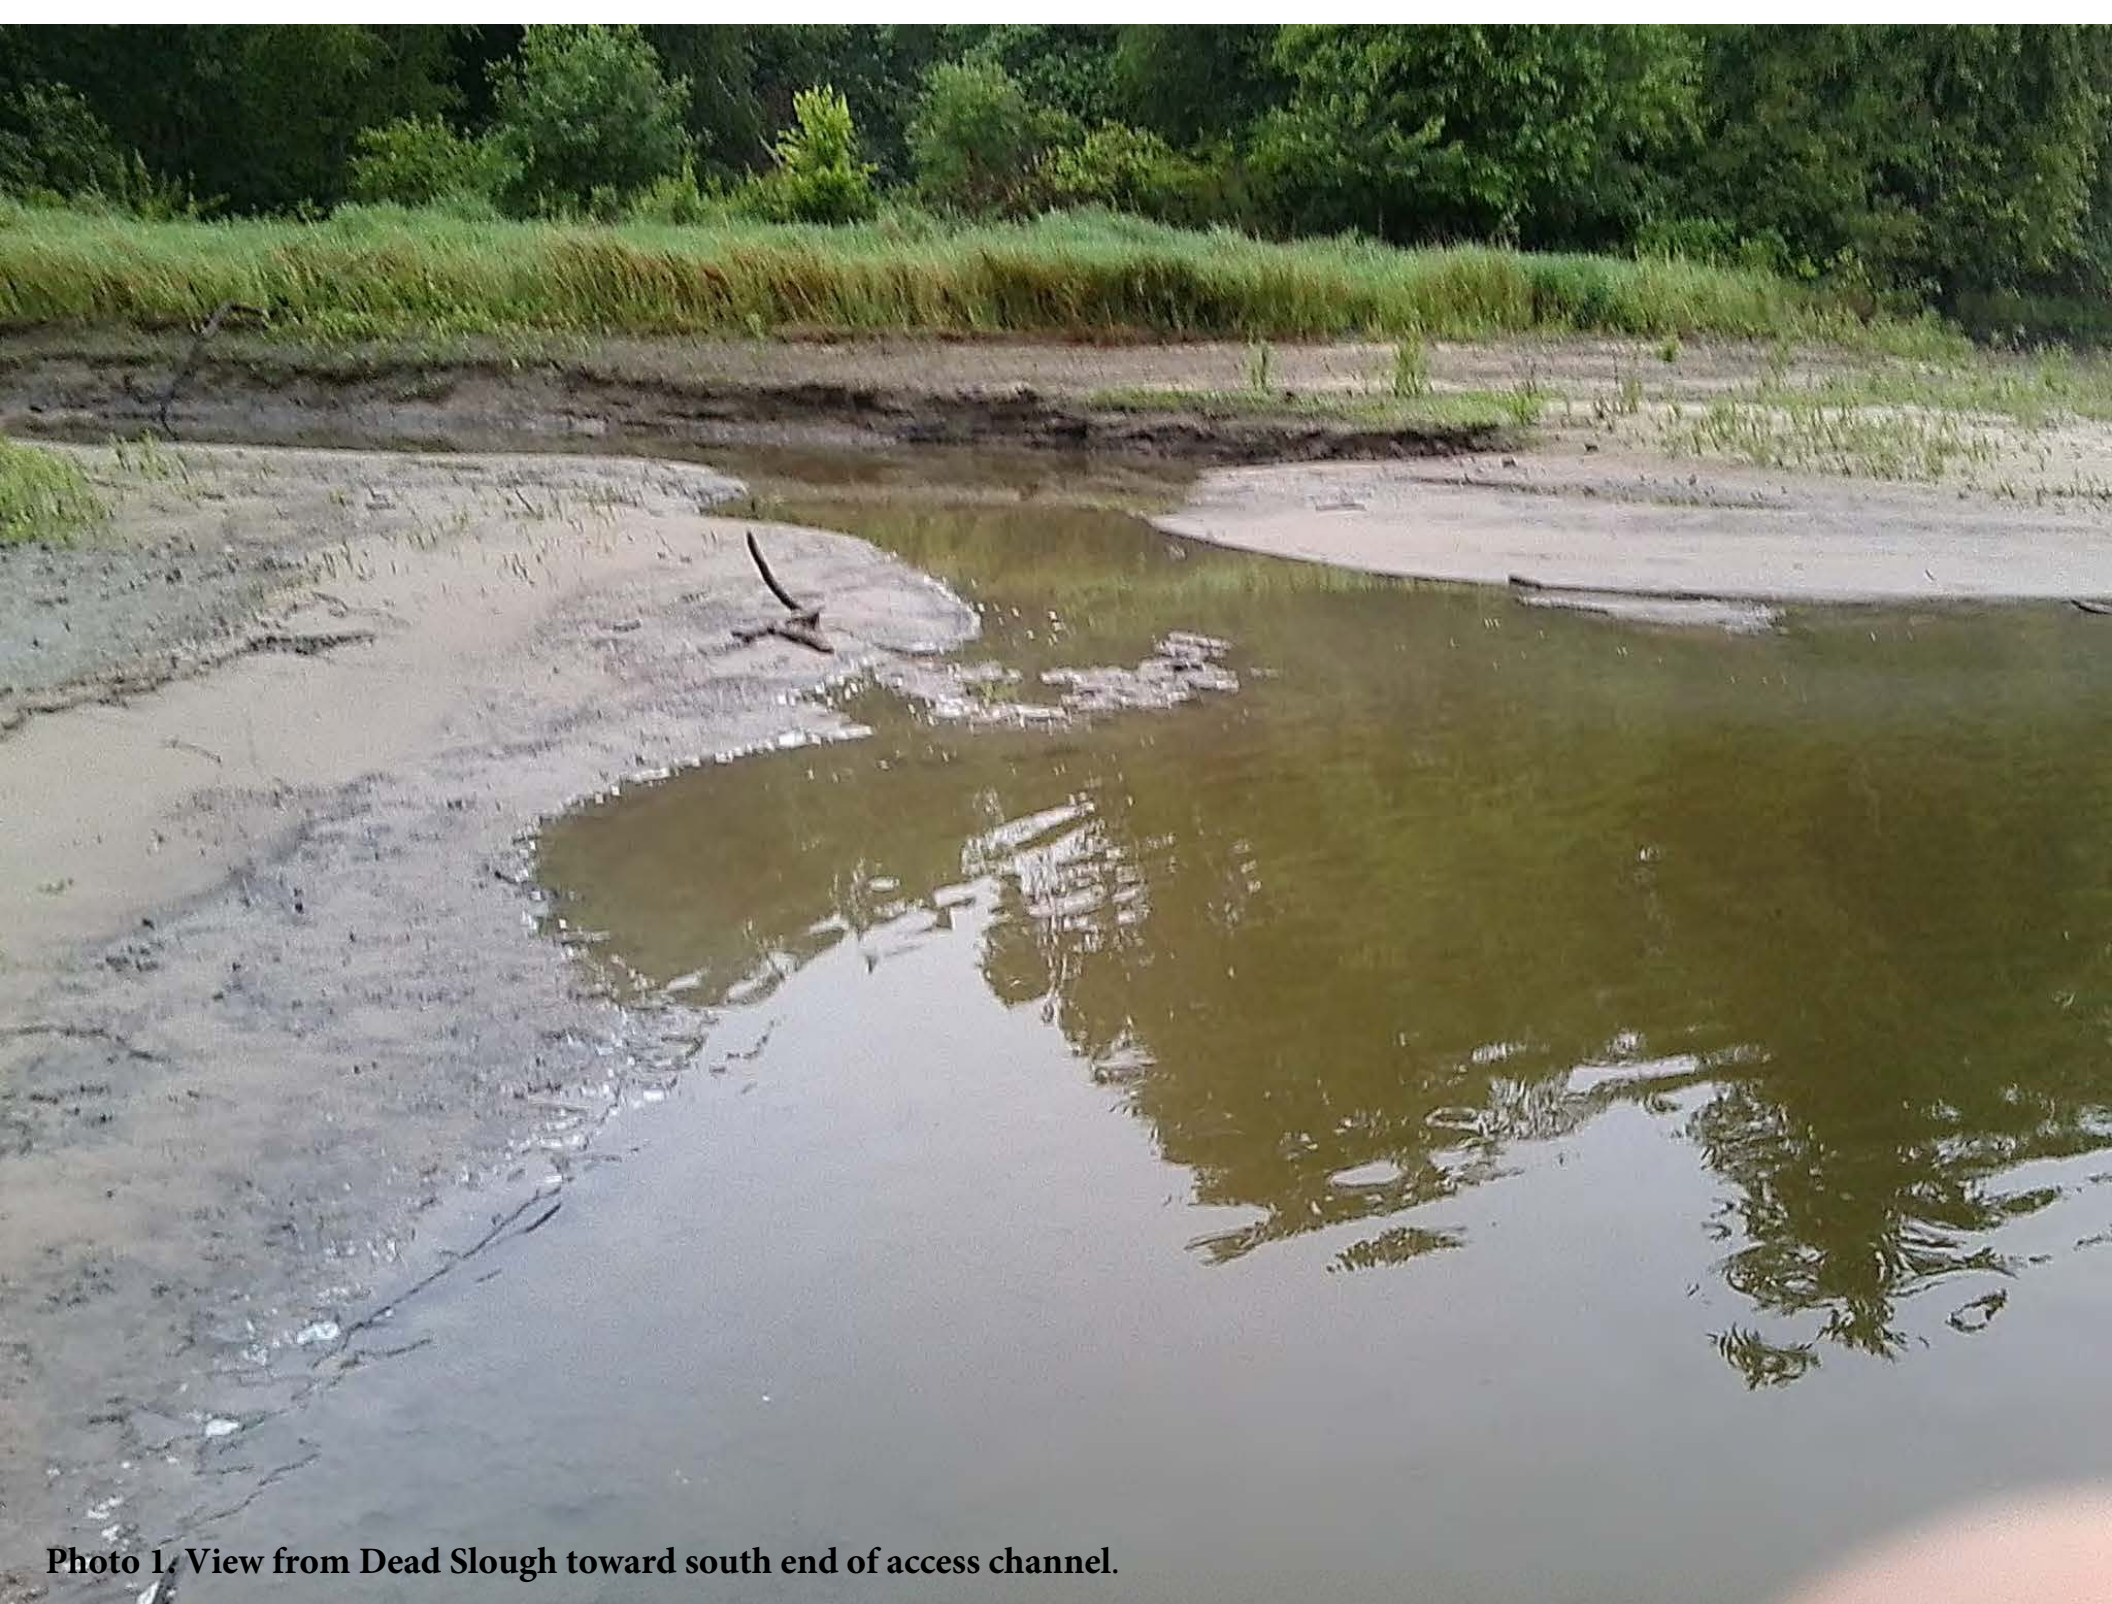
Photo 1. View from Dead Slough toward south end of access channel.

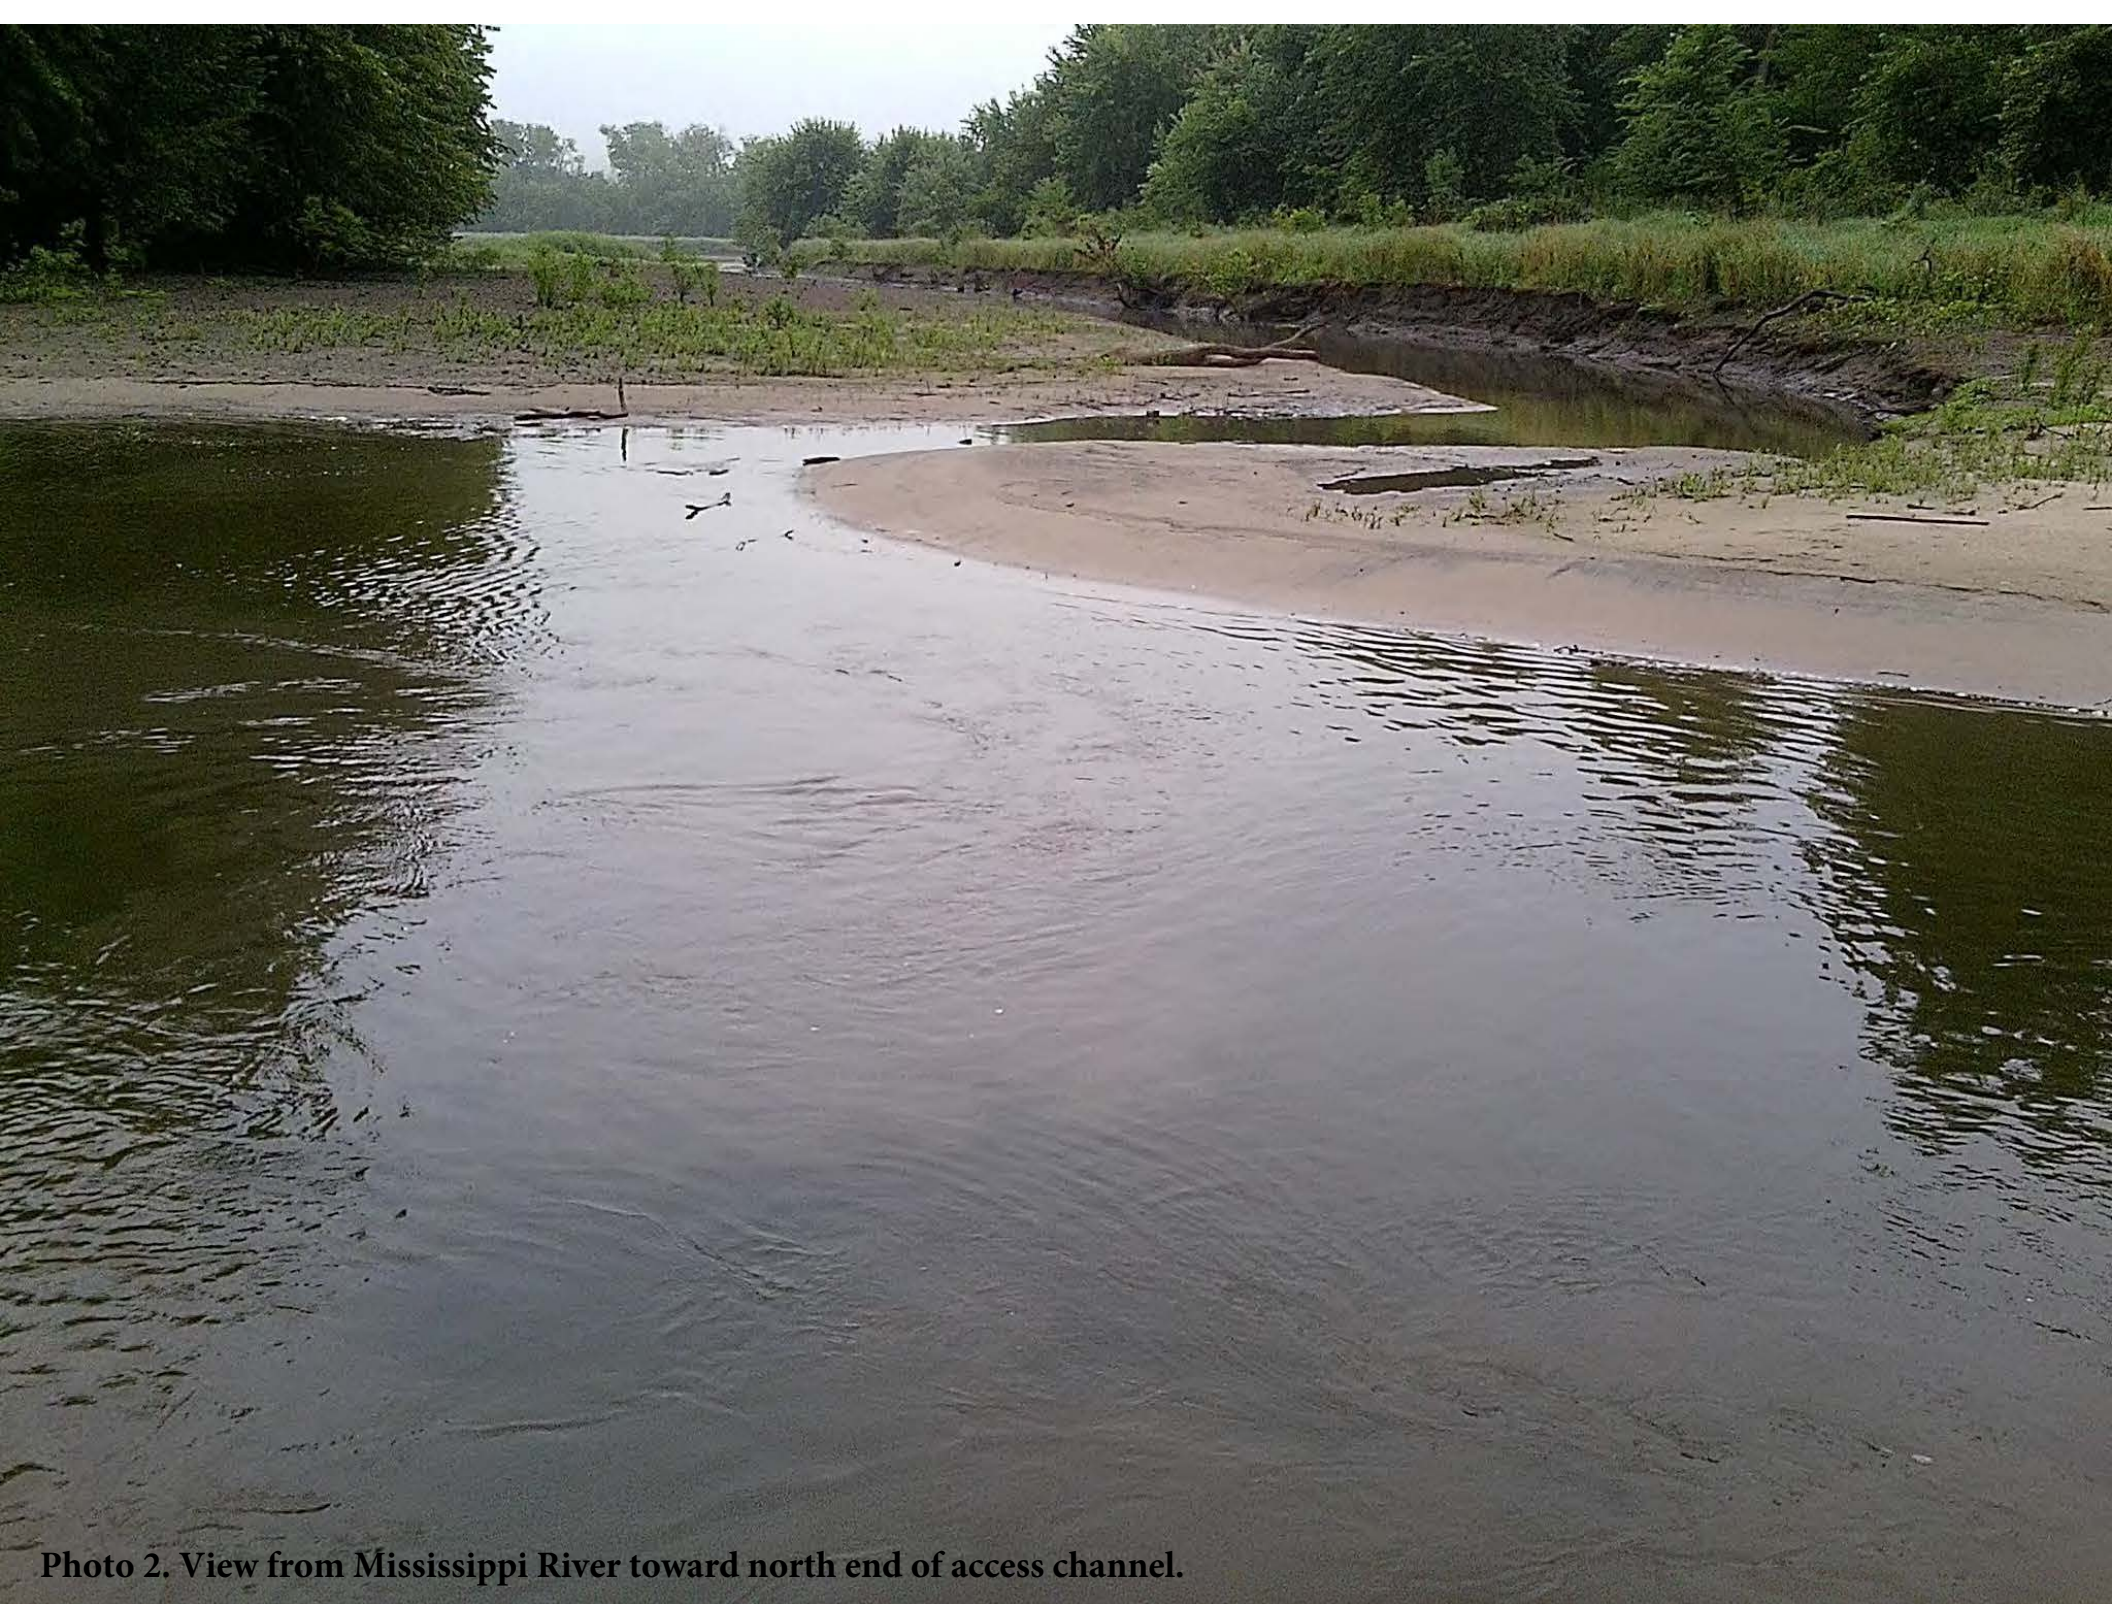
Photo 2. View from Mississippi River toward north end of access channel.

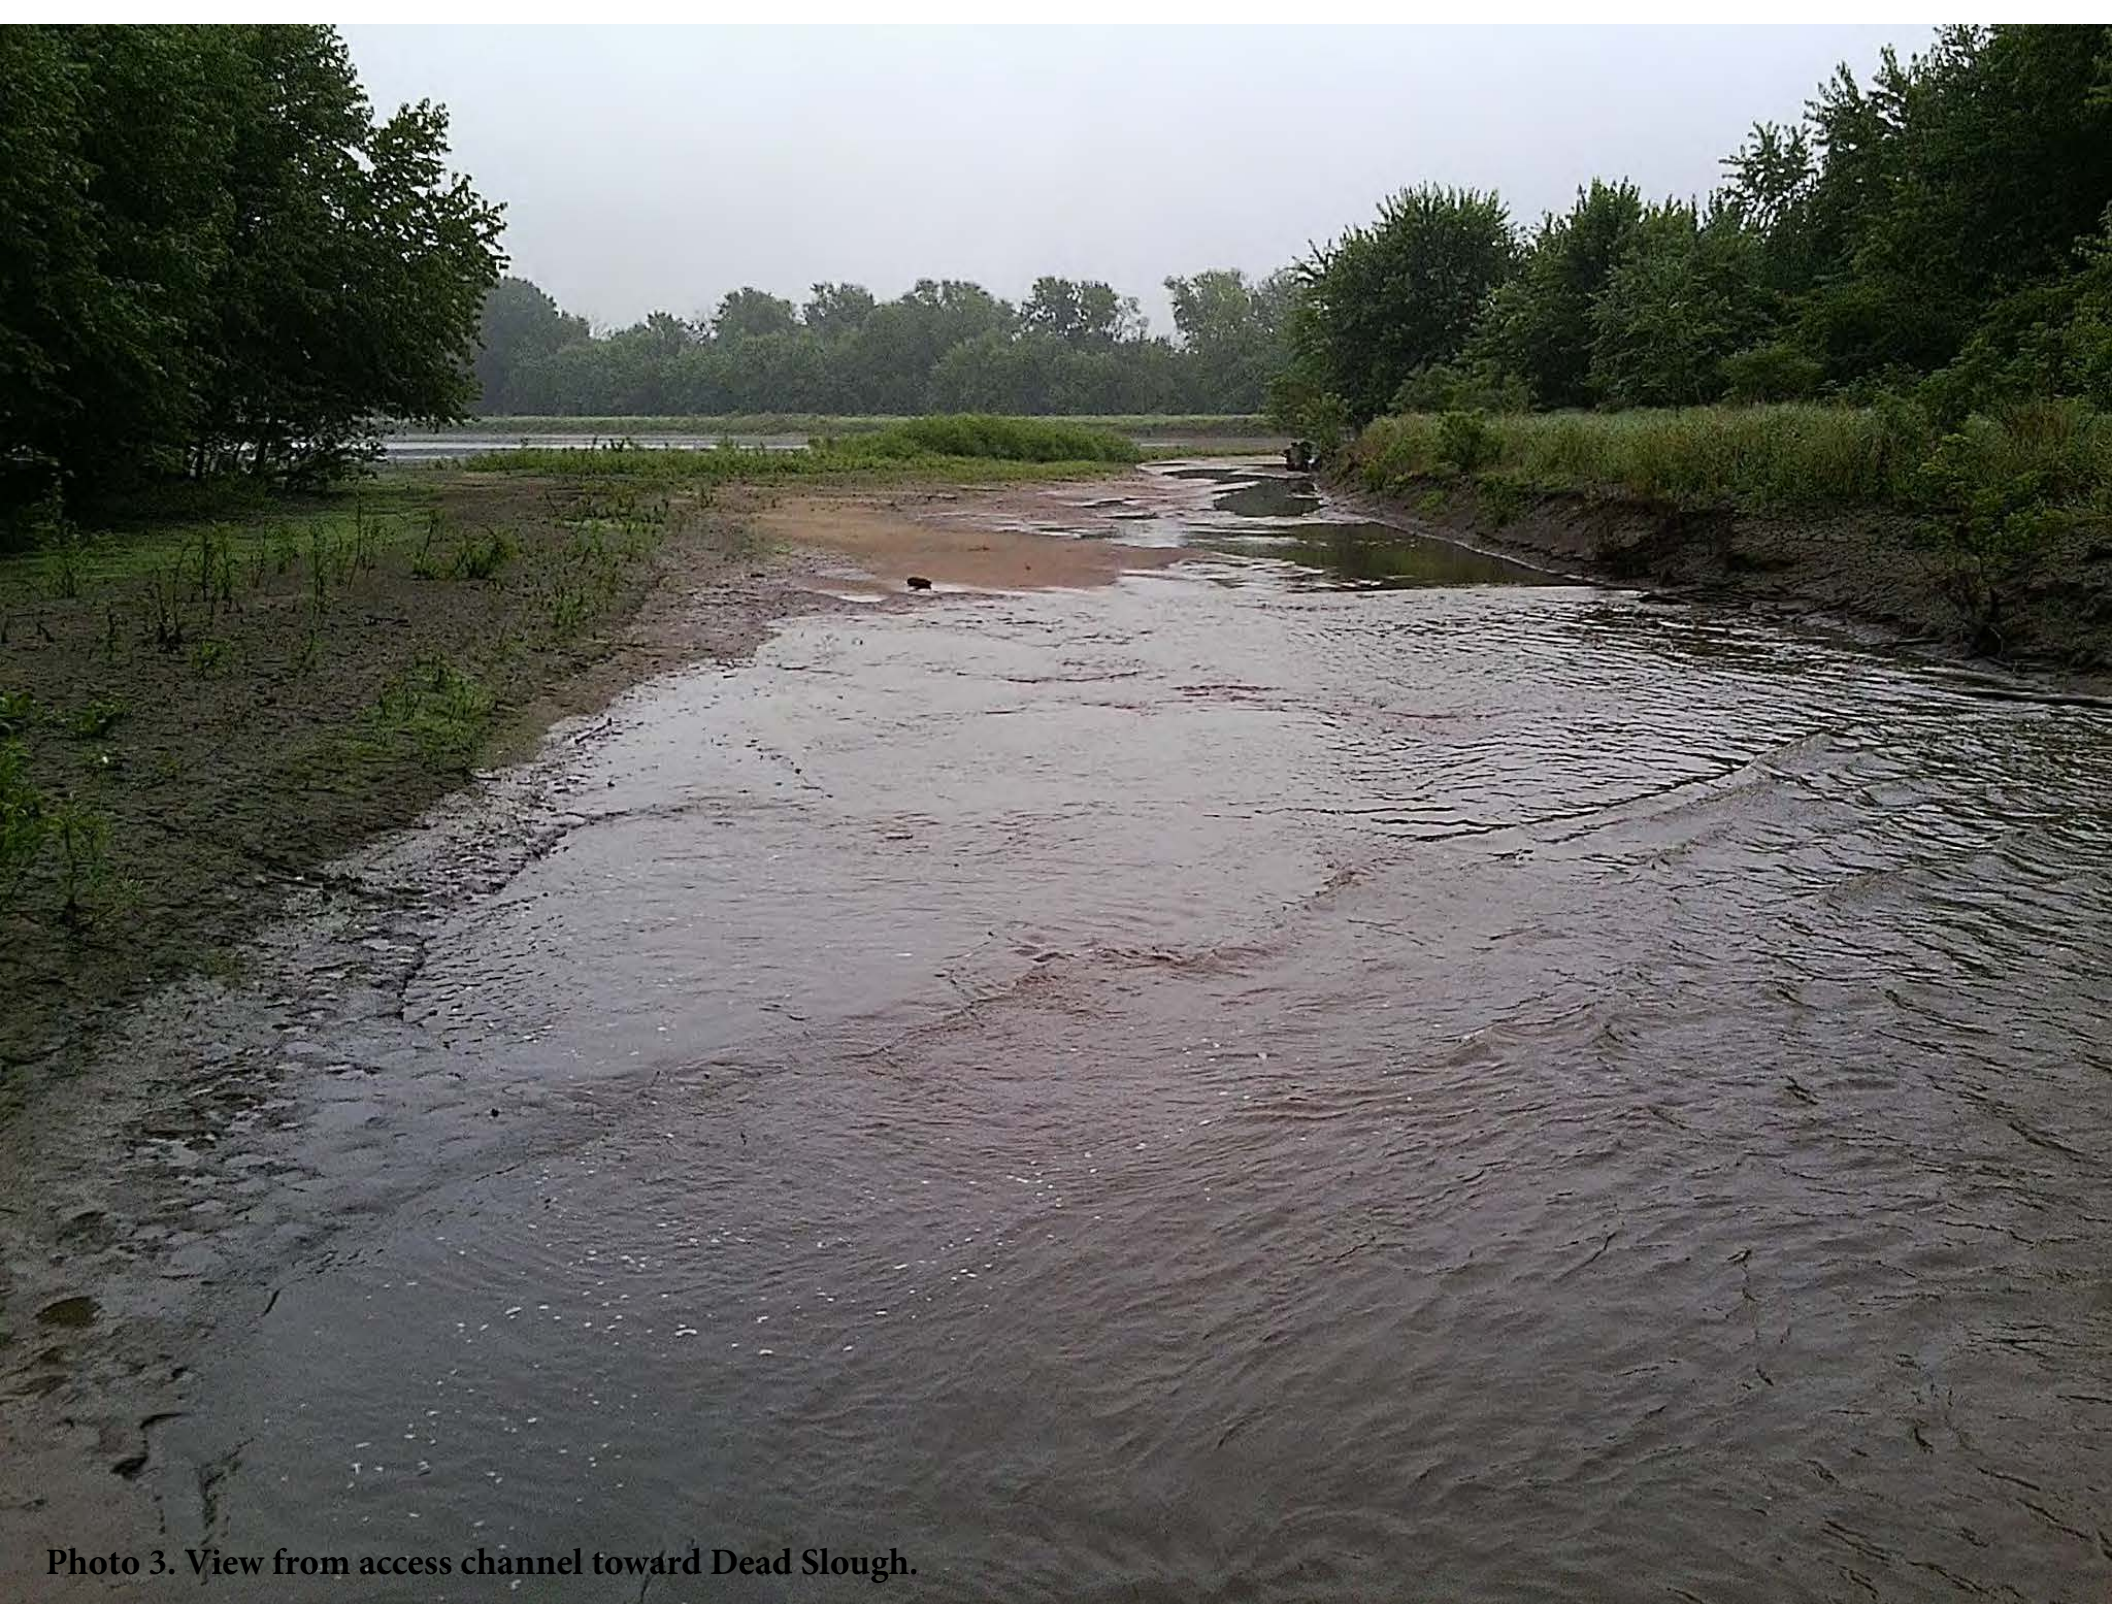
Photo 3. View from access channel toward Dead Slough.
