## **BANNER MARSH INSPECTION OF COMPLETED WORKS 2017**

Banner Marsh Habitat Rehabilitation and Enhancement Project (HREP)

LaGrange Pool, Illinois River, Miles 138-144, Fulton and Peoria Counties, Illinois

**IX. DATE OF FIELD VISIT:** June 26, 2017, Warm, overcast, mid 70's °F

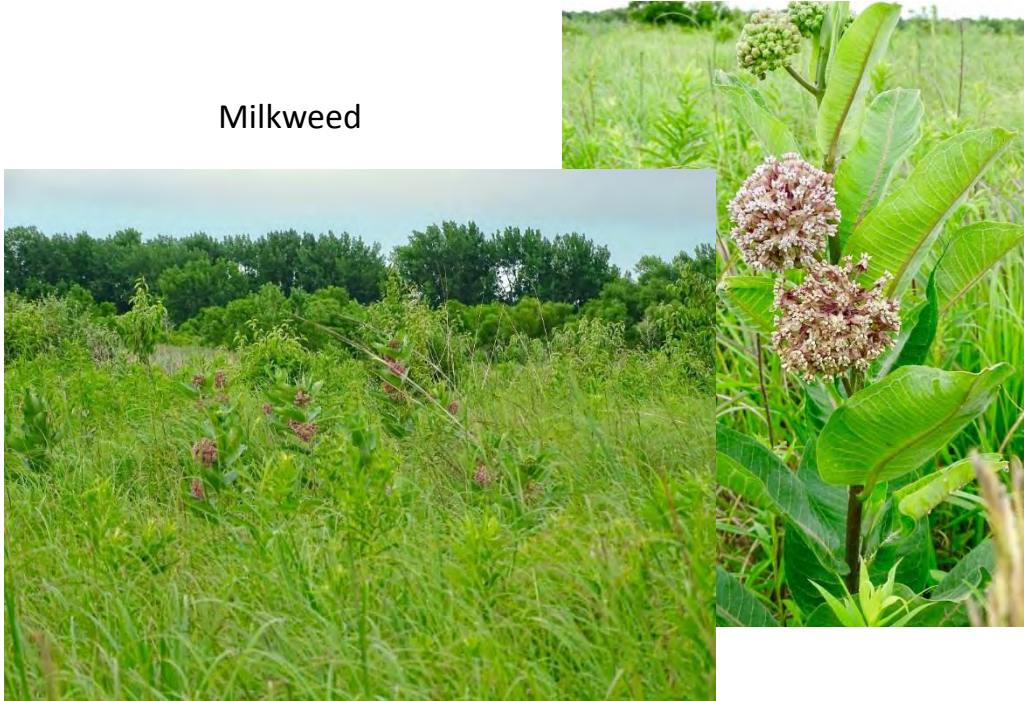
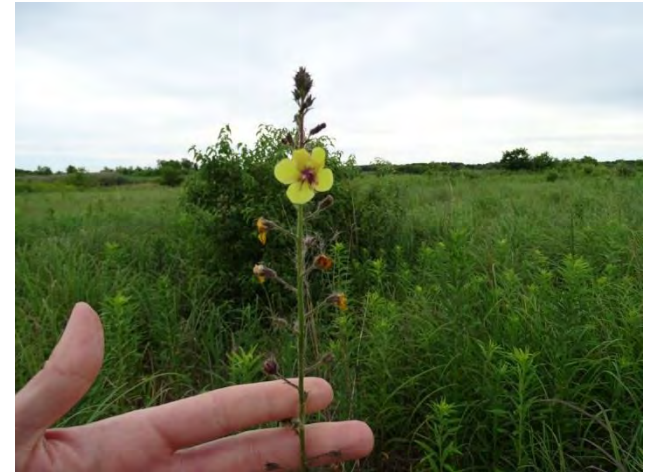
Moth mullein

Native and non-native species were noted, including Indian grass, moth mullein, poison hemlock, big blue stem, common milkweed, golden rod, swamp milkweed, water plantain, false indigo bush and some willows. The project measures continue to provide terrestrial habitat, meeting increased food and cover for birds and mammals. The prairie plantings are providing excellent cover for nesting waterfowl. Native grasses and forbs are dominate throughout the prairie planting. ILDNR crew burn the area biannually to prevent woody encroachment.

Invasive prairie species were also noted. *Pastinaca sativa*, a specific parsnip, which was noted on site, produces sap that can harm skin if exposed to UV light. It is recommended to mow down species before it seeds, using an enclosed mower and ensuring material does not get on the operator. Chemical treatment such as a broadleaf treatment is also a recommended management technique, but this will harm other prairie species. Addressing this concern as soon as possible will reduce future maintenance. The sponsor reports plans to do mechanical control of the parsnip on site.

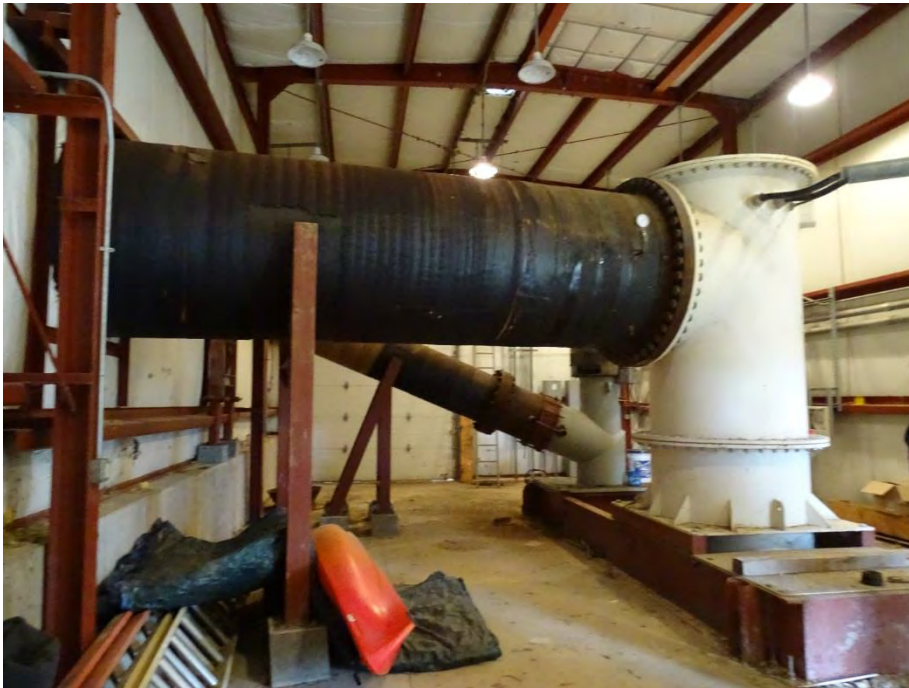
Interior of Pump Station

The pump station is designed for the 48" pump to be the primary pump and the 24" pump to be the backup pump when the marsh is at high water. However, the system does not operate as designed. The mercury floats and electronics are damaged and malfunctioning on the 48" pump. The pump is working but must be operated manually. The labor cost to operate it manually are prohibitively expensive except in emergency situations. The Illinois Department of Natural Resources (ILDNR) has spoken with a local electrician/pump contractor who stated that the damaged electrical components could be replaced for approximately \$20,000, and this would allow the pump to operate as designed. The contractor also stated that the mercury floats could be replaced with a more reliable laser system to determine water surface elevation.

Condensation has been an issue in the pump station in the past and the ILDNR confirmed that it is still in issue, especially during the humid summer months. According to the 2014 PER, the pump station was designed to keep water levels between 429 and 431. The ILDNR is currently operating the pumps to keep water levels in the marsh between 436 and 437. At this elevation there is no extra capacity for water storage, but it is the minimum elevation required to keep the site roads from being submerged. They stated that if they were able to get the 48" pump operating as designed, they would like to lower the marsh water levels by 8-12 inches. There were no concerns with the sump in regards to sediment or debris.

- Additional invasive species management in the prairie planting area
- Replace/repair electronics and floats for the 48 inch pump

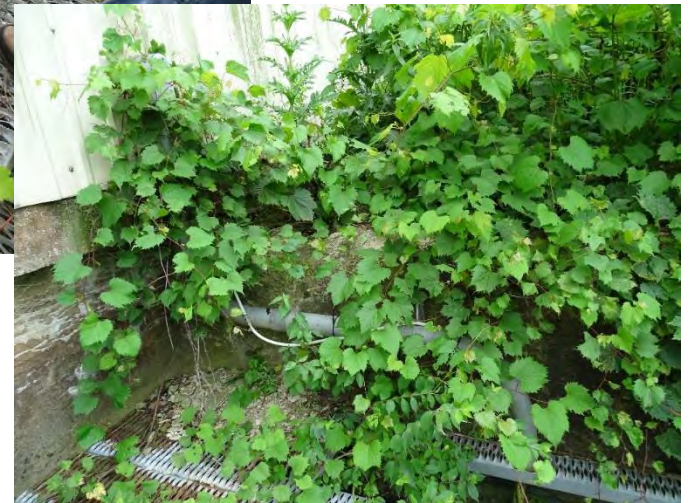
Vegetation encroaching  
on intake structure

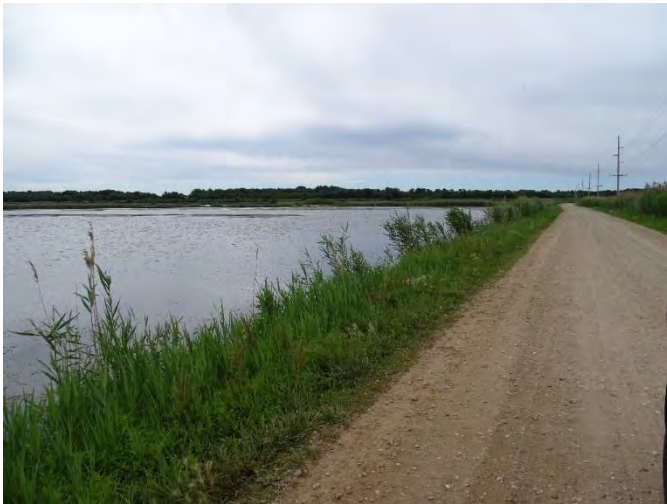
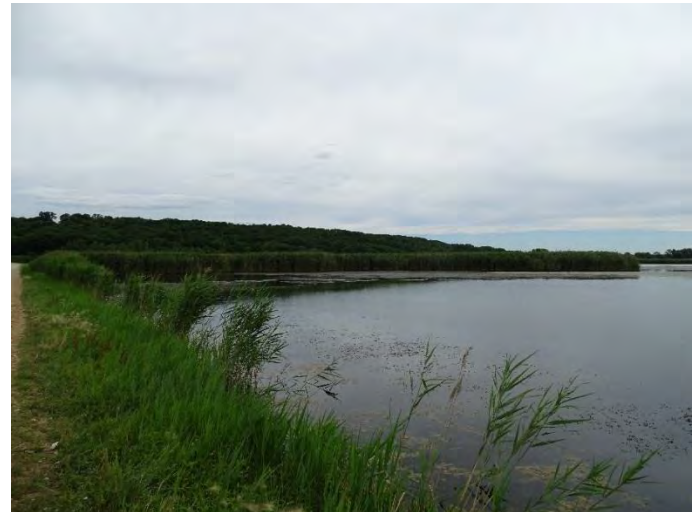
# Levee

The 9 mile levee surrounding the site continues to provide protection to the interior wetland, terrestrial and aquatic habitat.
