## MEMORANDUM FOR RECORD:

SUBJECT: Bay Island HREP, 10-Year Performance Evaluation Report, 2003

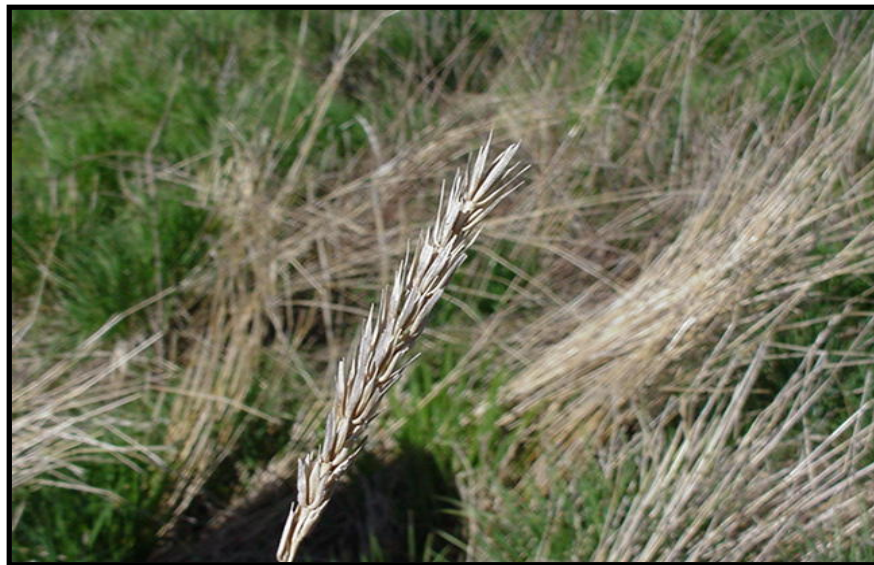
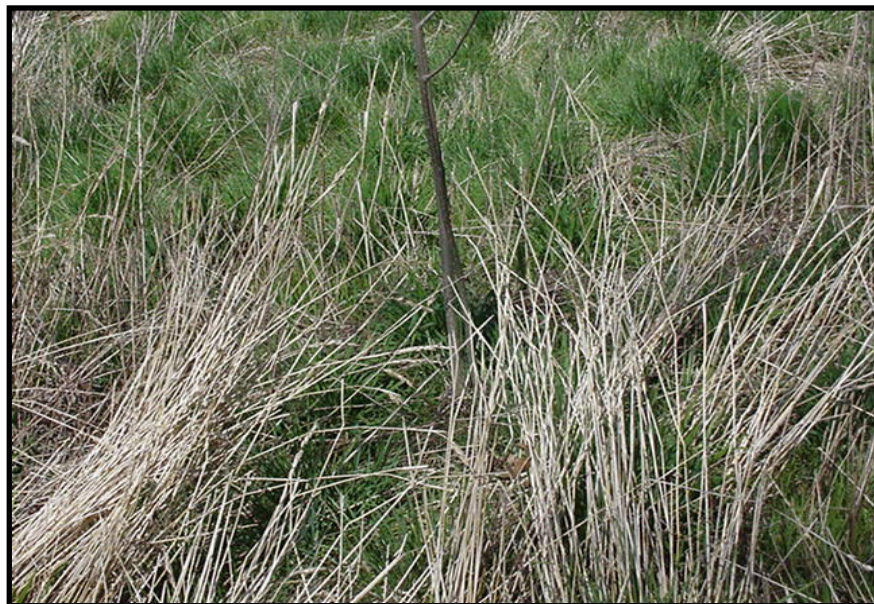
4. Cover plantings. MDC planted Virginia wild rye (*Elymus virginicus*) as a cover crop in tree planting areas and it appeared to be fairly successful at this HREP. Virginia wild rye is a native, cool-season grass similar to the related Canada wild rye (*E. Canadensis*) but considered to be more moisture-tolerant. The photos below show examples of last year's growth still present on the site, with new growth visible as well. Where this grass was planted, it appears to have been effective in controlling weedy growth (particularly of species such as giant ragweed) that otherwise could have prevented or inhibited mast tree survival and growth. Future HREPs that involve planting of mast trees in floodplain areas should evaluate the feasibility of using this species as ground cover.

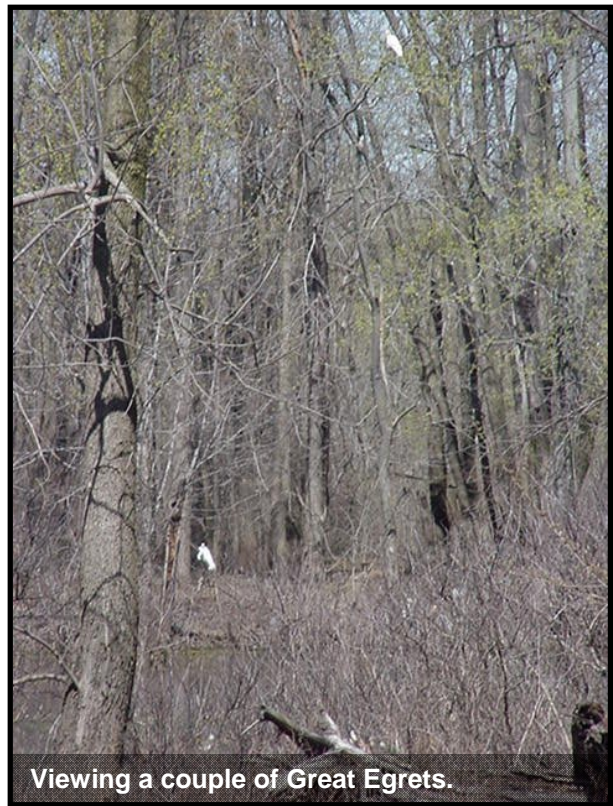
Viewing a couple of Great Egrets.
