**BAY ISLAND
INSPECTION OF COMPLETED WORKS
2017**

PROJECT: Bay Island Habitat Rehabilitation and Enhancement Project

LOCATION: Pool 22, Mississippi River Miles (RM) 311.0 - 312.0, Marion County, MO

DATE OF FIELD VISIT: June 20, 2017, warm, sunny, mid 80's °F

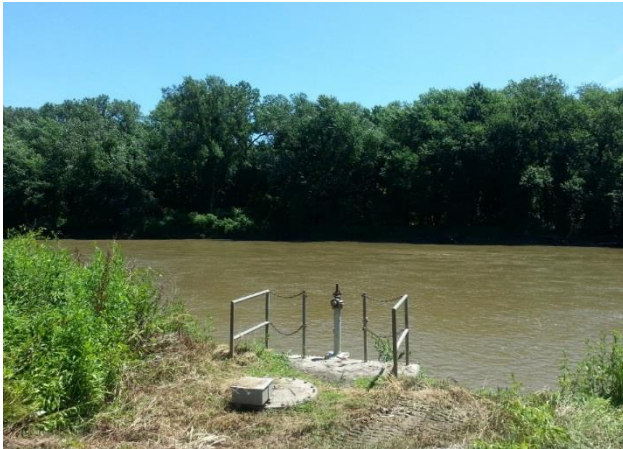
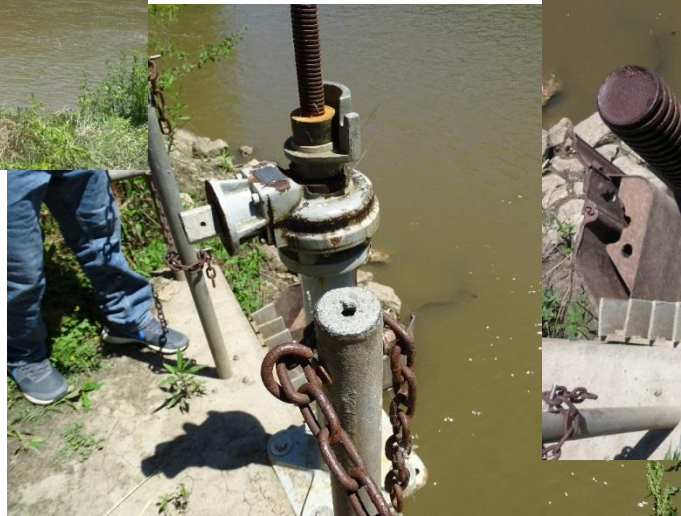
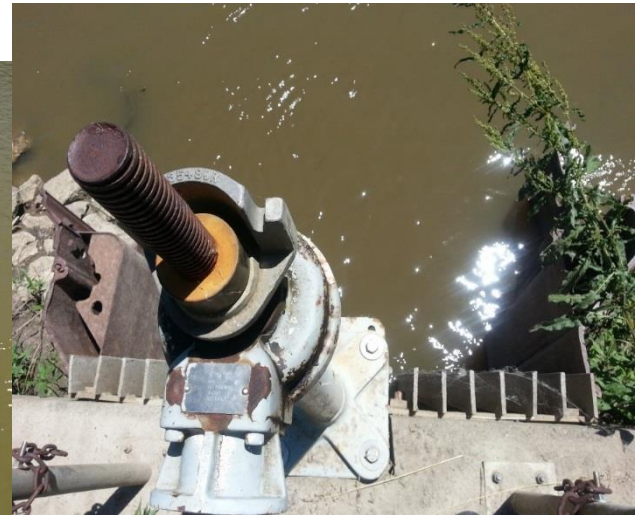
Pump Station

No concerns were noted in regards to the pump station structure. Regular maintenance is occurring. The only issue brought to USACE representatives' attention by the project sponsor was that leaf litter during the fall clogs the pump, causing it to shut down. The sponsor also noted the pump is working efficiently to bring water into the project area. However, getting water out of the project area during extended high water events has been a concern. Routinely long duration high stages of the Mississippi River prevent adequate drawdown of the HREP, which is leading to tree stress and death. Besides the water control structures, there is no other way to remove water from the HREP. The pump station only brings water in.

The site provides controlled water levels during waterfowl migration in both forested and non-forested areas. The water is managed through water control structures and a pump station.

1. Thin pin oak stand.
2. Determine actions to be taken to reduce leaf litter debris at pump station.
3. Replace stop log structures with gates.
4. Fix screw gate.
5. Repair erosion between borrow pit and levee (break through).

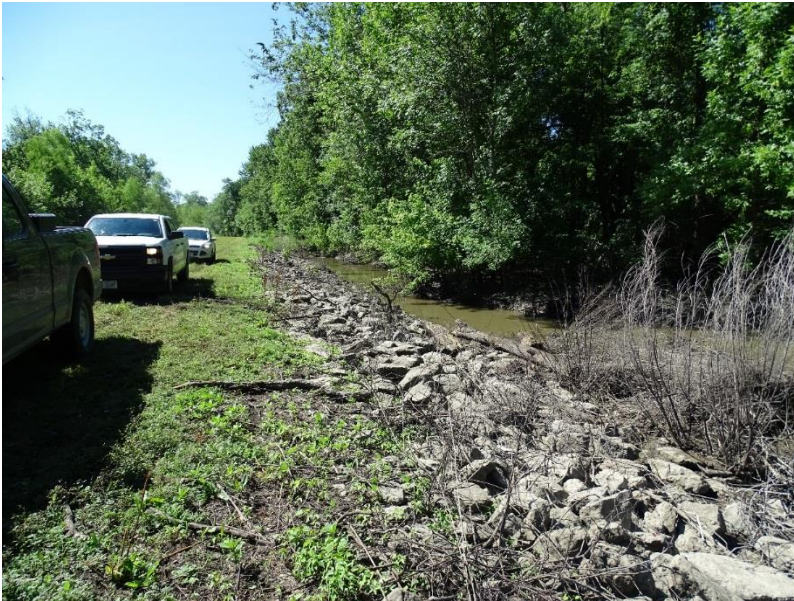
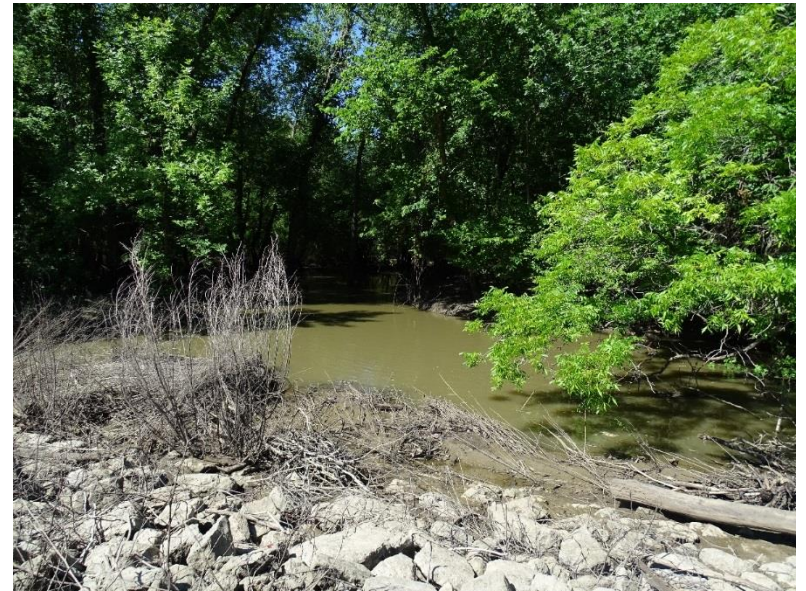
Riprap

The North Spillway is well maintained. There is no erosion, and unwanted vegetation is managed well in the riprap. Following flood events sediment needs to be scraped off. The South Spillway is in the same condition as the North Spillway. The condition of both spillways and riprap can be viewed in Attachment A.

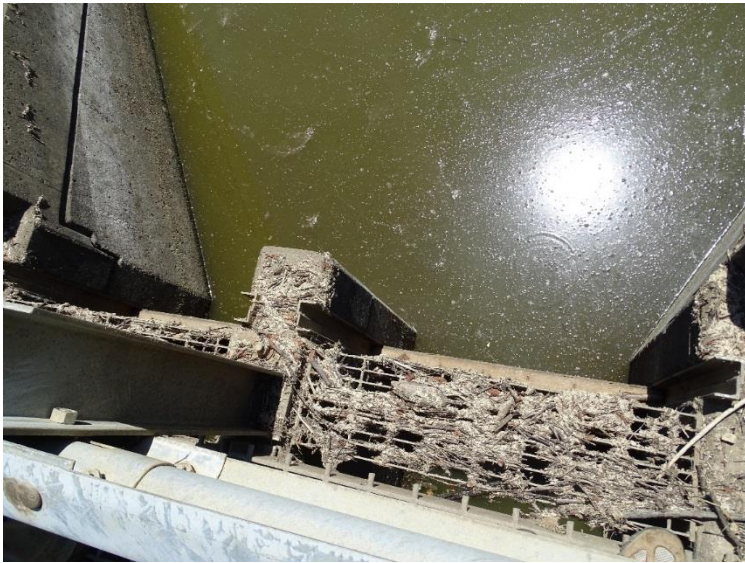
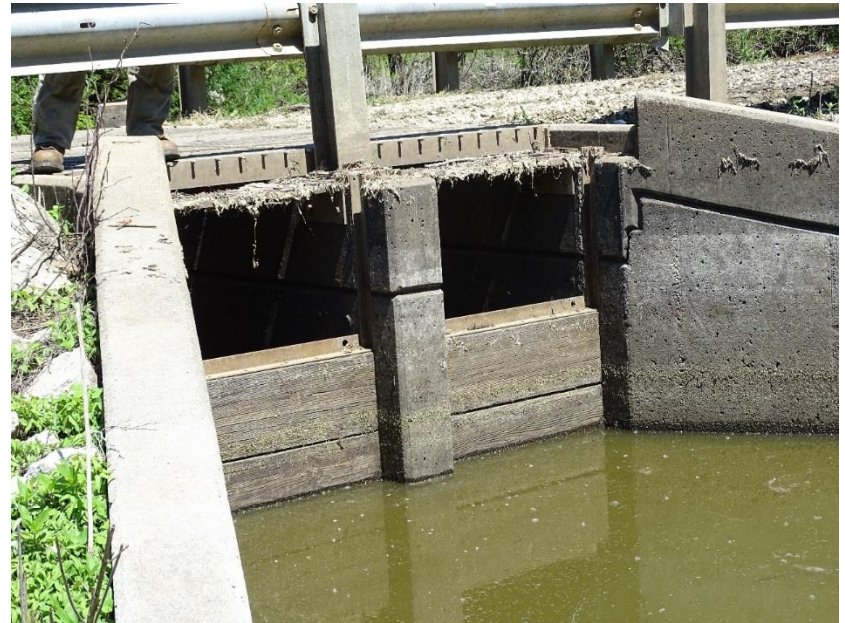
Water Control Structures

The water control structures along the North Perimeter levee is in good condition. The rip rap for the most part was still in place. There was no erosion adjacent to the structure, and only minimal concrete structural degradation adjacent to the grate decks above the stoplogs.

The stoplogs require two individuals to operate which is difficult to staff. The low guardrails and the awkward angle for insertion and removal of the lifting hooks may lead to safety concerns. The MODOC is hoping to modify the structures to ease the operation for water level management to one individual. This would occur pending the availability of funding.

Sponsor recommends not using stoplogs in future designs as they are extremely difficult to manage. A structure that can be manipulated with one person is more practical for local staff to manage.

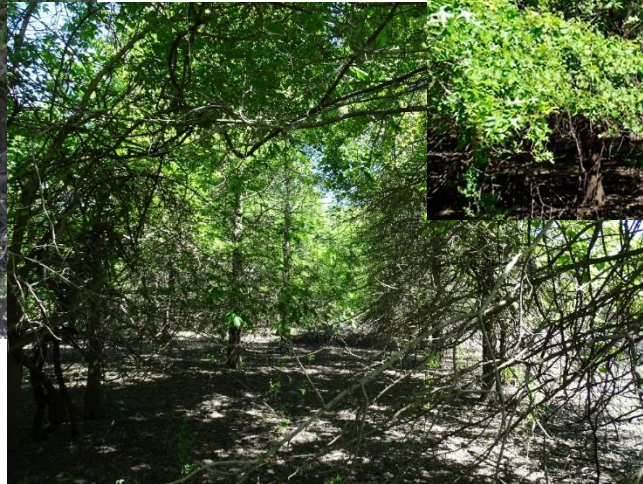
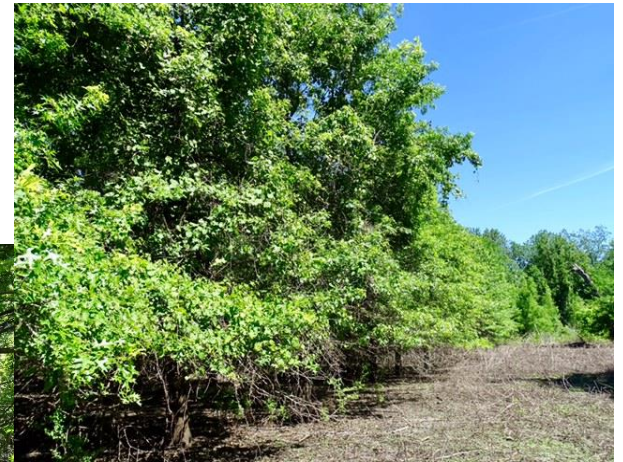
Mast trees which were planted for the project have grown significantly over the past 20 years, with large stands of pin oak trees observed.

Pin Oaks in need of thinning

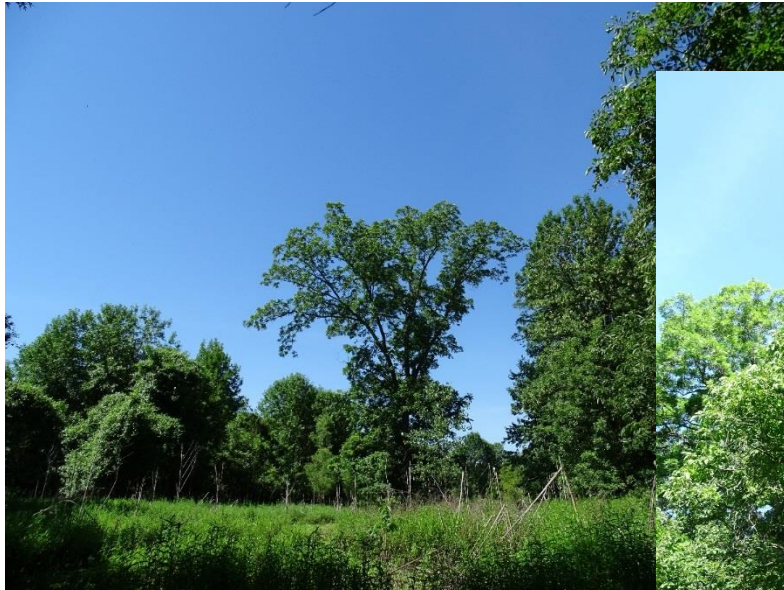
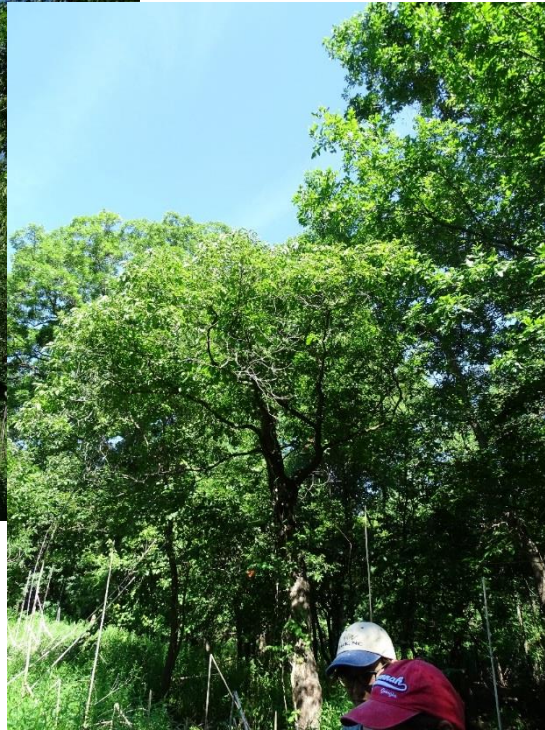
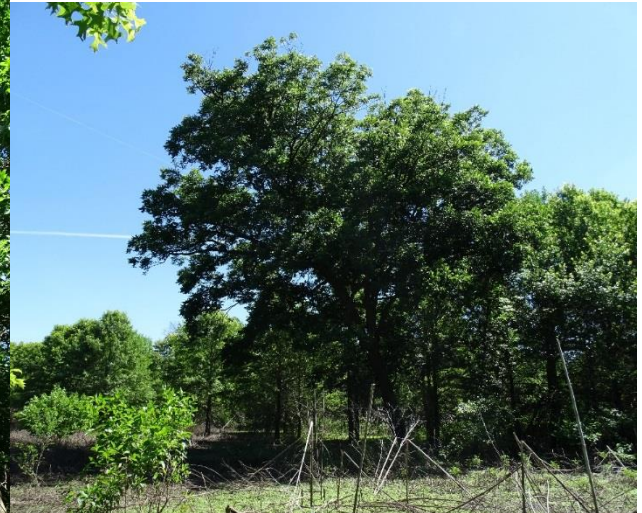
Vegetation

Numerous pecan trees, some approaching 100 years in age, were observed. Protection from frequent water level changes is provided by the embankment surrounding the wetlands. This protection increases the chances for hard mast tree survivability.

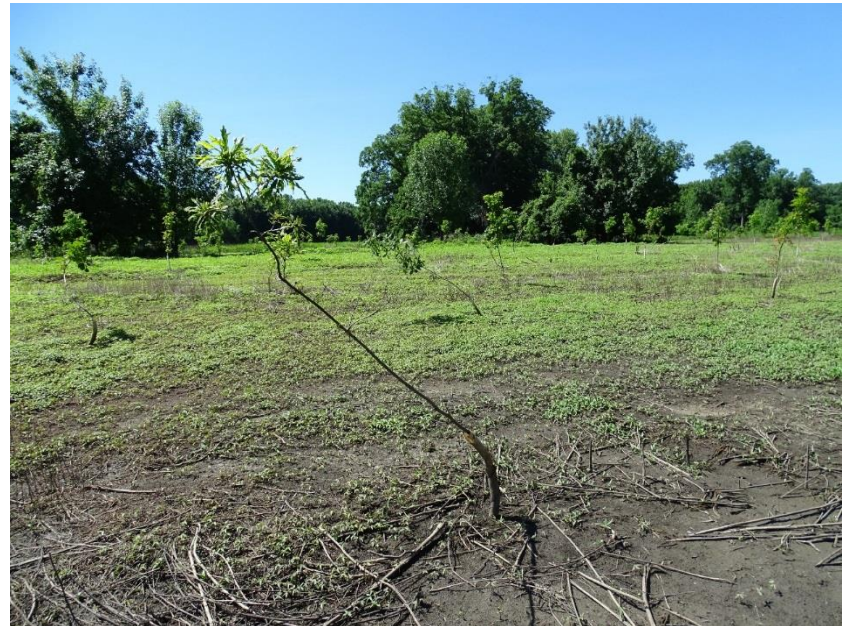
Trees falling or growing at an angle due to flooding
