## **UMRR BERTOM MCCARTNEY LAKES HREP INSPECTION OF COMPLETED WORKS**

Bertom and McCartney Lakes HREP

Mississippi River  
Pool 11  
River Miles 599 - 603  
Grant County  
Wisconsin

## X. DATE OF FIELD VISIT: August 11, 2016

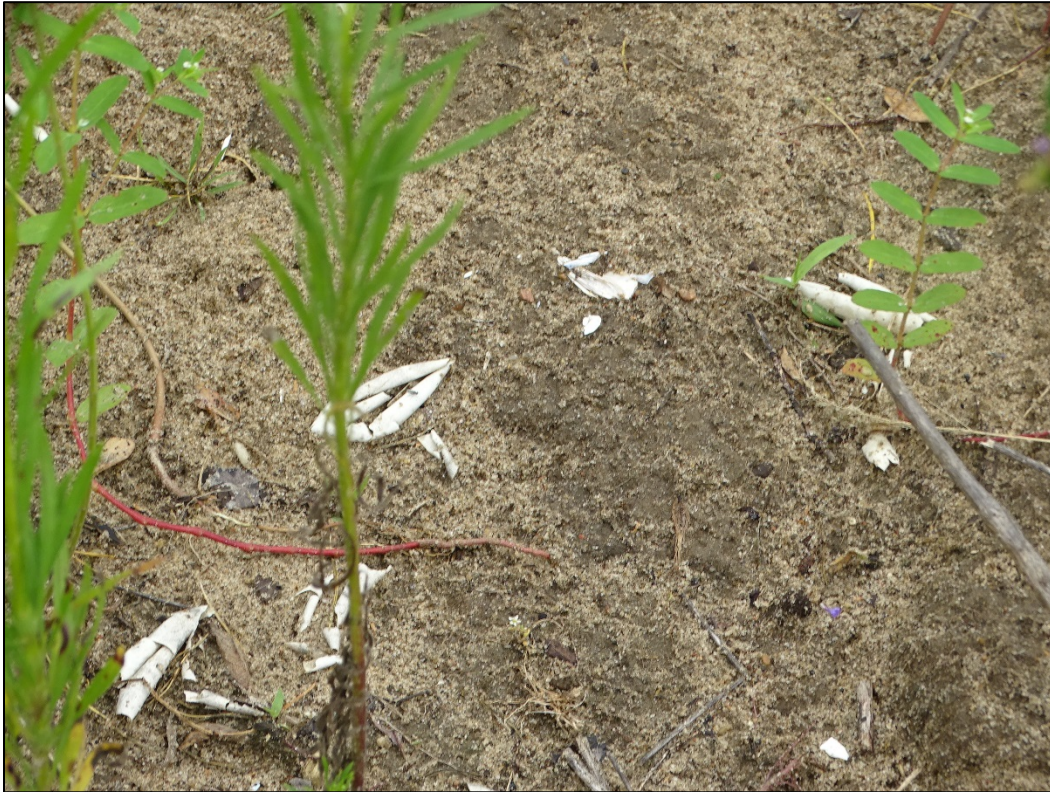
The dredged material placement site (Bertom Island) contains an isolated wetland created by a low central area. Wavewash and erosion is occurring on the upstream side of the placement site and will likely break through to the wetland over time (Photos 11, 12, 13, 14, 15, 16, 17, and 18). The placement site vegetation includes cottonwood, cedar, willows and silver maple, as well as

Photo 12. Upper shore of Dredged Material Placement Site.

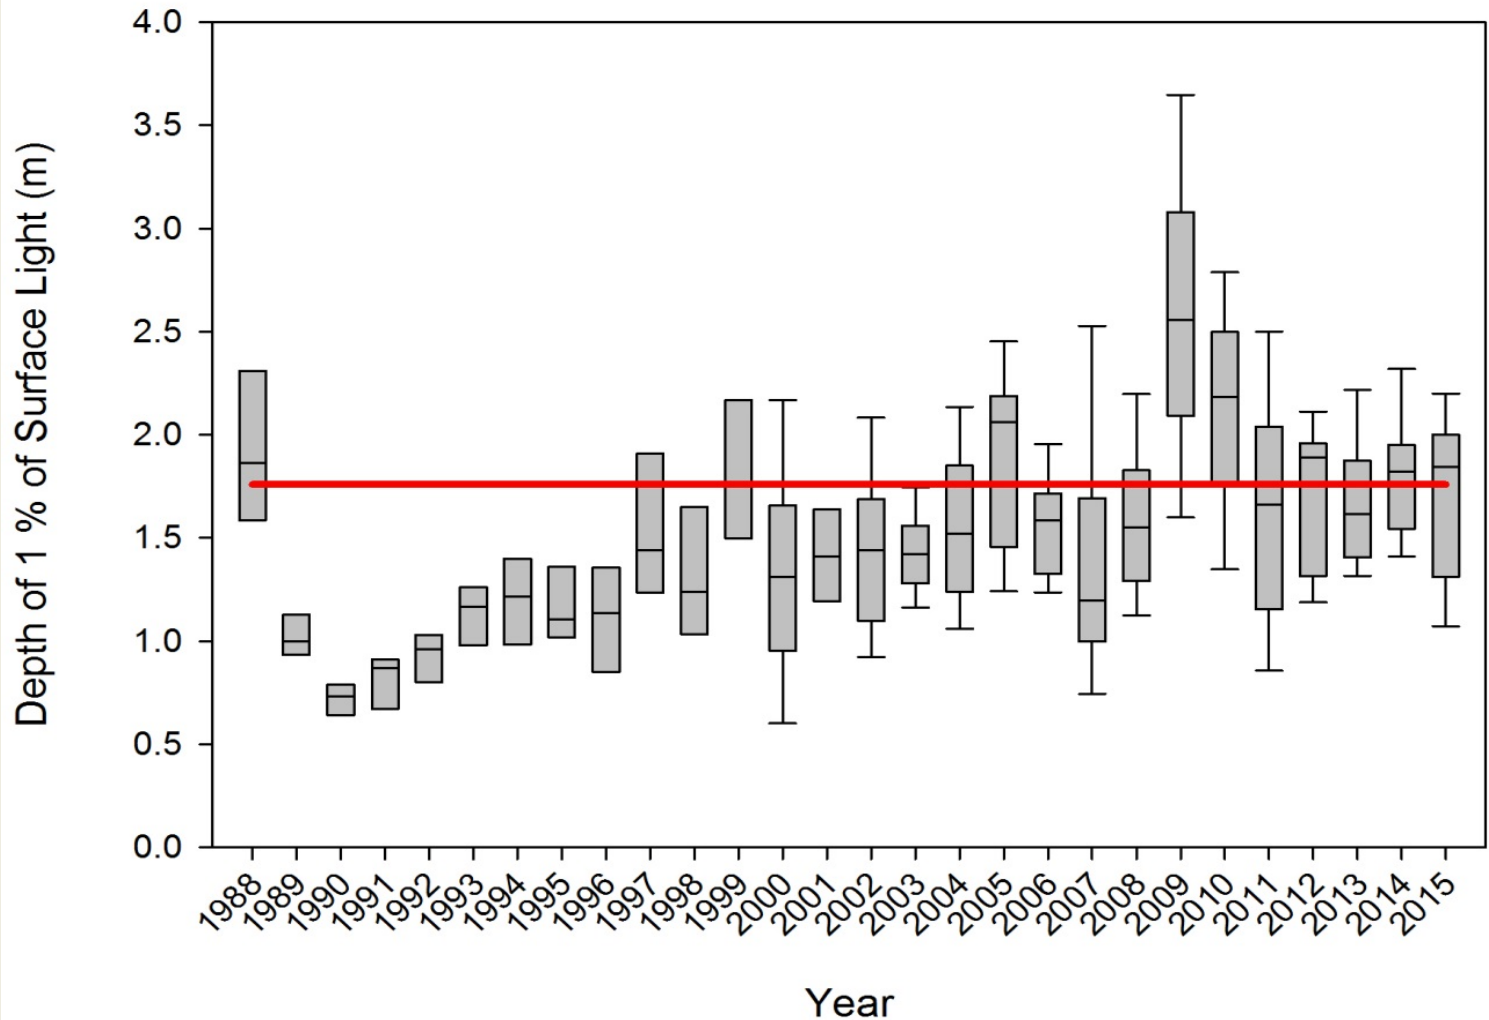
The depth of one percent of surface light is generally viewed as the delineation between the photic and euphotic zones. Figure 1 provides a fascinating and valuable look into the chronology of the River downstream of Lake Pepin since 1988. A lot of valuable insight can be gained from this dataset: from the collapse of vegetation post-1988, to the nearly ten years it took the Mississippi to reset back to a clearer state, to the extreme transparency we observed in 2009 and 2010.

For now, it appears that the fall 2010 flood was somewhat of a reset event for the River, with 2011-2015 light penetration looking fairly similar following the unusually clear years of 2009 and 2010. The red line indicates the equivalent one percent of surface light value which corresponds to 17 mg/L TSS- a threshold we've identified where fundamental shifts in the native and recreational fish community tend to occur (Figures 2 and 3).

Figure 1. Long term trends in one percent of surface light at Lock and Dam 8 and 9. The red line indicates the one percent of surface light value corresponding to 17 mg/L total suspended solids.

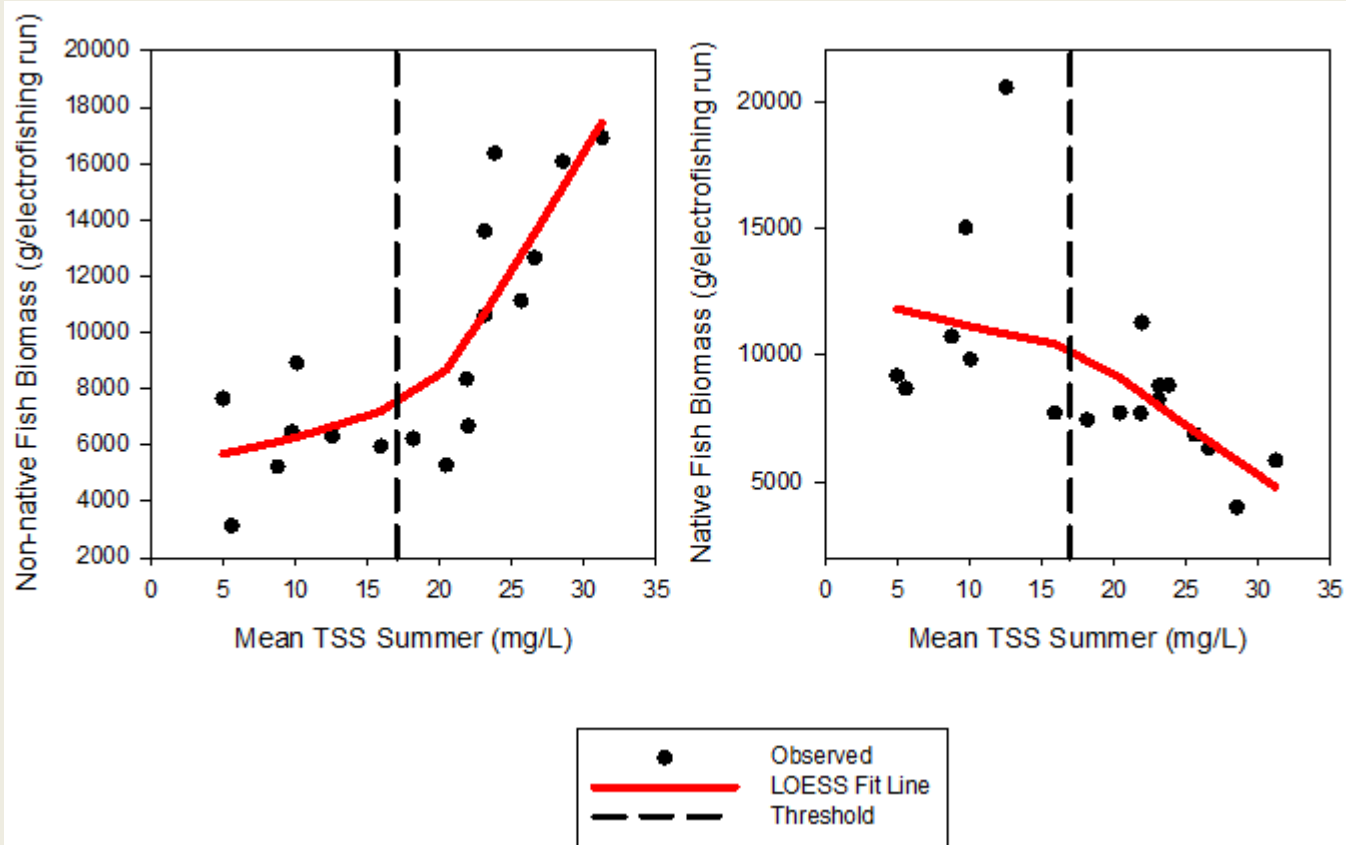
Figure 2. Relation between mean annual non-native and native fish biomass per electrofishing run and mean summer TSS in Pool 8 of the Upper Mississippi River (1993-2011). The solid line indicates the LOESS regression trend. The dotted line indicates the observed threshold (17 mg/L TSS).

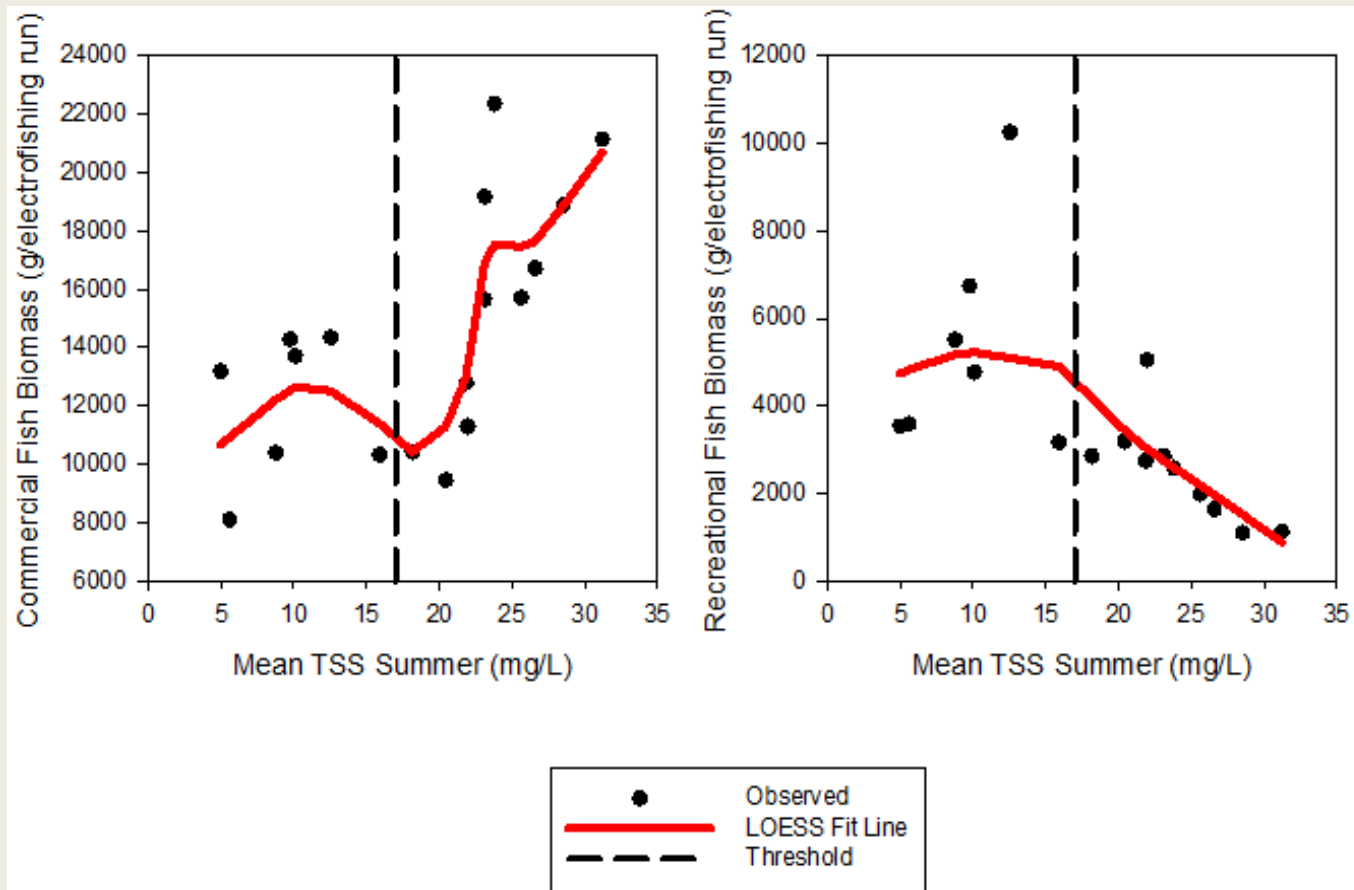
Figure 3. Relation between mean annual commercial and recreational fish biomass per electrofishing run and mean summer TSS in Pool 8 of the Upper Mississippi River (1993-2011). The solid line indicates the LOESS regression trend. The dotted line indicates the observed threshold (17 mg/L TSS).

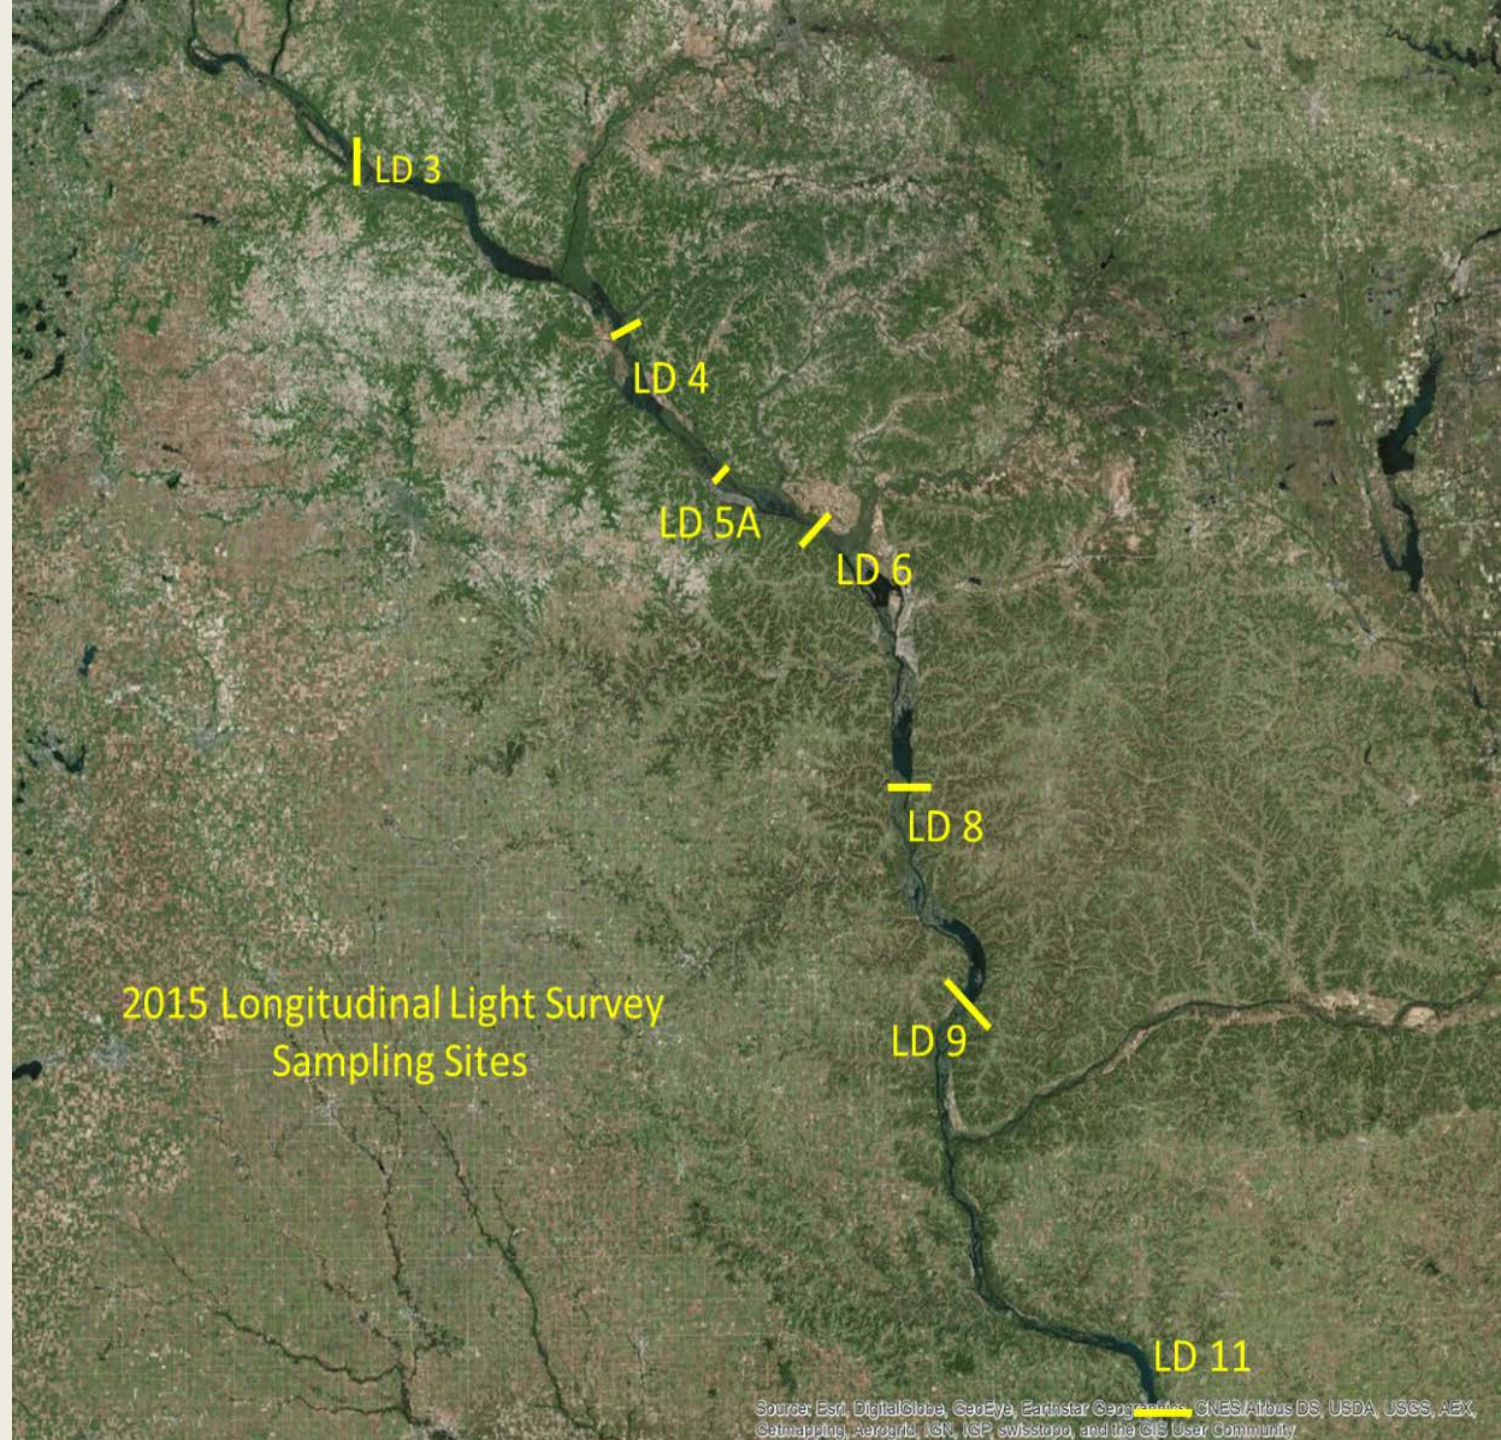
During the summer of 2015, WDNR Staff conducted a longitudinal survey of water clarity within Wisconsin waters (Lock and Dams 3-11). Since the geographic area I represent is substantial (Pools 3-12), this provides an efficient way to quickly assess WI waters. This approach also allows me to identify weak areas and areas where water clarity is rapidly declining. Water clarity improved substantially between Lock and Dams 3 and 4, as a result of the high sediment trapping efficiency of Lake Pepin (Figure 4). This also gives a great deal of insight into what the Mississippi River, within Wisconsin waters, will look like once Lake Pepin is filled with sediment. Water clarity continued to improve from LD4 to LD6, when peak transparency was reached near Trempealeau, WI. Downstream of LD6, water clarity steadily declined to the Illinois border. Slope analysis of water transparency identifies reaches where transparency is changing most quickly as a function of river mile (Table 1).

Figure 4. Longitudinal one percent of surface light data collected from Lock and Dams 3-11 during the summer of 2015.

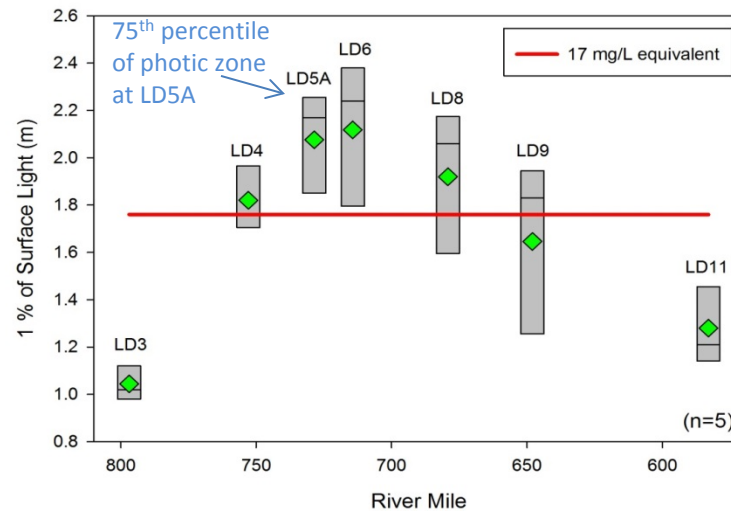
This dataset also provides a great deal of insight into the depth water would need to be dredged to establish plant edge habitat. The depth required to establish this critical habitat is very different in Pool 6 as compared to Pool 11. Gradients in light climate need to be a consideration in project planning (Figure 5).

Figure 5. Longitudinal one percent of surface light (photic zone) data collected from Lock and Dams 3-11 during the summer of 2015. The red line denotes the one percent of surface light equivalent to 17 mg/L TSS. This threshold has been identified as an ecological threshold for native and recreational fisheries. Below: Recommended dredge-to-depth by pool using the 75<sup>th</sup> percentile of photic zone plus 1 foot principle.

In relation to meeting the light threshold of 17 mg/L TSS to move the fish community to a more native species assemblage, we failed to meet our light goal upstream of Lake Pepin (Pools 3 and Upper 4) and again in Pools 9-11. This speaks to the need for projects to improve water clarity in these reaches of river through habitat projects (e.g. island building in windswept impounded areas of Pools 9 and 11) and watershed improvements. In areas where we are meeting our water clarity goals (Pools Lower 4-8), projects to improve water clarity do not appear to be needed at this time and we should consider directing our habitat activities toward other projects, like backwater dredging, to increase off-channel depth lost due to sedimentation. We should still strive to implement watershed improvements in this reach to extend the geographic extent of areas meeting our water clarity goals. This targeted approach to restoration would seek to put the right habitat project, in the right place, at the right time.
