**UPPER MISSISSIPPI RIVER SYSTEM
ENVIRONMENTAL MANAGEMENT PROGRAM
POST-CONSTRUCTION PERFORMANCE
EVALUATION REPORT (PER5D)**

**BIG TIMBER REFUGE
REHABILITATION
AND ENHANCEMENT**

OCTOBER 1995

**POOL 17
UPPER MISSISSIPPI RIVER
MILE 443-445
LOUISA COUNTY, IOWA**

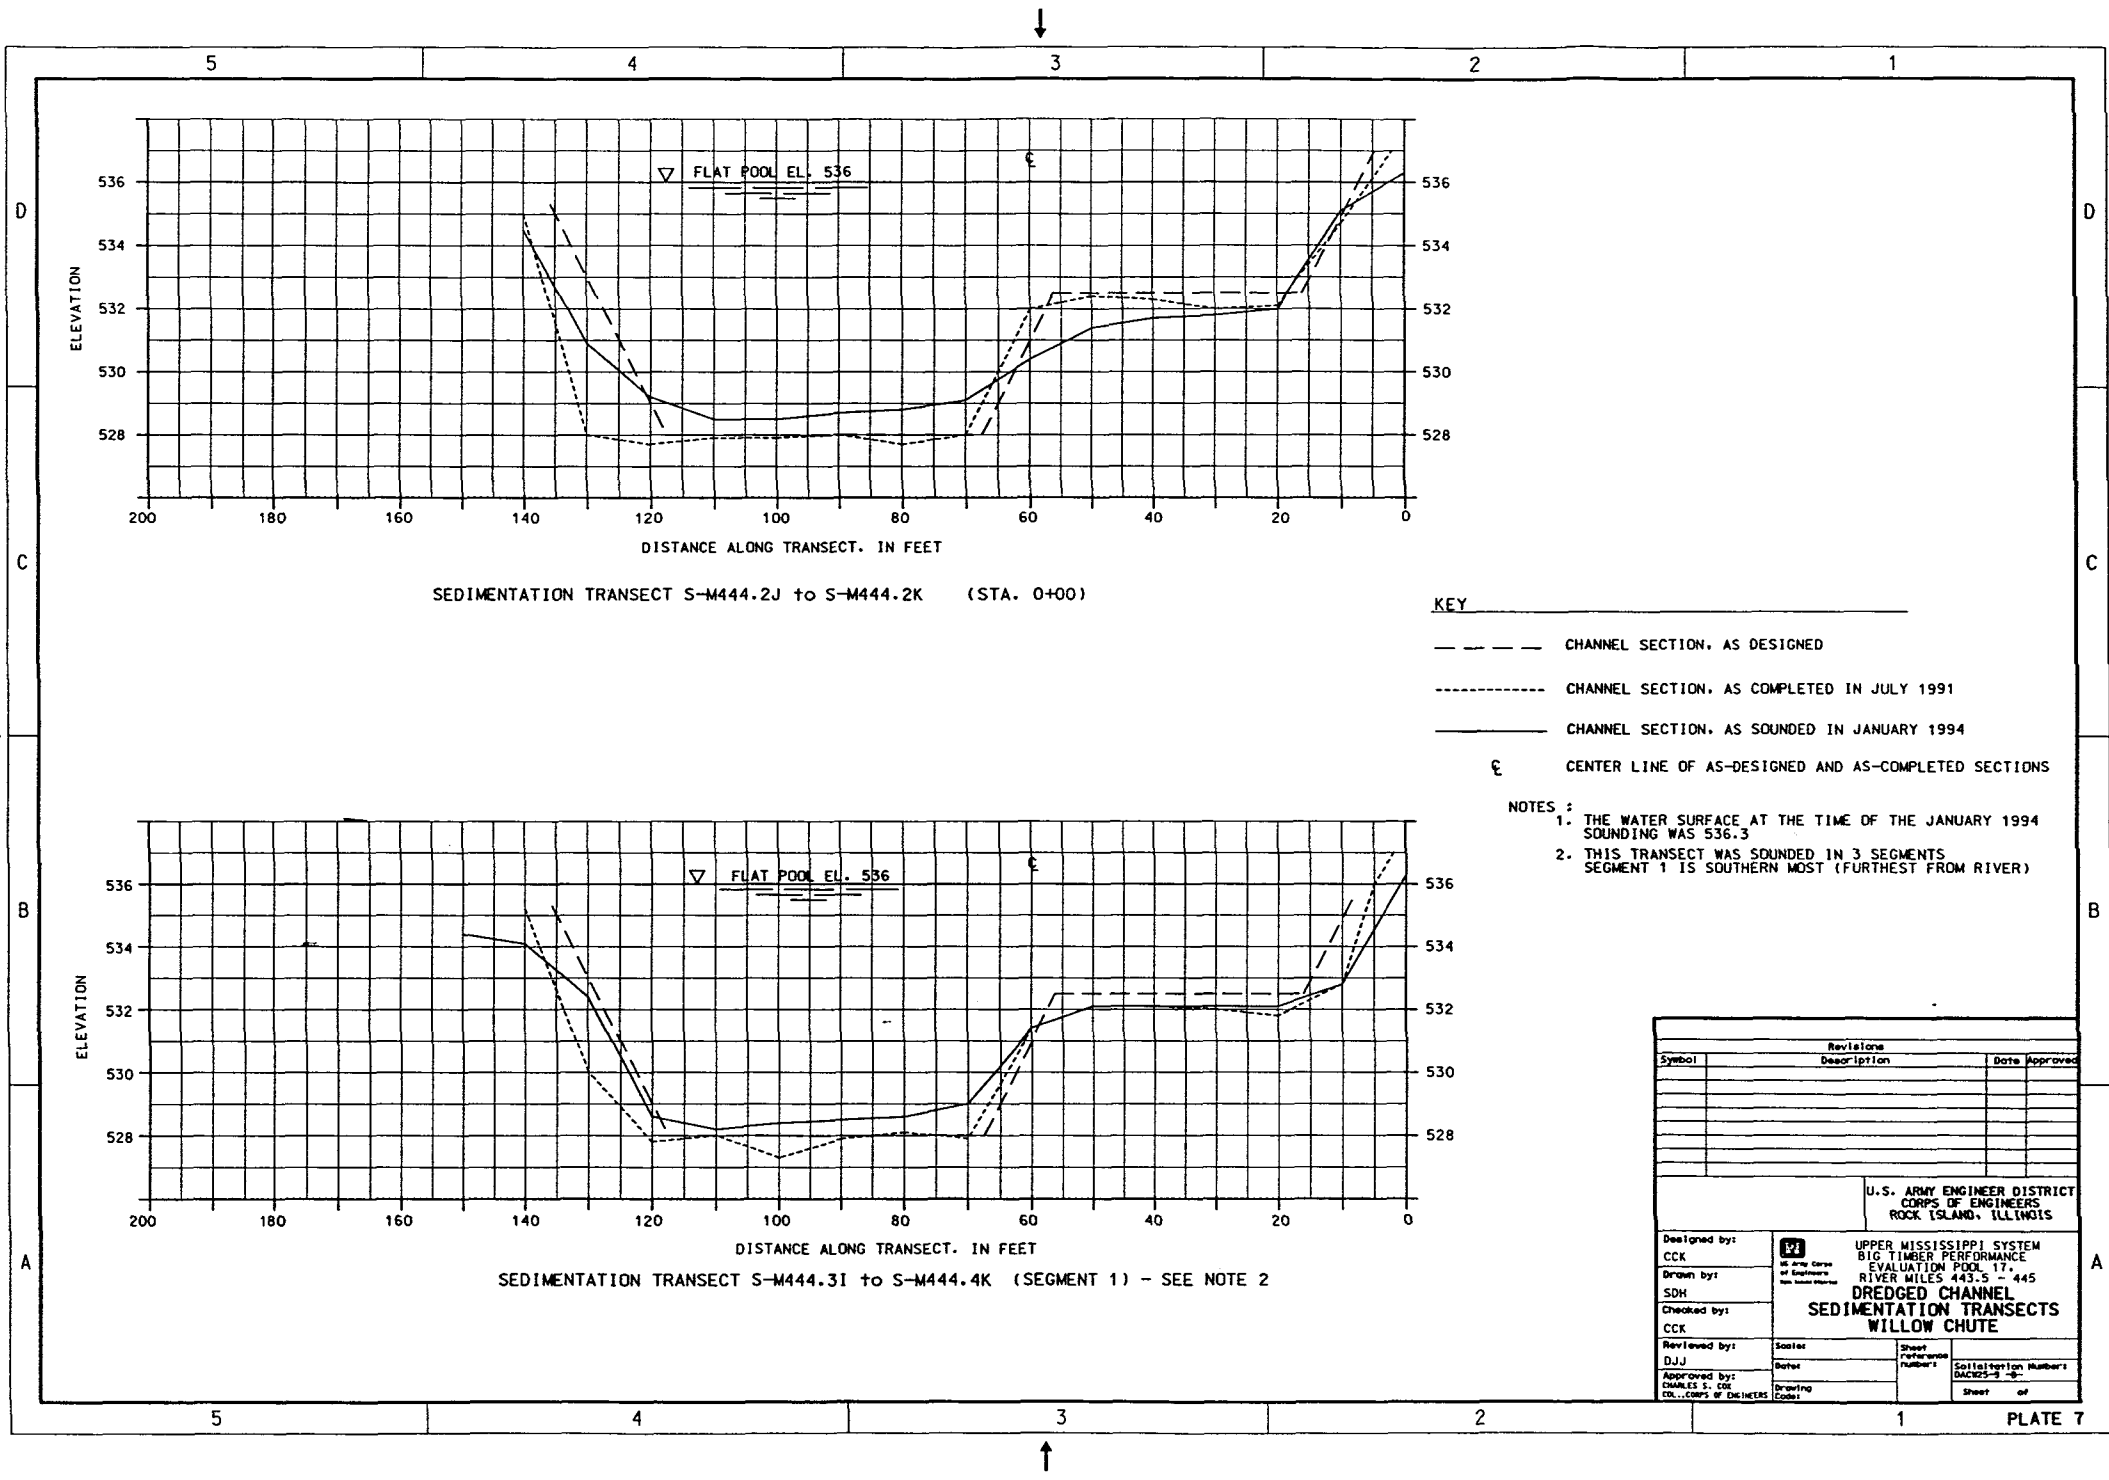
Timber project, soundings indicated that sedimentation was generally less than 4 inches but up to 2 feet in the reach known as Timber Chute. During the June 1995 USFWS Site Manager's project inspection, bank sloughing (approximately 3 feet) was observed throughout the east bank of Timber Chute (see Appendix C). The trees placed in the water for additional fish structure have remained in place. Aquatic vegetation, such as pondweed (*Potamogeton* sp.), has begun to inhabit the deep aquatic habitat.

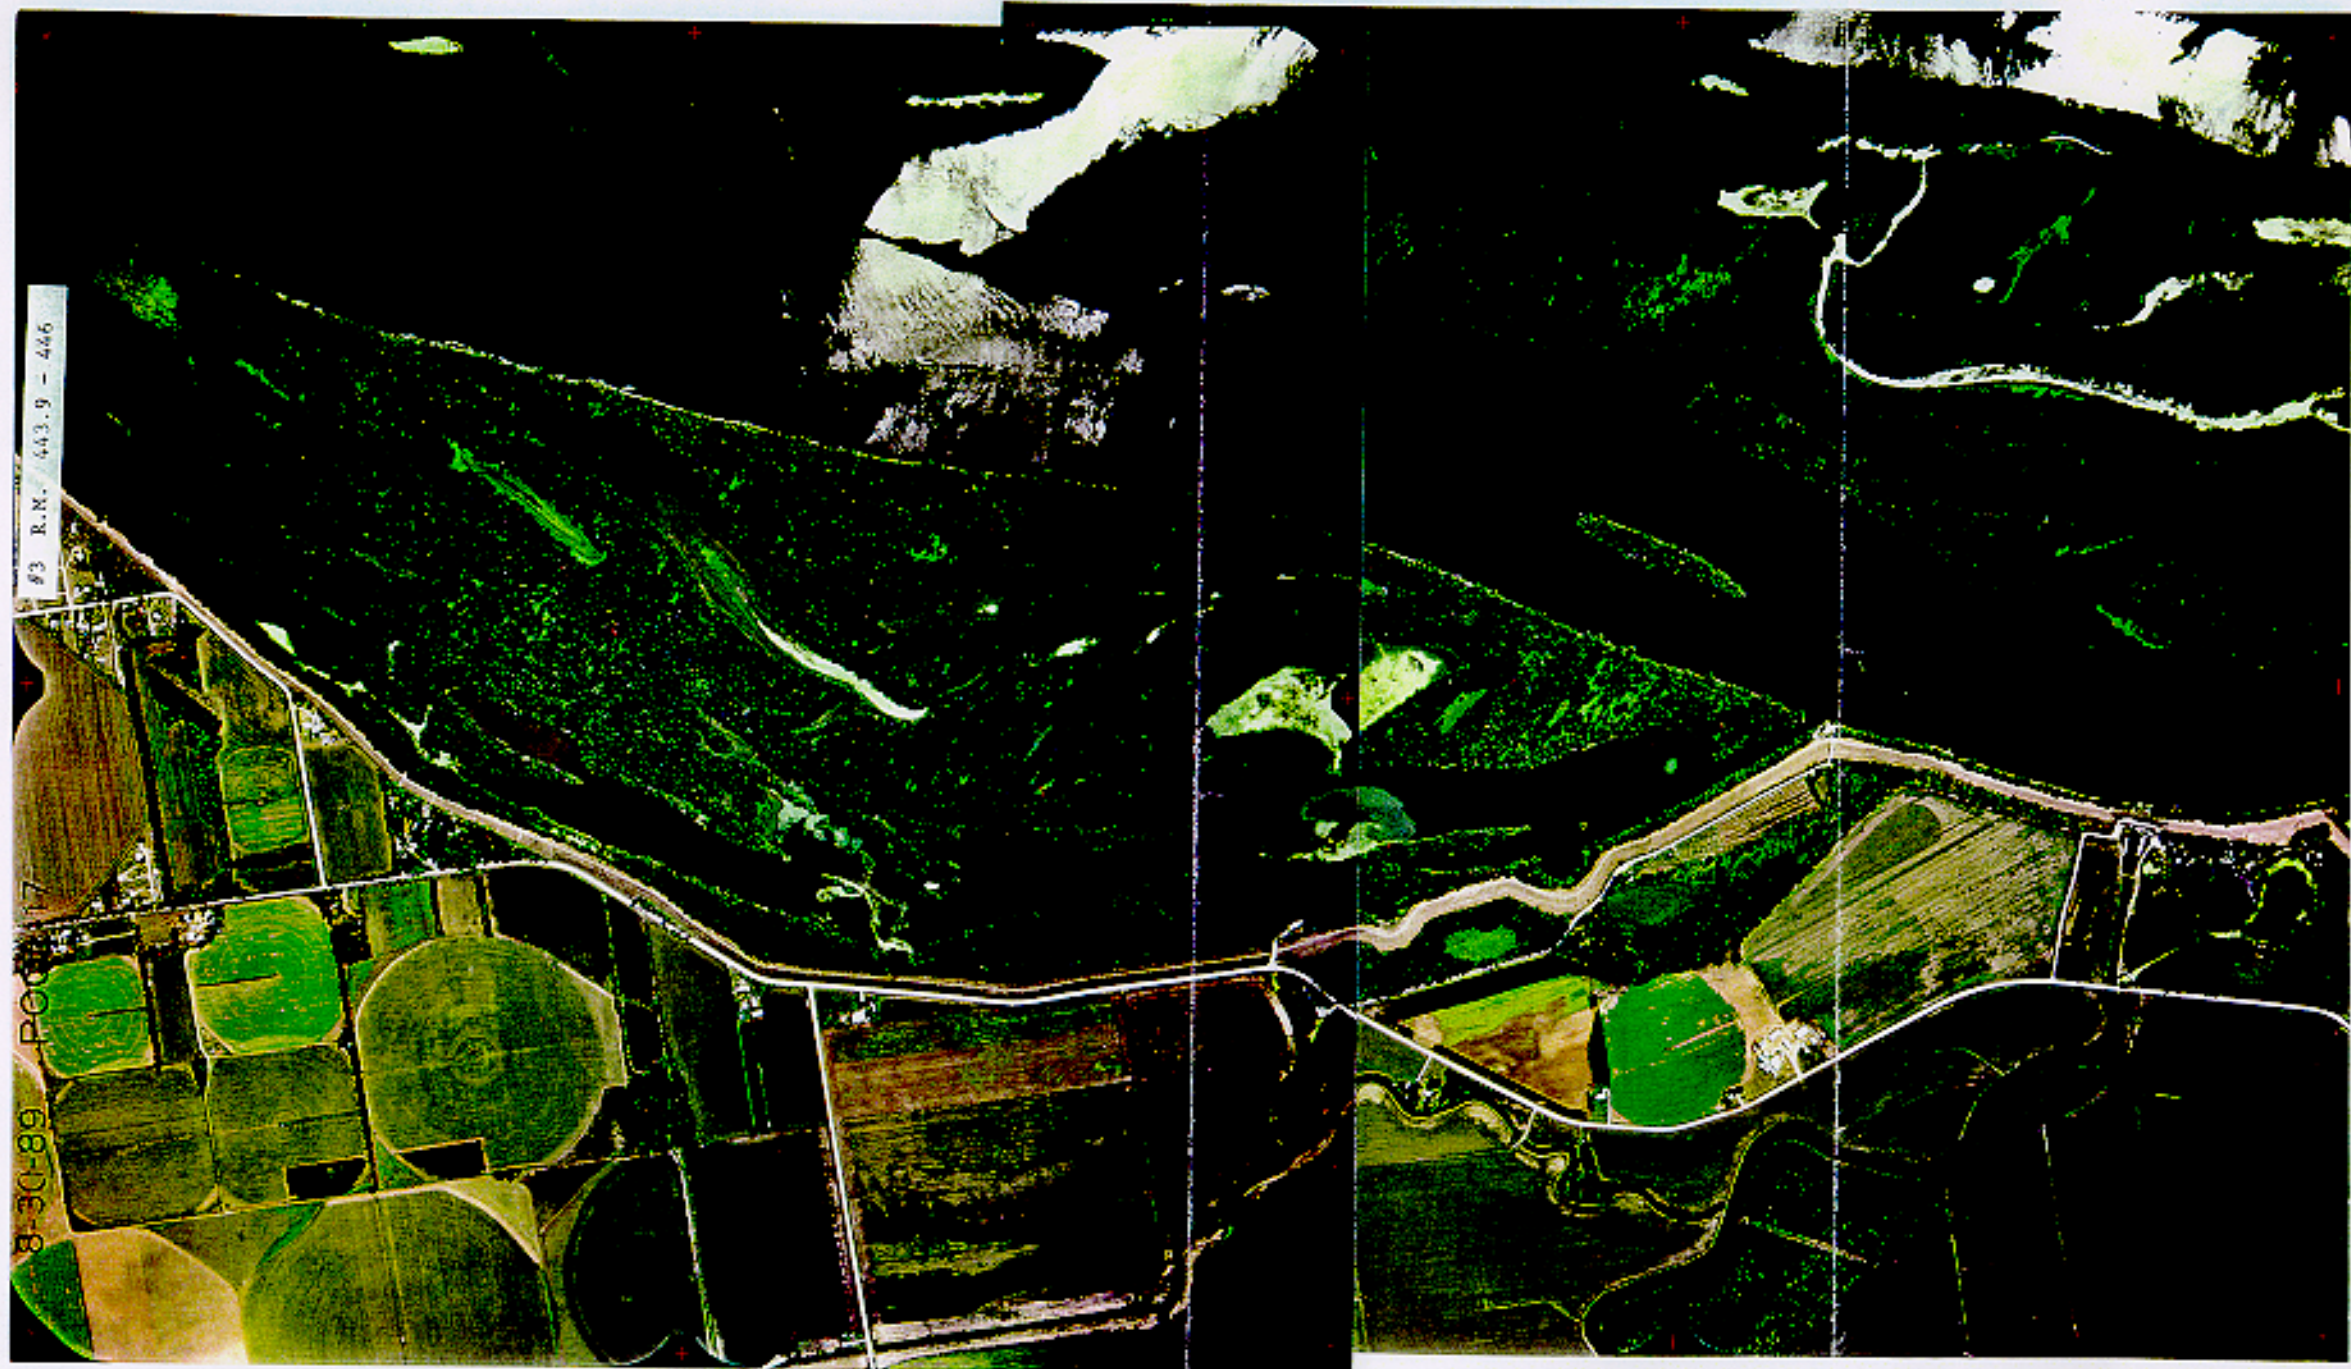
PLATE 15 - 1989 Aerial Photo - Pre-Project Conditions

(1) Monitoring Results. As shown in Appendix A, Table A-1, the Big Timber project was designed to increase reliable resting and feeding water areas by 21 acres at year 50 (11 acres deep aquatic habitat, 10 acres shallow aquatic bed, reference DPR, page 19). Pre-project conditions (plate 15) show that most of the project area was silted in and vegetated with willows, lotus, and mixed grasses. Plate 16 shows the post-construction project in 1994. Currently, 26 acres of reliable resting and feeding water areas exist for waterfowl in the project area. Migratory waterfowl peak populations are shown in Table 7-1.
