**CHAUTAUQUA REFUGE  
HABITAT REHABILITATION AND ENHANCEMENT PROJECT  
INSPECTION OF COMPLETED WORKS  
2017**

Chautauqua Refuge Habitat Rehabilitation and Enhancement Project (HREP)

Illinois River, Miles 124-130, Mason County, Illinois

September 6, 2017. Temperatures were in the 70s, and skies were mostly sunny. No precipitation occurred. Water elevation in Havana were approximately 430.03 ft

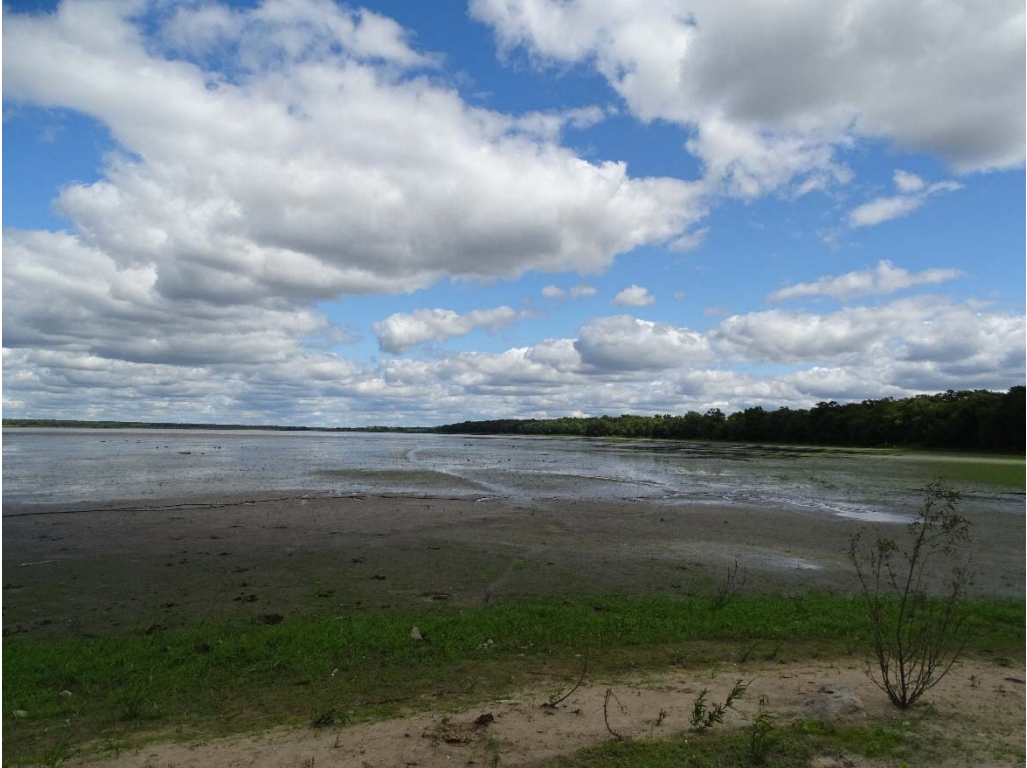
Figure 17: Upper Lake

The Upper Lake is managed by an interior gate/lift/pump system, and has had high water for several years. Water had recently dropped as noted during the site inspection, exposing mudflats critical for shorebird habitat.
