**FOX ISLAND DIVISION
INSPECTION OF COMPLETED WORKS
2020**

Fox Island Division Habitat Rehabilitation and Enhancement Project (HREP)

Pool 20, Upper Mississippi River, Miles 353.6 – 358.5, Clark, Missouri

IX. DATE OF FIELD VISIT: July 23, 2020

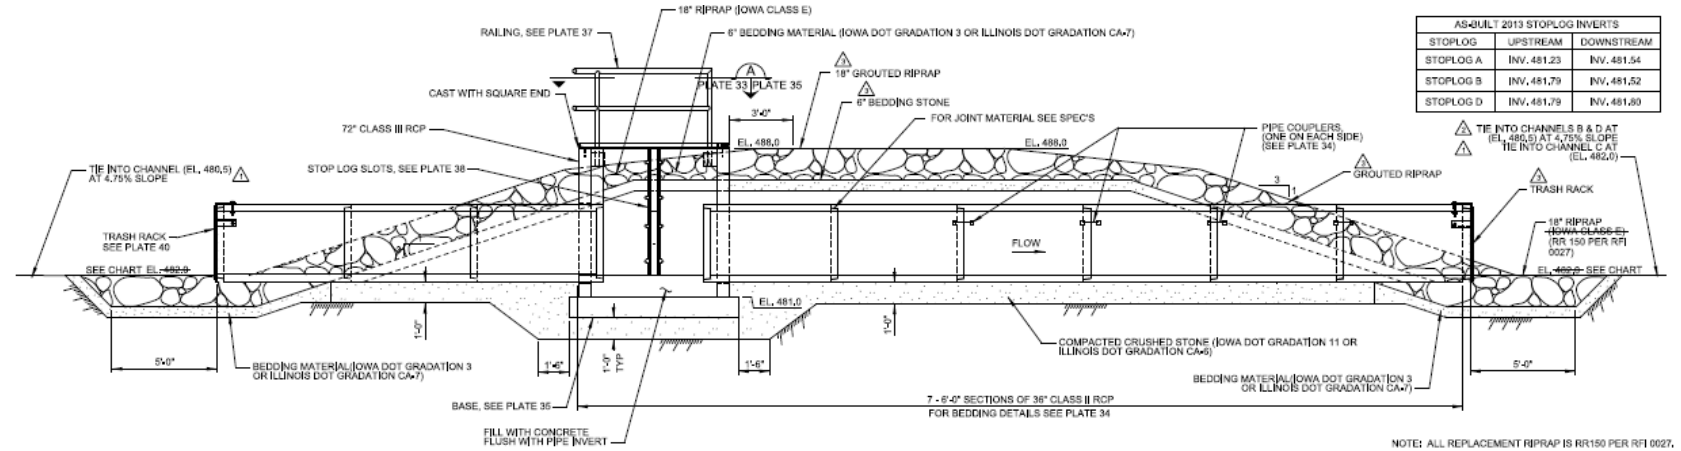
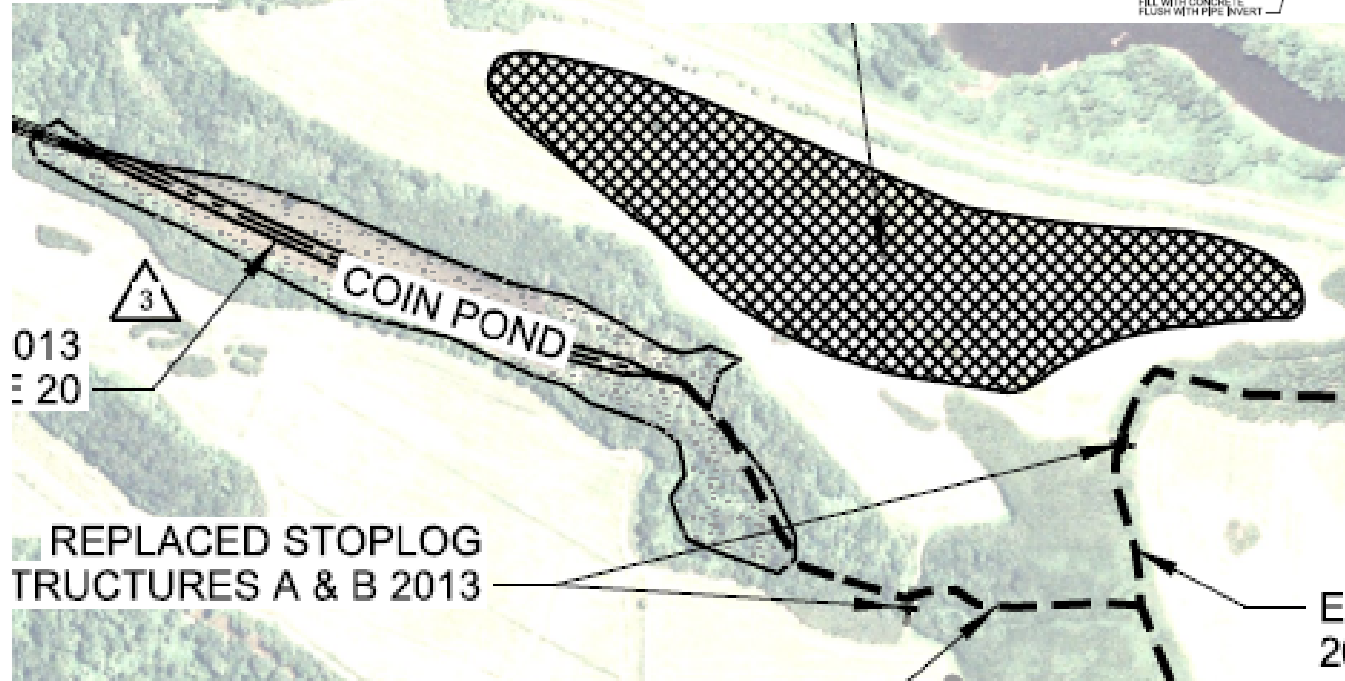
Stoplog Structure A

Stoplog Structure A. No concerns. FWS prefers the aluminum stoplogs. Vandalism and theft are not a concern as can be noted with stoplogs remaining unsecured next to the water control structure.

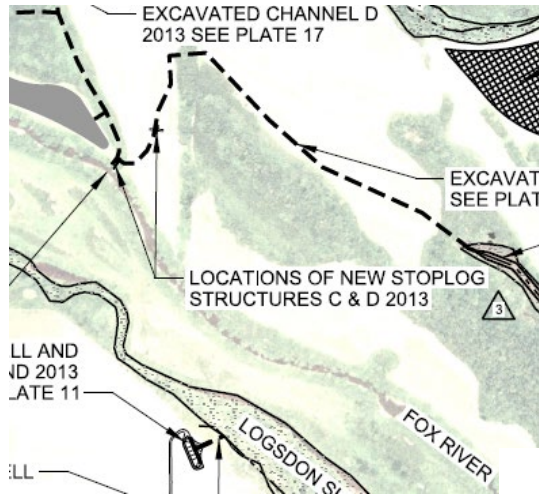
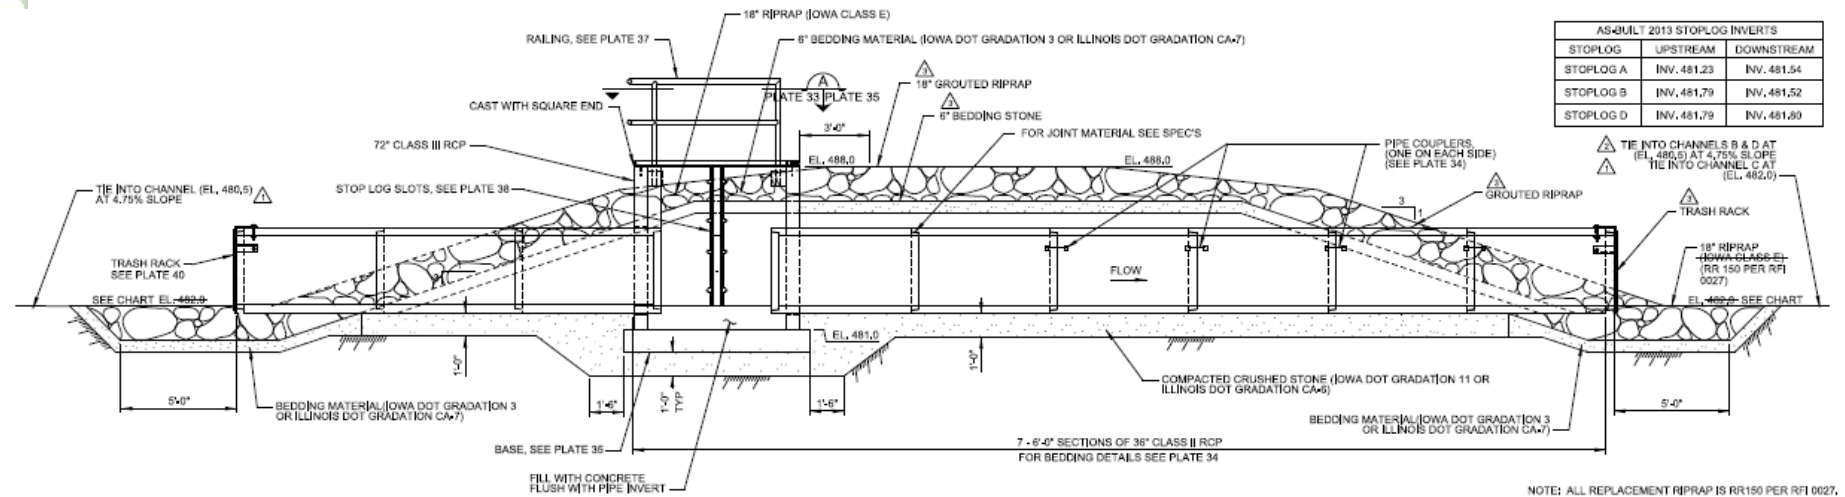
Stoplog Structure D

Stoplog Structure D. Minimal erosion noted adjacent to the structure, but the integrity of the structure was not a concern.
