MEMORANDUM FOR RECORD:

SUBJECT: Gardner Division (Long Island Division) HREP, 2004 Performance Evaluation Report

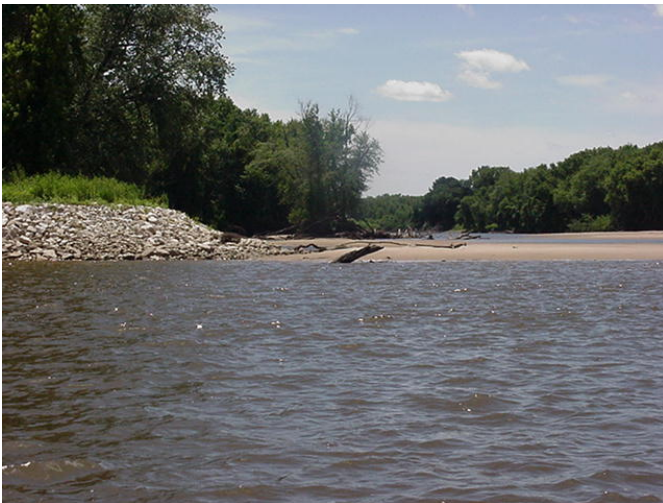
**Photo A-3:** Shandrew Island

2. The rock protection on the head of Islands A, B, C, D, and E were inspected from a boat. The photographs of the site visit are attached in Attachment A. Over all the rock protection has reduced erosion on the head of the islands to help restore habitat. On Island D, east side, a scour hole can be seen. It was discussed that the scour hole should be watched.
