UMRR HREP
INSPECTION OF COMPLETED WORKS

Long Island Division-Gardner Division (HREP)

Upper Mississippi River Restoration (UMRR)

X. DATE OF FIELD VISIT: 8/18/2016

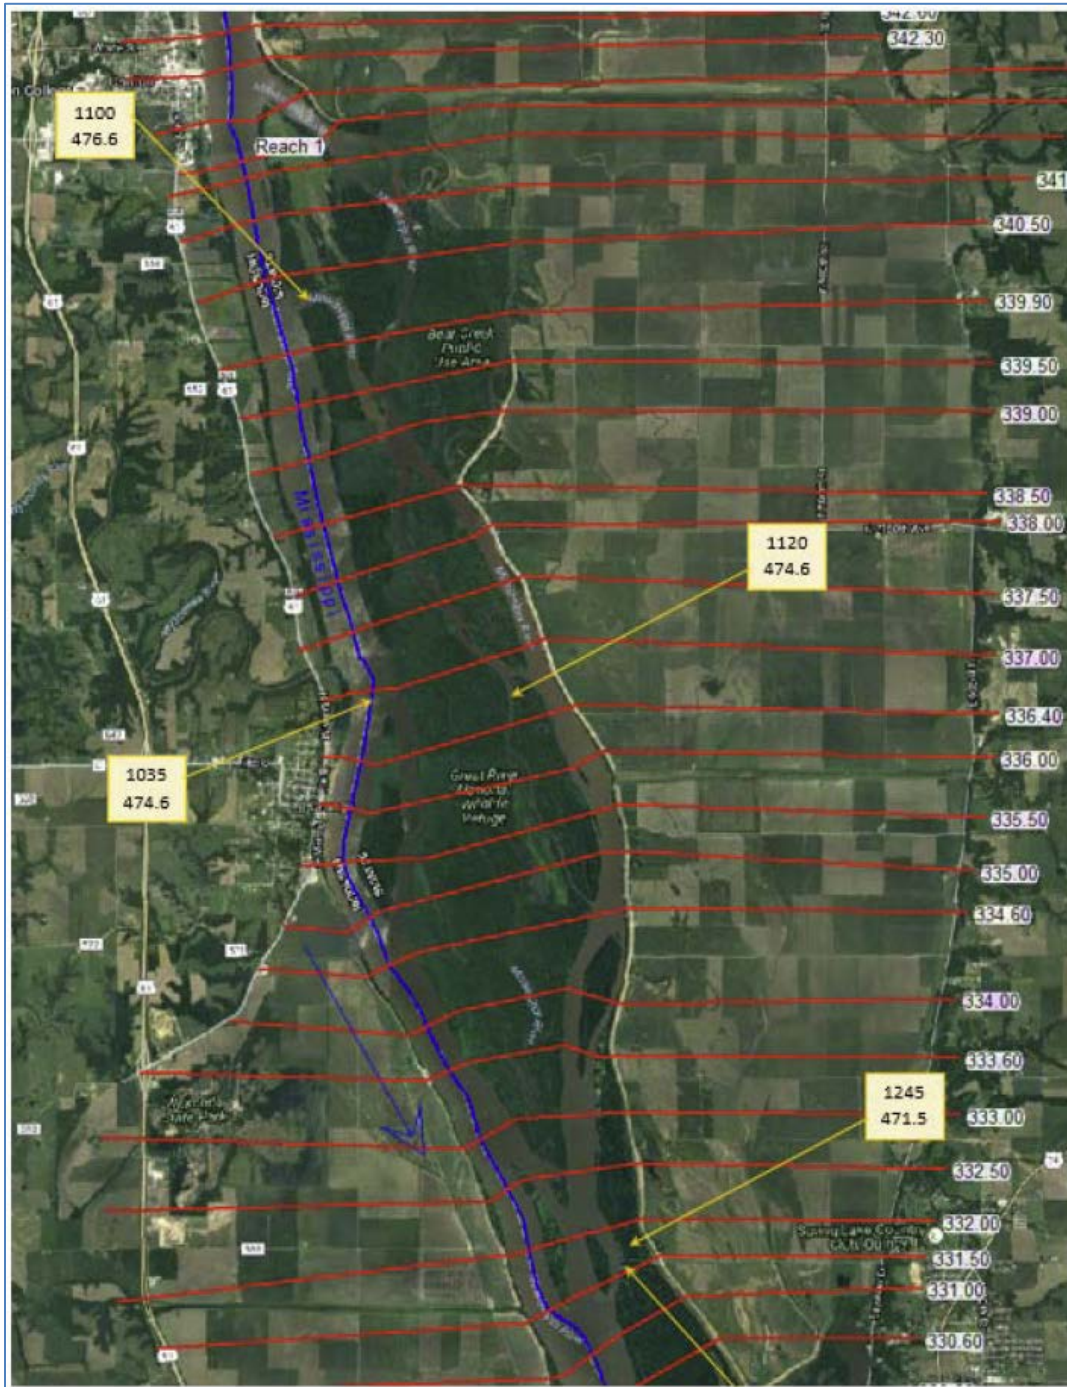
Figure 1. River stages August 18th, 2016.

The weather reached the low 90's and was very humid. The river was generally calm, although numerous Asian Carp were observed jumping. River levels seemed high, as the closure structure was under water and was designed to be emergent most of the time. On the day of the field visit the Mississippi River elevation ranged from 474.6' to 476.6', approximately four to six feet above flat pool (470' MSL).
