**UPPER MISSISSIPPI RIVER SYSTEM
ENVIRONMENTAL MANAGEMENT PROGRAM
POST-CONSTRUCTION PERFORMANCE EVALUATION
REPORT SUPPLEMENT (PERS1)**

**MONKEY CHUTE HABITAT REHABILITATION
AND ENHANCEMENT PROJECT**

**POOL 21, RIVER MILE 325
MARION COUNTY, MISSOURI**

APRIL 1998

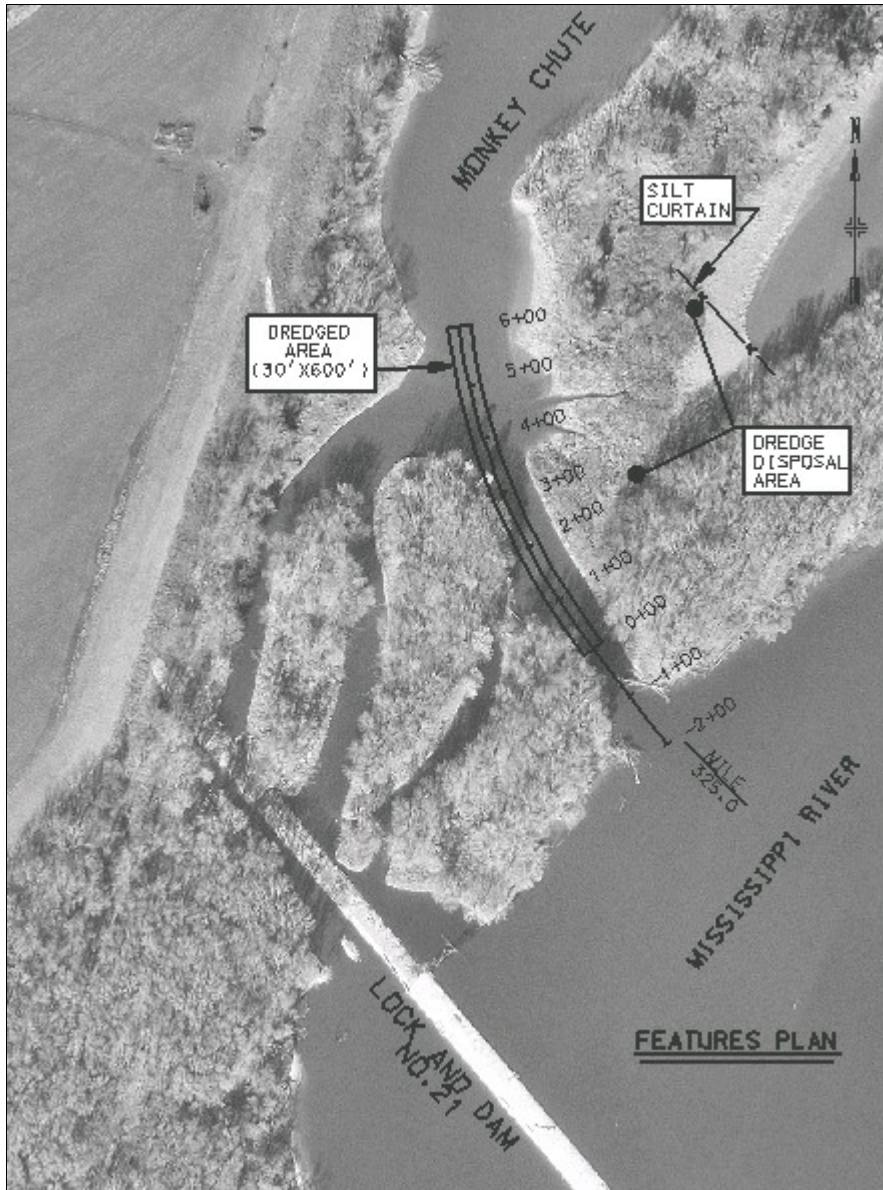
FIGURE 3-1. Project Features.

a. Project Features. The constructed project consisted of hydraulically dredging a channel 600 feet long by 30 feet wide to a depth of 6 feet below flat pool, and placing dredged material in an in-water confined placement site. A silt retaining fence was constructed approximately 200 feet upstream of an existing berm to hold the dredged material in place (see Figure 3-1 and plate 1).
