UPPER MISSISSIPPI RIVER SYSTEM
ENVIRONMENTAL MANAGEMENT PROGRAM
POST CONSTRUCTION PERFORMANCE
EVALUATION REPORT (PER 1F)

**MONKEY CHUTE
RESTORATION
PROJECT**

**POOL 21
UPPER MISSISSIPPI RIVER
MILE 325
MARION COUNTY, MISSOURI**

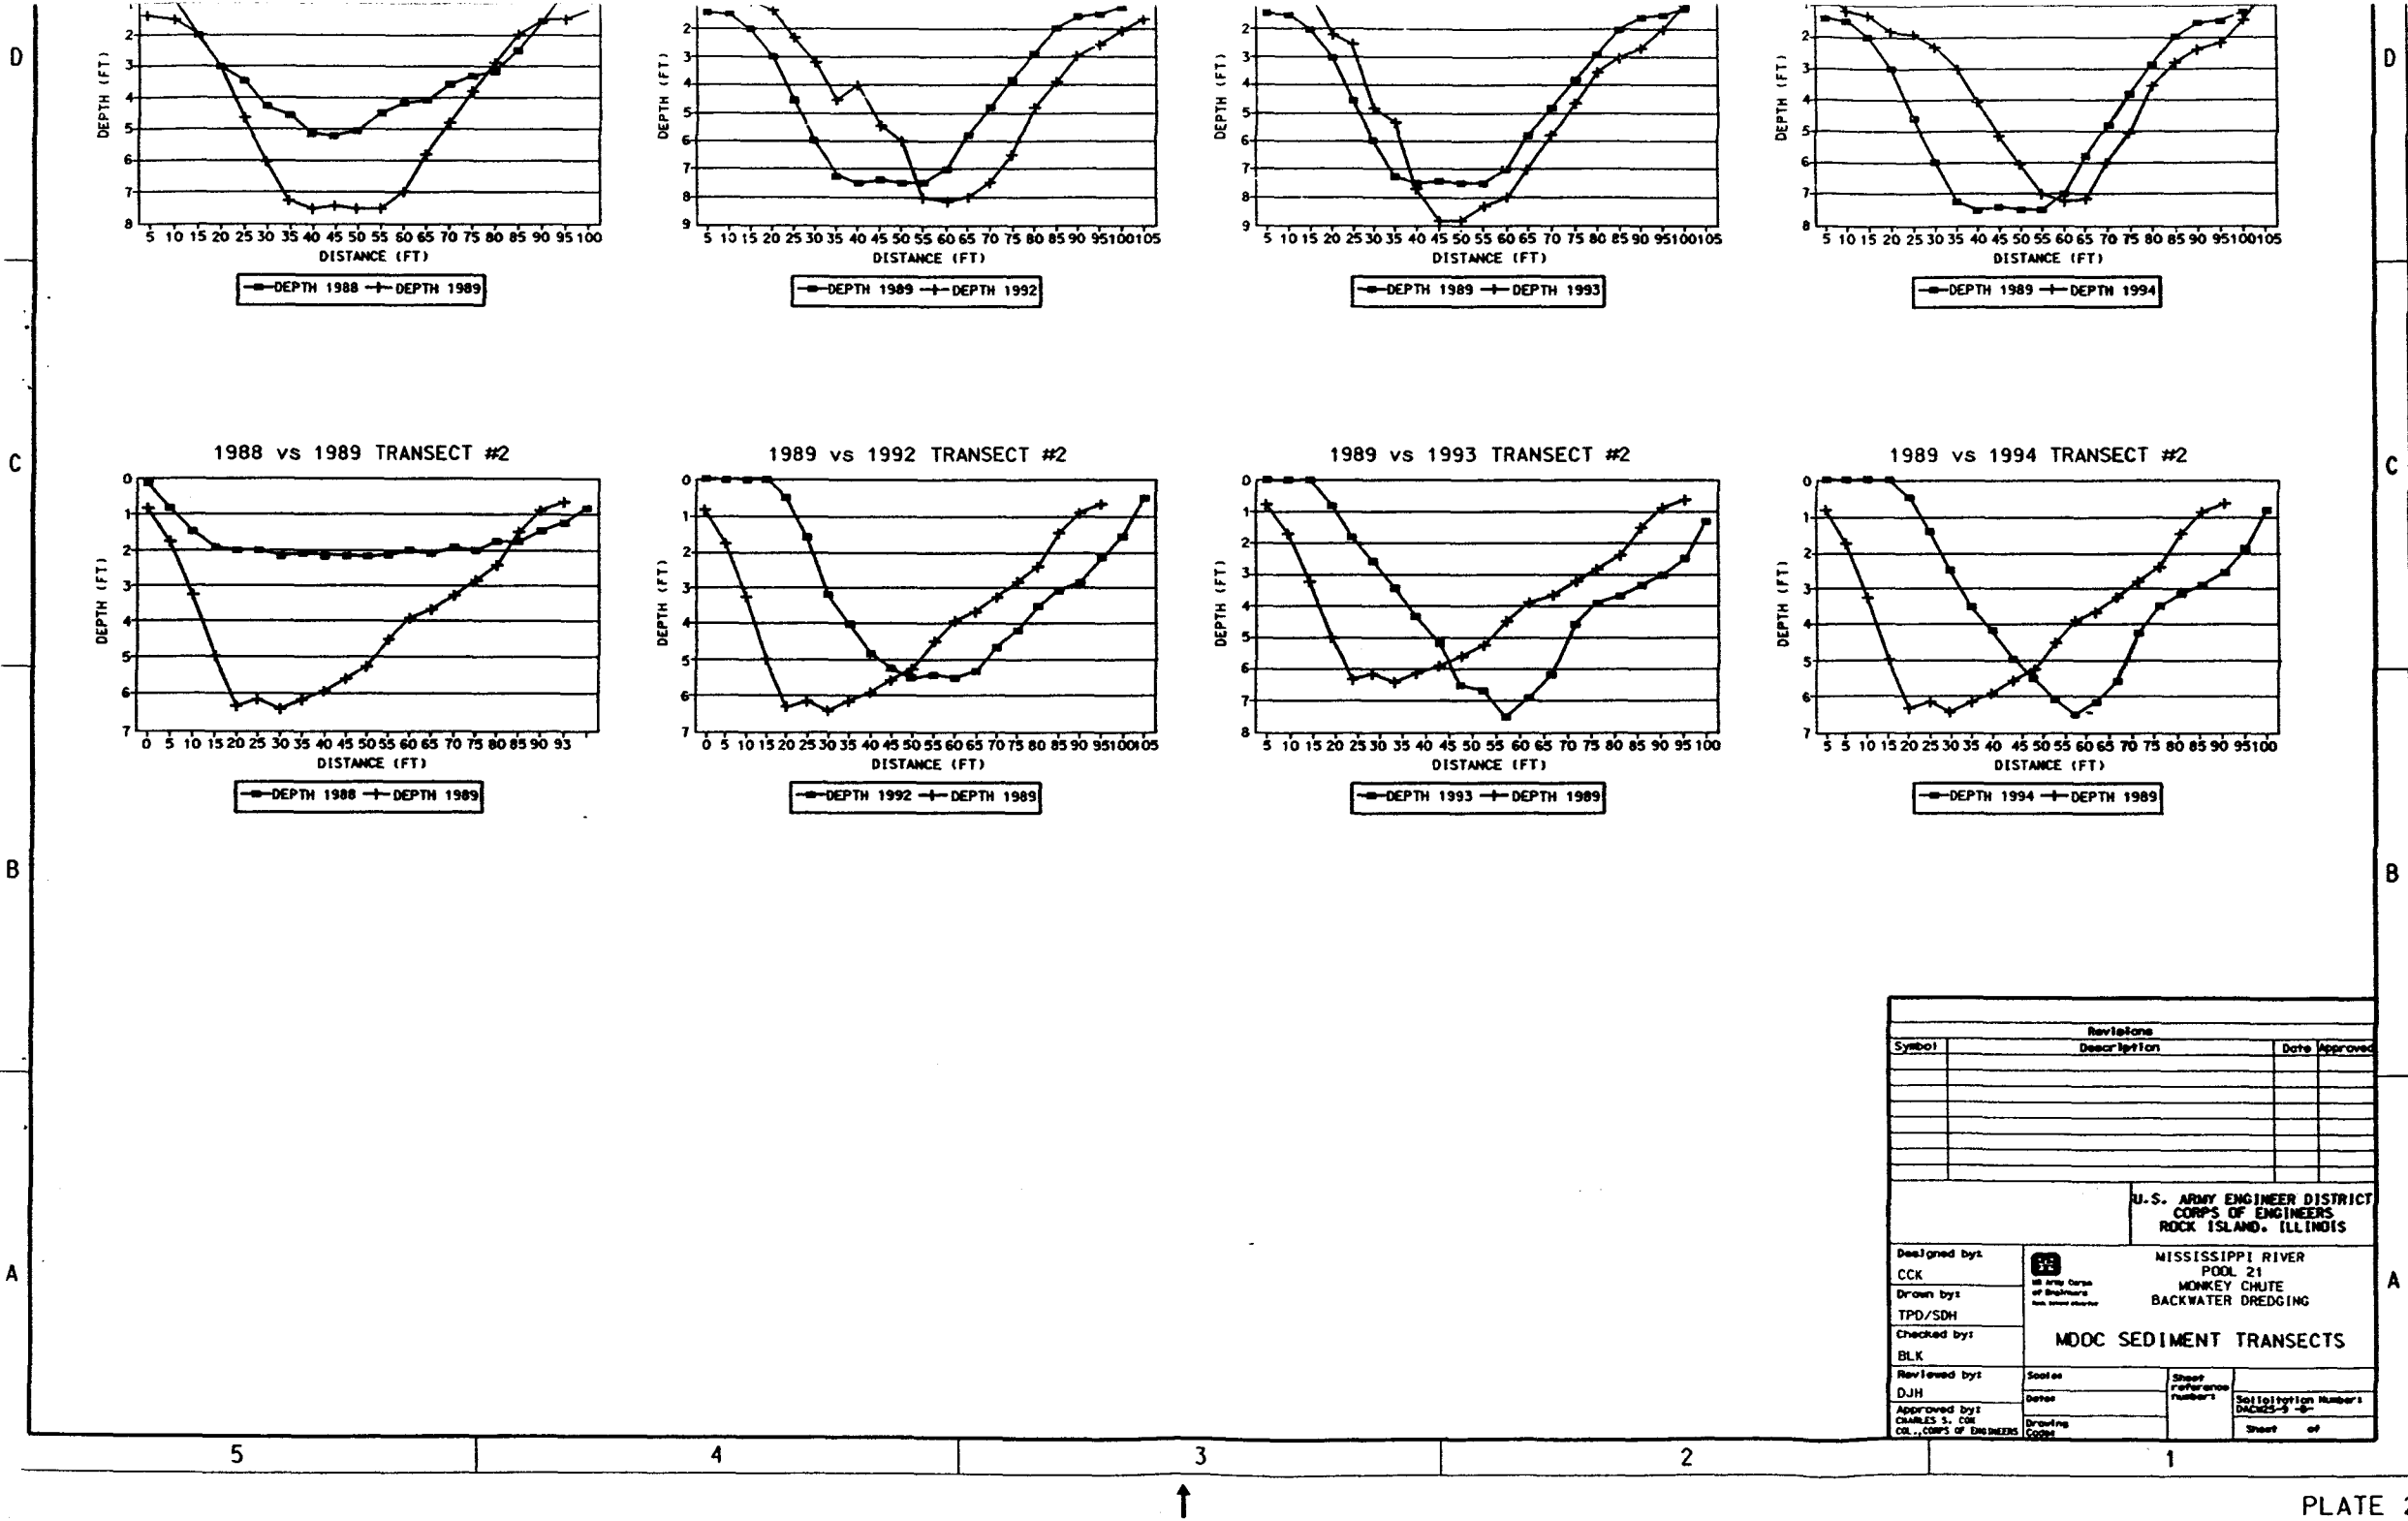
Transects 1 and 2 show little deposition, maintaining post project depths at approximately 7 feet. As the pre project depth at transect 2 was only 2 feet, it's encouraging to see the deep water here being maintained. Transects 3 and 4 show considerable reduction in depth as early as 1992, four years after the project was finished. In 1989, immediately following project construction, maximum depths at transects 3 and 4 were approximately 7 feet and 8 feet respectively. At these sites four years later, maximum depths recorded at 4 feet are approaching pre project conditions.
