UPPER MISSISSIPPI RIVER SYSTEM ENVIRONMENTAL MANAGEMENT PROGRAM POST-CONSTRUCTION PERFORMANCE EVALUATION REPORT - YEAR 3 (2001) AND FLOOD DAMAGE ASSESSMENT (2001)

## PRINCETON REFUGE HABITAT REHABILITATION AND ENHANCEMENT

NOVEMBER 2001

US Army Corps of Engineers Rock Island District POOL 14 MISSISSIPPI RIVER MILES 504.0-506.4R SCOTT COUNTY, IOWA

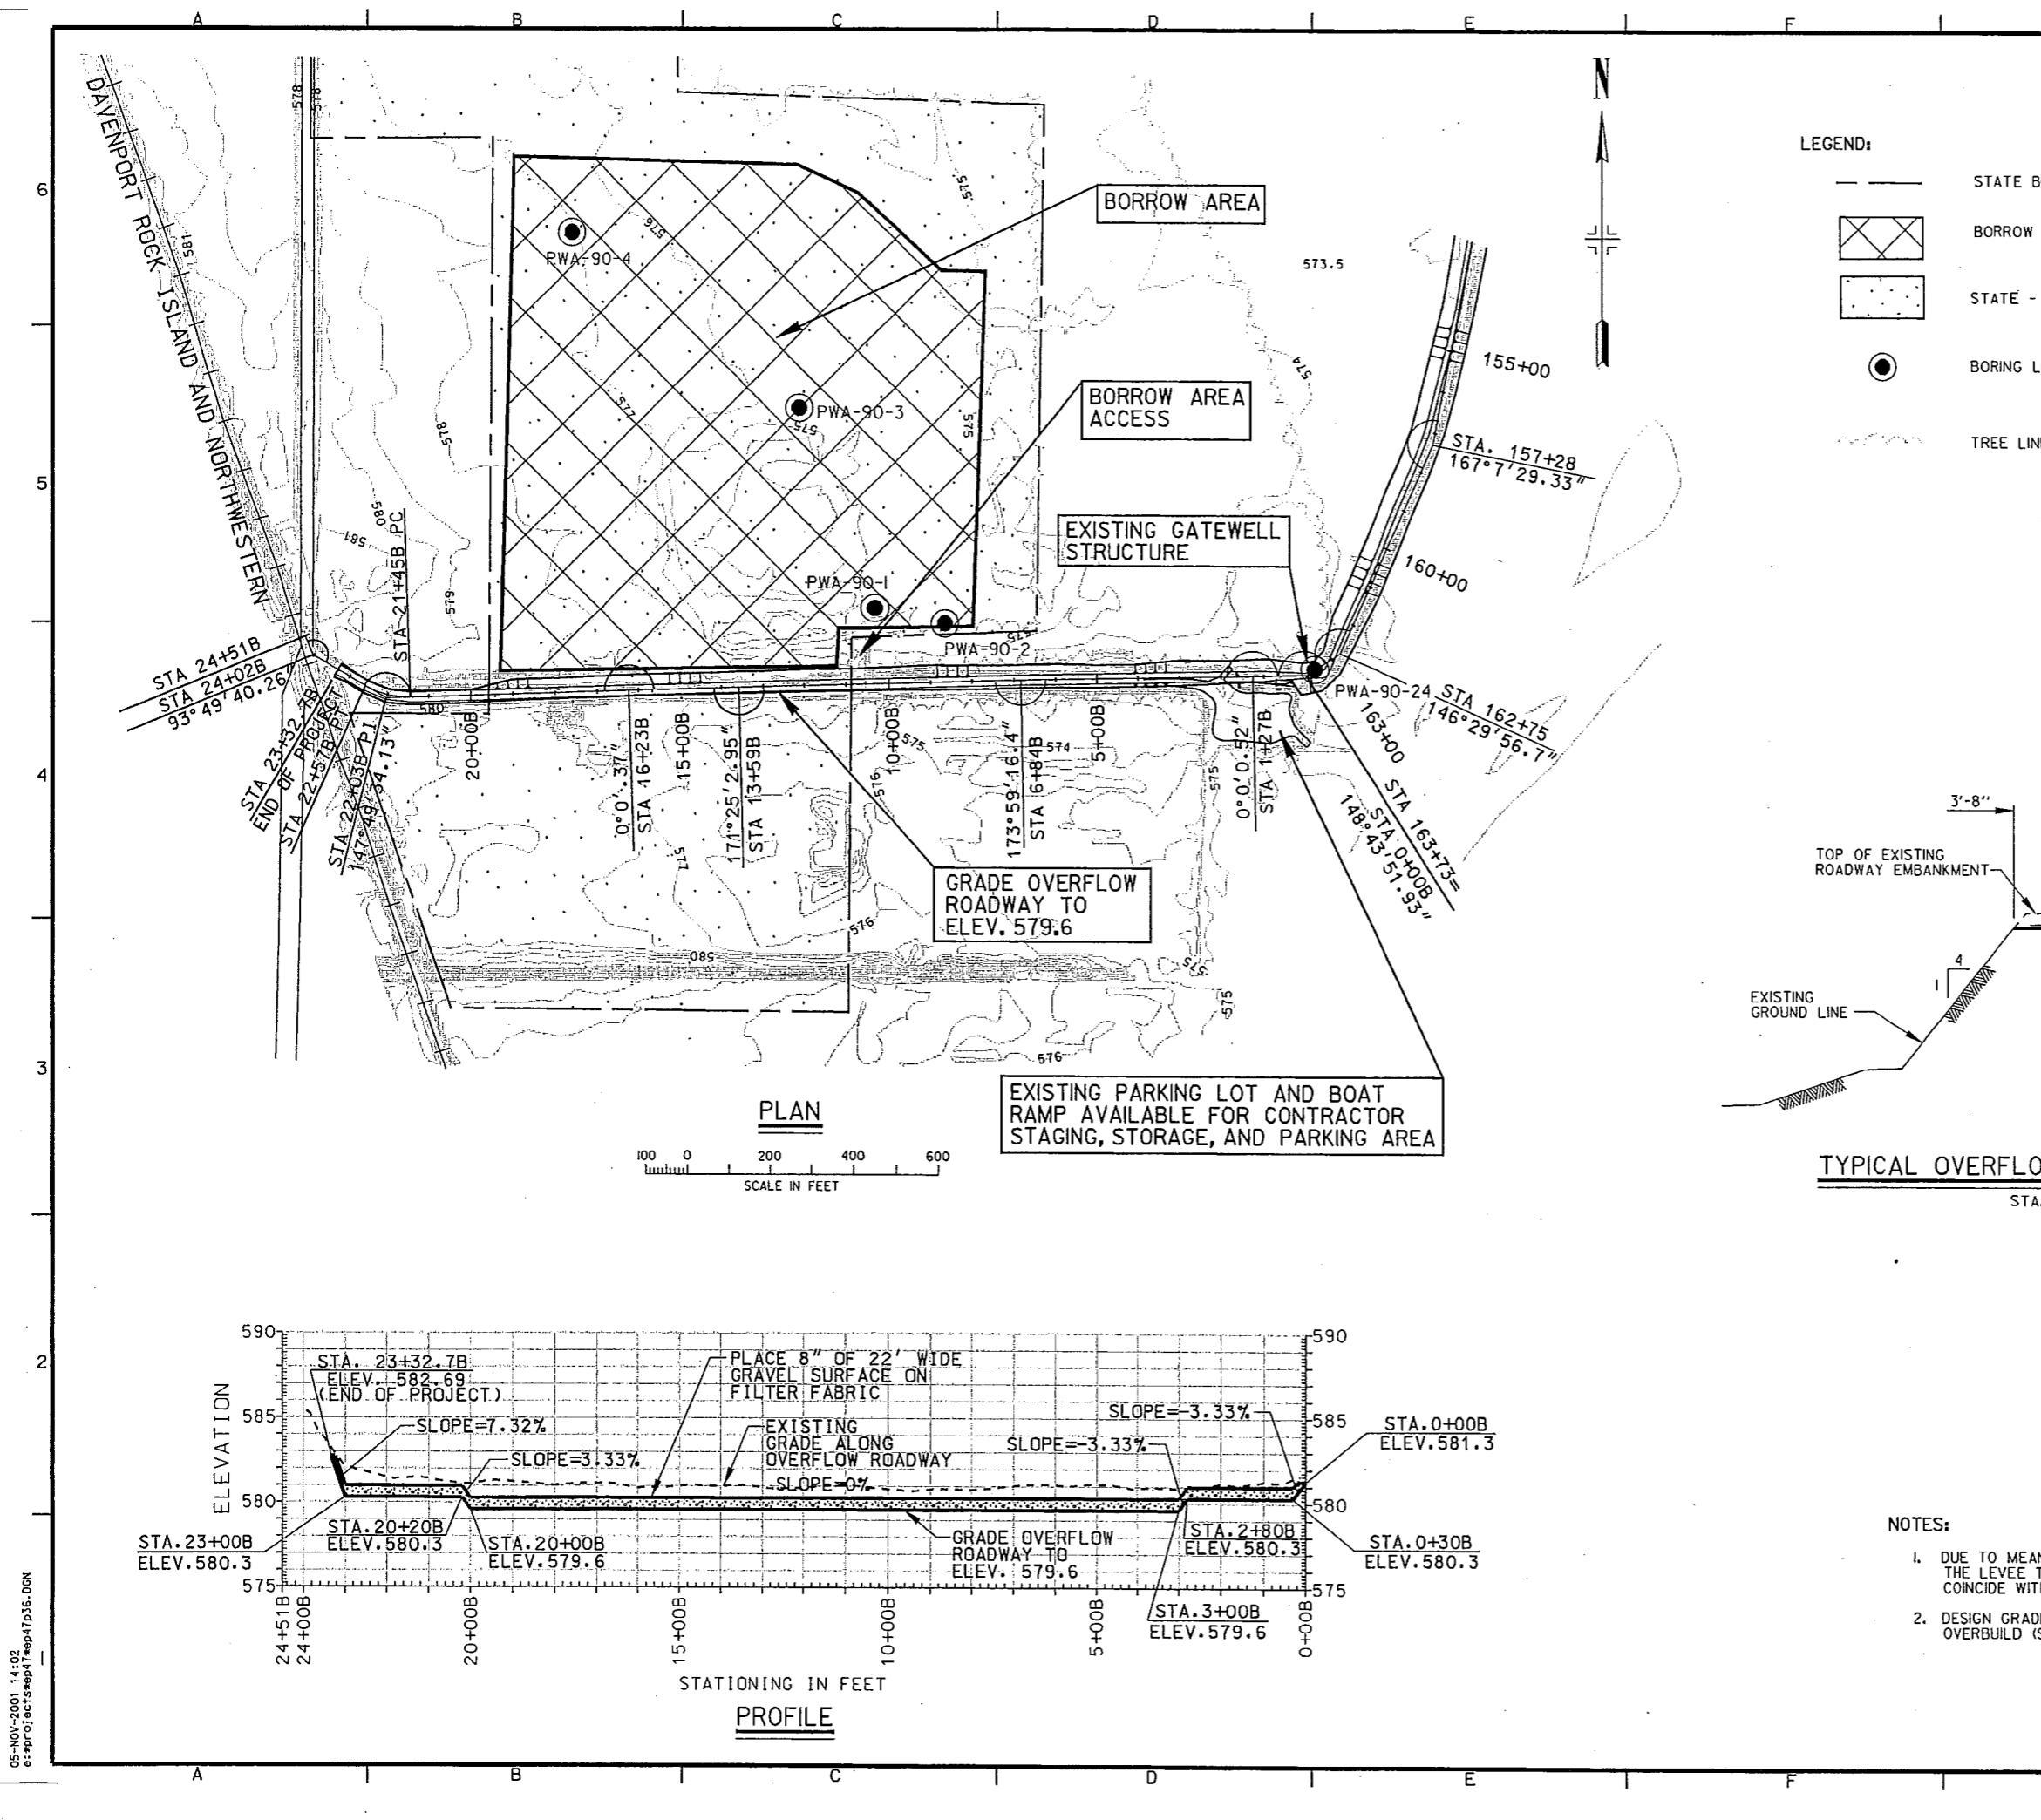
Sheet Reference Number: PLATE 36

G		<u>H</u> ]	
			US Army Corps of Engineers Rook Island District
E BOUNDARY			
OW AREA			Abpro
- OWNED LAND			Date
G LOCATION			
LINE	•		
			Description Revision
& OVERFLOW	ROADWAY		
PLACE 8" OF 22 WIDE GRAVEL SURFACE ON FILTER FABRIC	3'-8"		
ANTRATAT	EL. 579.	<u>6</u> <u></u>	CT Designed By: XX XX Drown by: XCF XX XXX Drown by: Scale: AS SHOP TPD-RLC Scale: AS SHOP TPD-RLC Project Code: Theread By: KJD Project Code: Reviewed By: KJS DACPSX-8XXX
LOW ROADWAY (S	ECT	TION	U.S. ARMY ENGINEER DISTRI D.S. COPPS OF ENGINEERS ROCK ISLAND, ILLINUIS ROCK ISLAND, ILLINUIS
WEANDERING OF THE EXISTING TRAVERSE ALIGNMENT DO WITH THE TOP OF THE LEVE RADE OF PERIMETER LEVEE D (SEE SPECIFICATIONS),	G TRAVERSE ALIGNMEN ES NOT NECESSARILY E IN SOME LOCATIONS DOES NOT INCLUDE 6-	іт, 5. -INCH	LOWER MISSISSIPPI RIVER SYSTEM ENVIRONMENTAL MANAGEMENT PROGRAM - POOL 14 PRINGETON WILDLIFE MANAGEMENT AREA LOWER ROVERFLOW ROADWAY

(4) <u>Alternative 4 - Construct setback levee, repair scour areas, lower overflow</u> <u>roadway</u>. The existing overflow roadway would be lowered from Station 3+00 to Station 20+00 in addition to Alternative 2. According to the as-built drawings, the north perimeter levee was constructed to elevation 582.3 feet MSL while the overflow roadway (spillway) was constructed to elevation 580.3 feet MSL or approximately 2 feet lower than the north end. However, these drawings reflect the final grade of the overflow roadway at elevation 580.3 feet MSL prior to 8 inches of granular surfacing. Therefore, the top of the overflow roadway may actually be at elevation 581 feet MSL. This alternative would lower the overflow roadway in order to provide a top elevation of 580.3 feet MSL after placement of granular surfacing as recommended in Appendix H of the DPR (refer to plate 36 in Appendix L). The results of a land survey performed in September 2001 confirmed what was suspected. The average top elevation of the overflow spillway was found to be 581.05 feet MSL.
