UPPER MISSISSIPPI RIVER SYSTEM ENVIRONMENTAL MANAGEMENT PROGRAM POST-CONSTRUCTION PERFORMANCE EVALUATION REPORT – YEAR 7 (2005)

PRINCETON REFUGE HABITAT REHABILITATION AND ENHANCEMENT PROJECT

US Army Corps of Engineers Rock Island District POOL 14 MISSISSIPPI RIVER MILES 504.0-506.4R SCOTT COUNTY, IOWA

JUNE 2005

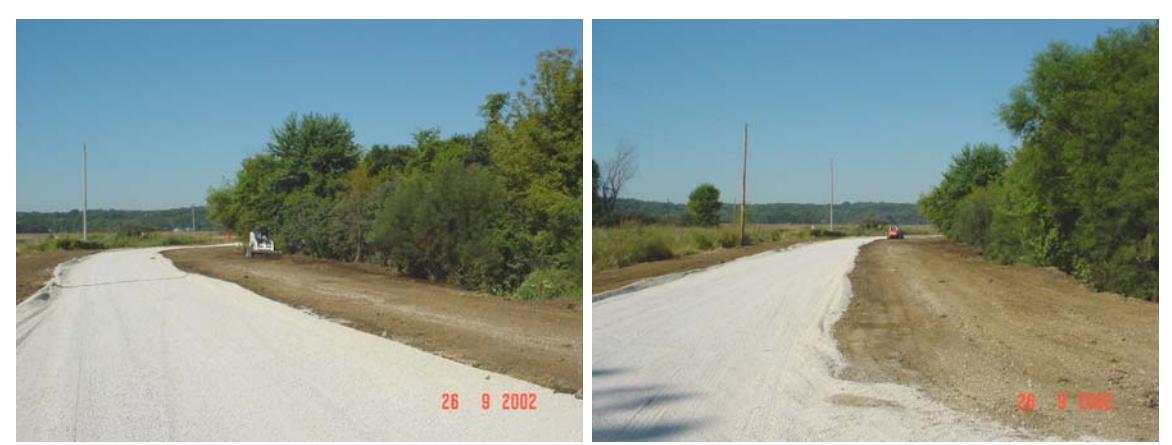
Photos 5, 6, & 7 – Stage IV initiation, geotextile fabric removal and roadway excavation

As a result, a Stage IV contract was awarded. This contract consisted of lowering the overflow roadway to an elevation at or below 580.3 feet NGVD (see Photos 5 through 23 in Appendix G). Construction was complete in September 2002. Stage IV drawings are illustrated in the O&M Manual, Appendix L, Plates 60 through 62. Since Stage IV completion, the overflow roadway has not been surveyed nor has a flood event occurred to test the functionality of this feature.

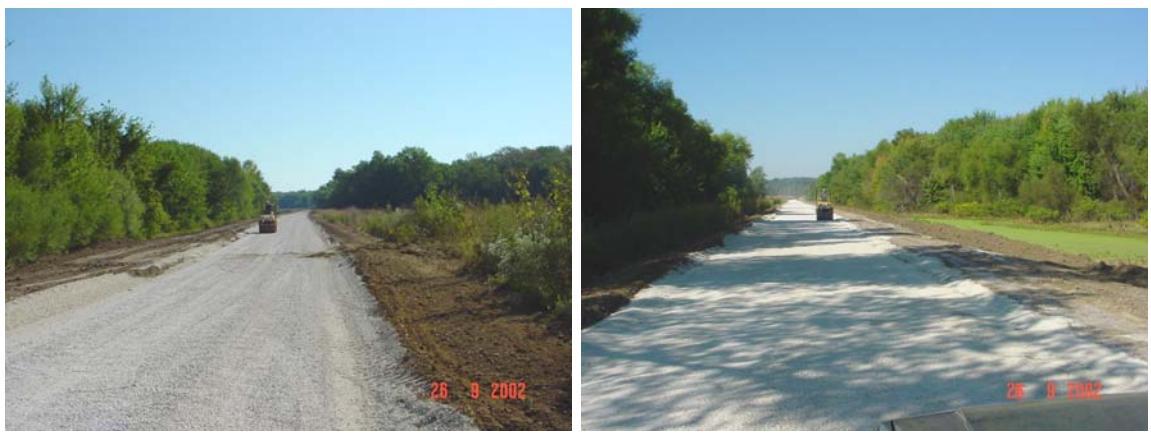
Photos 8 & 9 – Stage IV, placement of excavated material along interior slope and shaping **Photos 10 & 11** – Stage IV, placement of granular surfacing along roadway & compacting **Photo 12** – Stage IV, entrance to parking lot near west end of overflow roadway

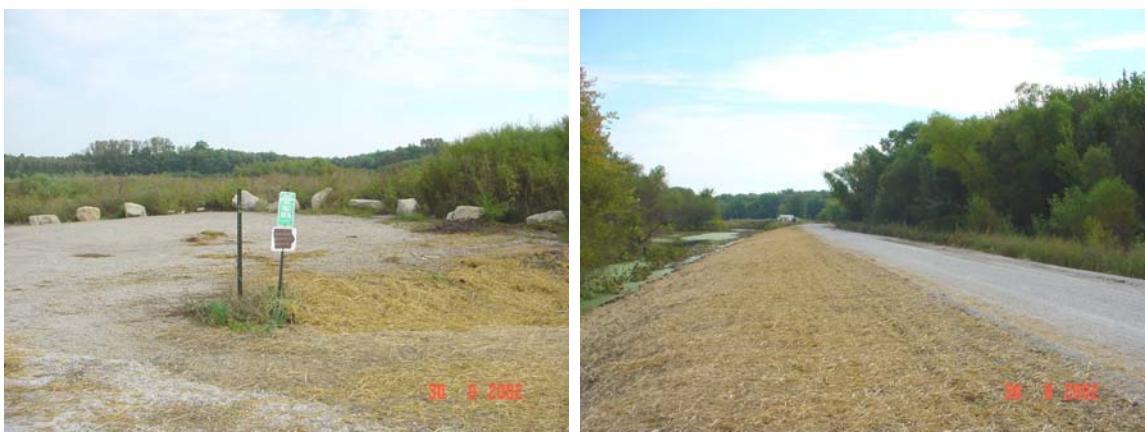
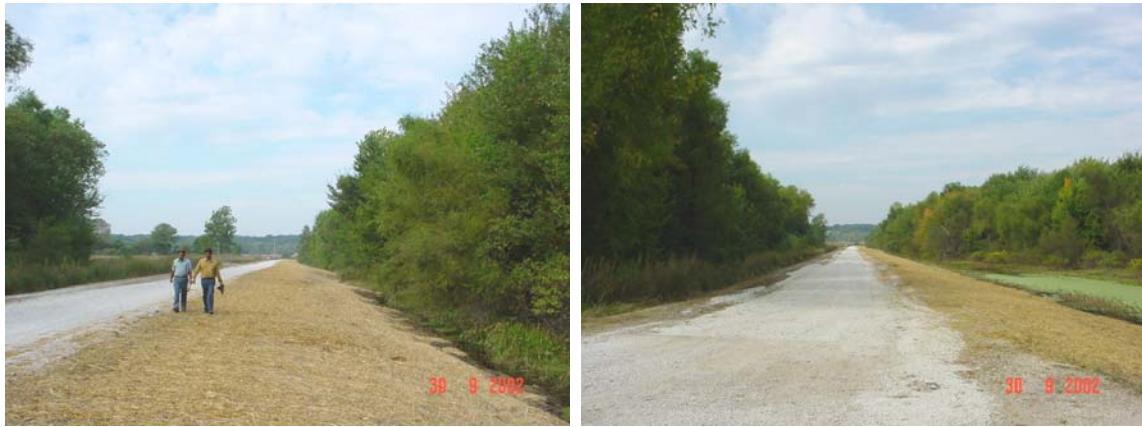
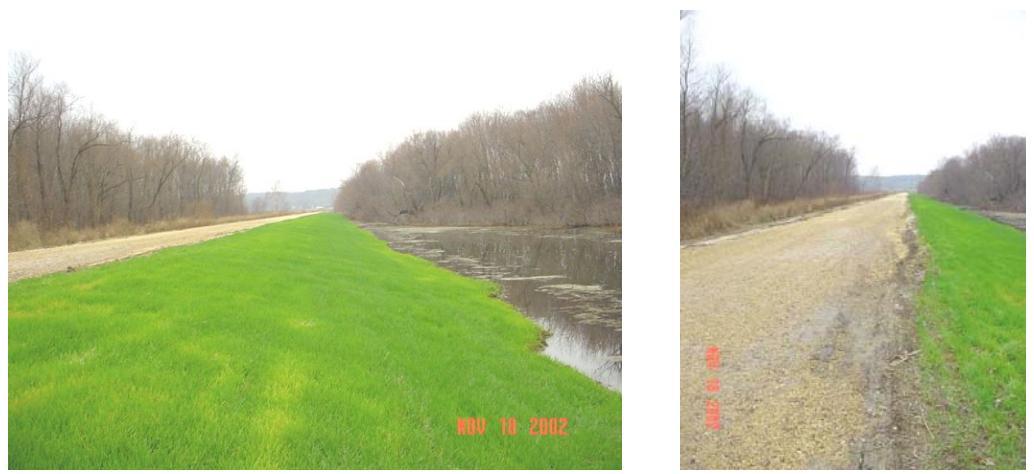
Photos 13 through 18 – Stage IV seeding, fertilizing, and mulching

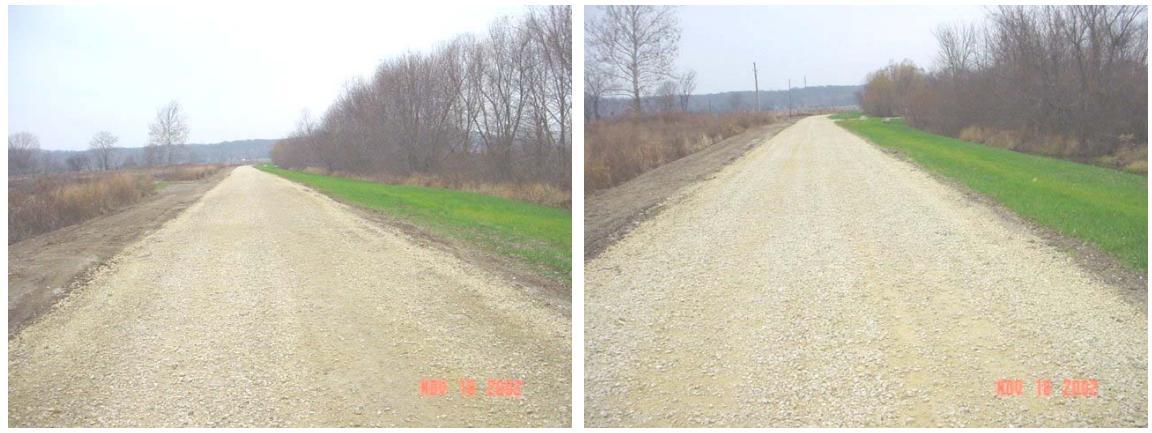
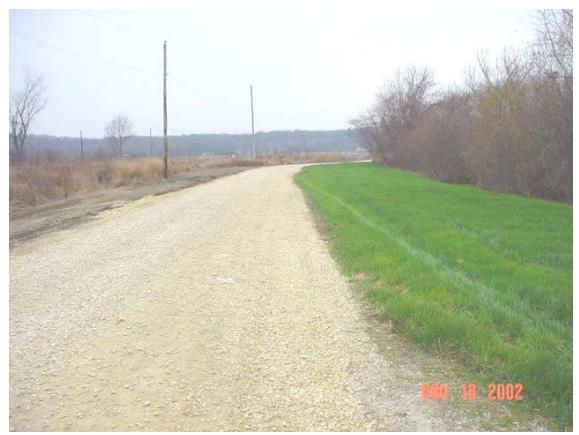
Photos 19 through 23 – Stage IV completion
