Performance Monitoring

Rock Island District

Kara N. Mitvalsky, P.E. CEMVR-EC-DN

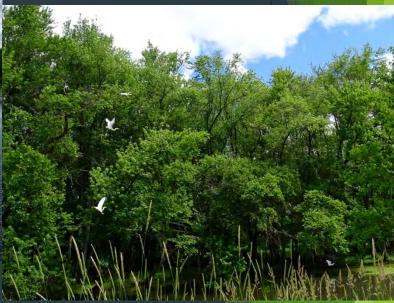
Numerous egrets and herons were noted along the perimeter levee.

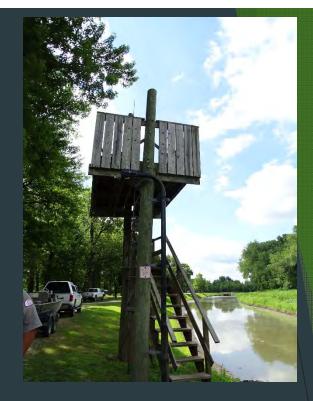
Existing pump station was pulled and the unit is being maintained with temporary pumps as well as possible until a permanent pump can be reinstalled.

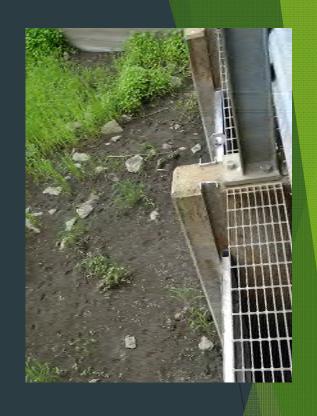
Operating 4 bays with stoplogs was not necessary in most conditions, so a local friends group funded the construction of aluminum gates, which were installed in ¾ of the 3 stoplog bays.

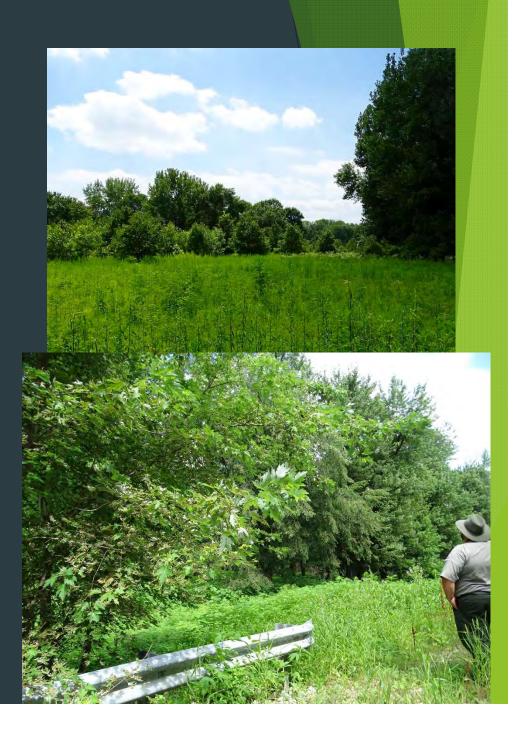
A variety of floodplain trees were planted within the complex and on the islands. Many of these trees continue to thrive. Upon funding availability, the IL DNR performs timber stand improvement in many of the planted areas.

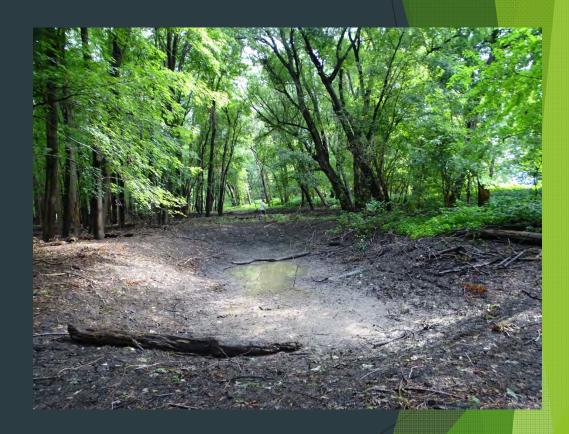
Select potholes were observed, but were not holding water and did not have any vegetation present.

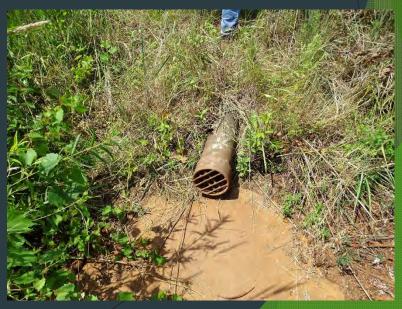
The well pump is maintained well and continues to operate for the service.

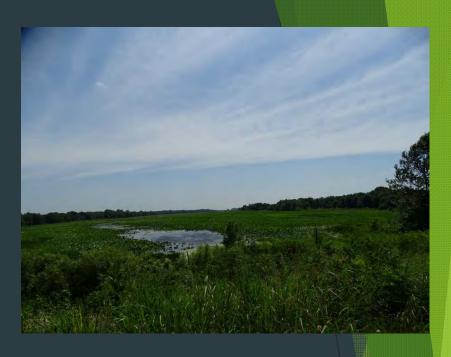
- Some of the dredge cut locations could be observed by changed or lack of aquatic vegetation.
- Most of these cuts have filled in more than expected, especially at the downstream end of the site.

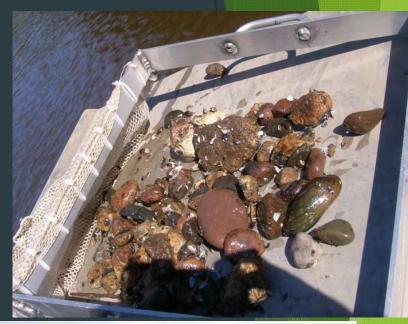
- A rock substrate aquatic habitat was constructed, and has been successful in providing habitat for mussels.
- The top photo, taken as part of the 2014 mussel survey, provides an indication of success at this site.
- Erosion beyond the rock channel was observed on a curve in the channel.

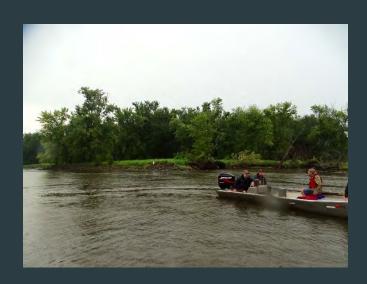
The rock substrate channel is protected by a rock closure structure which is still present on site.

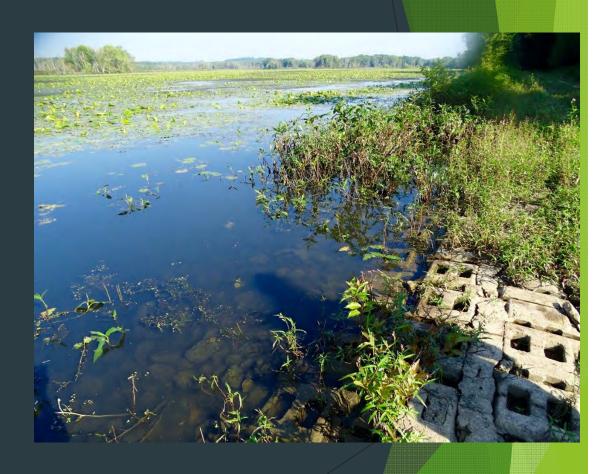
Spillways protect the berm surrounding the wetland allowing a protected surface for overtopping water. The articulated concrete mat spillway remains in good condition.

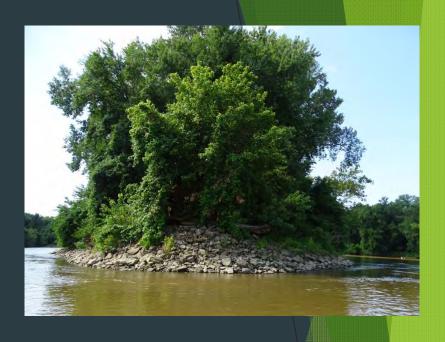
Small islands protected throughout the complex appeared to be well protected by the riprap, although downstream of riprap protection, active erosion was noted.

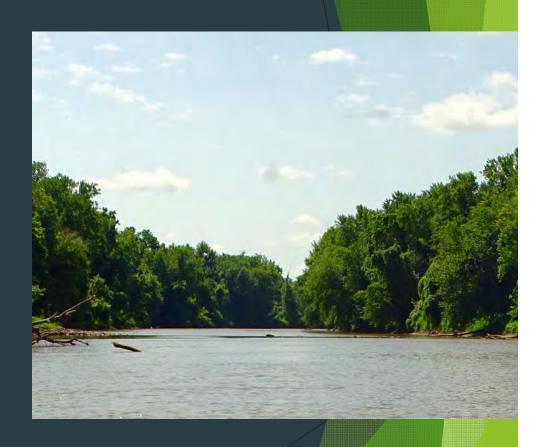
Due to elevated water levels, the closure structure was submerged. Riprap on bankline was observed. The river is being diverted away from the structure.

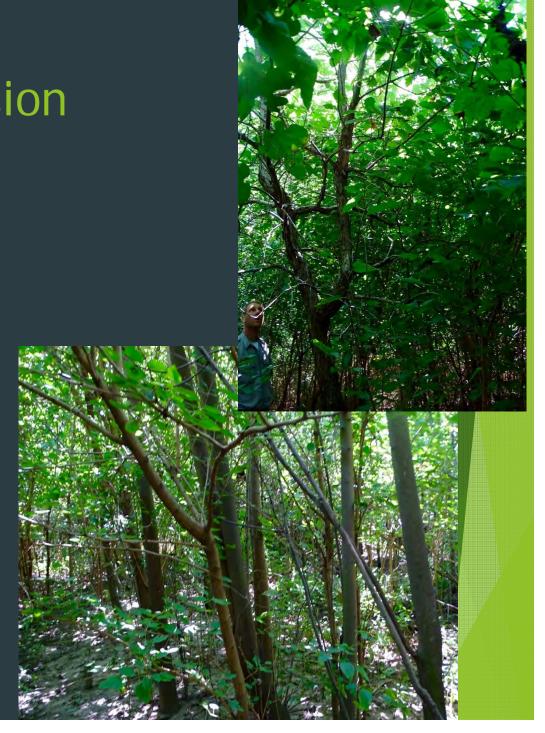
Fox Island

- Project Turned over to sponsor January 2016
- First Post Construction Inspection June 2017
