# **Interim Report For The Upper Mississippi River - Illinois Waterway System Navigation Study**

**US Army Corps  
of Engineers**

**November 1997**

## Bank Erosion Field Survey Report of the Upper Mississippi River and Illinois Waterway

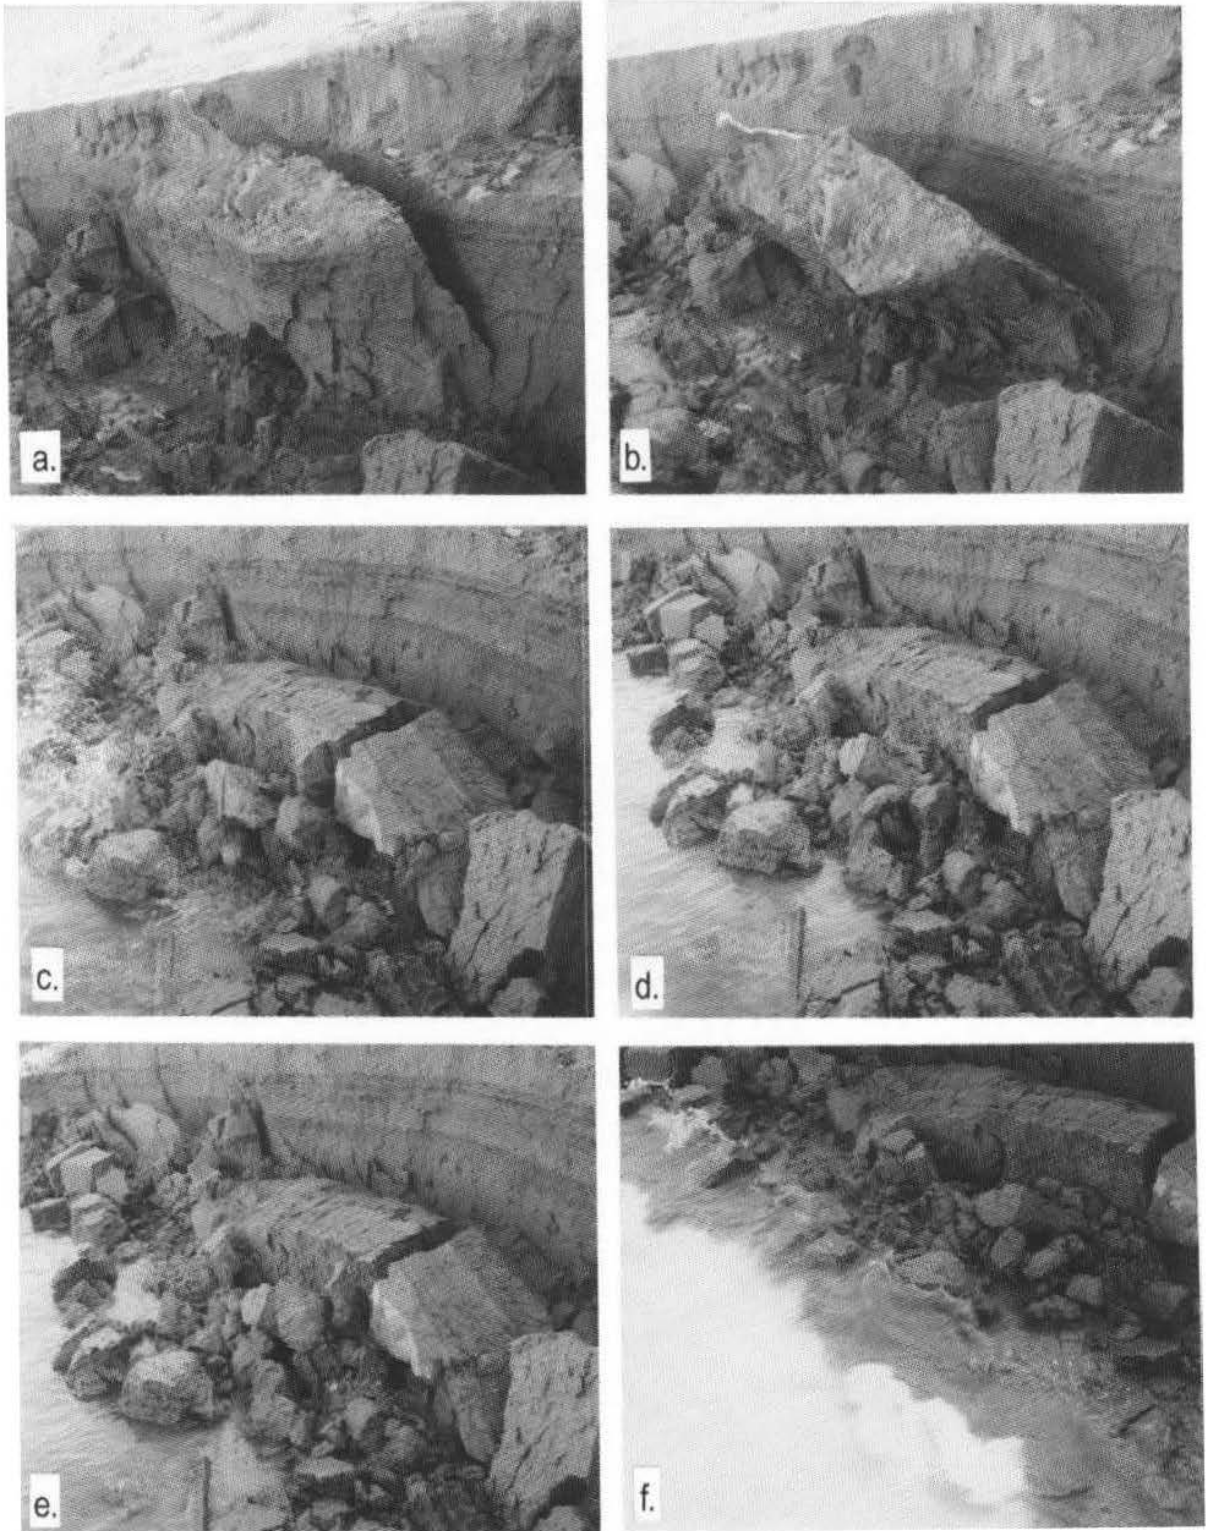
Another theoretical erosion pattern at and below the extremely high water mark in a free flowing system is shown in figure 5-4. This type of block failure was observed at several locations on the open river portion of the UMR shown by two sets of photographs in figures 5-5 and 5-6 for two water levels. Figure 5-5 shows a set of five photographs at RM 605, tip of the Sweezy Island on the UMR, taken when the water level was quite high and the bank eroded by waves overtopping. Figure 5-6 shows a riverbank at RM 52.3, site 42 on the UMR where bank failure took place due to failure of a sandy layer. Similar failure mechanisms were observed on the Illinois River. Again, riverbank failure and erosion can be interrelated with dominated erosional process and have been categorized in following these concepts. The following sections describe exactly what was done for both the Illinois and Mississippi Rivers.

Figure 5-6. Bank erosion due to undercutting, RM 52.3, UMR

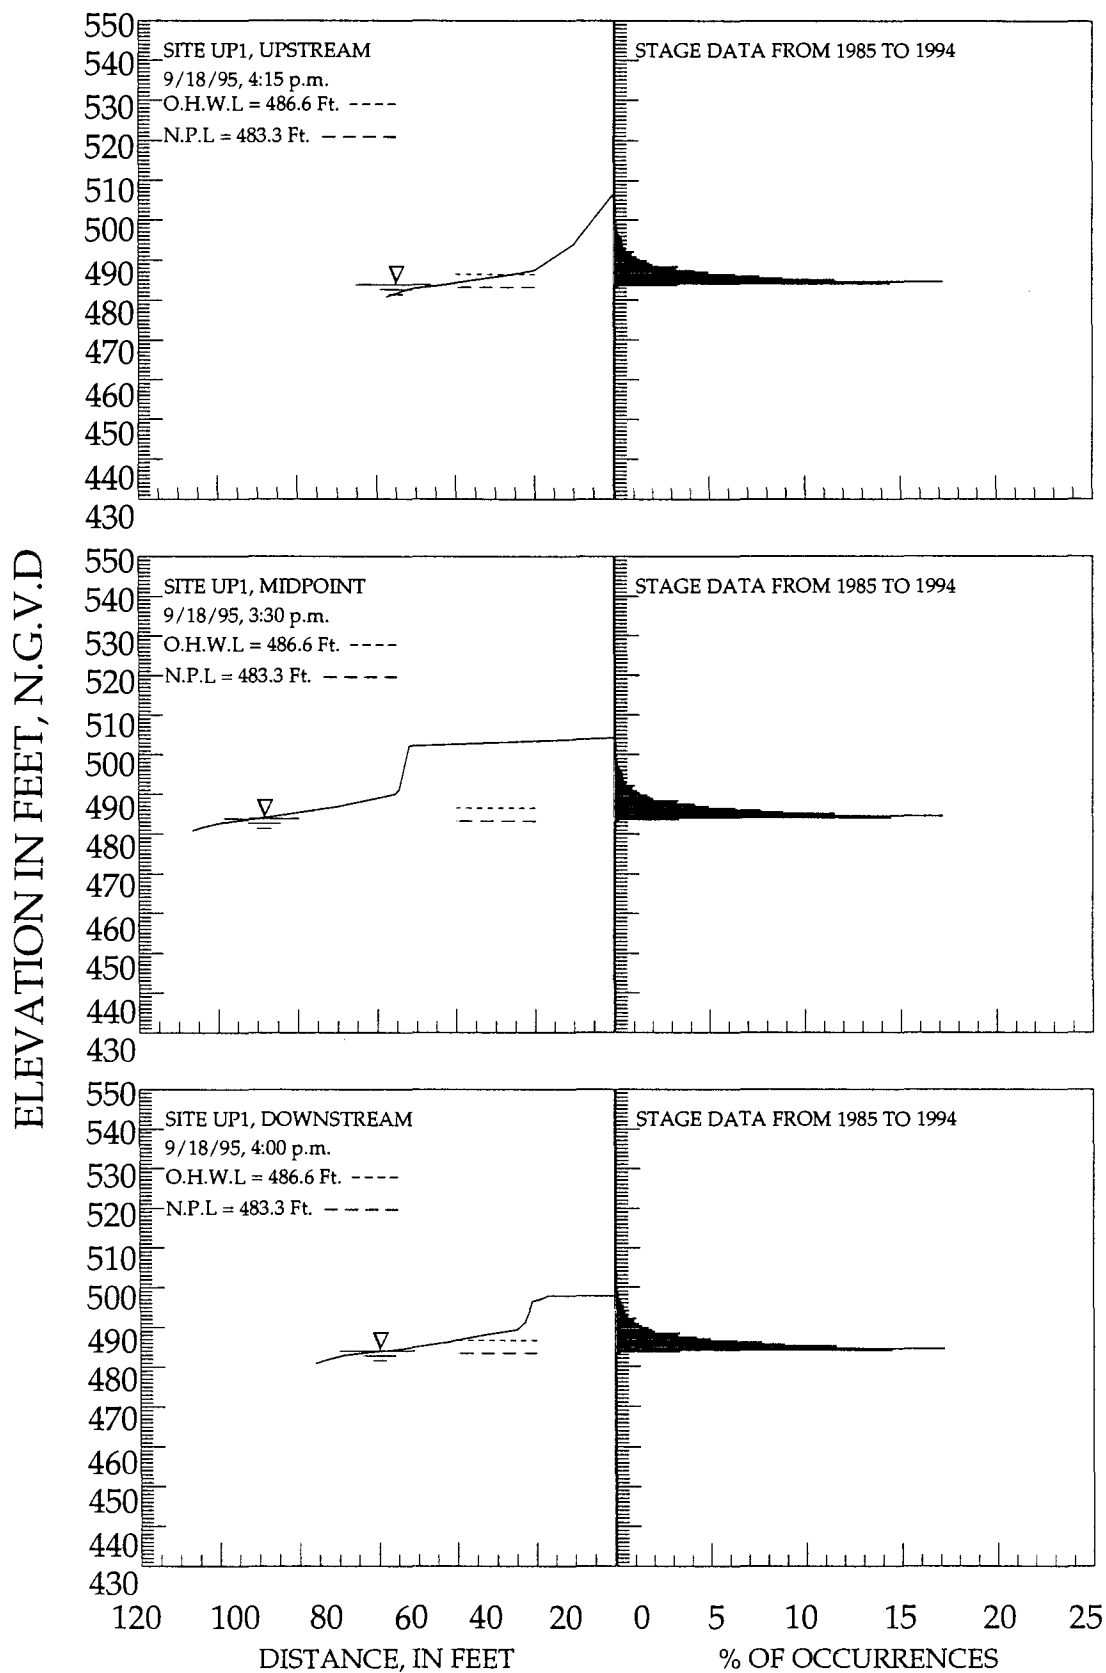
It should be noted here that figures 5-7 and 5-8 and all other similar plots were prepared to show the general orientation of the erosion sites. For example, site UP1 on the IWW is on the Right Descending Bank (RDB) of the river and site 22 on the UMR is on the Left Descending Bank (LDB) of the Mississippi River. Thus the bank sections were plotted on the right side of the figure looking from the top of the illustration to the bottom. Similarly, site 22 on the Mississippi River is on the LDB, and as such the bank sections were plotted on the left side of the illustrations looking from the top to bottom of the illustrations.

**Figure 5-7. Bank profile at site UP1 in Marseilles Pool of the Illinois River, RM 270.8, RDB stage histogram at tail gage of Dresden Island Pool, RM 271.5**

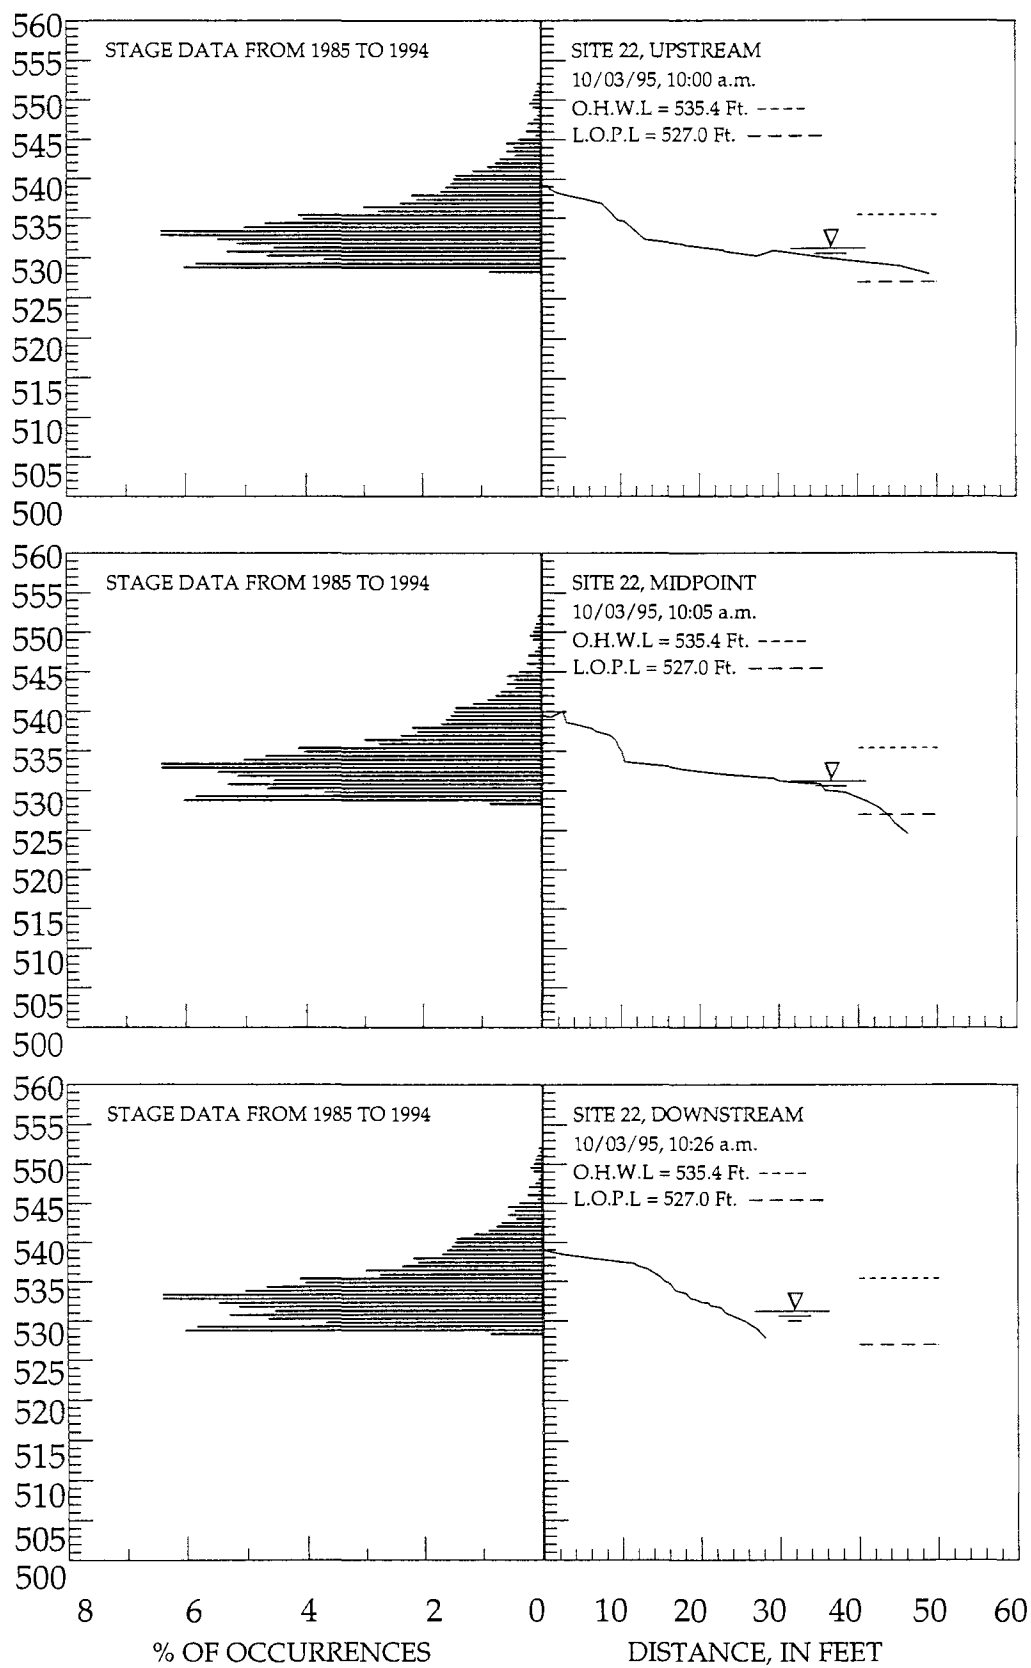
**Figure 5-8. Bank profile at site 22 in Pool 18 of the Mississippi River, RM 436.1, LDB stage histogram at tail water gage of L&D 17, RM 437.1**

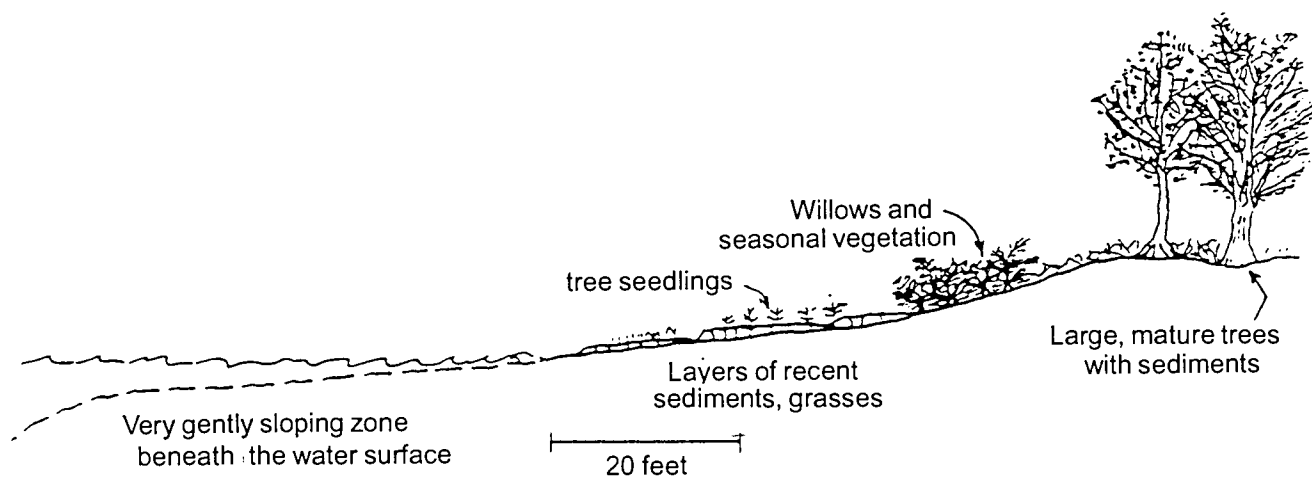
**Figure 6-9. Type 5 site--relatively stable with significant deposition and relatively dense vegetation cover, after Hagerty (1988)**

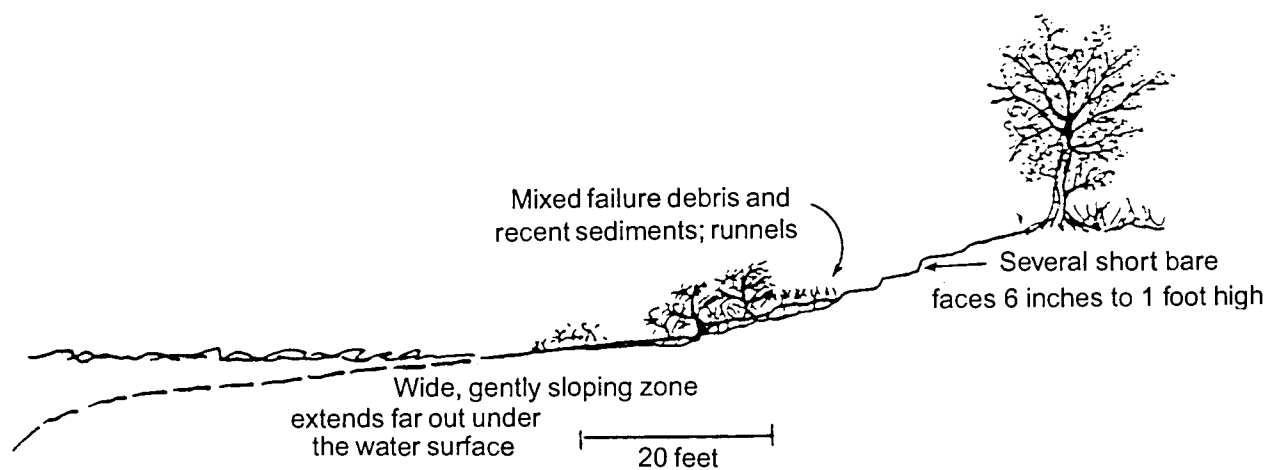
**Figure 6-10. Type 4 site--site of only slight apparent erosion; deposition and accumulation of failure debris on middle and lower bank, with willows and seasonal vegetation cover, after Hagerty (1988)**

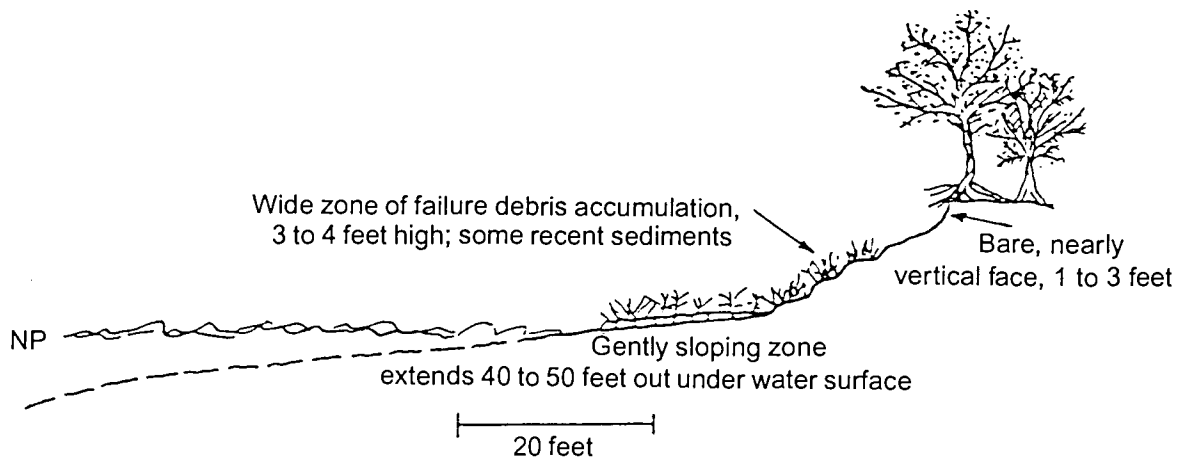
**Figure 6-11. Type 3 site--site of moderate to slight erosion, with some sedimentation and moderate vegetation cover, after Hagerty (1988)**

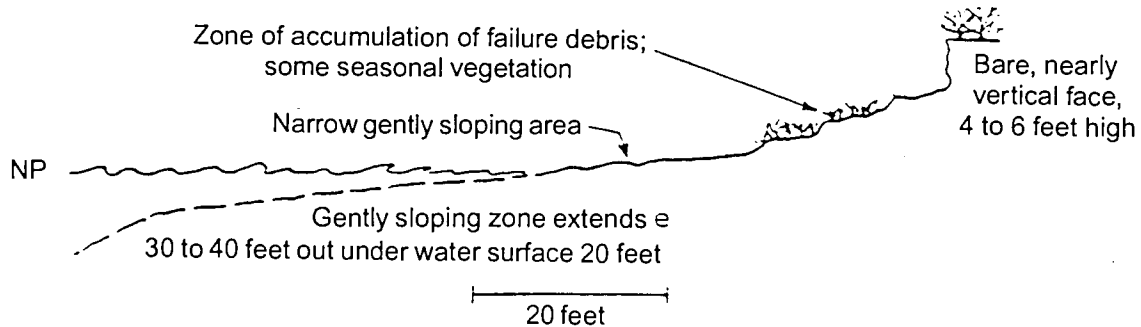
Figure 6-12 shows a “Type 2 site: At this site, the subaqueous bench dropped off steeply. The lower bank subaerial bench was narrow. Recently deposited sediments and failed soil accumulations formed berms 1 to 3 feet high in the middle portion of the bank. These berms contained deep runnels and seasonal vegetation. Nearly vertical faces 4 to 6 feet high were encountered within upper bank areas” (page 24).

**Figure 6-12. Type 2 site--apparently active site of moderate erosion very sparse cover of vegetation, after Hagerty (1988)**

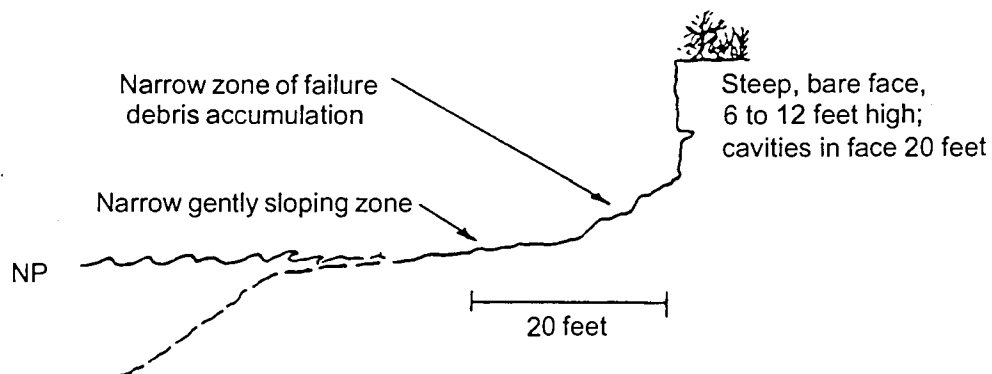
**Figure 6-13. Type 1 site--apparently active site of most severe erosion little or no vegetation cover, after Hagerty (1988)**

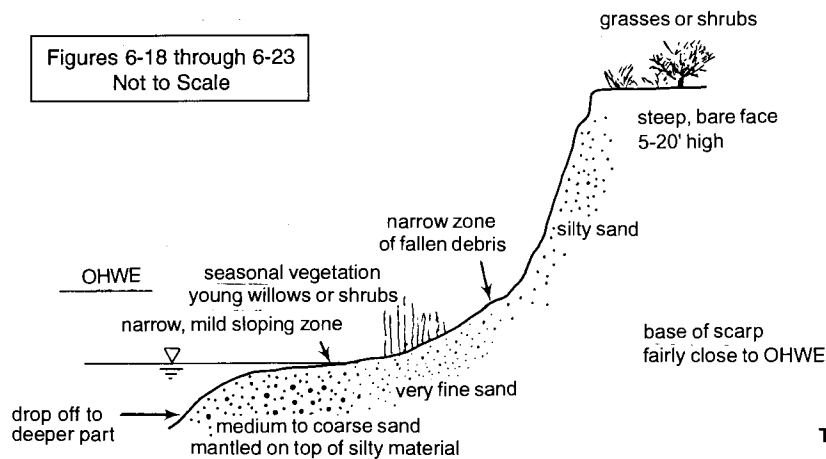
**Figure 6-18. Type 1 bank on the ILWW: steep bank with high bare face.**  
The ordinary high water elevation is low as compared to the bank elevation

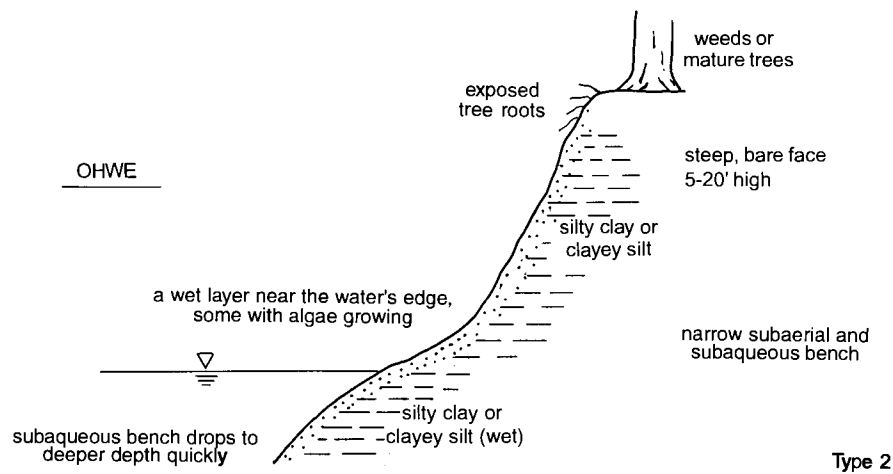
**Figure 6-19. Type 2 bank on the ILWW: steep bank with high bare face.**  
The ordinary high water elevation is comparable to the elevation at top of the bank

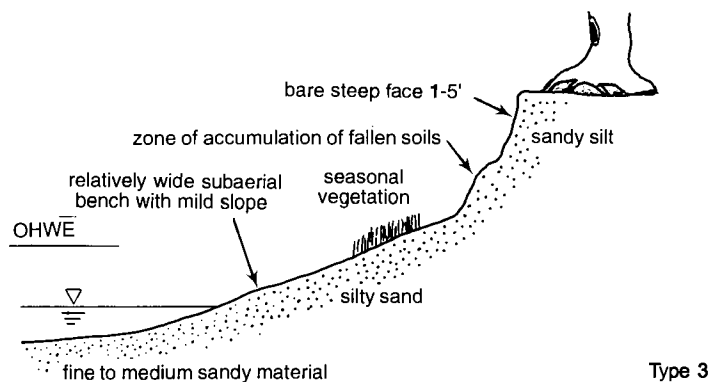
**Figure 6-20. Type 3 bank on the ILWW: short scarp face and fairly long bench.**  
The ordinary high water elevation is low as compared to the bank elevation

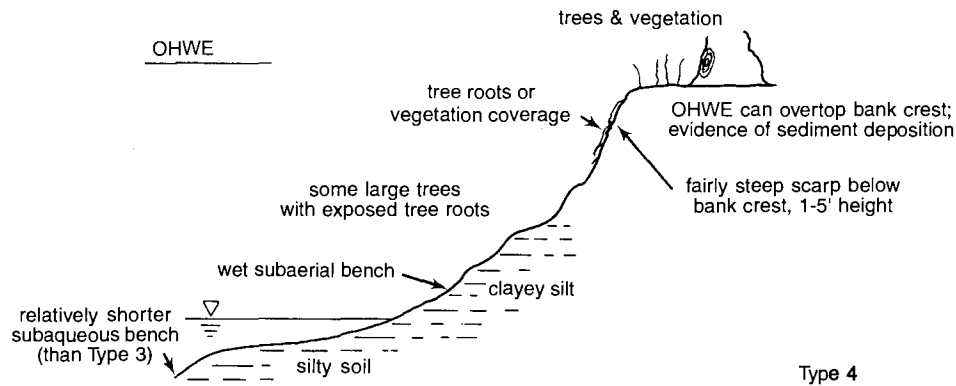
**Figure 6-21. Type 4 bank on the ILWW: small scarp face with bare bank.**  
**The ordinary high water elevation can overtop bank crest or reach the face of scarp.**

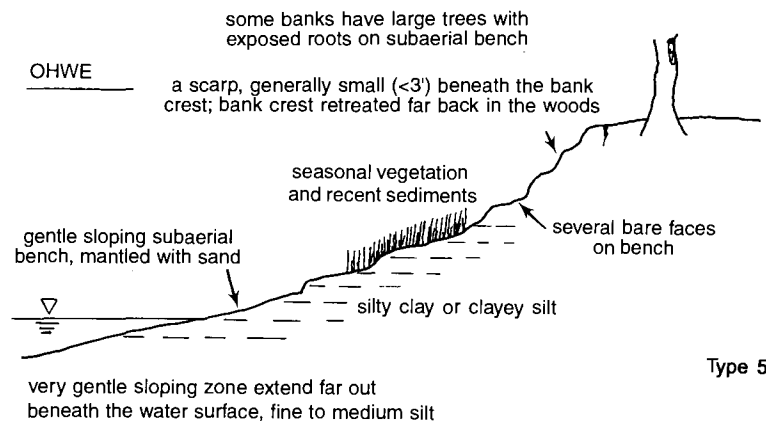
**Figure 6-22. Type 5 bank on the ILWW: small scarp face and fairly long bench.**  
**The subaqueous bench has a gentle slope and extends far-out.**

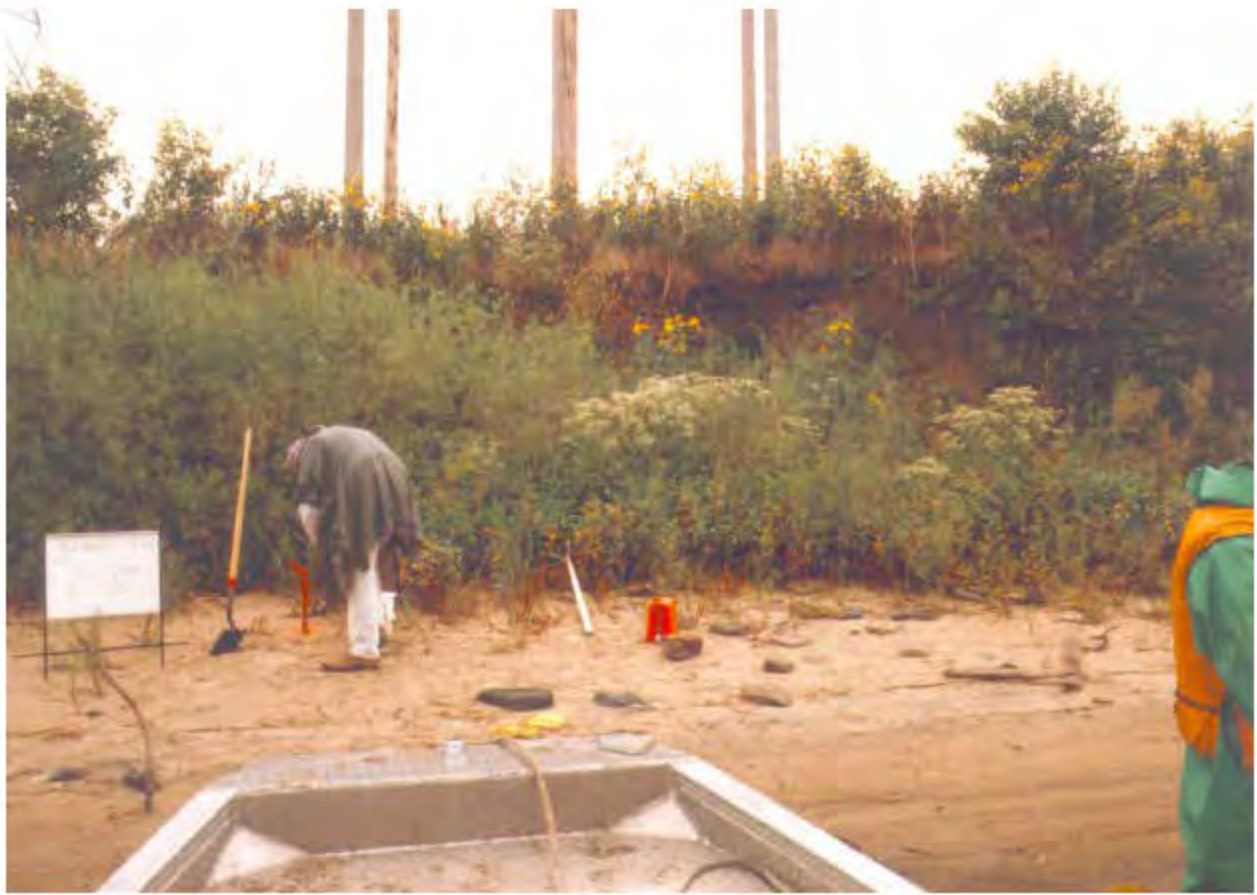
**Figure 6-34. Site UP1 on the Illinois Waterway**

An almost vertical failure face approximately 15 to 20 feet high is present at this site. Recession of the bank line is close to the support of a nearby powerline frame. One of the four legs of a nearby powerline support was only 3 feet away from the bank face.

The bench slope varied from 1V:6.8H to 1V:9.H. The bank at this site can be classified as a combination of types 1 and 3 (figure 6-18, 6-20, table 6-4). Floods and high water stages could be the major cause of bank erosion. There was a collapsed bank section. Failure could be due to erosional oversteeping. Several holes were observed on bank face indicating that piping could also be a factor in bank failure.

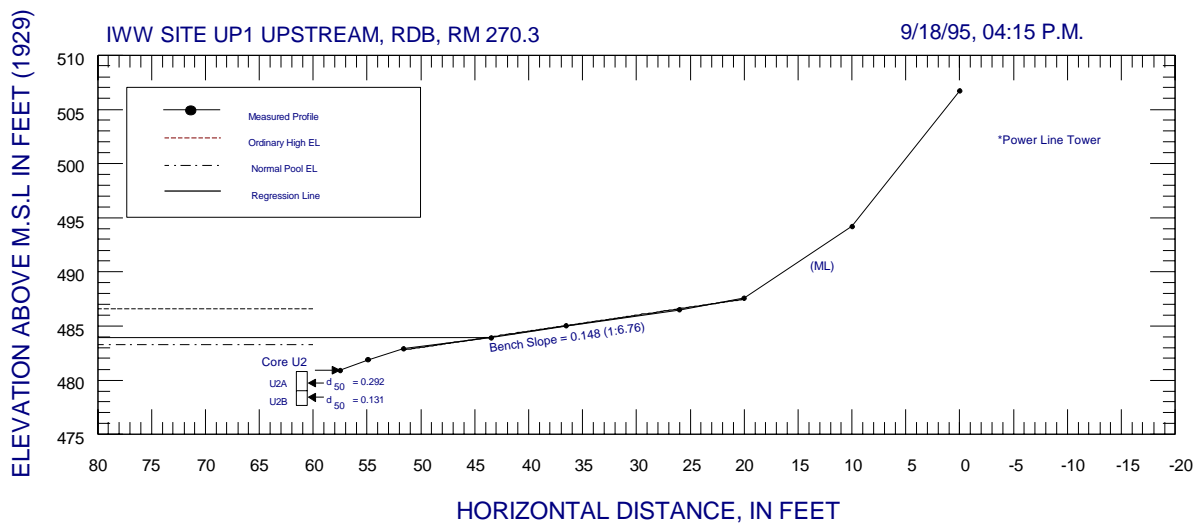
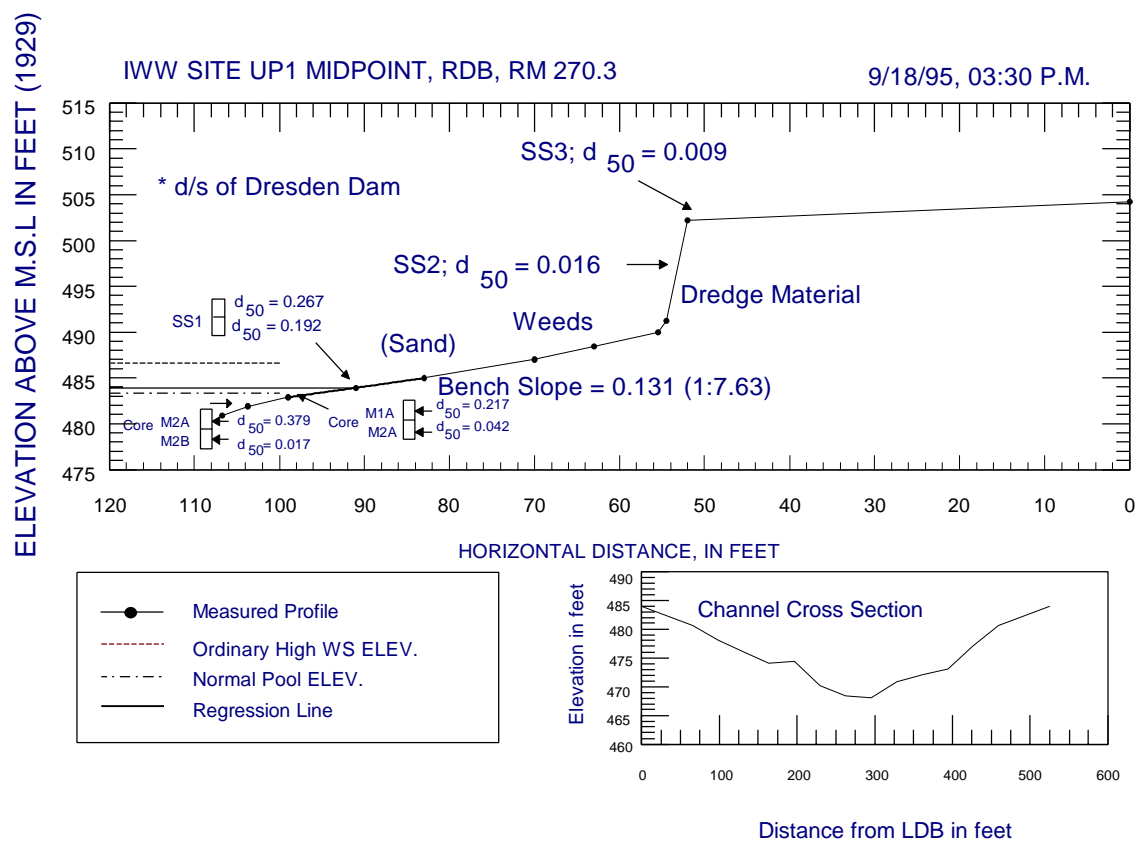
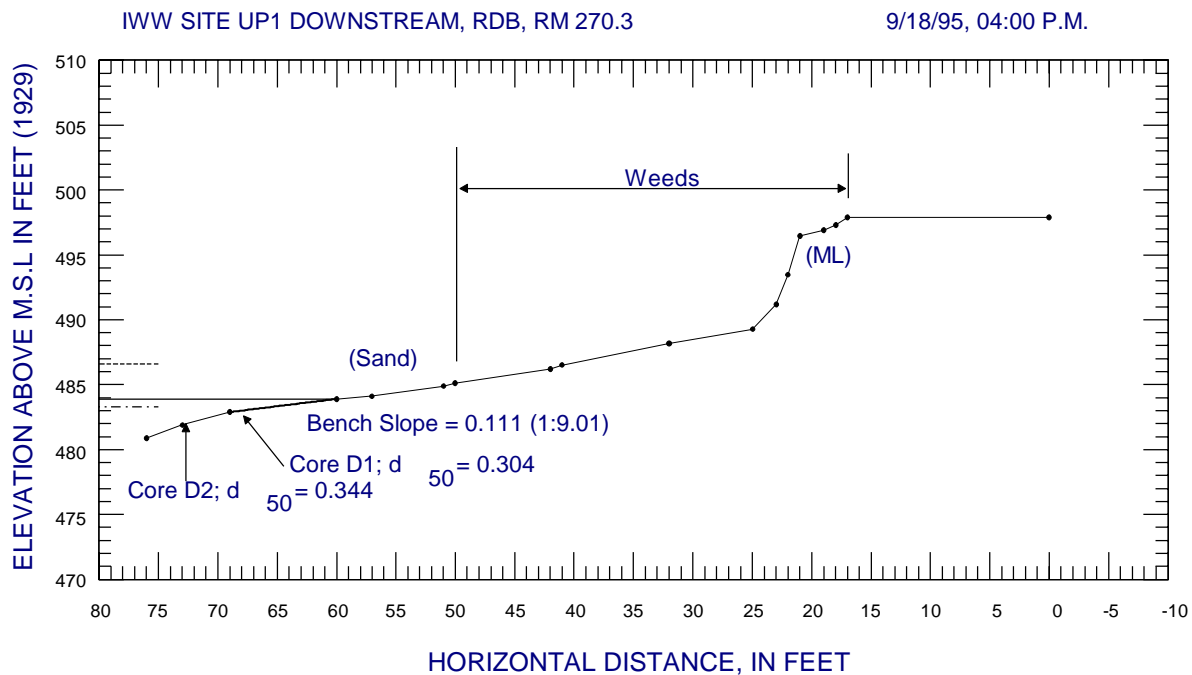
Figure 6-35. Bank sections at site UP1

Only one river cross section was measured at this site, and the detailed cross section and coordinates are shown in appendix G. Three bank sections were measured at this site, as given in figure 6-35 with the computed values of bench slopes and median diameters of the bank soils. For site UP1, the OHW is at 486.6 and NP is at 483.3 feet above msl, respectively. The NP elevation

corresponds to a break in the subaqueous bench slope. There were weeds growing on the bench near the base of the scarp. The bank above the OHW line is relatively high as compared to local stage fluctuations. According to 10-year stage data (see table 6-6), the OHW reaches the base of the scarp and only high stages (less than 10% exceedence frequency, or approximately at 489.9 feet) can reach the existing scarp face. Otherwise, normal stage fluctuations (the range between OHW and NP) occur mostly on the bench area.

The gradation plots of bank soils and nearshore sediment are presented in appendix F. At the midsection, the  $d_{50}$  varies from 0.009 mm at the top surface of the bank to 0.379 mm at the upper part of a core sample at a depth of about 2 feet of water.

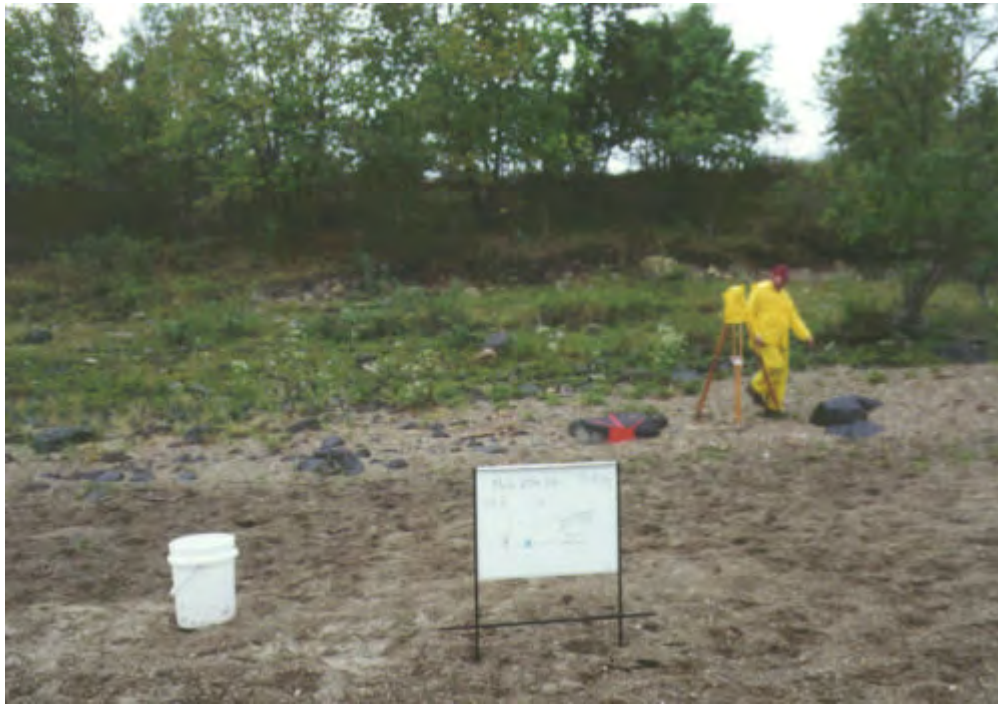
**Figure 6-36. Site UP2 on the Illinois Waterway**

**Site UP2, Marseilles Pool, 9/18/95.** This site is located on the Left Descending Bank (LDB) at RM 270.8, opposite site UP1. Figure 6-33 shows the position of the site on a GIS-based map of the Illinois navigation chart, and figure 6-36 shows one photograph of the site.

The bench slope was 1V:11.H, and the bench was covered with noncohesive sandy soil. This site can be classified as type 5 (see figure 6-22 and table 6-4). The scarp was above OHW stage. Erosion could have occurred during flood stages. The base of the scarp showed sand deposits indicating that seepage at the base could weaken the bank. Waves and currents could remove/transport failed soils that mantle the bench.

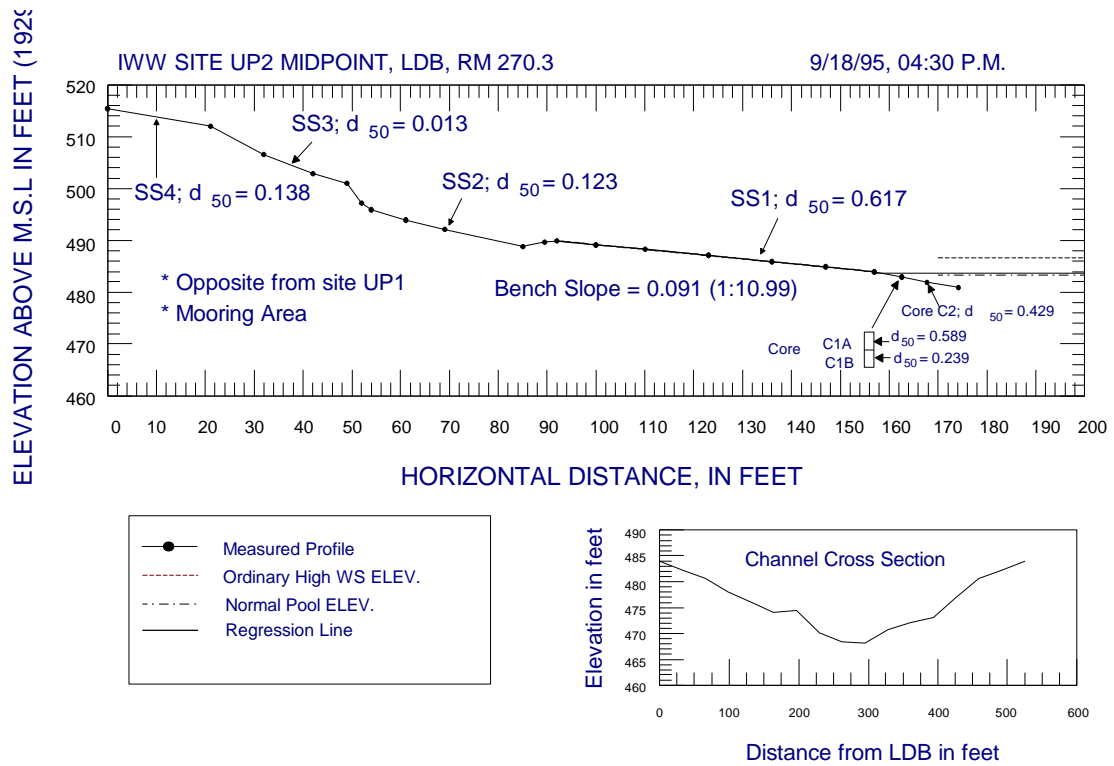
### **Figure 6-37. Bank section at site UP2, midsection**

The  $d_{50}$  varied from 0.138 mm at the top surface of the bank to 0.429 mm for a core sample at a depth of about 2 feet of water. Another core sample at 1 foot of water showed coarse sand ( $d_{50} = 0.589$  mm) on top and fine sand ( $d_{50} = 0.239$ ) at the bottom. Gradation plots of bank soils and nearshore sediment are presented in appendix F. The detailed cross section and coordinates are shown in appendix G.

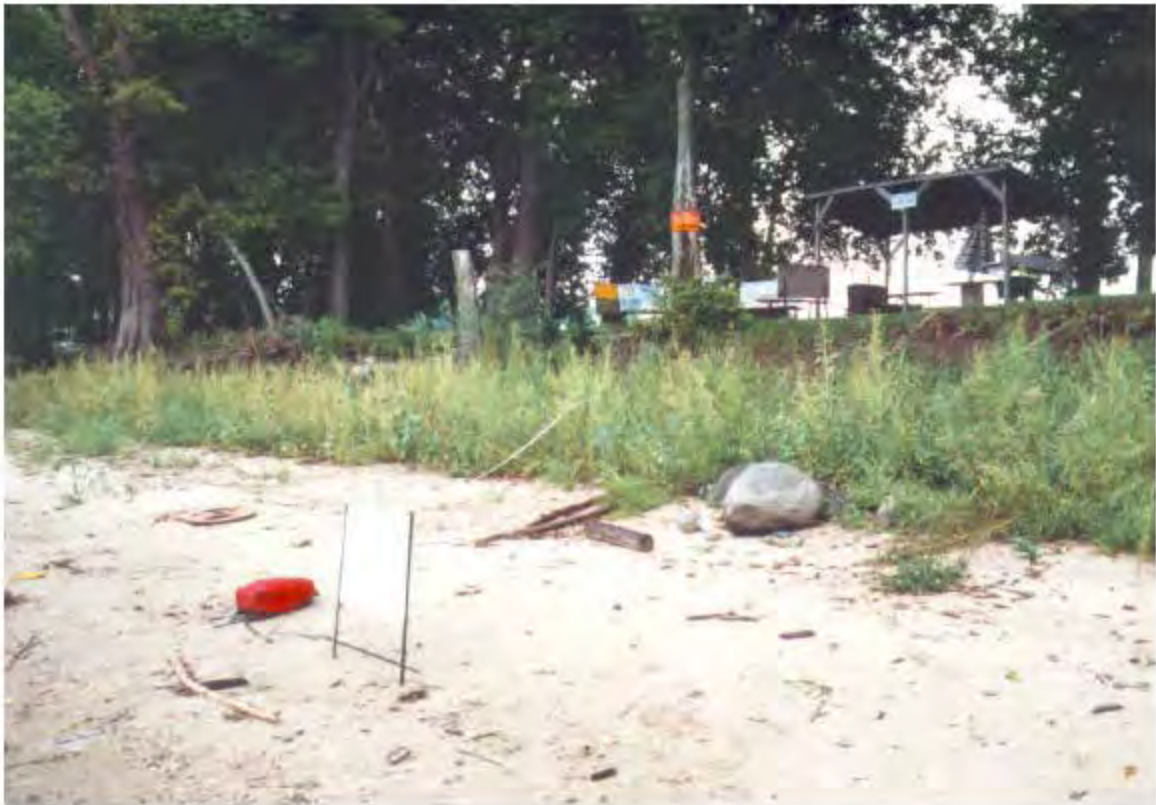
**Figure 6-39. Site UP3 on the Illinois Waterway**

**Site UP3, Marseilles Pool, 9/19/95.** This site is located on the LDB at RM 264.3; the reach is fairly straight. The Morris Boat Club Dock and Vogler Gravel Company are located across the river at RM 264.5. No major tributary enters this site. Figure 6-38 shows the position of the site on a GIS-based map of the Illinois navigation chart, and figure 6-39 shows one photograph of the site.

An obvious scarp approximately 5 to 10 feet high was present at this site. Erosion of the bench area, if not retreat of the bank line, could be described as significant when compared with a 1988 photo. Figure 6-40 shows the three measured bank sections and a reduced cross section. At the downstream section, a concave bank face was observed. The OHW is at 485.7 feet and NP is at 483.3 feet above msl. The NP elevation corresponds to a break in the subaqueous bench slope. The OHW reaches to the upper part of the bench and corresponded well with the lower end of the weed zone. The bank top is relatively high and only high stages exceeding the 10% occurrence frequency (at 488 feet, see table 6-8) can reach the berm or the scarp.

Bench slopes varied only slightly from 1V:21.7H, and the bench was covered with noncohesive sandy materials. This site can be classified as type 3 (see figure 6-20 and table 6-4). Erosional undercutting, rework and transport by waves and currents at high stages or during floods could be major causes of erosion at this site. After the flood receded, the bank soil may slip and fall as blocks, as shown in the downstream section. Land use as a trailer park can be a factor at this site too. Seepage at the recession stage of a flood could also play a significant role in bank failure. Waves and disturbances created by local boating activities can cause entrainment of recently deposited sediments from bench areas.

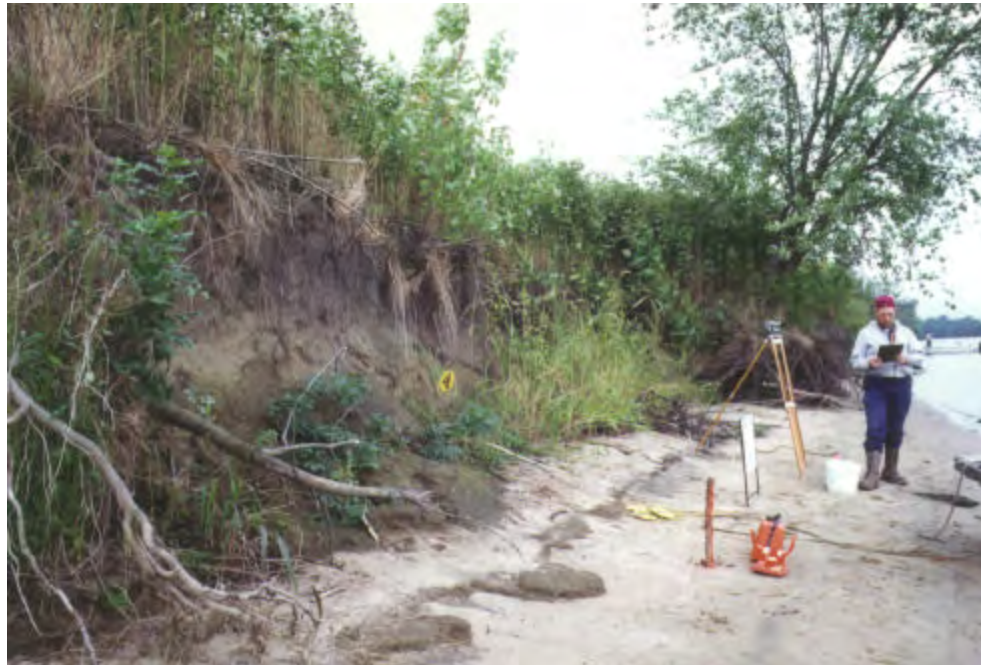
**Figure 6-42. Site UP4 on the Illinois Waterway**

Site UP4 is in a fleeting area where the distance to a red buoy marking the navigation channel was less than 50 feet from shore. Land use on top of the bank was agriculture (corn), and tall weeds were encountered on the bank crest. A scarp 5 to 10 feet high had its top portion covered with exposed roots and its lower portion had piping holes. The lower bank was a narrow sand bench. Failed riprap existed downstream of the site at an entrance channel to a gravel pit. Local tow traffic at this reach can be very frequent. Figure 6-43 shows the three measured bank sections and a reduced cross section. A slumped bank face was observed at the downstream section. The OHW is at 485.5 feet and NP is at 483.3 feet above msl. Except at the downstream section, the base of the scarp is slightly higher than the OHW level. At higher stages (10% occurrence frequency, 488 feet, see table 6-9) wave and current can have a direct contact on the scarp.

Bench slopes varied from 1V:12.5H to 1V:7.5H, and the subaqueous bench becomes steeper. Piping holes at the scarp and moist soils on the lower portion of the bank were noted. This site can be classified as a combination of types 2 and 3 (see figures 6-19, 6-20, and table 6-4). The bank soils appeared to be cohesive, but the bench was sandy with several clay outcrops. Seepage could weaken the base support and cause the bank to slip, as shown at the downstream section. Failed soils and/or recently deposited sediment on the bench are reworked and transported by wind or tow-generated waves. The steep dropoff in subaqueous benches is indicative of effects of direct vessel contact or traffic-induced velocities.

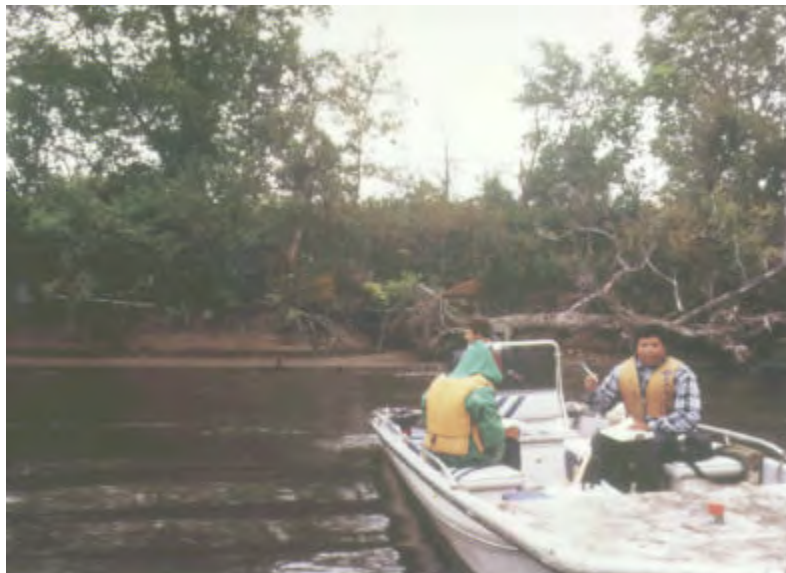
**Figure 6-44. Site UP5 on the Illinois Waterway**

**Site UP5, Marseilles Pool, 9/20/95.** This is at the bank opposite site UP4. Figure 6-41 shows the position of the site on a GIS-based map of the Illinois navigation chart, and figure 6-44 shows one photograph of the site. Site UP5, is in a straight reach downstream from a mild bend. Bhowmik and Schicht (1980) marked this site as an erosion site and also indicated dredge material displacement on this bank. A 1 by 1 loaded barge passed in the upstream direction while the team was on the bank. Although the barge slowed down at the site, the drawdown induced by this traffic event was approximately 1.5 feet vertically. Four to five large waves with crests approximately 0.9 feet higher than pool level came in after the drawdown.

The site is about 300 feet from the sailing line and there is no major tributary at this location. The bank section has a scarp with exposed roots and piping holes. However, the bench was wet and did not have heavy sand deposition as on the opposite bank. A subaqueous scarp was found at the water's edge. Figure 6-45 shows one measured bank section and a reduced cross section. The OHW is at 485.5 feet and NP is at 483.3 feet above msl. The subaqueous bench extends at least about 100 feet from the water's edge. A 10-year stage data analysis (table 6-10) shows that stages higher than 25% recurrence frequency (the OHW) would submerge the base of the scarp; those higher than 10% recurrence frequency (above 490 feet) will overtop the bank.

The bench slope was 1V:26H. Some algae were observed on the subaerial bench. This site is classified as a combination of types 4 and 5 (see figures 6-21 and 6-22 and table 6-4). Banks are susceptible to erosion by tractive forces from flows at OHW or during floods. Piping, seepage, and weathering could loosen the bank soils which are then subject to removal by currents and waves. At this site, traffic-induced currents and waves can erode failed soils and recently deposited sediments within bench areas during periods of normal pool stages.

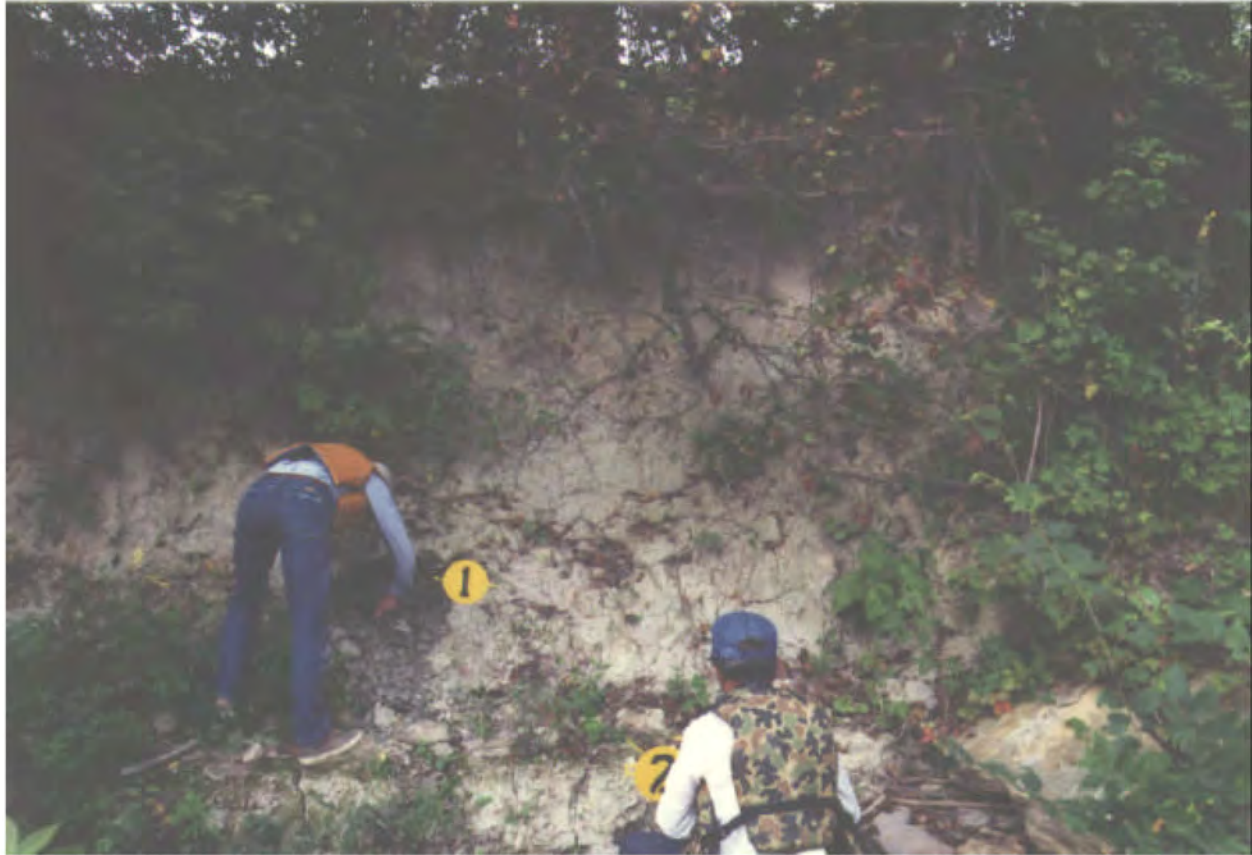
**Figure 6-47. Site 1 on the Illinois Waterway**

Neither Bhowmik and Schicht (1980) nor Hagerty (1988) observed erosion at this site. Hagerty (1988) noted rock instead. During this survey a near vertical scarp about 8 feet high was encountered. Exposed tree and grass roots covered the top of the scarp, and some leaning tall trees were found on the scarp. Flat slabs or rocks approximately 1 to 2 inches in length and only about quarter inch in thickness were found on the bench at the foot of the scarp. Rocks increased in size to about 4 or 5 inches long near the waters edge. Rock crops out along the Moores Creek. Figure 6-48 shows the two measured bank sections and a reduced cross section. Available stage data from the Marseilles Lock and Dam is used for interpolating stage information at this site (table 6-11). The OHW is at 460 feet and NP is at 458.5 feet above msl. Stages higher than 461.8 feet will submerge the scarp.

Bench slopes varied from 1V:6.1H to 1V:17.2H. This site can be classified as type 1 (figure 6-18 and table 6-4). Surficial bank materials slake and are loosened by weathering with subsequent collapse. Reworking and transport of failed materials and recently deposited sediments occurs within bench areas during high flows.

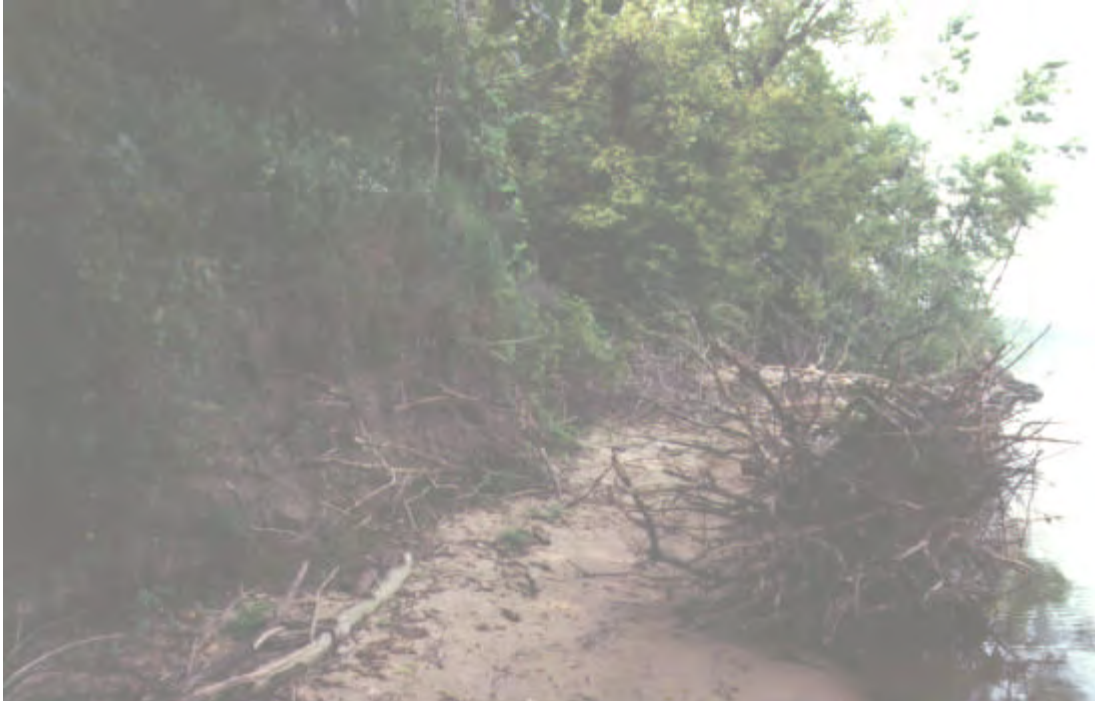
**Figure 6-49. Site 2 on the Illinois Waterway**

Hagerty (1988) noted erosion, but Bhowmik and Schicht (1980) indicated riprap at this site. During the survey there was a fairly long stretch of eroded bank with a nearly vertical scarp about 6 to 7 feet in height. Trees of 6 inch diameter stood at the edge of the scarp, some with extensive root exposure on the bank face, and some downed trees were lying on the bench. The relatively narrow bench was covered with fine sand. Nearshore materials were mostly fine sand on soft silt.

and table 6-4). The scarp was nearly vertical and covered with fine roots. There was a moist layer at the base of the scarp and the subaerial bench was narrow and covered with sand. Several factors contribute to bank failure: tractive forces during floods, wave and current actions at stages above OHW, and seepage at the base of scarp could all contribute to the rework and erosion of failed bank soils and recently deposited sediment.
