# **Interim Report For The Upper Mississippi River - Illinois Waterway System Navigation Study**

**US Army Corps  
of Engineers**

**November 1997**

## Bank Erosion Field Survey Report of the Upper Mississippi River and Illinois Waterway

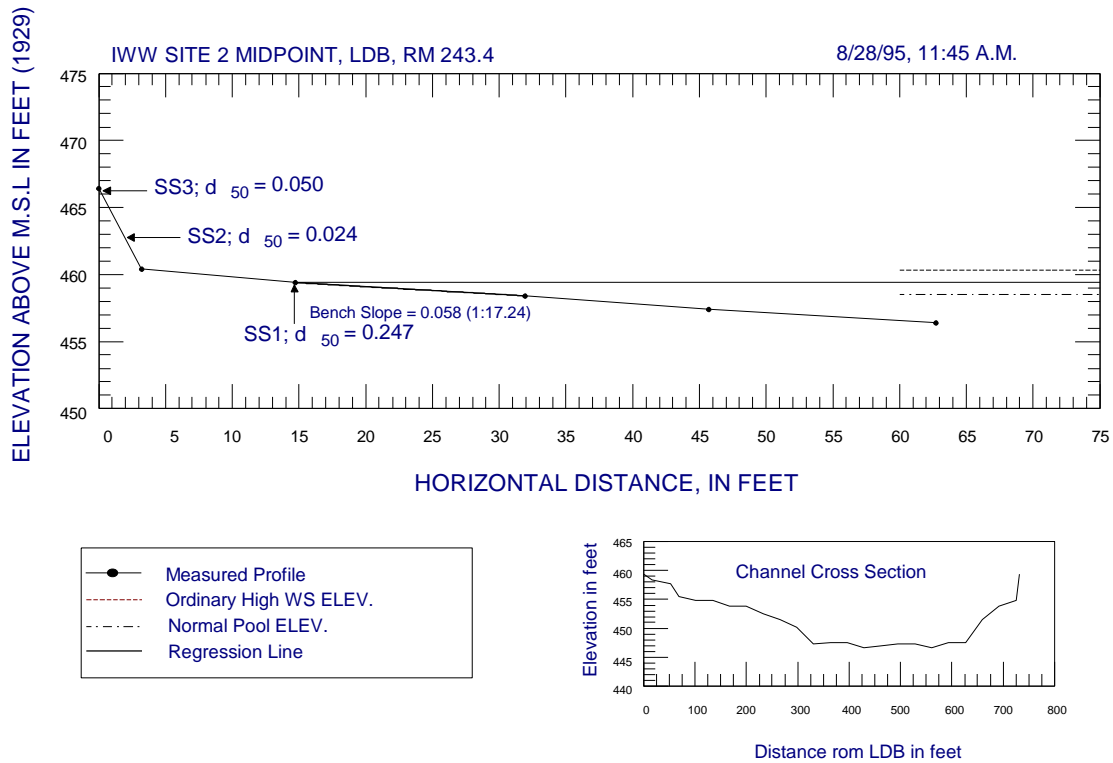
**Figure 6-50. Bank section at site 2**

Figure 6-50 shows the measured bank section and a reduced cross section. The OHW is 459.5 feet and NP is 458.5 feet above msl. According to 10-year stage data (Table 6-12), stages with 25% or less exceedence frequencies will reach the base of the scarp, and any stage higher than OHW elevation will be on the scarp.

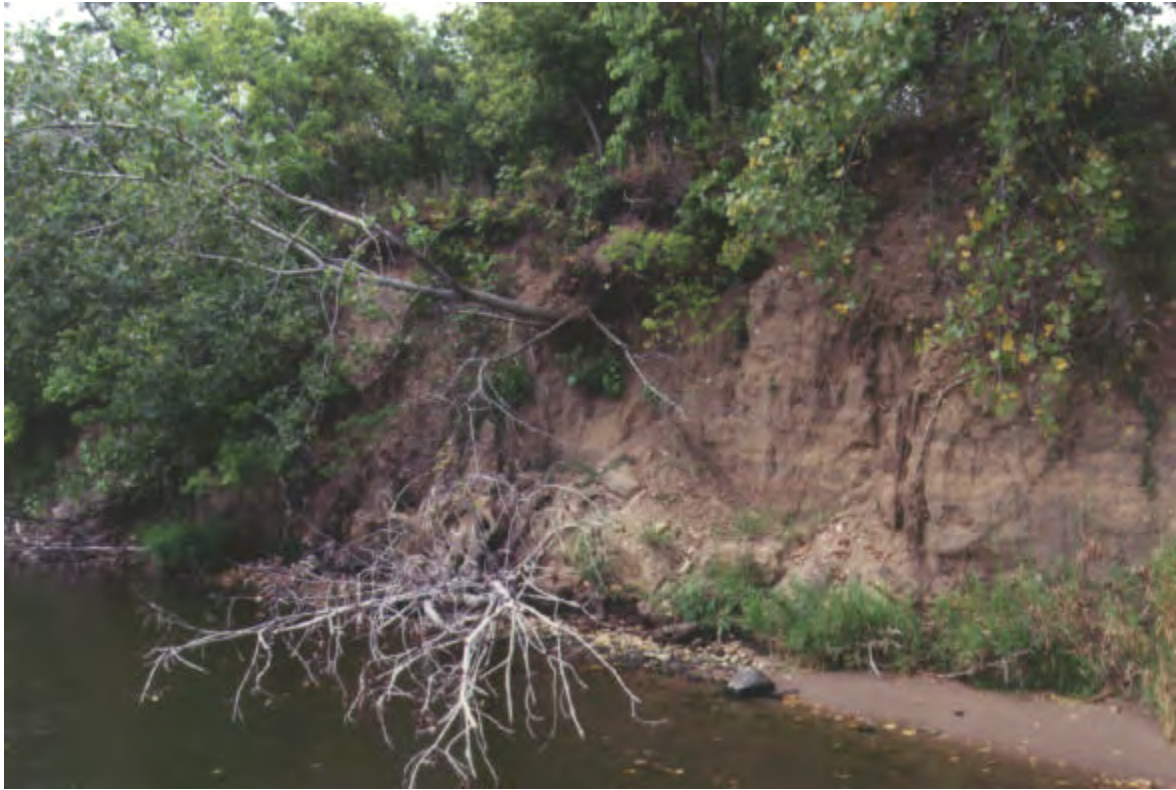
**Figure 6-52. Site 3 on the Illinois Waterway**

The bank consisted of a bare face approximately 15 to 20 feet high. Toppled trees halfway up the bank face supported stems re-grown to upright directions. Fine sand and gravel were found at the water's edge. Although the reach is straight, the three sections surveyed all were measured from locally concave banklines. These concavities were about 50 feet wide, and all had either gravel or trees at the water's edge, at the upstream end. Several mass failures had occurred at the downstream ends, which indicated the concave sections were widening.

Bench slopes varied from 1V:50H at the upstream section to 1V:8H at the midsection. The bank consisted mostly of noncohesive sandy materials. The three sections can be classified as a combination of types 1 and 6 because of the extended subaqueous bench width (figures 6-18 and 6-23, and table 6-4). Rework and transport of failed soils and recently deposited sediment occur during floods. Eddy currents induced by the trees or gravel upstream of concave sections can cause bank failure and eddies are generated at stages when the flows are disturbed by trees or gravel.

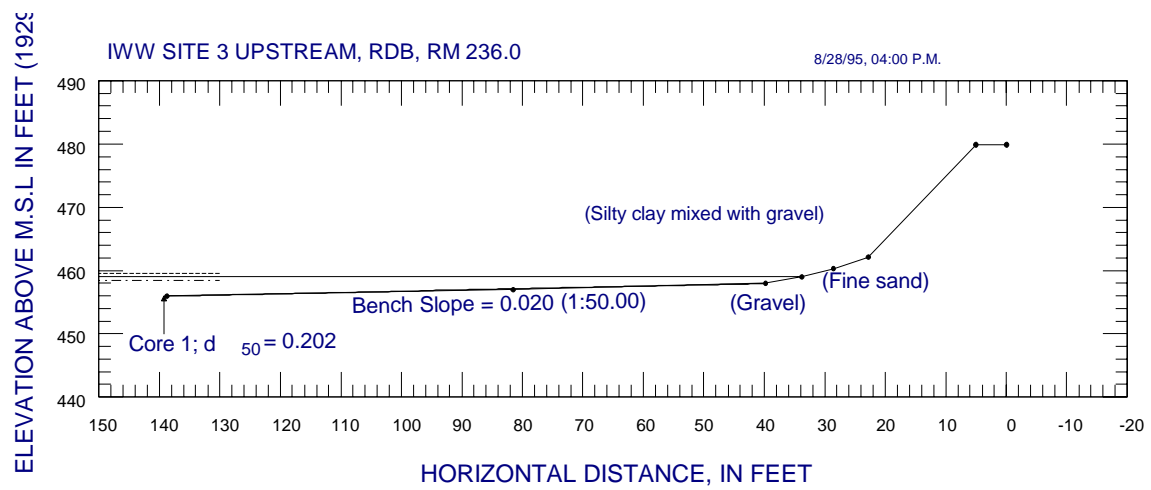
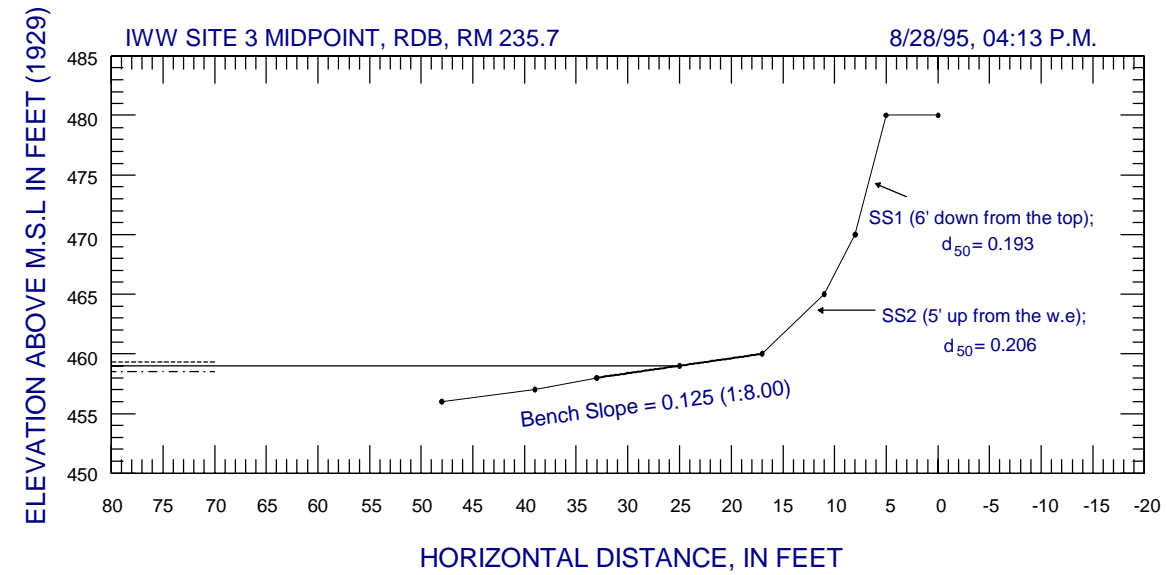
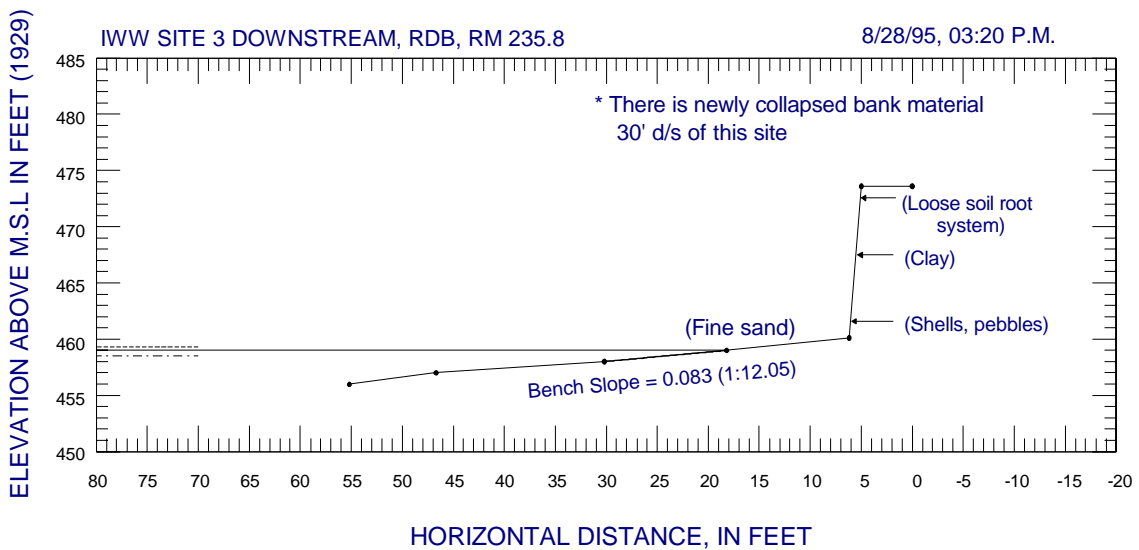
**Figure 6-53. Bank sections at site 3**

Figure 6-53 shows the three measured bank sections and a reduced cross section. The bank slopes were steeper towards the downstream limit. The OHW is 459.3 feet and NP is 458.5 feet above msl. This range of fluctuation is within the bench area. Ten-year stage data (table 6-13) shows that only stages with less than 10% recurrence frequency can reach the base of the bank face.

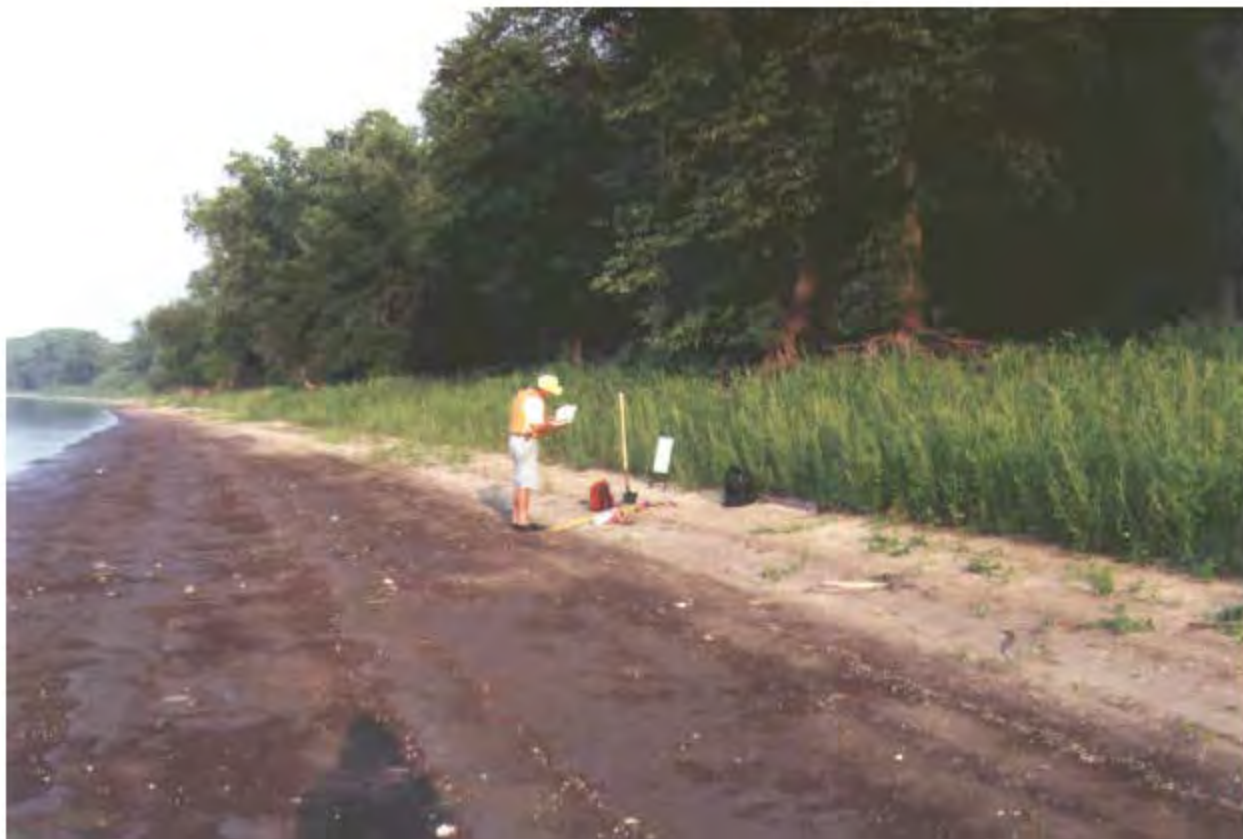
**Figure 6-55. Site 4 on the Illinois Waterway**

Site 4 is about 360 feet from the sailing line. No major tributary enters the IWW at this location, but a state highway bridge crosses the river at RM 229.6. Bhowmik and Schicht (1980) selected both banks as erosion sites (sites 18 and 19) with surveys completed on the RDB and one survey on the LDB (site 20). Erosion of these two sites was indicated on Hagerty's (1988) chart also. At site 4, a mildly sloped bench lies under a small scarp, with mature trees growing behind the scarp. The bench was very wide, sandy, and mostly covered with tall weeds. Tall trees survive in an area between the weed zone and scarps with roots exposed to the air. The root crown is approximately at the same level as the top of the bank. The bench is clay mantled with sand mixed with shells.

Bench slopes varied slightly from 1V:18.2H at the upstream section to 1V:25.6H at the downstream section. This site can be classified as type 5 (figure 6-22 and table 6-4). The bank seemed to be stable in 1995 but was an eroded site in 1978 (Bhowmik and Schicht, 1980). The elevation of the scarp was fairly high compared to NP or OHW stages where piping was noted. Erosion of bench soils or recently deposited sediments can occur during flow at stages higher than OHW.

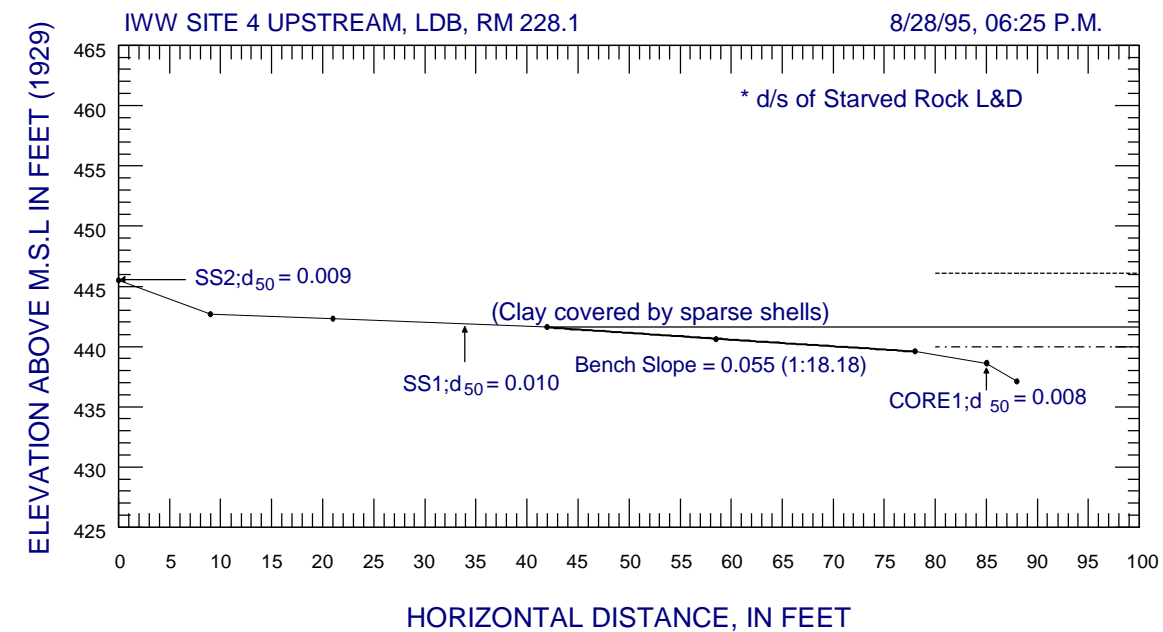
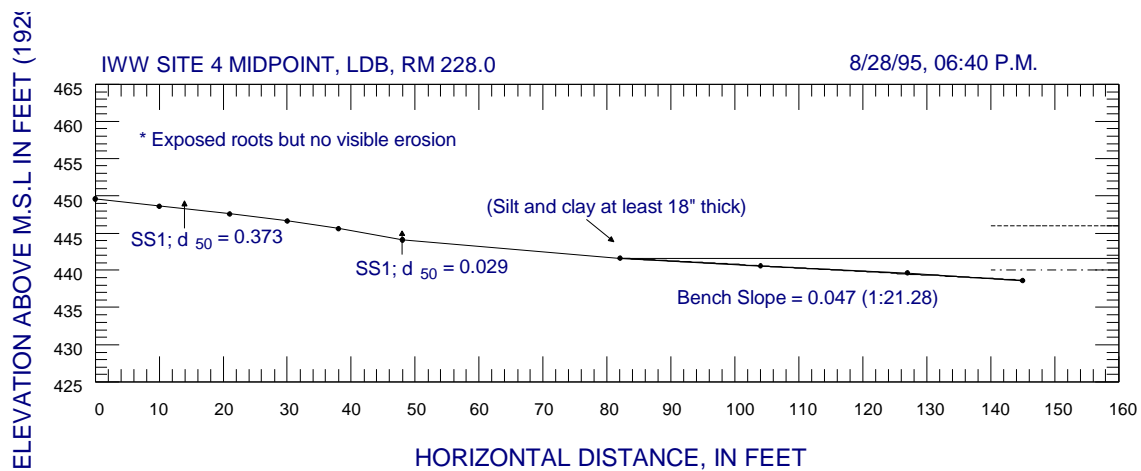
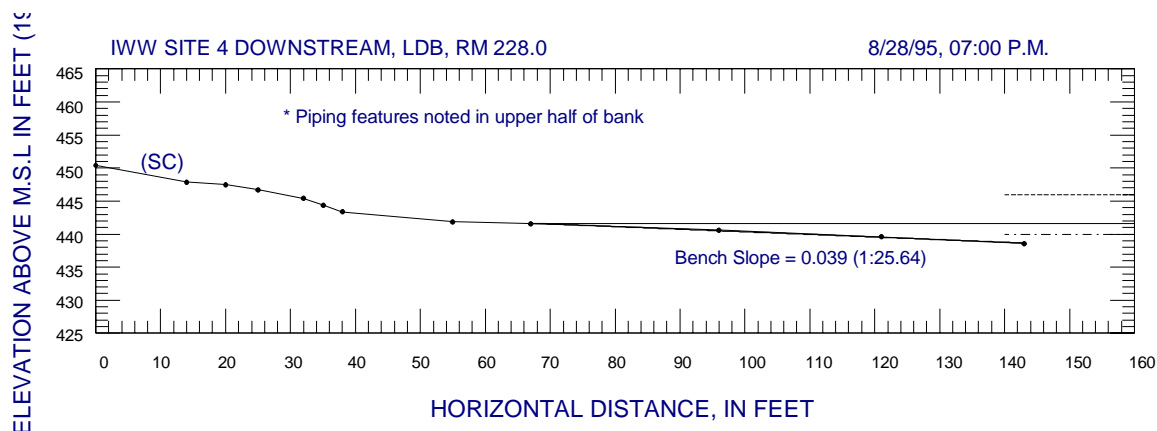
Figure 6-56. Bank sections at site 4

Figure 6-56 shows the three measured bank sections and a reduced cross section. Bank sections were fairly uniform at this site. The OHW is 446 feet and NP is 440 feet above msl. The range of fluctuation between the OHW and NP covers the entire bench.

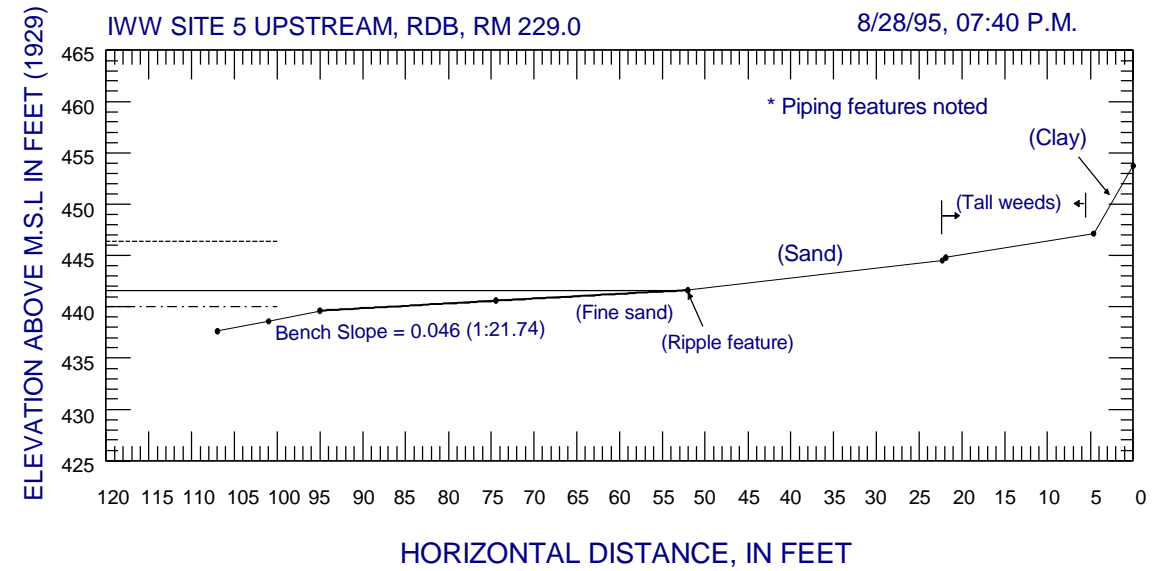
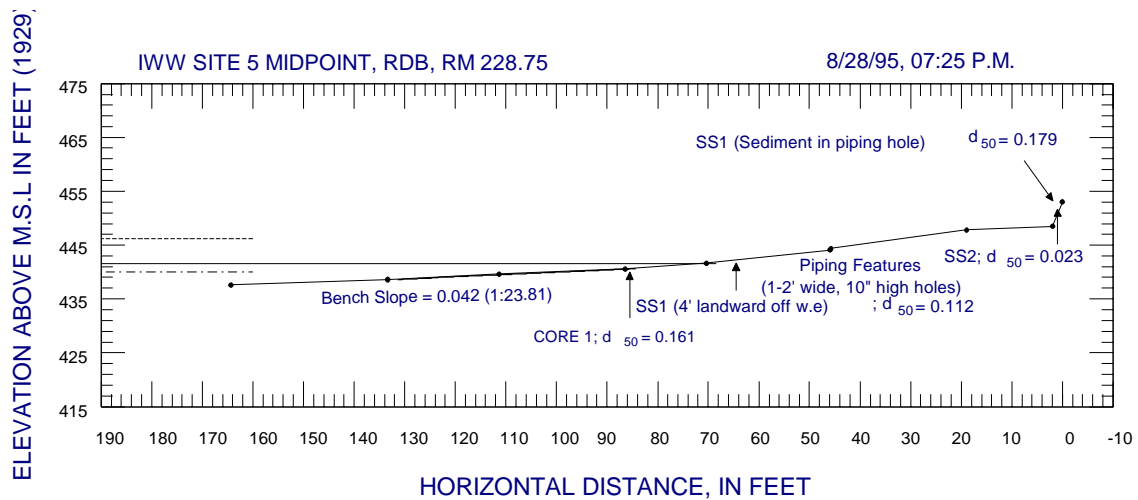
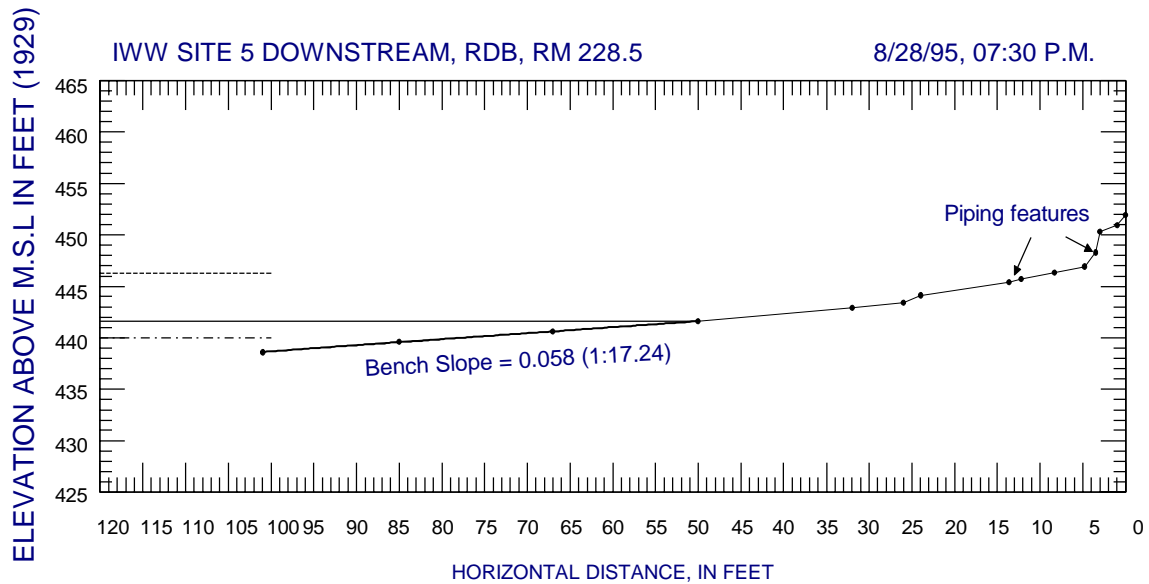
Figure 6-57. Bank sections at site 5

Bench slopes varied slightly between 1V:23.8H and 1V:17.2H. With a scarp over a gentle bench slope, this site is classified as a combination of types 3 and 5 (figures 6-20 and 6-22, and table 6-4). The scarps have layered failure features and were initiated by piping and surface drainage. Waves and currents at OHW cause erosion of failed soil or recent sediments on the bench area.

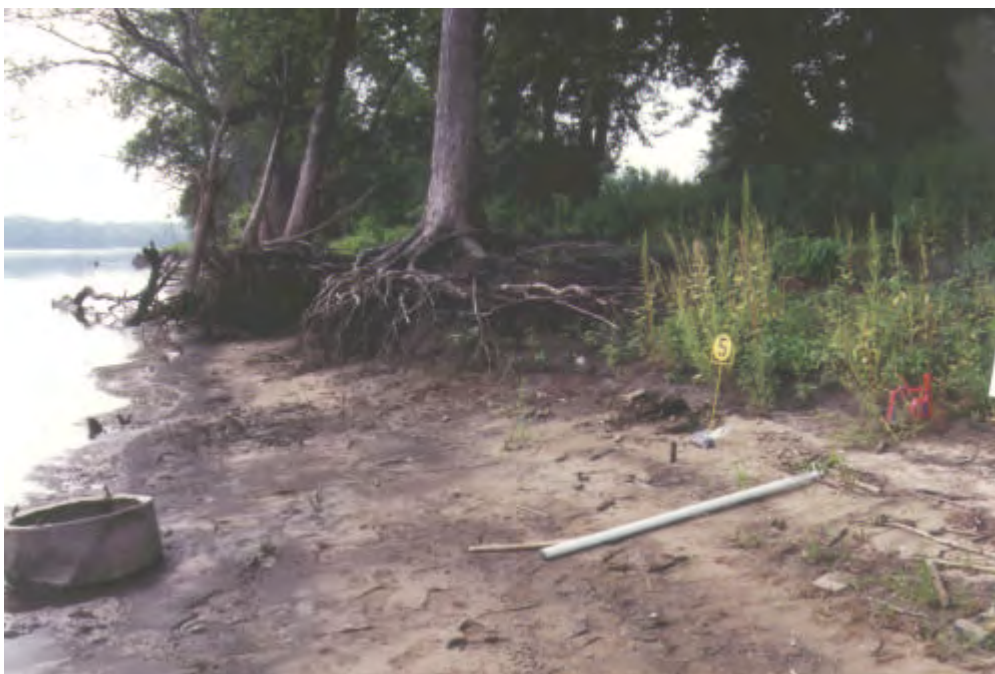
**Figure 6-59. Site 6 on the Illinois Waterway**

The site is about 310 feet from the sailing line. In plan form it is on the outer side of a bend. Bhowmik and Schicht (1980) observed erosion on both banks, while Hagerty (1988) noted erosion only on the RDB, but his site extended further upstream and downstream from the entrance of the lake. The bank contains small scarps, and the top of the bank is covered with some fine tree roots. Agriculture (corn) is the land use for the upstream section and woods cover the bank for the other two sections. At the most upstream end point of this reach (immediately downstream from the lake outlet), the subaqueous bench dropped more than 11 feet right off the water's edge, a feature not observed at the remaining sections. Judging from the plan form this truncation could be caused by tow-induced current passing through the bend. Small worm holes existed on the truncated bench face near the water's edge.

Bench slopes varied only slightly from 1V:16.1H at the midsection and downstream section. The three sections, from upstream to downstream, are classified as types 4, 5, and 6 (figures 6-21, 6-22, 6-23, and table 6-4). Traffic-induced currents appear to be a significant factor for the subaqueous scarp at the upstream section. Small worms nesting in the bank soils also will weaken the bank strength. Eddy currents, induced by fallen trees or nearshore land features, exist at the midsection and downstream section. These eddy currents can cause local scours. Other erosion mechanisms include surface drainage for the upstream section, piping, and floods for the whole reach.

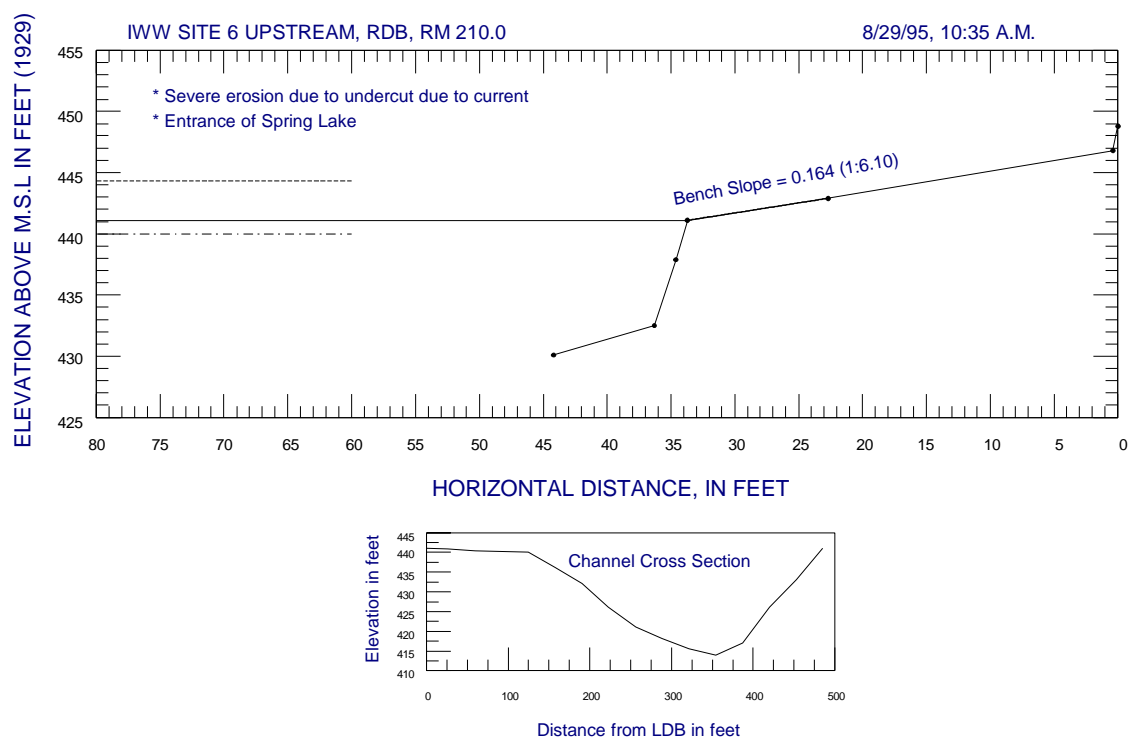
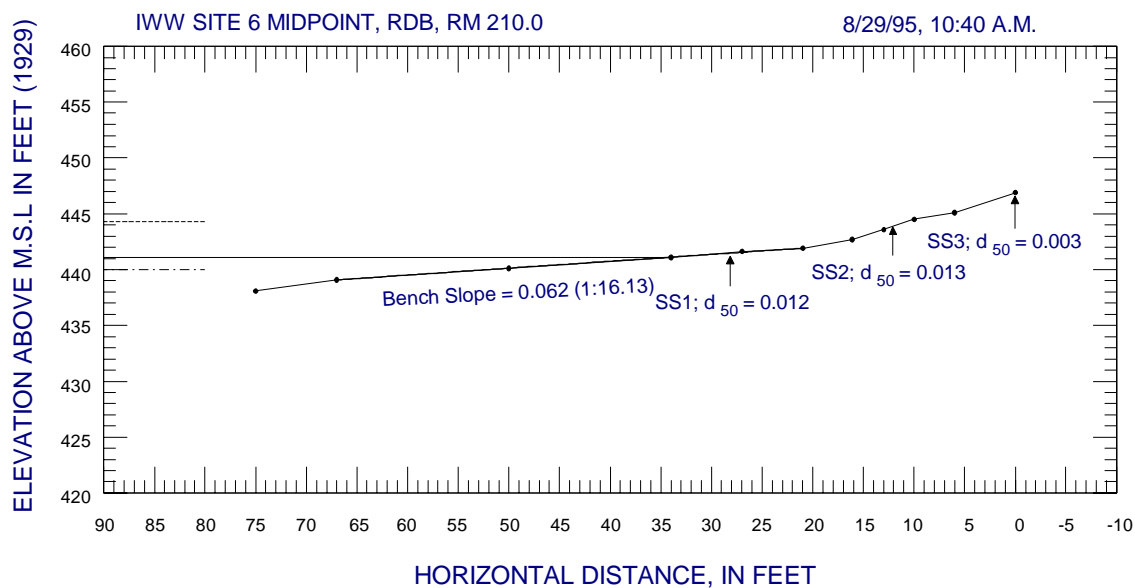
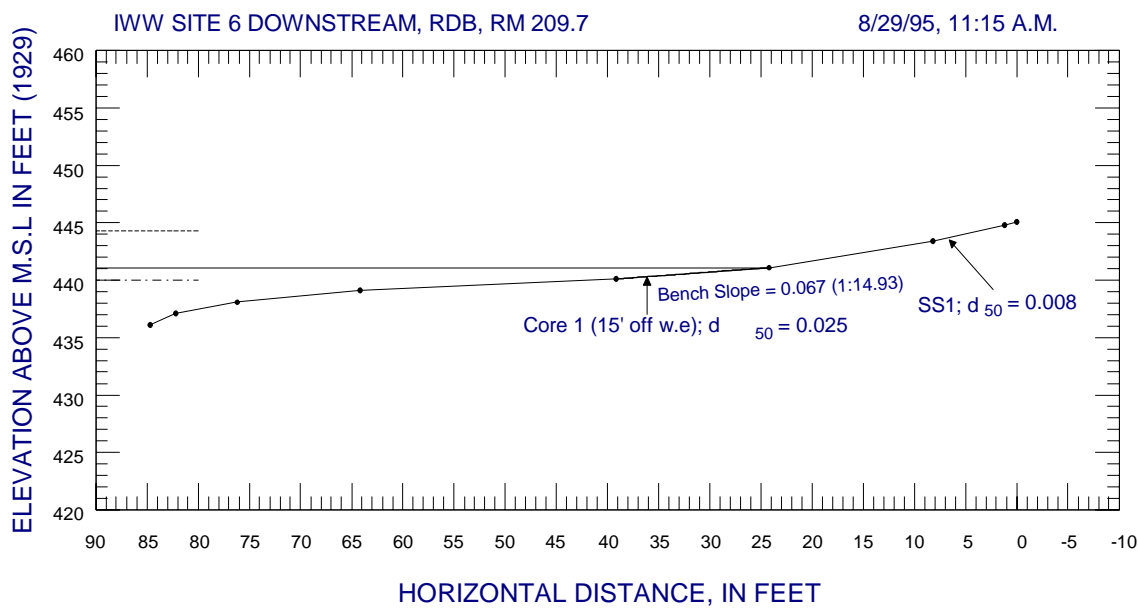
**Figures 6-60. Bank sections at site 6**

Figure 6-60 shows the three measured bank sections and two reduced cross sections. The thalweg was farther away from the water's edge downstream. The OHW is 443.2 feet and NP is 440.0 feet above msl. Mature trees were growing at the water's edge; the midsection and downstream section were measured between trees. Banks between the trees were eroded. The crown of the tree roots appeared to be higher than the bank top. A flood stage higher than 10% recurrence frequency will overtop the bank (see table 6-16). Standing (but dead) trees were in place in water at the NP level.

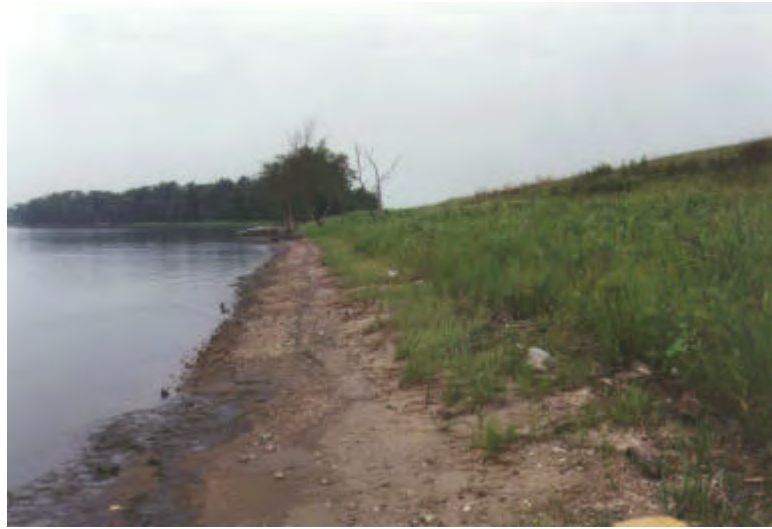
**Figure 6-62. Site 7 on the Illinois Waterway**

Site 7 is at the Hennepin Levee System about 400 feet from the sailing line, and no tributaries enter the site. Bhowmik and Schicht (1980) noted almost the entire riverbank from the Upper Twin Sister Island to site 6 as eroding bank. Hagerty's observation (1988) was similar to that of Bhowmik and Schicht (1980), but the erosion reaches indicated by Hagerty (1988) were shorter and were shown mostly on the RDB. Hagerty (1988) also noted erosion on both the Upper and Lower Twin Sister Islands on the sides facing the channel. The back side (facing levee) of Upper Twin Sister Island also had a long reach of overhanging matted roots as noted by Hagerty (1988).

Bench slopes varied only slightly from 1V:23.3H. This site can be classified as type 5 (figure 6-22 and table 6-4). The scarp was located above most flood stages. Rework and transport by wave and currents are major factors in removing failed soil or recent sediments from the bench.

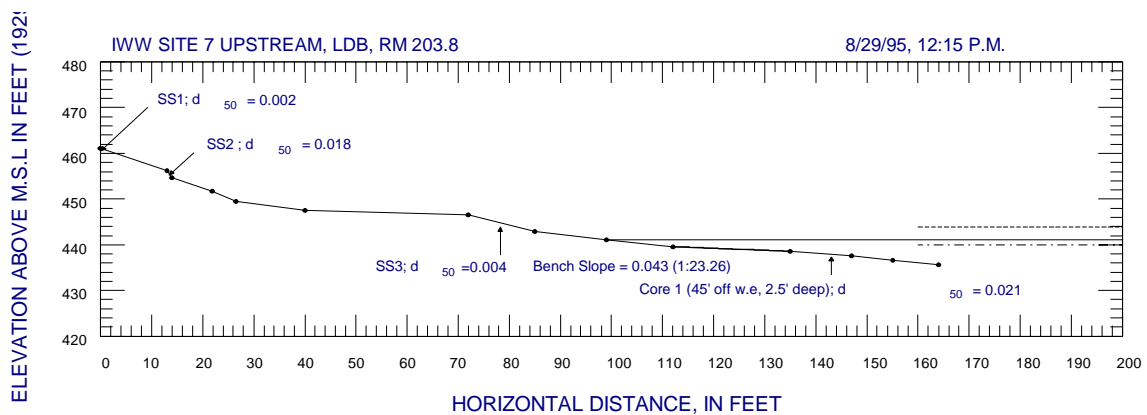
**Figure 6-63. Bank sections at site 7**

At the site, a scarp 3-5 feet high was located about 2 to 4 feet below the levee crown. Tall weeds were growing on the berm and many small scarps were observed on the bench. Figure 6-63 shows the three measured bank sections and a reduced cross section. The OHW is 443.9 feet and NP is 440.0 feet above msl. The OHW corresponded well with the lower edge of the weed zone on the shore where debris was found, in the bench area. Stages above 447.5 feet (about 10% recurrence frequency, see table 6-17), reach the base of the scarp near the top of the levee.

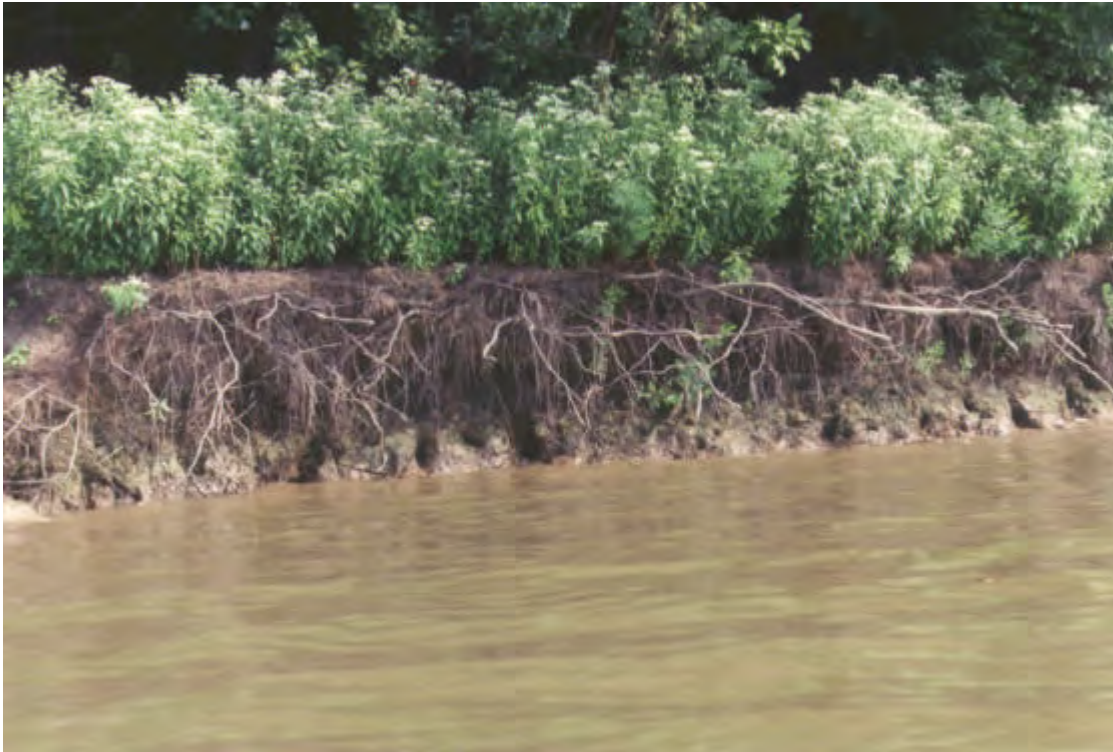
**Figure 6-65. Site 8 on the Illinois Waterway**

The site is about 330 feet from the sailing line. Hagerty (1988) recorded this site as severely eroded, while Bhowmik and Schicht (1980) noted erosion at the opposite bank. The opposite bank had several moored barges at the time of the survey. The site had a steep scarp right on the edge of the water. The scarp is about 3 to 5 feet high and covered with fine roots on the top. These roots belonged to the mature trees inside the bank area, but the top of the bank is covered with tall seasonal vegetation. The scarp was composed of cohesive soil and contains piping holes or holes that riverine animals use, generally with a diameter of 1 to 4 inches. The subaqueous bench was gently sloping, extends far out, and was covered with silt and clay.

Bench slopes varied from 1V:83.3H to 1V:47.6H. This site is classified as a combination of types 4 and 5 (figures 6-21, 6-22, and table 6-4). Bank failures are initiated by piping or burrowing activities from riverine animals. Rework and transport of failed bank soils by wave action at NP appeared to be significant. Wave action probably was responsible for an erosion scarp at water's edge.

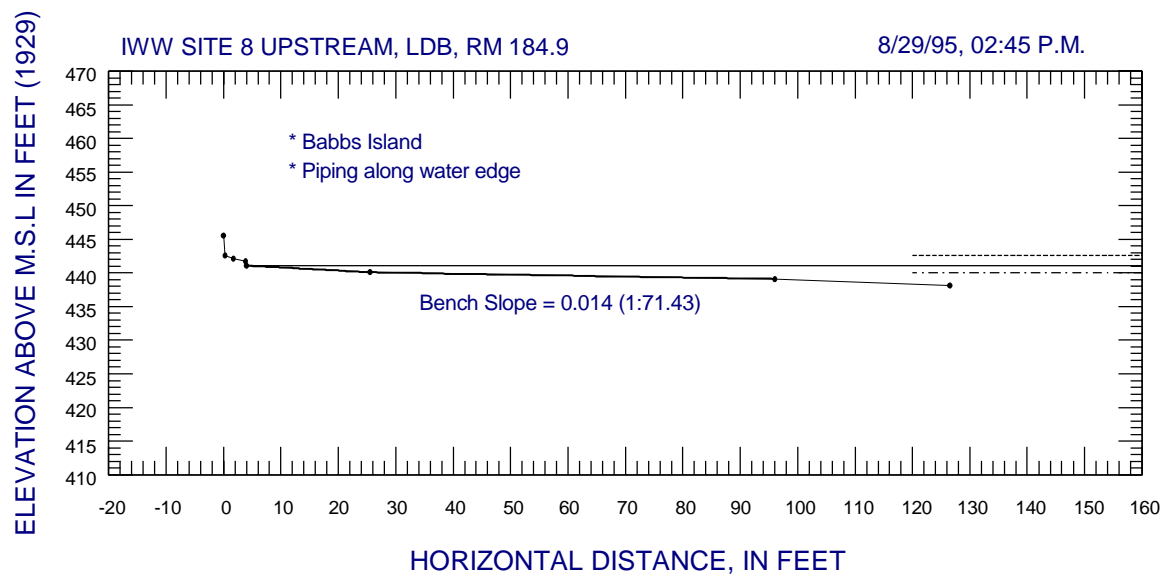
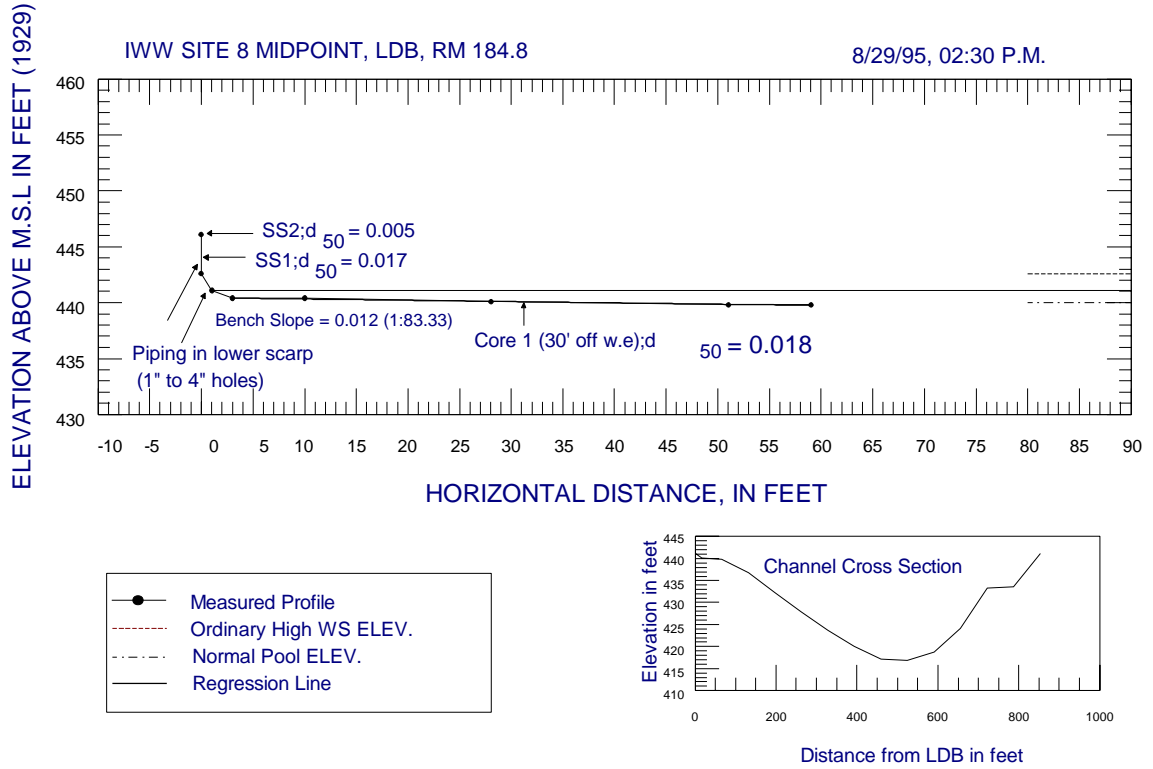
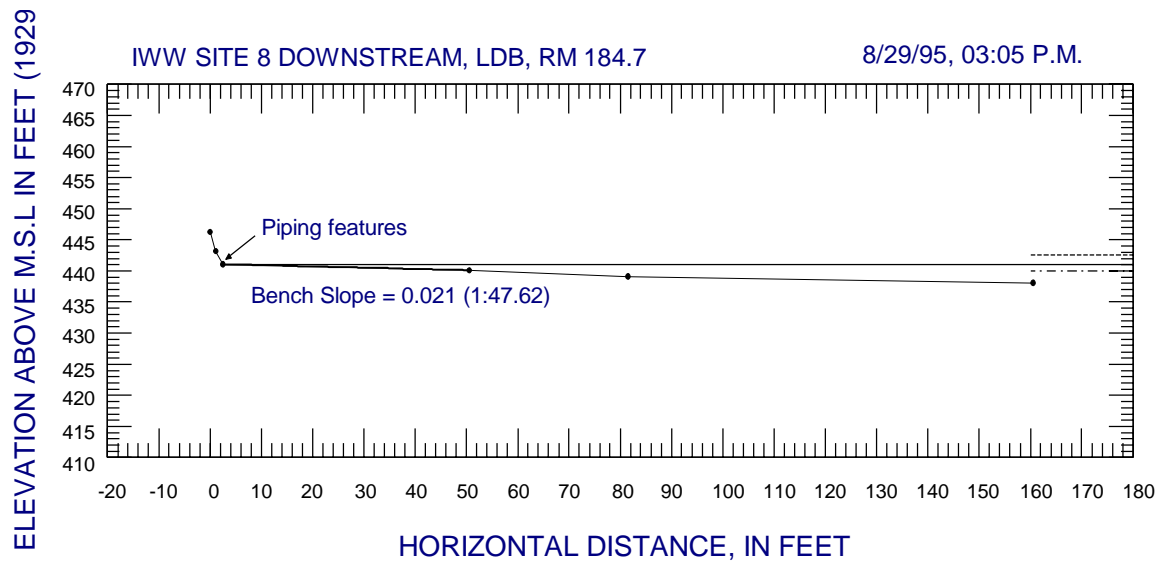
**Figure 6-66. Bank sections at site 8**

Figure 6-66 shows the three measured bank sections and a reduced cross section. The OHW is 442.6 feet and NP is 440.0 feet above msl. The OHW corresponds to the base of the scarp. Floods with stage higher than 447.5 feet (about 10% recurrence frequency) overtop the bank (table 6-18).

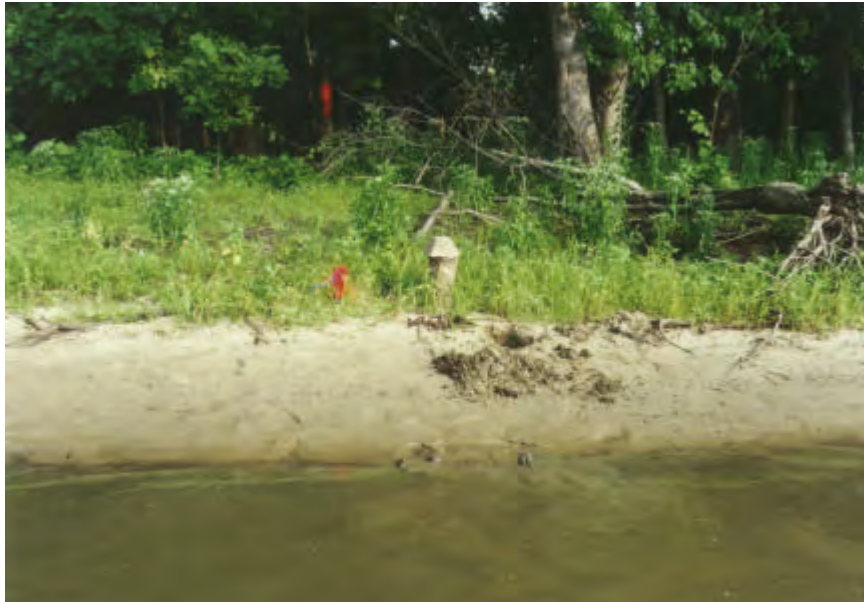
**Figure 6-68. Site 9 on the Illinois Waterway**

The site is about 310 feet from the sailing line, and the Chillicothe Sports & Marine Small Boat Harbor is located across the river. Bhowmik and Schicht (1980) and Hagerty (1988) marked this as an erosion site. The bank was mildly sloped and covered with weeds of medium density. The foundation of an old monument on shore was exposed for about a foot. A scarp about 0.3 feet high existed on the lower bank where the weed zone ends, above sandy bench. A scarp also existed at the water's edge. The wet bench did not support large weights. Submerged nearshore material, however, was hard clay mantled with sand.

Bench slopes varied from 1V:21.3H at the upstream section to 1V:14.1H at the downstream section. This site is classified as types 4 and 6 (figure 6-23, and table 6-4). The combinations of wave actions and seepage within bench near NP elevations could be the major causes of erosion at this site. Recreational and commercial traffic volumes are high at site 9. Traffic-induced waves and current can also be the cause of erosion at this site.

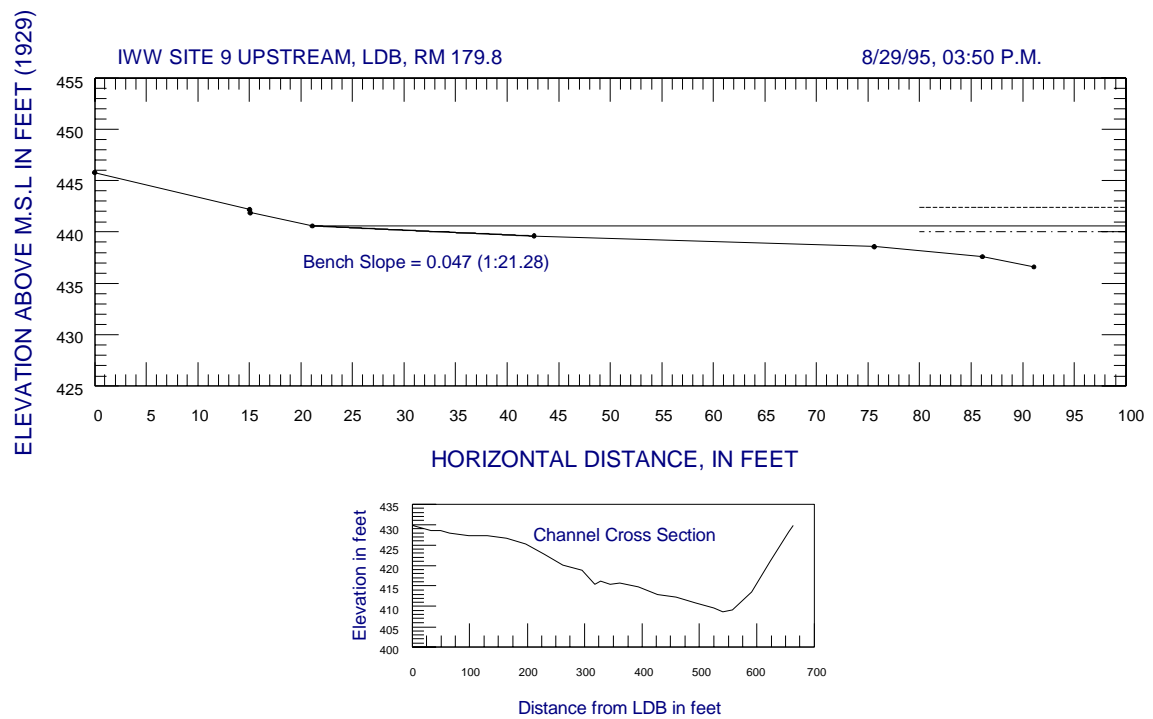
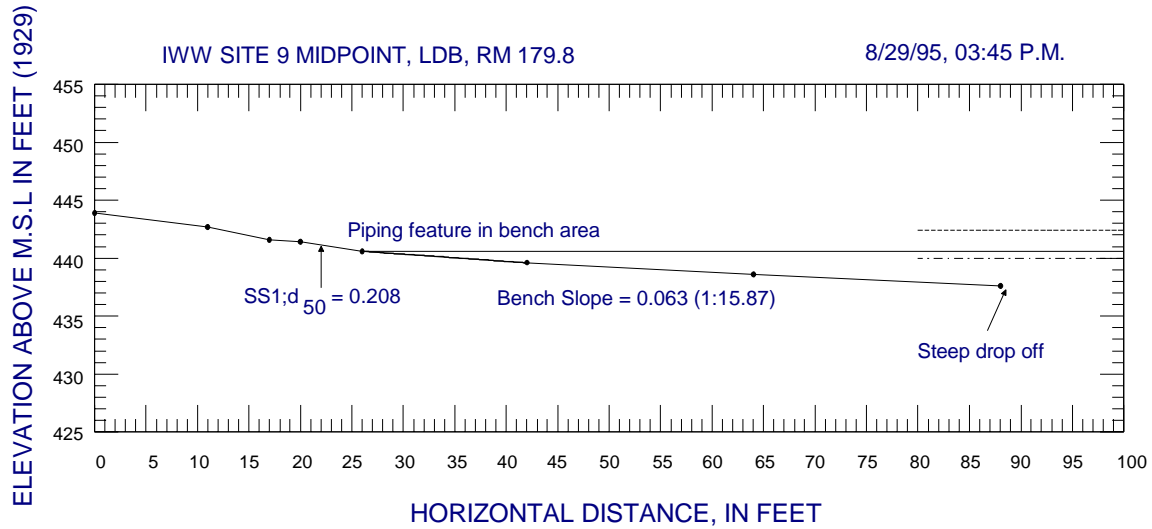
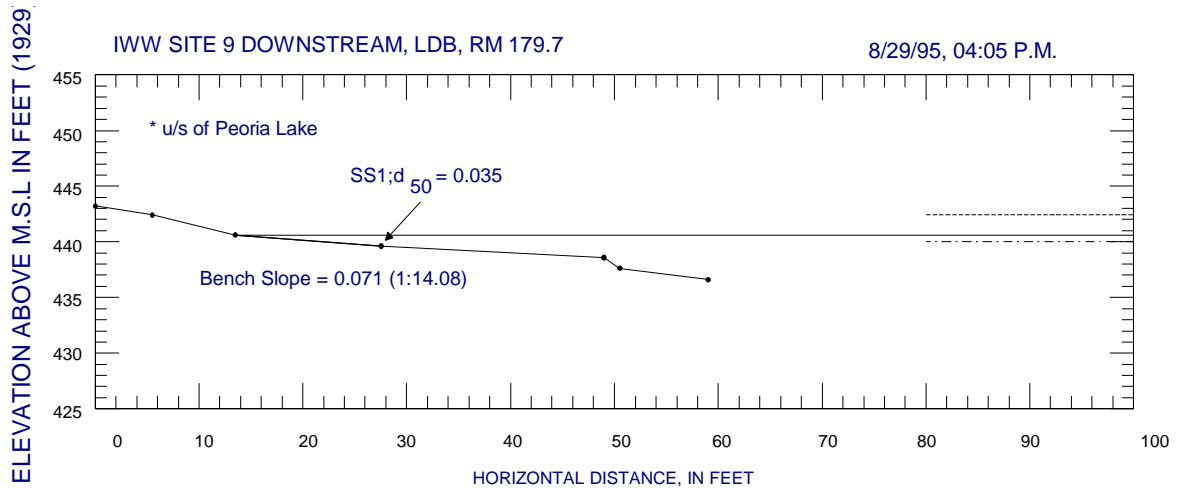
**Figure 6-69. Bank sections at site 9**

Figure 6-69 shows the three measured bank sections and a reduced cross section. The OHW is 442.4 feet and NP is 440.0 feet above msl. The OHW corresponds well to the lower edge of the weed zone. Stage exceeding 447.5 feet (10% recurrence frequency, table 6-19) submerges the entire bank.

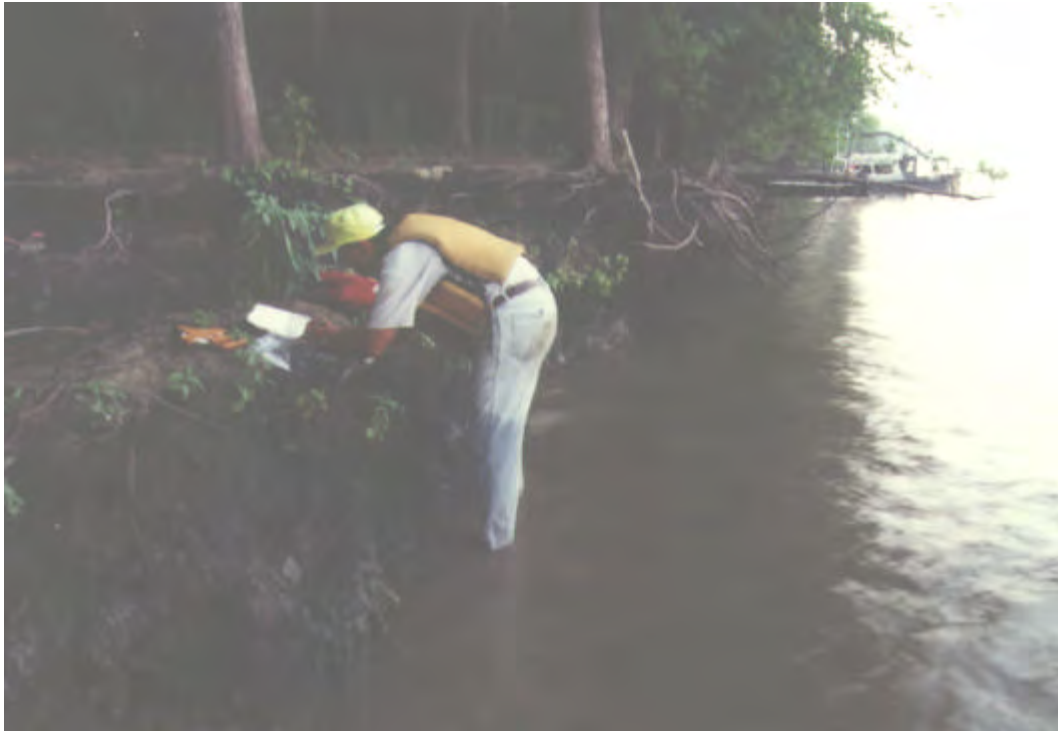
**Figure 6-71. Site 10 on the Illinois Waterway**

Site 10 is about 430 feet from the sailing line. Kickapoo Creek enters the IWW at RM 159.6 on the RDB. At the upstream end of the site a drawbridge is located at RM 160.8. Neither Bhowmik and Schicht (1980) nor Hagerty (1988) recorded the site as an erosion site. Parked barge fleets were noted on the LDB about 1,000 feet upstream from this site. This bank bore some resemblance to site 8, but trees were growing at the water's edge, and there was not much seasonal vegetation on top of the bank. A scarp 3 to 5 feet high and some piping holes were observed near the water's edge. The underwater bench extended four toward the channel, and a thick layer of fine materials was noted on the subaqueous bench. Strong currents were encountered near the bank.

Bench slopes varied between 1V:15.0H and 1V:5.6H, and the subaqueous bench extends more than 70 feet. Soils on the scarp were cohesive. The site can be classified as a combination of types 4 and 5 (figures 6-21 and 6-22, and table 6-4). Piping related internal erosion weakens the bank. Soils exposed and displaced by bank failures are susceptible to removal by wave and current actions during normal stages. Traffic is heavy at this site and could add to the tractive forces by waves and currents.
