# **Interim Report For The Upper Mississippi River - Illinois Waterway System Navigation Study**

**US Army Corps  
of Engineers**

**November 1997**

## Bank Erosion Field Survey Report of the Upper Mississippi River and Illinois Waterway

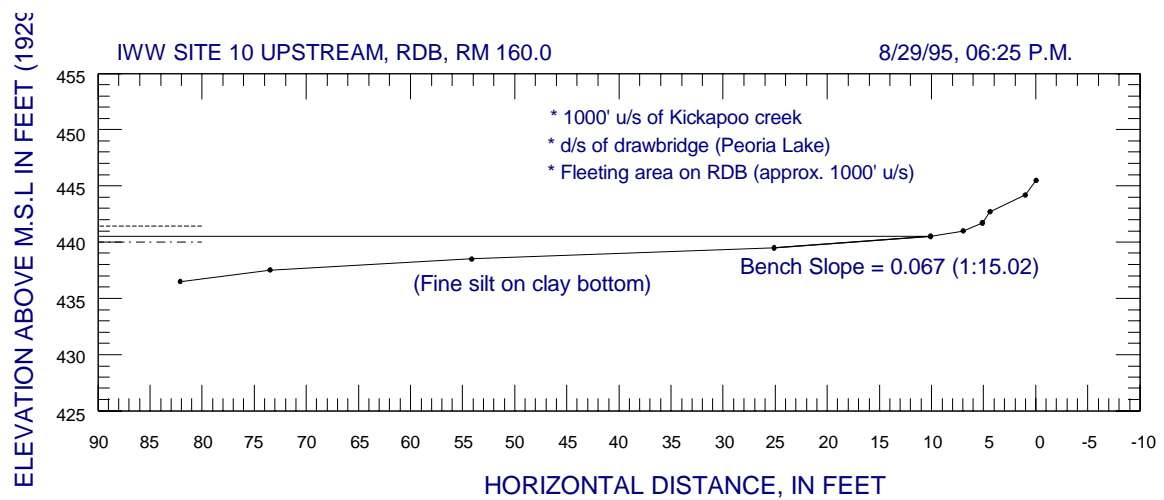
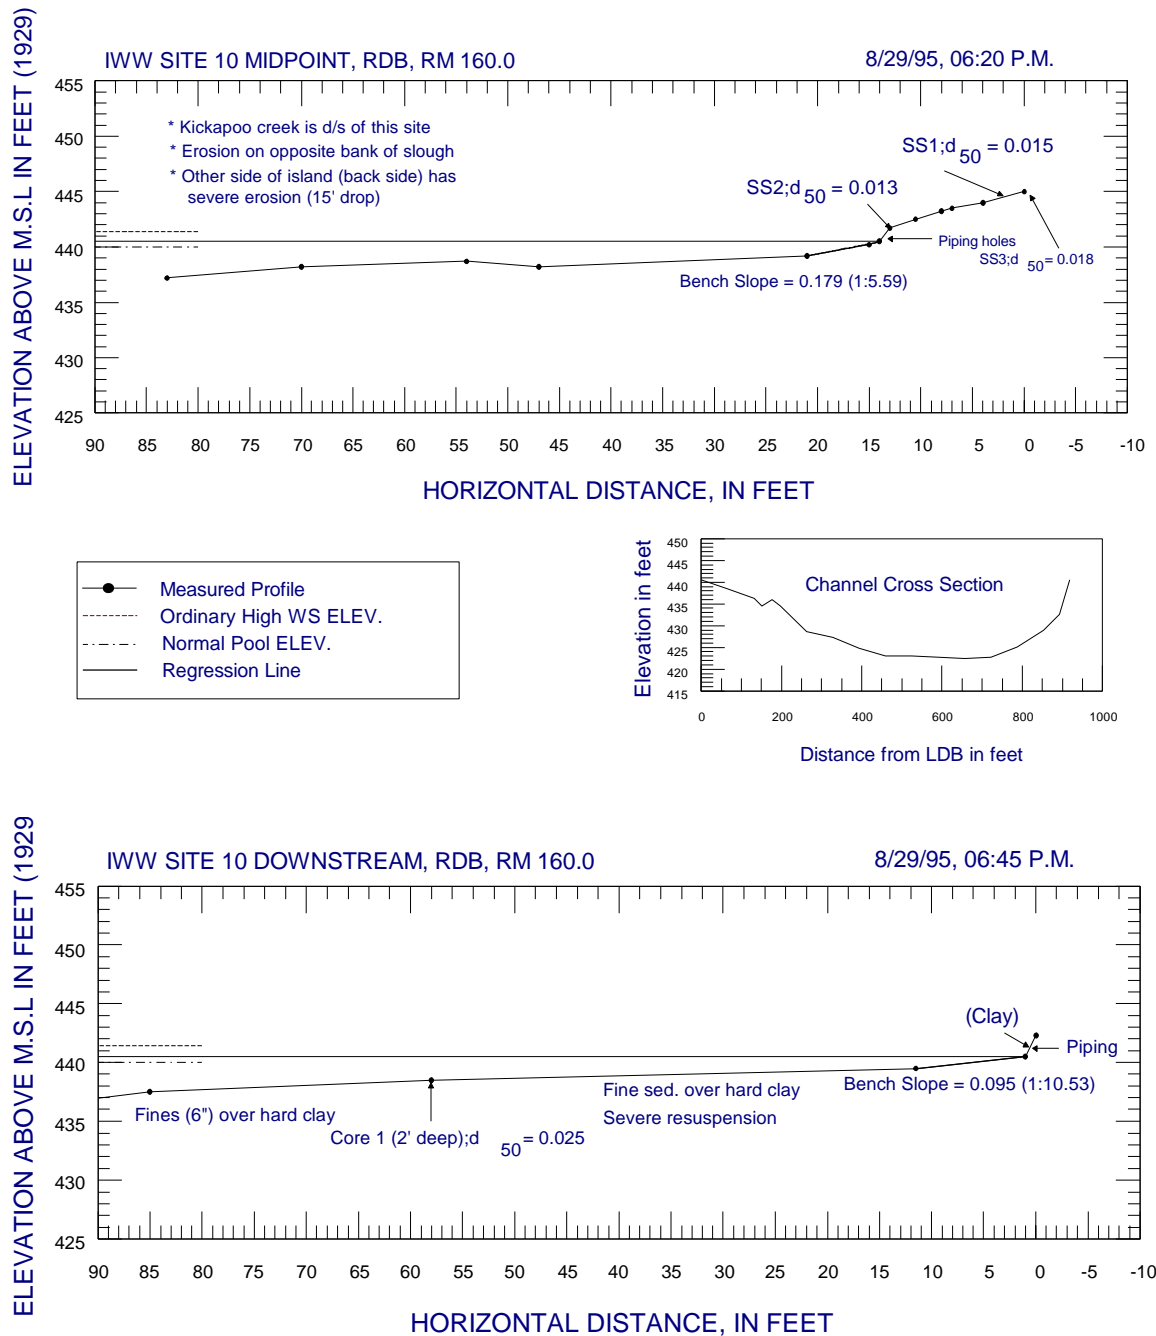
**Figure 6-72. Bank sections at site 10**

Figure 6-72 shows the three measured bank sections and a reduced cross section. The OHW is 441.4 feet and NP is 440.0 feet above msl. Water surface elevation was at the base of the scarp. At stages corresponding to OHW, the scarp is mostly submerged. Floods of stage higher than 445.4 (10% recurrence frequency, table 6-20) overtop the bank crest. There was sediment deposition on top of the bank.

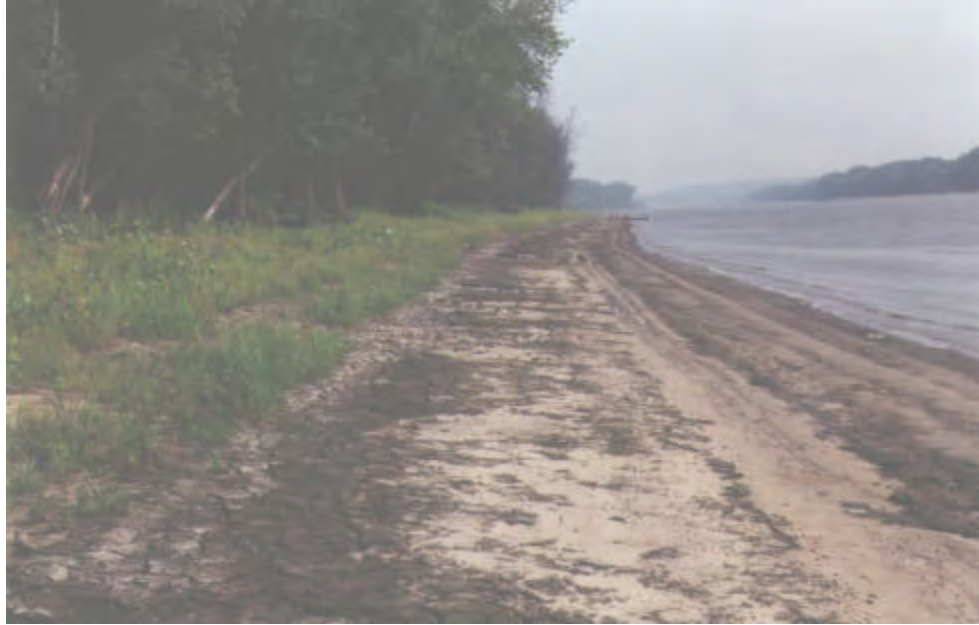
**Figure 6-74. Site 11 on the Illinois Waterway**

The navigation sailing line is near the RDB at site 11, (the distance from the navigation chart is about 250 feet). Lick Creek enters the IWW from the LDB at RM 156.5. Bhowmik and Schicht (1980) noted some erosion on both banks around RM 156, while Hagerty (1988) noted dredged material cited on the navigation chart for both banks.

Bench slopes varied slightly between 1V:11.2H and 1V:9.0H. This site is classified as type 6 (figure 6-23 and table 6-4). Wave actions are primarily responsible for rework and transport of failed soil or recently deposited sediments on the bench at various stages within the normal range of pool level fluctuations.

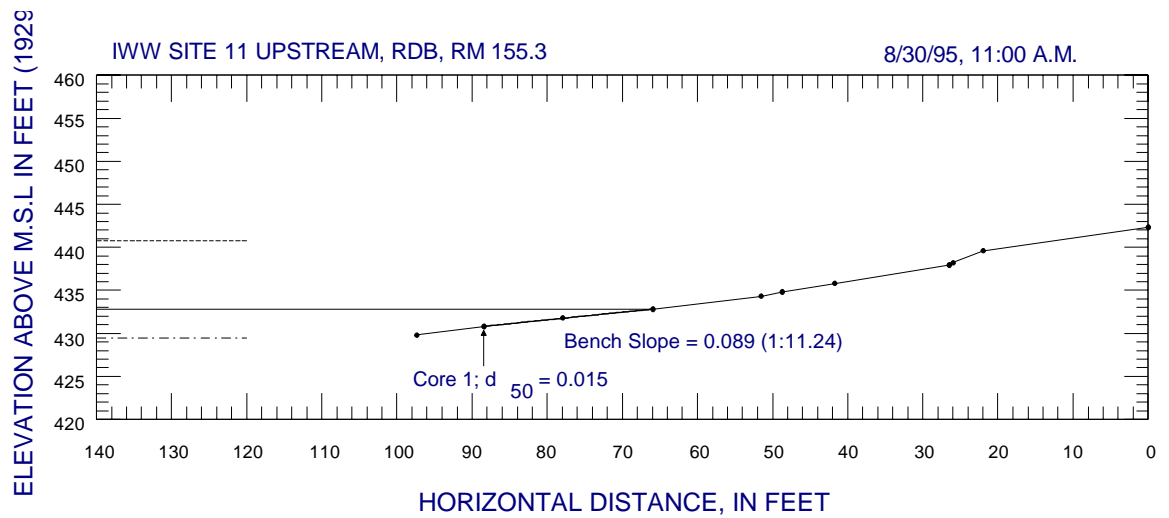
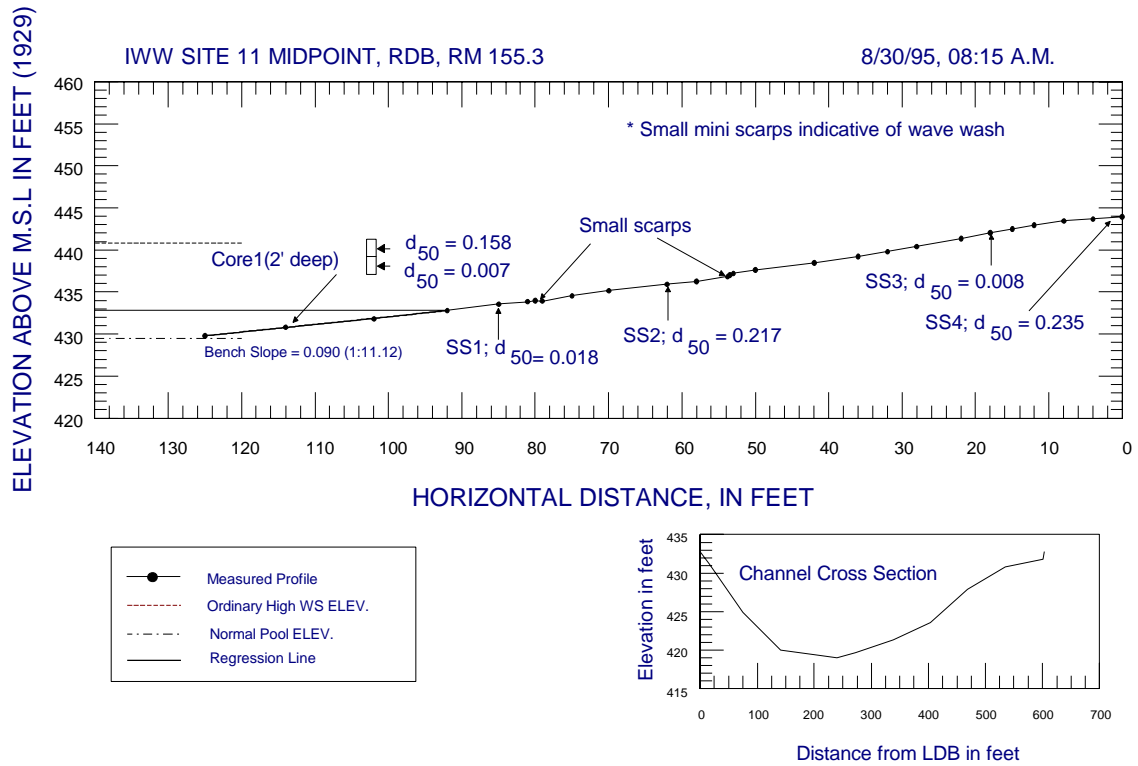
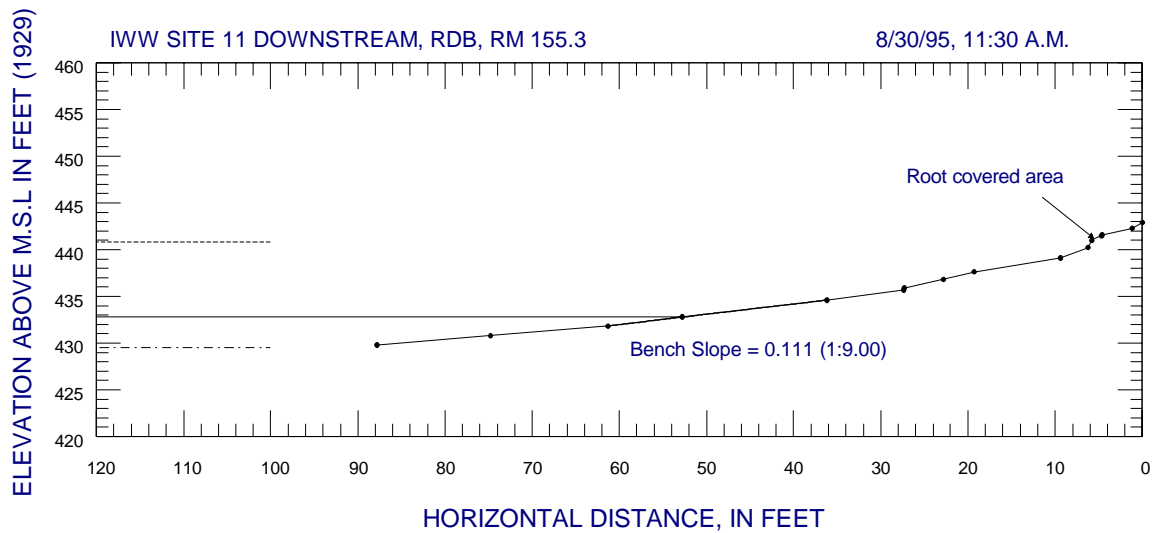
**Figure 6-75. Bank sections at site 11**

Figure 6-75 shows the three measured bank sections and a reduced cross section. The whole bank is mildly sloped with a small scarp remote from the water at the top of the bank. Trees with exposed roots exist at the crest of the bank, above a weed zone and a bare bench with several small wave scarps covered with recent sediments. The OHW is 440.8 feet and NP is 429.5 feet above msl. Stage fluctuations at the upper part of the pool are generally large, and banks often are presented with mildly sloped benches. The OHW can reach the upper part of the bank close to the base of a small scarp at the downstream section. Table 6-21 shows the recurrence frequencies for various stages at this site.

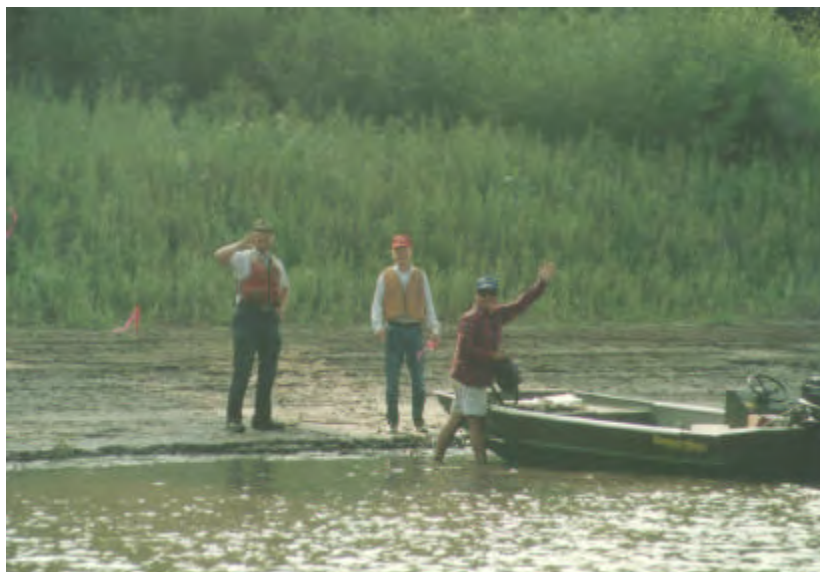
**Figure 6-76. Site 12 on the Illinois Waterway**

Site 12 is about 320 feet from the sailing line, and no major tributary enters the IWW at this location. Bhowmik and Schicht (1980) and Hagerty (1988) noted erosion on both sides of this reach of the waterway.

Materials on the scarp are cohesive. This site can be classified as type 4 (figure 6-21 and table 6-4). Under normal stages, waves and turbulence created by traffic are causes for bank erosion. Rework and transport by current at stages within the normal range of pool level fluctuation can be significant. Seepage and nesting worms can also weaken bank strength.

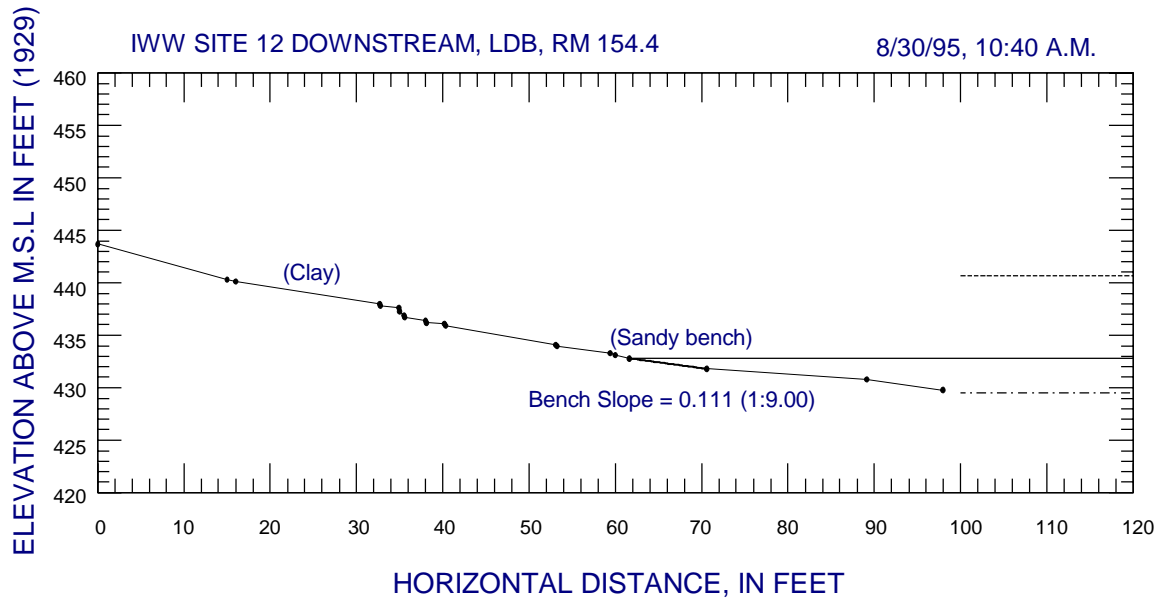
**Figure 6-77. Bank sections at site 12 (concluded)**

An obvious scarp was present at the water's edge. Figure 6-77 shows the three measured bank sections and a reduced cross section. The wide bench has a mild slope. At the top of the bank, tall trees and a scarp were hidden behind a belt of tall weeds and young willows. Vegetation formed a band approximately 90-100 feet wide on the bank. A berm was present inside the vegetation zone and its soils were desiccated. The open bench area was wet and clayey, and had piping features. The OHW is 440.7 feet and NP is 429.5 feet above msl. At OHW, the water would submerge some of the vegetation on the bank. Small scarps in the vegetation zone were below the OHW level and the scarp at the upstream section was at the water's edge. Table 6-22 gives the recurrence frequencies for various stages at this site.

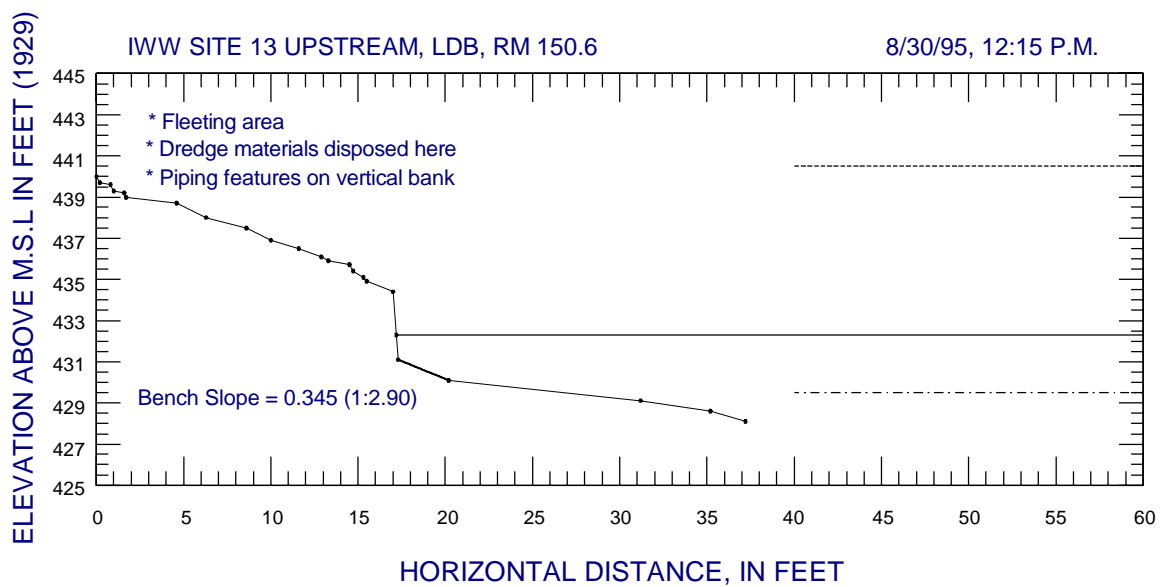
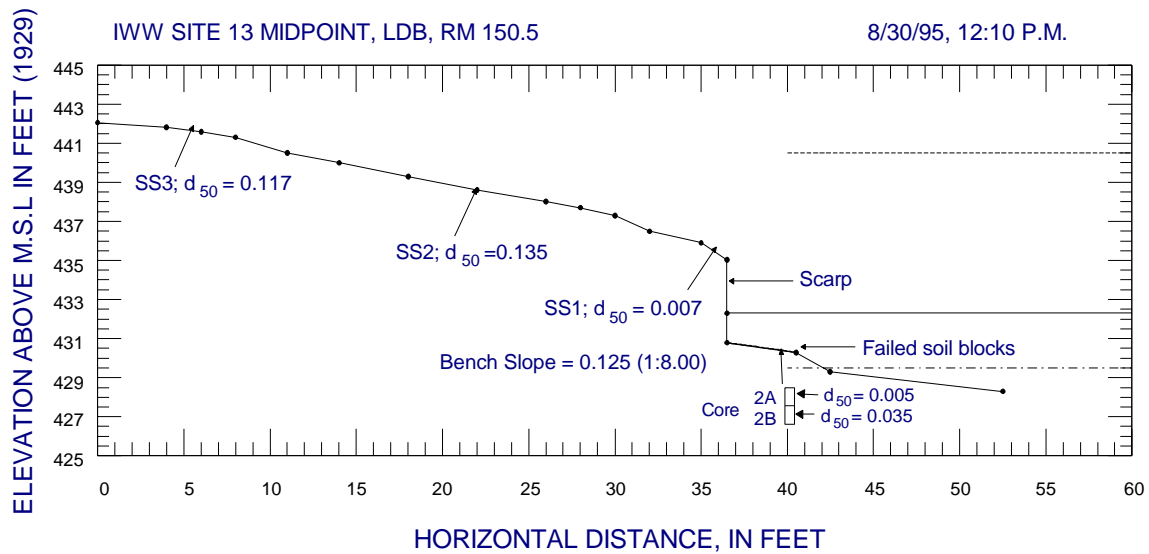
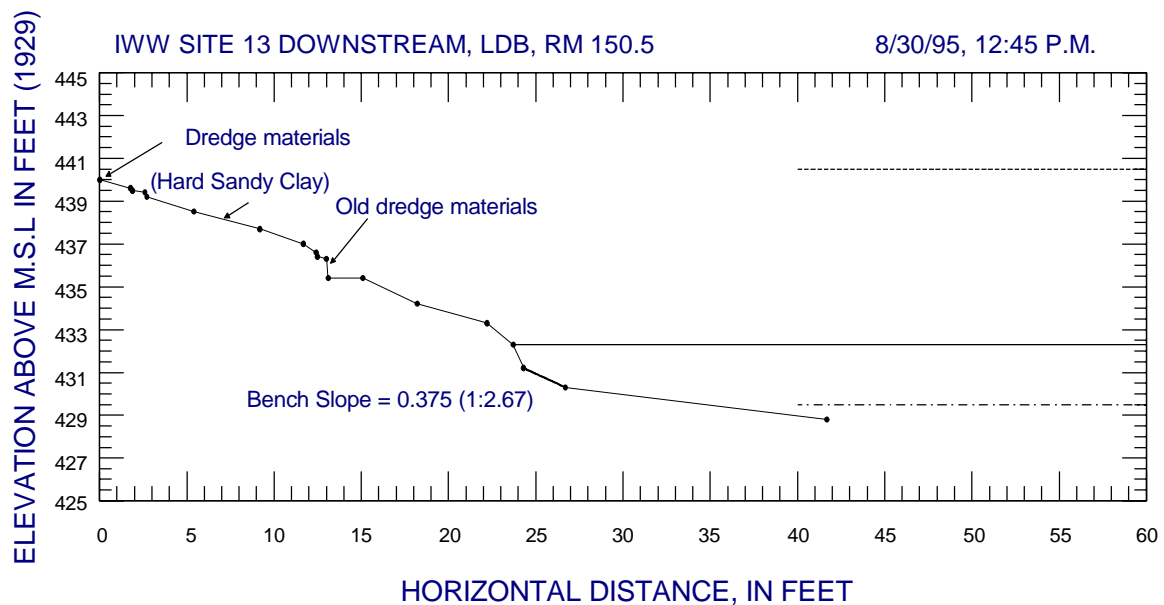
**Figure 6-80. Bank sections at site 13**

Figure 6-80 shows the three measured bank sections and a reduced cross section. The OHW is 440.5 feet and NP is 429.5 feet above msl. The NP elevation is about at the base of the berm, and the OHW reaches the upper part of the bank. Table 6-23 gives the stages for various recurrence frequencies at this site.

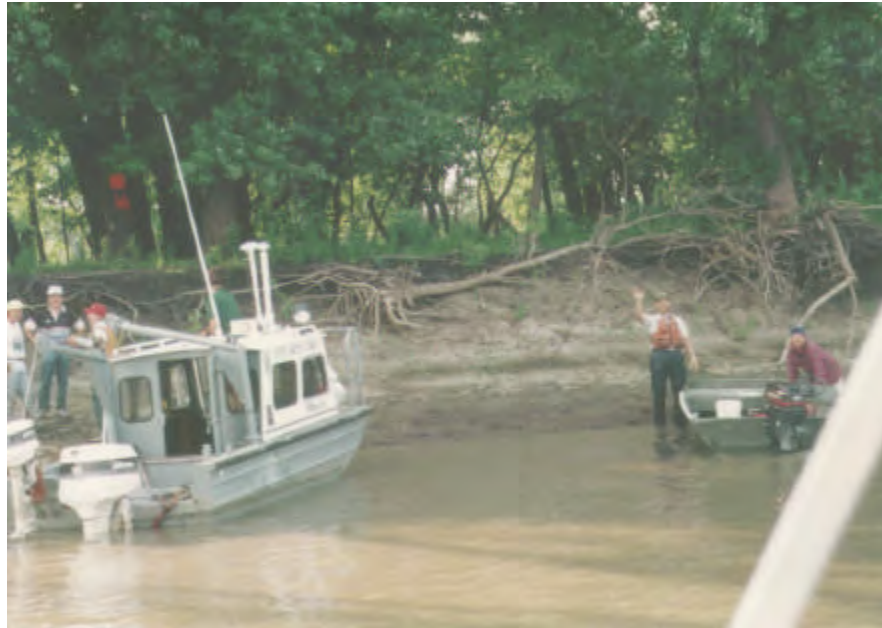
**Figure 6-82. Site 14 on the Illinois Waterway**

Site 14 is about 270 feet from the sailing line, and no major tributary enters the IWW at this location. Approximately 600 feet behind this site is the East Liverpool Levee System. Bhowmik and Schicht (1980) marked erosion on the opposite bank on an island. Hagerty observed erosion on this bank but not on the opposite bank. Trees are close to the bank crest at many locations at this site, and some roots extended beyond the bank face. A scarp about 1.5 feet high was located on the upper part of the bank, which was covered by seasonal grasses. Several breaks in the bank sections appeared to correspond to different erosion mechanisms at this site. Dislodged peds and some micro-scale piping existed on a bare bench area. The bench between the scarp and the water's edge was covered with moist, soft clay.

Bench slopes varied from 1V:10.1H at the upstream section to 1V:7.9H at the midsection. The slope for the subaqueous bench was 1V:14.5H below a water's edge scarp at the downstream section. The site is classified as type 4 (figure 6-21 and table 6-4). The subaerial bench was wet due to poor drainage. Wave wash, in combination with piping, appeared to have created the downstream small scarp on the bench. Rework and transport of failed soils and recently deposited sediments at stages within the normal range of pool-level fluctuations could be significant.

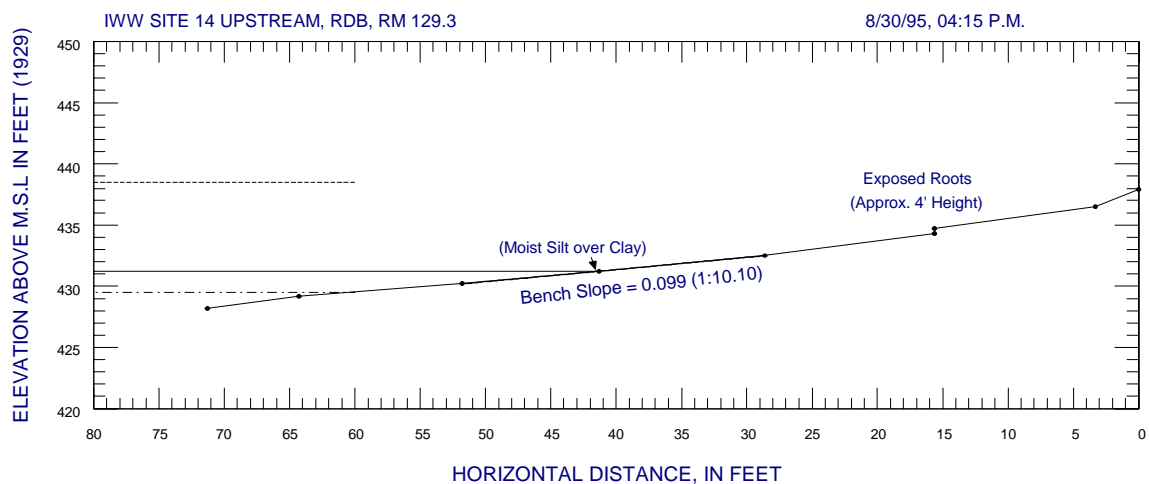
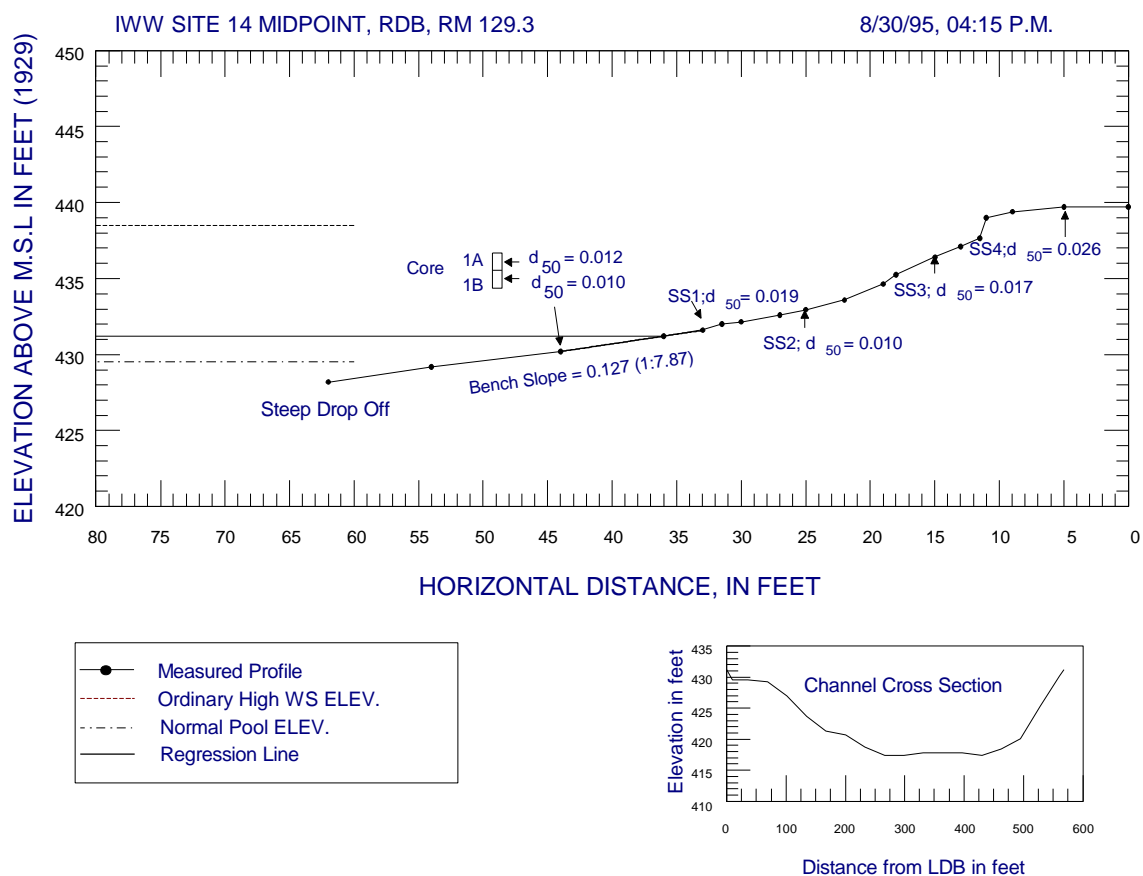
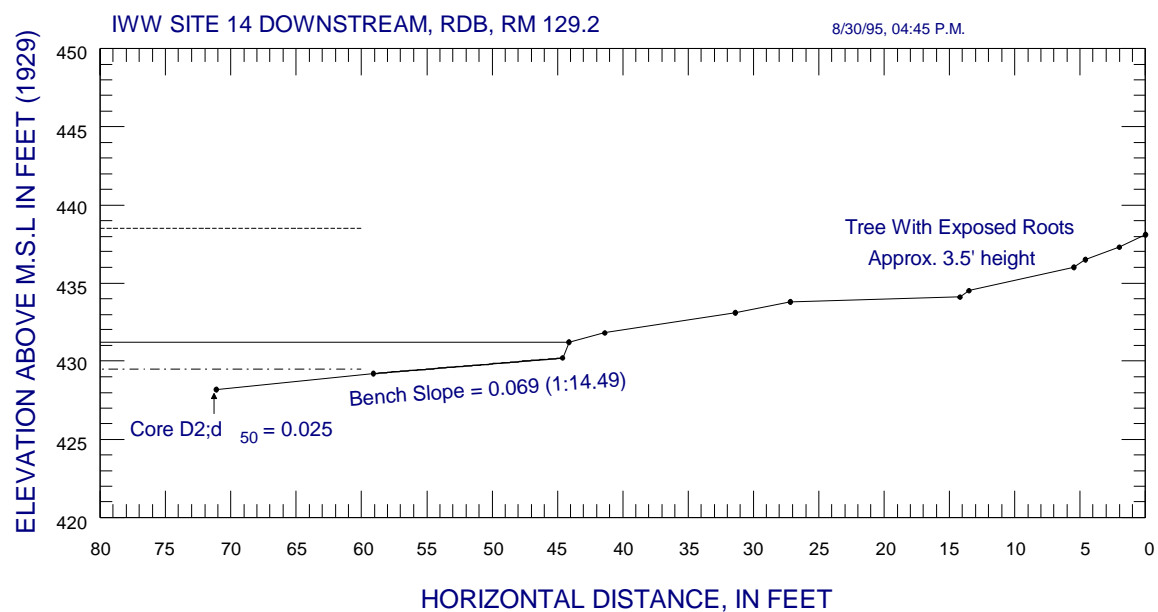
**Figure 6-83. Bank sections at site 14**

Figure 6-83 shows the three measured bank sections and a reduced cross section. The OHW is 438.5 feet and NP is 429.5 feet above msl. A scarp was noted at the downstream section, where the NP elevation matched the base of the scarp. The OHW elevation is about the same height as the short scarp at the midsection, and any stages higher than the OHW elevation will top the bank (see table 6-24 for the recurrence frequencies for various stages).

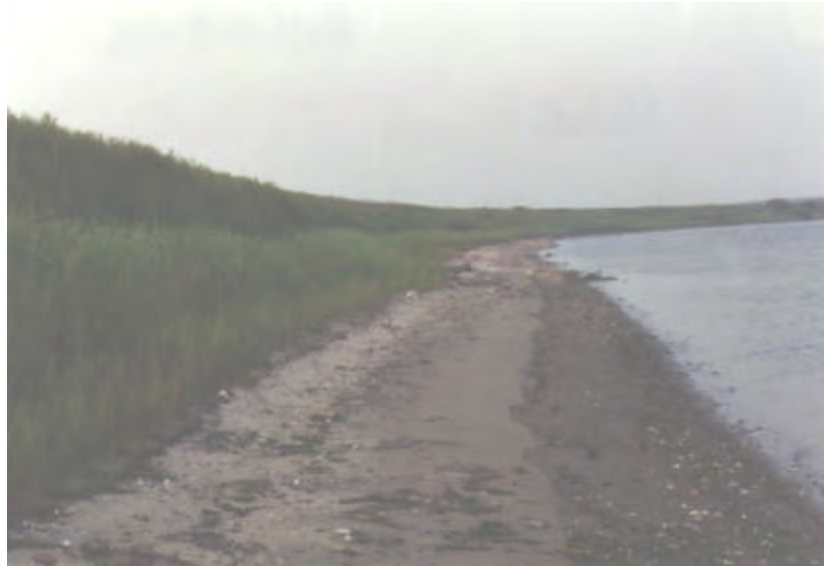
**Figure 6-85. Site 15 on the Illinois Waterway**

The site is about 310 feet from the sailing line. No major tributary enters the IWW at this location. Bhowmik and Schicht (1980) noted erosion along a long stretch of this side of the river, while Hagerty (1988) marked dredged material at the site as well as some old dredged material on

Bench slopes varied from 1V:8.1H at the upstream section to 1V:11H at the downstream section. This site is classified as a combination of types 3 and 5 (figures 6-20 and 6-22, and table 6-4). The existing scarp was located at higher elevations that could be caused by floods. The peds indicated seepage activities. Rework and transport by waves and currents on failed soils or recent sediments could also be important at this site.

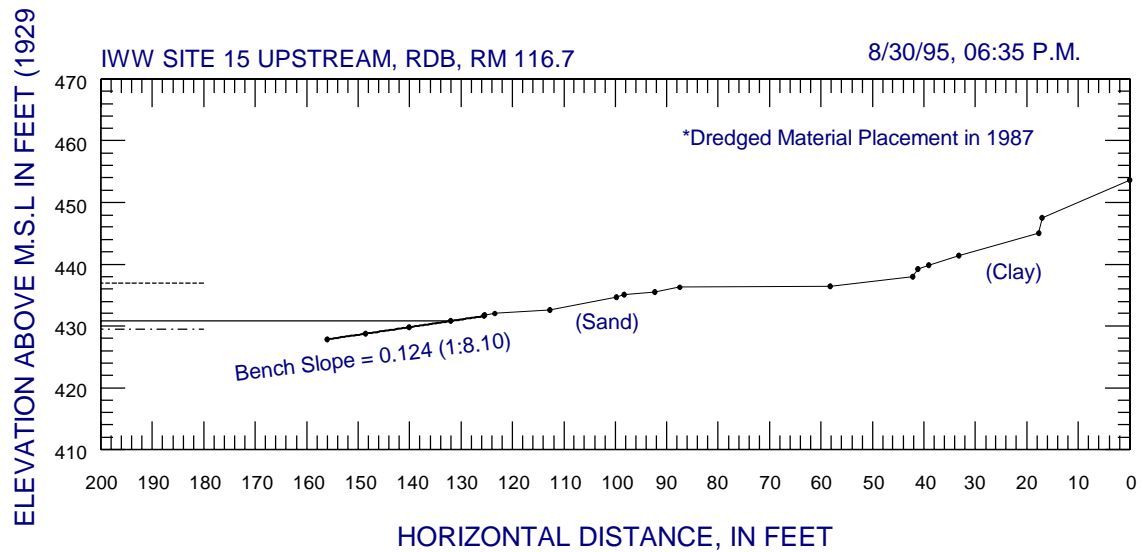
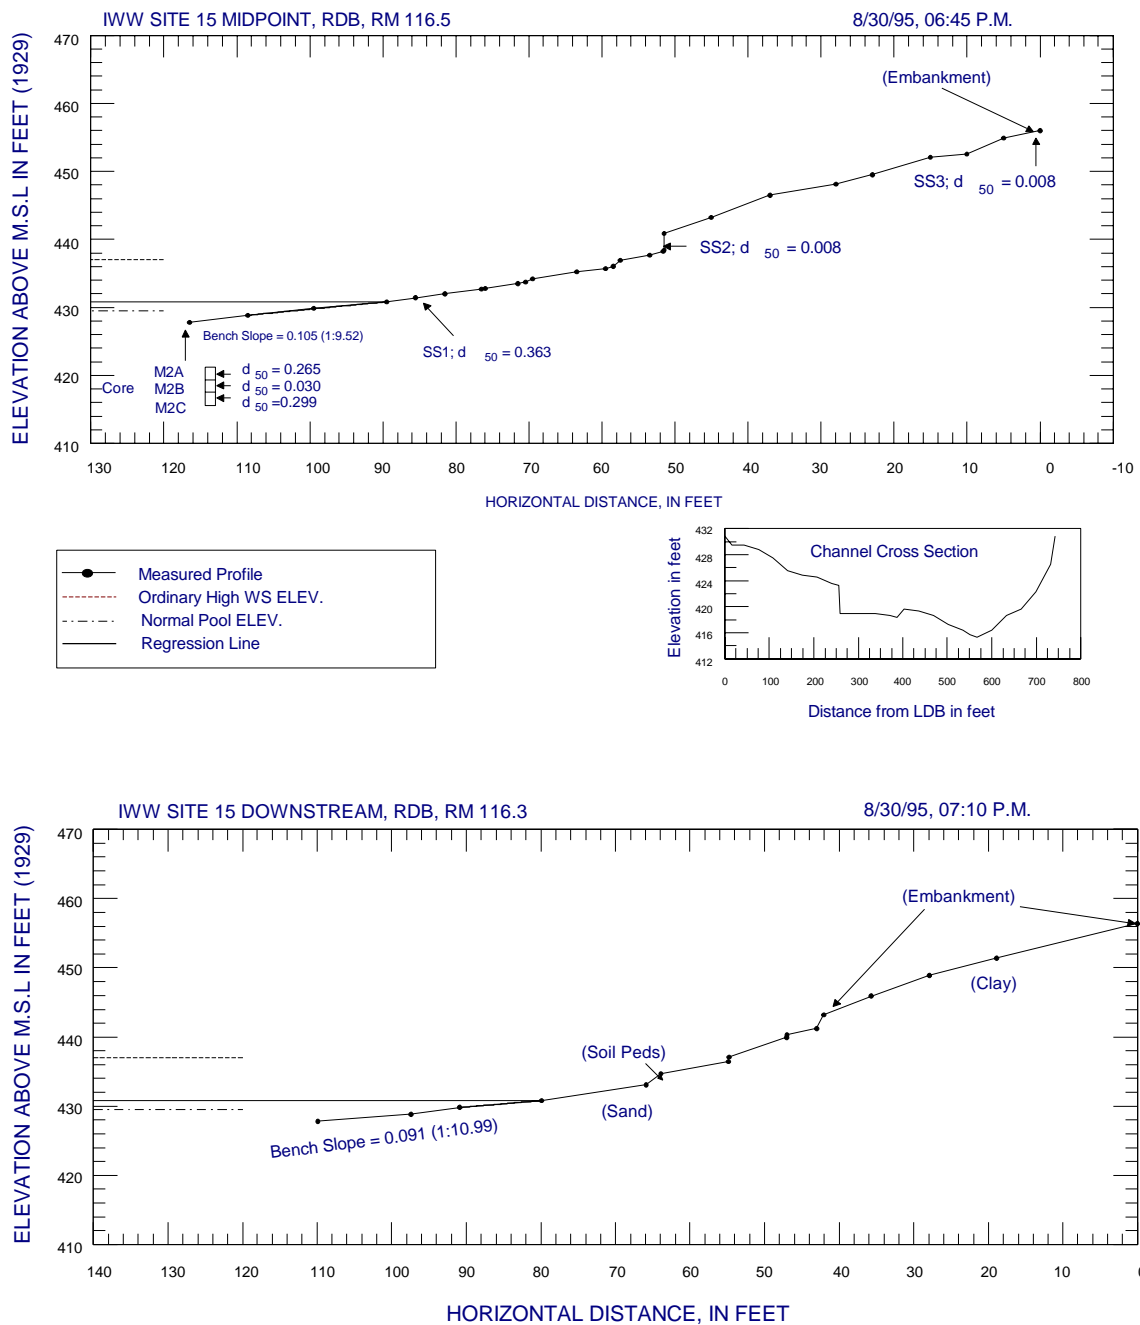
**Figure 6-86. Bank sections at site 15**

Figure 6-86 shows the three measured bank sections and a reduced cross section. The OHW is 437.0 feet and NP is 430.8 feet above msl. The NP elevation corresponds to a break in the subaqueous slope. From figure 6-86, the OHW elevation corresponds to the base of a small scarp.

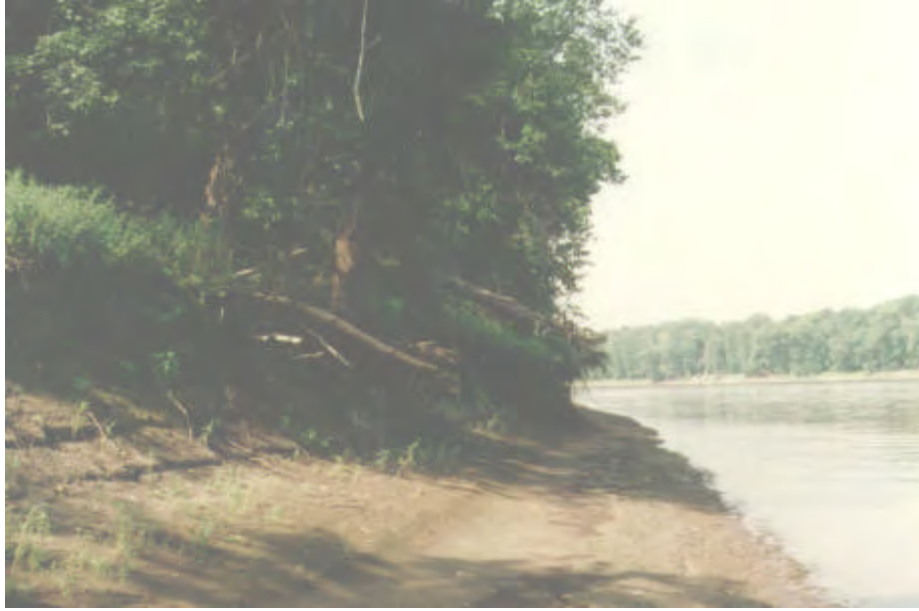
**Figure 6-88. Site 16 on the Illinois Waterway**

Site 16 is about 250 feet from the sailing line, and large lakes are located on both sides of the river. No tributary enters the IWW at this location. According to Bhowmik and Schicht (1980), erosion was occurring at an upstream reach above RM 110.2 on both sides of the river, but approximately between RM 109.5 and 109.8, only an LDB reach was eroded. Hagerty (1988) indicated both banks were eroded. The present study also observed that both banks were eroded. Large debris (dead trees) crowded the bank. There was also a steep scarp near the upstream section, and the opposite side was designated as site 17.

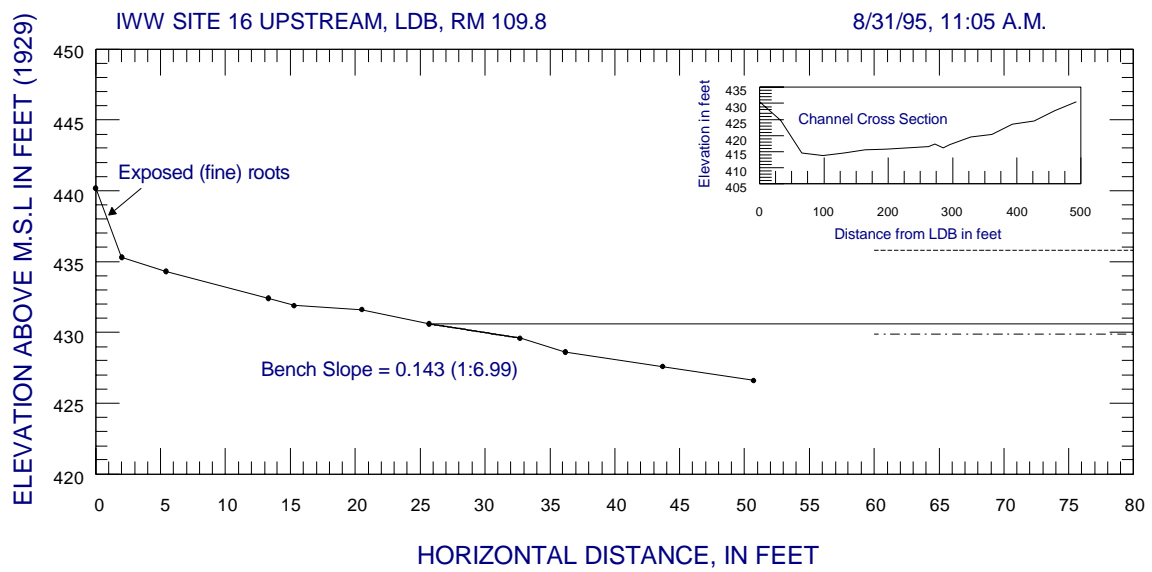
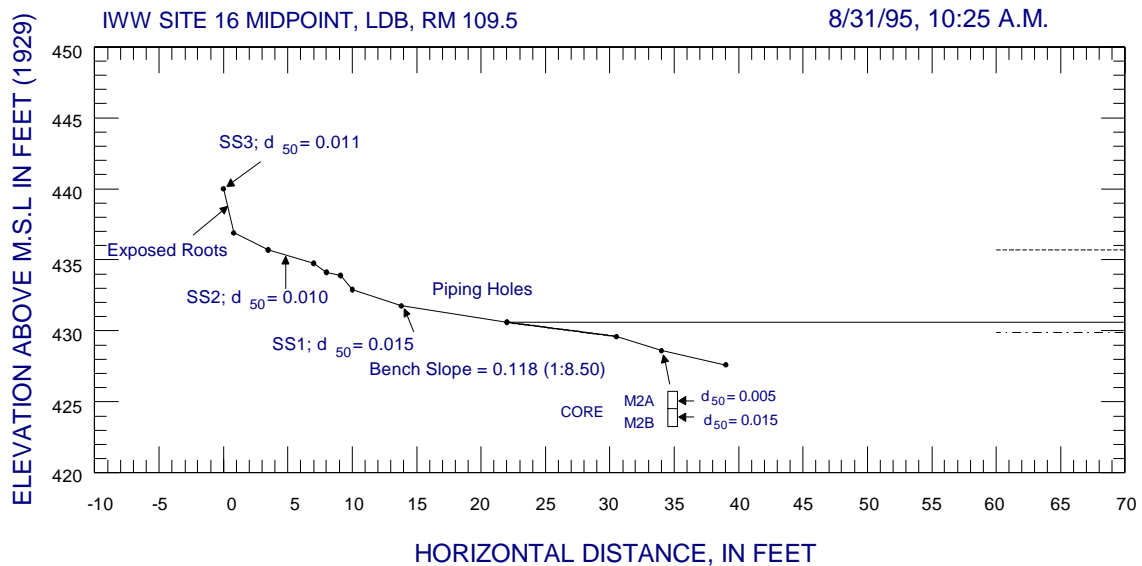
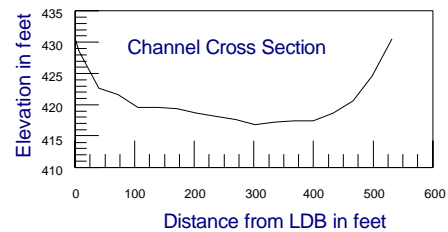
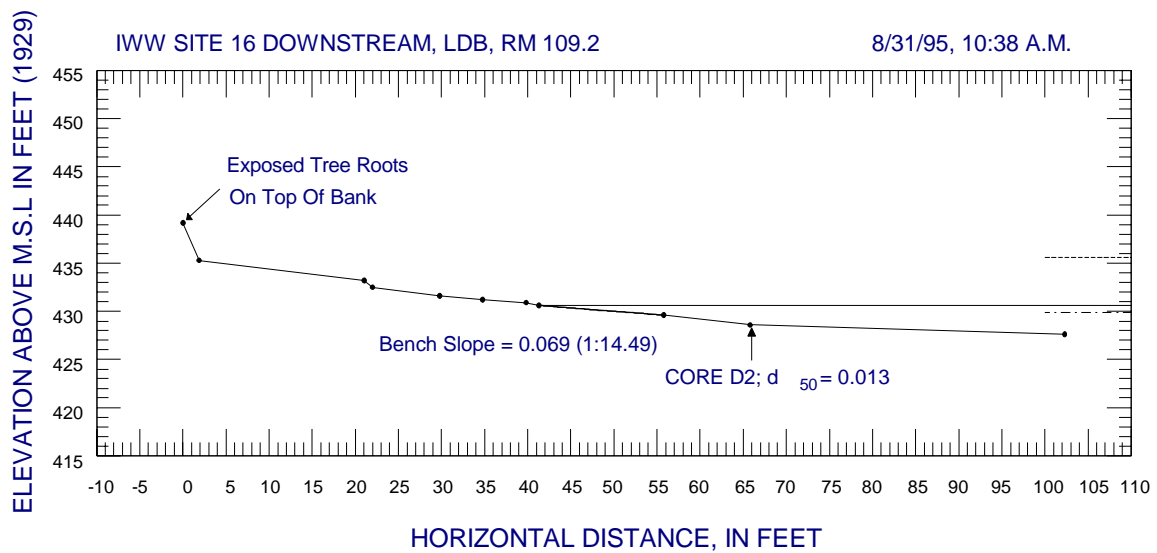
**Figure 6-89. Bank sections at site 16**

Figure 6-89 shows the three measured bank sections and two reduced cross sections. The OHW is 435.7 feet and NP is 429.9 feet above msl. The NP elevation corresponds well to a break in the subaqueous bench slope. Water at the OHW elevation generally reaches the base of the scarp or submerges part of the scarp; higher stages (table 6-26) overtop the bank. Most of the lower scarp and recent sedimentation were observed between NP and OHW.

At the midsection, the  $d_{50}$  varied from 0.011 mm at the top surface of the bank to 0.005 mm at the upper portion of a core sample at a water depth of about 2 feet. The  $d_{50}$  of the lower portion of this core sample, 0.015 mm, is similar to that of other materials found on the bank. Gradation plots of bank soils and nearshore sediment are presented in appendix F. The detailed cross section and coordinates are shown in appendix G.

Bench slopes varied rapidly from 1V:7.0H at the upstream section to 1V:14.5H at the downstream section. The upstream section and midsections are classified as type 2, and the downstream section is classified as type 3 (figures 6-19, 6-20, and table 6-4). Rework and transport of bench materials occur at stages within the normal range of pool-level fluctuations. Erosion of in-place soils occurs at stage above OHW. Seepage and piping affect the extent of failure during recession periods when the river stages can drain.

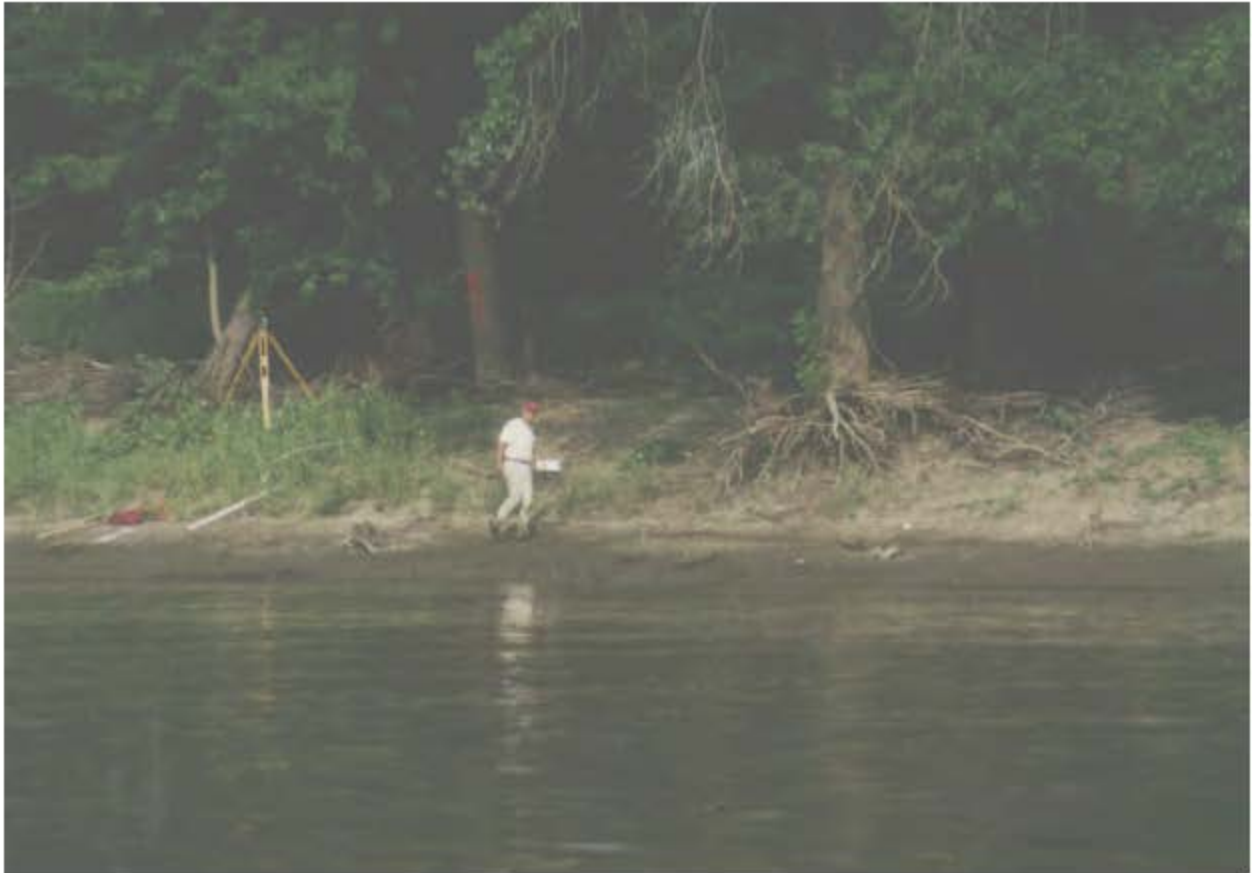
**Figure 6-90. Site 17 on the Illinois Waterway**

**Site 17, La Grange Pool, 8/31/95.** This site is located at the outside of the bend across the river from site 16. The whole area is within Anderson Lake Conservation Area. Figure 6-87 shows the position of the site on a GIS-based map of the Illinois navigation chart, and figure 6-90 shows a photograph of the site.

The site is about 280 feet from the sailing line. This site was described as severely eroded by Hagerty (1988). According to Corps personnel, this was formerly a dredged material placement site, containing about 8 feet of dredged materials. However, floods apparently have removed all the dredged materials. Seepage flows containing oxidized iron (brownish color) were observed along the bank. Seepage may be attributed to the presence of adjacent Anderson Lake behind this site.

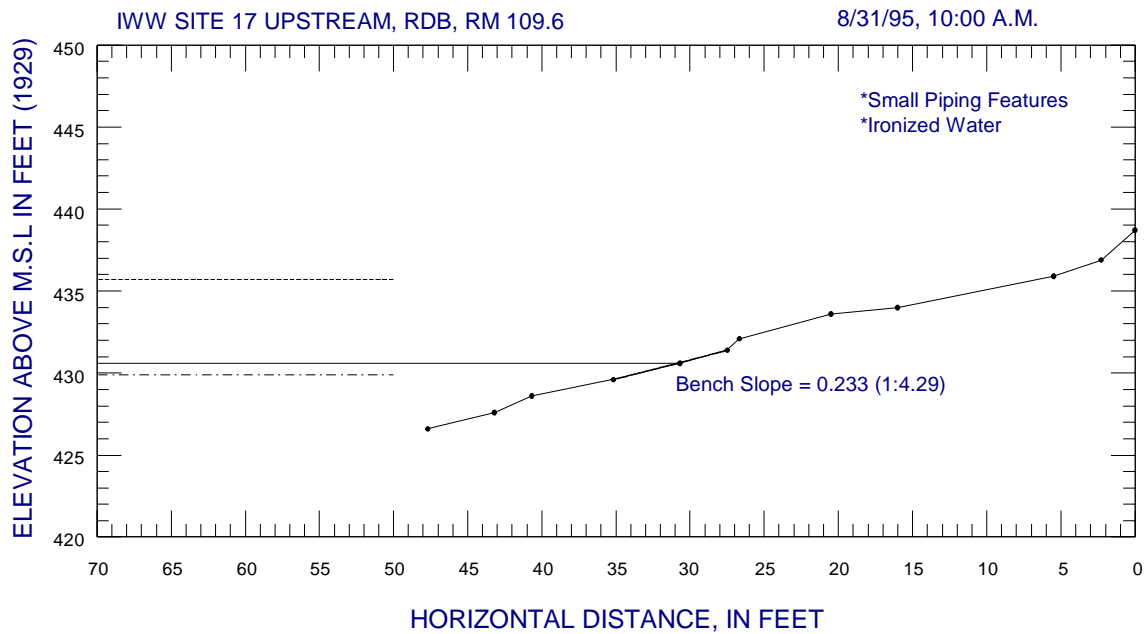
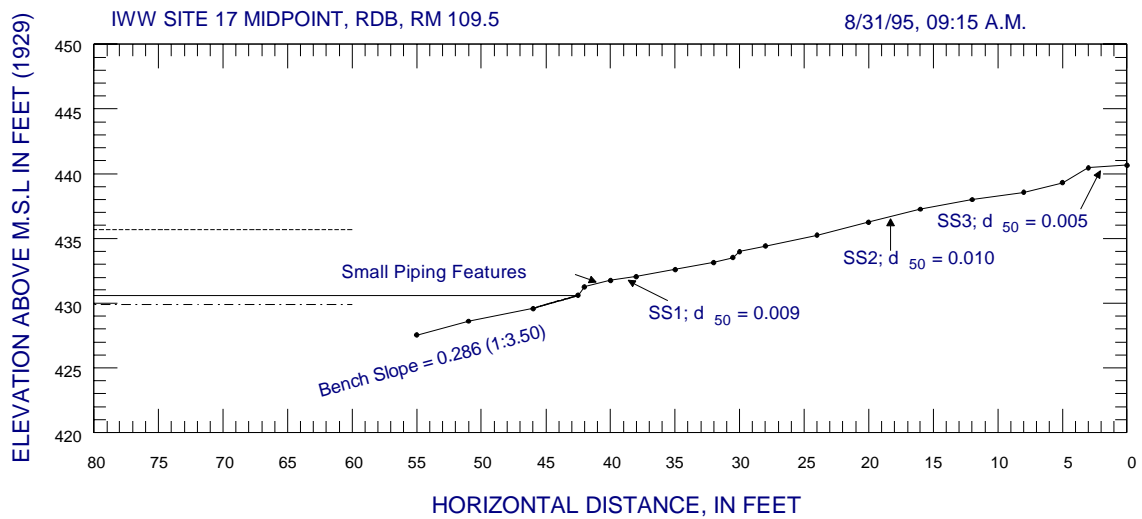
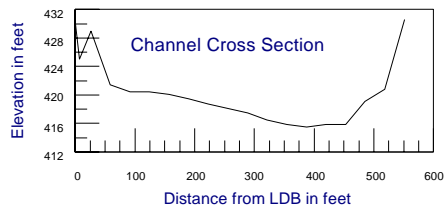
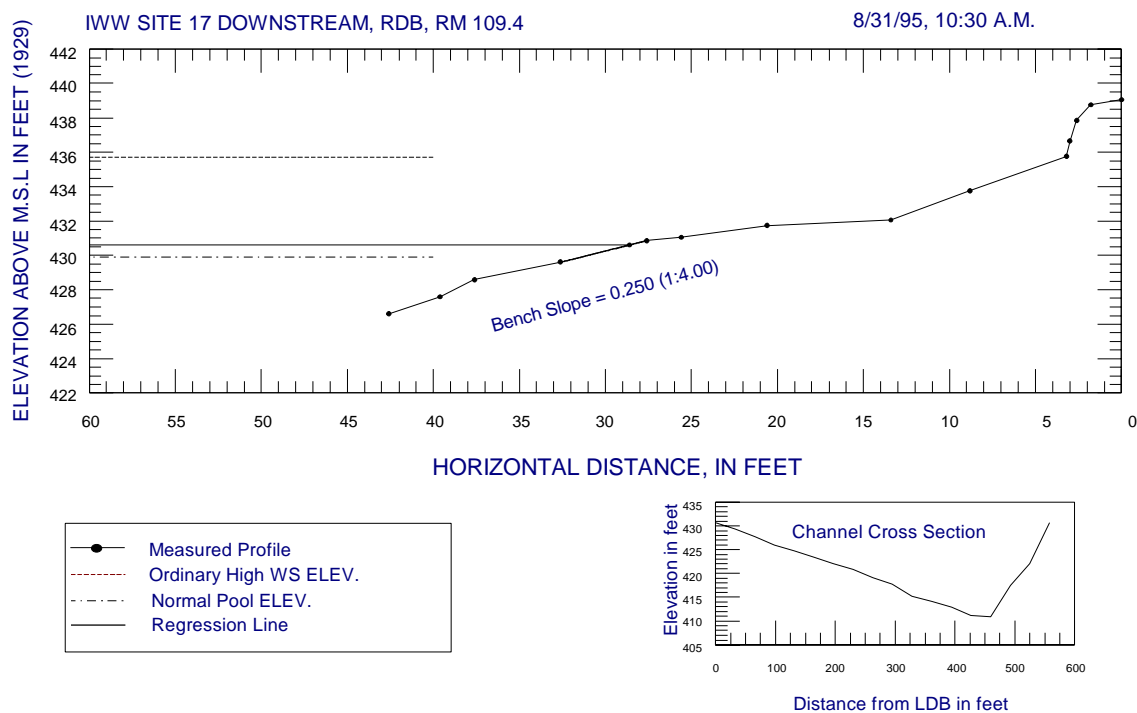
**Figure 6-91. Bank sections at site 17**

Figure 6-91 shows the three measured bank sections and two reduced cross sections. The OHW is 435.7 feet and NP is 429.9 feet above msl. There is a scarp near the water's edge and downslope from areas of seepage flows; the OHW elevation is above a zone of seasonal grasses. The OHW elevation corresponds well to the base of a scarp on the upper portion of the bank. Other stages and corresponding features are given in table 6-27.

At the midsection, the  $d_{50}$  varied from 0.005 mm at the top surface of the bank to 0.009 mm near the water's edge. Bank materials are similar. Gradation plots of bank soils and nearshore sediment are presented in appendix F. The detailed cross section and coordinates are shown in appendix G.

Bench slopes varied around 1V:4.0H. Both the upstream section and midsection are classified as type 5, and the downstream section is classified as type 4 (figures 6-21, 6-22, and table 6-4). Seepage at NP stages could weaken the bench materials and wave wash could create scarps on the bench. As at site 16, the subaerial bench was moist. Waves and currents at stages within the normal range of pool fluctuations cause erosion on bench and berm. These forces move failed soil or recent sediment away from the bank sections also.
