# **Interim Report For The Upper Mississippi River - Illinois Waterway System Navigation Study**

**US Army Corps  
of Engineers**

**November 1997**

## Bank Erosion Field Survey Report of the Upper Mississippi River and Illinois Waterway

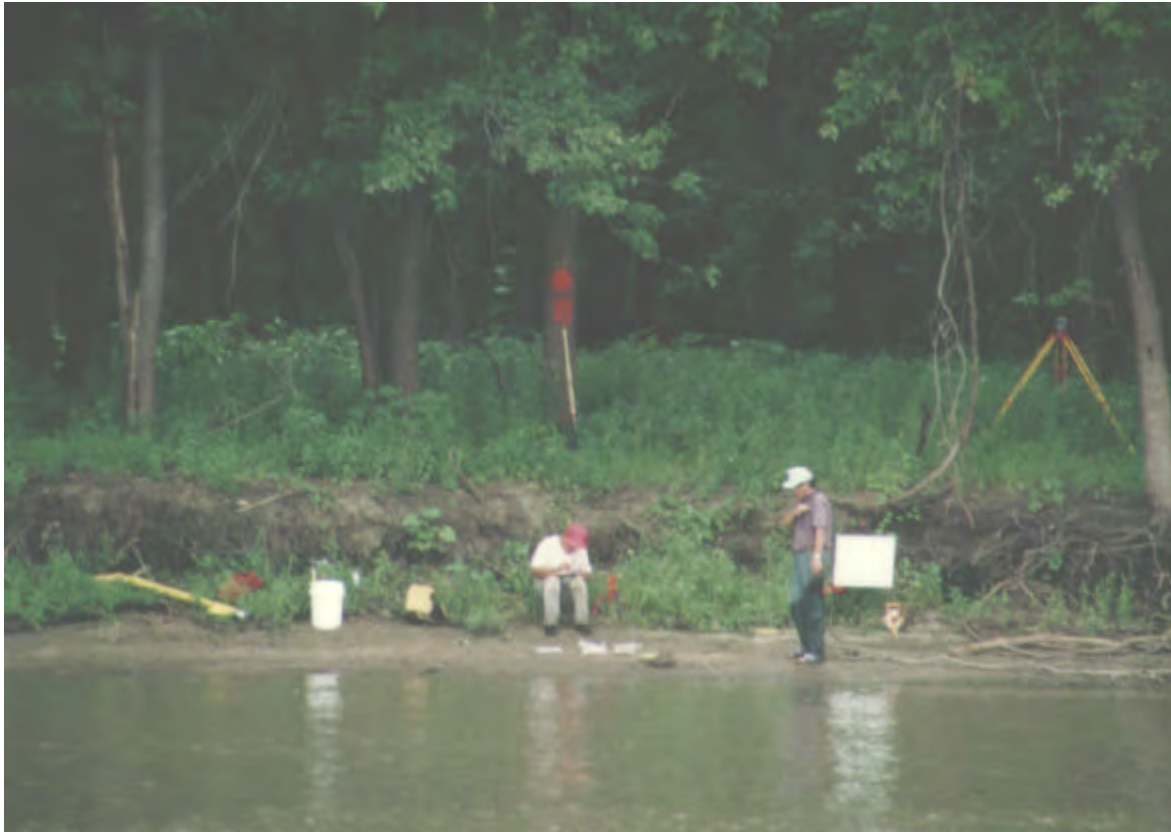
**Figure 6-93. Site 18 on the Illinois Waterway**

The site is about 250 feet from the sailing line. Both Bhowmik and Schicht (1980) and Hagerty (1988) observed erosion immediately upstream and downstream from the mouth of Sugar Creek, but did not indicate erosion at the current site. However, scarps and displaced trees were found on the bank in this trip. The bank had a thick cover of sand over exposed clay in several places. Dredged material was placed here in the 1960s, according to Corps personnel. In this 1995 trip, the previously eroded section was covered with sand, with shells and gravel at the water's edge. For comparison purposes, the upstream section was taken from that previously eroded section.

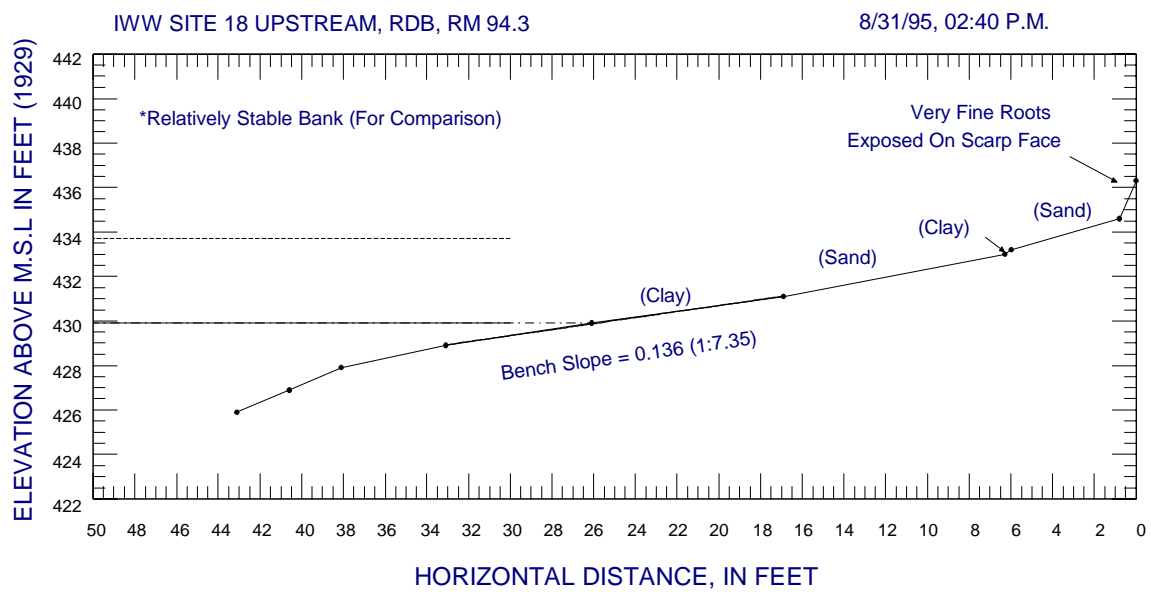
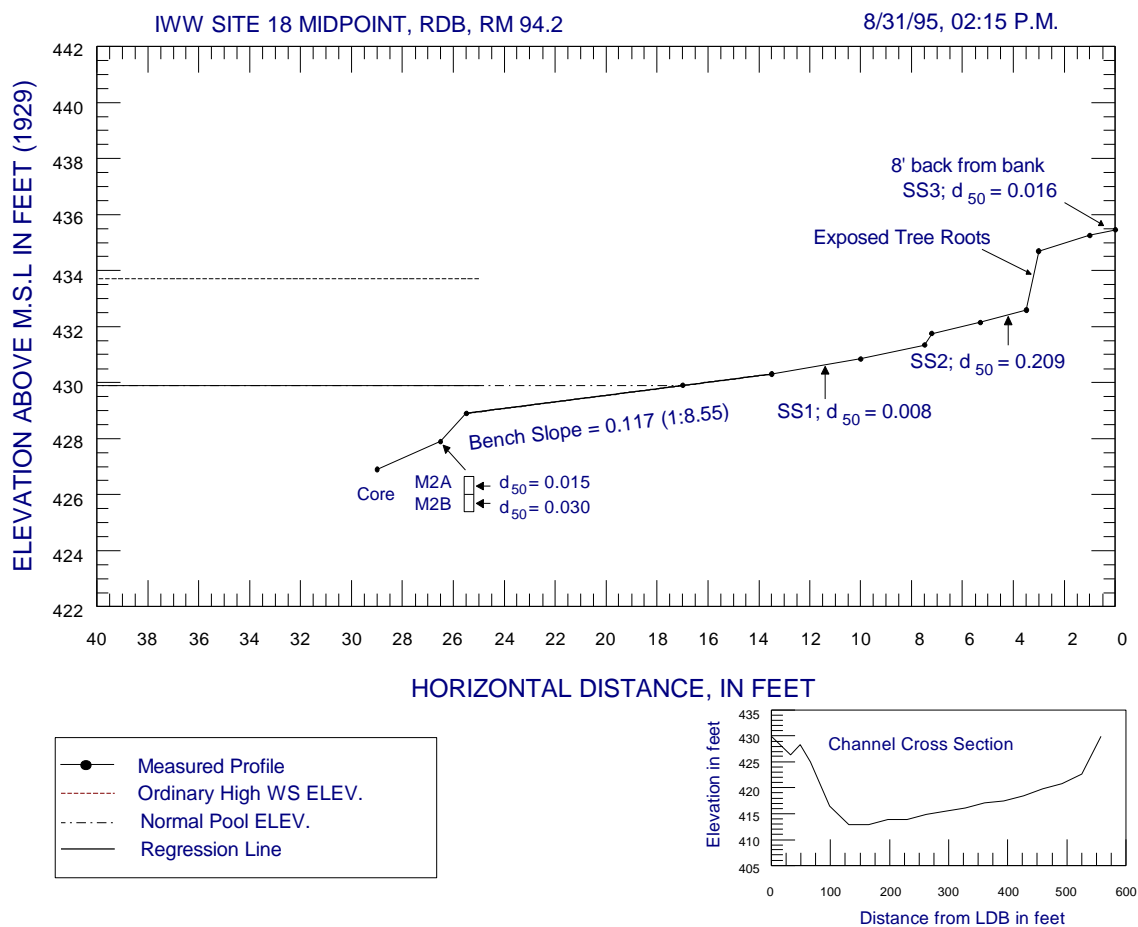
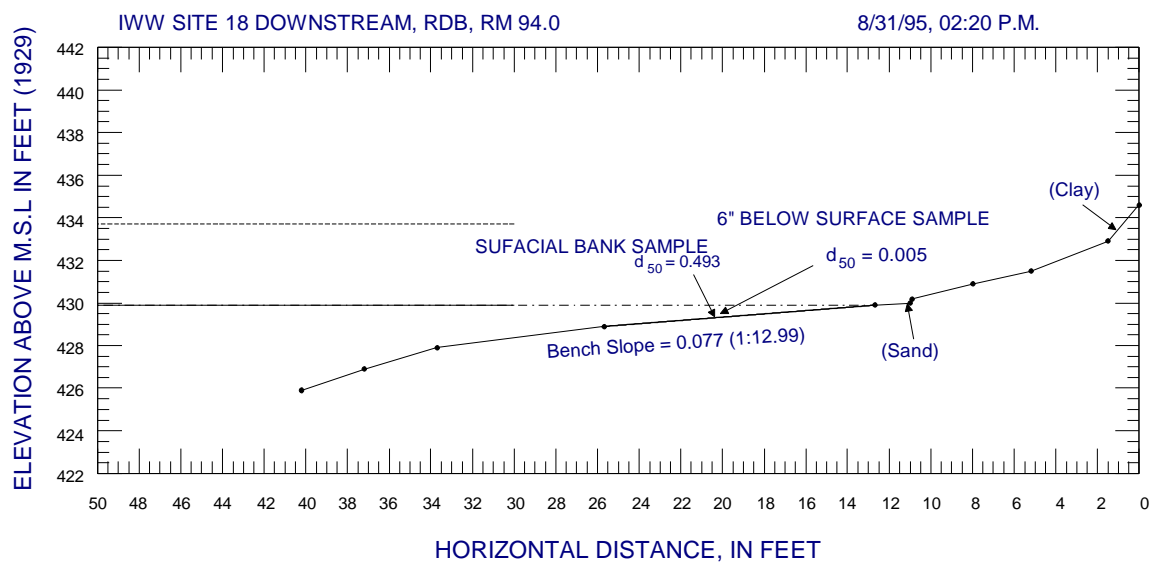
**Figure 6-94. Bank sections at site 18**

Figure 6-94 shows the three measured bank sections and a reduced cross section. All three sections were cut by a scarp, but scarp elevations were different. At this site, the OHW is 433.7 feet and the NP is 429.9 feet above msl. The scarp was above the OHW elevation at the upstream section, but the scarp elevations were lower for the midsection and downstream sections. The midsection and downstream section had small scarps in the stage range between the OHW and NP, but the upstream section did not have such scarps. Table 6-28 contains the stages with corresponding recurrence frequencies at this site.

At the midsection, the  $d_{50}$  varied from 0.016 mm at the top surface of the bank to 0.015 mm at the upper part of a core sample at a water depth of about 2 feet. Gradation plots of bank soils and nearshore sediment are presented in appendix F. The detailed river cross section and coordinates are shown in appendix G.

The bench slopes varied from 1V:7.4H at the upstream section to 1V:13.0 at the downstream sections. The subaqueous bench dropped off quickly at the midsection at this site. Both the upstream and downstream sections are classified as type 4, but the midsection is classified as a combination of types 2 and 4 (figures 6-19, 6-21, and table 6-4). The bank crest was covered by dense vegetation, and roots from that vegetation provided additional bonds to bank materials. The bank showed vertical cracks, which apparently were caused by basal scour. Sandy materials underneath the scarp seeped out after rapid stage recession. Waves and currents can rework and transport failed soils or recent sediments at stages within the normal range of pool-level fluctuations.

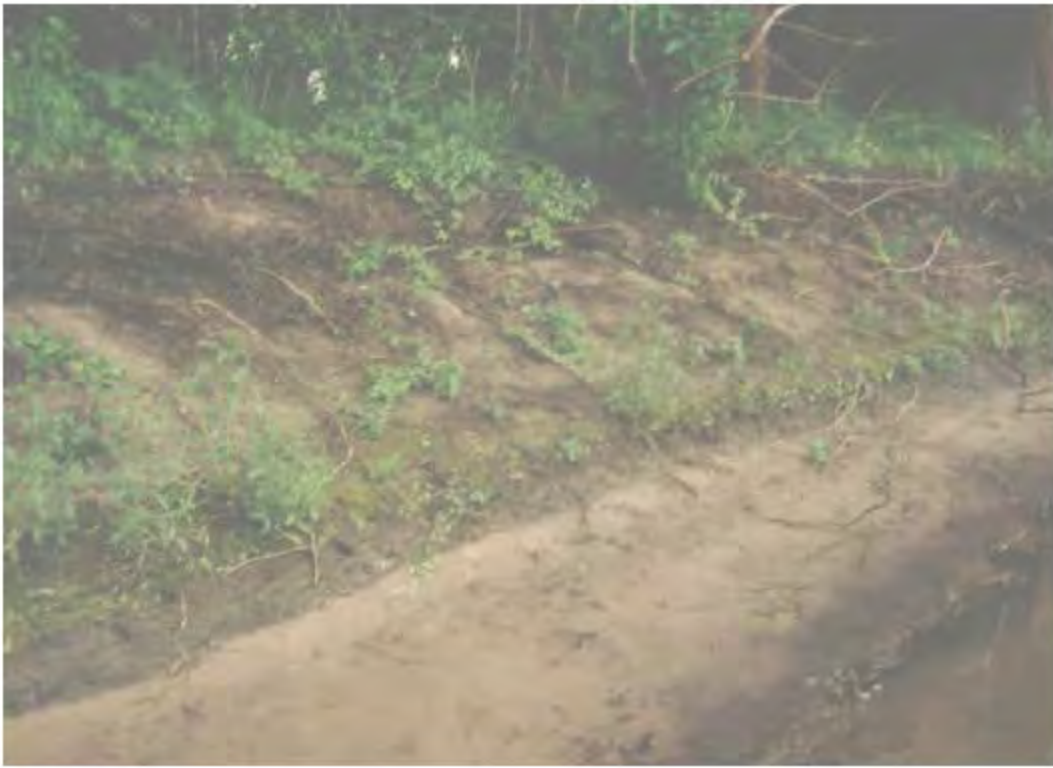
**Figure 6-96. Site 19 on the Illinois Waterway**

The site is about 310 feet from the sailing line. A Chicago Burlington & Quincy railroad line is located just behind the site. Hagerty (1988) marked this site as an erosion site, but it appeared to be stable when Bhowmik and Schicht (1980) surveyed. A depression between the bank and the railroad embankment will retain floodwater or rainwater, and cause seepage to the bank. The depression was a borrow pit for the construction of the railroad embankment. Some large dead trees and exposed roots were observed. Velocities were relatively high at a close distance from the shore.

A scarp approximately 4 to 6 feet high was present. The lower bank and berm area contained several scarps and a moist soil layer at the toe. Some sand deposition was found on the narrow bench area. Figure 6-97 shows the three measured bank sections and a reduced cross section. The upstream bank section was extended approximately 160 feet to include the top of the embankment for the Chicago Burlington & Quincy Railroad. The OHW is 433.3 feet and NP is 429.9 feet above msl. The OHW elevation is at the base of the large scarp. The stage at the time of the field visit was at NP level.

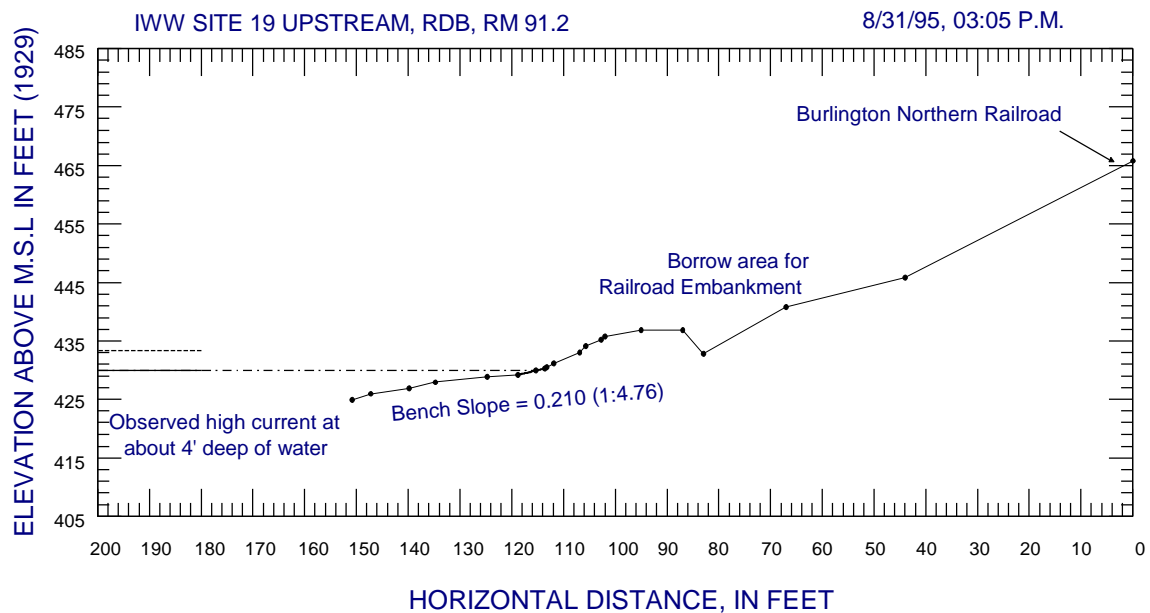
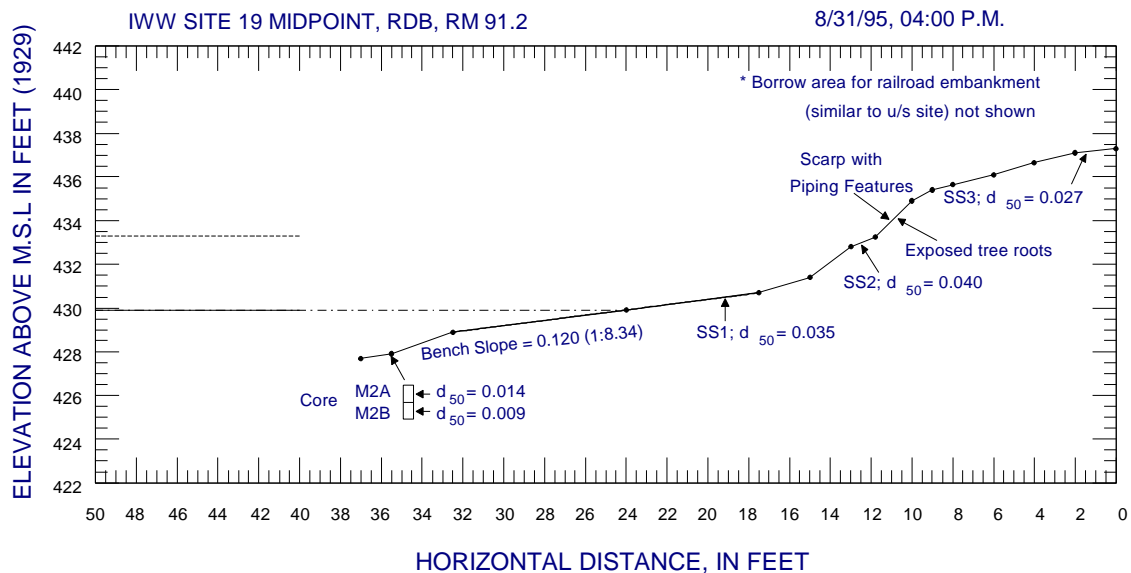
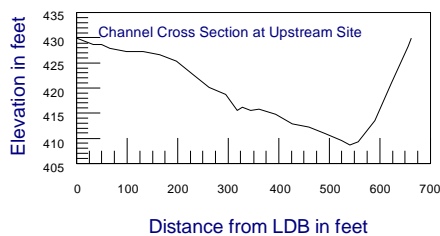
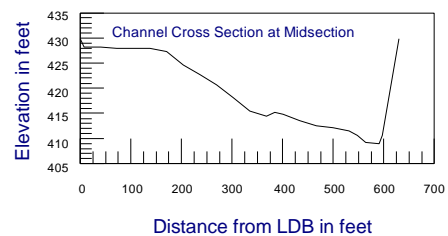
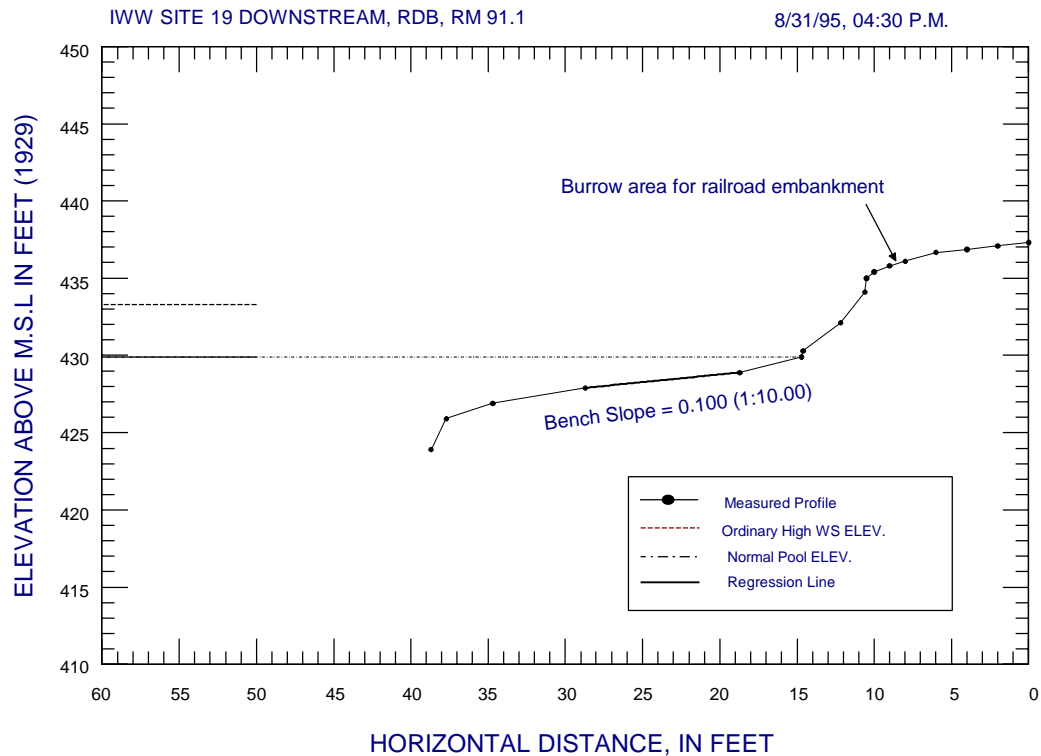
Figure 6-97. Bank sections at site 19

At the midsection, the  $d_{50}$  varied from 0.027 mm at the top surface of the bank to 0.014 mm at the upper part of a core sample at a water depth of about 2 feet. Gradation plots of bank soils and nearshore sediment are presented in appendix F. The detailed river cross section and coordinates are shown in appendix G.

Bench slopes varied from 1V:4.8H at the upstream section to 1V:10H at the downstream section. This site is classified as a combination of types 2 and 4 (figures 6-19, 6-21, and table 6-4). Seepage initiated bank failure, rework and transport of failed soils occurred at stages within the normal pool-level fluctuations. Traffic-induced disturbances should be considered because the closeness to the barge terminal. Rapid drop of depth at mid- and downstream sections may reflect such a factor.

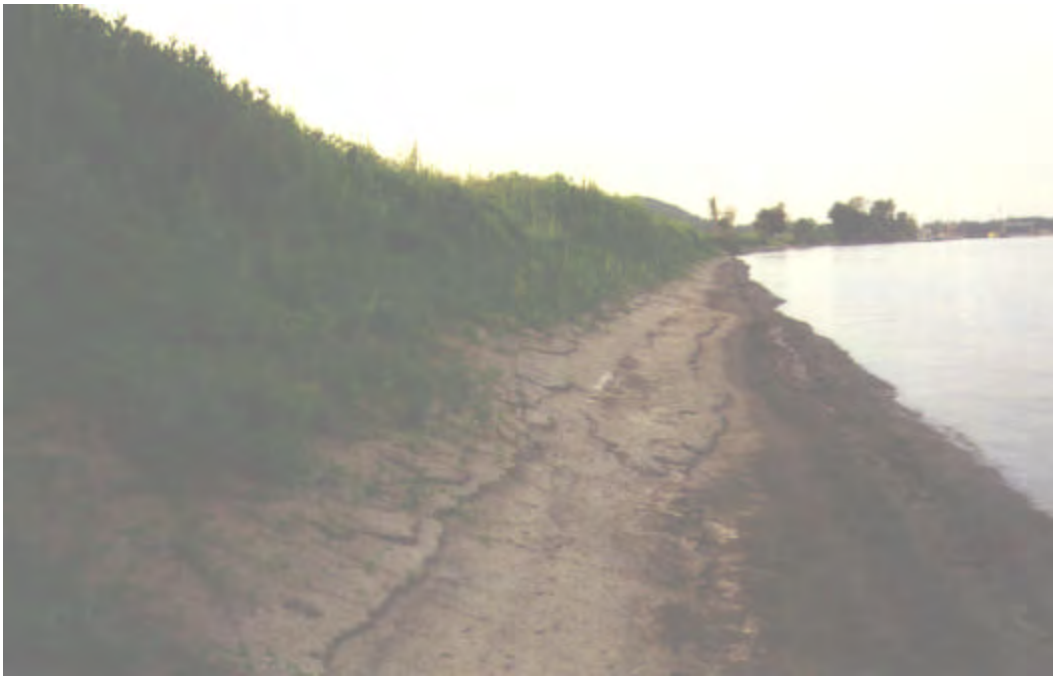
**Figure 6-99. Site 20 on the Illinois Waterway**

The navigation channel is fairly close to site 20; the bank is about 230 feet from the sailing line. No major tributary enters the IWW at this location. The opposite side of the river is used as a mooring area as barges wait for lockage. Bhowmik and Schicht (1980) noted erosion on both sides of the river downstream from the L&D. Hagerty (1988) selected this site for further survey and also indicated scarps about 12-14 feet high. In 1995, the face of the bank was bare, and the upper bank covered with short grasses. A fairly clear wet/dry line was present at the lower portion of the bank. The subaqueous bench dropped very quickly toward the channel. The land use on the top of the bank is agriculture (corn).

At the midsection, the  $d_{50}$  varied from 0.023 mm at the top surface of the bank to 0.004 mm near the water's edge. Seepage water quickly filled a trench dug on the bank (figure 6-99) even though the bank material was hard and cohesive. Gradation plots of bank soils and nearshore sediment are presented in appendix F. The detailed river cross section and coordinates are shown in appendix G.

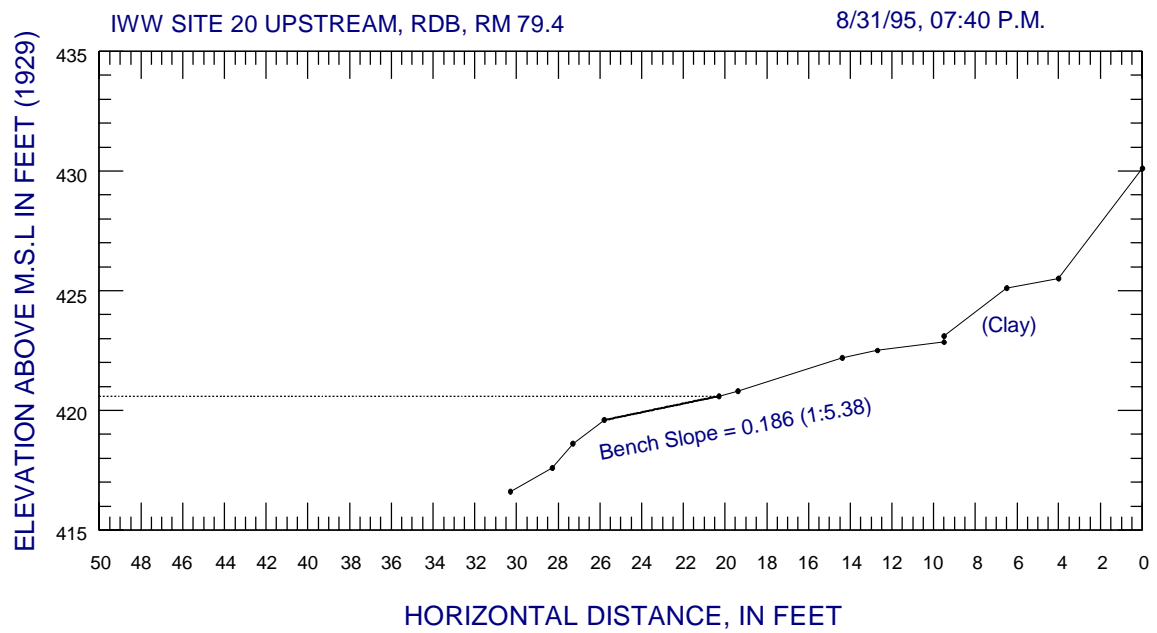
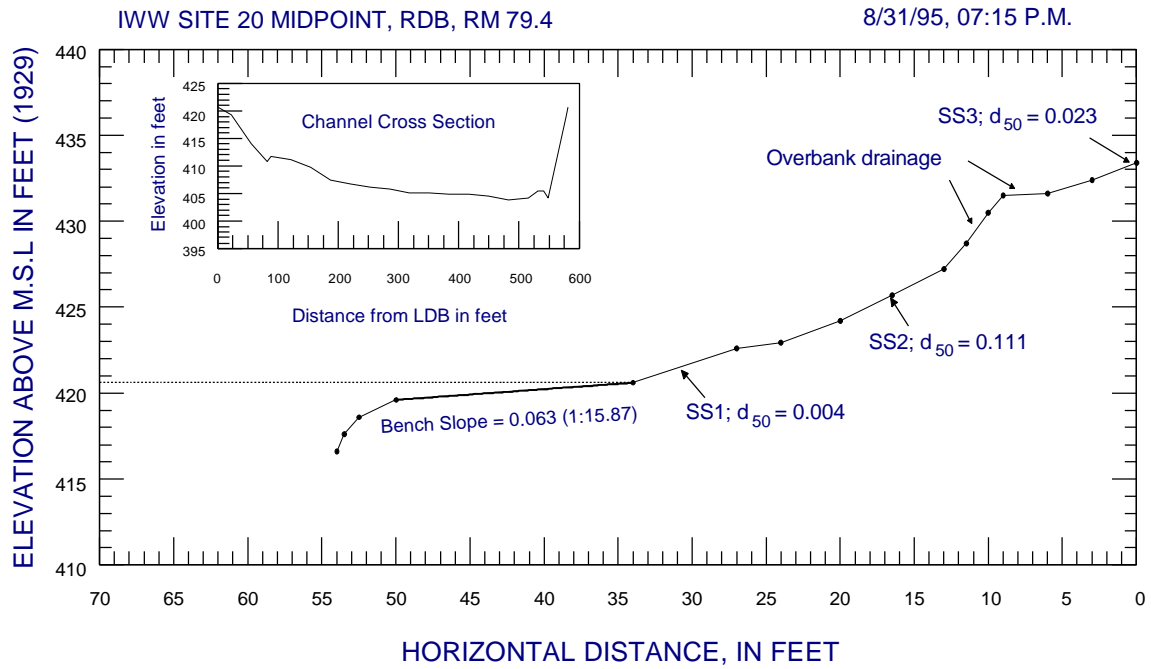
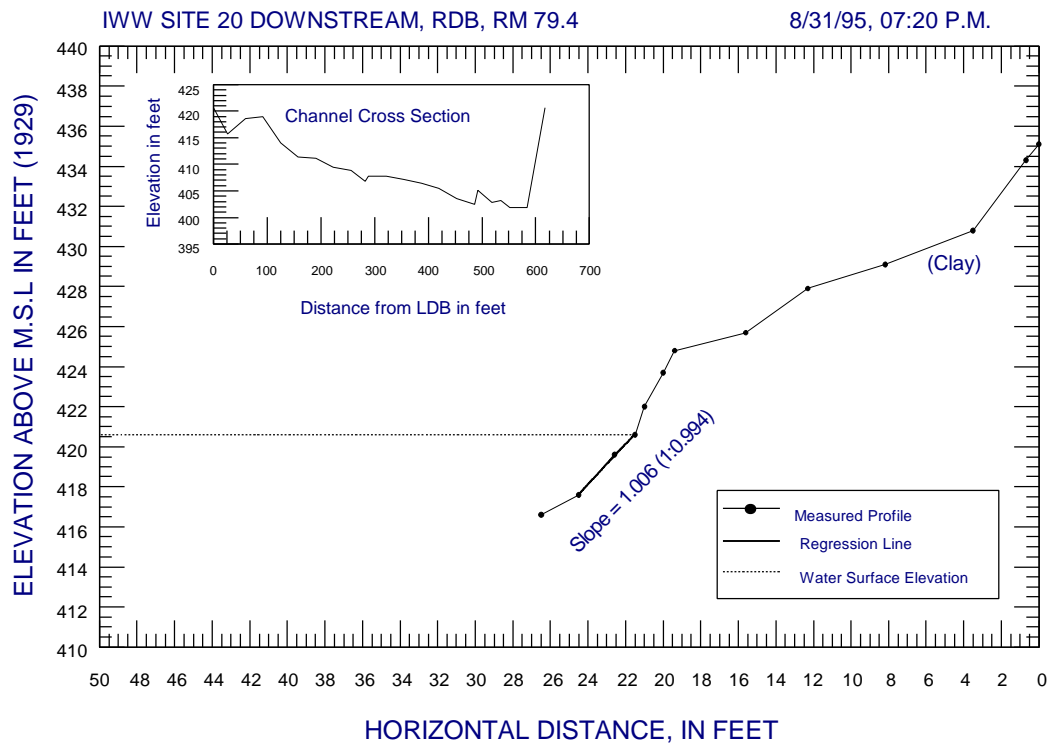
**Figure 6-100. Bank sections at site 20**

Figure 6-100 shows the three measured bank sections and two reduced cross sections. The bench narrowed at the downstream section. The OHW and NP elevations were not available for the Alton Pool, but analysis of the historical data indicated that the river stage at the time of survey had a recurrence frequency of about 90%. As shown in table 6-30, the bare bank area lies between the NP level and the 50% recurrence frequency stage (425.7 feet above msl).

Bench slopes varied from 1V:5.4H to 1V:15.9H to 1V:0.99H from upstream to downstream sections. This site can be classified as type 2 (figure 6-19 and table 6-4). Traffic approaching the L&D gets close to this site. High velocity flows released from the lock of the La Grange L&D, and turbulence induced by navigation traffic appeared to be the major cause of erosion at this site, but seepage effects also appeared to be significant.

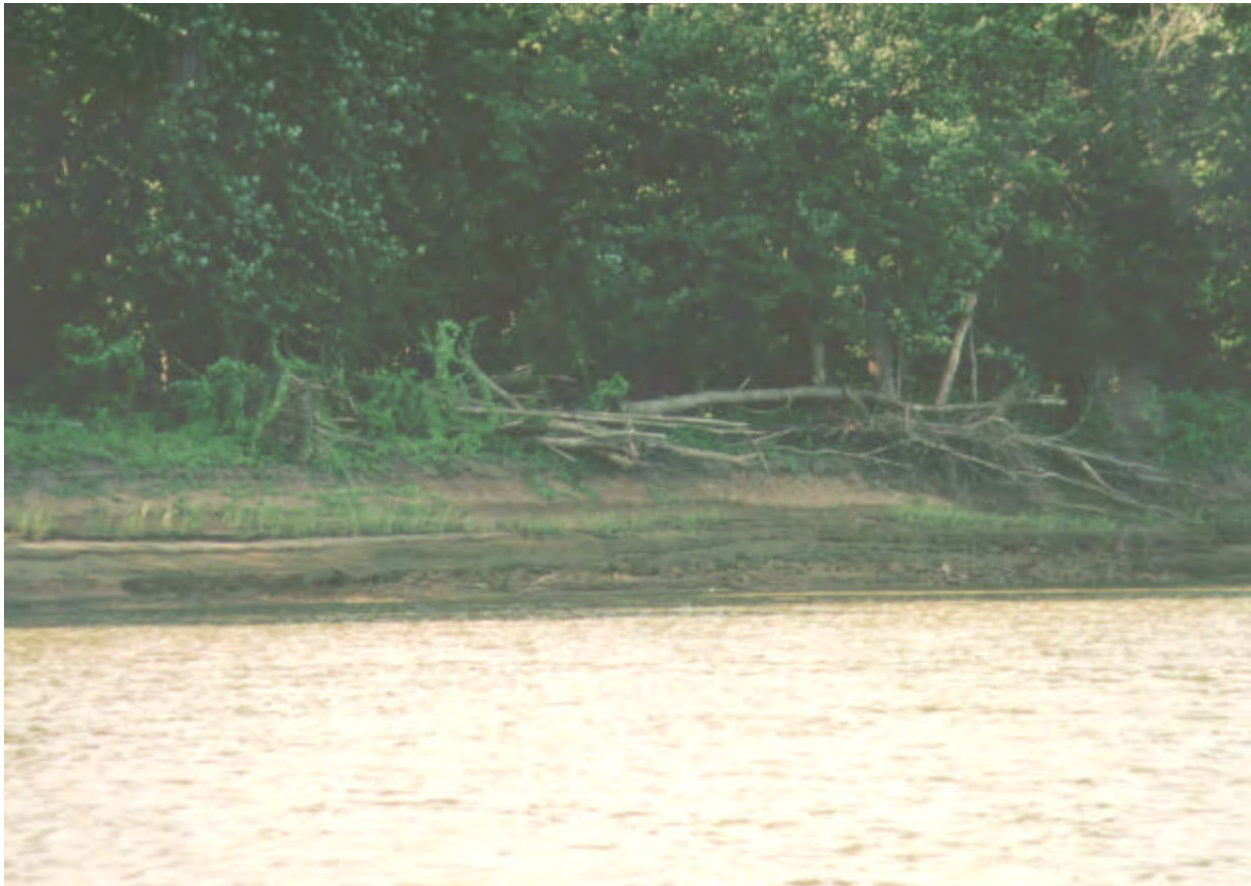
**Figure 6-102. Site 21 on the Illinois Waterway**

The navigation channel is close to this site; the bank is about 230 feet from the sailing line. A pumping station is located on the opposite bank, and there are several wing dams upstream in this reach. Bhowmik and Schicht (1980) did not note erosion in 1978, but Hagerty (1988) observed erosion around RM 61.9 on this bank. Silver maples are growing on the edge of the bank. Slaked blocks were mantled with grass and trees; tree roots extended out on the scarp.

Seasonal grasses were growing on the upper portion of the bank face. A bare bench with springs coming out of a clay layers extended from the failed soil blocks to the water's edge. Dead trees were present on the upper part of the bench.

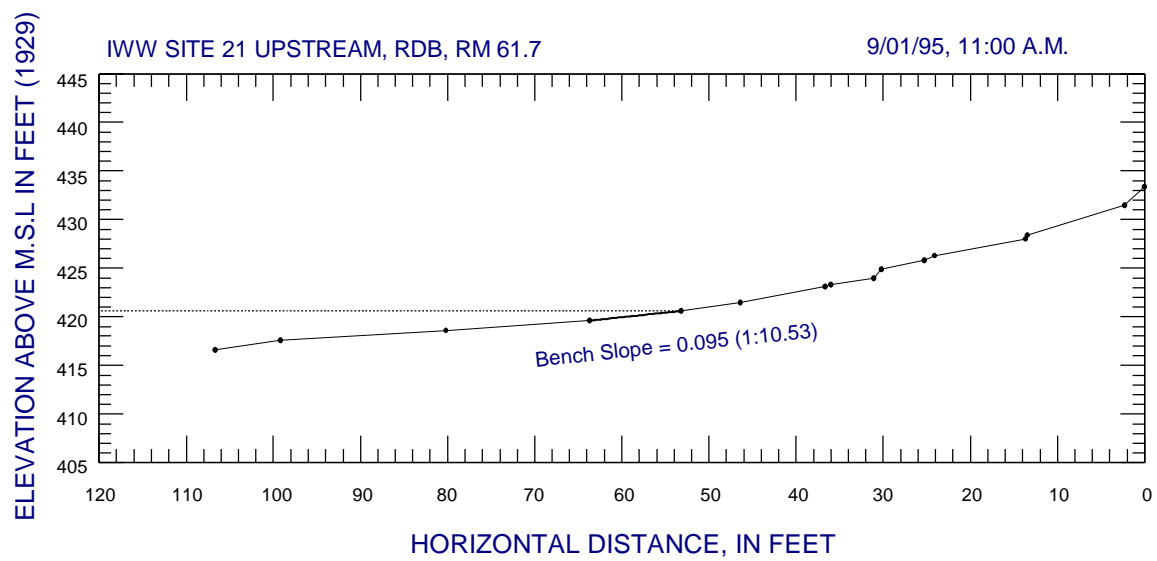
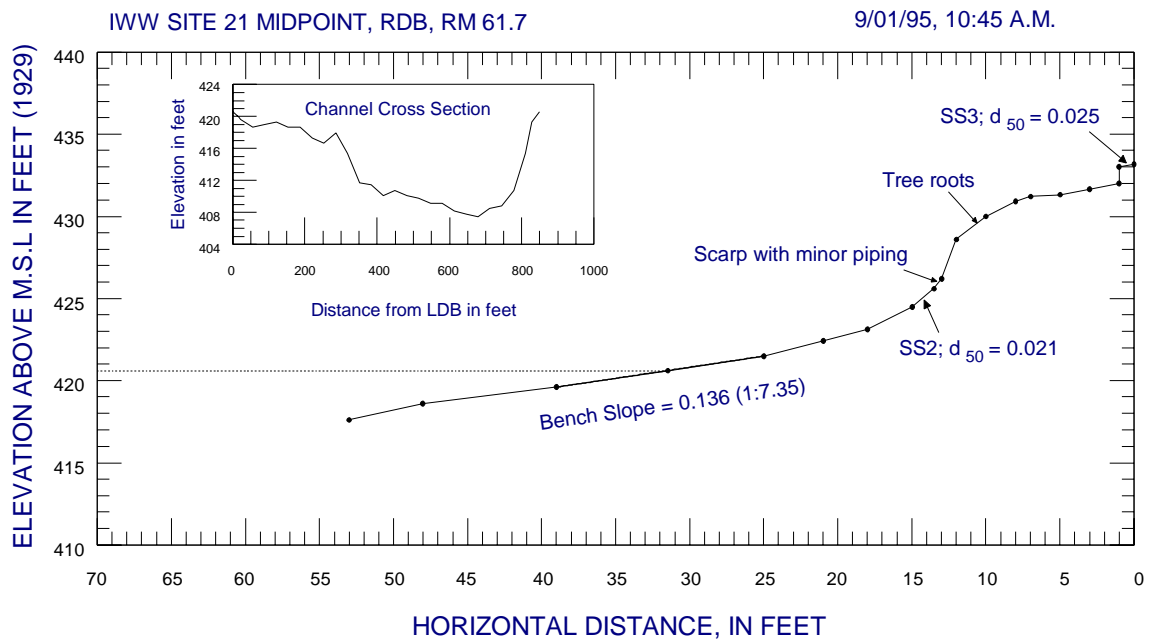
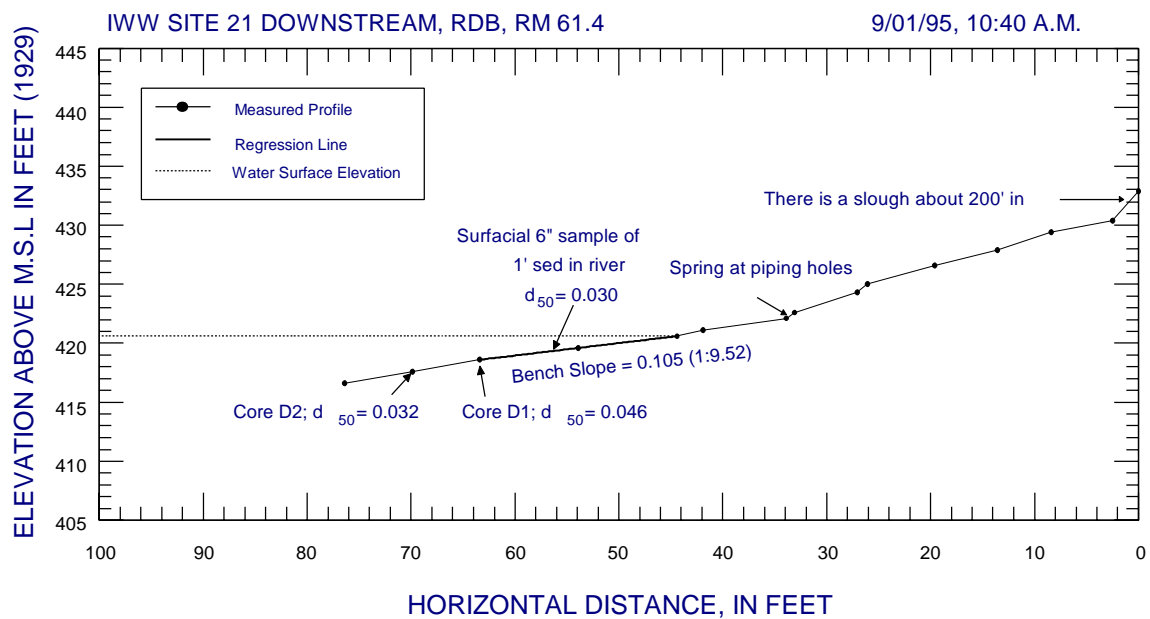
**Figure 6-103. Bank sections at site 21**

Figure 6-103 shows the three measured bank sections and a reduced cross section. The bank sections at the midsection differs from the up- or downstream sections. The stage at the time of survey corresponded to approximately 90% recurrence frequency. The scarps observed in the upstream and downstream sections were present in the range of stage fluctuation between 50% to 25% (424.5 and 429.1 feet, respectively, see table 6-31); this was also the range of scarp in the midsection.

Bench slopes varied from 1V:10.5H to 1V:7.4H. The upstream and downstream sections are classified as type 5, and the midsection is classified as type 4 (figure 6-21 and 6-22 and table 6-4). Wave wash apparently produced some small scarps on the bench area. Springs and seepage weakened the bench soils and made them susceptible to wave erosion. Currents at high stages or during floods can erode in-place bank soils.

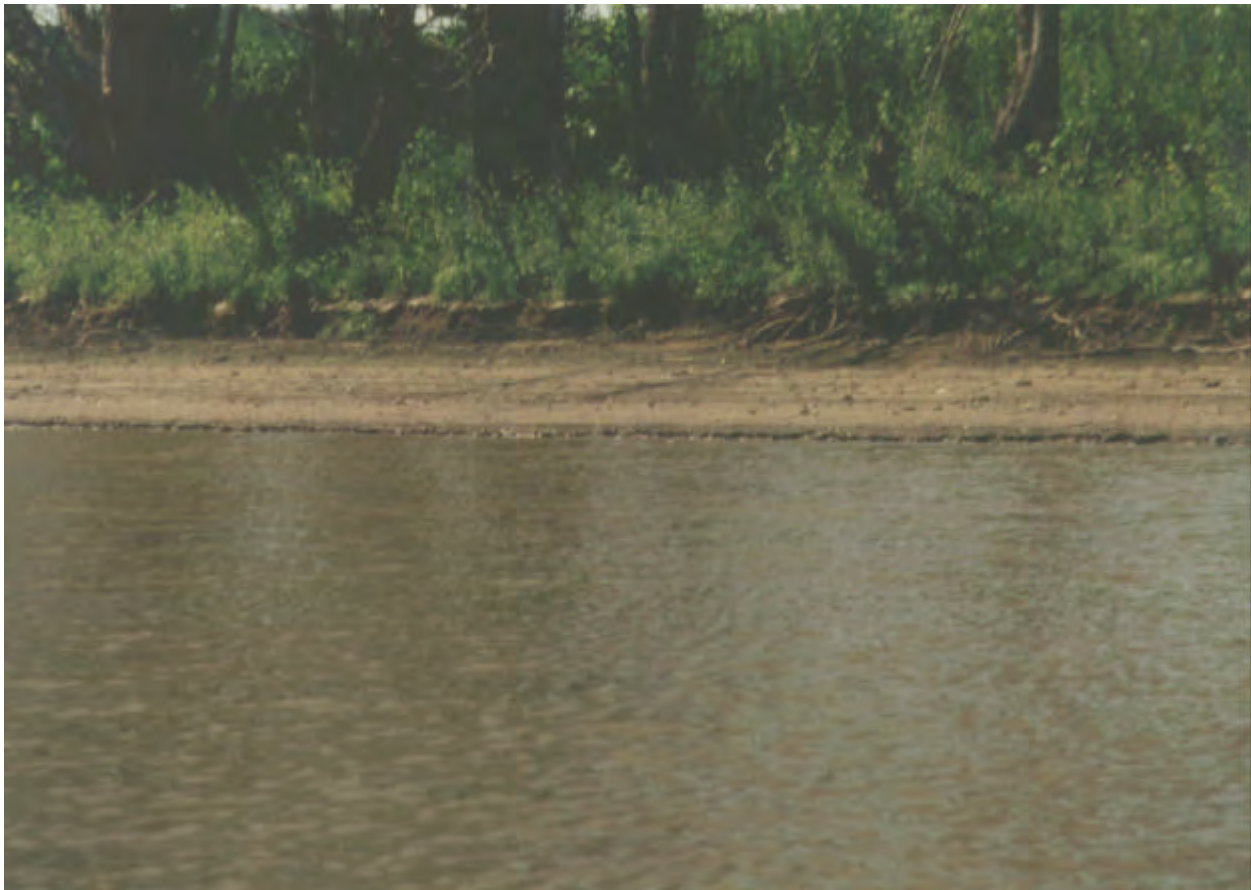
**Figure 105. Site 22 on the Illinois Waterway**

high. Below the scarp, a bench was composed of very soft silty soil with many peds on the silt surface. The bench was fairly moist.

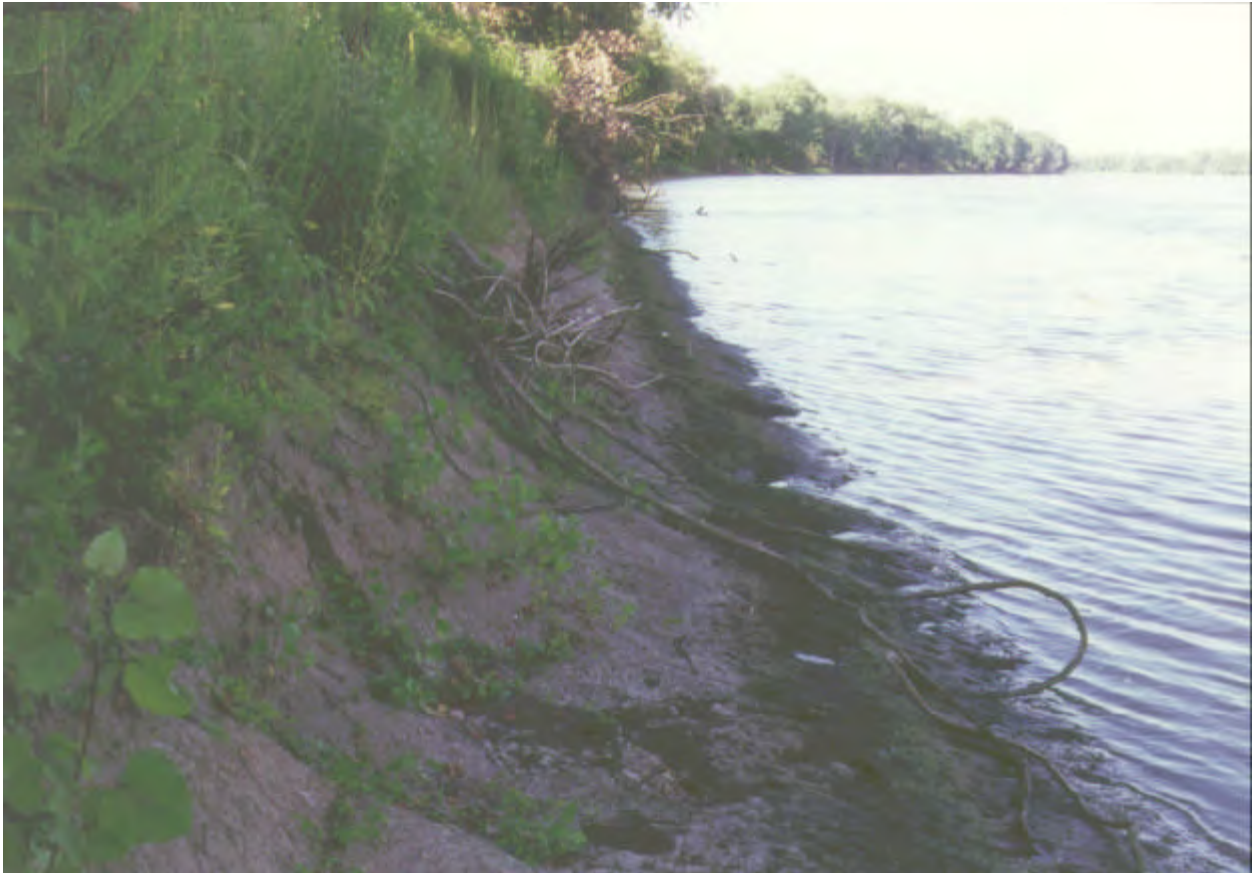
**Figure 6-108. Site 23 on the Illinois Waterway**

The navigation channel is close to this site; the bank is about 180 feet from the sailing line. Bhowmik and Schicht's (1980) Reach 1 was located at RM 24.0 on the opposite bank. Hagerty (1988) marked erosion on both bank sections, but eroded reaches were shown in several segments. For this site, Hagerty (1988) noted 6 feet of bare scarp.

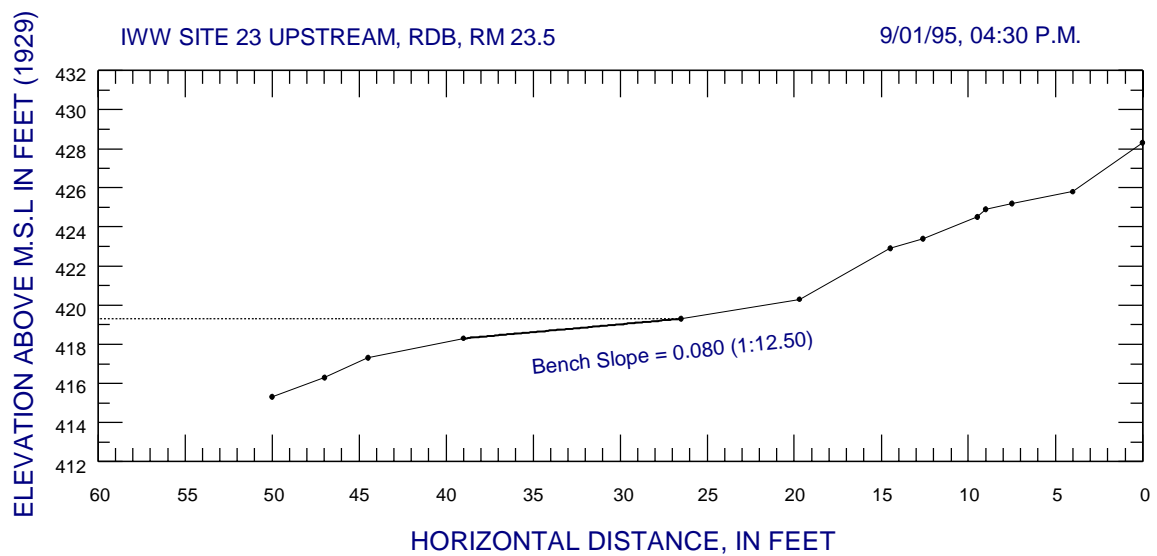
**Figure 6-109. Bank sections at site 23**

Figure 6-109 shows the three measured bank sections and a reduced cross section. The stage at the time of survey was at about the 90% recurrence frequency stage. Dense seasonal vegetation covered the upper portion of the bank face, and the bank slope was steeper downstream. Bank materials were similar to those at other bank sections in the Alton Pool, with a hard clayey layer at the upper part of the bank, and a lower bank covered by moist, soft clayey soil. Algae were growing near the water's edge. As shown in table 6-33, the bare bank face corresponds well to the stage ranging between 50% and 25% recurrence frequencies. The 50% recurrence stage is about 420.3 feet at the base of the scarp.

At the midsection, the  $d_{50}$  varied from 0.016 mm at the surface of the bank to 0.020 mm at the upper part of a core sample at a water depth of about 2 feet. The  $d_{50}$  values were very uniform at the midsection. Gradation plots of bank soils and nearshore sediment are presented in appendix F. The detailed river cross section and coordinates are shown in appendix G.

Bench slopes varied from 1V:12.5H at the upstream section to about 1V:5.0H at the midsection and downstream section. The upstream section and midsection are classified as type 4 and the downstream section is classified as type 2 (figures 6-21 and 6-19 and table 6-4). There was erosion due to surface drainage; other apparent causes are seepage, rework, and transport by levees and currents at various stages of pool-level fluctuations.

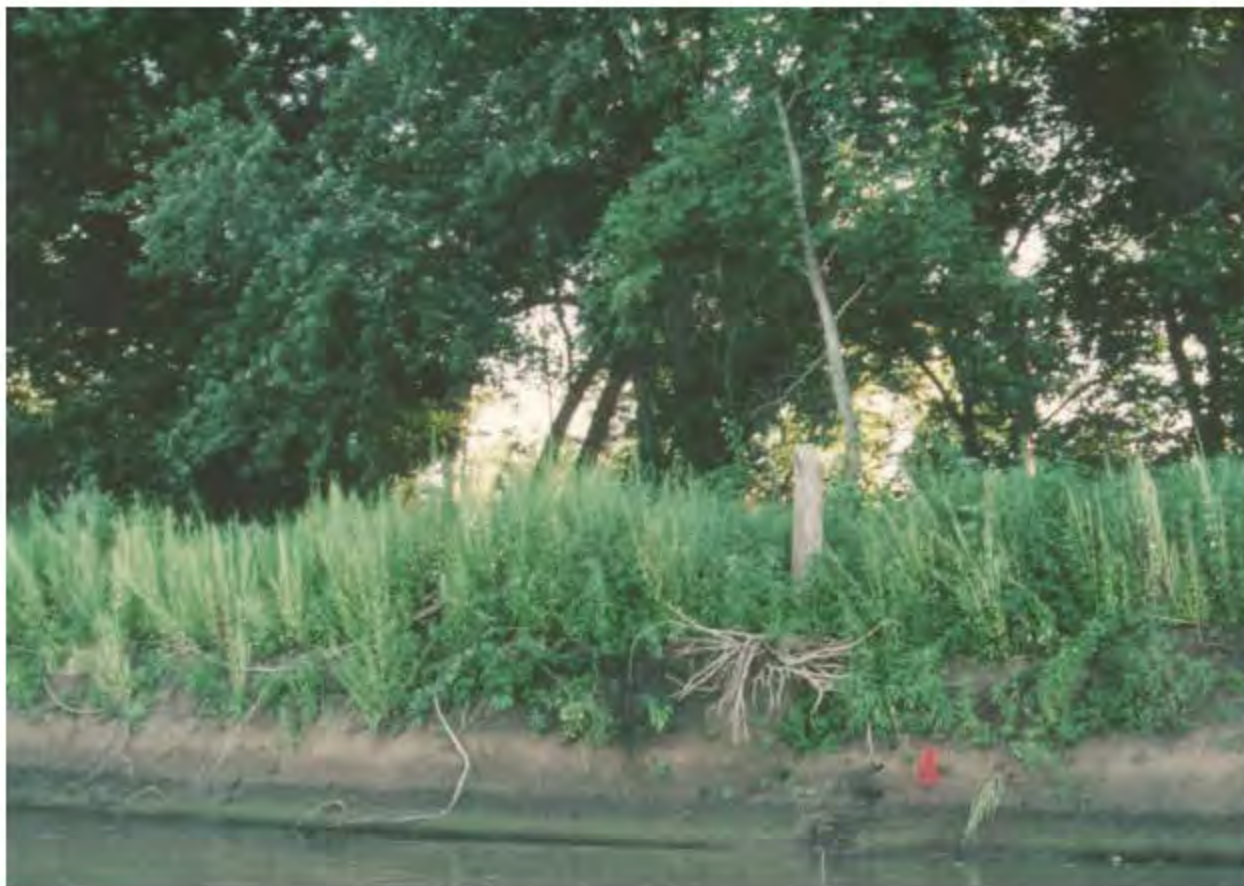
**Figure 6-111. Site 24 on the Illinois Waterway**

**Site 24, Alton Pool, 9/1/95.** This site is located on the RDB at RM 13.1 on the outside of a bend. Upstream on the RDB is the (old) Hadley's Landing (RM 13.4) and across the river is Twelve Mile Island. Figure 6-110 shows the position of the site on a GIS-based map of the Illinois navigation chart, and figure 6-111 shows a photograph of the site.

The bank characteristics are similar to those at other sites in the Alton Pool. Figure 6-112 shows the three measured bank sections and a reduced cross section. Land cover on the top and upper portion of the bank was dense seasonal vegetation, mostly above the water line. The sloping bank below the vegetation zone was bare; the base of the bare area was moist and algae was growing near the water's edge. The stage at the time of the survey was at about the 90% recurrence frequency stage. The subaqueous bench at the site was broader and flatter than the bench at site 23. The bench was covered with a layer of thick sediment in the nearshore area, but farther riverward the bench surface was hard. The stage analysis (table 6-34) indicated that the bare bank face was located between the 50% and 25% recurrence stages. The 50% recurrence stage, 420.3 feet, was at the base of the scarp.

Bench slopes varied slightly from 1V:25.0H to 1V:15.9H in this reach. The bank soils were cohesive. This site can be classified as a combination of types 2 and 5 (figures 6-19, 6-22, and table 6-4). Erosion processes could be traced as initiated by piping; debris-induced local currents and wave wash extend the erosion; rework and transport by waves and currents at various stages of pool-level fluctuation then remove the failed soils or recently deposited sediment.

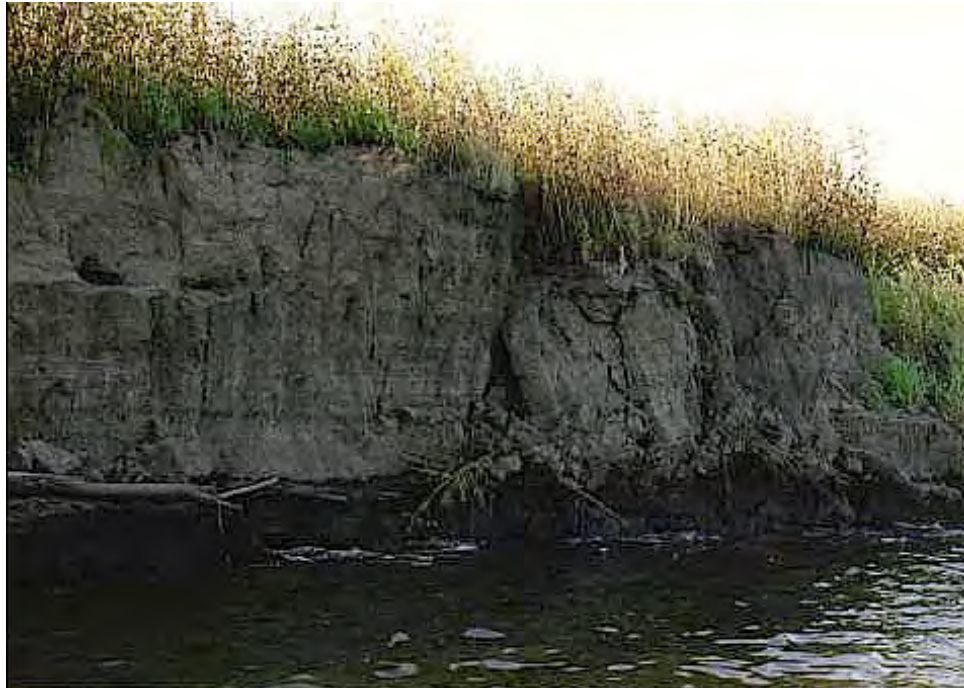
**Photo 7-1 Type A eroded-bank site (Site 28, RM 357.6)**

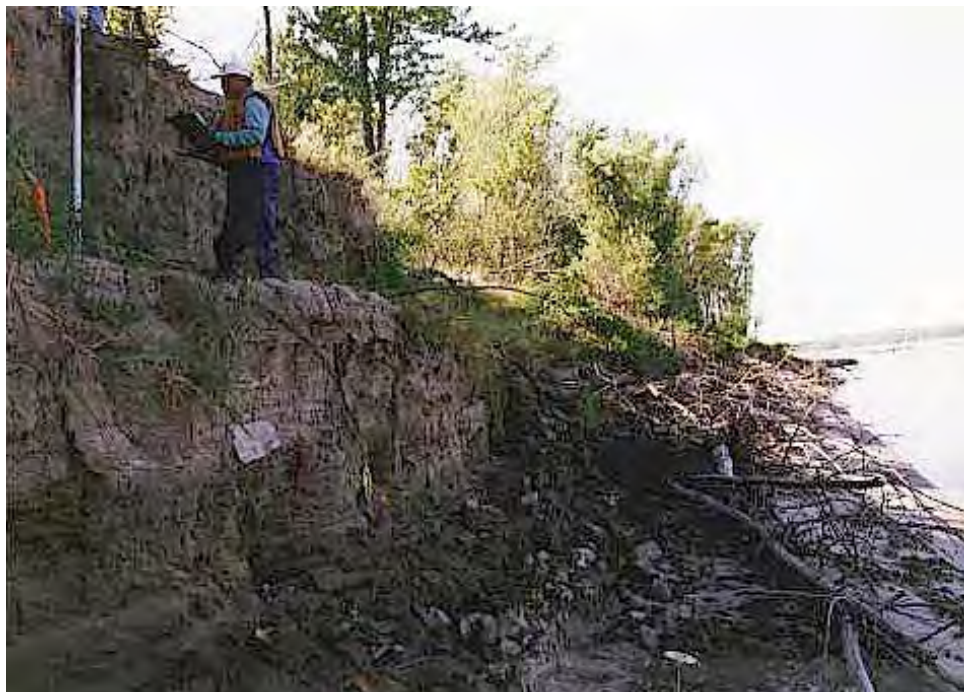
**Photo 7-2 Combination of Type A and Type B eroded-bank sites  
(Site 44, RM 26.0)**

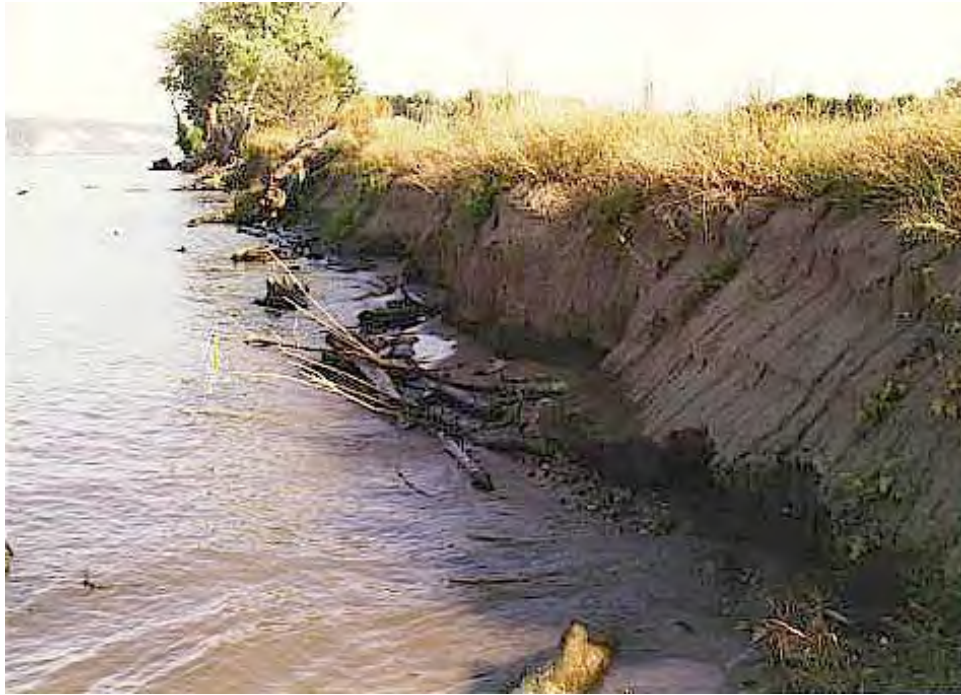
**Photo 7-3 Type C eroded-bank site (Site 36, RM 217.5)**

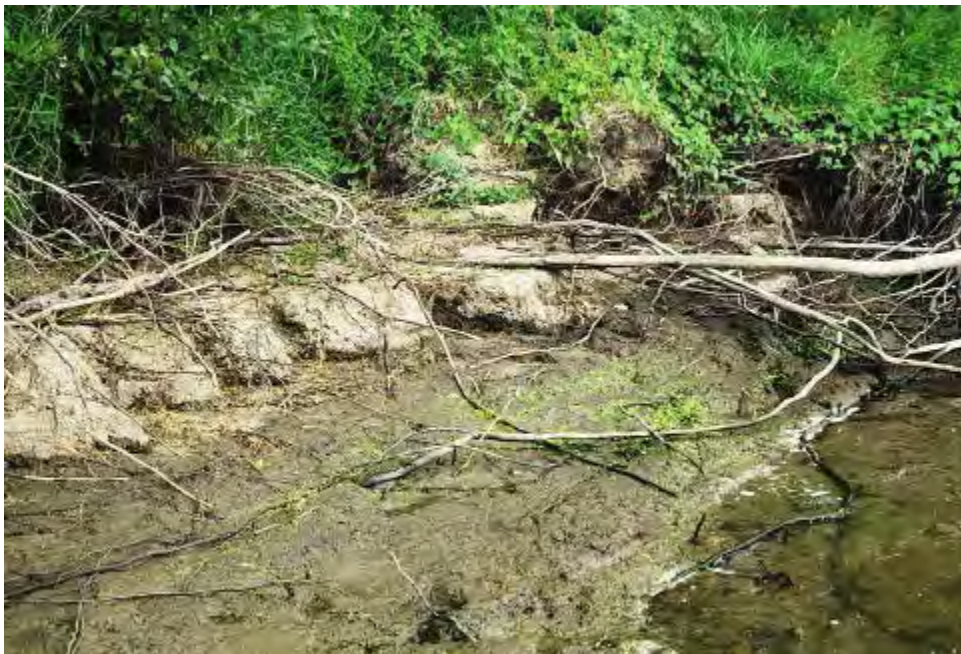
**Photo 7-4 A combination of Type D and Type E eroded-bank sites (Site 18, RM 432.3)**
