# **Interim Report For The Upper Mississippi River - Illinois Waterway System Navigation Study**

**US Army Corps  
of Engineers**

**November 1997**

## Bank Erosion Field Survey Report of the Upper Mississippi River and Illinois Waterway

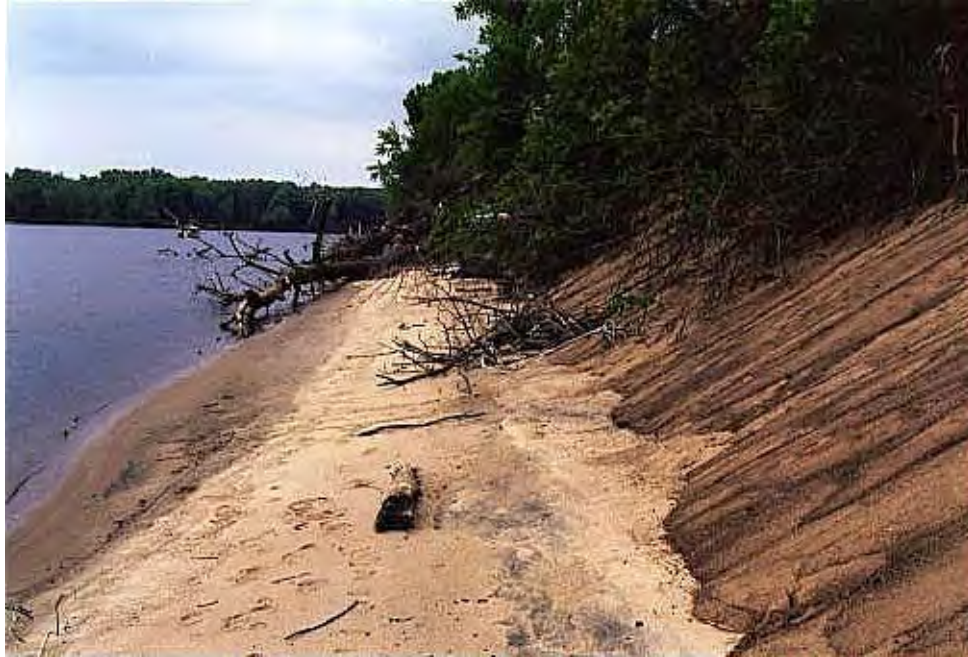
**Photo 7-5 Type F eroded-bank site (Site 3, RM 763.4)**

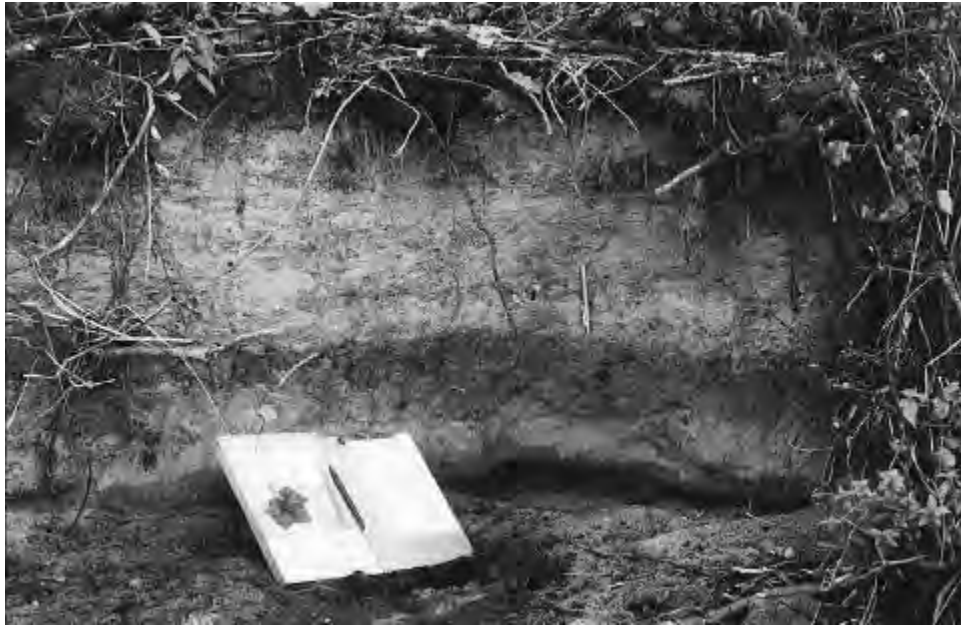
**Photo 7-6 Buried native soil below historical alluvium observed at Site 4, RM 751.1 (the lighter colored upper unit is the historical deposit)**

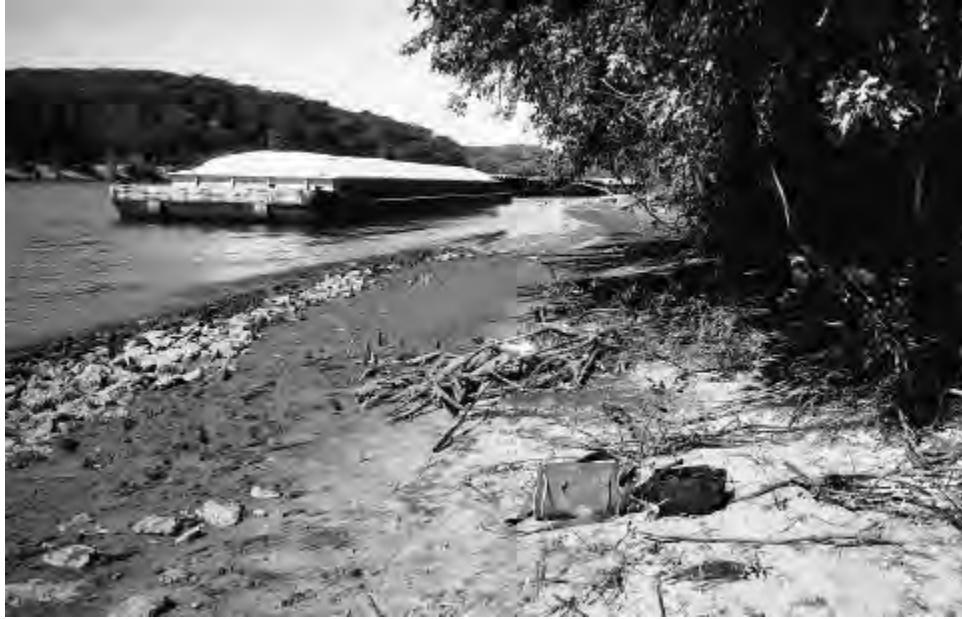
**Photo 7-7 Severe bank erosion at barge mooring area observed at Site 15, RM 576.0**

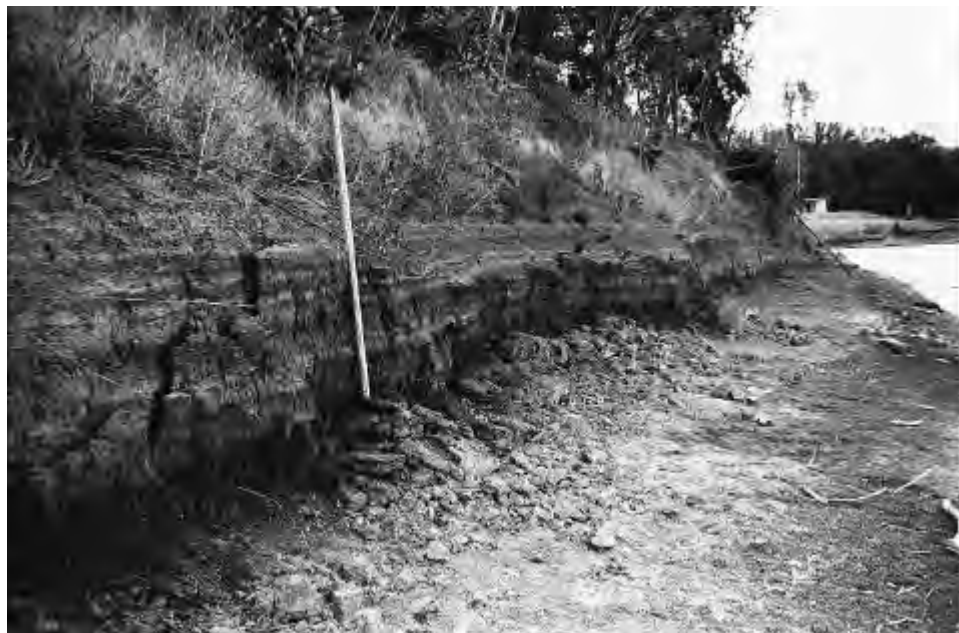
Below the confluences with the Illinois and Missouri Rivers, Holocene-aged surfaces along the channel margin all but disappear and are replaced by thick-bedded historical alluvium, as shown in Photo 7-8. With the exception of a few areas, a continuous levee

**Photo 7-8 Thick historical alluvium overlying the native soil observed at Observation Site, RM 194.0 (the bottom of stadia rod indicates the native soil surface)**

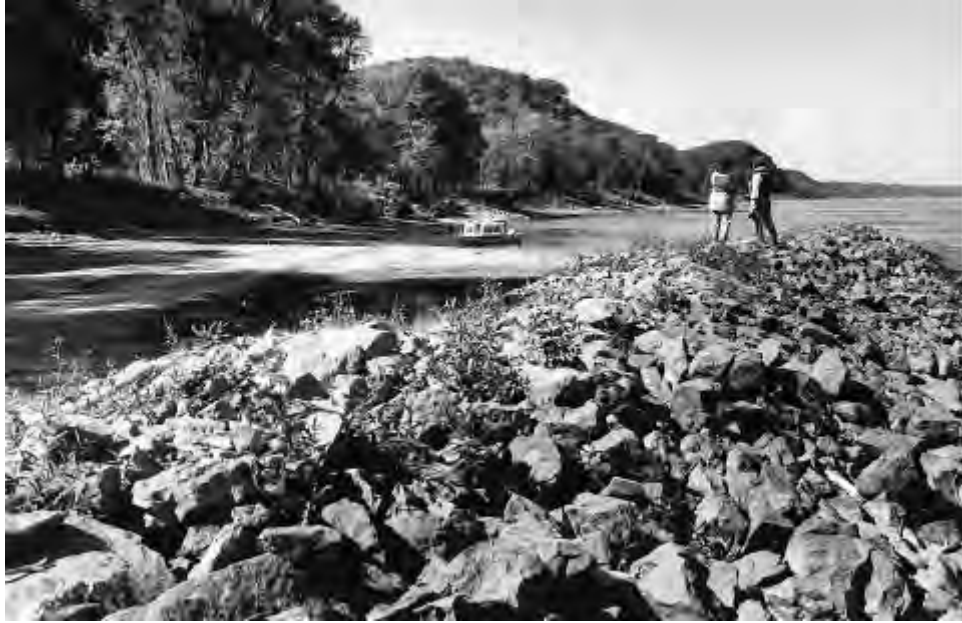
**Photo 7-9 Observation Site, RM 134.1 -- looking north upstream --  
(this photo shows study team members standing on CCC-placed  
riprap (ca. 1930s) About 150 ft of bank erosion has occurred  
westward to the left since riprap placement)**

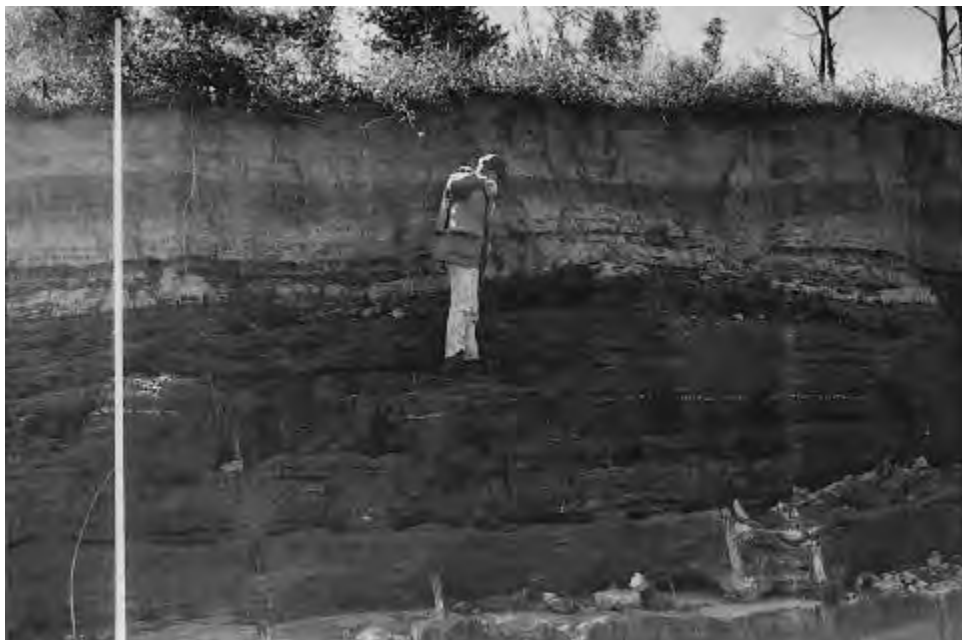
**Photo 7-10 Bank face showing a profile composed entirely of recent historical  
alluvium at Site 39, RM 112.4**

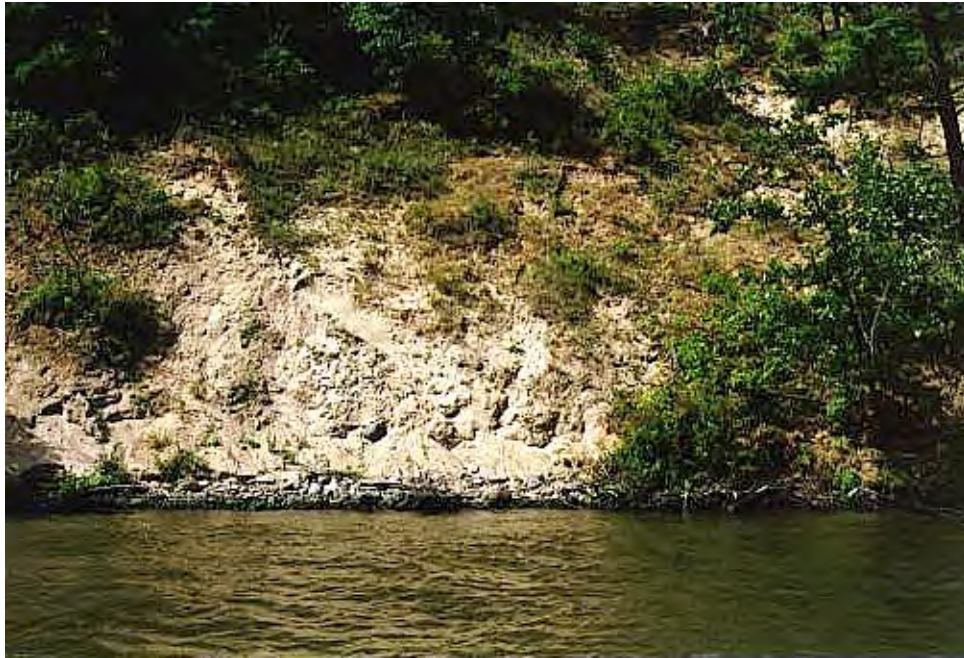
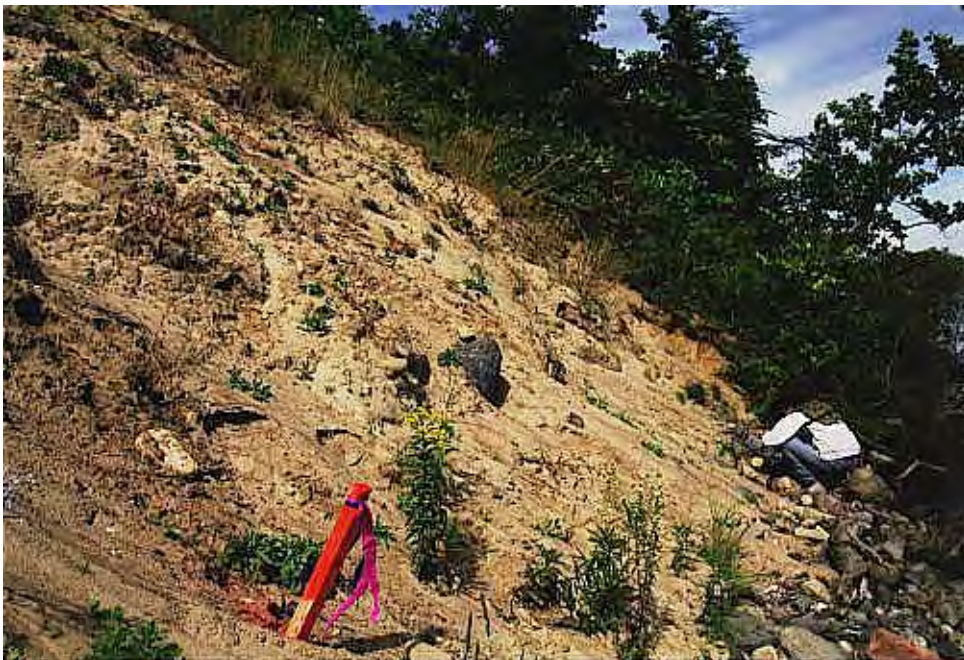
This right-bank site shown in figure 7-6 is located along the outer bank of a sharp river bend, and is very close to the thalweg sailing line. Side and upstream views of the site are shown in Photos 7-11 and 7-12, respectively. As can be seen in figure 7-7, the active steeply failing bank slope, approximately 90 ft high, consists primarily of glacial deposits.

Primary causes of bank retreat at this site study include gravitational fall of the loose material, flood erosion and oversteepening, and current and wave wash. The loose bank soils close to the sailing line are susceptible to impacts of high-stage flood flows and subsequent wave erosion. As can be seen in Photos 7-11 and 7-12, failed fine soil and recently deposited sediment had been washed out and only large gravel or boulder lag remain near the water's edge. This erosion site is classified as bank Type F (see figure 7-4). The principal information for this site and every other site is summarized in tables 7-5a, 7-5b, and 7-5c.

**Photo 7-11 A side view of Site 1 midpoint**

**Photo 7-12 An upstream view of Site 1 midpoint**

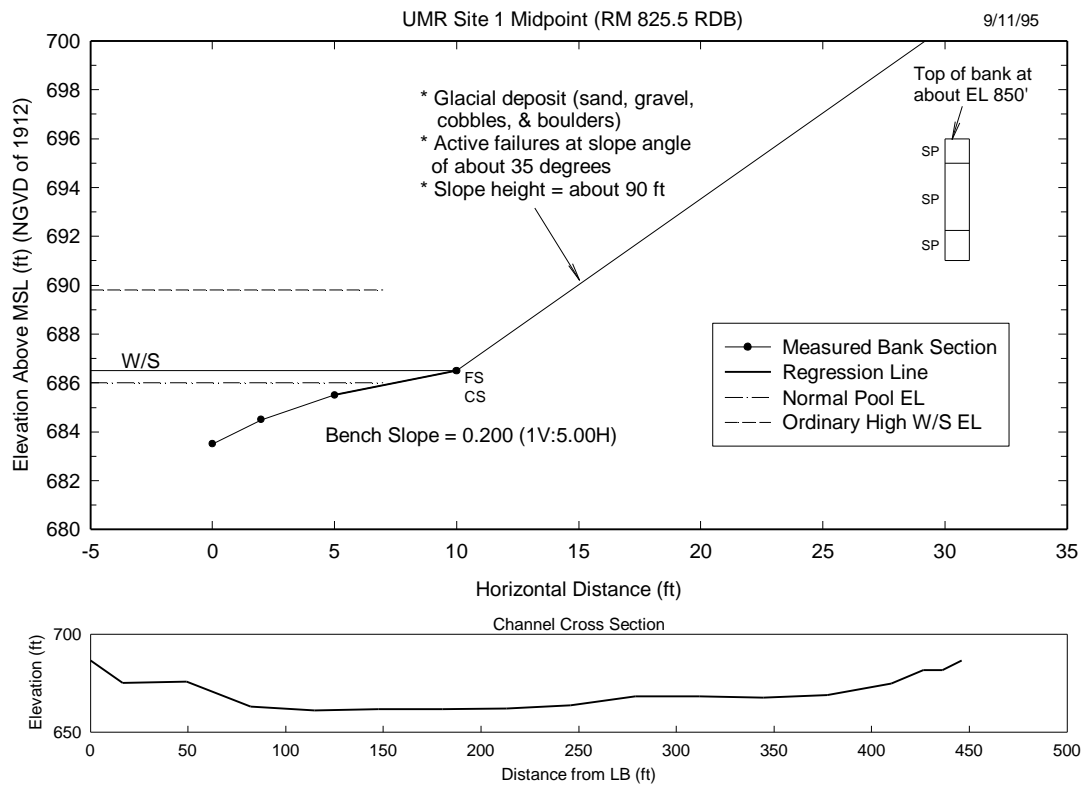
**Figure 7-7 Bank section and channel cross section measured at Site 1 midpoint**

The surficial soil near the water's edge at this site is fine to coarse sands (FS and CS, see table 7-3 for soil-gradation scales), and the tube soil sample taken at the top of the bank was classified as poorly-graded gravelly sands (SP, see table 7-4 for definition). The bank soils also include very coarse sands, gravels, cobbles, and boulders. The bench slope was estimated to be 0.200, as shown in figure 7-7. A regression line, shown by a thick solid line in each bank-section plot and noted as Regression Line in the legend, shows the bench. The river cross section shown in this figure does not indicate a typical profile for the concave bank in which flow depth and velocity are much larger along the outer bank.

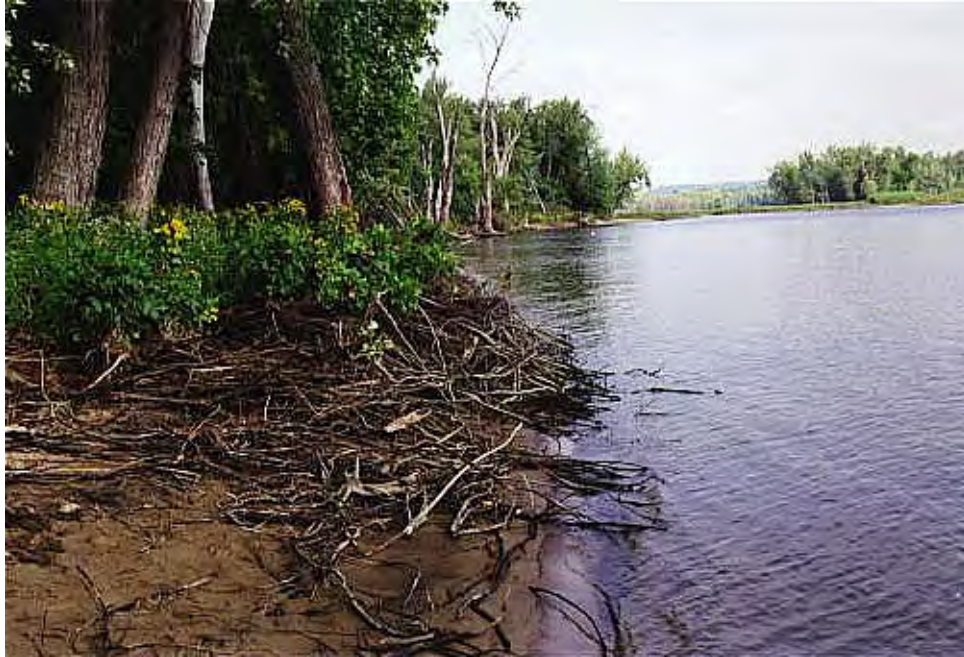
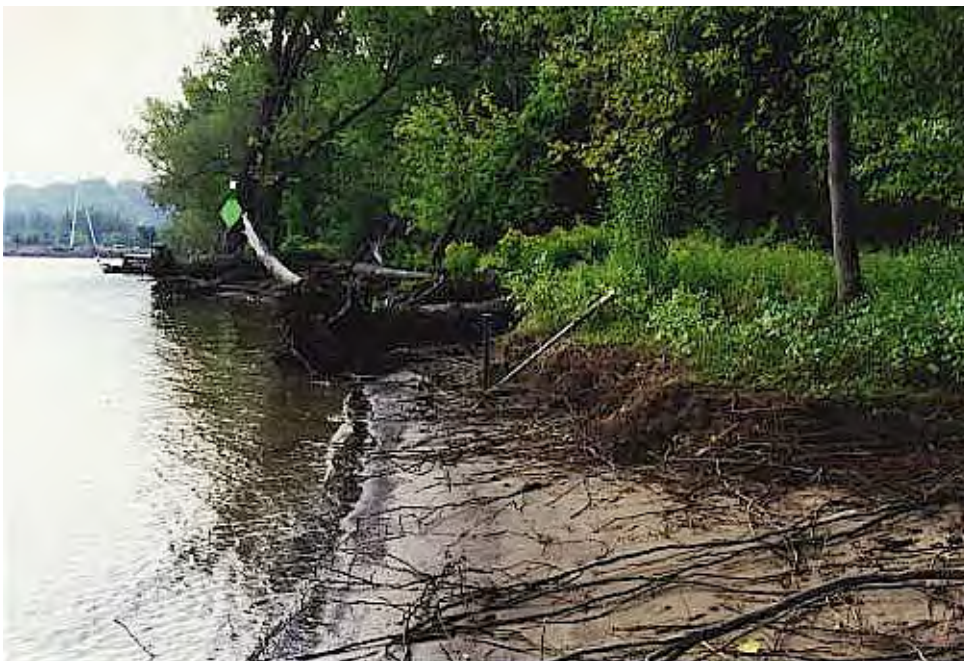
Three sections were established on the outside of a bend, as shown in figure 7-8. Photos 7-13 and 7-14 show upstream and downstream views of the site, respectively. Figures 7-9, 7-10, and 7-11 show the bank sections obtained at the upstream point, midpoint, and downstream point, respectively. As at Site 1, the river cross section at the upstream point did not exhibit a deep channel along the right bank. However, the

**Photo 7-13 An upstream view of Site 2 midpoint**

**Photo 7-14 A downstream view of Site 2 midpoint**

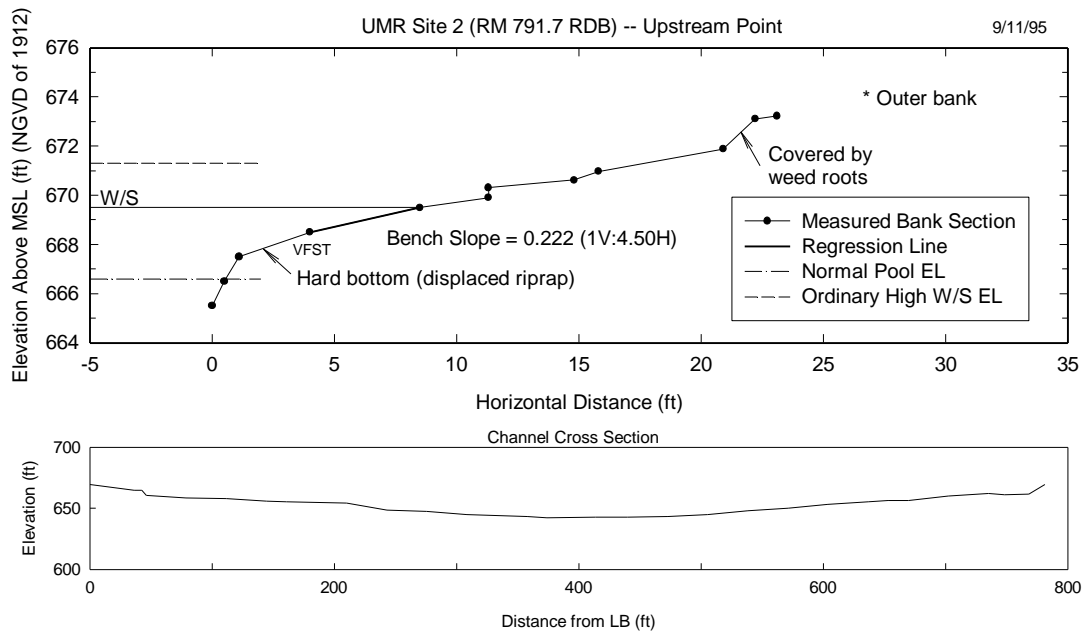
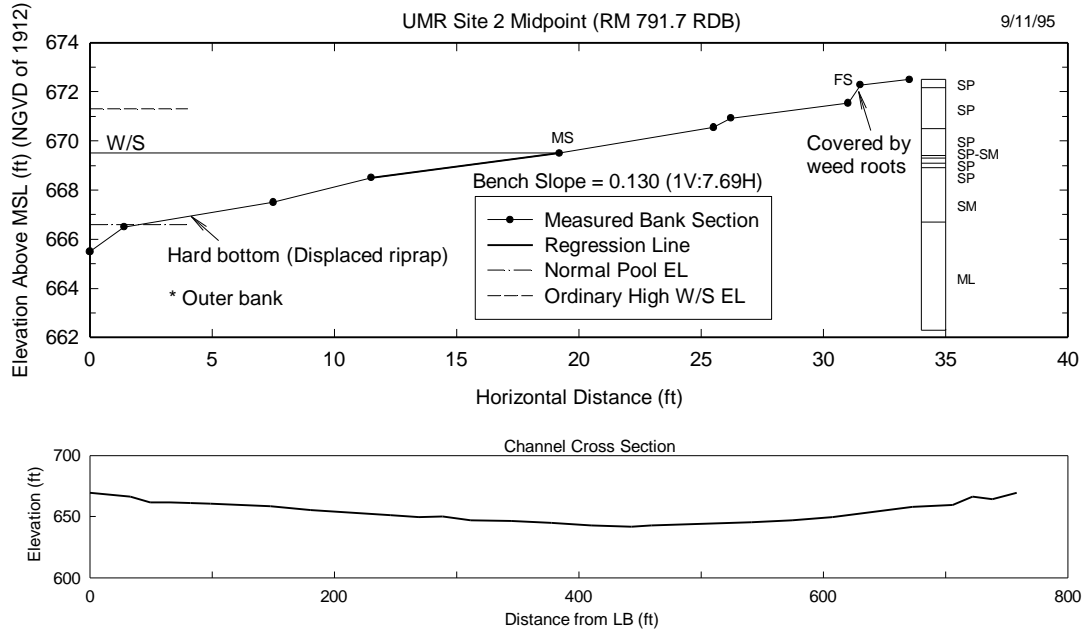
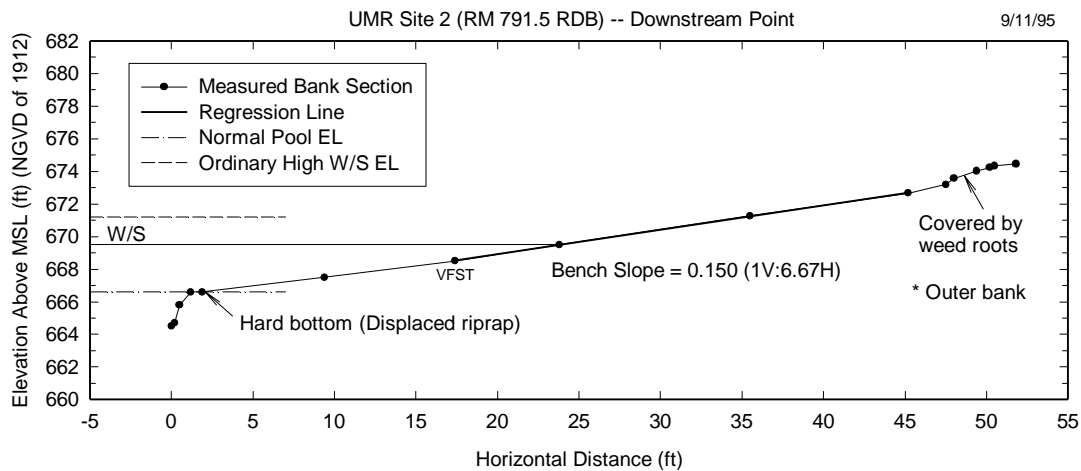
midpoint river cross section shows a shape typical for a mildly curved channel. As can be seen in these three figures, the bank soils are predominantly sands varying from fine

sand (FS) to medium sand (MS); the stone slope-protection revetment apparently had failed. Subaqueous soil is very fine silt (VFST). Figure 7-9 exhibits a typical rework-transport bank-section pattern which is illustrated in figure 7-5. Several subaerial parallel benches seen in figures 7-9 and 7-10 are considered to be formed at different river stages within a range of stage between NPL and OHWL. Those parallel benches formed at different bank elevations were observed at many other sites investigated.

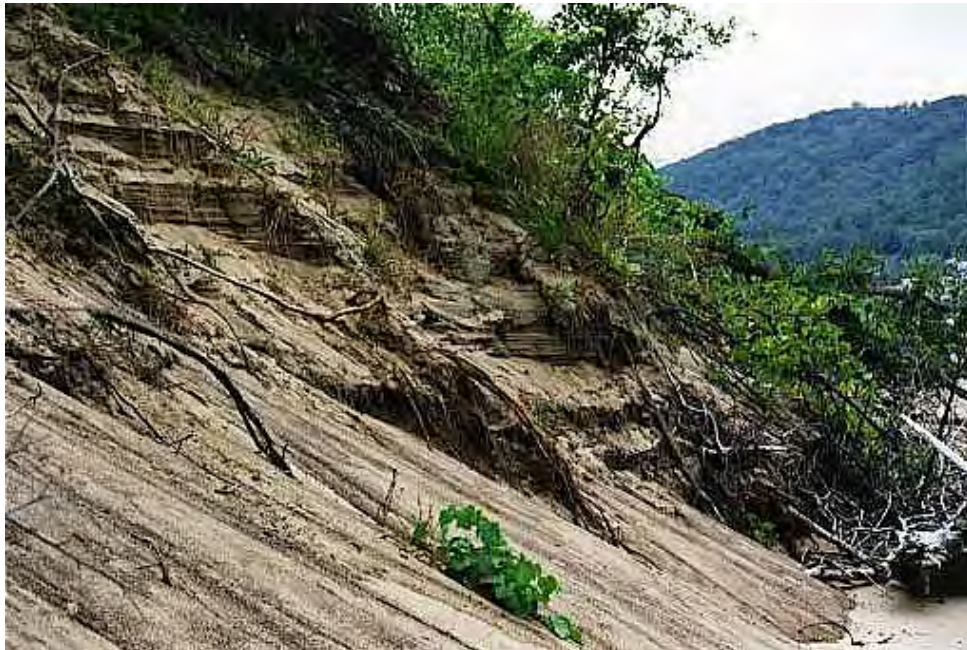
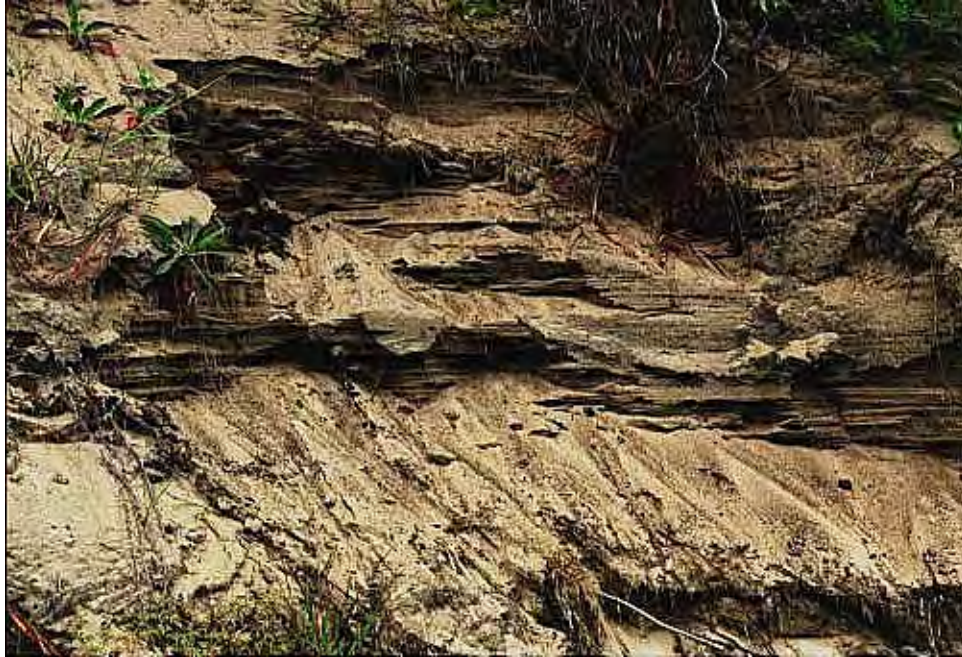
Site 3 is located at the distal end of the historical portion of a Chippewa alluvial fan complex. Numerous abandoned tributary channels (former fan outlets) were observed. Two sampling tube cores, taken at this site, indicate that sandy dredged material caps recent historical flood laminae. The native pre-settlement (before ca. 1830) soil was not encountered.

Because there is no erosion protection at this site, dredged material was reworked and transported to the river. The bank-section bench area can be seen clearly in figure 7-14 at the midpoint section. Dredged material at this site is prone to current and wave erosion. The bank sections at the upstream and downstream points are classified as a combination of bank Type E and Type F, and the midpoint section as Type F.

**Photo 7-15 A downstream view of Site 3 midpoint**

**Photo 7-16 Detailed bank-soil structure of Site 3 midpoint**

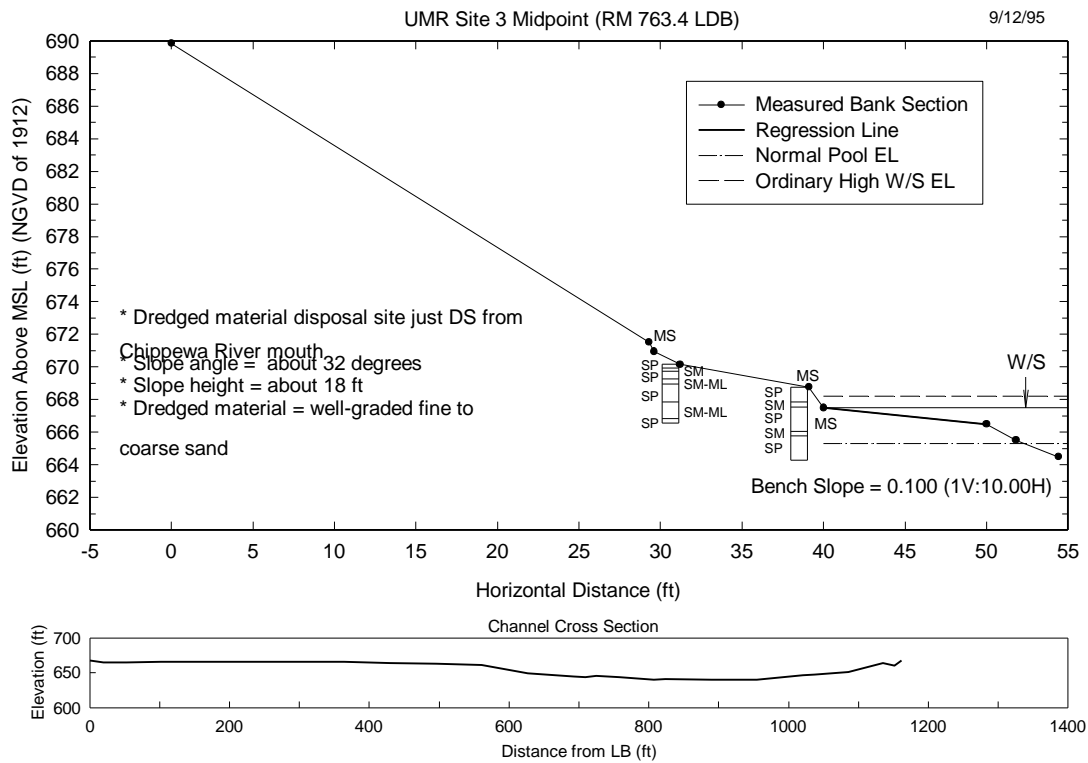
**Figure 7-14 Bank section and channel cross section measured at Site 3 midpoint**

channel is located about 600 ft to 800 ft away from the left bank. The dredged bank material consists primarily of medium sand (MS). Subaqueous soil is sand (MS-CS). At the midpoint section, the bank slope was found to be approximately 32°, typical of the angle of shearing resistance of medium dense sand.

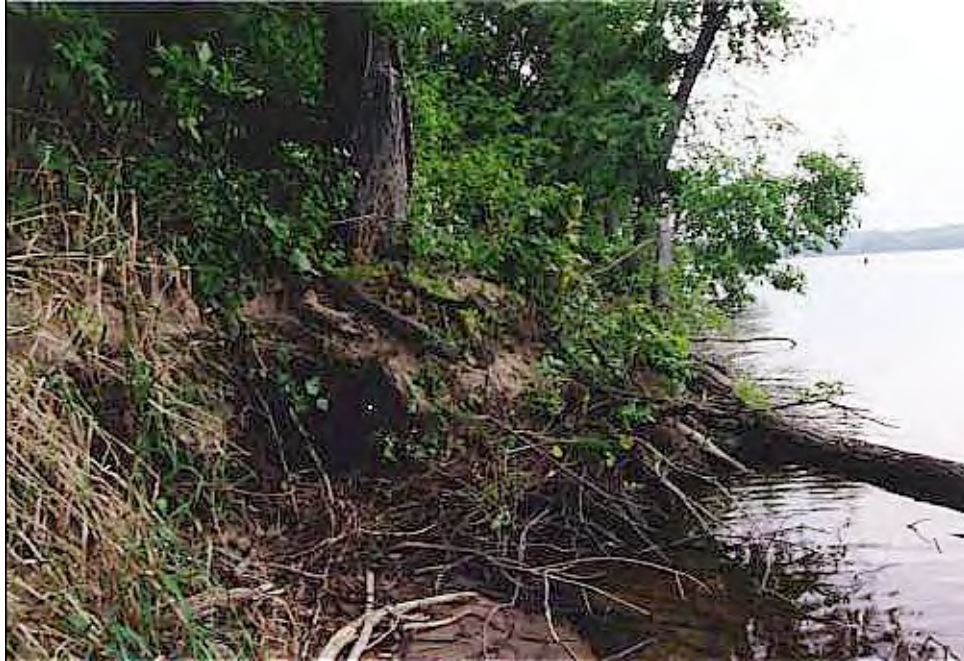
**Photo 7-17 A downstream view of Site 4 midpoint**

This left-bank site, shown in figure 7-16, is located only about 2 miles downstream from Lock & Dam No. 4, and is adjacent to mooring facilities used by two nearby power plants. A downstream view of the site is shown in Photo 7-17. As shown in figures 7-17 through 7-19, very steep subaqueous slopes exist at this site, which is indicative of in-channel erosion. At the downstream section, evidence of failed revetment was found near the water's edge (see figure 7-19). The bank soils are primarily FS. The soil core sample, taken at the bank and shown in figure 7-18, show multiple layers of SP-ML (see table 7-4) which are judged to be historical deposits due to a series of flood events.

Causative factors for bank retreat at this site include flood erosion and rapid recessional loading and failure, and wave and rework-transport of failed soil and recently deposited sediments. Because of the closeness to the thalweg sailing line and mooring activities, this bench area cover is eroded by waves. All three bank sections are classified as bank Type E.

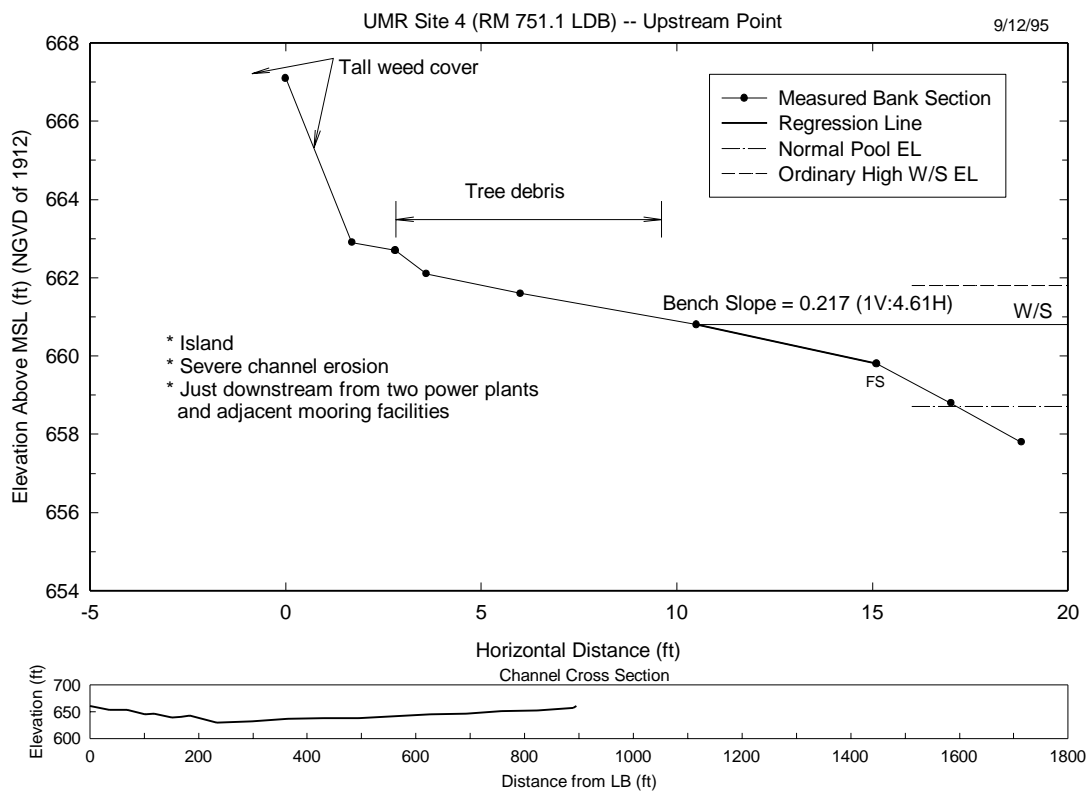
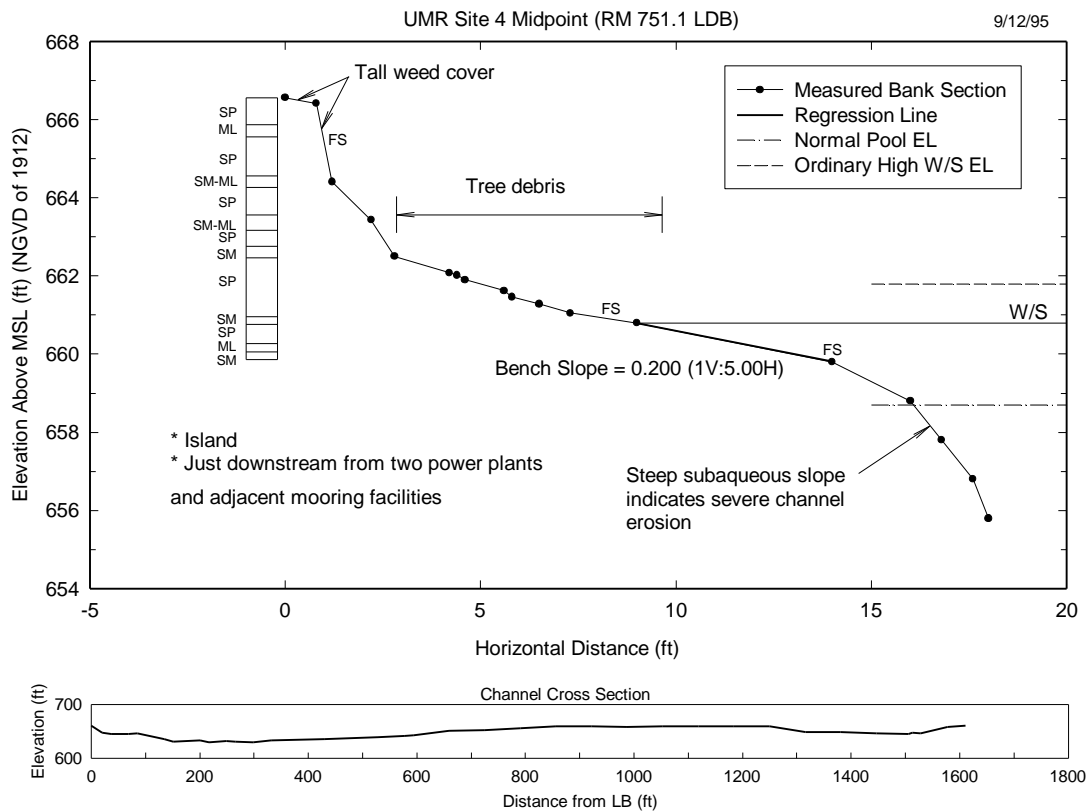
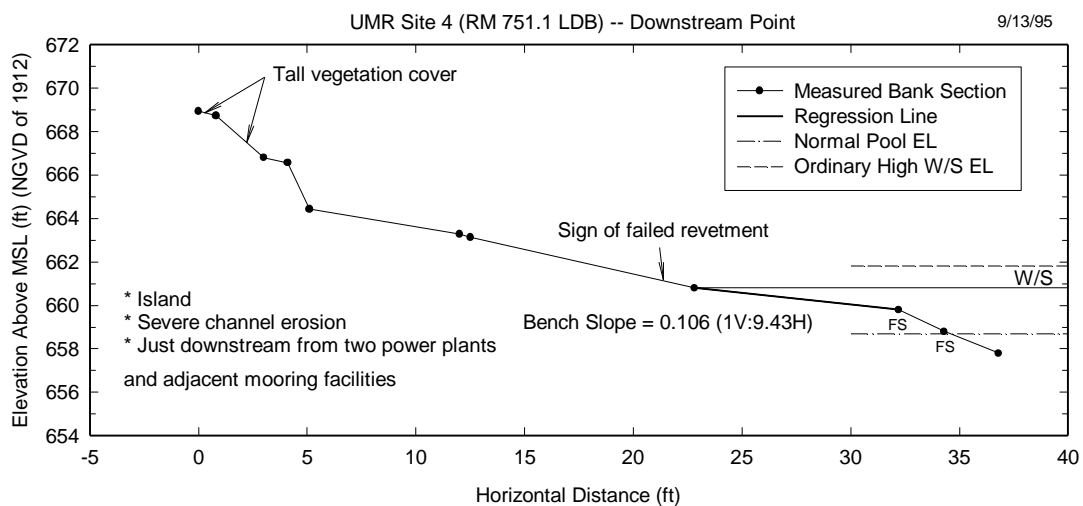
**Figure 7-17 Bank section and channel cross section measured at Site 4 upstream point**

**Figure 7-18 Bank section and channel cross section measured at Site 4 midpoint**

**Figure 7-19 Bank section measured at Site 4 downstream point**

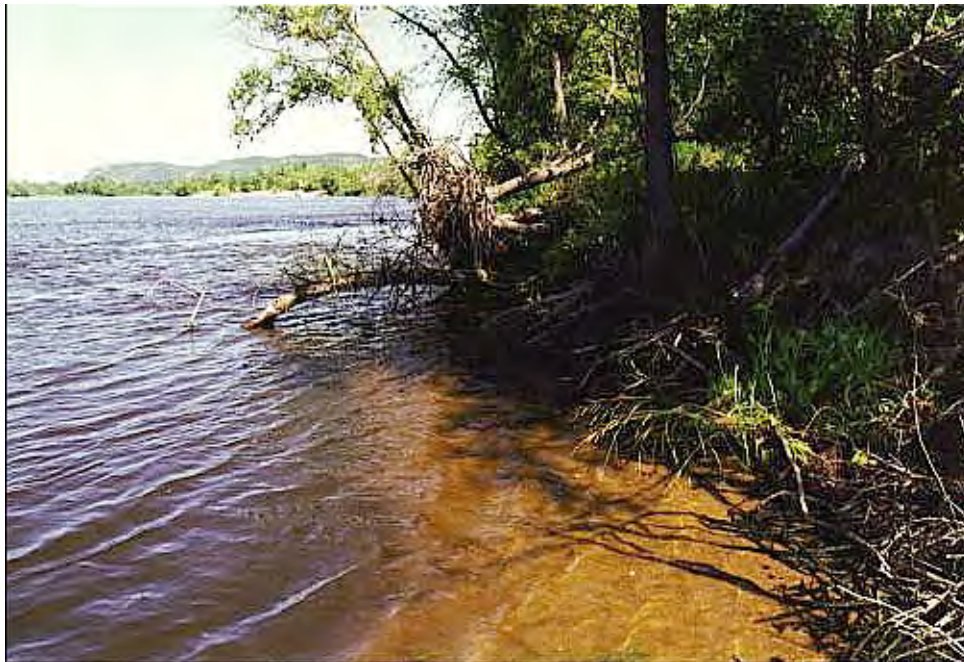
**Photo 7-18** An upstream view of Site 5 upstream point (see in-channel erosion)

Causative factors for bank retreat at this site include wave and rework-transport of failed soil and recently deposited sediments and flood erosion. Wave erosion within berm and bench areas appear to be significant at this site. The bank section for this site is classified as Type F.

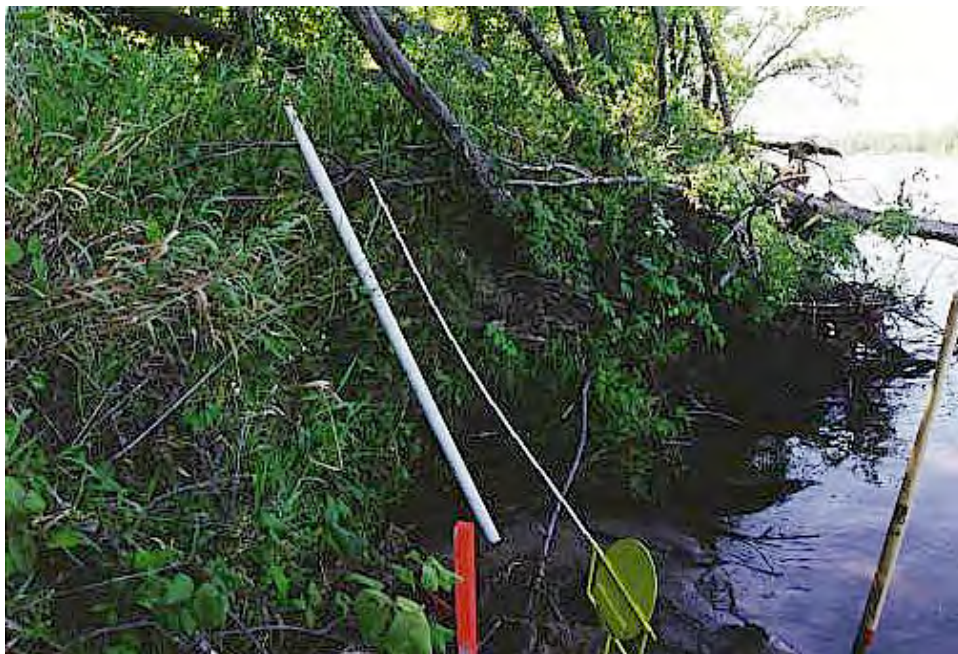
**Photo 7-19** A downstream view of Site 5 midpoint

channel. The bench slope gradually decreased from 0.313 at the upstream point to 0.183 at the midpoint, and to 0.139 at the downstream point along the island. These eroded island banks exhibit steep bench topography near the tip of the island and the bench slope decreases toward the toe of the island. These morphological characteristics were observed at other island sites.

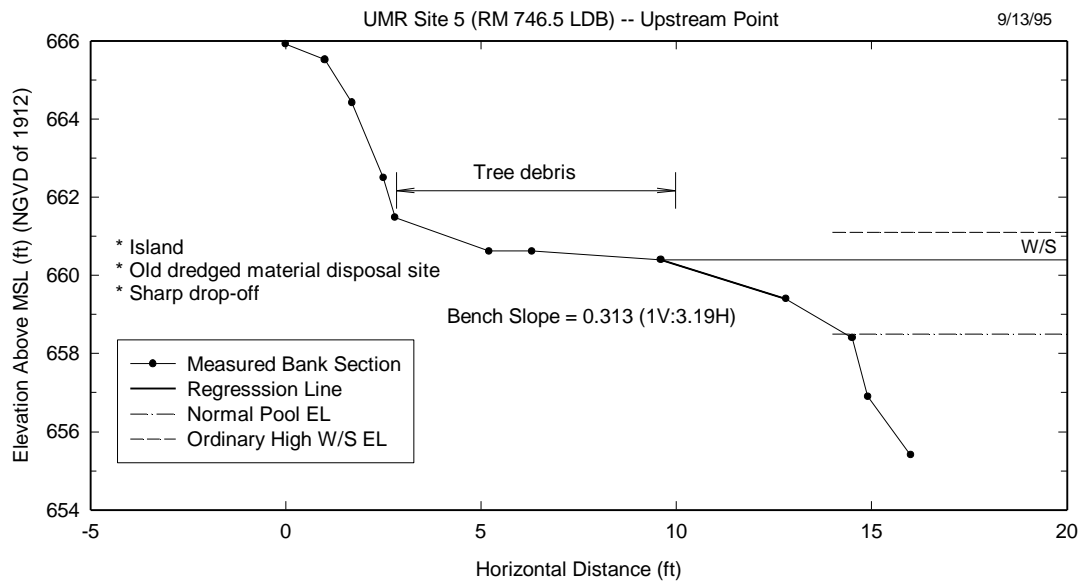
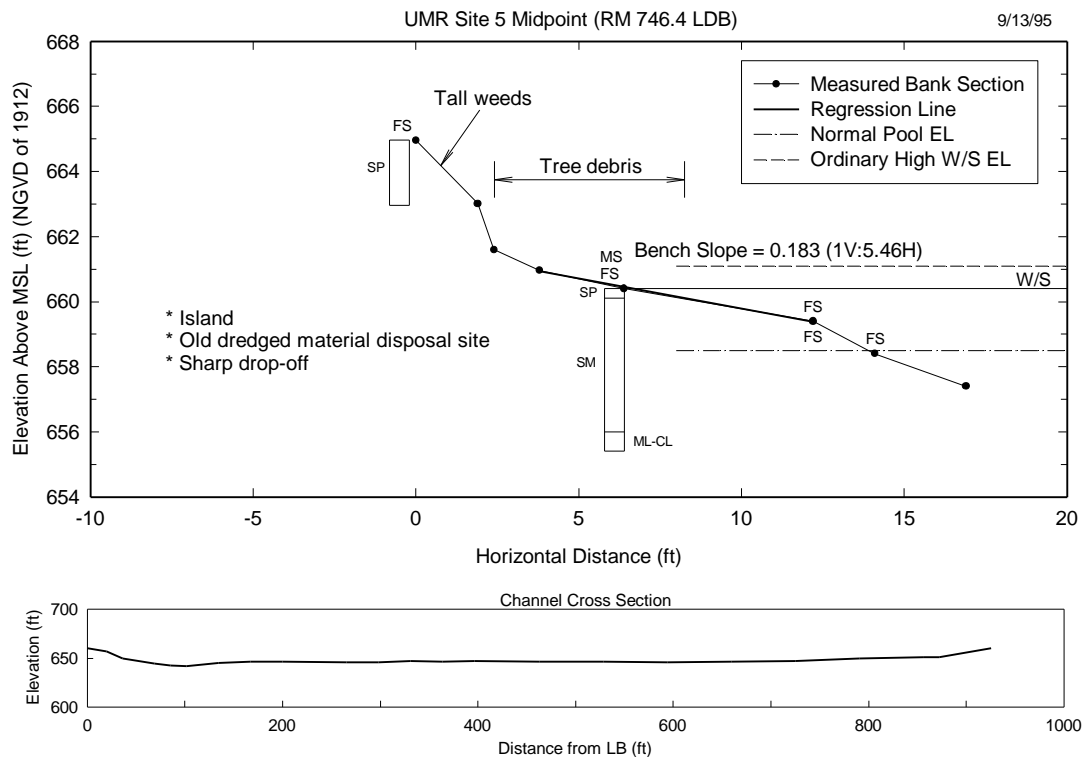
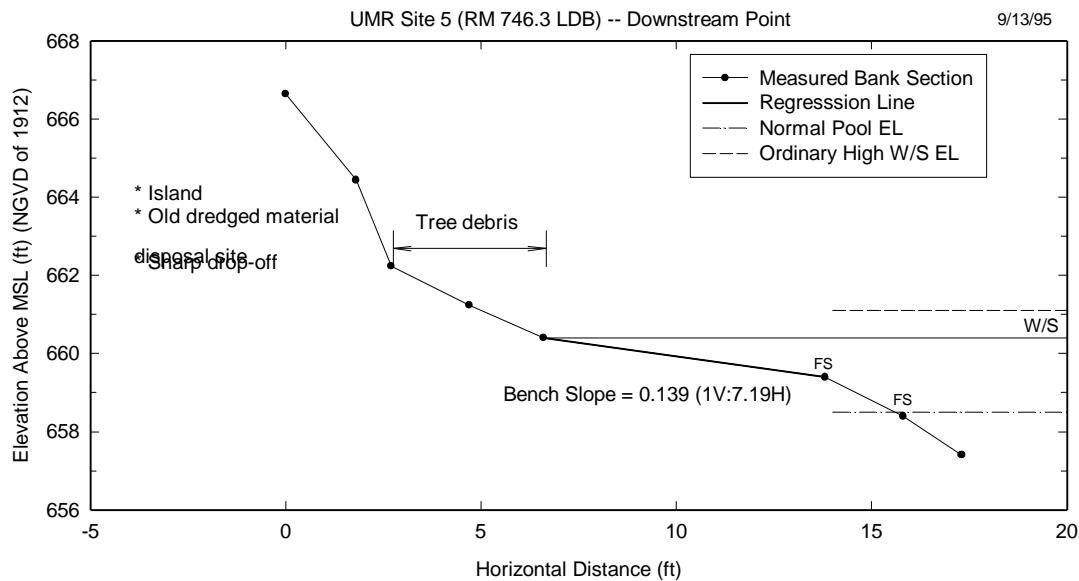
**Figure 7-21 Bank section measured at Site 5 upstream point**

**Figure 7-22 Bank section and channel cross section measured at Site 5 midpoint**

**Figure 7-23 Bank section measured at Site 5 downstream point**

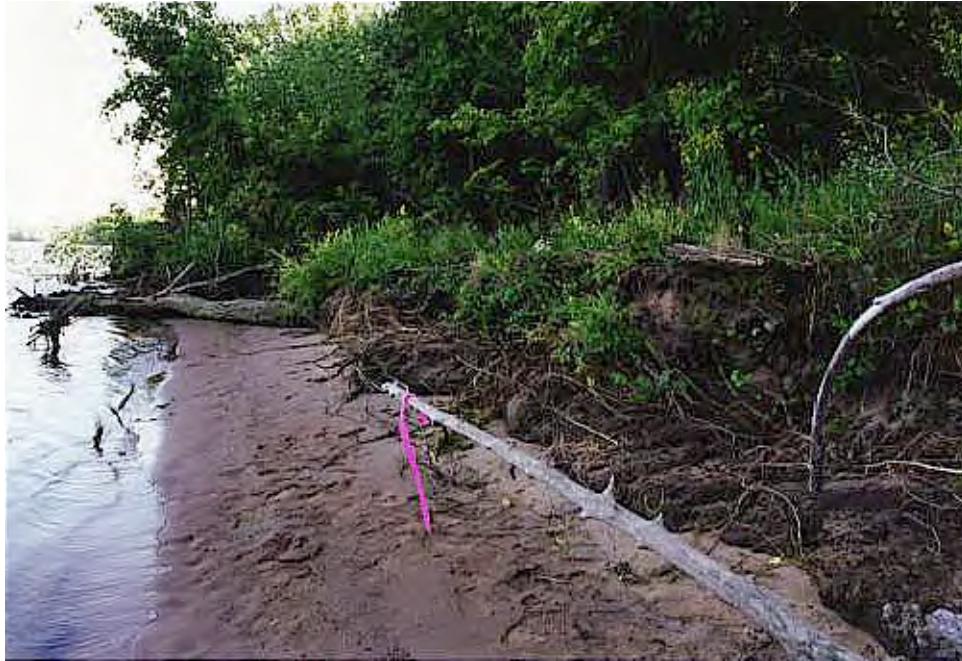
**Photo 7-20 A downstream view of Site 6 midpoint**

Primary causative factors for bank retreat at this site include flood-flow erosion and rapid recessional loading and failure, wave and rework-transport of failed soils and recently deposited sediments, and minor piping. Wave erosion of sand cover occurs within bench areas at this site. This site is classified as Type E.

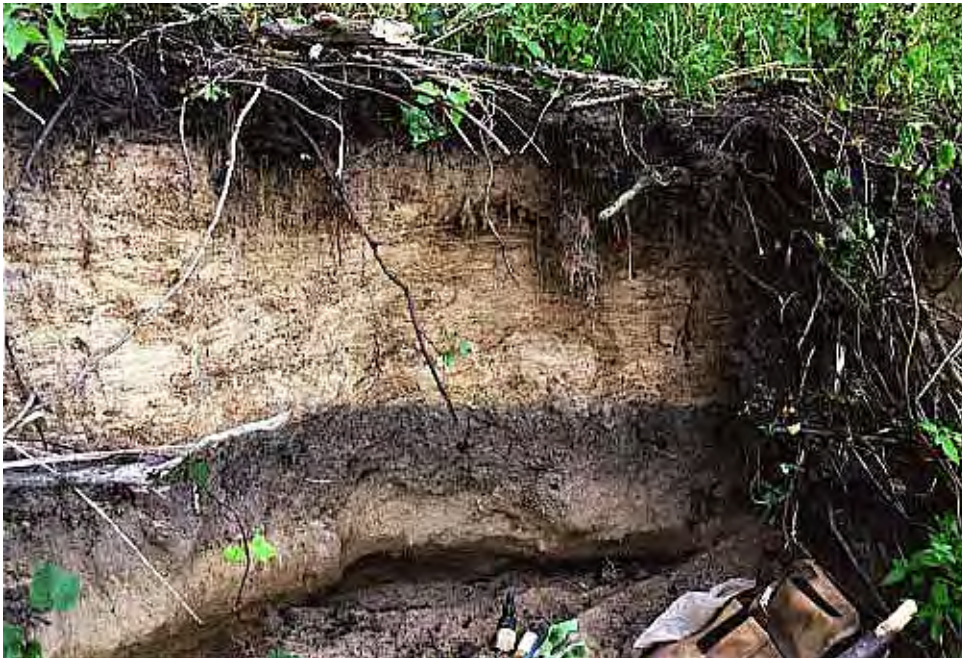
bank. The bank soil is primarily sand (VFS-MS) and subaqueous sediment is sand (FS-MS). The scarp was covered by grass roots and tree debris.

**Photo 7-21 A close-up view of scarp at Site 6 midpoint**

Observations indicate lateral bank erosion with minor surface erosion. No historical deposits were found in the core sample. Three paleosols were observed in the profile, developed in levee deposits, and they appear to be of late Holocene age. It should be noted that the buried soils occur in a MR natural levee deposit. Because of the buried soils and location in the upper pool, there is potential for buried archaeological material although there are no recorded archaeological sites nearby.

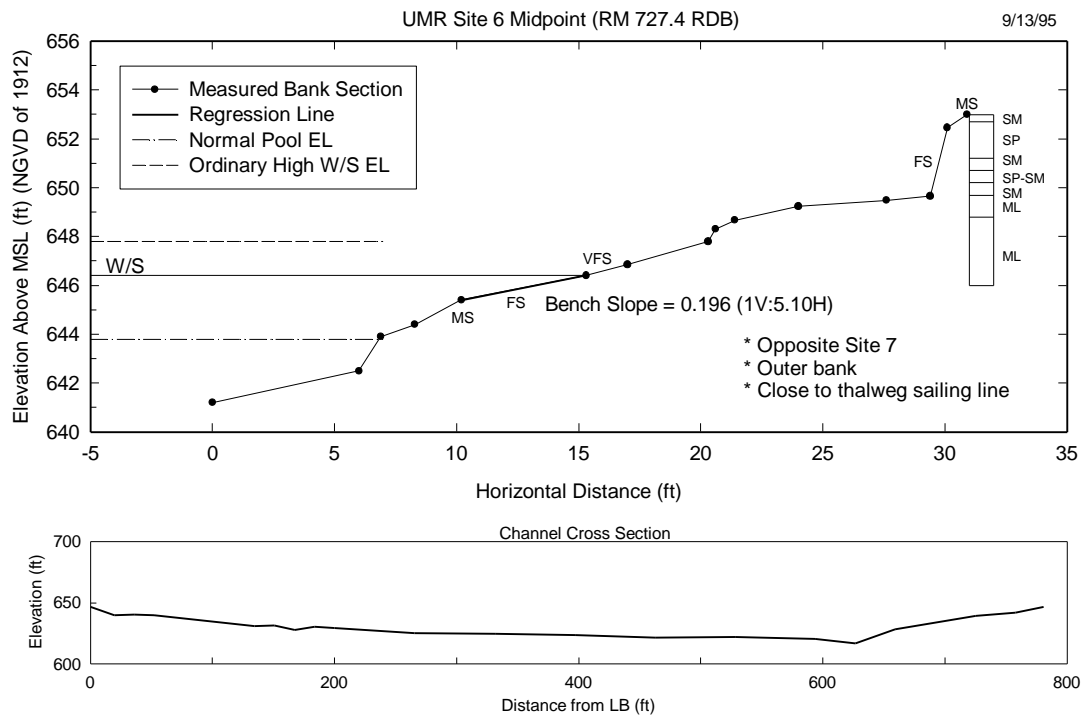
respectively. The three bank sections obtained at this site are depicted in figures 7-25 through 7-27. The river cross section in figure 7-26 shows the thalweg near the right

**Figure 7-26 Bank section and channel cross section measured at Site 6 midpoint**
