# **Interim Report For The Upper Mississippi River - Illinois Waterway System Navigation Study**

**US Army Corps  
of Engineers**

**November 1997**

## Bank Erosion Field Survey Report of the Upper Mississippi River and Illinois Waterway

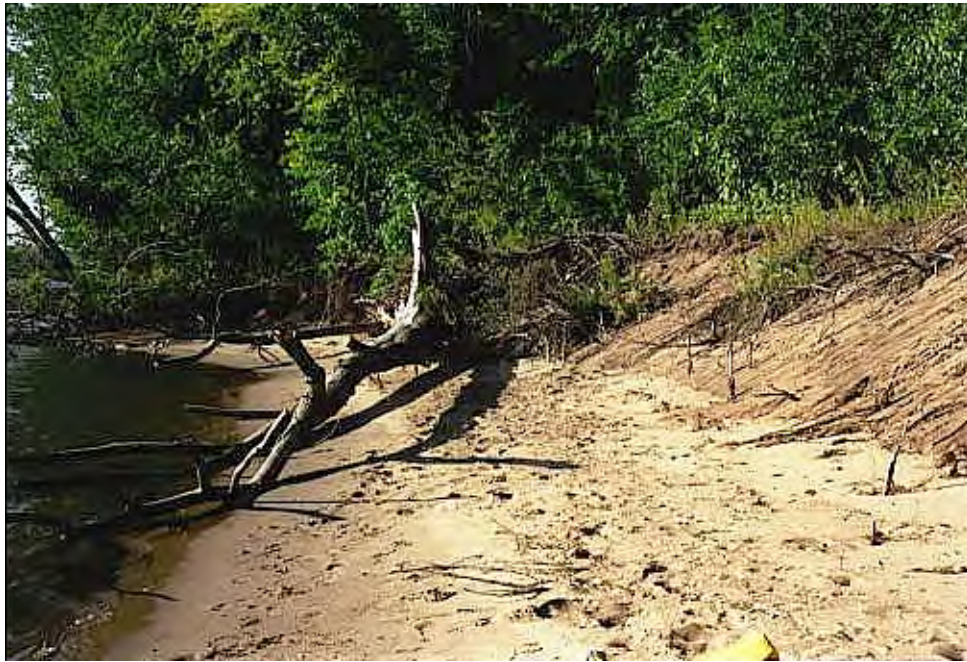
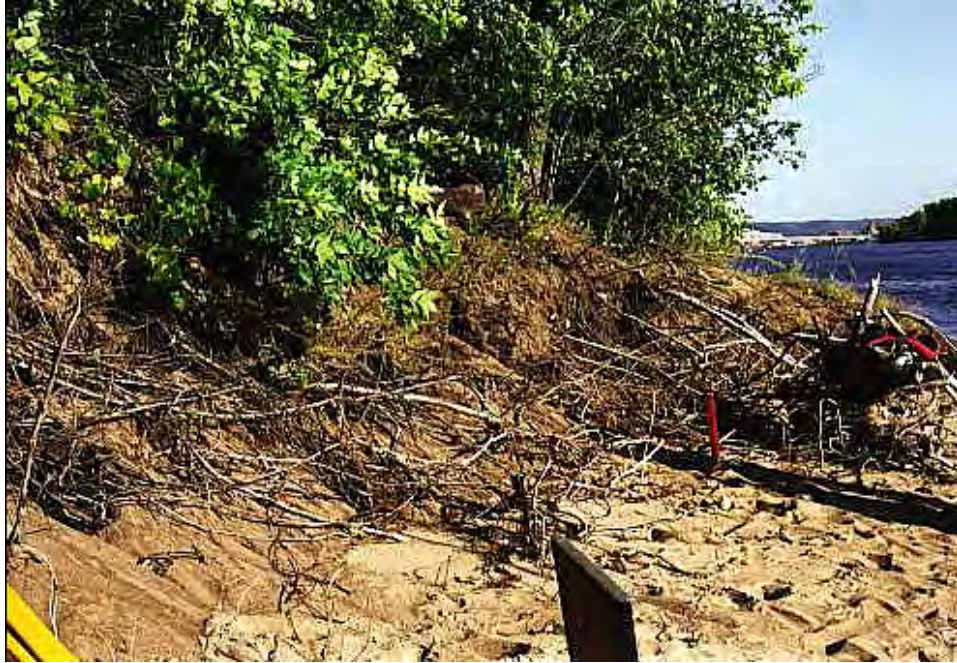
Primary causative factors for bank retreat at this site include flood erosion, wave and rework-transport within bench and berm areas, and minor piping. Because bench cover is primarily sand, erosion by traffic-induced waves was observed. This site is classified as bank Type E.

**Photo 7-22 An upstream view of Site 7 midpoint**

**Photo 7-23 A down stream view of Site 7 midpoint**

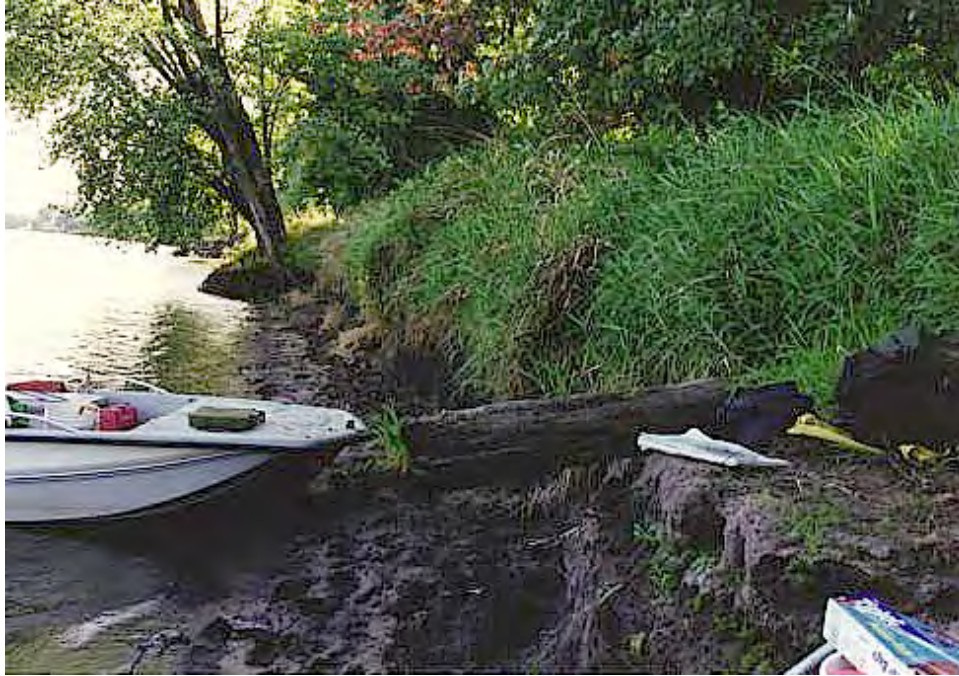
**Photo 7-24 A downstream view of Site 8 midpoint**

Causative factors for bank retreat at this site include flood-flow erosion, wave-flow related rework-transport of failed soils and recently deposited sediments, and piping. Potential for wave erosion of bench areas is significant. This site is classified as Type C.

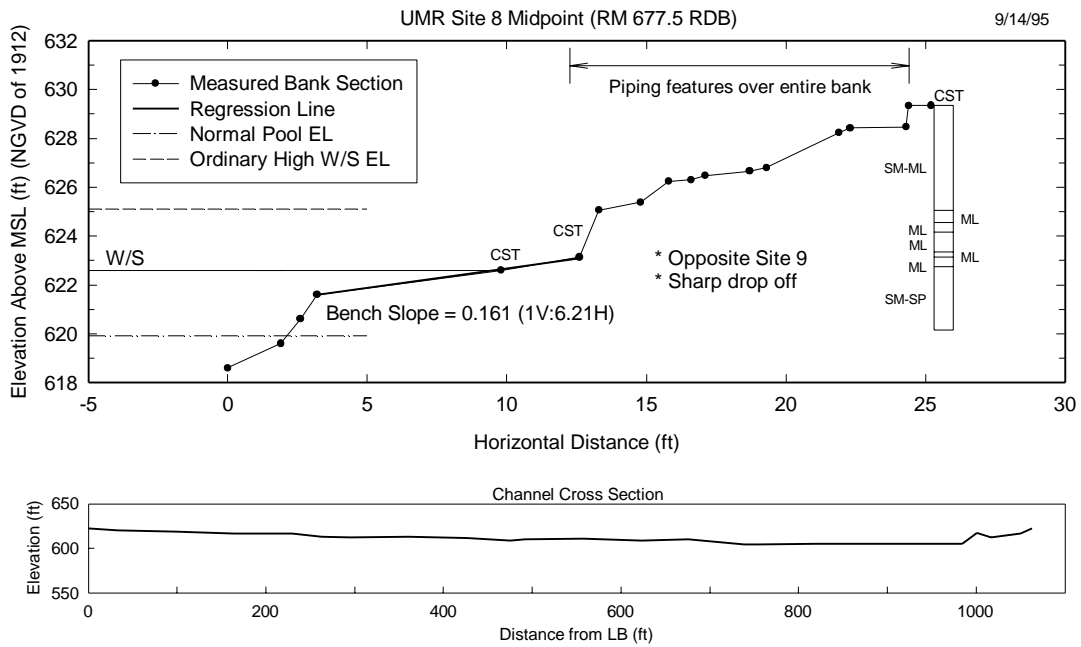
section shown in figure 7-31 is typical for a river bend. Bed level at this site drops off sharply, and the thalweg sailing line is very close to the site. As shown in figure 7-29,

Historical alluvium was encountered from the surface to a depth of 4.3 ft, as shown in figure 7-31. Below the alluvium are late Holocene levee deposits with two buried soils. Multiple-age Holocene surfaces are encountered in this part of Pool 9. The

**Figure 7-31 Bank section and channel cross section measured at Site 8 midpoint**

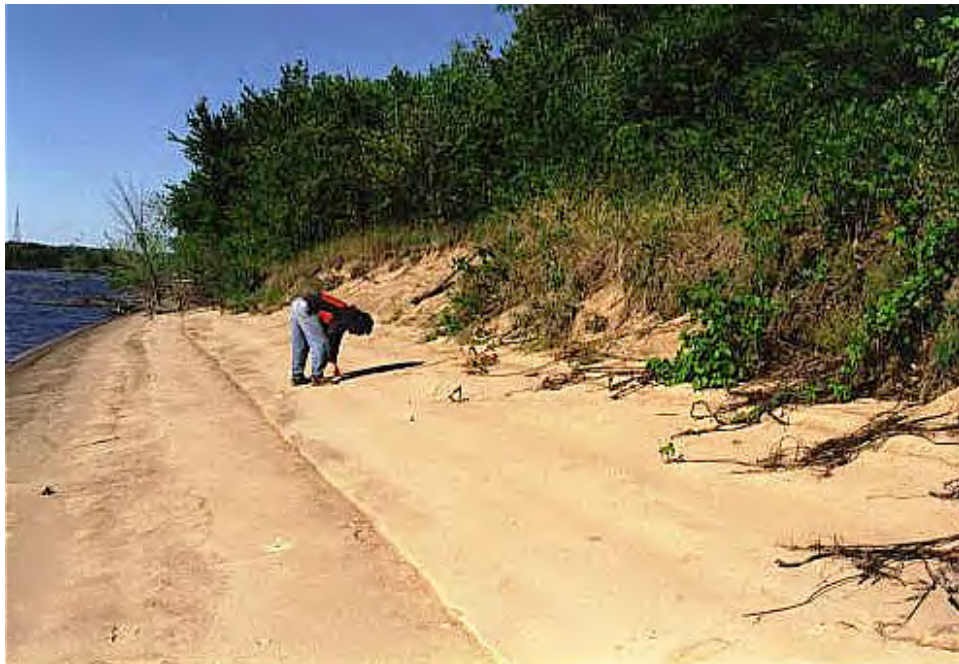
**Photo 7-25 An upstream view of Site 9 midpoint**

The site is far from the thalweg sailing line. Causative factors for bank retreat at this site include wave and rework-transport of failed soils and recently deposited sediments in berm and bench areas, and flood and secondary current erosion. Because of the nature of sandy bench cover, there is potential for wave erosion in bench areas. This site is characterized by a combination of bank Type E and Type F.

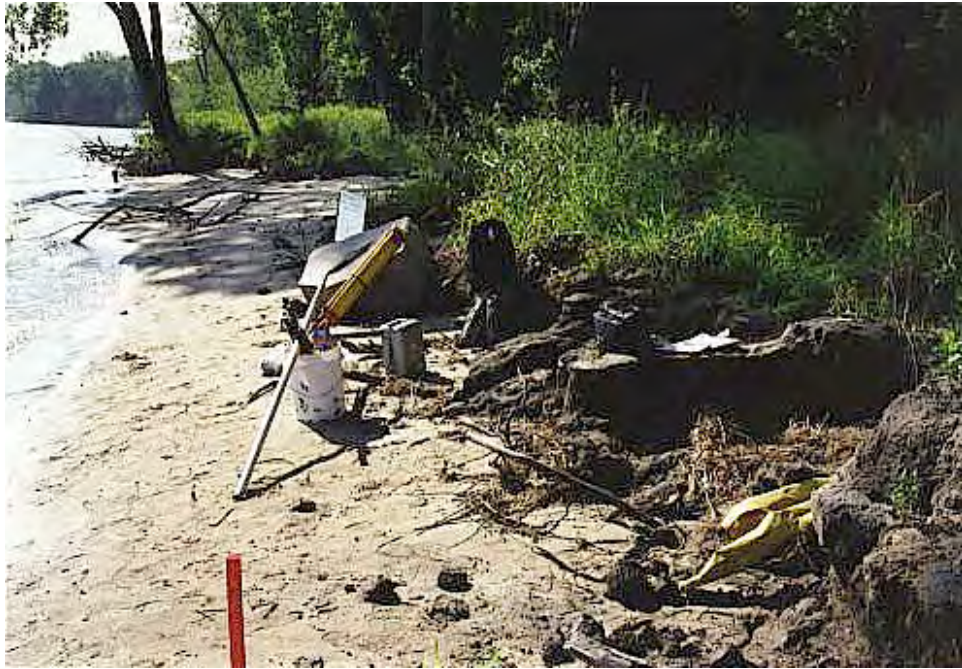
**Photo 7-26 A downstream view of Site 10 midpoint**

bench, which indicates that Site 10 is an active bank failure and erosion location. At the upstream section, a rocky bottom was observed about 30 ft from the water's edge (see figure 7-35).

Causative factors for bank retreat at this site include flood-flow erosion, secondary currents, overland flow, wave and rework-transport of failed soils and recently deposited sediments, and piping. There is potential for wave erosion in bench areas. The bank section at this site is classified as a combination of bank Type D and Type E.

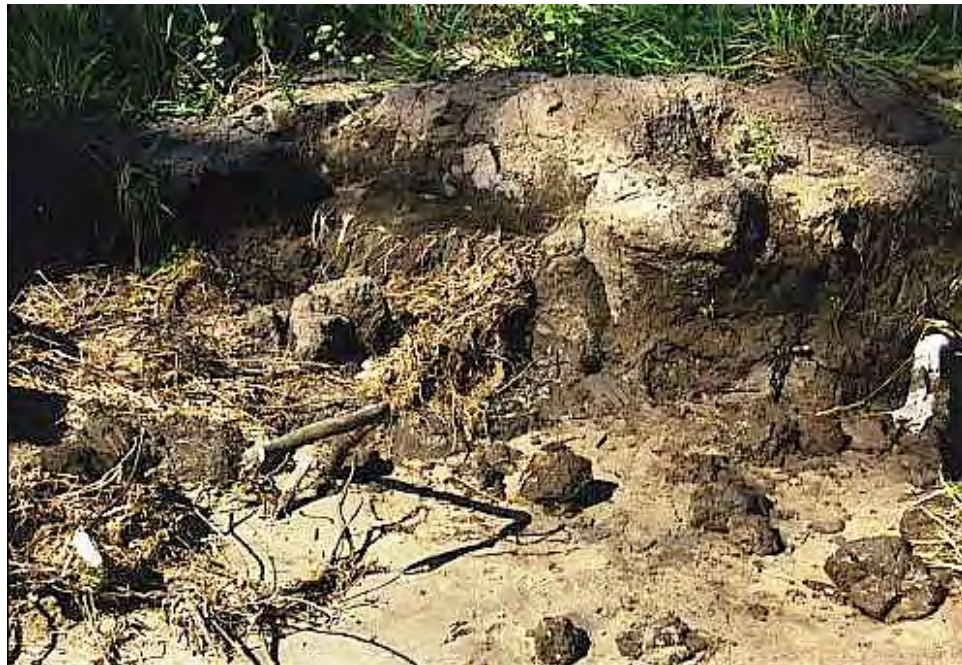
**Photo 7-27 A close-up view of scarp at Site 10 midpoint**

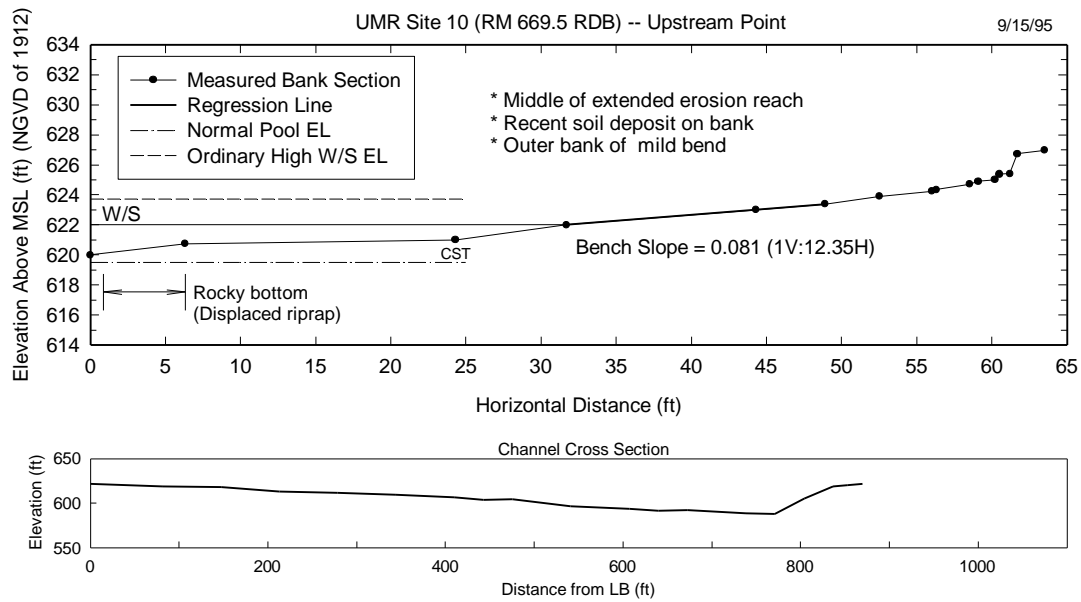
**Figure 7-35 Bank section and channel cross section measured at Site 10 upstream point**

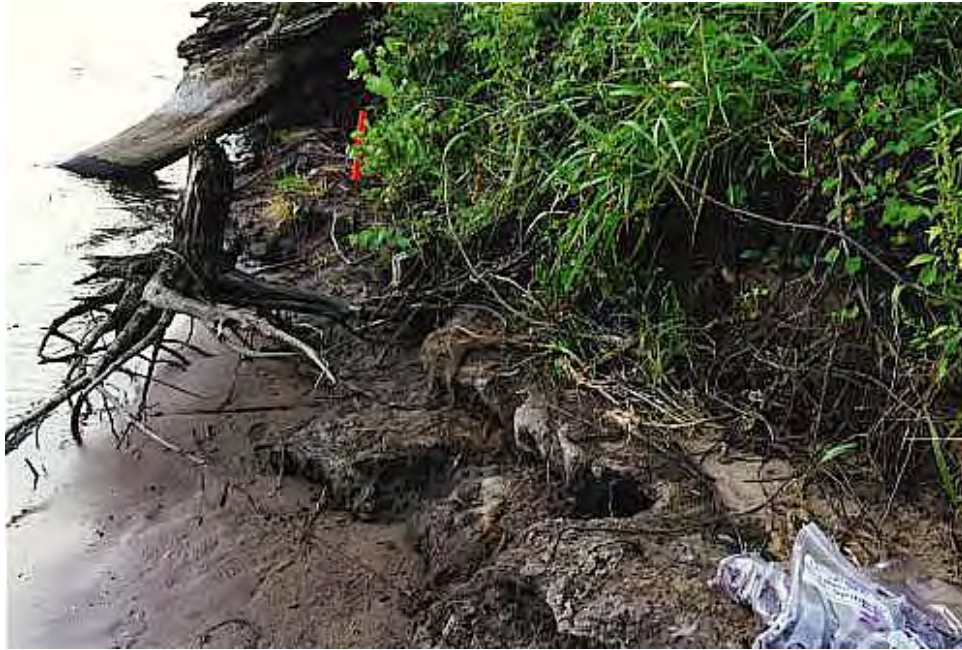
This island site, shown in figure 7-38, is located within a relatively narrow section of the valley, about 5.5 miles upstream from Lock & Dam No. 10, in the crossover reach between two mild bends. Upstream and downstream views of this site are shown by Photos 7-28 (see undercutting) and 7-29, respectively. Three bank sections are shown in figures 7-39 through 41. There are two wing dams, the upstream wing dam extends about 700 ft, and the downstream wing dam extends approximately 1,000 ft from the island. The midpoint section is just upstream from the longer downstream wing dam. The river

**Photo 7-28 An upstream view of Site 11 midpoint**

Causative factors for bank retreat at this site include flood-flow erosion, rework-transport of failed soils and recently deposited sediments within bench areas, undercutting, and piping. Because this site is located away from the sailing line along the right bank, impacts of traffic-induced waves on erosion of bench areas is minor. This eroded bank is classified as a combination of bank Type D and Type E.

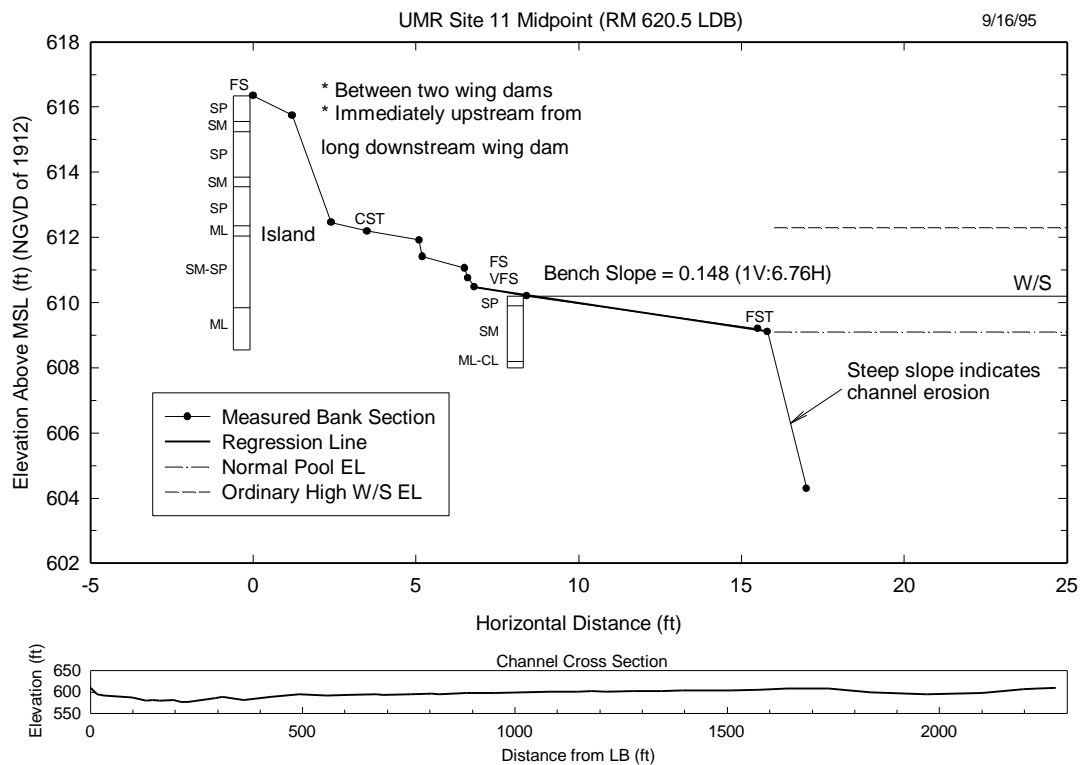
cross section in figure 7-40 seems to indicate that the thalweg developed along this left bank. It appears that the shorter upstream wing dam is not able to direct river flow

**Figure 7-40 Bank section and channel cross section measured at Site 11 midpoint**

toward the main channel, which resulted in strong currents impinging on the longer downstream wing dam, eroding the subaqueous bank at the midpoint section. The bank section in figure 7-40 shows a sharp drop of the bed near the bank. At both the upstream and downstream sections, near-bank water depth was small. The bank soils consist primarily of coarse silt (CST) and sand (VFS-FS).

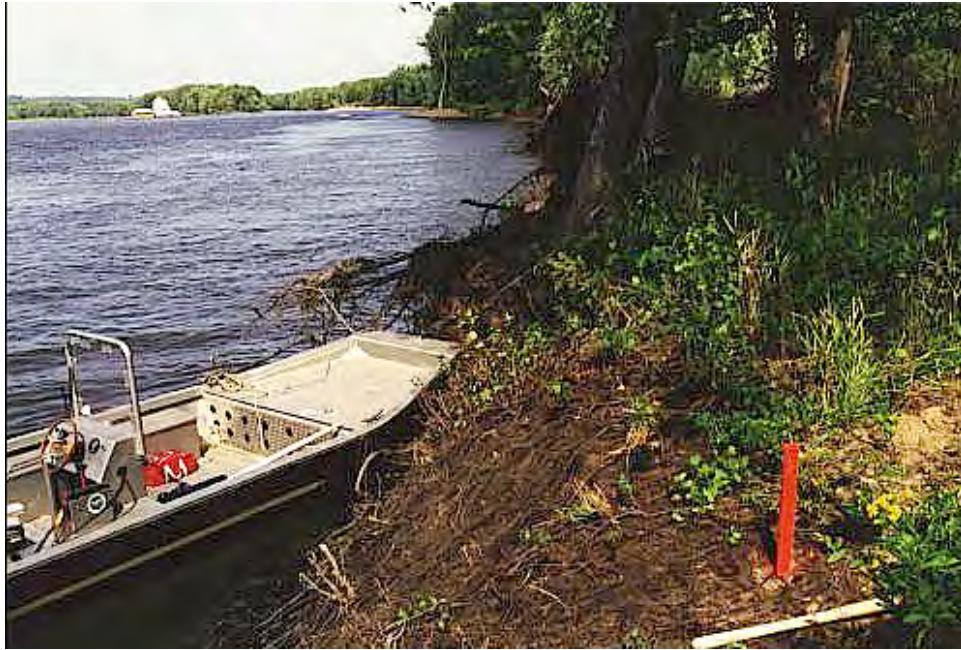
**Photo 7-30 An upstream view of Site 12 midpoint**

7-43 through 7-45. Bank retreat at Site 12 since 1984 is apparent in figure 7-42. As can be seen in figure 7-44, the thalweg is very close to this left bank, and evidence of severe channel erosion was observed at the site. This site was a dredged material disposal site. At the upstream section, failed revetment rocks were found adjacent to the water's edge (see figure 7-43). Since the upper end of Cassville Slough (eastern limb of the MR) was closed when Lock & Dam No. 10 was completed in 1938, the new MR channel flow, downstream from the dam spillways located on the west side of the river, had a tendency to return to the old channel slough, resulting in Ackerman's Cut. According to Nakato (1983), as much as 28 percent of the river flow was passing through Ackerman's Cut, causing reduction of sediment-transport capacity of the main channel and transport of sediment into the slough. In order to protect the fishery resources of Cassville Slough and to reduce dredging requirements in the downstream navigation channel, the COE-RID constructed partial closure structures in Ackerman's Cut in 1985. A post-construction study was conducted in 1986 and it was found that the flow diversion rate was reduced to 18 percent from the previous 28 percent (Toda and Nakato 1987). The bank was covered

Causative factors for bank retreat at this site include flood damage which includes erosional oversteepening and rapid recessional loading and failure, wave and rework-transport of failed soils and recently deposited sediments within berm and bench areas, cleft pressures and block displacement, and minor piping. There is potential for traffic-generated wave erosion at this site. This bank section is classified as a combination of bank Type E and Type F.

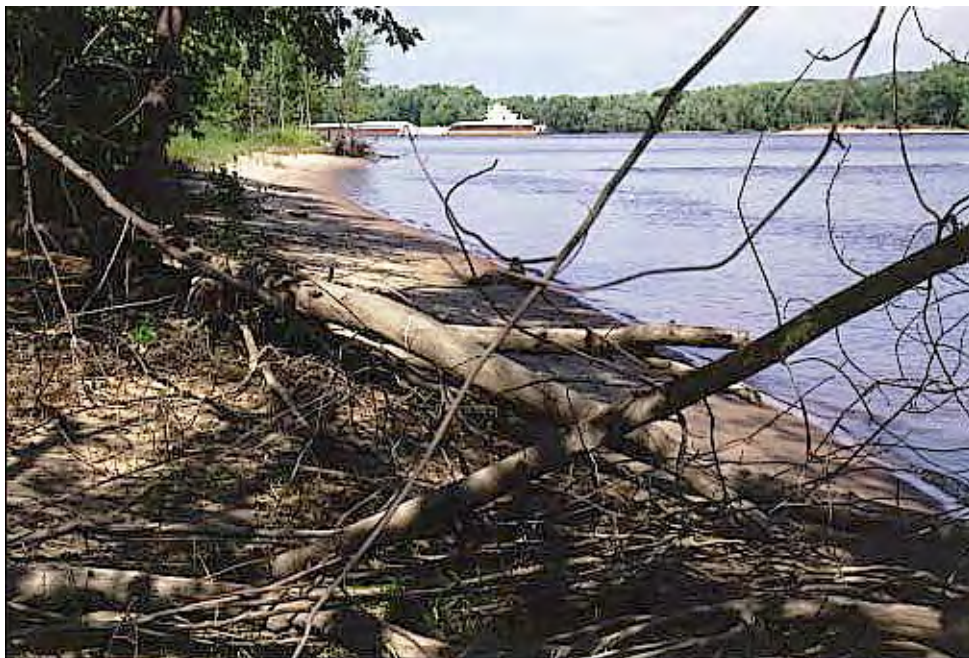
**Photo 7-32 An upstream view of Site 13 midpoint**

32 and 7-33, respectively. The bank section is shown in figure 7-46. The site is located within a wing-dam field and the low-lying island is connected to a marsh area. There is a barge-mooring facility located about 100 ft upstream from this site. The bank bench and berm area cover consists of recent silt (MST) and sand (FS-MS) deposits left by floods.

Causative factors for bank retreat at this site include piping failure, and wave and flow rework-transport of recently deposited sediments in bench areas. This site is classified as bank Type E.

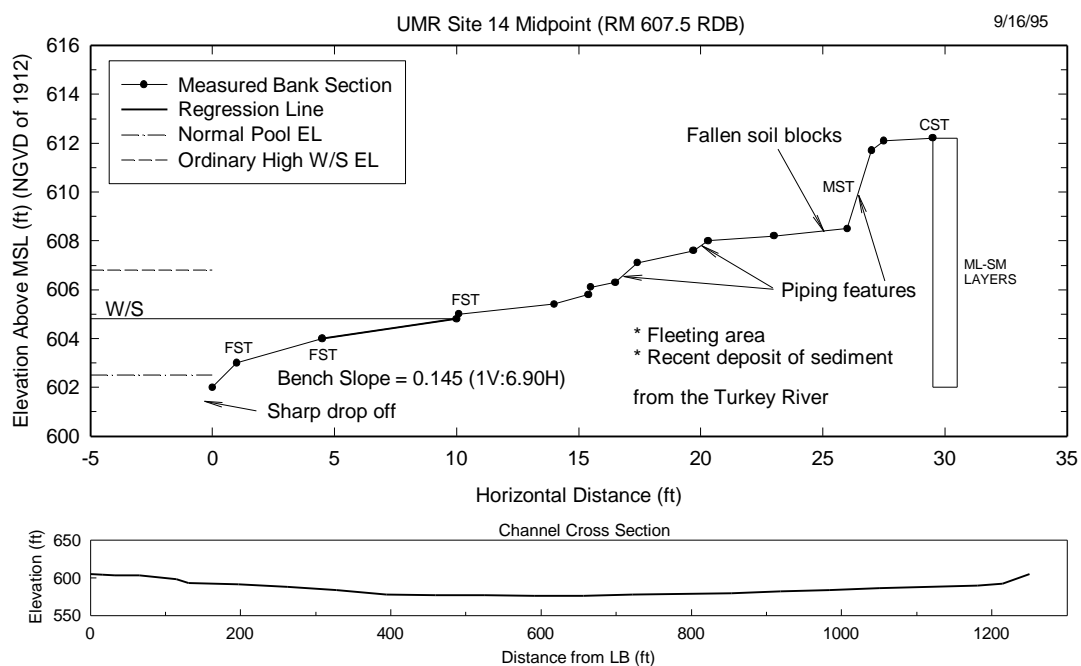
**Figure 7-49 Bank section and channel cross section measured at Site 14 midpoint**

50. The bank soils consist of fine silt (FST) to coarse silt (CST). Fallen soil blocks were observed at the base of the scarp, and piping features were observed within the bank scarp as well as at minor scarps within the berm and bench rework-transport zones. As can be seen in figure 7-49, the surveyed river cross section is atypical for a river bend because the site is located near the upstream end of the bend.

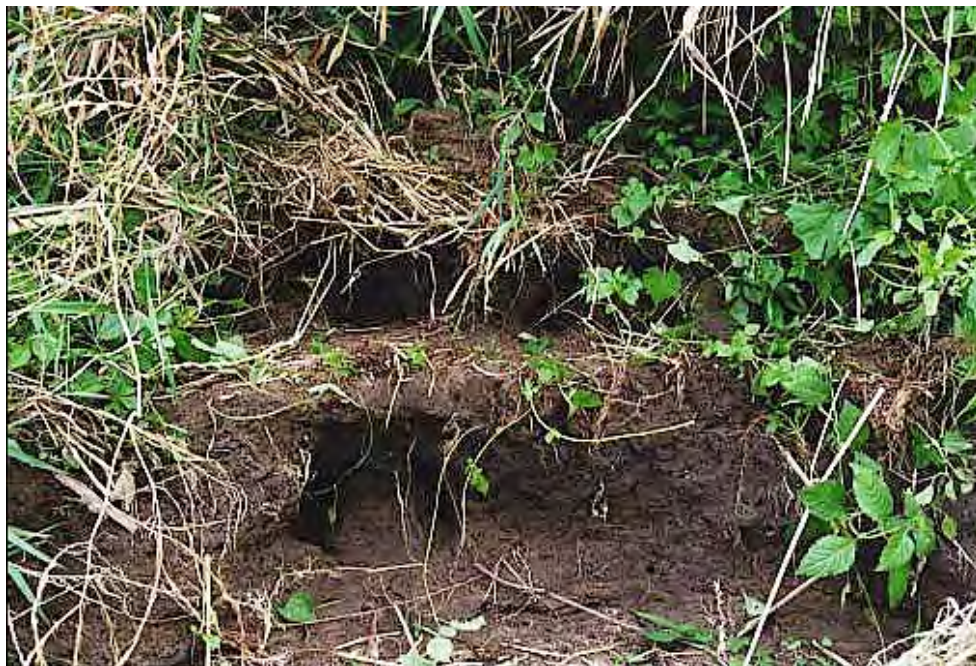
**Photo 7-36 Piping feature of Site 14 midpoint**

Causative factors for bank retreat at this site include flood-flow oversteepening and rapid recession slumping, wave and rework-transport of deposited sediments within berm and bench areas, and piping-related cantilever and block failures (see Photo 7-36). The thalweg sailing line is remote from this site; however, heavy fleeting activities surrounding this site generate significant waves (see Photo 7-37 for evidence of wave erosion). A combination of Type A and Type B characterizes Site 14.

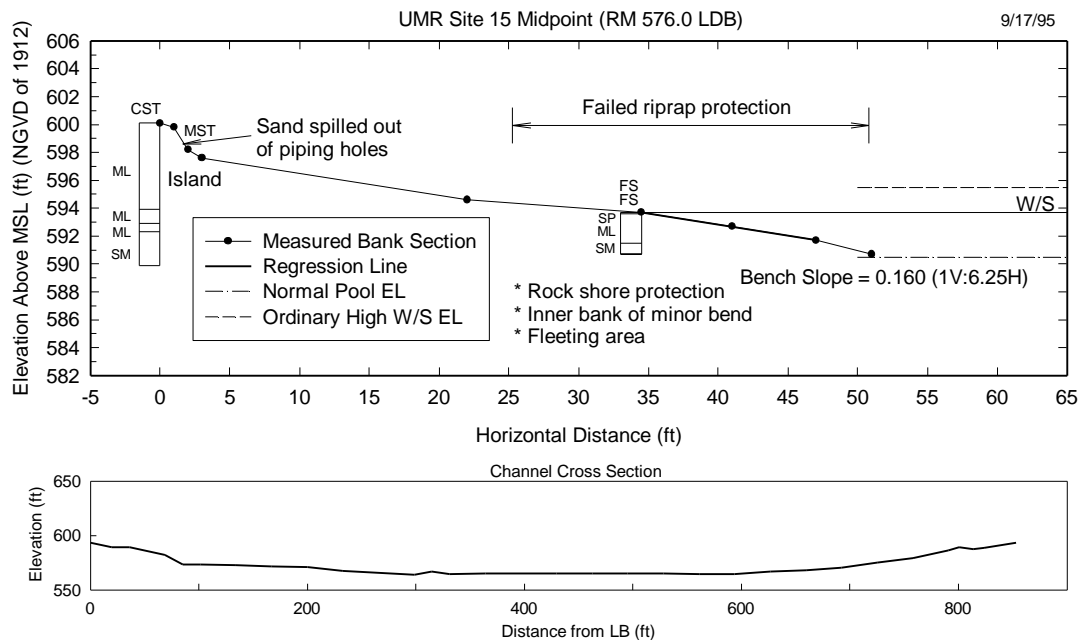
**Figure 7-53 Bank section and channel cross section measured at Site 15 midpoint**

field are shown in figures 7-52 through 7-54. The bank soils are primarily MST to CST and the soil near the water's edge is FS. Subaqueous sediments are sand (VFS-FS). Failed revetment stone was observed along the bench, as indicated in figure 7-53.

The site is on a late Holocene island, and two sampling tube cores advanced at the site showed thick historical alluvium to at least 10 ft, as shown in figure 7-53. Archaeological site 11JD124 is located approximately 1 mile upstream from the erosion site, and site 11JD126 is about 1 mile downstream.

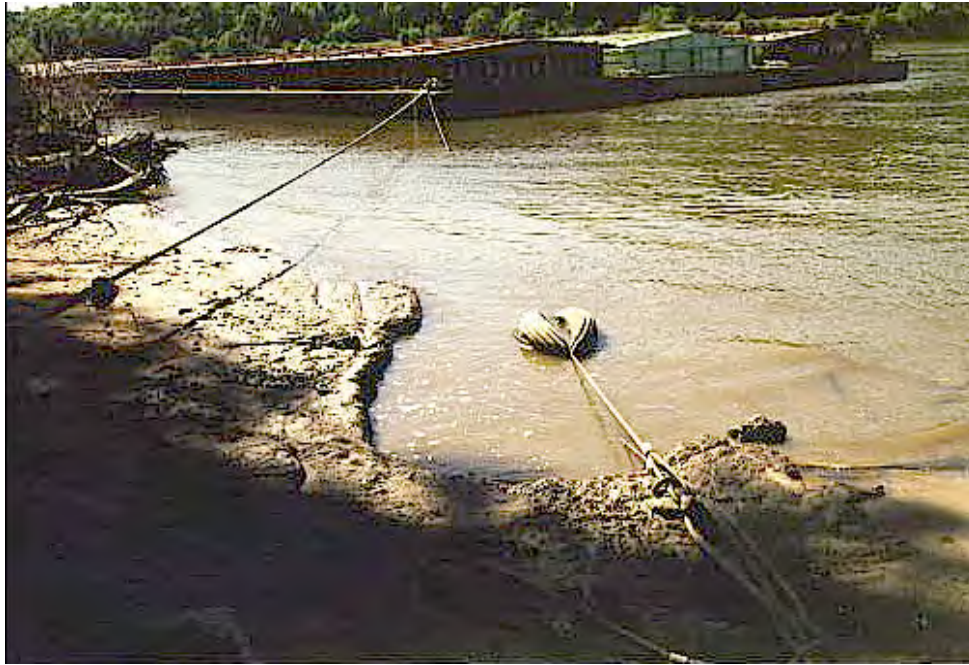
**Photo 7-39 Disturbed bankline of Site 15 midpoint**

Evidence of severe erosion was observed where barges were moored. Heavy infestation of zebra mussels was observed on riprap materials as well as on moored barges. Photo 7-39 shows the bankline disturbed by mooring activities. There were some piping features within the scarp, and fine sand at the midpoint section was being displaced by piping (see Photo 7-40). Causative factors for bank retreat at this site include wave

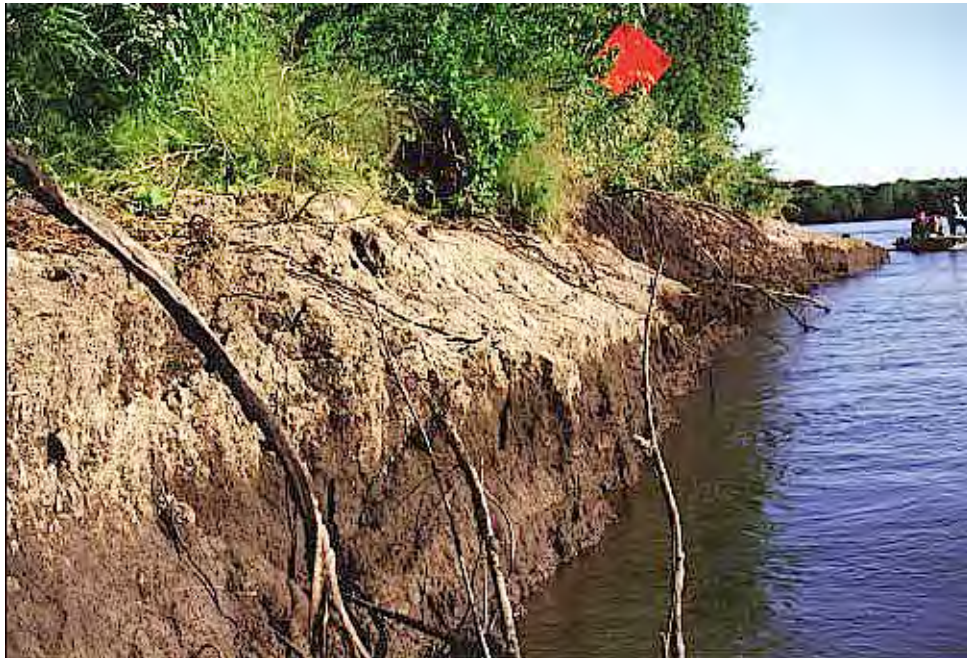
**Photo 7-44 A close-up view of Site 16 midpoint**

Both at the upstream section and the midpoint section, the scarp contained piping features, and fallen soil blocks were found in the water. Causative factors for bank retreat at this site include flood-flow related oversteepening and recessional slumping, lower-bank piping-related cantilever and block failures, wave and flow rework-transport actions, and secondary currents. Type C characterizes Site 16.

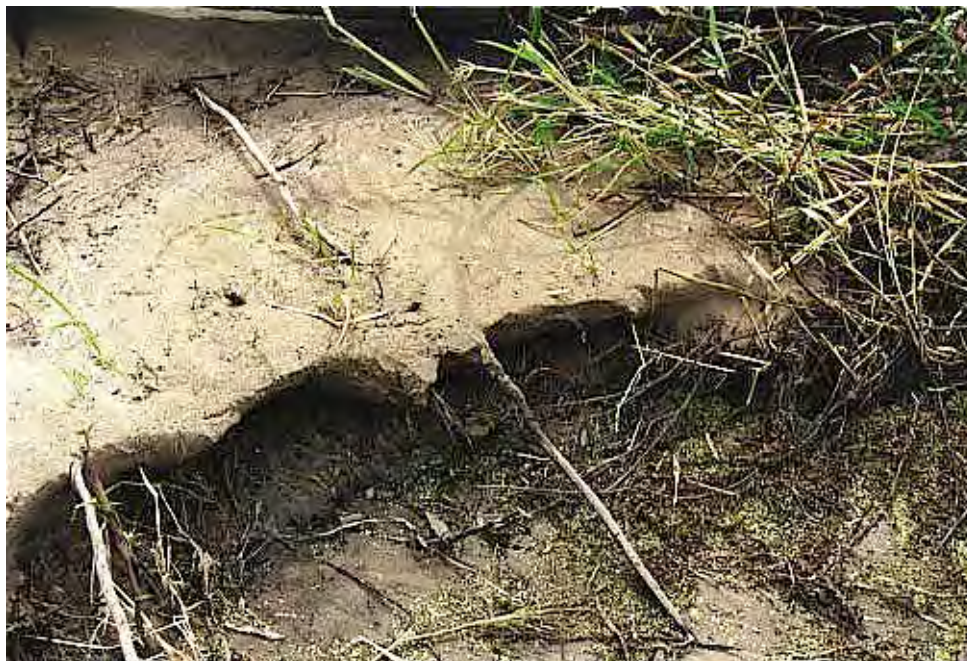
**Photo 7-48 Sand removal near toe of island of Site 17**

This site is a mid-channel island site in a rather straight river reach, 9.8 miles downstream from Lock & Dam No. 14, as shown in figure 7-59. Upstream and downstream views of the midpoint site are shown in Photos 7-45 and 7-46, respectively. Photo 7-47 shows an upstream view of the toe of the island, and Photo 7-48 shows wave removal of sand from the bench cover near the toe of the island. Substantial downstream accretion of the island since 1984 can be seen in figure 7-59. In order to investigate bank erosion characteristics on the island, five bank sections were taken along the channel side and two sections were taken along the back channel (see figures 7-60 through 7-66). The bench area cover is primarily sand with recently deposited silt. Subaqueous sediments are medium sand (MS) at the upstream limit, coarse silt (CST) at the midpoint section, and CST on top of FS at the downstream limit, indicating the reduction in bed-material particle size along the island. The island is located within two large wing dams which extend toward the main channel from the left bank approximately 1,700 ft, and immediately downstream from Beaver Slough along the right bank. Beaver Slough is heavily used by barge traffic, and the area across from this island site is a busy fleeting site. The upstream tip of this island is eroded and the toe of the island appears to be extending downstream, indicating that the island is shifting downstream.

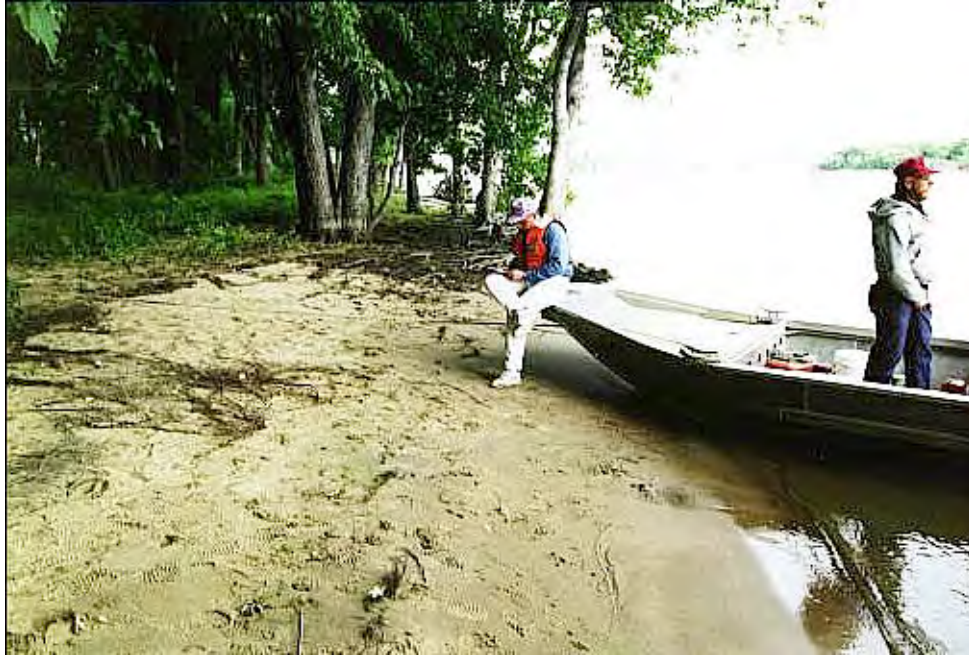
**Photo 7-49 An upstream view of Site 18 midpoint**

an upstream view of the site, and Photo 7-50 shows a close-up view of the bankline. Three bank sections were taken at this site and they are shown in figure 7-68 through 7-70. No bank erosion was visible; however, very steep subaqueous bed slopes indicate severe channel erosion at this site.

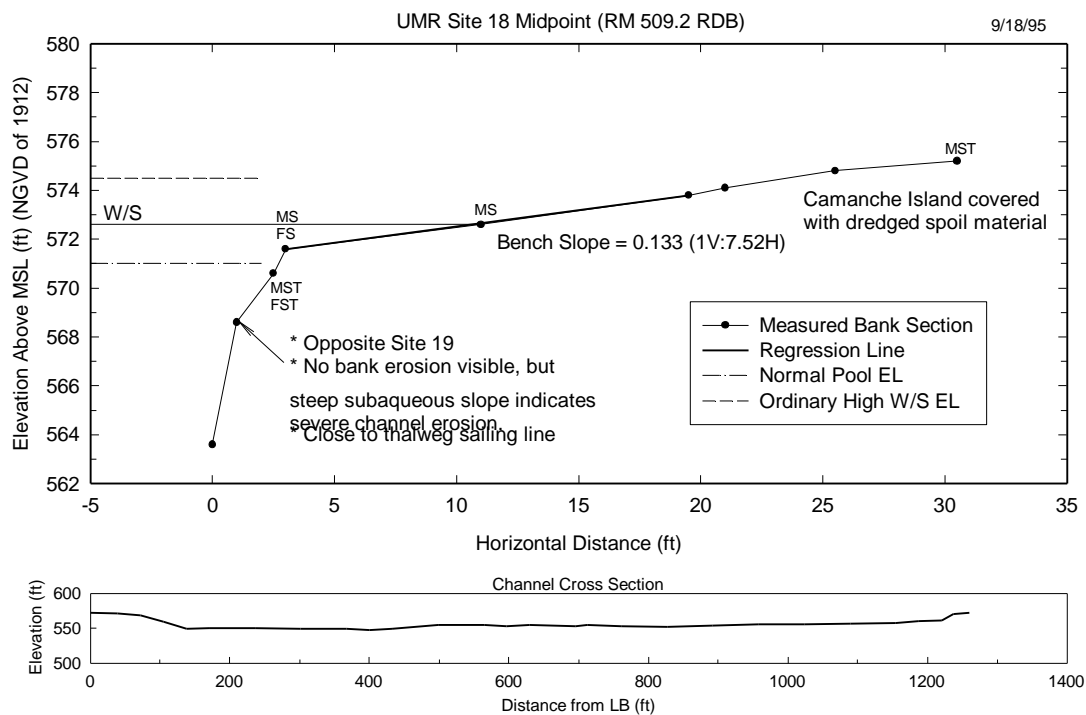
**Figure 7-69 Bank section and channel cross section measured at Site 18 midpoint**

As can be seen in figure 7-69, the scarp of the subaqueous bank is practically vertical at the midpoint section. Causative factors for bank retreat at this site include primarily undercutting by currents, and wave and rework-transport of recently deposited sediments within berm and bench areas. Because of the closeness of the channel thalweg to this site, potential for further in-channel flood-flow erosion exists at this site. This site is characterized by a combination of Types D, E, and F.

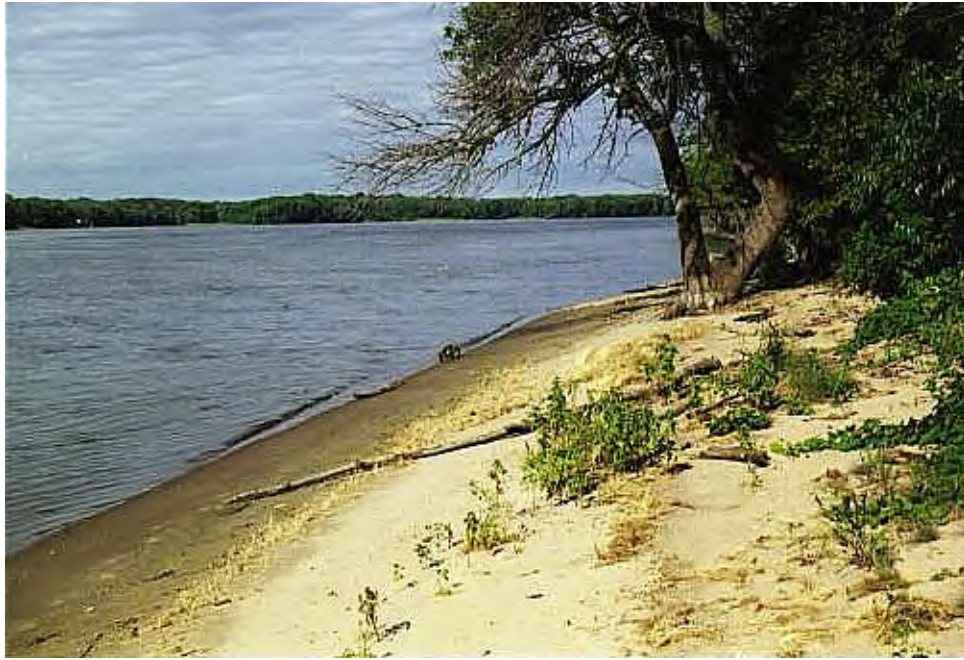
Photo 7-51 shows an upstream view of the site. The bank face was covered by tall weeds and shrubs, as can be seen in Photo 7-52. Two bank sections were taken at this site and

**Photo 7-51 An upstream view of Site 19 midpoint**

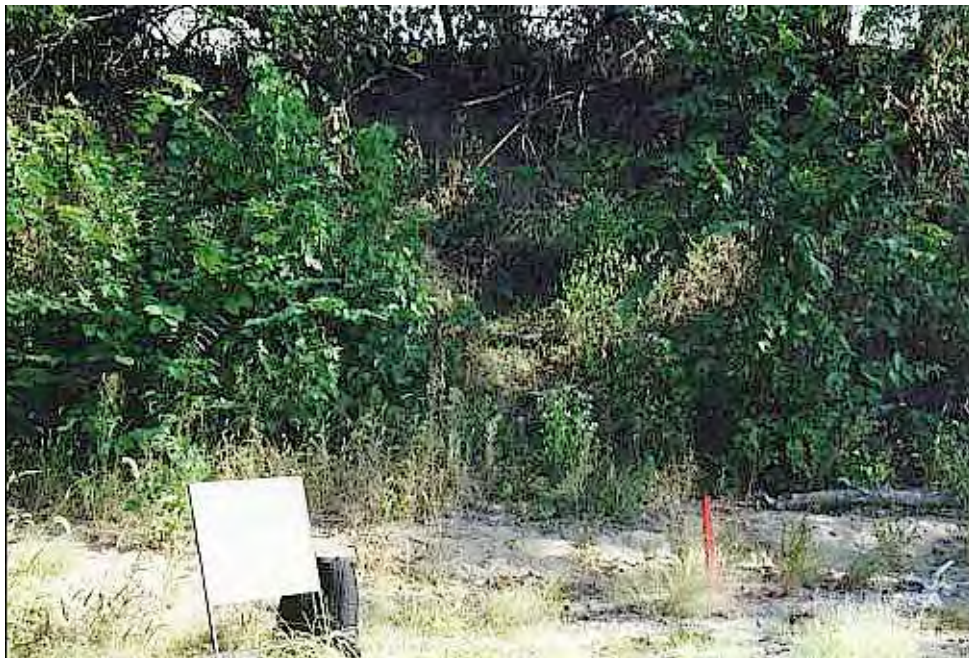
**Photo 7-52 A perpendicular view of Site 19 midpoint**

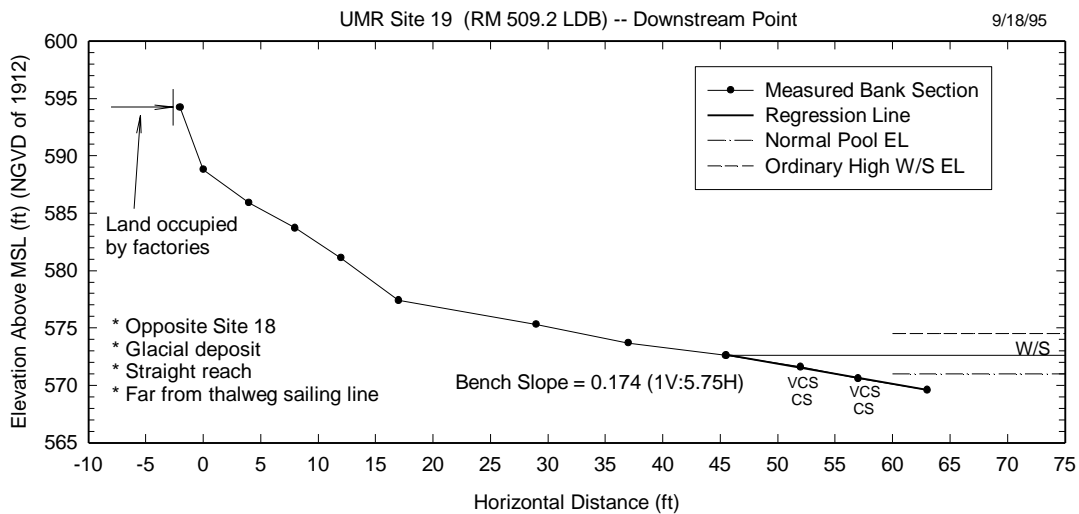
**Figure 7-72 Bank section measured at Site 19 downstream point**

As shown in figure 7-72, subaqueous bed sediments (CS and VCS) are much coarser than the bank soil, indicating high fine-sediment transport along this site. Causative

factors for bank retreat at this site include flood-flow undercutting followed by cantilever and slab failures, debris slides, piping, and wave and flow rework-transport actions within bench-area sand cover. Type F characterizes Site 19.

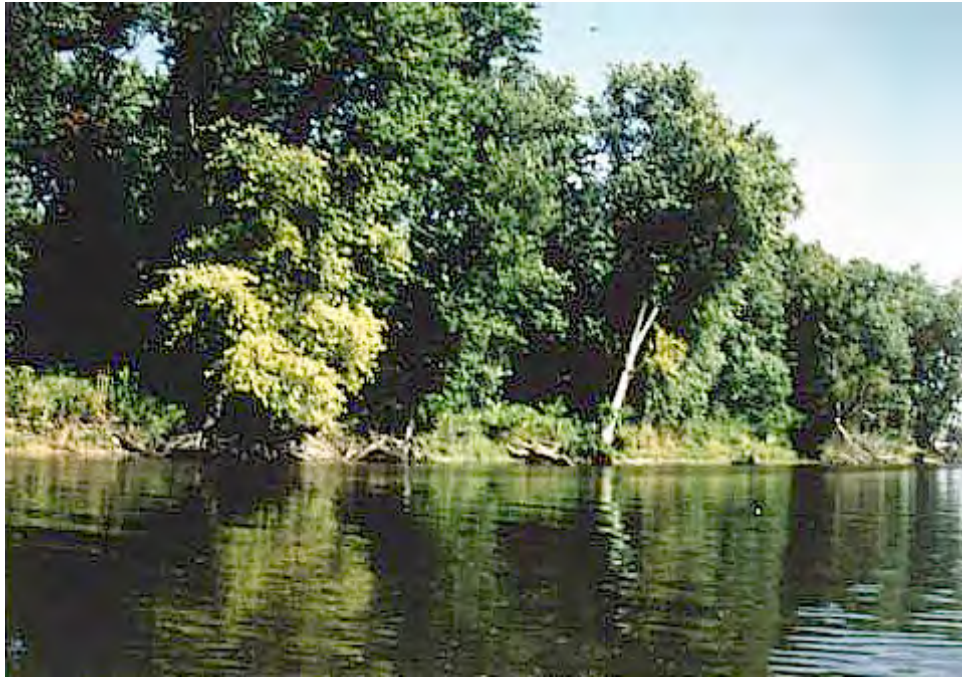
**Photo 7-53 A side view of Site 21 midpoint**

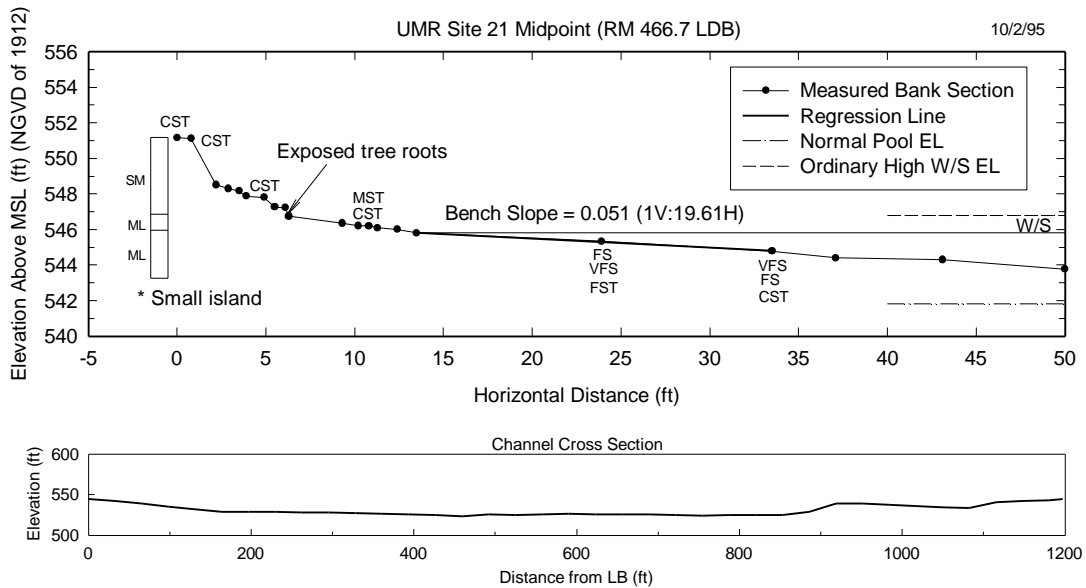
This left-bank island site, shown in figure 7-73, is located in a straight reach, 9.8 miles upstream from Lock & Dam No. 16 and 16.2 miles downstream from Lock & Dam No. 15. This small, mid-channel island lies in the Andalusia Gorge across from Andalusia Island which extends approximately 9 miles from RM 464.0 to RM 473.0 along the left bank. A side view of the midpoint section is shown in Photo 7-53. As at Site 17, seven detailed bank sections were taken around the island at this site and they are shown in figures 7-74 through 7-80. The bank soil is silt (MST-CST) with sandy silt lenses. Subaqueous soil consists of layers of silt (FST-CST) and sand (VFS-FS). There are some piping features at the upstream tip of the island, as shown in figure 7-74, and the bench slope there is 0.295. The bench slope appears to decrease in the downstream direction, as was the case for Site 17. At the downstream end of the island, flow depth was extremely small; depth was only 3 ft even 570 ft riverward from the water's edge. It appears that this island is moving downstream. There are a series of wing dams along the right river bank opposite this site, and the river cross section near the right bank is quite complex, as can be seen in figure 7-77 for the midpoint section.

**Figure 7-77 Bank section and channel cross section measured at Site 21 midpoint**

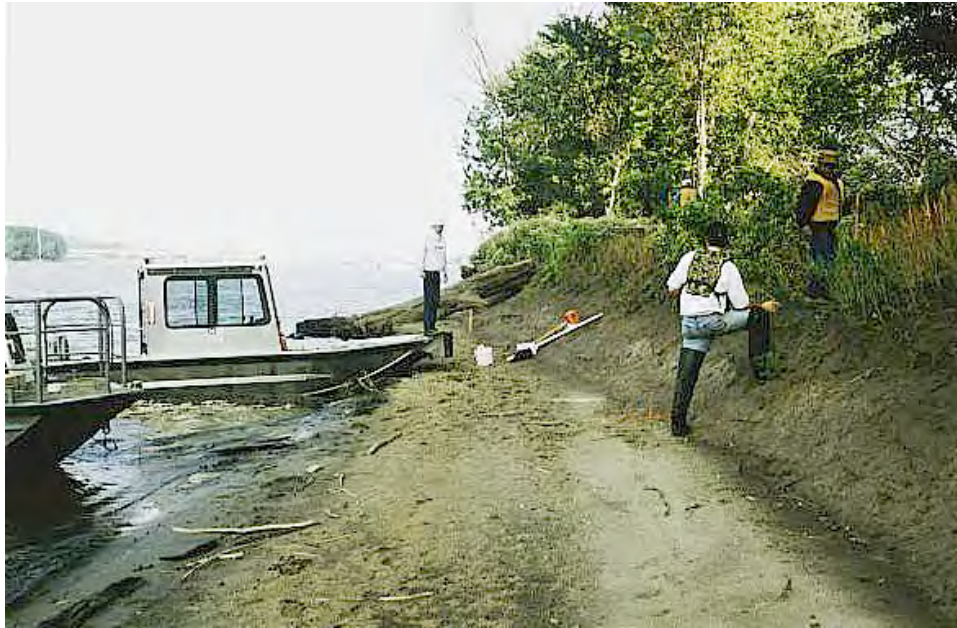
**Photo 7-54 An upstream view of Site 22 midpoint**

An upstream view of the midpoint section is shown in Photo 7-54. Five bank sections were taken at the erosion site: at the upstream limit; the upstream quarter point; the midpoint; the downstream quarter point; and the downstream point. The sections are depicted in figures 7-82 through 7-86. As can be seen in figure 7-84, the channel cross

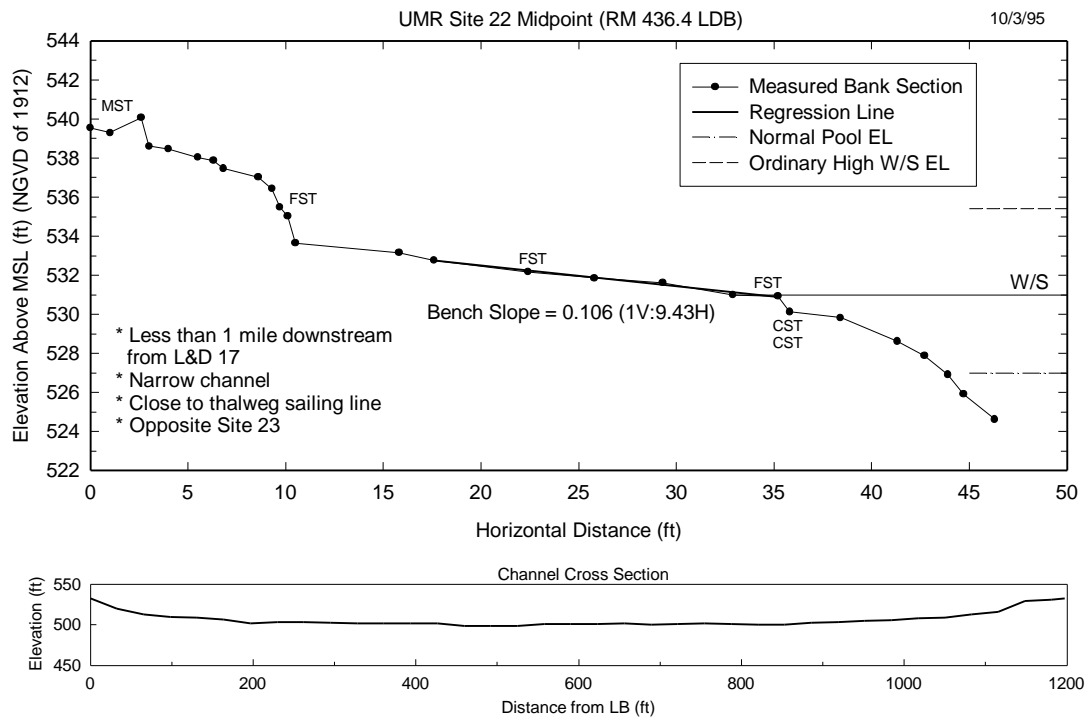
section is a typical parabolic shape common to straight channels. The bank soils consist of silt (FST-MST) with moderate piping features and subaqueous sediments are silt (MST-CST) and sand (VFS). Site 22 is very close to the thalweg sailing line. Steep subaqueous bank slopes observed along the bank downstream from the midpoint section indicate that this reach is subject to strong currents and vessel-induced prop-wash.

**Figure 7-84 Bank section and channel cross section measured at Site 22 midpoint**

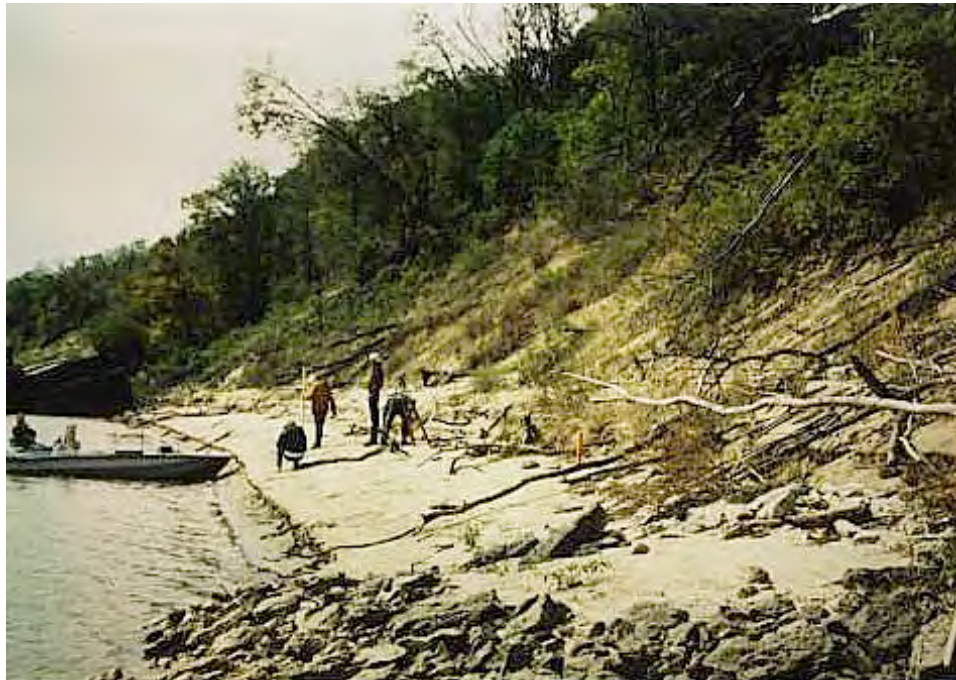
This right-bank site is located on the upper portion of Keg Island across the channel from Site 22 (see figure 7-81). A downstream view of the upstream site is shown in Photo 7-55. Two bank sections were taken at upstream and downstream points, and they are shown in figures 7-87 and 7-88. No midpoint section was established. The site is located far from the thalweg sailing line. As can be seen in figure 7-87 and Photo 7-55, stone slope-protection failure was observed at the upstream section. The bank soils consist of lensing silt (FST-CST) and some sand (FS) was found on the surface along the water's edge. Subaqueous sediments are silt (MST-CST) at the upstream section, and are silt (MST-CST) and sand (MS) at the downstream section.

Causative factors for bank retreat at this site include flood-flow erosion and recessional piping failures, and wave and flow rework-transport of bench-area failed soils and recently deposited sediments. Site 23 is classified as bank Type C.

**Photo 7-55 A downstream view of Site 23 upstream point**
