# **Interim Report For The Upper Mississippi River - Illinois Waterway System Navigation Study**

**US Army Corps  
of Engineers**

**November 1997**

## Bank Erosion Field Survey Report of the Upper Mississippi River and Illinois Waterway

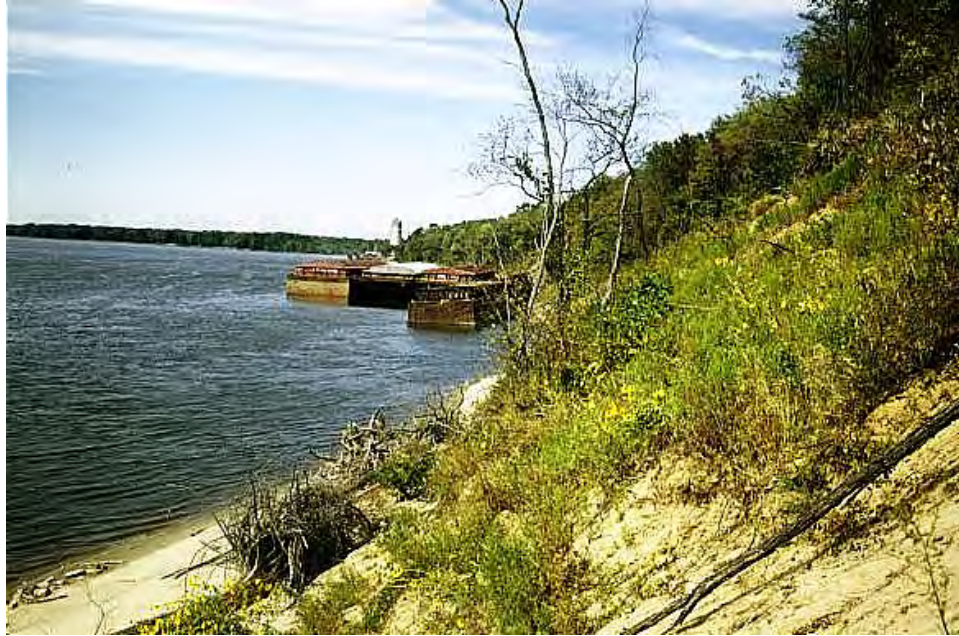
This left-bank site, shown in figure 7-89, is located along the outside of the downstream extent of a sharp bend, only 1.7 miles downstream from the mouth of the Iowa River (RM 434). The site is 4.8 miles downstream from Lock & Dam No. 17, and is close to the thalweg sailing line. An upstream view of this site is shown in Photo 7-56. Three bank sections taken at this site are shown in figures 7-90 through 92. The bank soils consist of sand (FS-CS), and a steep sandy slope rises approximately 40 ft above the berm. This feature is shown in the bank sections.

Causative processes for bank retreat at this site include flood erosion and recessional failures, and wave and flow rework-transport of bench-area failed soils and recently deposited sediments. Because the bank soils are primarily fine sand, wave erosion is extensive. This site is characterized by bank Type F.

**Photo 7-56 An upstream view of Site 24 midpoint**

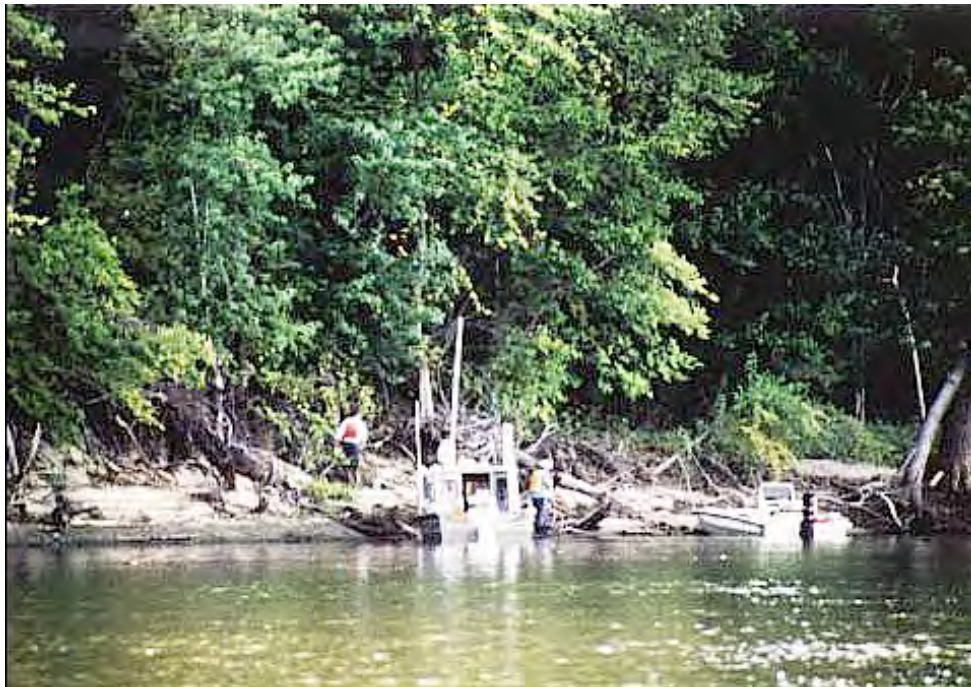
This right-bank island site is located opposite Site 24. An oblique view of this site is shown in Photo 7-57. One bank section taken is shown in figure 7-93. The bank soils are primarily silt (VFST-MST), and subaqueous soil is silt (MST) and sand (FS).

**Photo 7-57 A side view of Site 25 midpoint**

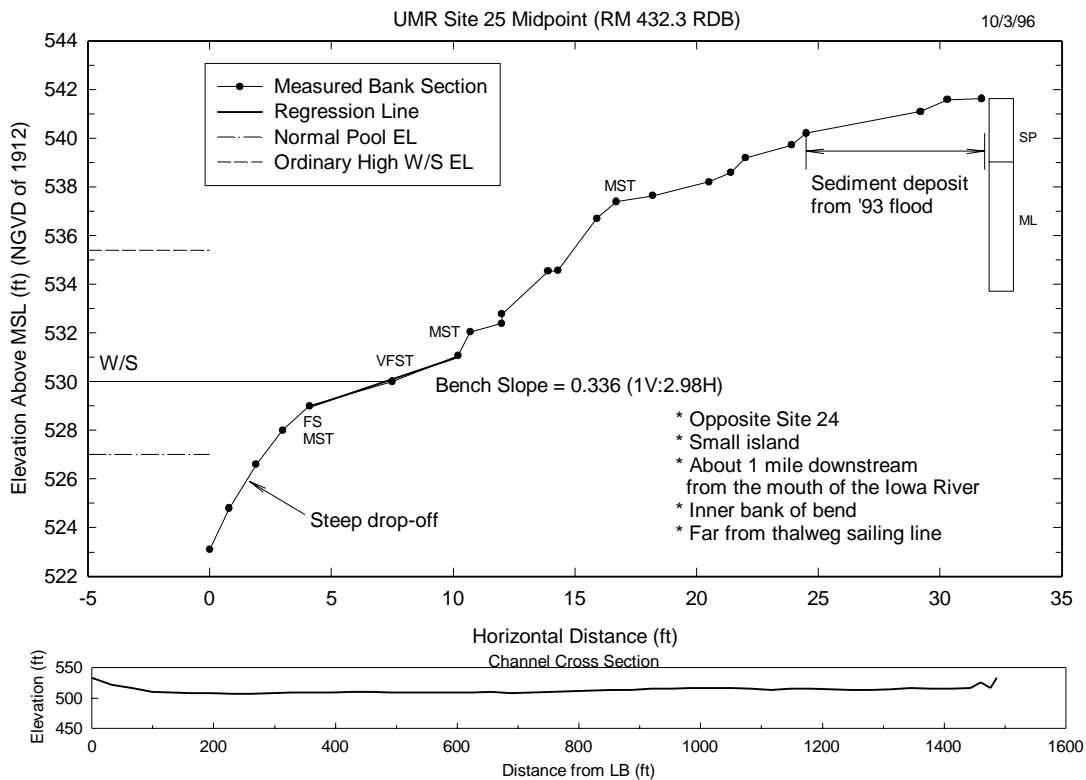
The island is covered by a recent sand deposit, about 3 ft deep, apparently from the Great Flood of '93. Causative factors for bank retreat at this site include flood-flow bank oversteepening and rapid recessional slumping and seepage, piping collapse, and wave and flow rework-transport of failed soils and recently deposited sediment cover within bench areas. The steep subaqueous drop-off is a strong indication of channel erosion at this site, as referenced in figure 7-93. Eroded bank type is a combination of Type C and Type D.

**Figure 7-93 Bank section and channel cross section measured at Site 25 midpoint**

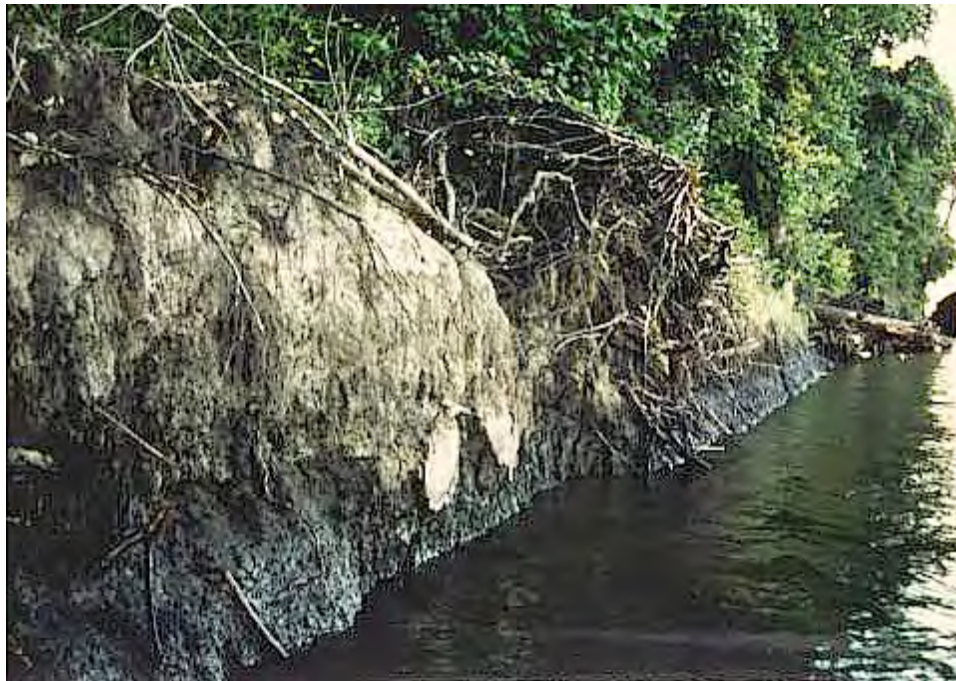
This right-bank site, shown in figure 7-94, is located on Camp Island along a straight channel reach. The site is about 9.5 miles upstream from Lock & Dam No. 18. Camp Island is one of numerous islands formed downstream from the confluence of the Mississippi River and the Iowa River. An upstream view of this site is shown in Photo 7-58. Three bank sections taken at this site are shown in figures 7-95 through 7-97. The bank soils are mainly silt (FST) and sand (MS-CS), and subaqueous bench soil is silt (VFST-MST). As can be seen in the river cross section (figure 7-96), the thalweg is developing along this island. Severe in-channel erosional bank oversteepening is indicated by the steep subaqueous bank slope.

**Photo 7-58 An upstream view of Site 26 midpoint**

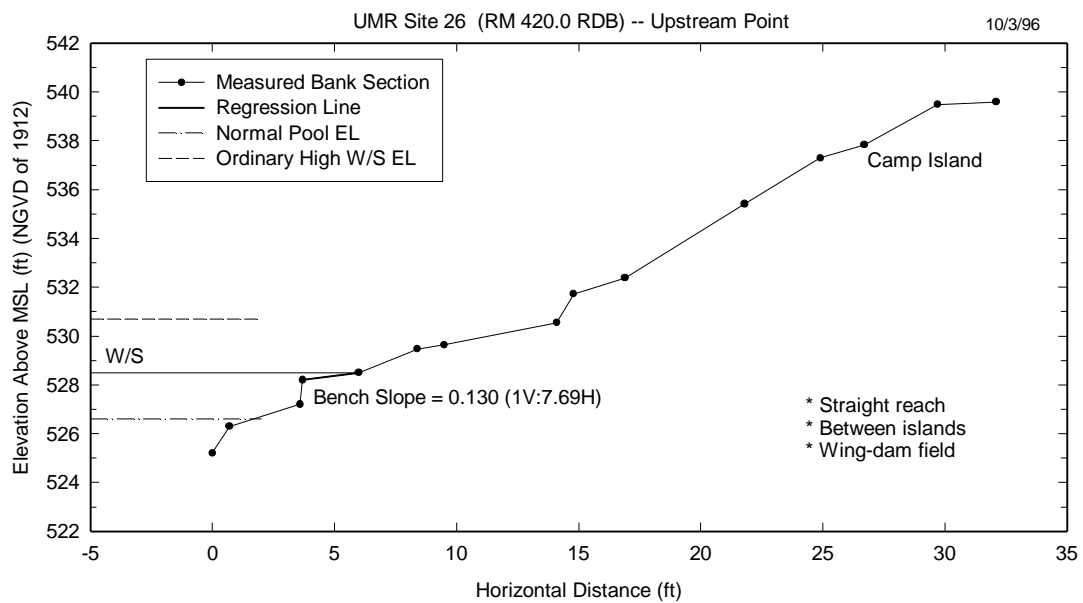
**Figure 7-95 Bank section measured at Site 26 upstream point**

Causative factors for bank retreat at this site include flood-flow erosion and recessional slumping of oversteepened banks and piping-related collapse with seepage, and wave erosion within bench areas affecting rework-transport of failed bank soils and recently deposited sediments. Because of the closeness to the thalweg and silty bank soils, wave erosion is more extensive at this site. A combination of bank Type E and Type F characterizes this site.

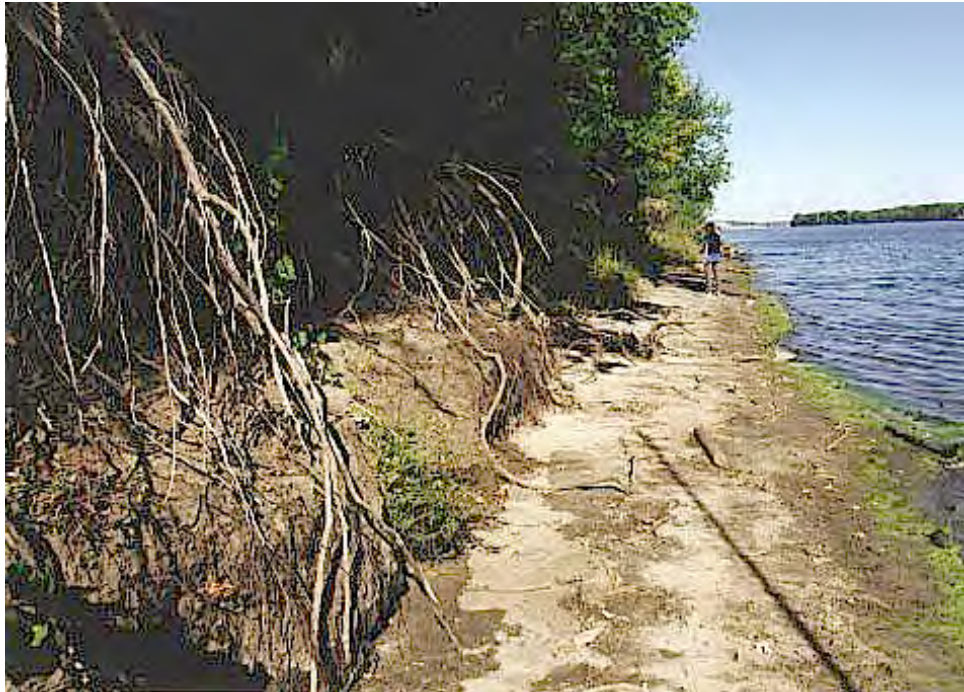
**Photo 7-59** An upstream view of Site 27 midpoint

Causative factors for bank retreat at this site include flood-flow erosion and recession and piping-initiated slumping, slaking, seepage, and wave and flow rework-transport of failed and slaked bank soils and recently deposited sediments within bench areas. Site 27 is classified as Type A.

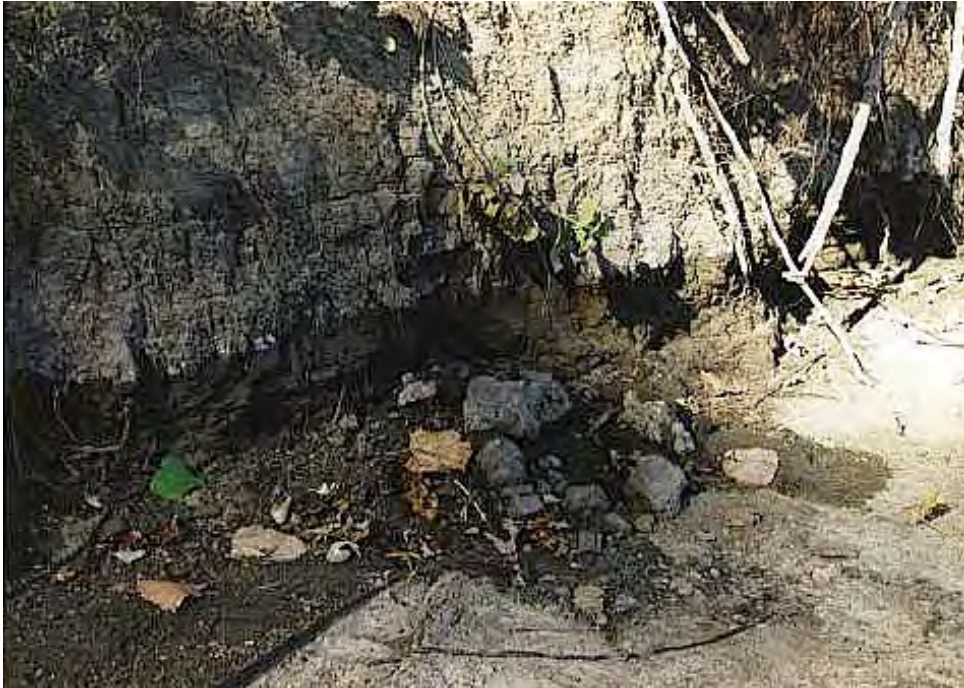
This erosion site had been mapped as a late Holocene surface; however, the site is characterized by thickly bedded historical alluvium. One sampling tube core showed silty to very fine sandy historical deposits to a depth of at least 8.2 ft. The site included desiccated blocks of failed historical alluvium bank soils at the toe of the scarp and within the bench area.. Desiccated vertical cracks formed deep into the soil profile during the summer of 1995. The cracks result from contraction or shrinkage of smectite expandable silts/clays. As moisture is removed, this creates dry soil conditions. The smectite silts/clays swell during moist periods and close the vertical cracks, which adds the cohesiveness to the medium to fine-grained soils. During the late dry summer of 1995,

river stage levels were lower compared to periods earlier in the year. Soil blocks were observed to be calving and slumping into the river's channel margin. The instability of the banks, indicated by the slumping soil blocks, may be caused by several factors,

**Photo 7-60** A close-up view of scarp at Site 27 midpoint

including (1) weakening of the soil body from vertical fracturing; (2) a lower river stage which caused a steepening of the bank slope; (3) wave actions undermining fine sands along the bank interbedded by silt/fine sand alluvial sequence; (4) head differences between the water table and river level, causing groundwater flow along weaker fine sand seams; and finally, (5) less hydraulic bank support during low water dry periods. Moist conditions and higher river stages, higher water table elevations, and improved soil moisture would tend to provide hydraulic support of the soil body.

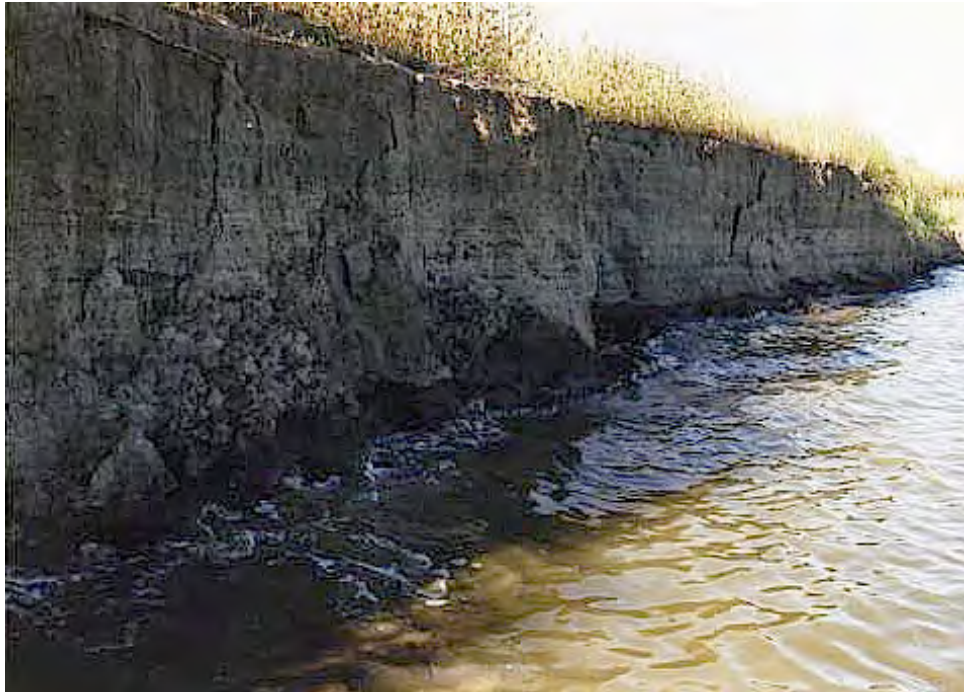
**Photo 7-61 An upstream view of Site 28 midpoint**

shows an upstream view of the site and Photo 7-62 is a close-up of the scarp. Photo 7-63 shows extensive vertical cracks associated with block failures along the bank face, and Photo 7-64 shows piping features and vertical cracks. Shown in figure 7-100 is the bank section obtained at this erosion site. The river cross section shown in figure 7-100 has a typical shape for a crossover reach characterized by a nearly constant depth across the width. The scarp, about 7 ft high, is nearly vertical, and the bank soils are predominantly MST.

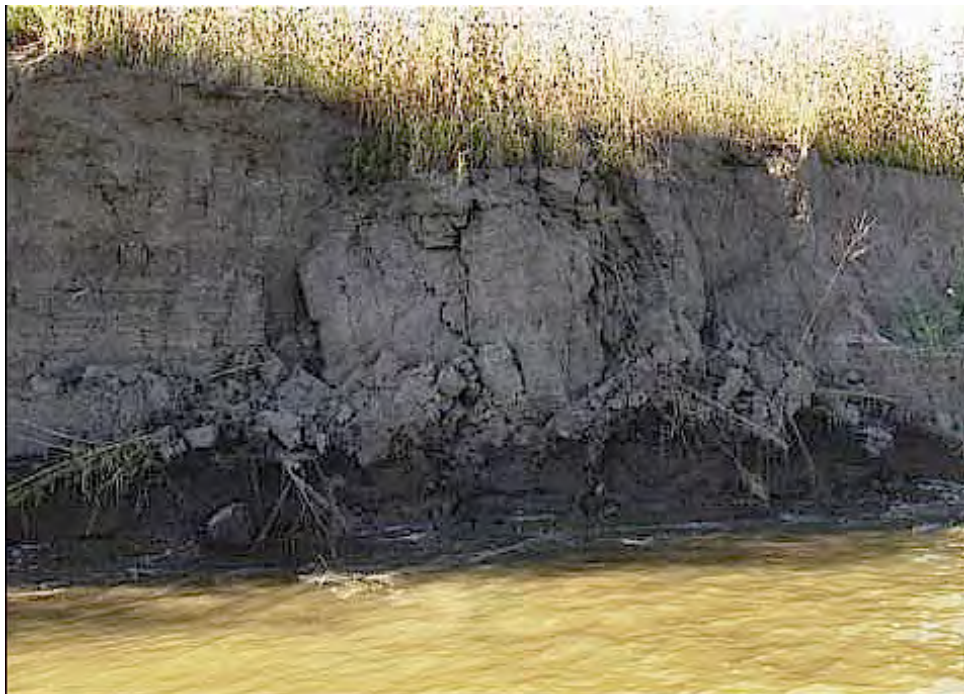
**Photo 7-62 A close-up view of scarp at Site 28 midpoint**

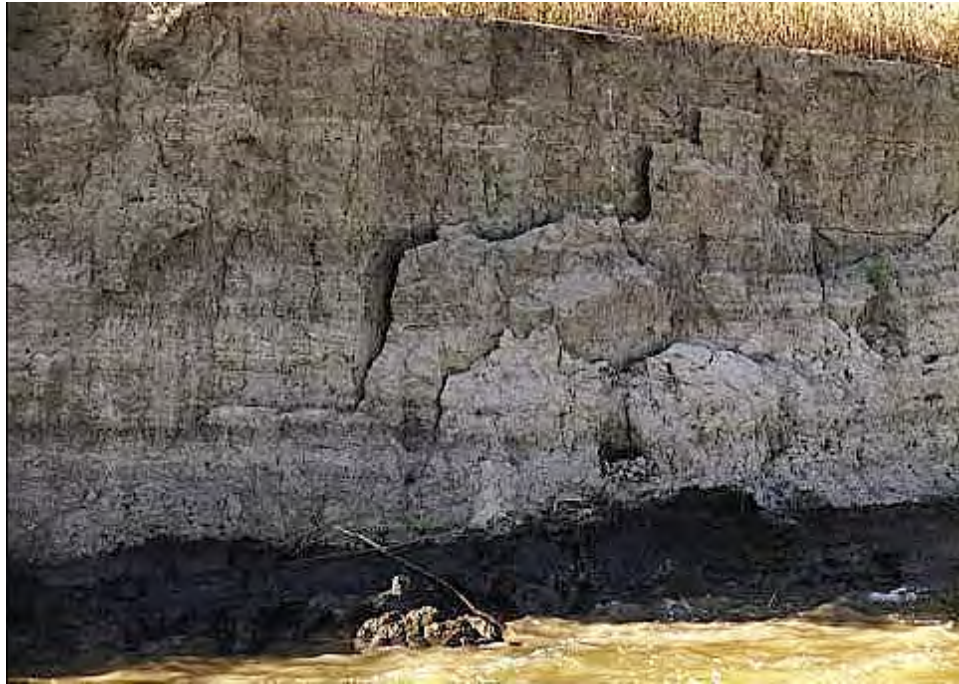
**Photo 7-63 Vertical cracks and massive block failures at Site 28 midpoint**

Extensive piping features were present within the scarp. Surface erosion due to overland drainage was visible at the site. Causative factors for bank retreat at this site include displacement of slabs, slaking, piping and flood erosion and rapid recession-related slumping, slab and block failures, cleft pressure, and overland drainage. A defined rill formation of failed soils and recently deposited sediments is evident within bench areas. Because the site is close to the thalweg sailing line, wave erosion exists here. Type A is the best description of this site.

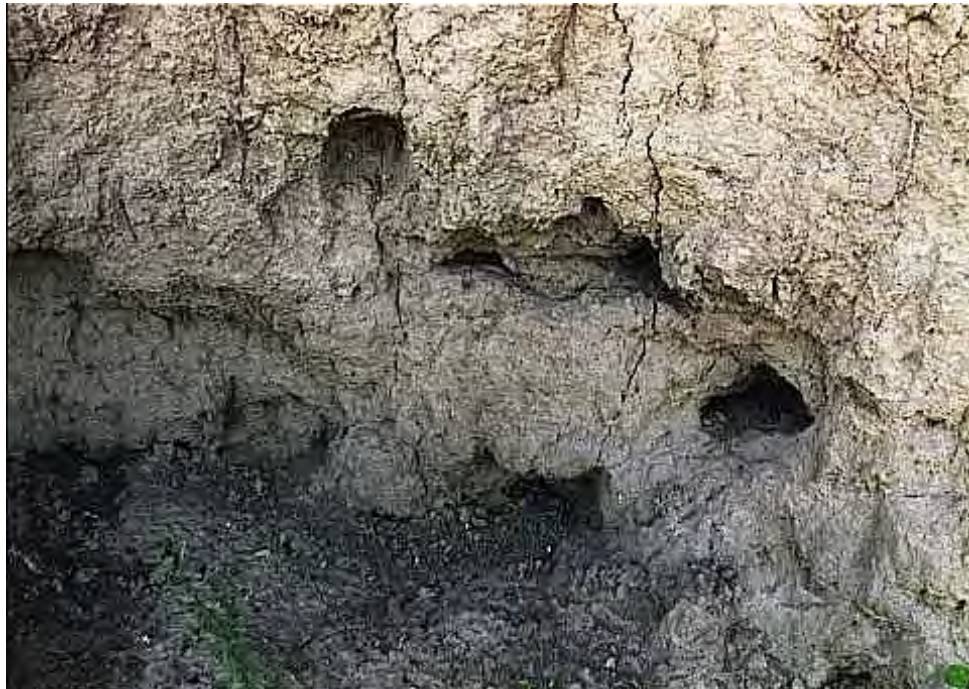
**Photo 7-64 Piping features and vertical cracks seen at Site 28 midpoint**

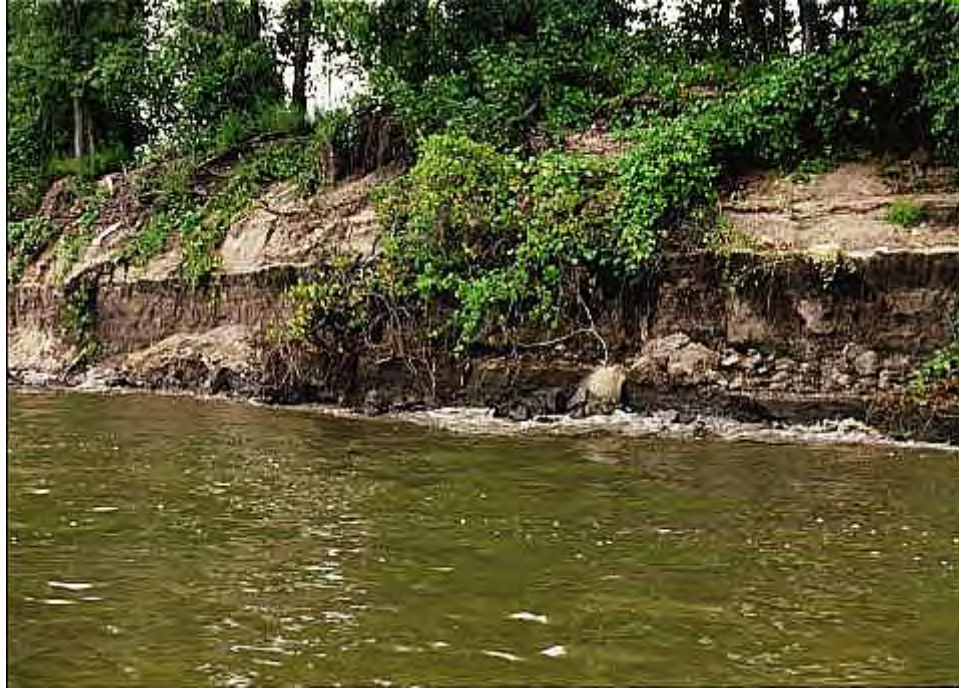
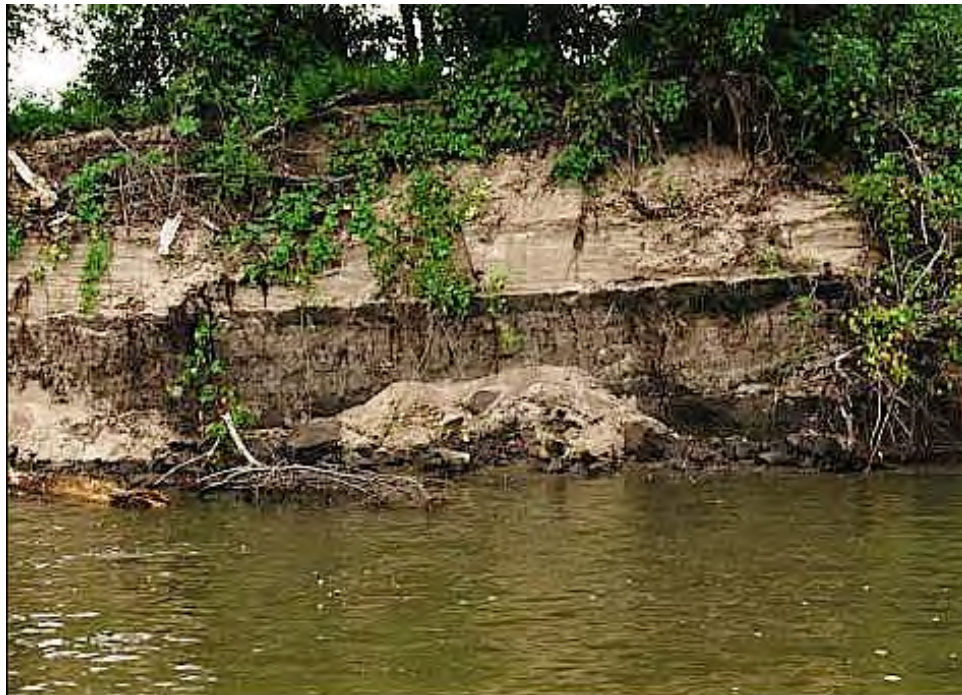
This left-bank site, shown in figure 7-101, is located between two wing dams on a small island, detached from Long Island situated along the left bank of a straight stretch of the MR. It is 3.9 miles downstream from Lock & Dam No. 20. Bank retreat since 1984 is visible in figure 7-101. Photos 7-65 and 7-66 show an upstream view and a perpendicular view of the site. Three bank sections are shown in figures 7-102 through 104. The bank soils are layered silt (MST) and sand (FS-MS). Subaqueous soil is FS. Piping features and related block failures were observed at this site. There were multiple scarps within the bank. The thalweg sailing line is located in the mid-channel. Drawdown by fifteen upstream-bound empty barges, as measured at this site, was about 0.2 ft.

Causative factors for bank retreat at this site include piping, flood-flow erosional oversteepening and rapid recession and piping-initiated failures, block failures, and wave and flow rework-transport of failed soils and recently deposited sediments within bench areas. This site is characterized by a combination of Types A, B, and C.

**Photo 7-65 An upstream view of Site 29 midpoint**

**Photo 7-66 A perpendicular view of Site 29 midpoint**

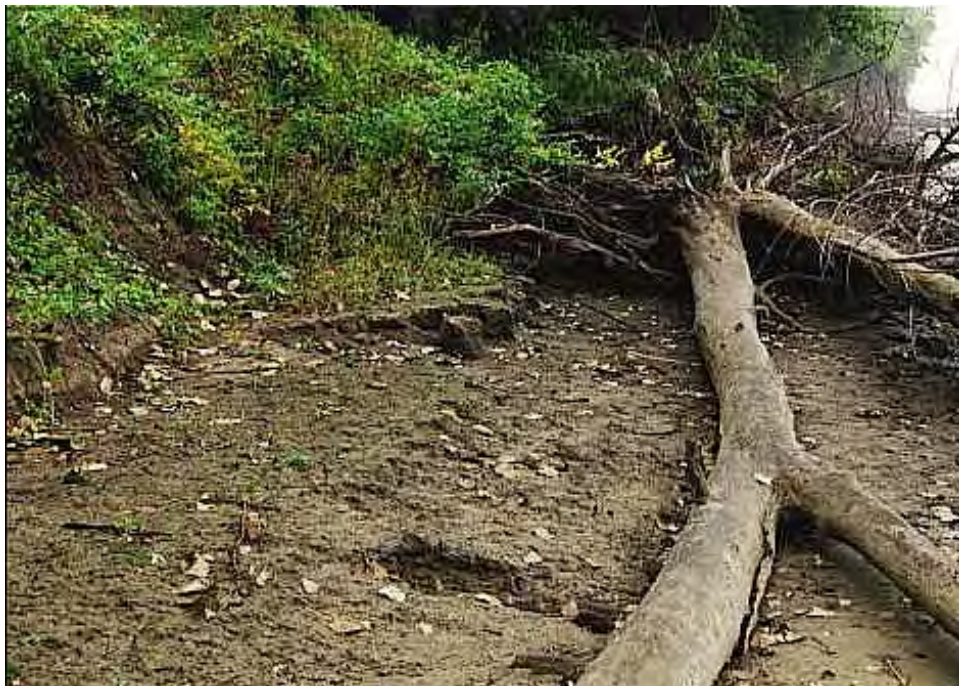
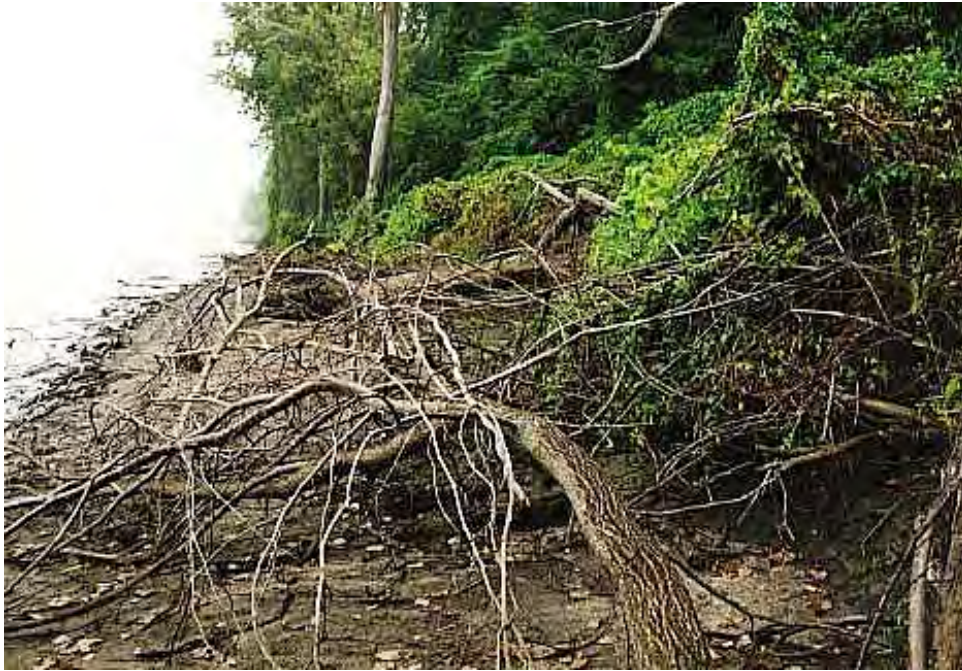
This right-bank site is located opposite Site 29. Photos 7-67 and 7-68 show upstream and downstream views of the site. Only one bank section was taken at this site, as shown in figure 7-105. The scarp is almost 6 ft high. The bank soils are silts (VFST-MST) and subaqueous soil is CST.

**Photo 7-67 An upstream view of Site 30 midpoint**

**Photo 7-68 A downstream view of Site 30 midpoint**

Causative factors for bank retreat at this site include flood-flow erosional oversteepening and rapid recession and piping-initiated failures, and wave and rework-transport of failed soils and recently deposited sediments within bench areas. Secondary wave erosion occurs within berm and bench areas. The bank is classified as Type C.

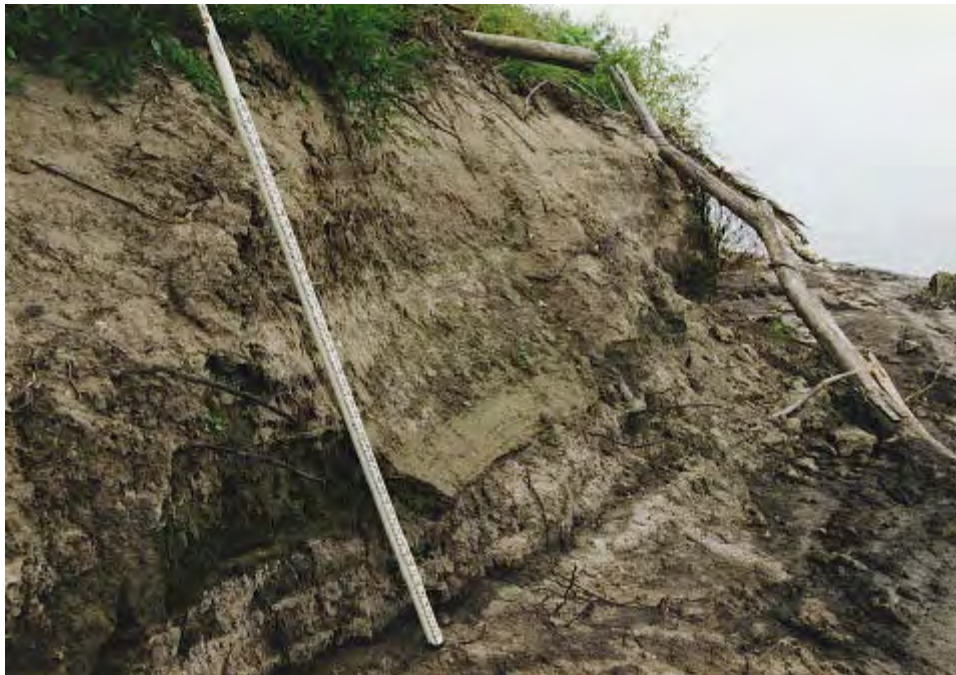
This right bank observation site, located about 2 miles downstream from Lock & Dam No. 21, had several interesting topographic features, including direct impacts on river banks of barge mooring (tows wait for up-bound locking procedures), piping cavities, and large block failures. Photos 7-69 shows a trace of bank-surface scraping by a barge during higher river stages, and Photos 7-70 and 7-71 show the barge-impact smearing within the bench. Numerous piping holes were observed at this site. Photos 7-72 through 7-74 show close-up views of piping cavities. The piping feature shown in Photo 7-74 was about 3 ft wide and 4 ft high, and extended about 6 ft horizontally at that size. Photos 7-75 and 7-76 show vertical slabbing failures within bank upslope from

**Photo 7-69 Bank soil scraped by a barge - Observation Site at RM 322.9 RDB**

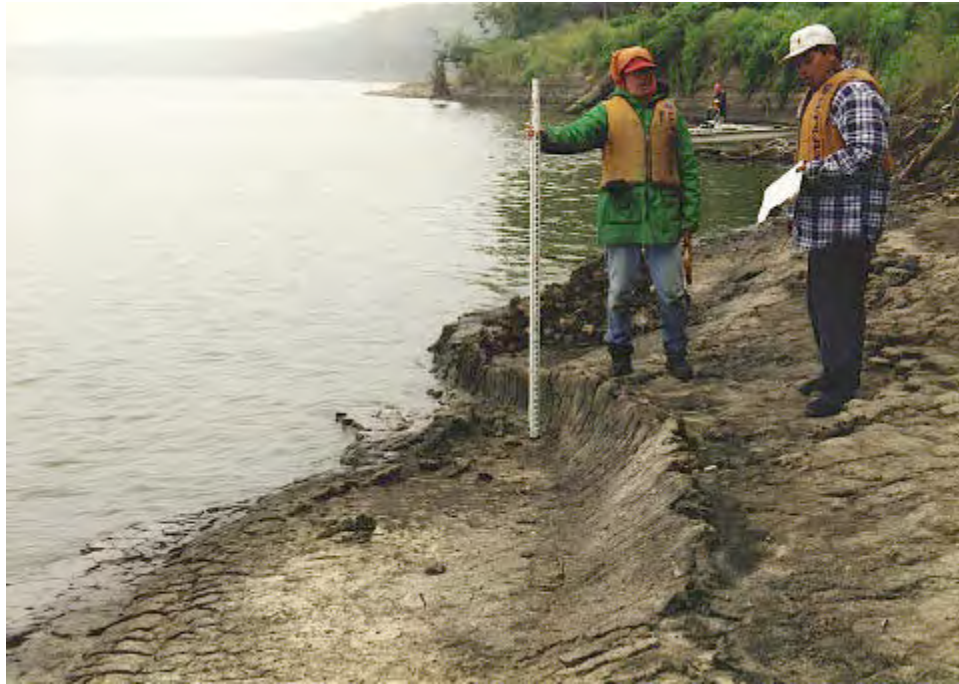
**Photo 7-70 Bench smeared by a barge - Observation Site at RM 322.9 RDB**

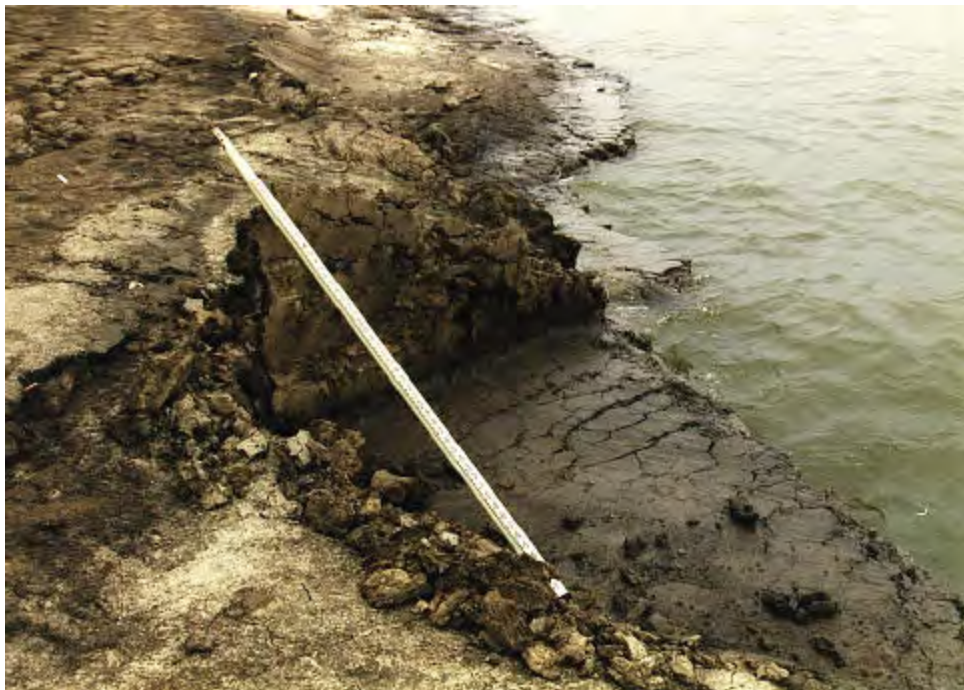
**Photo 7-71 Close-up of smeared bench - Observation Site at RM 322.9 RDB**

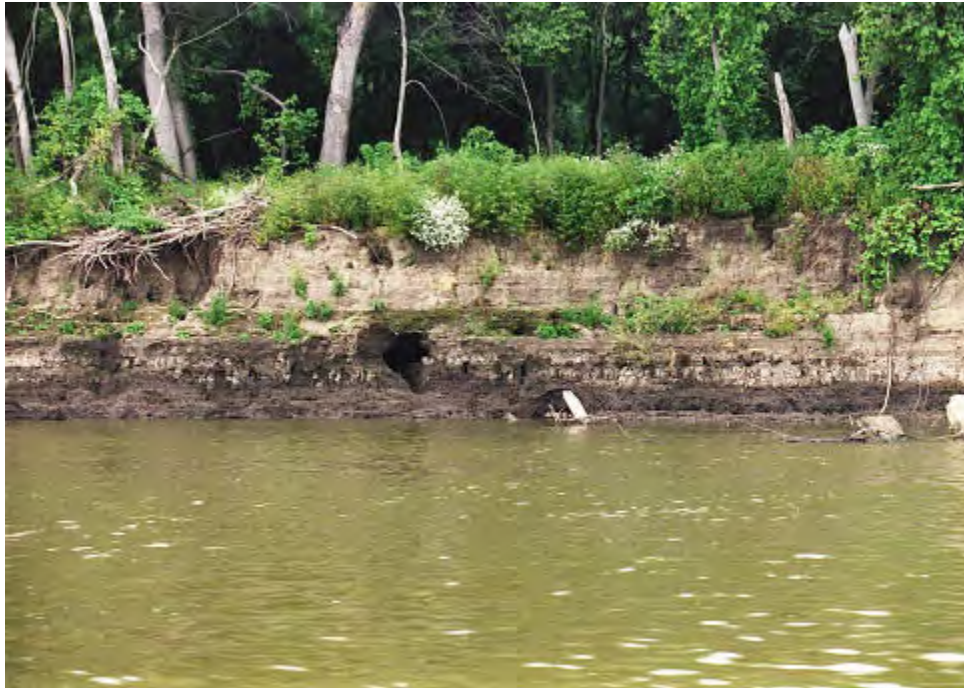
**Photo 7-72 Piping features - Observation Site at RM 322.9 RDB**

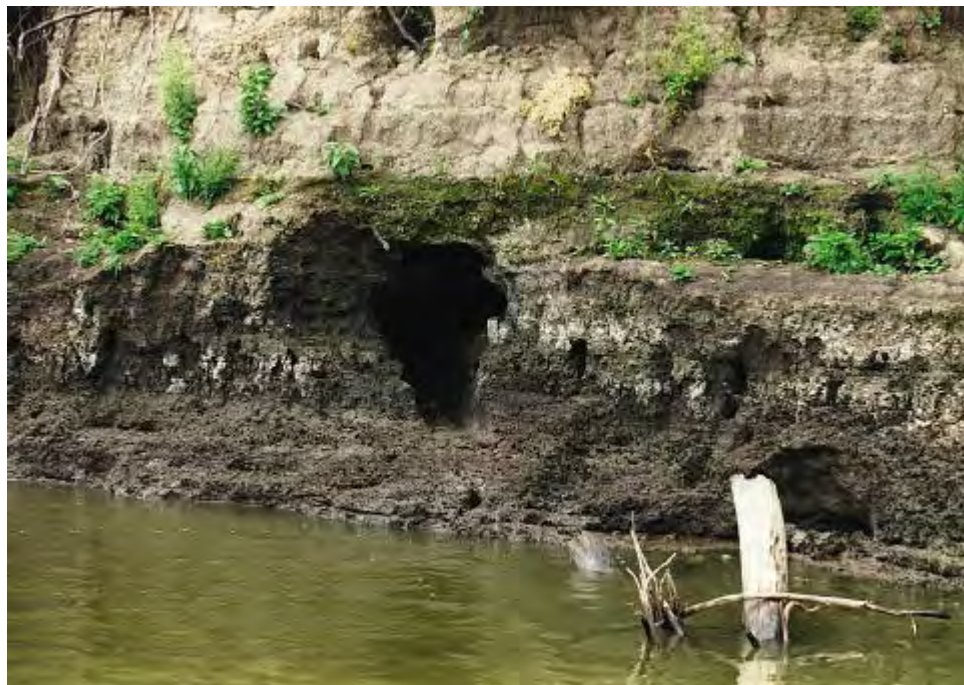
**Photo 7-73 Close-up of piping features - Observation Site at RM 322.9 RDB**

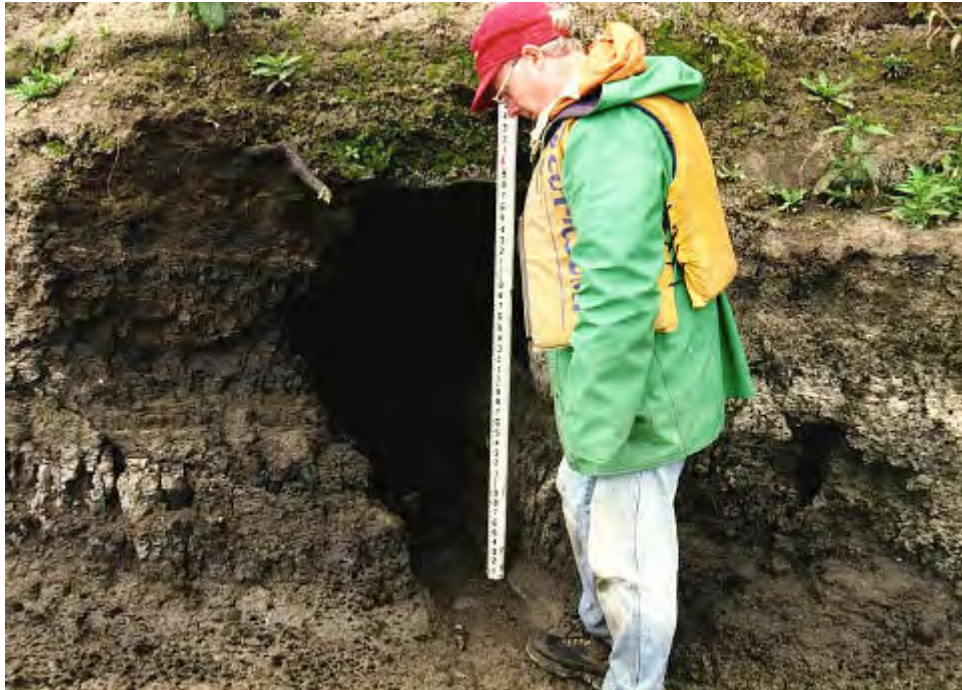
**Photo 7-74 Further close-up of piping features - Observation Site at RM 322.9 RDB**

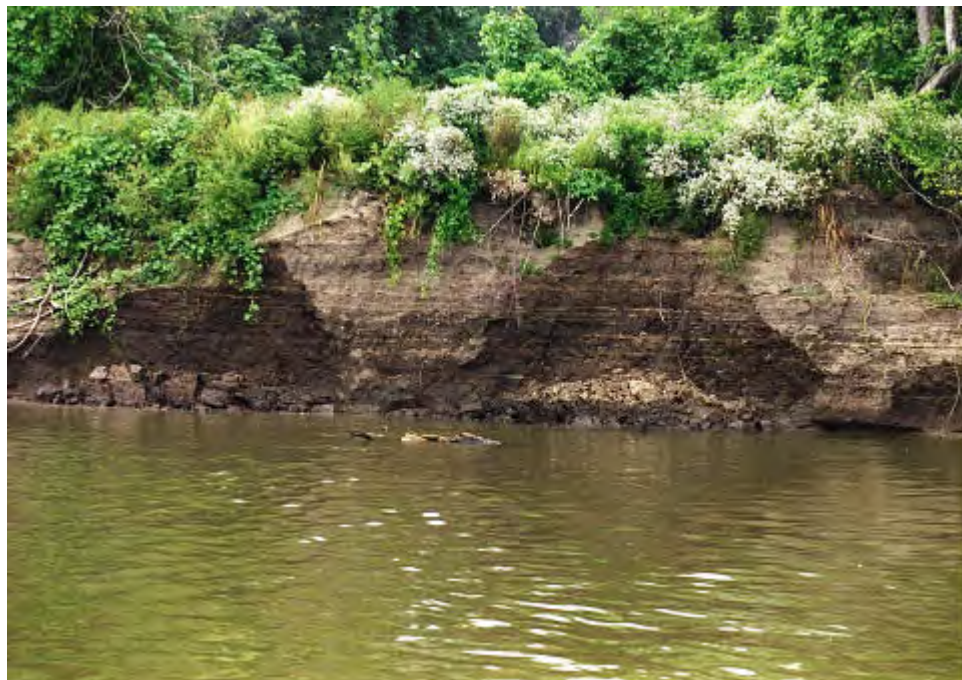
**Photo 7-75 Vertical bank failure - Observation Site at RM 322.9 RDB**

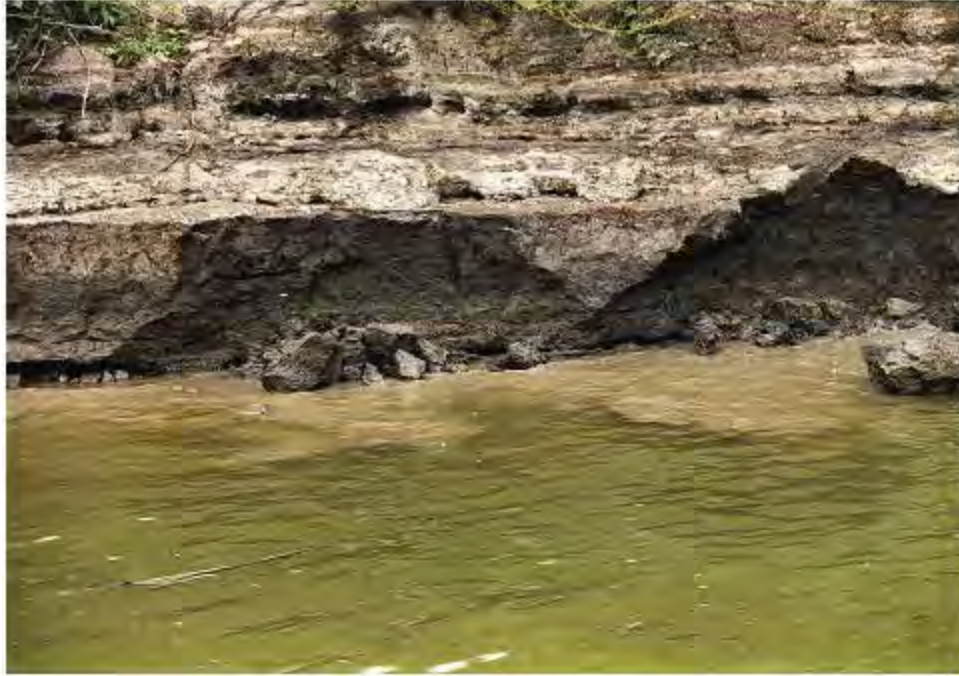
**Photo 7-76 Vertical failure of lower bank - Observation Site at RM 322.9 RDB**

pipng features. Neither bank sections nor soil samples were taken at this observation site. However, visual observations indicated that the upper scarp consisted of ML (see table 7-4) and the lower scarp consisted of two layers of soils (CH on top of SM).

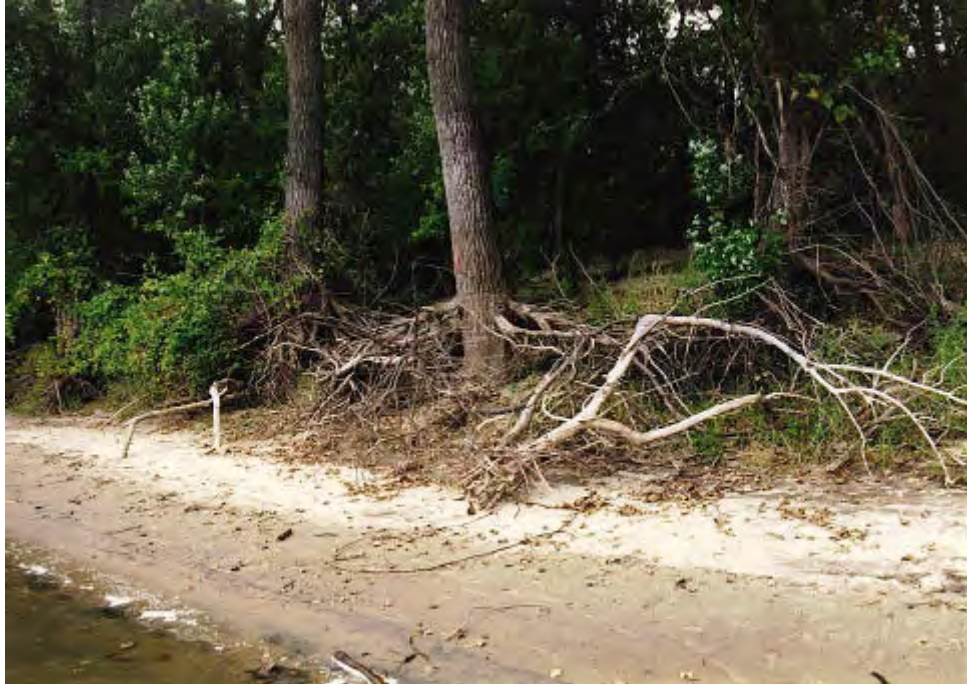
This left island site, shown in figure 7-106, is located on the inside of a bend in a wing-dam field along the upper portion of Denmark Island, about 8.2 miles downstream from Lock & Dam No. 22. ***It should be noted that there is no Lock & Dam No. 23.*** An upstream view of the site is shown in Photo 7-77, and sand deposits on Denmark Island are shown in Photo 7-78. The bank section taken at the midpoint is shown in figure 7-107. The river cross section, shown in figure 7-107, is typical for a river bend, with a larger flow depth along the concave bank. The bank soils are primarily sand (VFS-FS)

**Photo 7-77 An upstream view of Site 31 midpoint**

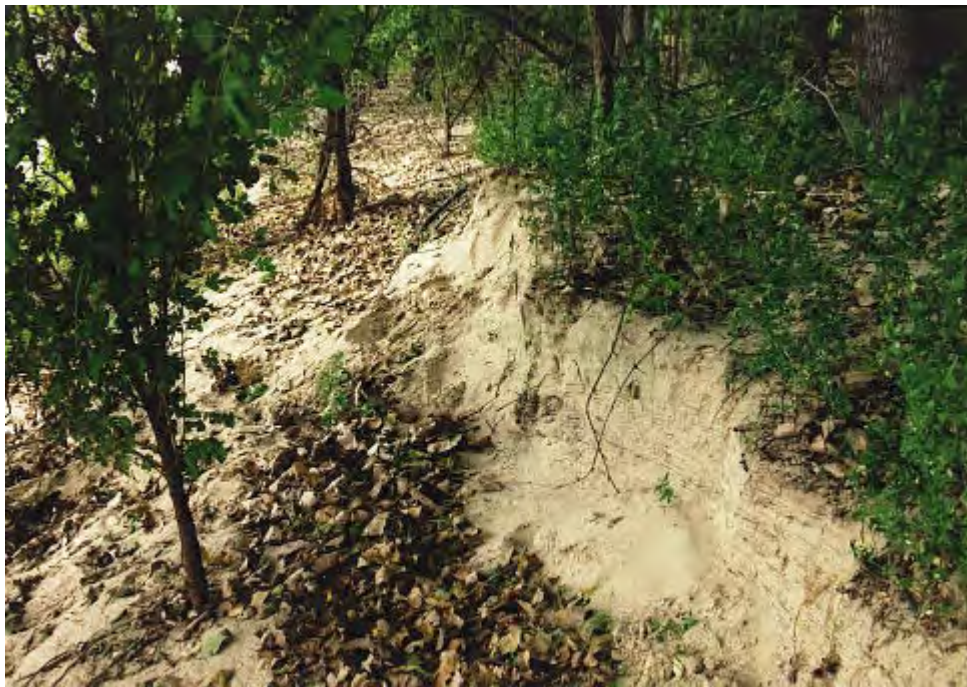
with some medium silt (MST). Denmark Island is covered with sand deposit from the Great Flood of '93. No geomorphic soil core samples were taken at Site 31.

**Photo 7-78 Sand deposits on Denmark Island of Site 31 midpoint**

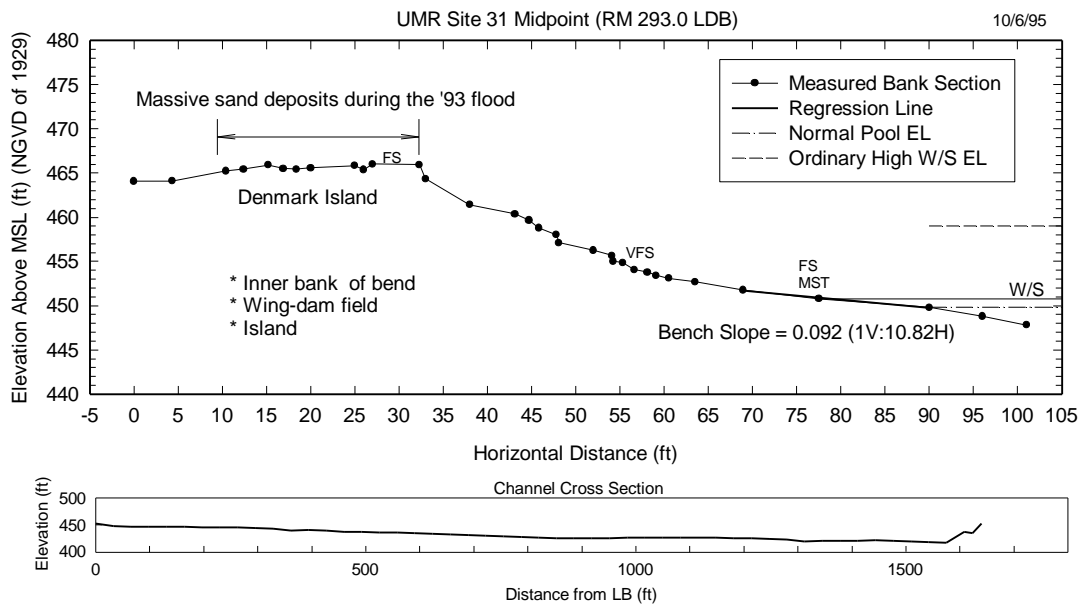
**Figure 7-107 Bank section and channel cross section measured at Site 31 midpoint**

Causative factors for bank retreat at this site include flood-flow erosion, piping-related collapse, and wave and flow rework-transport of failed soils and recently deposited silty sand which covers bench areas. A combination of Types D and E characterizes this site.

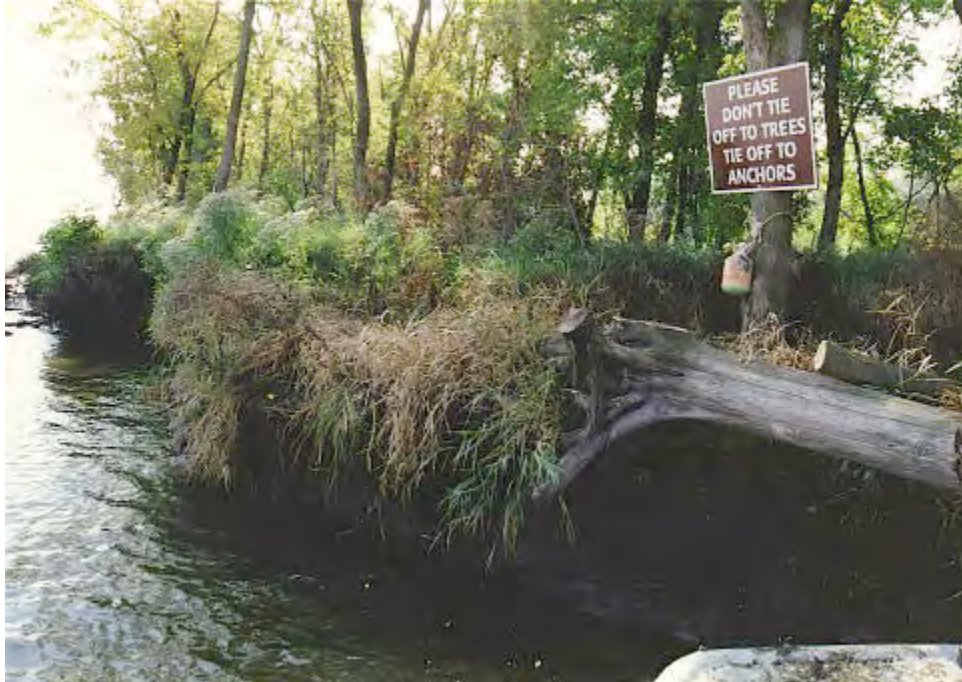
This right-bank inside-bend site, shown in figure 7-108, is located in a mooring zone, only 2 miles upstream from Lock & Dam No. 24. Photo 7-79 shows a downstream view of the site, and Photo 7-80 shows a close-up view of the bank disturbed by mooring activities. Note the sign on the tree shown in Photo 7-79. Only one bank section was taken at this site, which is shown in figure 7-109. The bank material is silt (CLT-MST). Subaqueous soil is primarily silt (VFST-FST). This site is used heavily as a barge-mooring site where tow boats wait for downstream locking at Lock & Dam No. 24. Although this erosion site is located along the inner bank, the river cross section in figures 7-109 indicates that the thalweg is developing along the right bank. Evidence of severe in-

**Photo 7-79 A downstream view of Site 32 midpoint**

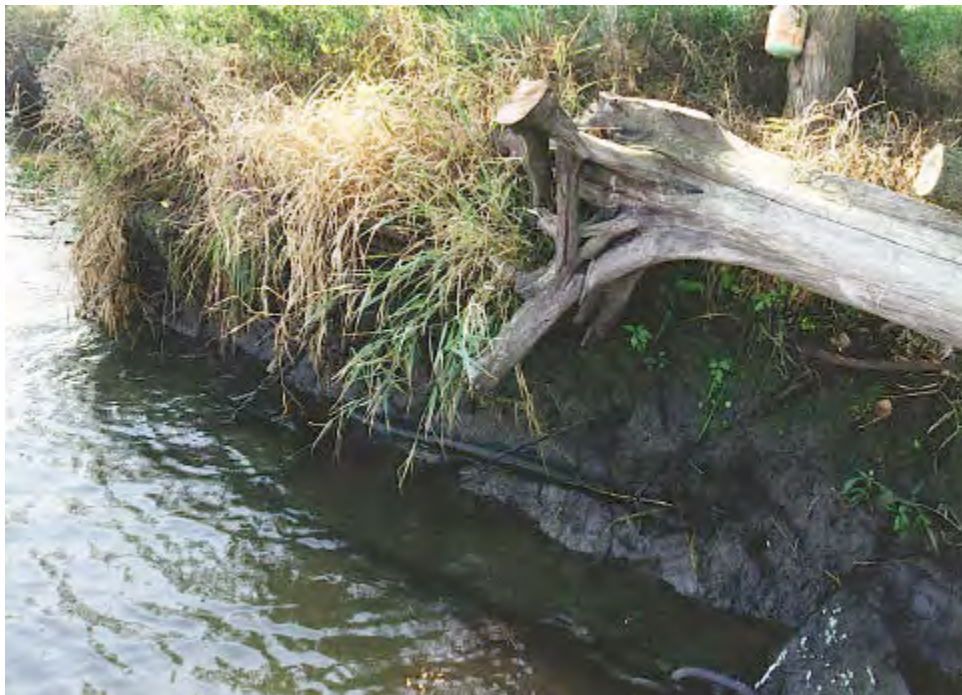
**Photo 7-80 A close-up view of mooring activities at Site 32 midpoint**
