# **Interim Report For The Upper Mississippi River - Illinois Waterway System Navigation Study**

**US Army Corps  
of Engineers**

**November 1997**

## Bank Erosion Field Survey Report of the Upper Mississippi River and Illinois Waterway

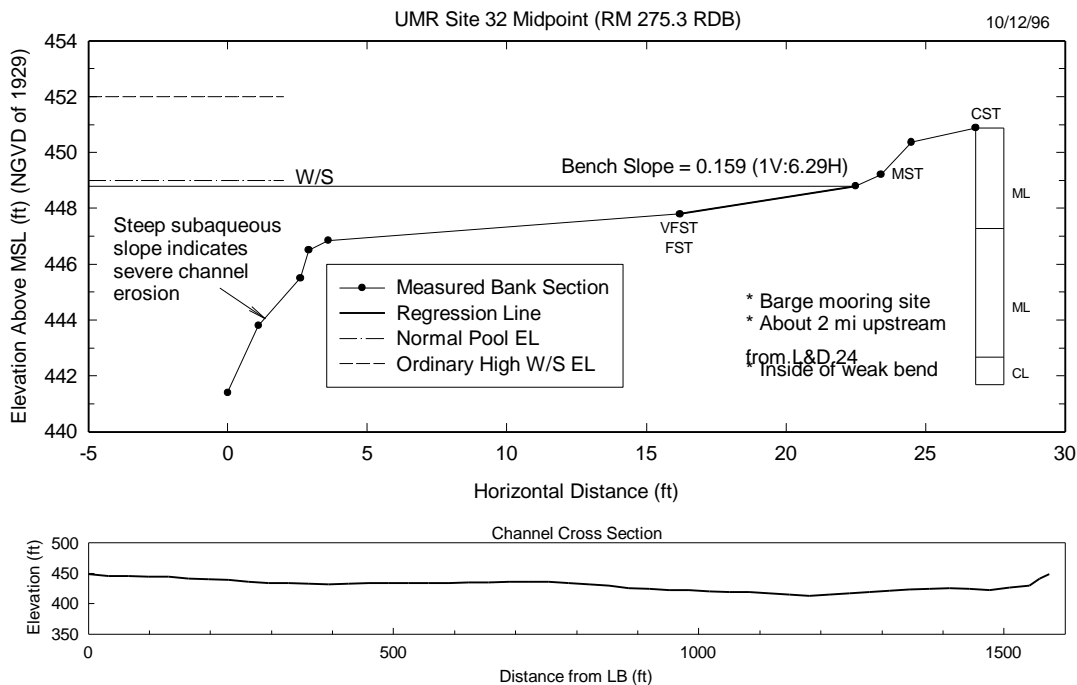
**Figure 7-109 Bank section and channel cross section measured at Site 32 midpoint**

This right-bank inside-bend site, shown in figure 7-108, is located in a mooring zone, only 2 miles upstream from Lock & Dam No. 24. Photo 7-79 shows a downstream view of the site, and Photo 7-80 shows a close-up view of the bank disturbed by mooring activities. Note the sign on the tree shown in Photo 7-79. Only one bank section was taken at this site, which is shown in figure 7-109. The bank material is silt (CLT-MST). Subaqueous soil is primarily silt (VFST-FST). This site is used heavily as a barge-mooring site where tow boats wait for downstream locking at Lock & Dam No. 24. Although this erosion site is located along the inner bank, the river cross section in figures 7-109 indicates that the thalweg is developing along the right bank. Evidence of severe in-

channel flood-flow erosional oversteepening is visible in the bank-section defined topographic features.

Causative factors for bank retreat at this site include flood-flow erosional oversteepening and subsequent failures, bench-area rework-transport of failed soils and recently deposited sediments by waves, and barge-mooring activities. Evidence of erosion due to traffic-generated waves and turbulence, and barge mooring exists at this site. Type A is the most representative classification for Site 32.

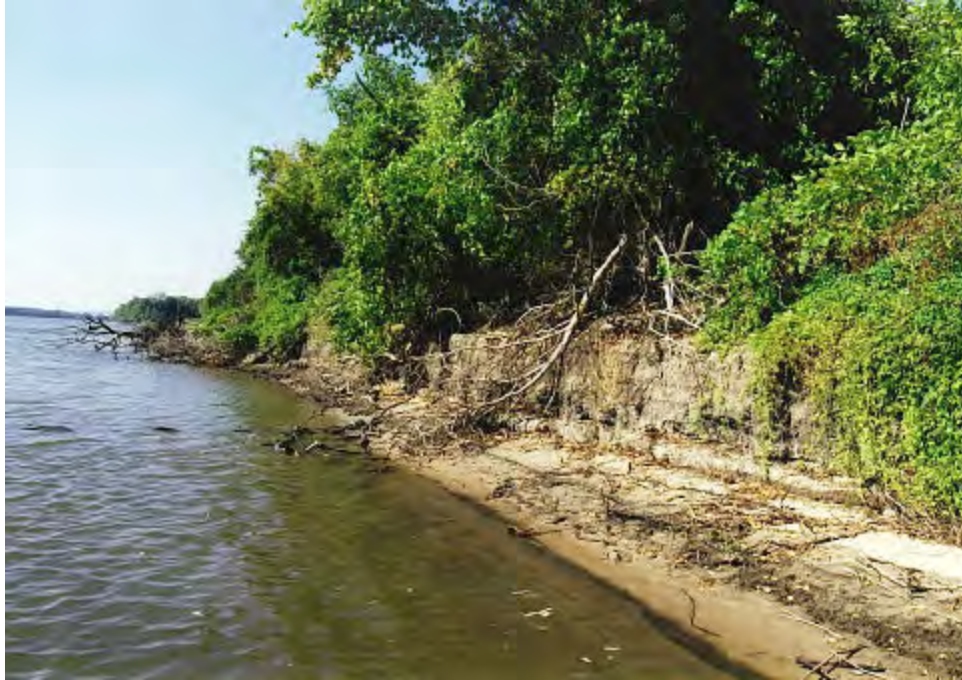
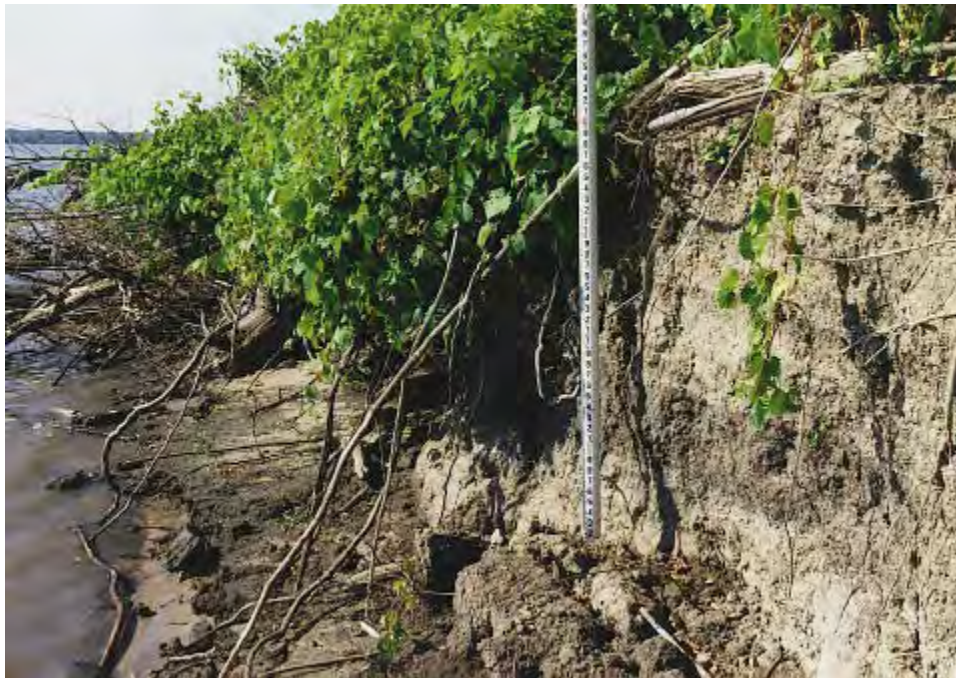
One bank section taken at the midpoint is shown in figure 7-111. The bank soils are primarily silt (VFST-CST). The scarp is almost vertical and contains numerous piping features. Failed soil blocks had accumulated at the toe of the scarp.

**Photo 7-81 An upstream view of Site 33 midpoint**

**Photo 7-82 A close-up view of Site 33 midpoint**

Causative factors for bank retreat at this site include piping and flood-flow related erosion and block failures, and wave and rework-transport of failed soils and recently deposited sediments from bench and berm areas. Type A characterizes this erosion site.

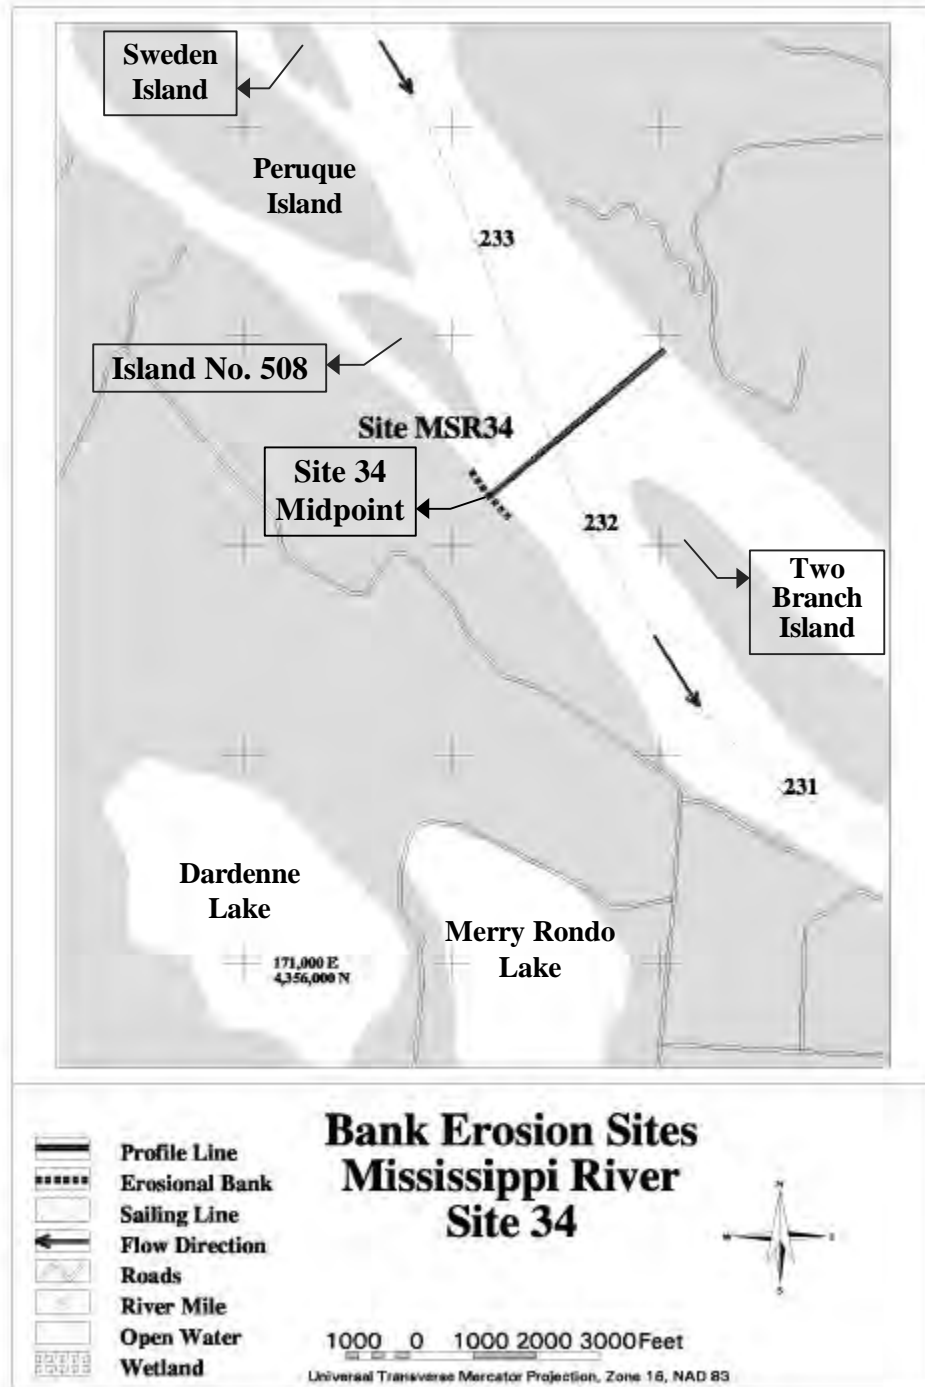
Figure 7-112 A map showing Mississippi River Site 34

This right-bank site, shown in figure 7-112, is located 15.3 miles downstream from Lock & Dam No. 25 and 29.3 miles upstream from Lock & Dam No. 26. This erosion site is immediately downstream from Cuivre Slough outlet behind Island No. 508. Photos 7-83 and 7-84 show upstream and downstream views of this site, respectively. The bank section taken at this site is shown in figure 7-113. The bank soil is primarily VFST and FST. Subaqueous soil sample taken at 1 ft depth is VFST. The severely eroded bank face

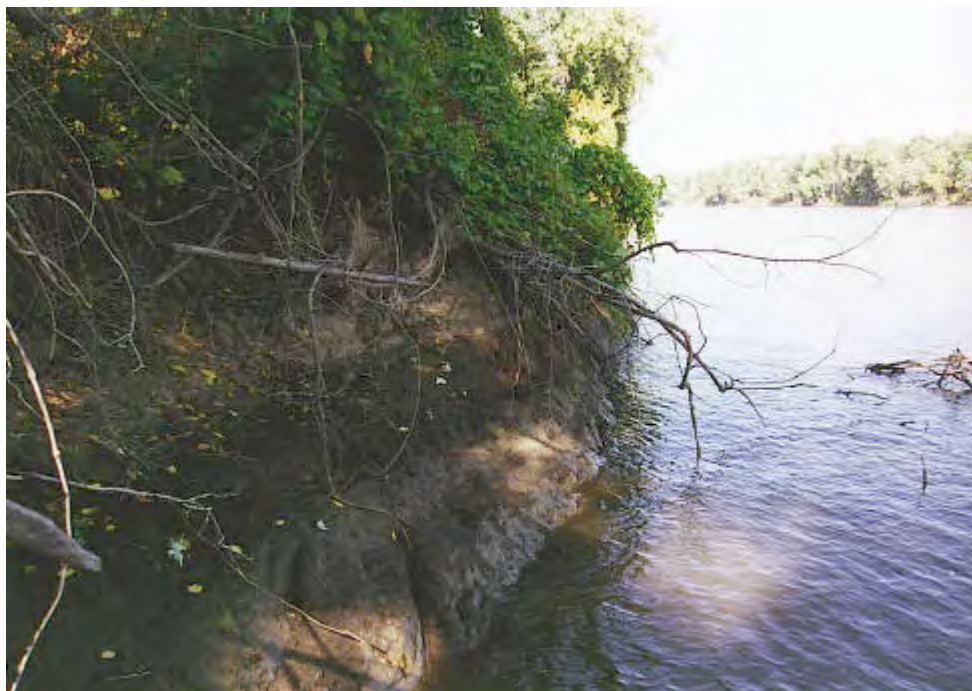
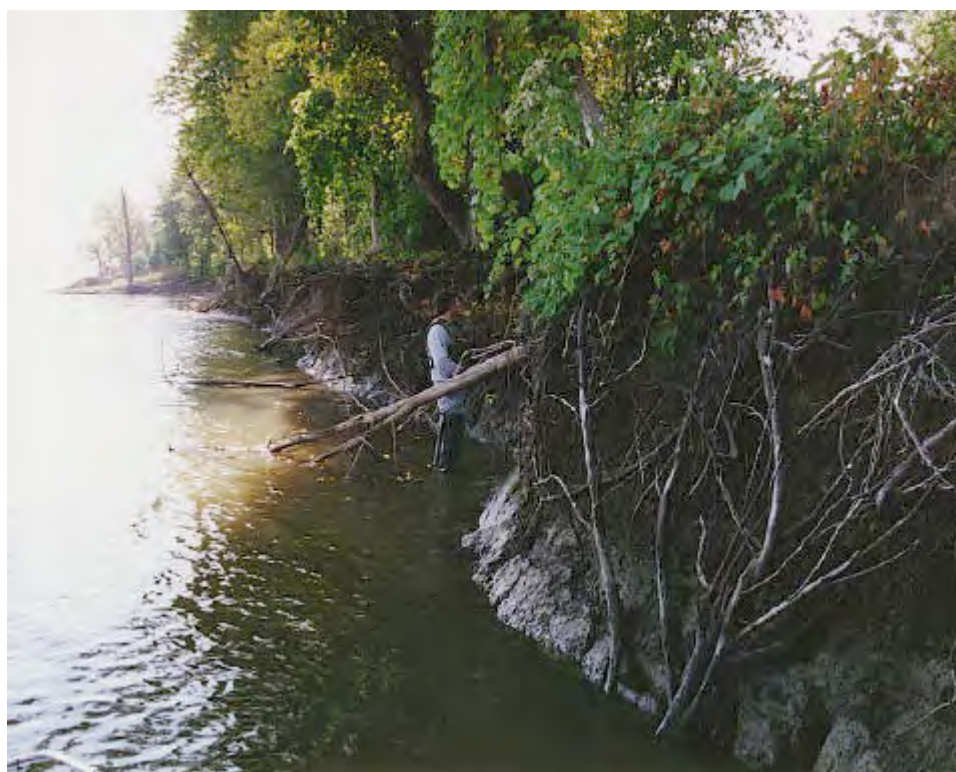
with minor piping, about 8 ft high, indicates that erosional oversteepening and collapse occurred during the Great Flood of '93 and the floods of

**Photo 7-83 An upstream view of Site 34 midpoint**

**Photo 7-84 A downstream view of Site 34 midpoint**

1994 and 1995. Drawdown generated by the transiting of 16 loaded upstream-bound barges was measured as about 0.25 ft.

Causative factors for bank retreat at this site include flood-flow erosion and rapid recession failures, and minor piping and collapse. There is potential for wave erosion of failed soil and recently deposited sediments which cover bench and berm areas. Type A is the best bank type for this site.

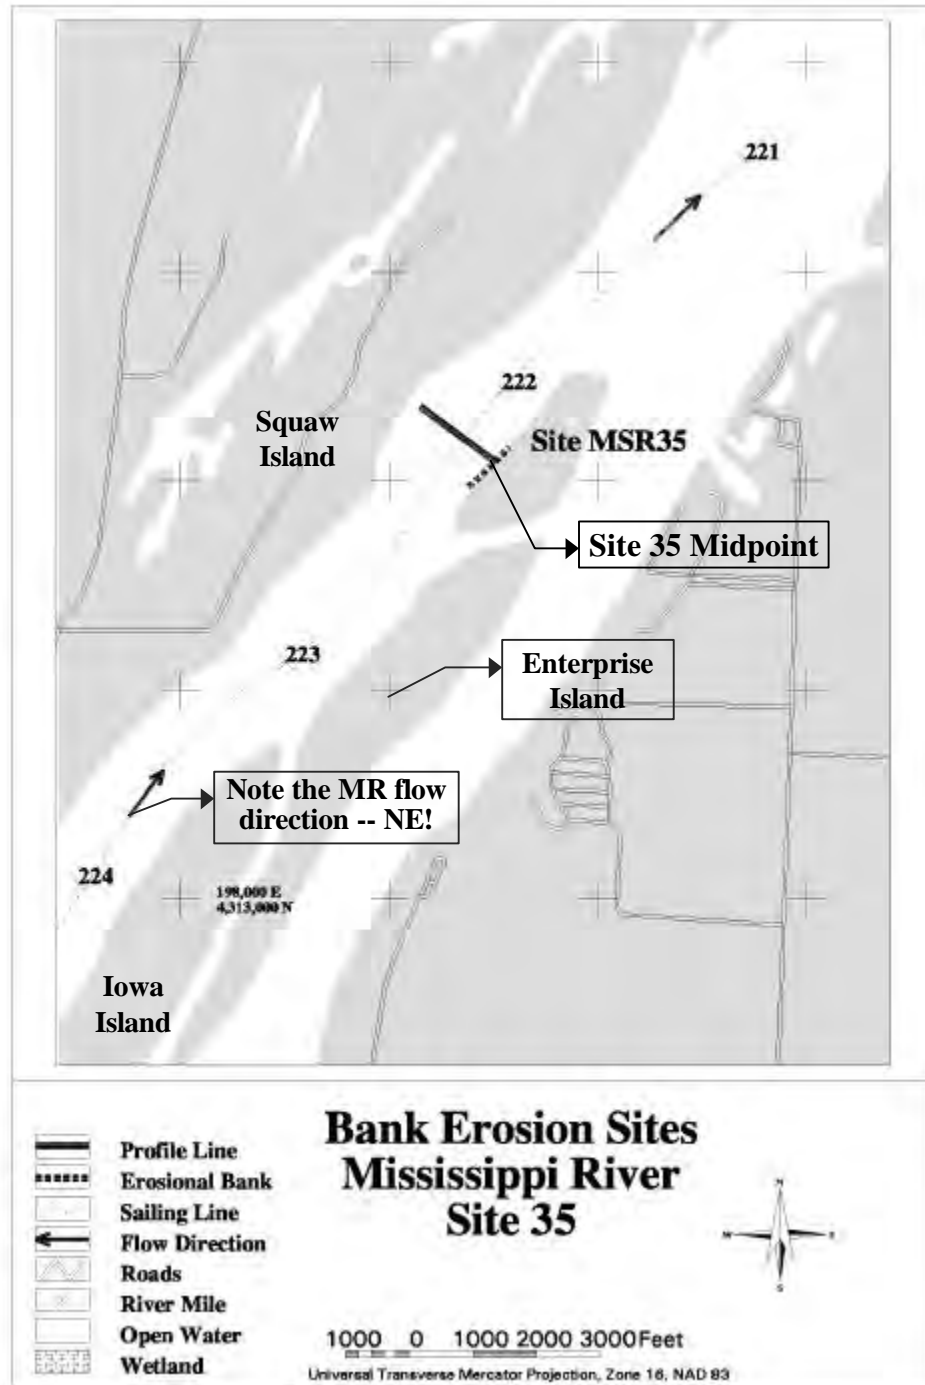
**Figure 7-114 A map showing Mississippi River Site 35**

This right-bank island site, shown in figure 7-114, is located in a straight reach on Island No. 521, 25.4 miles downstream from Lock & Dam No. 25 and 4.7 miles upstream

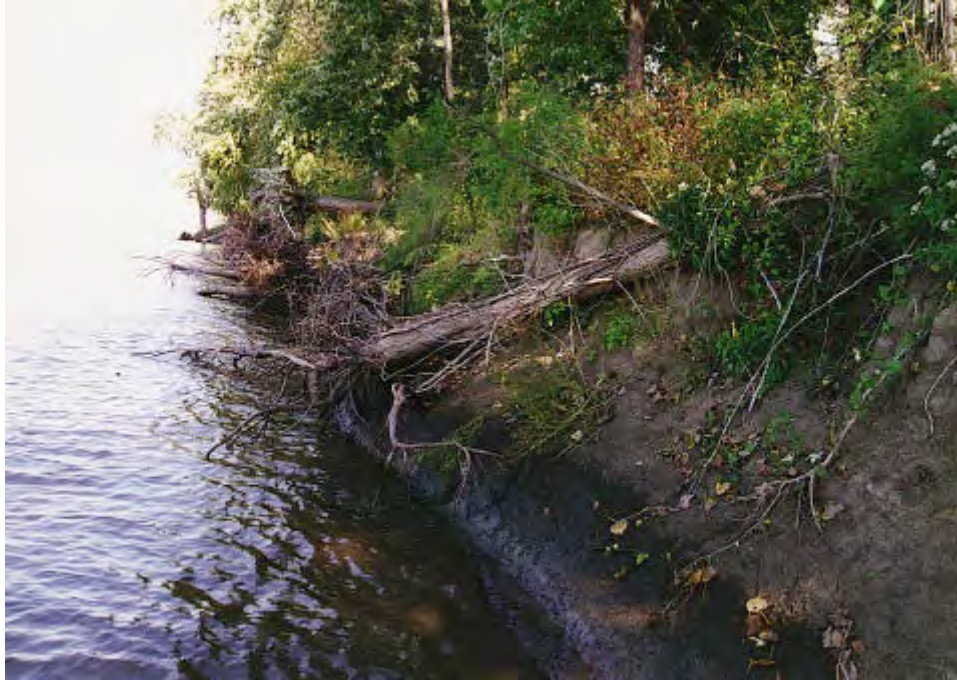
**Photo 7-85 A downstream view of Site 35 midpoint**

from the confluence of the Illinois River. Photo 7-85 shows an upstream view of this site, and Photo 7-86 shows exposed tree roots. Three bank sections taken are shown in figures 7-115 through 7-117. The bank soils are fine silt (FST) to coarse clay (CC).

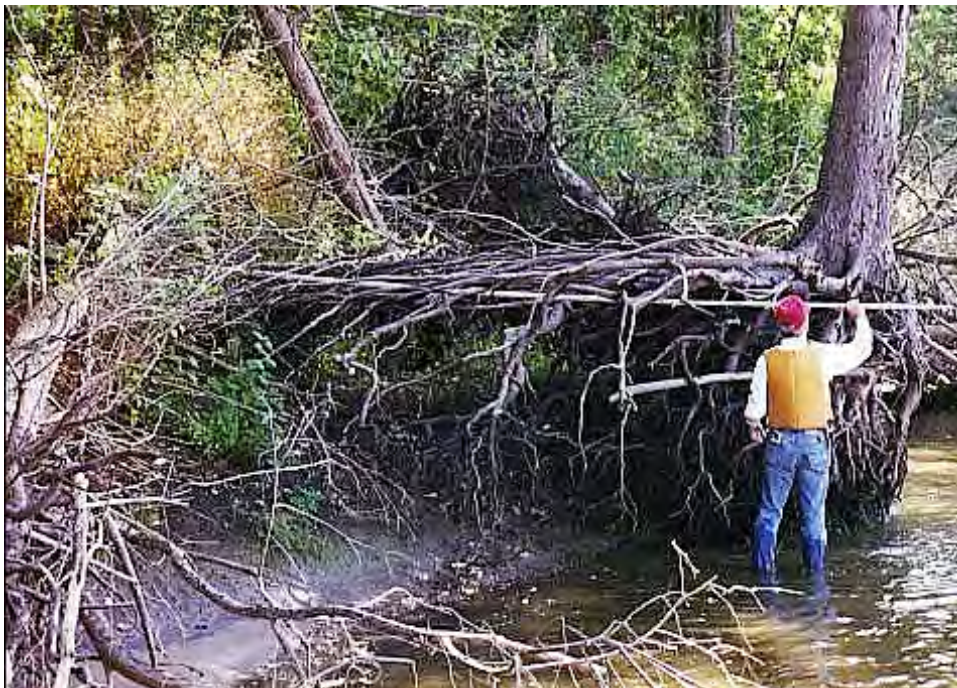
**Photo 7-86 Inspection of tree roots at Site 35 midpoint**

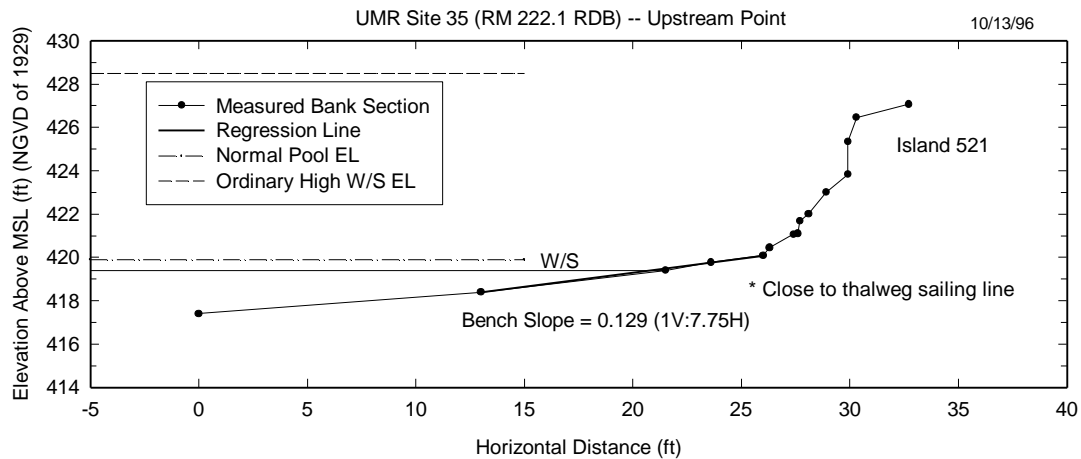
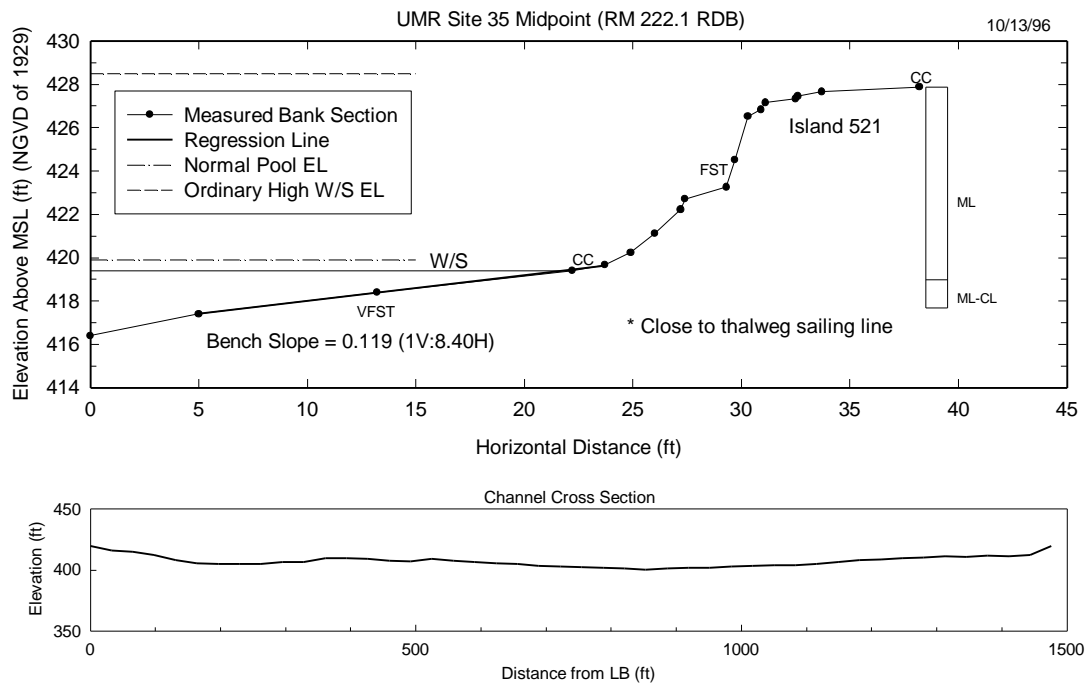
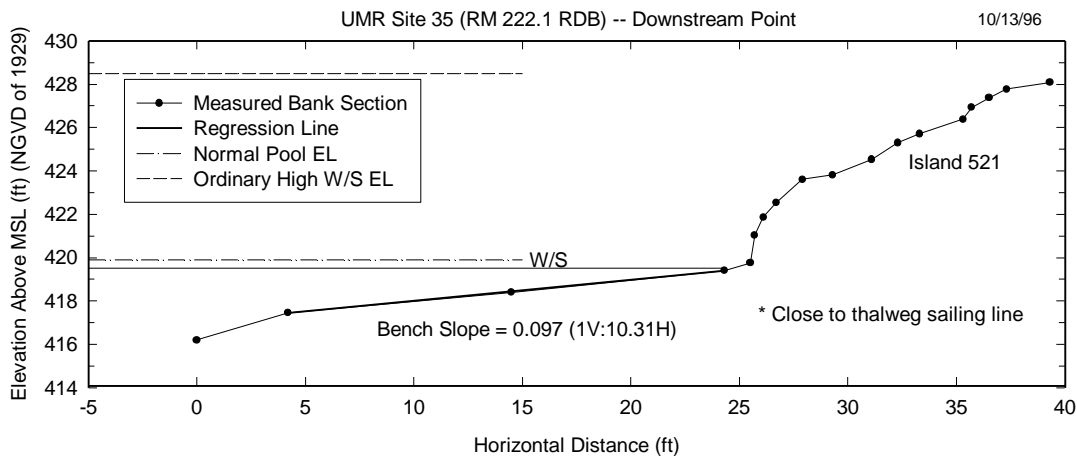
**Figure 7-115 Bank section measured at Site 35 upstream point**

**Figure 7-116 Bank section and channel cross section measured at Site 35 midpoint**

**Figure 7-117 Bank section measured at Site 35 downstream point**

Causative factors for bank retreat at this site include flood-flow erosion and rapid recessional slumping, minor piping and collapse, and wave and rework-transport of failed soils and recently deposited sediments within bench areas. Because the site is very close to the thalweg sailing line, wave erosion within bench areas is more significant. Site 35 can be classified as Type A.

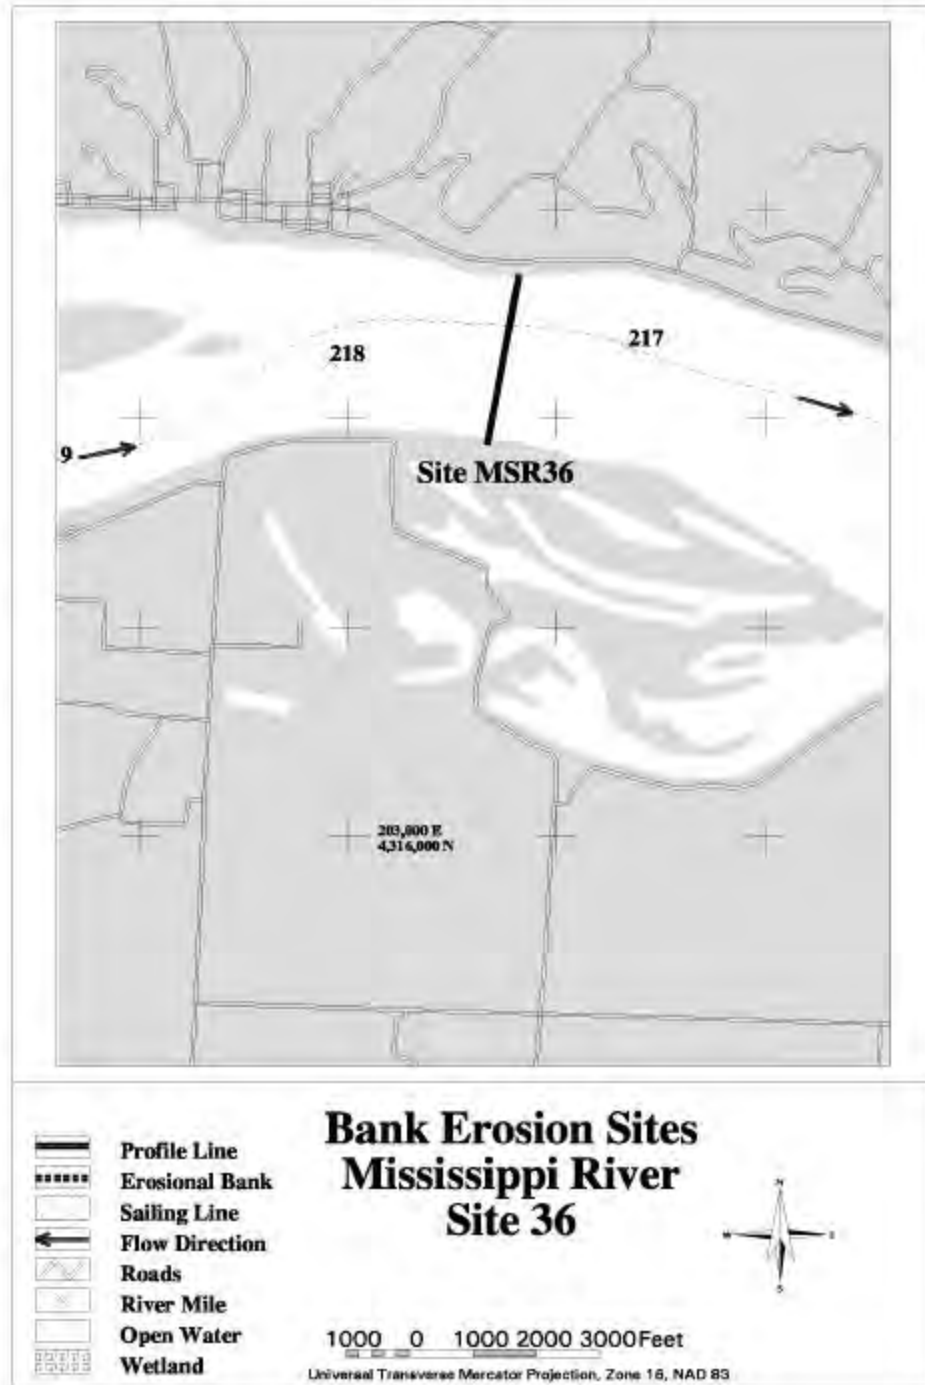
Figure 7-118 A map showing Mississippi River Site 36

This right-bank site, shown in figure 7-118, is located along a rather straight reach, just 0.5 mile downstream from the confluence of the Illinois River, 14.6 miles upstream from Lock & Dam No. 26. Photo 7-87 shows a downstream view of the site, and Photo 7-88 shows a close-up view of the scarp. The bank section taken is shown in figure 7-119. The river cross section indicates that the site is located in the convex bank of a minor bend. At the top of the bank is a farm field, and some segments of a local road were found to be collapsing due to bank retreat. The bank soils consist of fine to medium silt (FST-MST) and fine sand (FS). Subaqueous sediments are fine sand (FS).

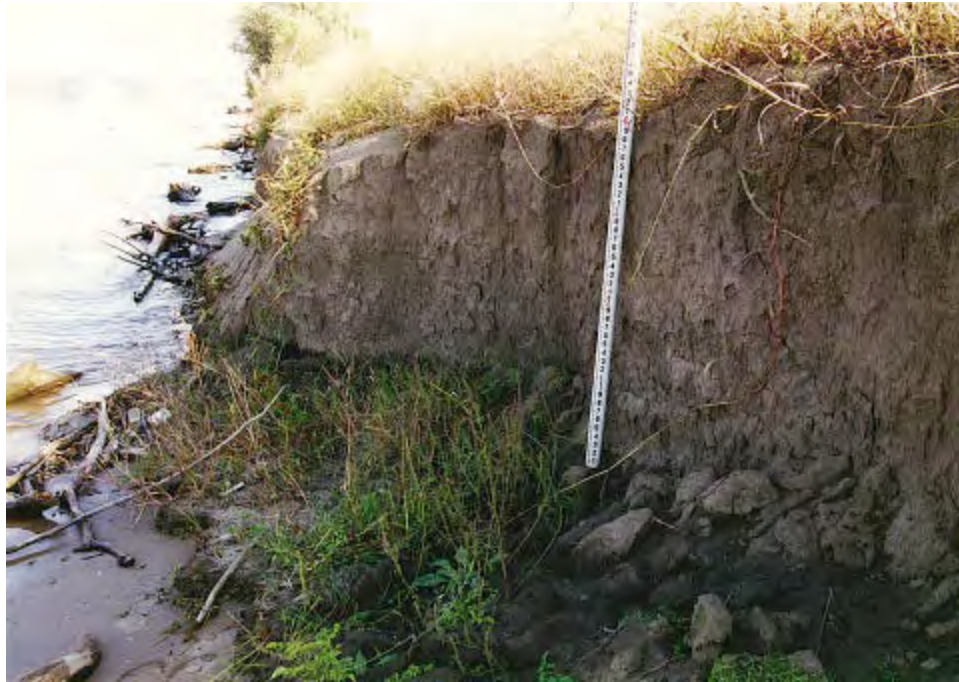
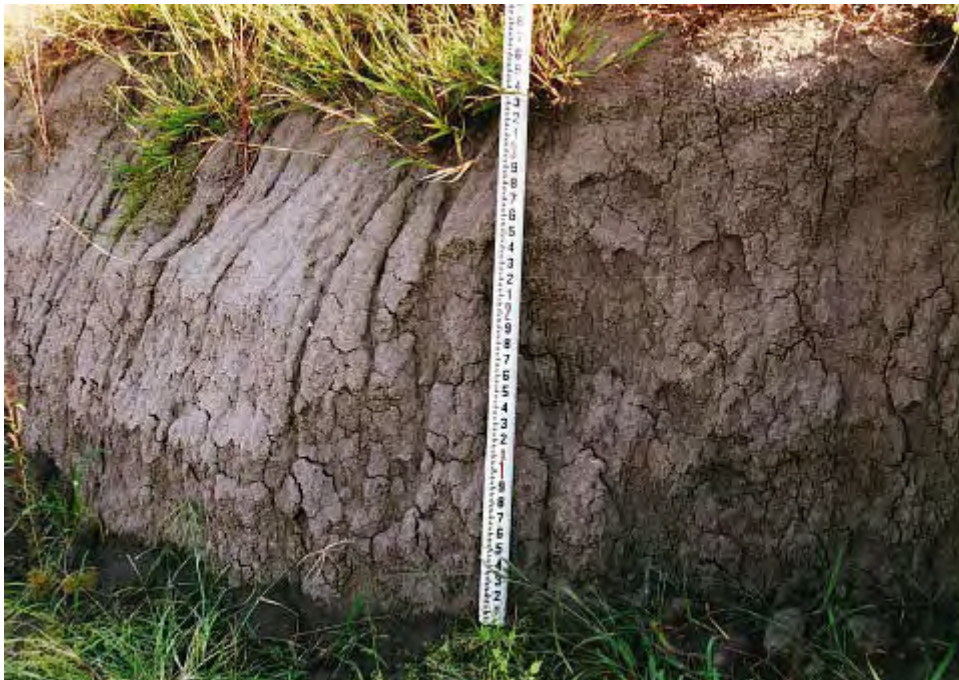
**Photo 7-87 A downstream view of Site 36 midpoint**

**Photo 7-88 A close-up view of scarp of Site 36 midpoint**

Causative factors for bank retreat at this site include flood-flow erosion and recessional block failures, piping and collapse, slaking, overland drainage, and wave and seepage rework and transport of failed and slaked soils and recently deposited sediments within bench areas. Because the thalweg sailing line is far from the site, traffic-generated wave erosion appear to be minor. Type C can best describe Site 36.

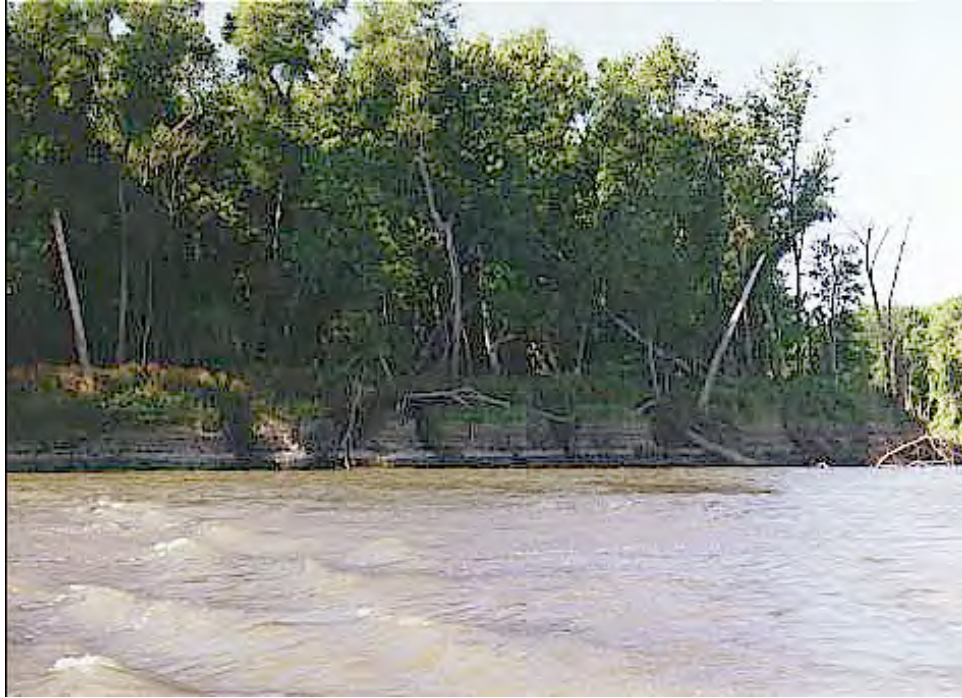
**Photo 7-89 A side view of Observation Site at RM 200.2 RDB**

drainage. Bank-line incisions (gullies) cut by overland drainage and seepage can be seen in Photo 7-89. Photo 7-90 shows a close-up view of the scarp, which exhibits many features, including slaking, gully formation, vertical cracking, flood-flow related erosional oversteepening and recessional slumping, and piping and collapse. The bank soil was primarily silt and clay.

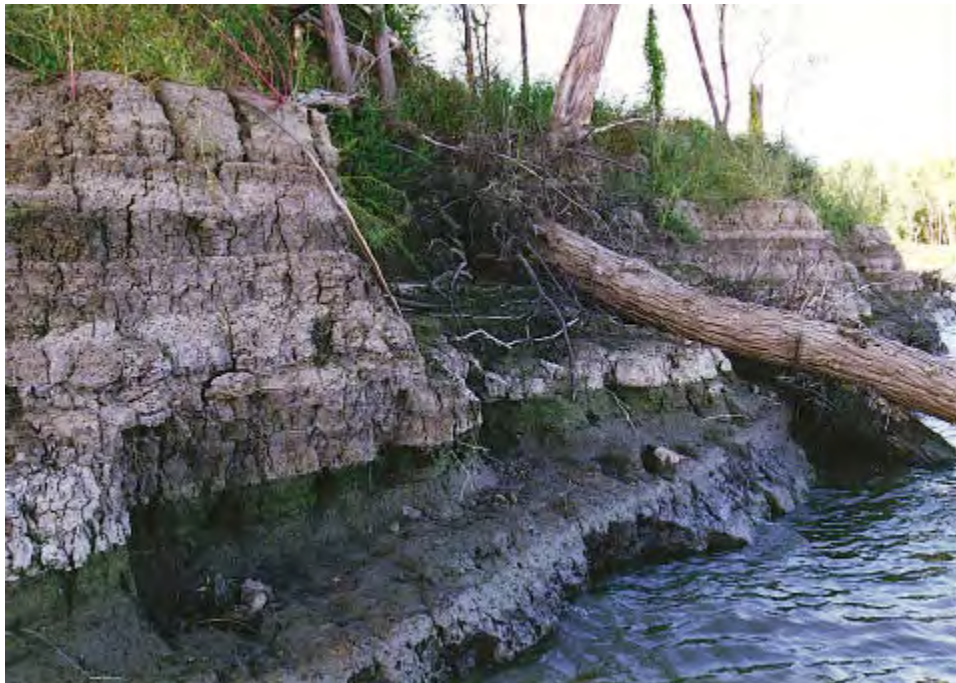
**Photo 7-90 A close-up view of Observation Site at RM 200.2 RDB**

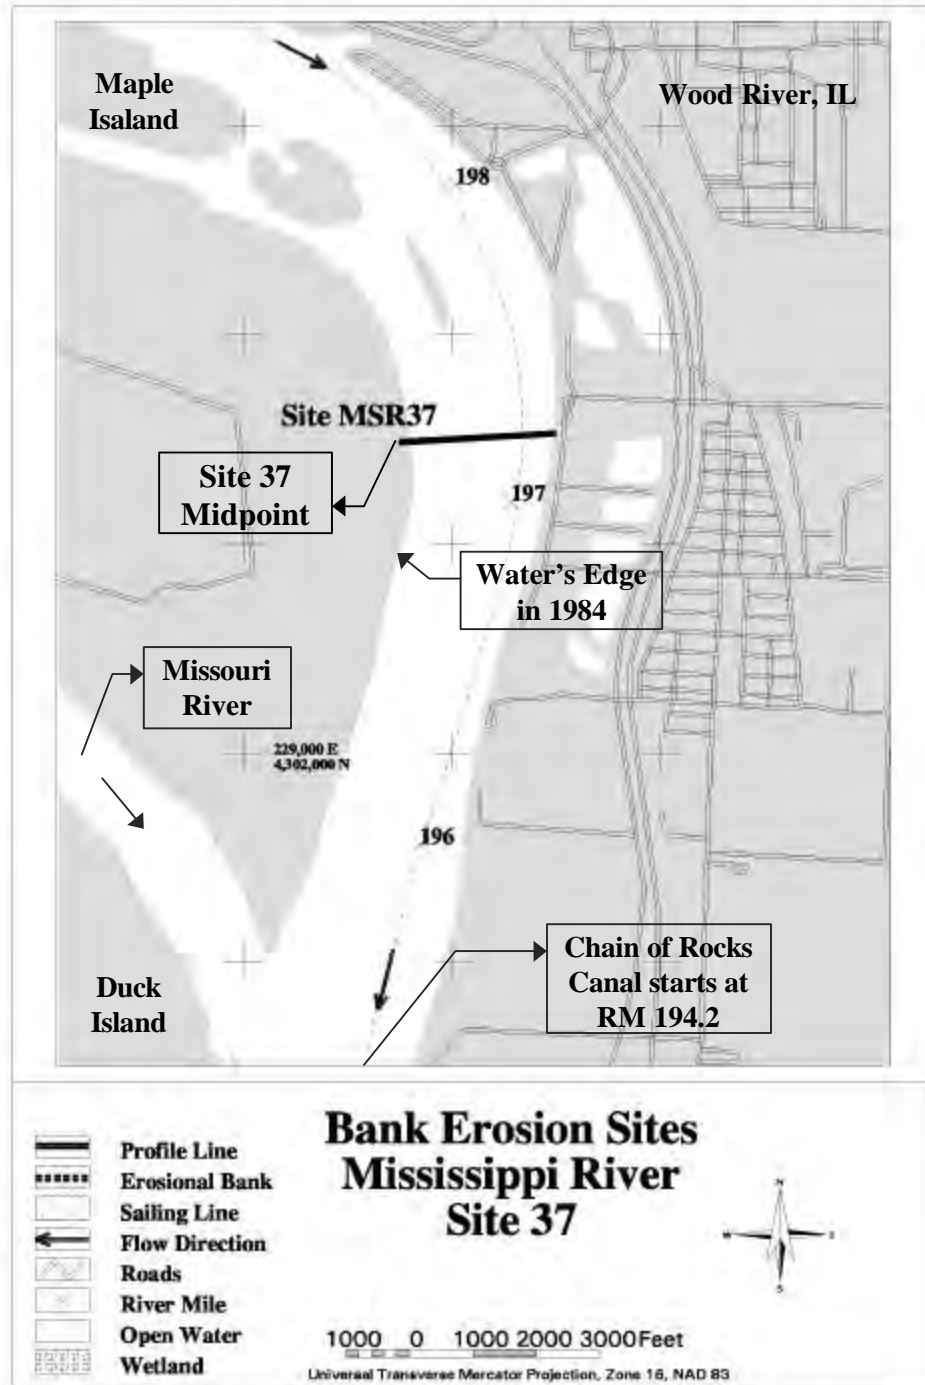
Figure 7-120 A map showing Mississippi River Site 37

This right-bank site on the inside of a sharp bend, shown in figure 7-120, is located less than 3 miles upstream from the Missouri River confluence at RM 195. Bank retreat since 1984 is evident in figure 7-120. Photos 7-91 and 7-92 show upstream and close-up views of the site, respectively. The bank section taken is shown in figure 7-121. The river cross section in figure 7-121 shows topography representative of the sharp bend along the site. The bank soils are primarily silt. The site is far from the thalweg sailing line. There is a barge-mooring site immediately downstream from the erosion site. There are several scarps within the bank. The levee along Mobile Island was overtopped during the Great Flood of '93, and this site is located where a breached portion of the levee was being repaired.

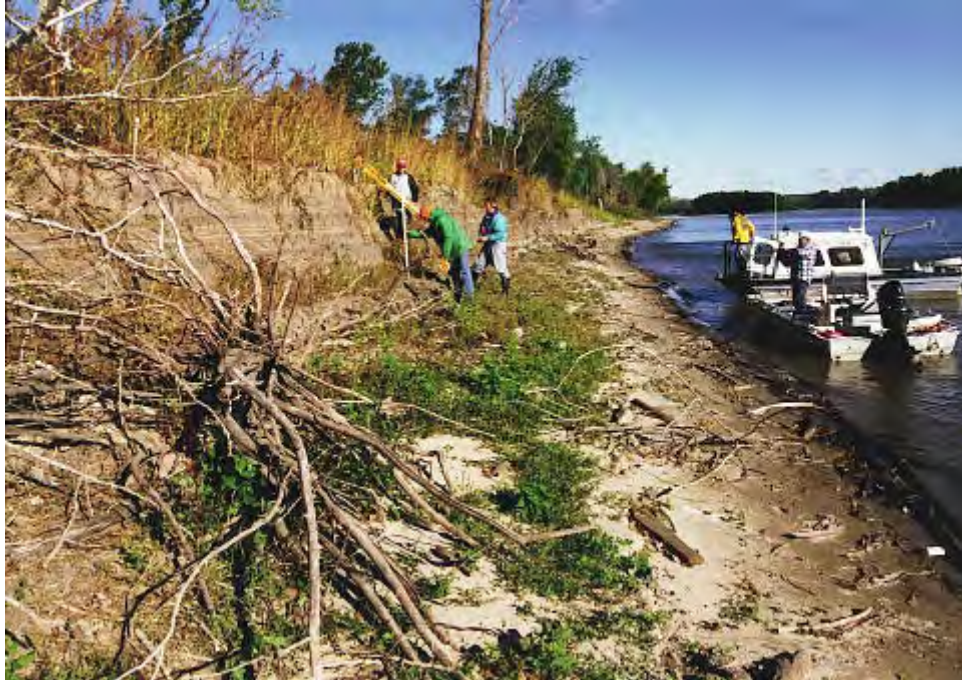
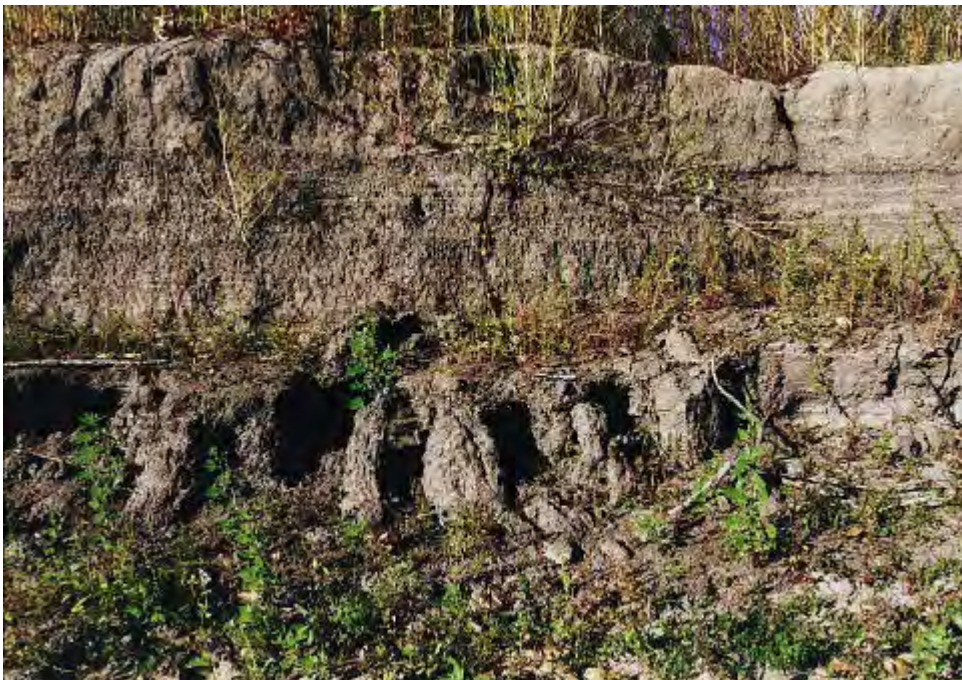
As at Site 36, causative factors for bank retreat at this site include flood-flow erosion and recessional failures, piping and collapse, slaking, overland flows, and wave and rework transport of failed soils and recently deposited sediments in bench areas. Due to nearby fleeting activities, more extensive wave erosion occurs at this site. Type C best characterizes Site 37.

**Photo 7-91 An upstream view of Site 37 midpoint**

**Photo 7-92 A close-up view of Site 37 midpoint**

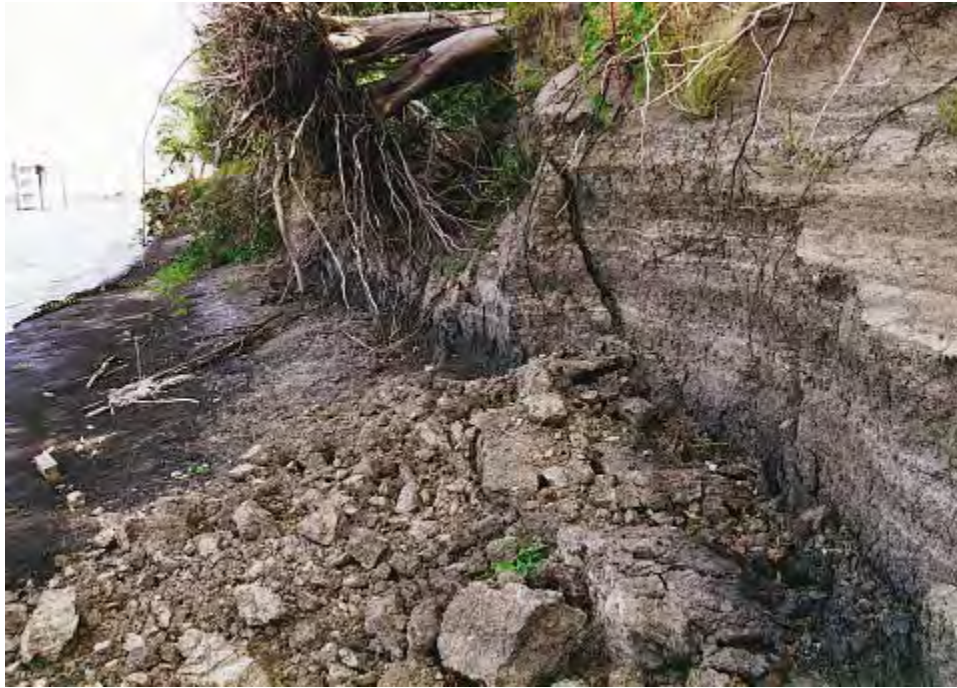
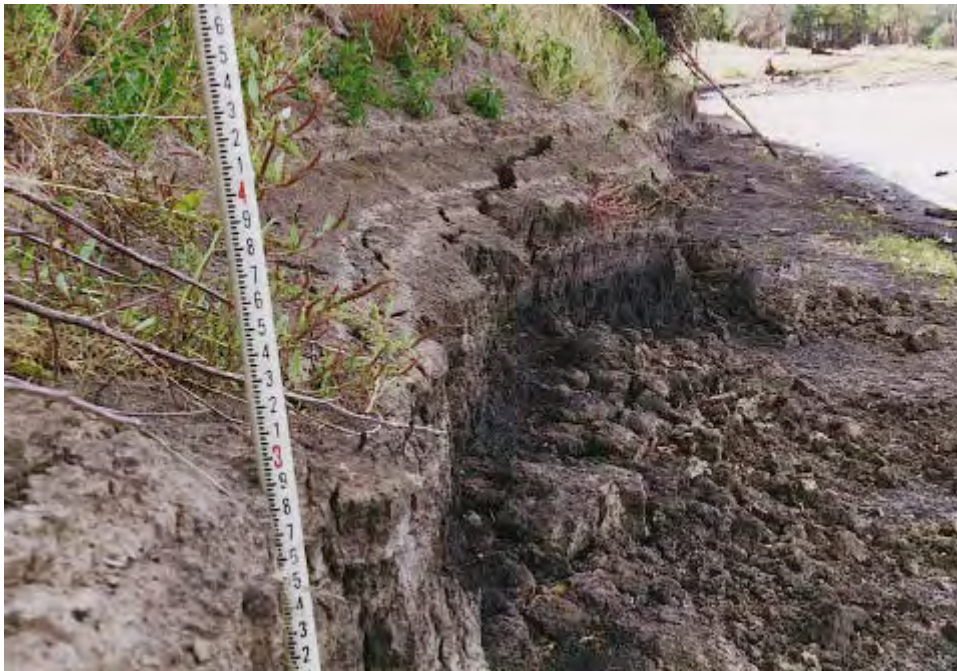
This left-bank observation site is located immediately upstream from the mouth of the Oahokia Creek diversion channel, and directly opposite the confluence of the Missouri River. The scarp exposes silty clay and clayey silt layers and is about 4 ft to 6 ft high. Historical deposits can be seen clearly in Photos 7-93 and 7-94. A dark-color native soil at the bottom of the scarp, as well as vertical cracks and fallen soil blocks, can be seen in these photos. At this site, a simple field experiment was conducted to demonstrate how fast a block of failed bank soil would disintegrate in water. A block of soil, about 4 in. high, 4 in. wide, and 8 in. long, was carefully placed in water, as shown in Photo 7-95. Only the bottom portion, about 1 in., was wet initially; however, the block disintegrated as soon as it was wetted. The process of this block disintegration is illustrated by Photos 7-96 through 7-98. Within 3 minutes, the entire block disintegrated. These photos are extremely important in describing the unique characteristics of failed soil blocks and peds which cannot resist wetting and slaking. Wetting destroys capillary

**Photo 7-93 An upstream view of Observation Site at RM 195.1 LDB**

**Photo 7-94 A downstream view of Observation Site at RM 195.1 LDB**

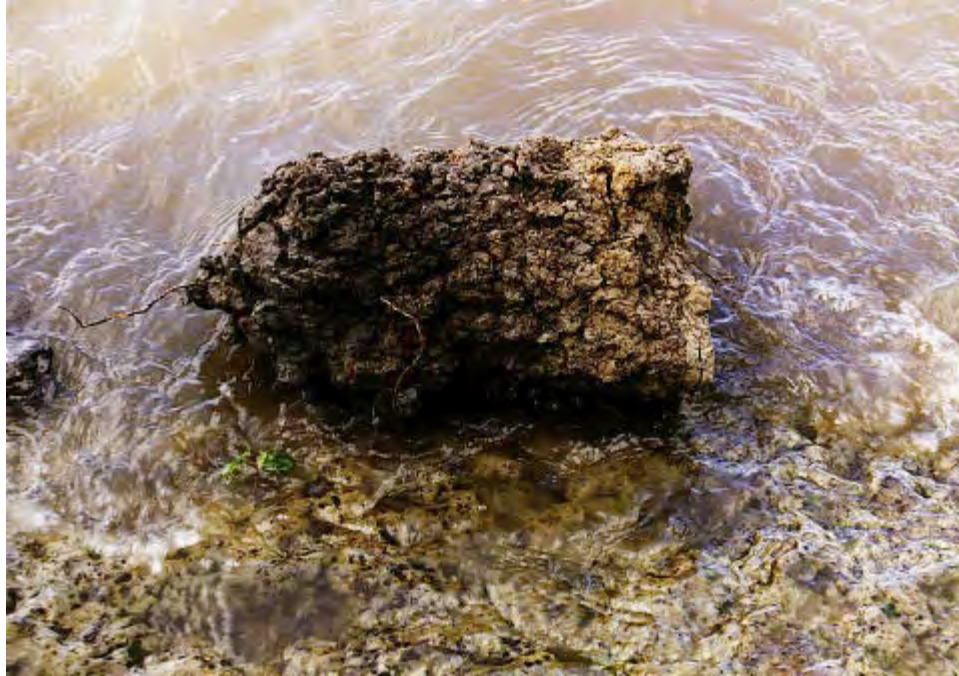
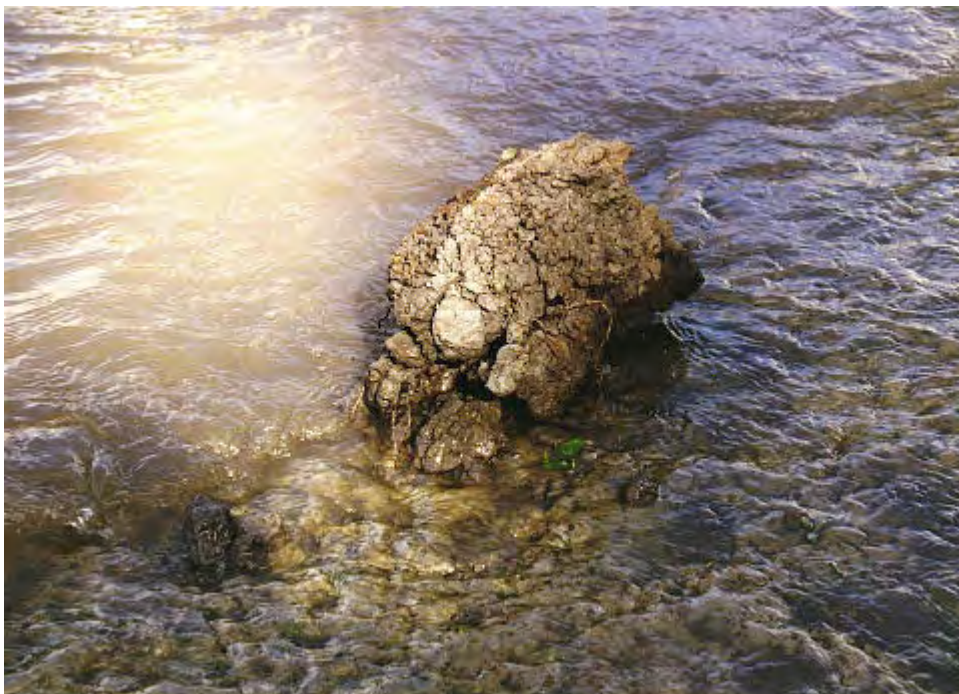
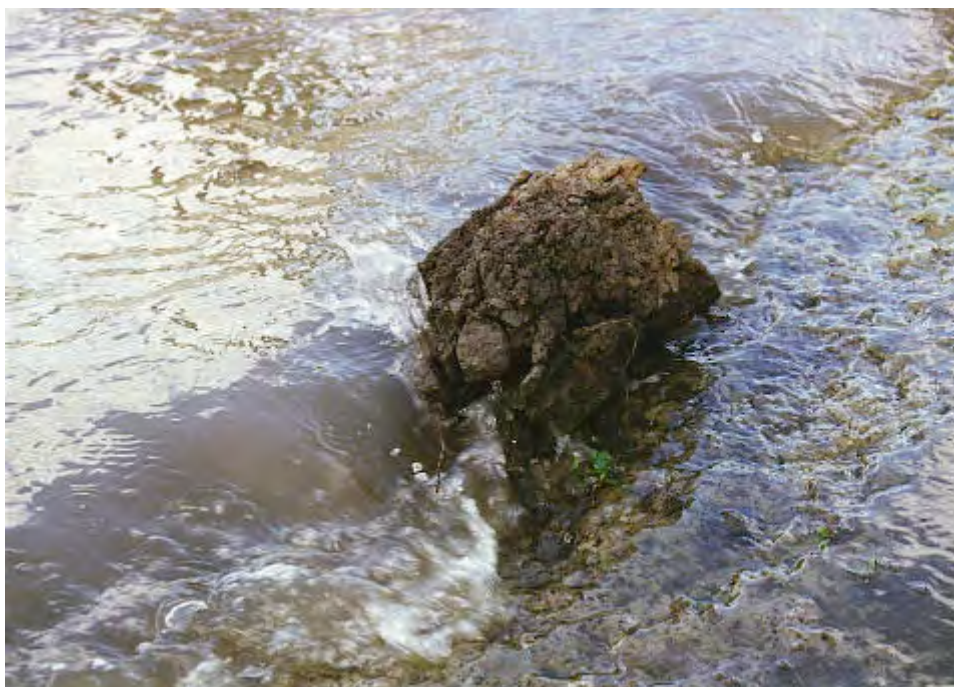
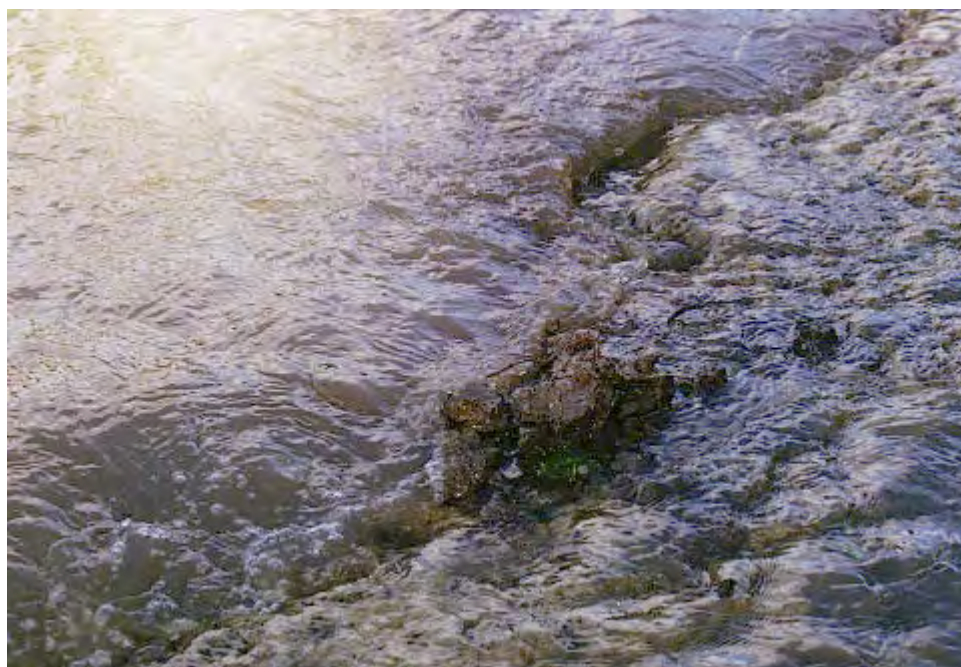
**Photo 7-95 A block of failed bank soil placed in water ( $t = 0$ ) -- Observation Site at RM 195.1 LDB**

**Photo 7-96 A block of failed bank soil placed in water ( $t = 1$  min.) -- Observation Site at RM 195.1 LDB**

**Photo 7-97 A block of failed bank soil placed in water (t = 2 min.) --  
Observation Site at RM 195.1 LDB**

**Photo 7-98 A block of failed bank soil placed in water (t = 3 min.) --  
Observation Site at RM 195.1 LDB**

action in fissures between peds, and the block disintegrates into individual fissure-defined pieces (peds). Any banks composed of unsaturated soils would be susceptible to wet/dry slaking. This observation site was eroded severely during the Great Flood of '93 and possibly during the flood of 1994 and the flood of 1995. The site demonstrates typical characteristics of bench area rework and transport described earlier. This erosion site can be classified as Type A.
