# **Interim Report For The Upper Mississippi River - Illinois Waterway System Navigation Study**

**US Army Corps  
of Engineers**

**November 1997**

## Bank Erosion Field Survey Report of the Upper Mississippi River and Illinois Waterway

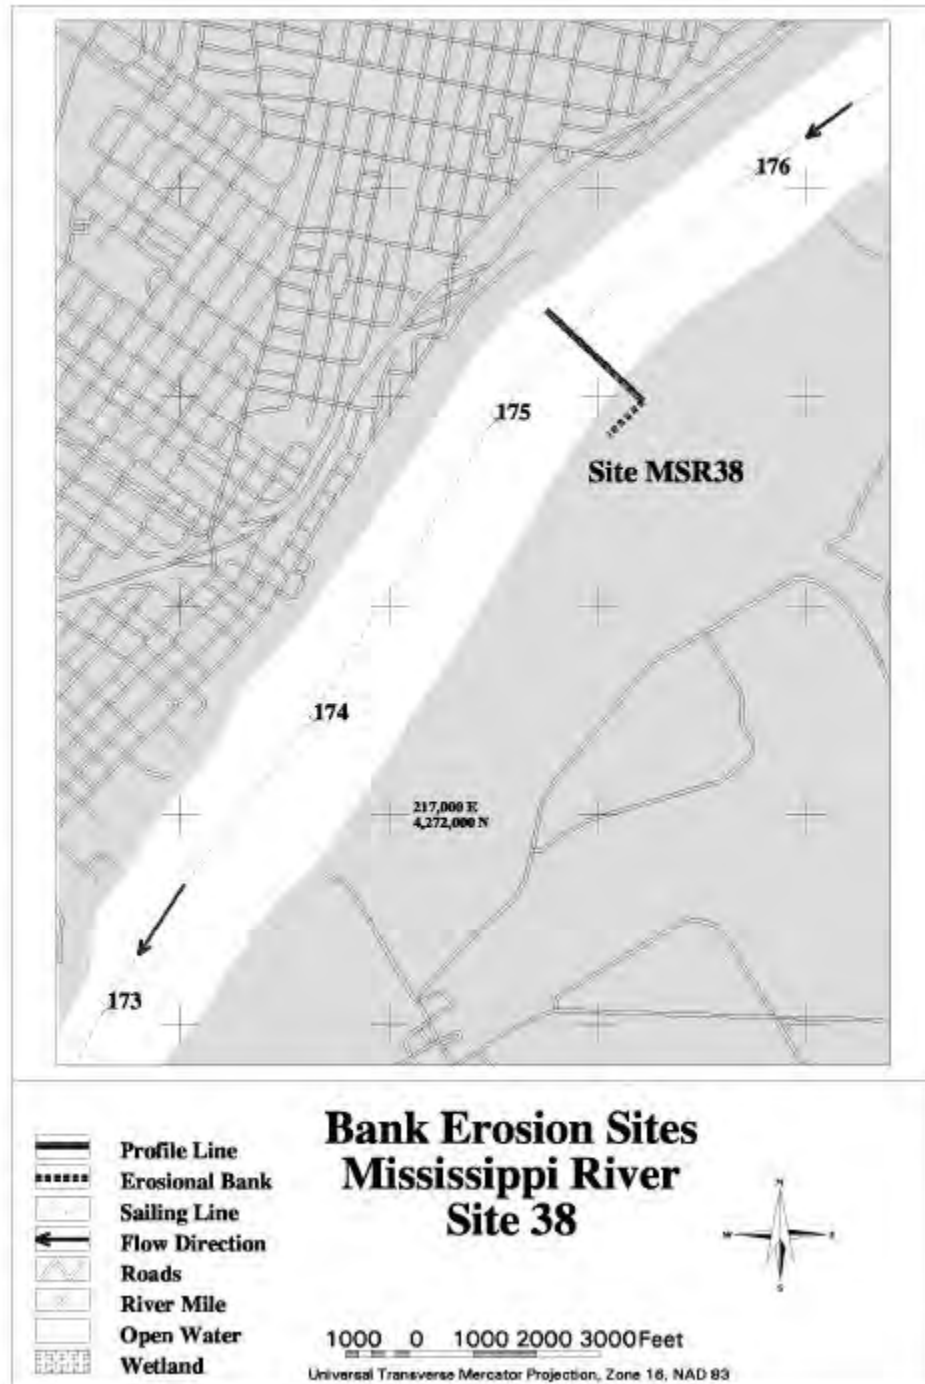
Figure 7-122 A map showing Mississippi River Site 38

This left-bank site, shown in figure 7-122, is located within a busy fleeting area along a straight reach near St. Louis, Missouri. As can be seen in figure 7-122, the bank appears to have retreated considerably since the current navigation chart, based on the 1984 COE aerial survey, was published in 1989. Photos 7-99 and 7-100 show upstream and close-up views of the site, respectively. Photo 7-101 shows an upstream view of the bench, and Photo 7-102 shows a close-up view of wave attack on the lower bank which consists of recently deposited sand. Only one bank section was taken at this severely eroded bank site, which is shown in figure 7-123. The bank soils are primarily MST and FS. There were three distinct scarps with extensive piping features, as shown in figure 7-123. At the top of the bank is a farm field covered by two large sand dunes, 2 to 3 ft high and about 200 ft wide. The first row of dunes was located along the edge of the bank, and the second was located about 1,000 ft from the bank line. Both dunes were oriented parallel to the bank line. This silty sand deposition and dune formation is believed to have been produced by the Great Flood of '93 and subsequent floods of 1994 and/or 1995. Fine

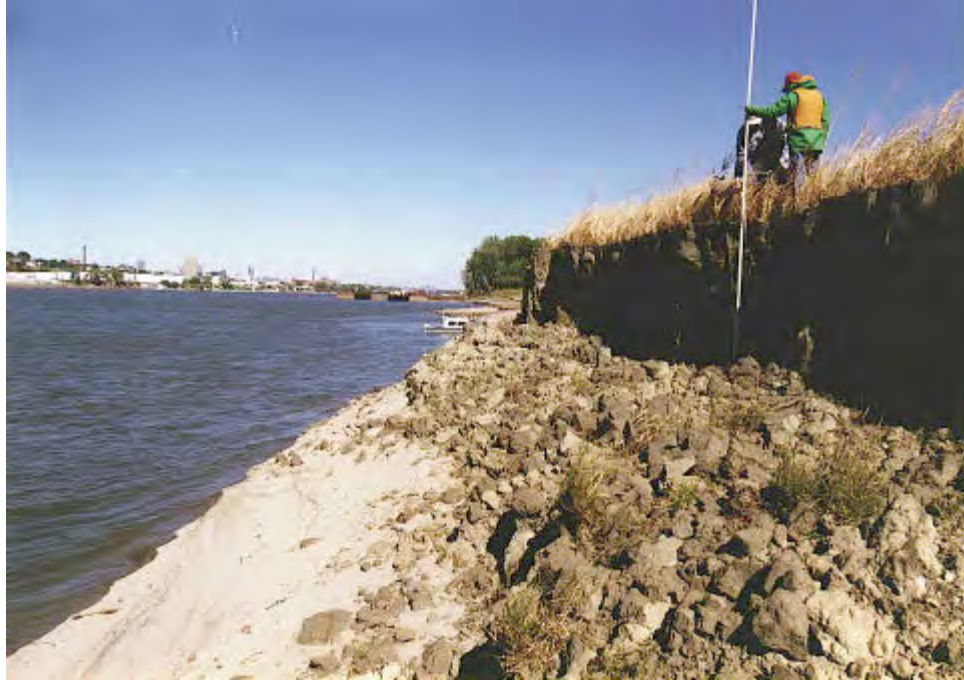
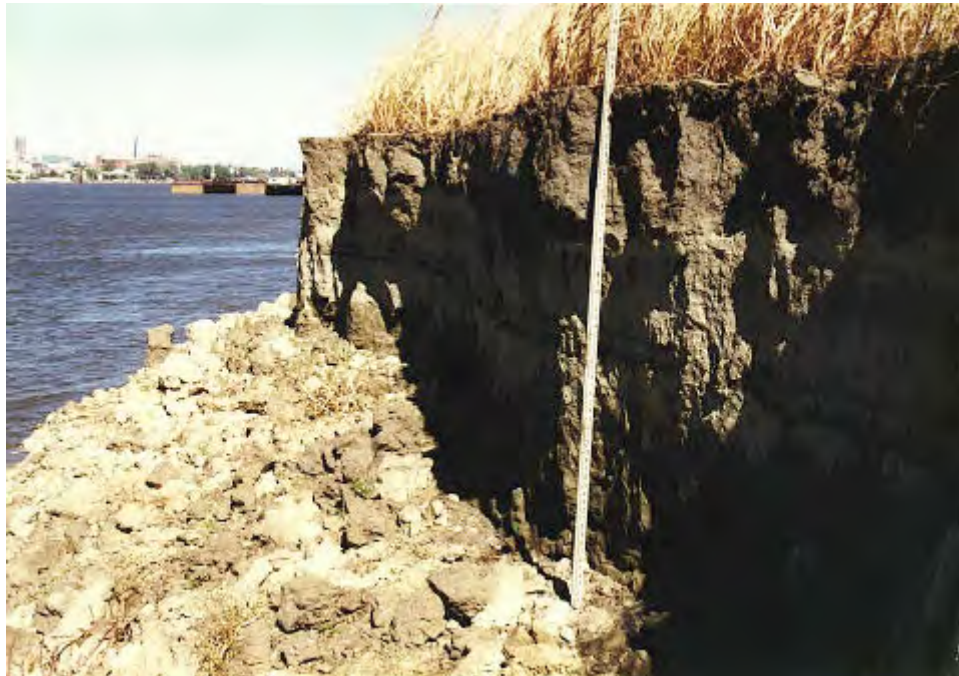
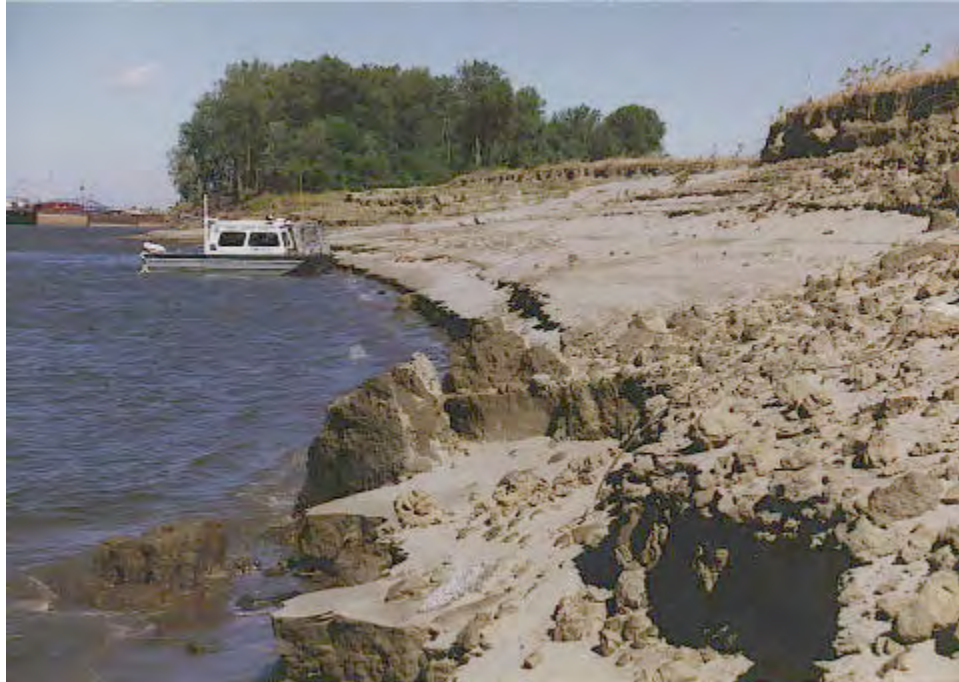
**Photo 7-99 An upstream view of Site 38 midpoint**

**Photo 7-100 A close-up view of Site 38 midpoint**

**Photo 7-101 An upstream view of bench of Site 38 midpoint**

Causative factors for bank retreat at this site include flood-flow erosion and recession and piping failures, slaking, wave and rework-transport of failed soil peds and recently deposited silty fine sand, and aeolian deflation. Barge fleeting-related wave erosion occurs within the bench area at this site. A combination of bank Types A, B, and C describes Site 38.

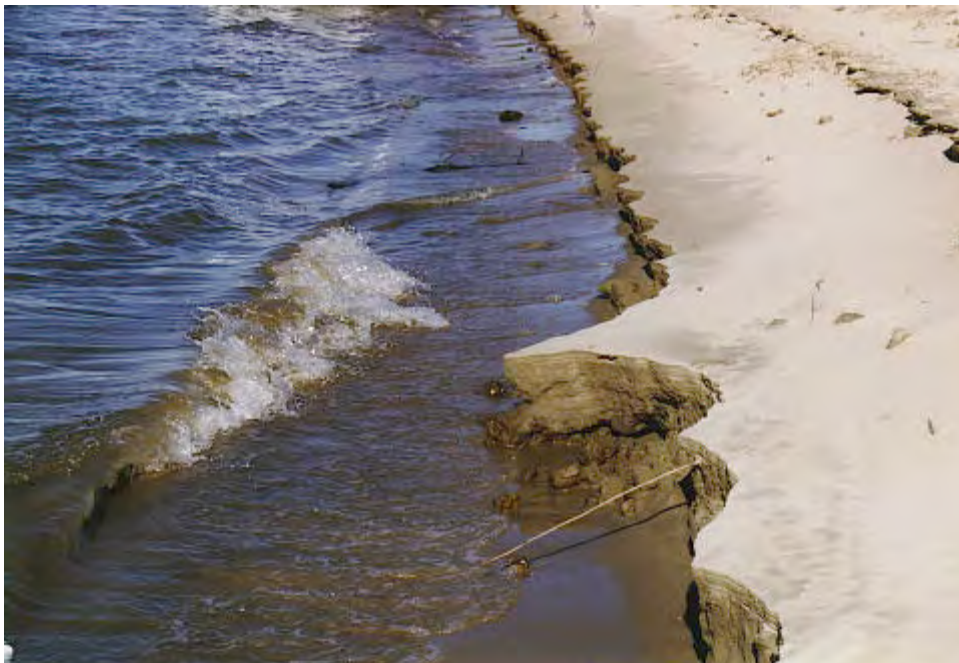
**Photo 7-102 A close-up view of wave erosion at Site 38 midpoint**

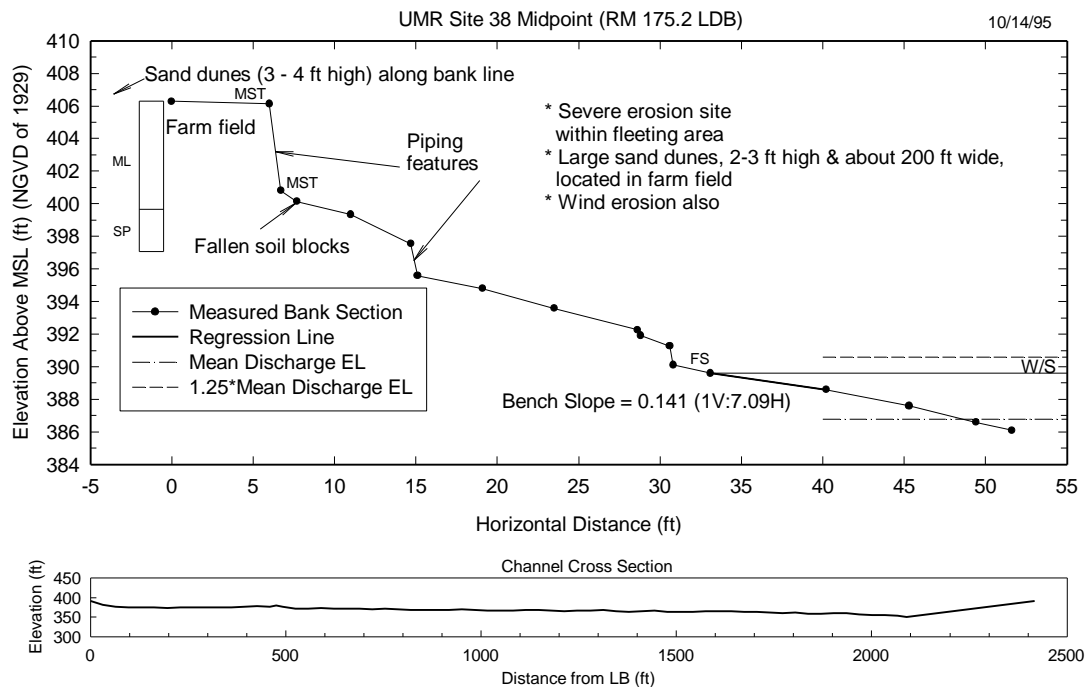
**Figure 7-123 Bank section and channel cross section measured at Site 38 midpoint**

sand was observed blown by strong winds. Numerous failed soil blocks were observed on the bank below the head scarp, as indicated in figure 7-123.

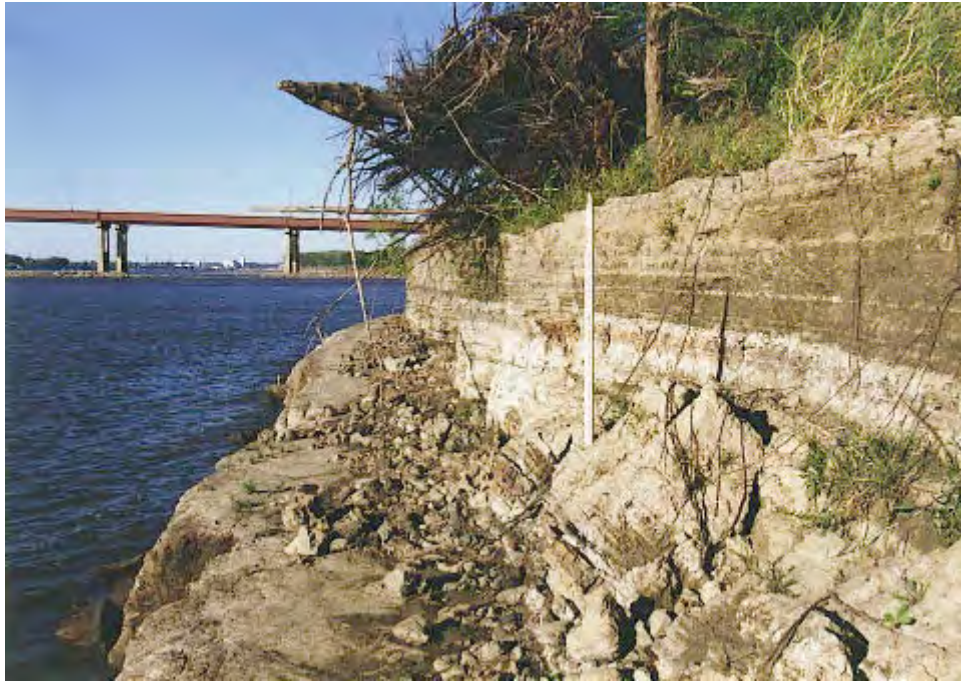
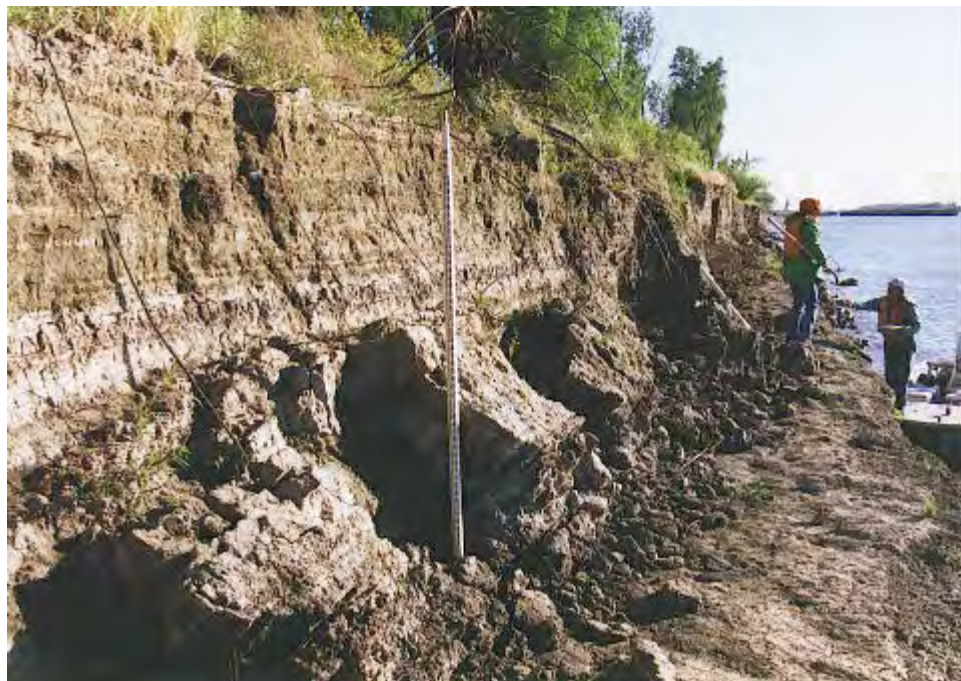
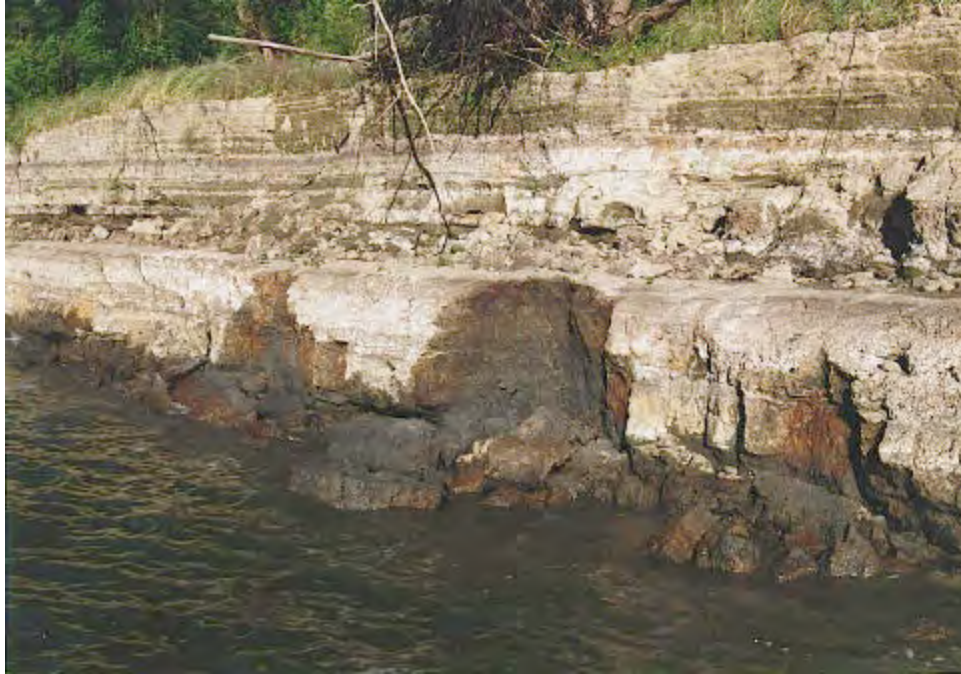
**Photo 7-103 An upstream view of Observation Site at RM 168.5 LDB**

**Photo 7-104 A downstream view of Observation Site at RM 168.5 LDB**

**Photo 7-105 A close-up view of Observation Site at RM 168.5 LDB**

filled flow-training structure. As shown in Photos 7-103 through 7-105, multiple layers of historical deposits consisting of silty clay and clayey silt are exposed within each scarp. There was a sand lens, about 3-in. thick at the bottom of each scarp. These lenses are shown in Photo 7-106. This site is characterized by Type B. It should be noted that many bank-erosion sites within the open-water reach were located immediately downstream from rock-filled flow-training structures.

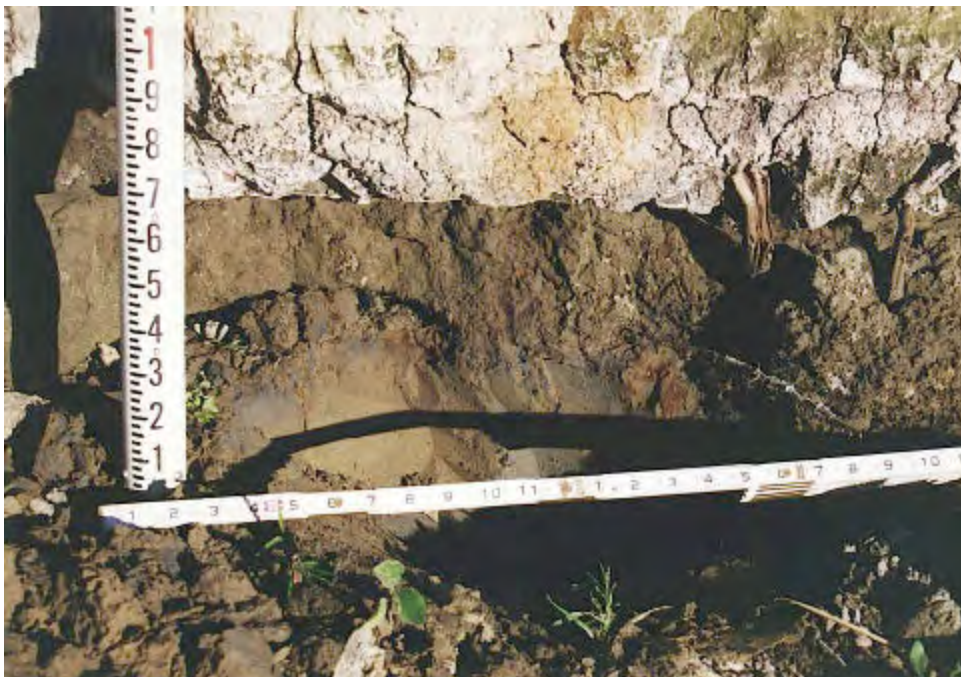
**Photo 7-106 Sand lens found at terrace of Observation Site at RM 168.5 LDB**

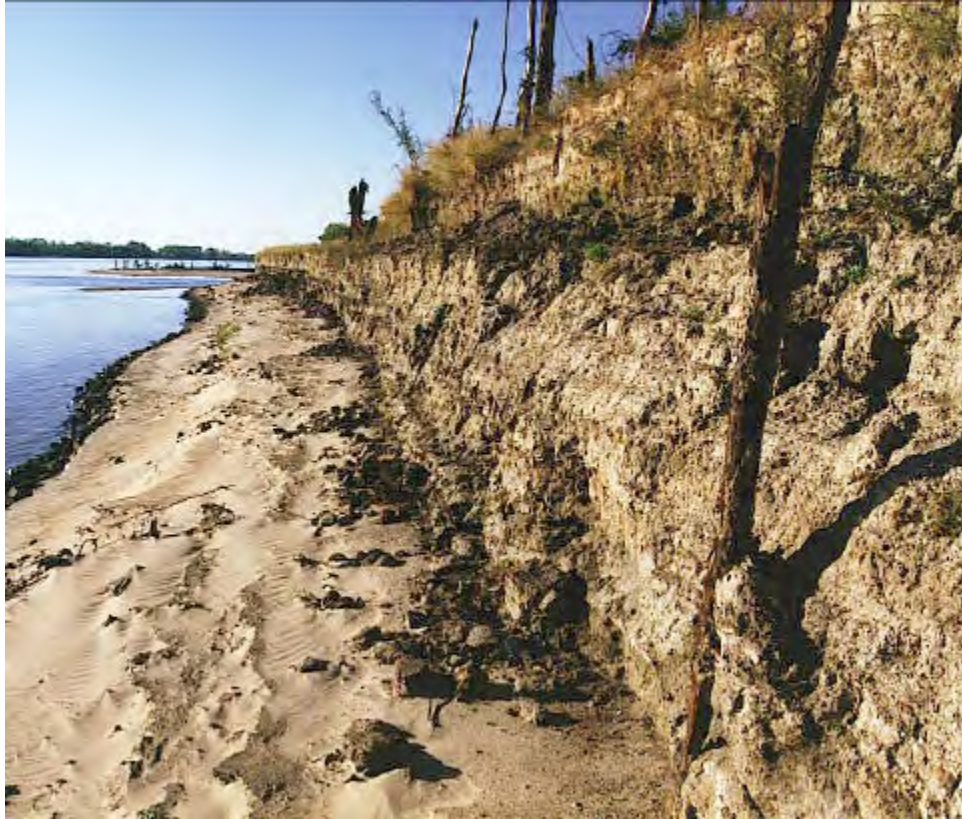
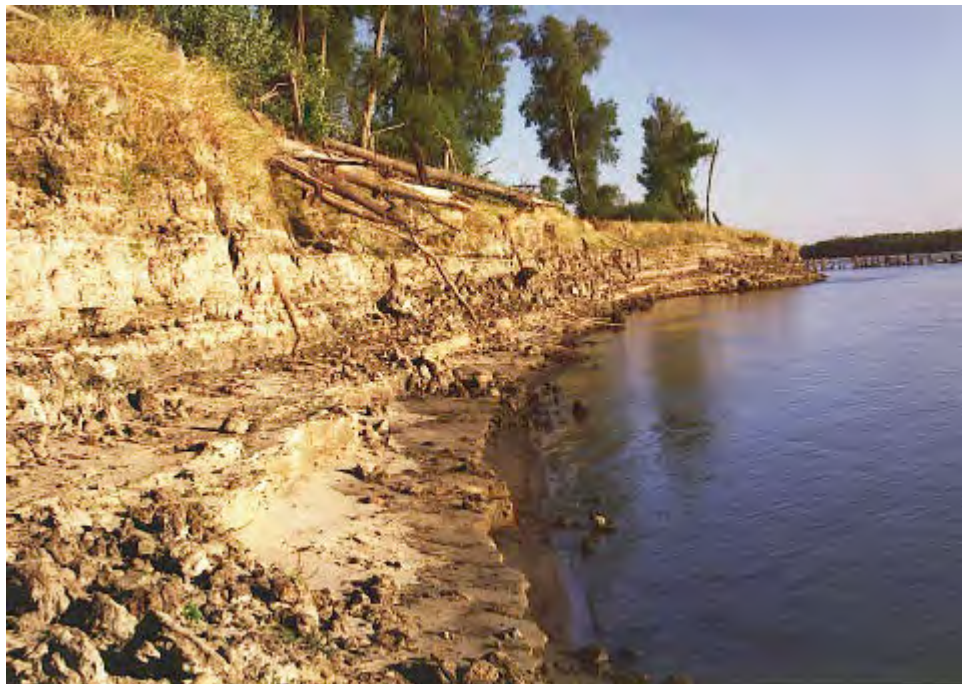
This left-bank site, shown in figure 7-124, is located inside a bend on a small island. Photos 7-107 and 7-108 show upstream and downstream views of the site, respectively. Photo 7-109 shows eroded bank near the tip of the island and Photo 7-110 shows a close-up view of eroded bench. Although the site map does not show this bank to be on an island, erosion along the left bank at about RM 112.5 had formed a small island. The back channel of this island meets the MR at around RM 111.6. There are several large wing dams, and this erosion site is located between two wing dams. Around the upstream tip of the island, flow velocities toward the back channel were estimated to be about 8 ft/s. These flows are eroding the island. This erosion along the concave bank was initiated by the Great Flood of '93. The back channel apparently was eroded deeply during the flood, creating a large differential head between the main MR channel and the slough.

**Photo 7-107 An upstream view of Site 39 midpoint**

**Photo 7-108 A downstream view of Site 39 midpoint**

Causative factors for bank retreat at this site include flood-flow erosion, impacts by flow-control structures, piping and failures, and wave and rework-transport of failed soils and recently deposited sediments within berm and bench areas. Although the thalweg sailing line is far from this site, silty sand deposits are eroded by waves. A combination of Types A, B, and C characterizes Site 39.

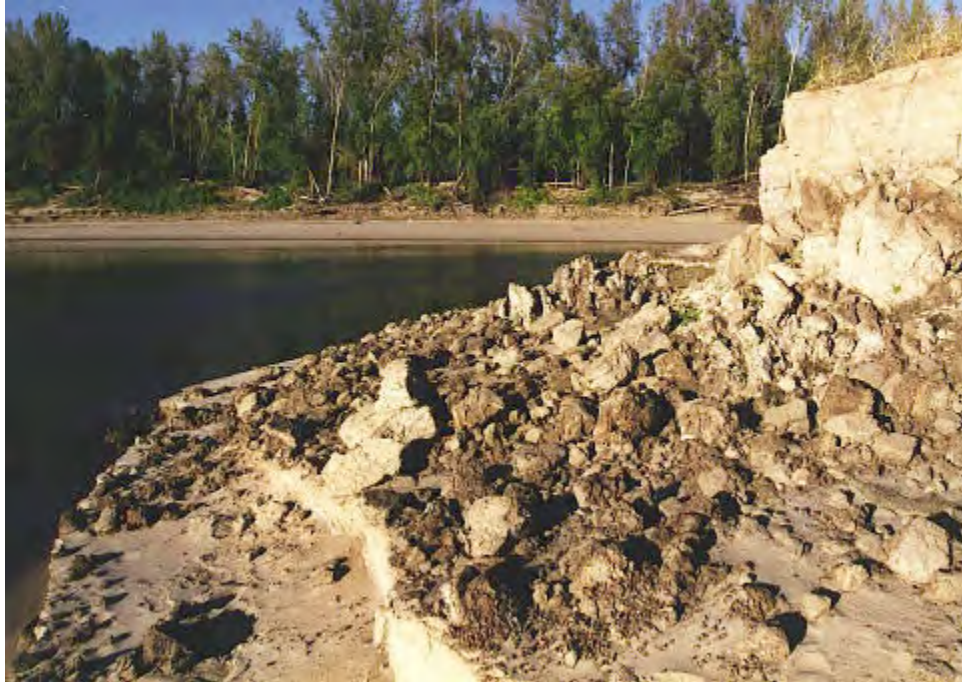
A wing dam and a large sand bar, located just upstream from the island tip, exacerbates island erosion by creating additional differential head where it diverts the MR flow toward the slough. The sand bar upstream of the island appeared to act as a dam to produce differential head. As shown in figure 7-125, multiple scarps with piping features were present with failed soil blocks. The total height of scarps was almost equal to the bank height, about 20 ft, and the bank soils are primarily medium silt (MST) and fine sand (FS). Subaqueous bed sediments consist of fine sand (FS).

**Photo 7-109 An upstream view of the tip of island at Site 39**

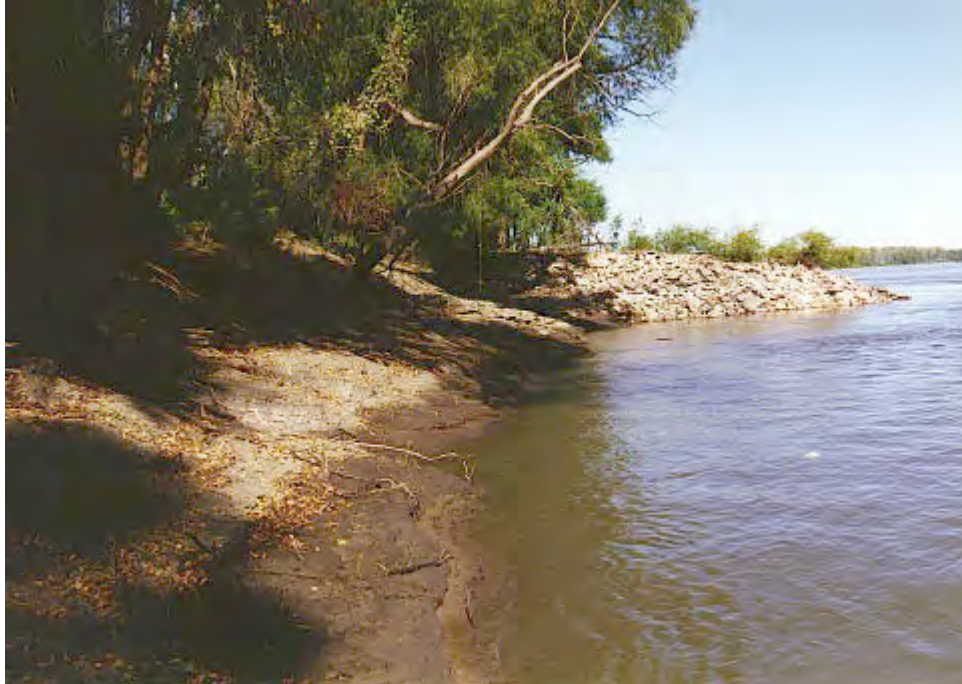
**Photo 7-111 An upstream view of Site 40 downstream point**

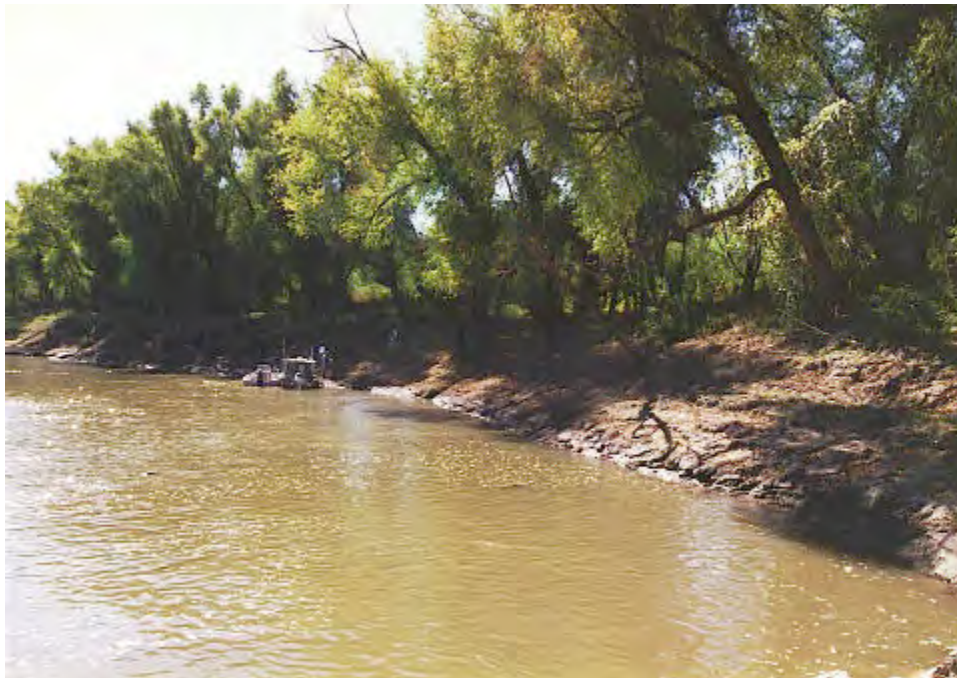
**Photo 7-112 A downstream view of Site 40 downstream point**

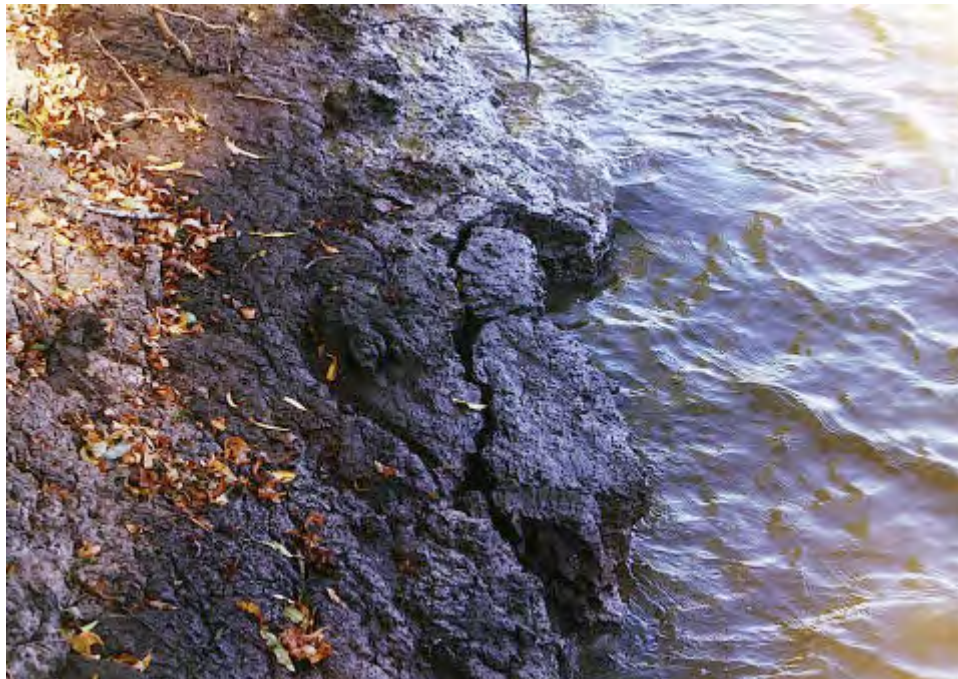
**Photo 7-113 A close-up view of eroded bench at Site 40 downstream point**

Causative factors for bank retreat at this site include flood-flow erosion and recessional failures, piping and collapse, seepage and overland-flow surface erosion, wave and rework-transport of failed soils and recently deposited sediments within berm and bench areas, and impacts due to flow-training structures. Type C describes this site.

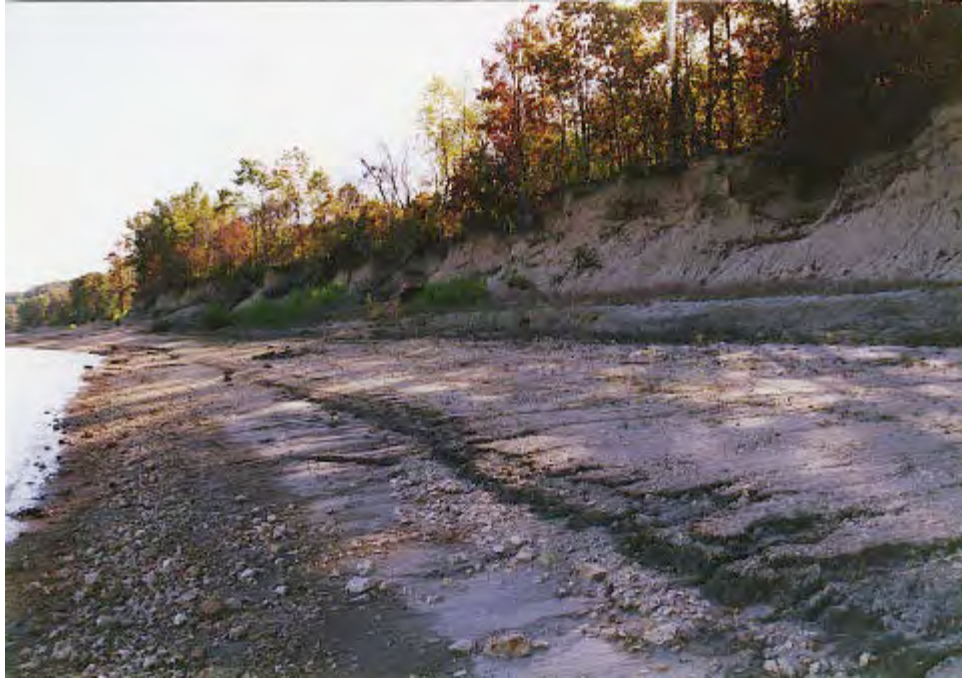
**Photo 7-114 An upstream view of Site 41 midpoint**

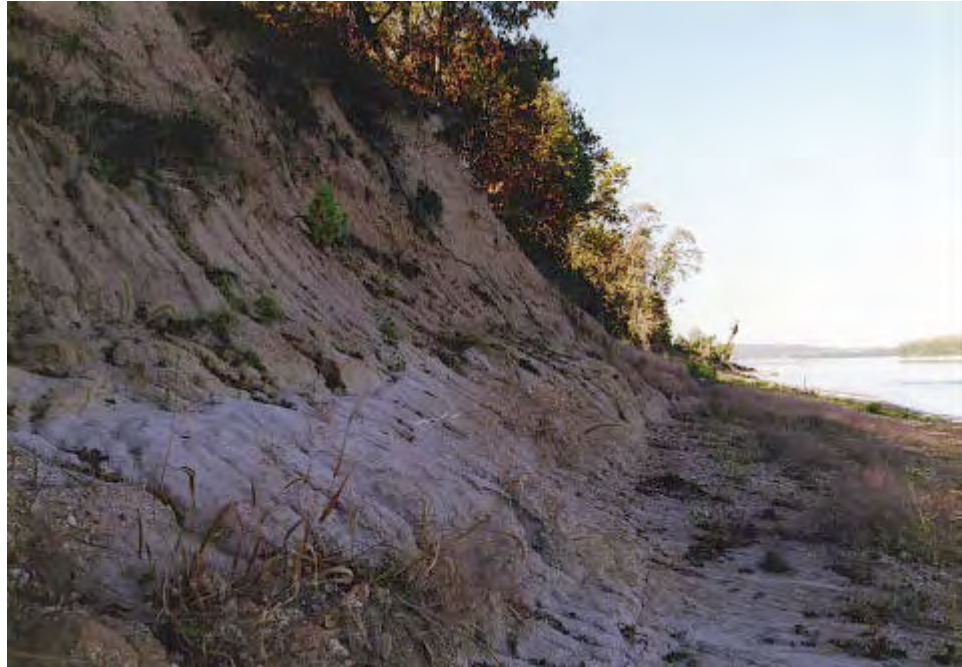
**Photo 7-115 A downstream view of Site 41 midpoint**

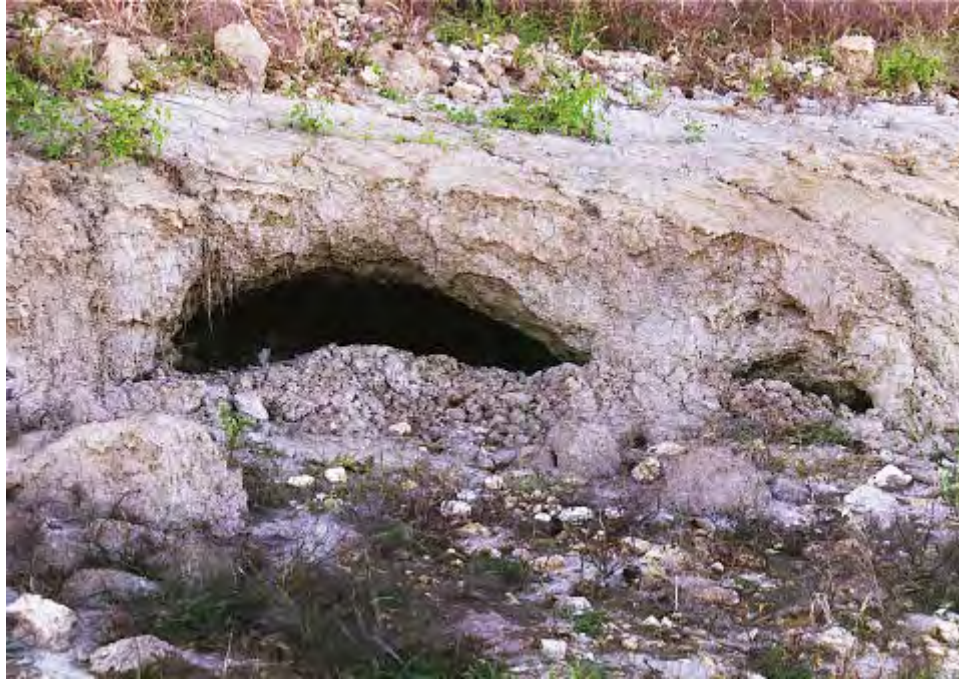
**Photo 7-116 Piping features of Site 41 midpoint**

forming layers and lenses. These deposits are over 25 ft thick. At the base of the scarp, where piping cavities were observed, deposits are silty. Photo 7-117 shows piping cavities.

Causative factors for bank retreat at this site include flood-flow erosion and rapid recessional failures, piping and collapse, overland drainage erosion, and wave actions which erode failed soils and recently deposited sediments within berm and bench areas. A combination of Type E and Type F describes Site 41.

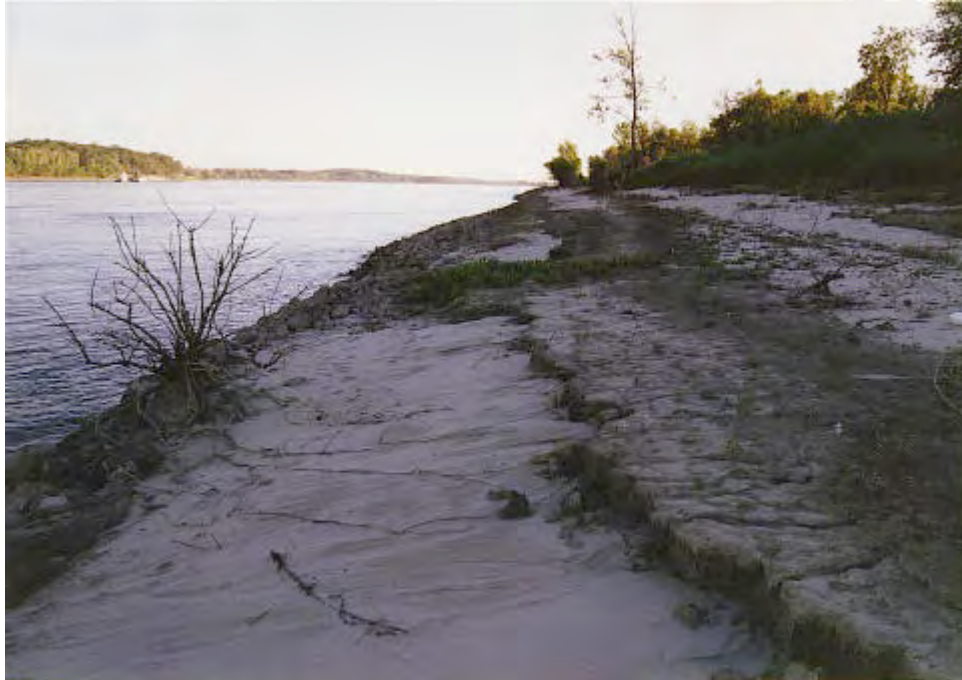
This left-bank erosion site, shown in figure 7-131, is located along the outside of a bend in the MR at Cape Girardeau. The river channel at this site is about 1,800 ft wide. Photo 7-117 shows an upstream view of the site and Photo 7-118 shows a close-up view of a revetment failure. Photo 7-119 shows a downstream view of the site. Photo 7-120 shows bank failure which was taking place. Undercut blocks fell onto the sandy lower bank. Three bank sections are shown in figures 7-132 through 7-134. The bank soils are primarily MST, FS, and VFS. This site is located within a failure of a hand-placed revetment. Piping features and failed soil blocks were observed at this site. Apparently, bank undercutting occurred and the toe of revetment was truncated, resulting in upslope launching of revetment stone. Once the revetment base, consisting of limestone gravel, is launched, waves or high water flows would erode the slope, resulting in further launching of upper revetment stone.

**Photo 7-117 An upstream view of Site 42 midpoint**

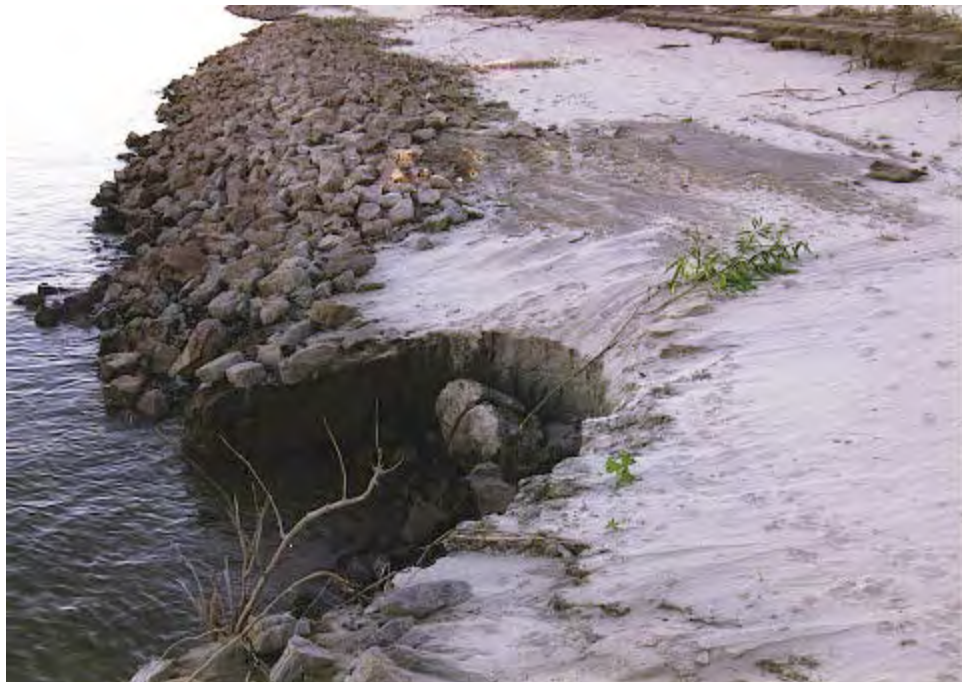
**Photo 7-118 A close-up view of revetment failure at Site 42 midpoint**

Causative factors for bank retreat at this site include flood-flow erosion and oversteepening, recession and piping collapse, stone launching, and wave and rework-transport of failed soils and recently deposited sediments within berm and bench areas. Type A conditions best describe Site 42.

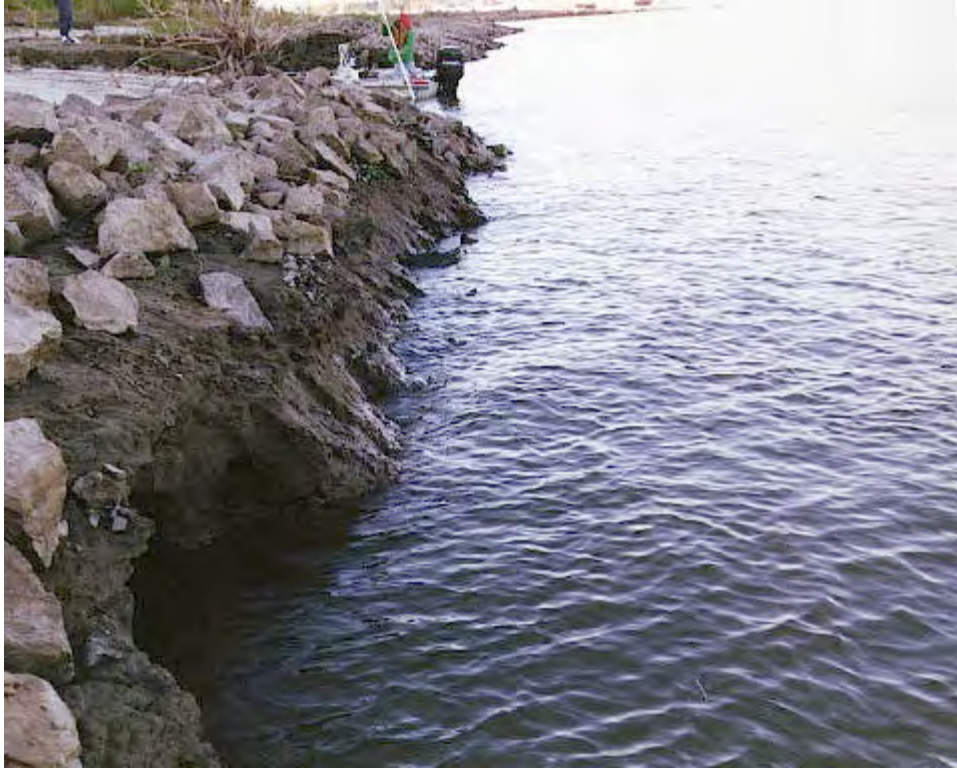
**Photo 7-119 A downstream view of Site 42 midpoint**

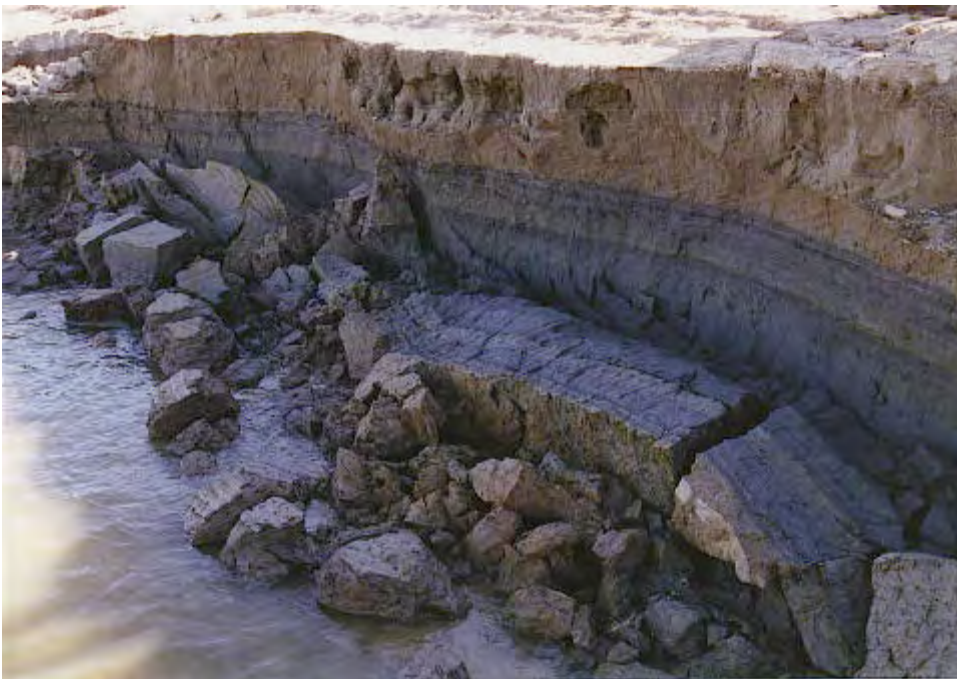
**Photo 7-120 A close-up view of bank failure of Site 42 midpoint**

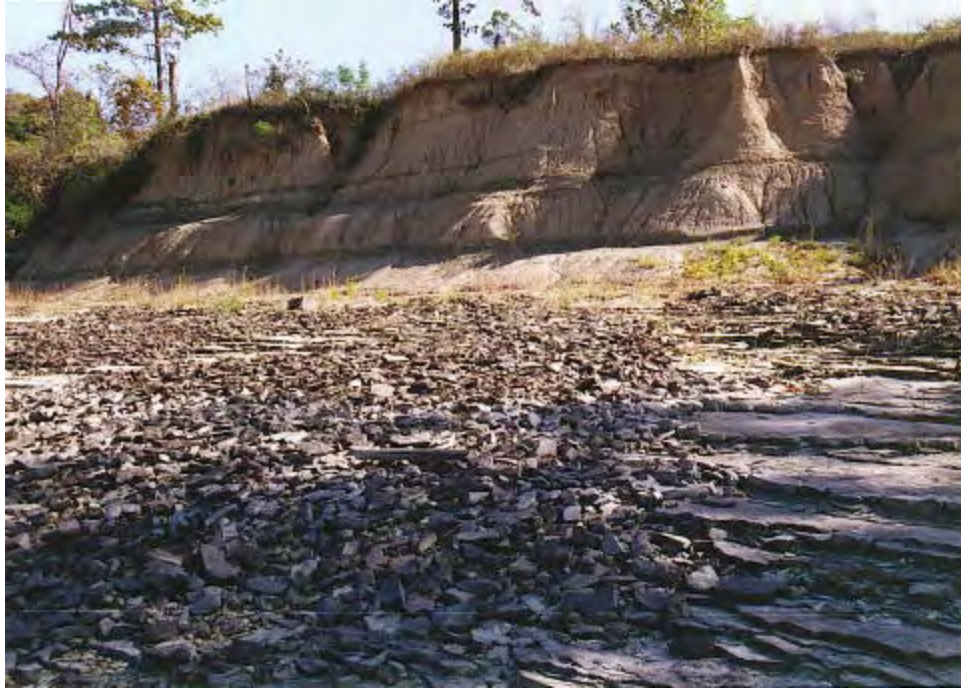
This left-bank site, shown in figure 7-135, is located in a narrow straight reach, immediately downstream from a sharp bend. The bank lies on a shaley siltstone, as depicted in Photo 7-121 and figure 7-136. Photo 7-122 shows a close-up view of the scarp which exposes medium silt (MST) and coarse clay (CC). Photo 7-123 shows the reddish brown bank soil when it was placed in water. The river cross section at Site 43 has a very peculiar shape, practically triangular, indicating a rather steep-slope bedrock-defined channel, with active erosion.

**Photo 7-121 An upstream side view of Site 43 midpoint**

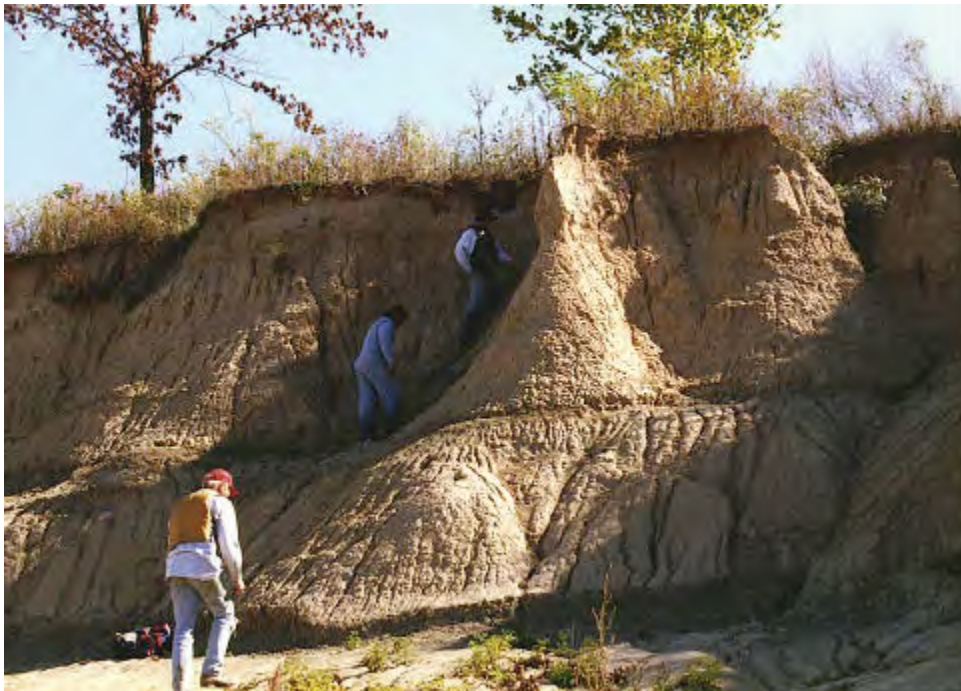
**Photo 7-122 A close-up of scarp face of Site 43 midpoint**

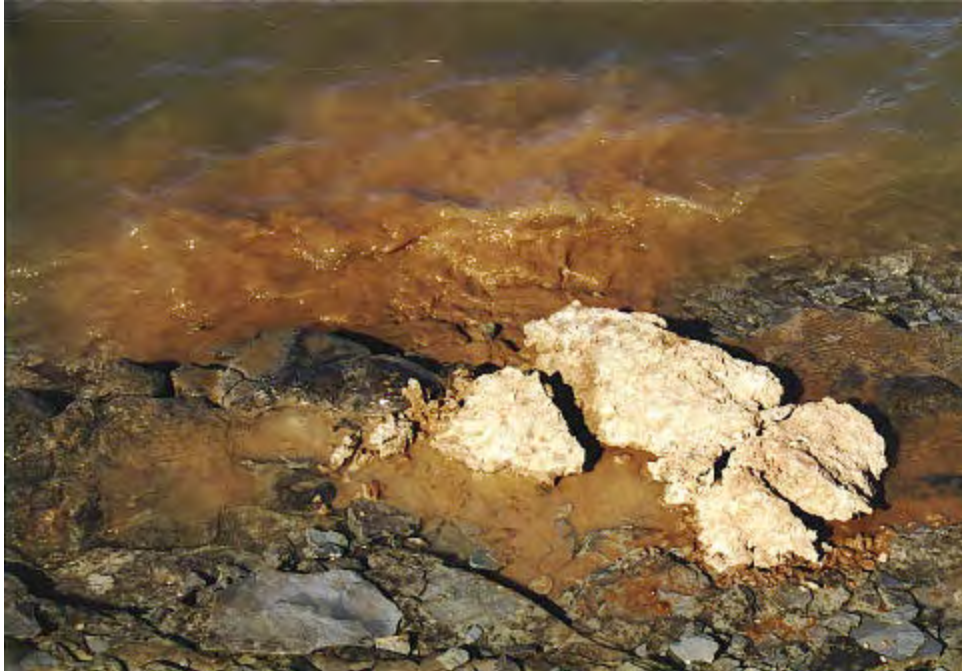
**Photo 7-123** Reddish brown color of soil block in water at Site 43 midpoint

Causative factors for bank retreat at this site include flood-flow erosion, recession and piping related failures and slaking, overland drainage, and wave and flow rework and transport of failed and slaked soils within bench areas. Type A characterizes Site 43.

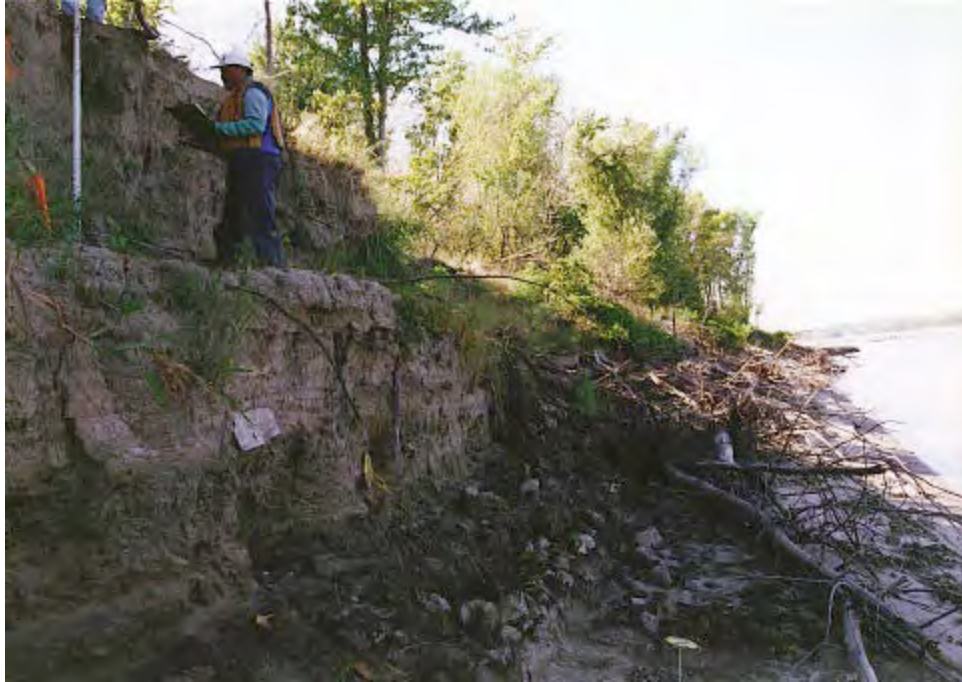
**Photo 7-124 An upstream view of Site 44 midpoint**

the Global Positioning System (GPS)-determined river's cross-section end point of Site 44 is located farther into the island, indicating that severe bank retreat took place since 1984. Photos 7-124 and 7-125 show upstream and downstream views of the site, respectively. Photo 7-126 shows a close-up view of a piece of plastic sheet buried in the bank. The bank section taken is shown in figure 7-138. There are several scarps and failed soil blocks at piping cavities. Bank erosion at Site 44 appeared to have been exacerbated by the wing dams surrounding the site. The top of the bank is covered by FS, and soils within scarps consist of FST and FS. Subaqueous sediments consist of silt and sand ranging from CST to VFS.

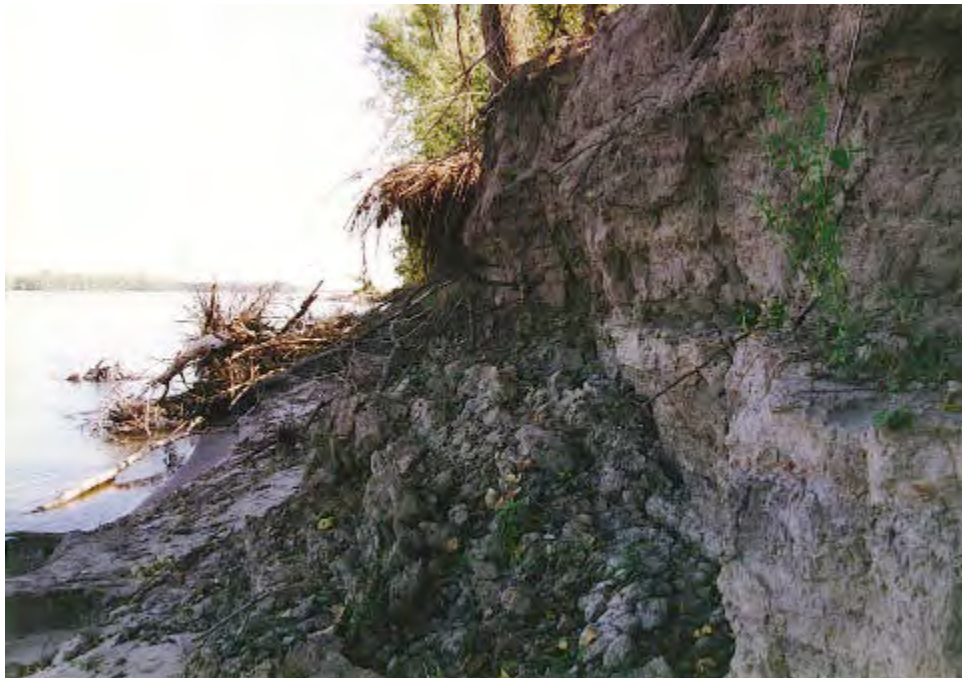
**Photo 7-125 A downstream view of Site 44 midpoint**

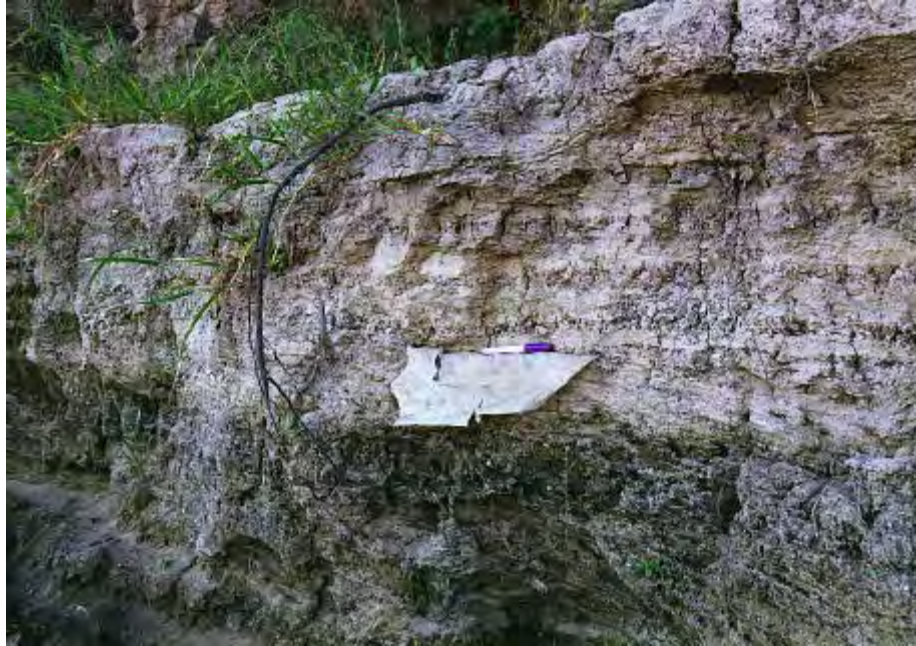
**Photo 7-126** A close-up view of buried plastic sheet at Site 44 midpoint  
(see Photo 7-124 for its relative location)

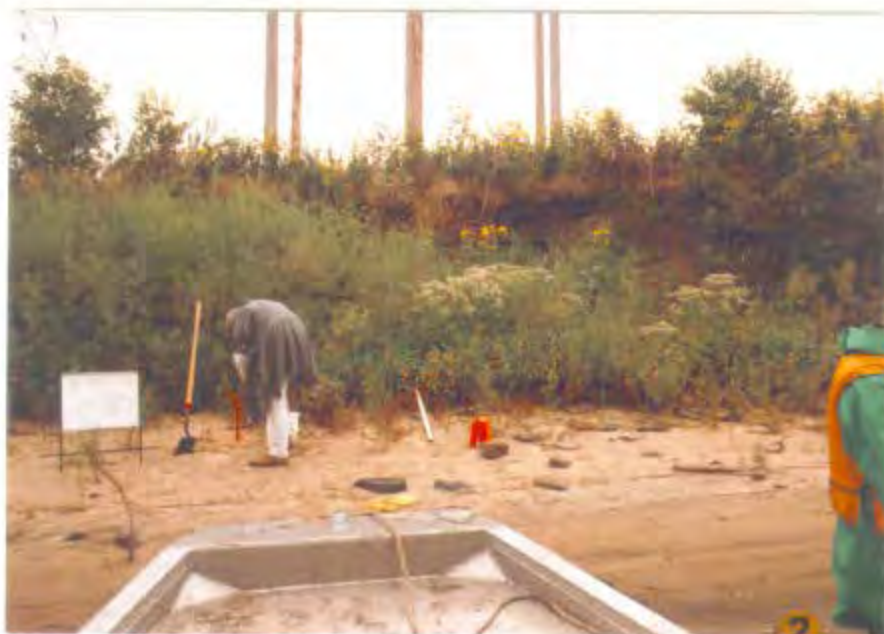
Site UP1, RDB of RM 270.3, Site overview
