# **Interim Report For The Upper Mississippi River - Illinois Waterway System Navigation Study**

**US Army Corps  
of Engineers**

**November 1997**

## Bank Erosion Field Survey Report of the Upper Mississippi River and Illinois Waterway

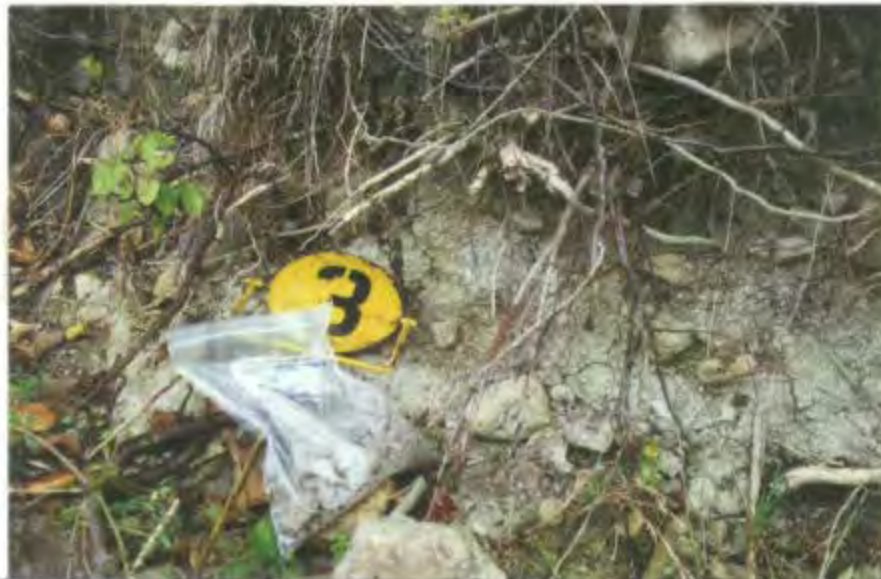
Site UP2, LDB of RM 270.3, Scarp face with sample mark #3 and a sample bag

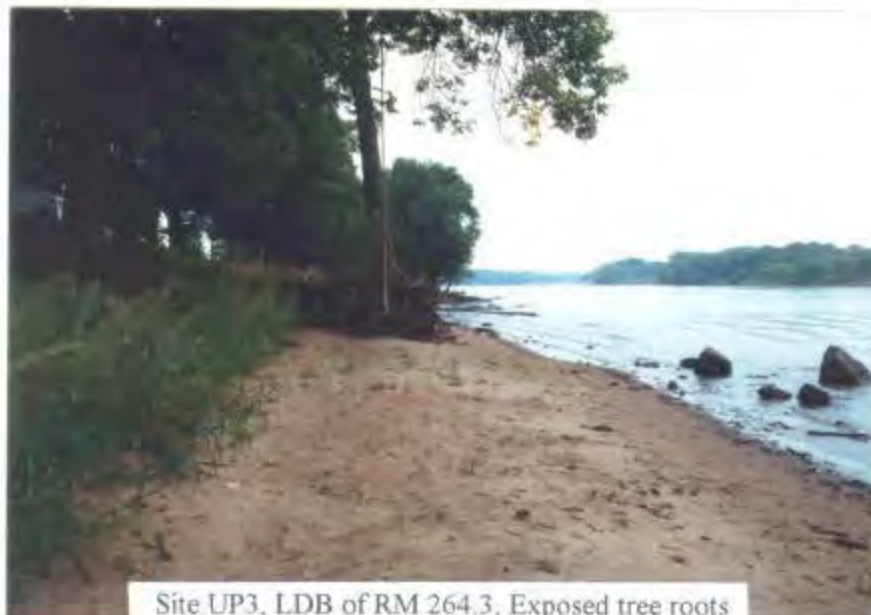
Site UP3, LDB of RM 264.3, Exposed tree roots

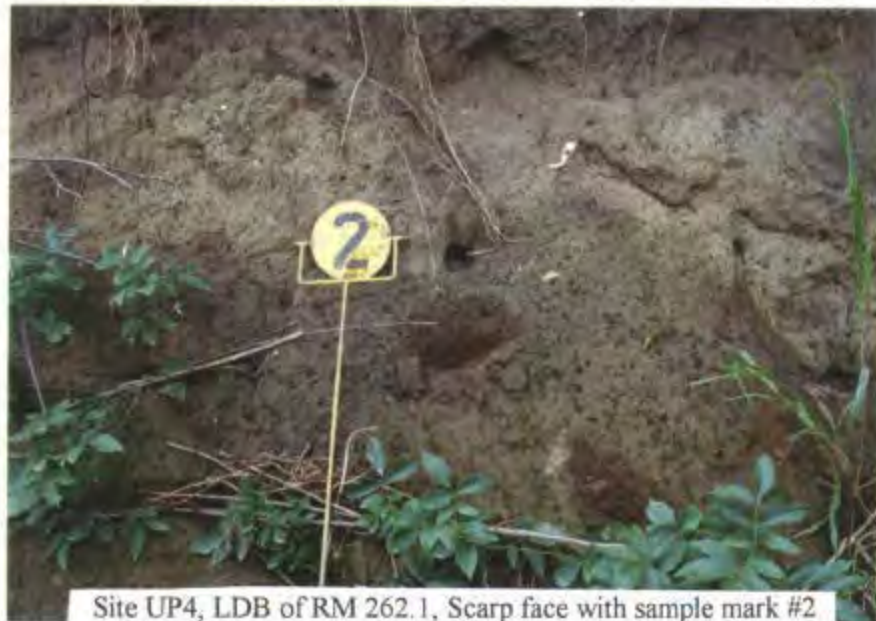
Site UP4, LDB of RM 262.1, Scarp face with sample mark #2

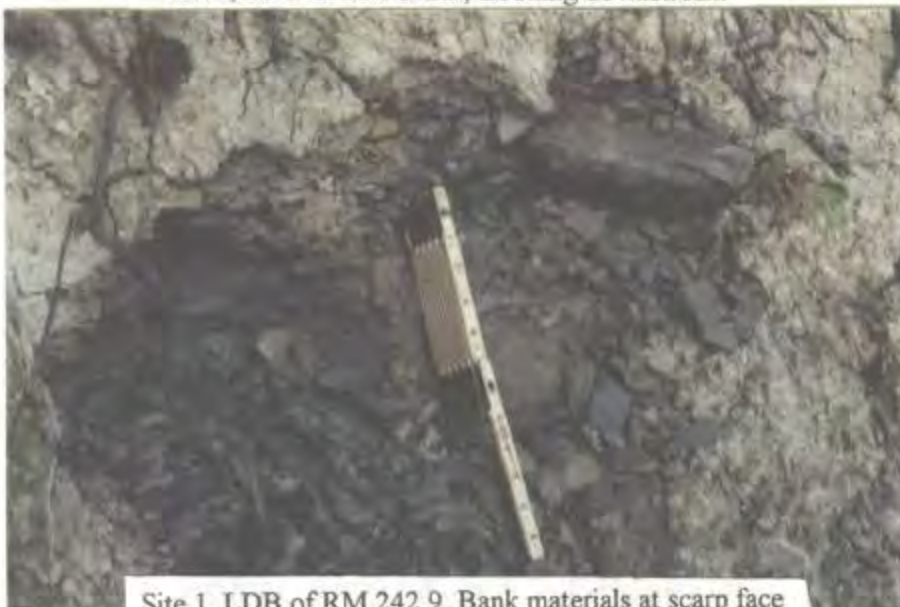
Site 1. LDB of RM 242.9. Bank materials at scarp face

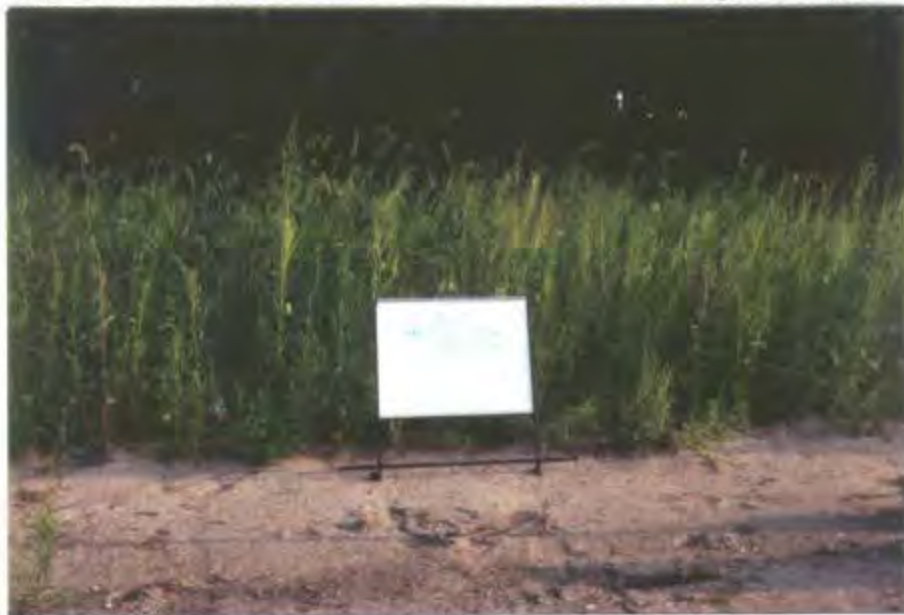
Site 4, LDB of RM 228.1, Site view with the sign for each midsection

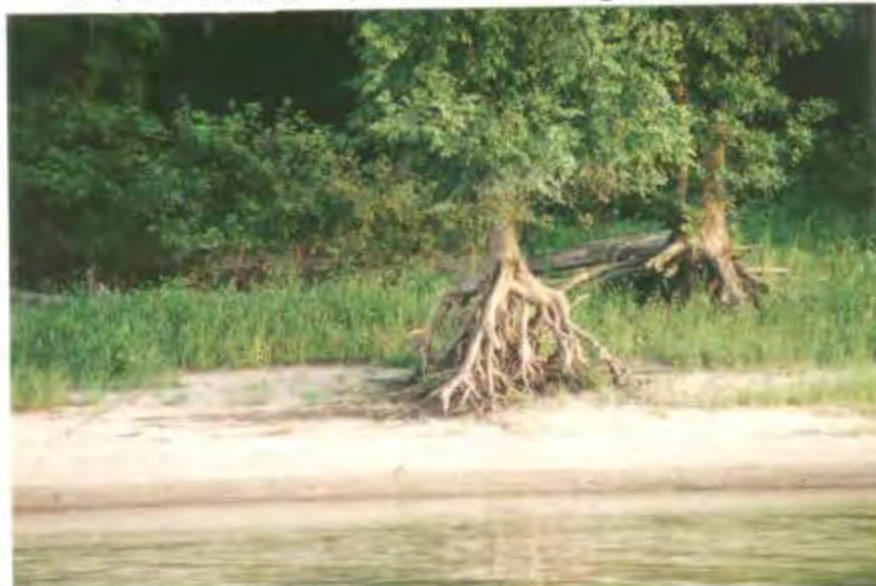
Site 4, LDB of RM 228.1, Downstream section view with exposed tree roots

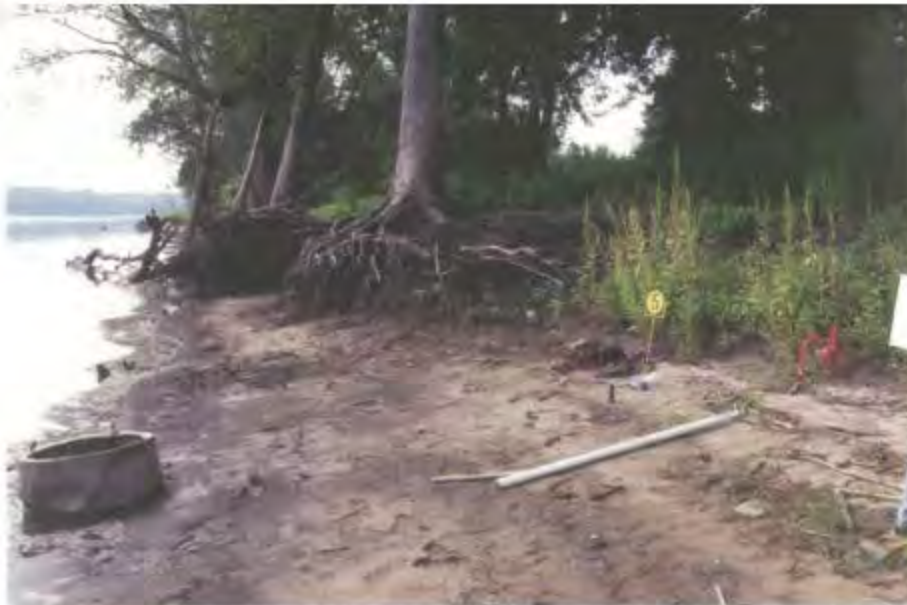
Site 6, RDB of RM 210.0, Site view with soil sampling location

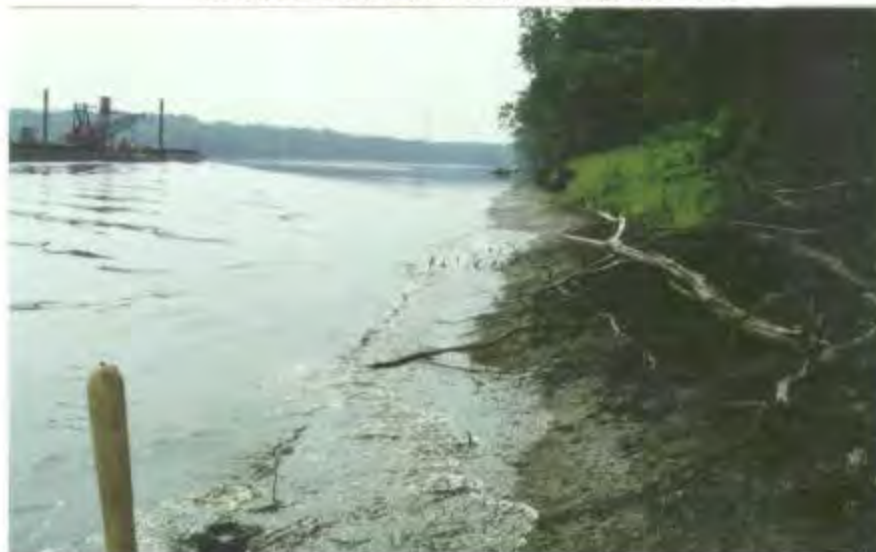
Site 6, RDB of RM 210.0, Looking downstream with a work barge passing the site and the SWS Monitor at the downstream limit

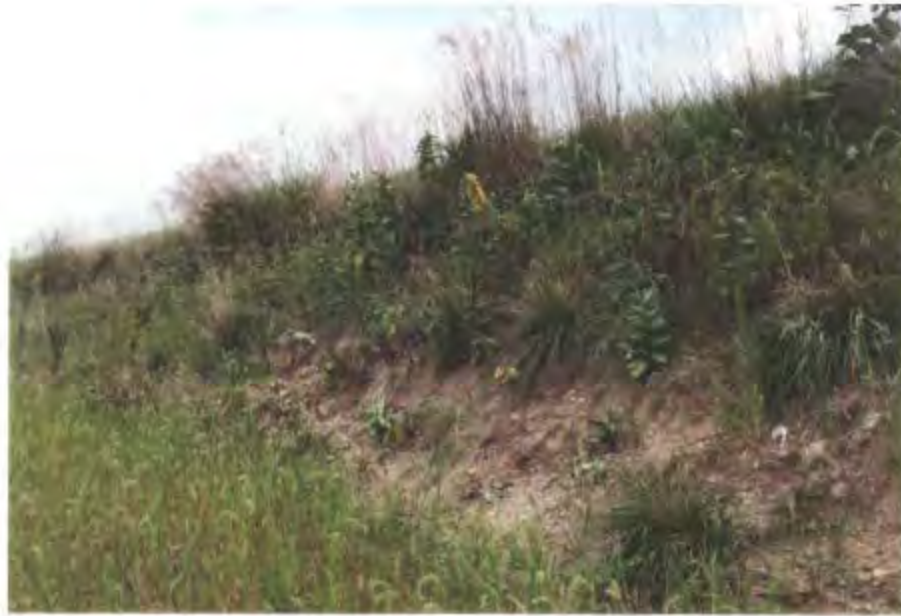
Site 7, LDB of RM 203.8, Scarp face at upper portion of the bank

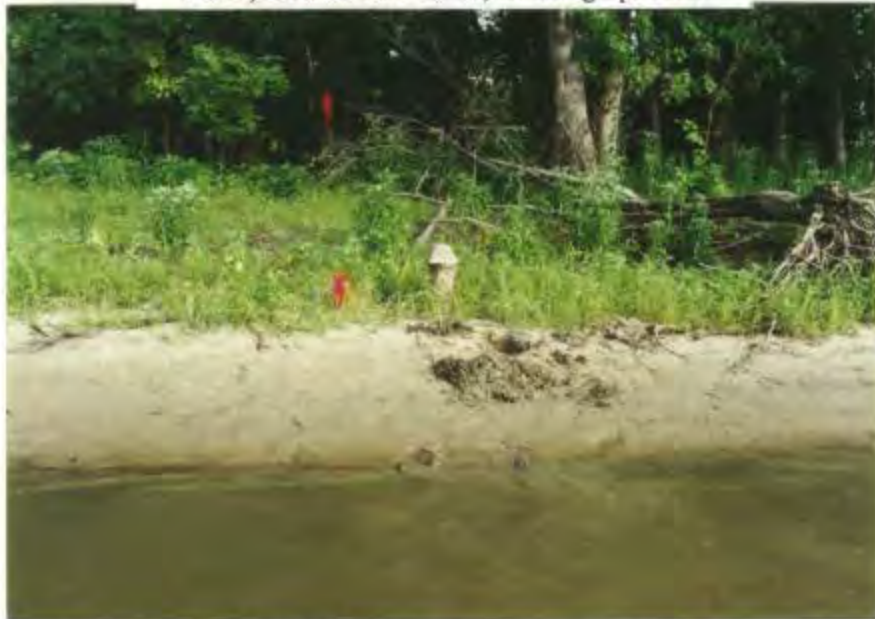
Site 9, LDB of RM 179.8, Mid-section view with an old monument.

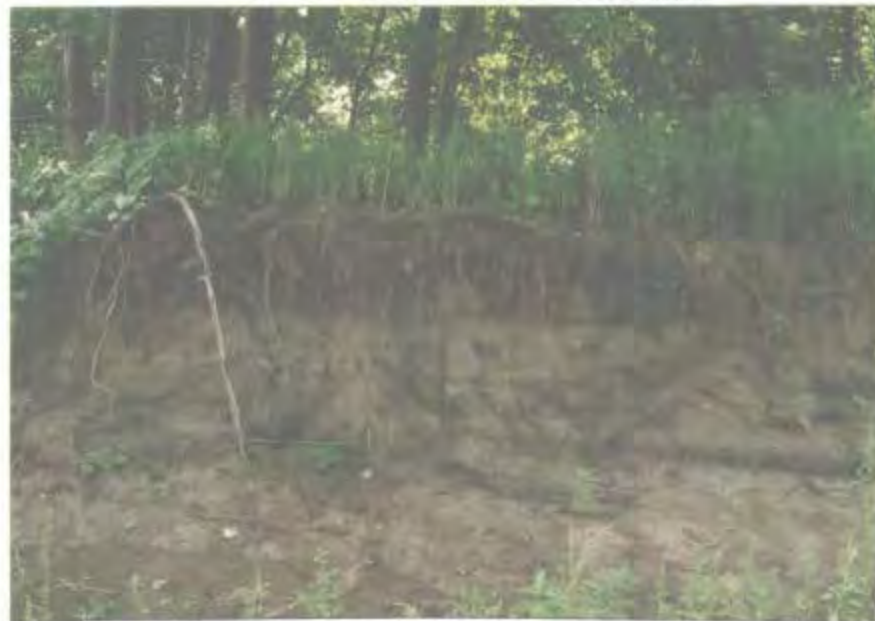
Site 16, LDB of RM 109.5, Scarp face at 100' upstream

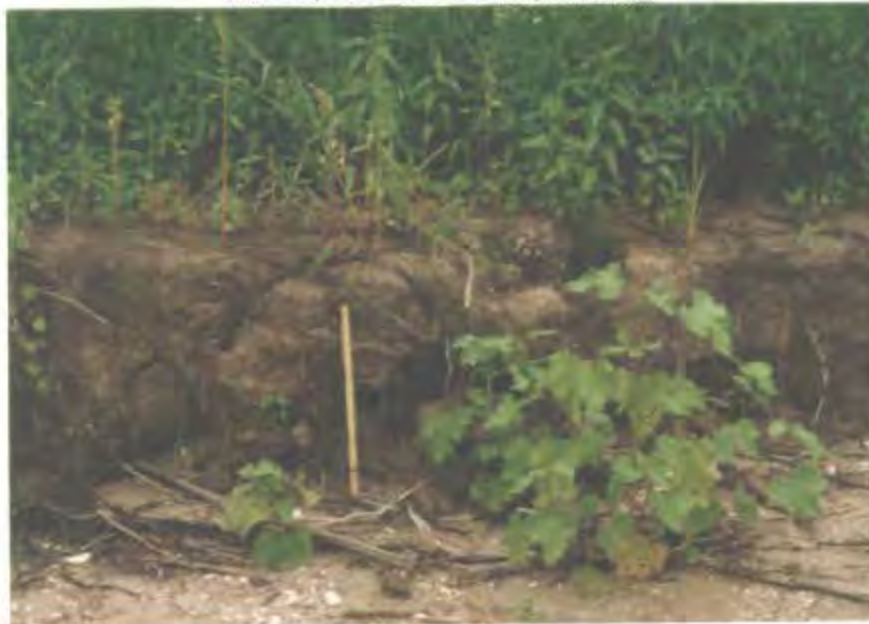
Site 18, RDB of RM 94.3, Mass collapsed on site

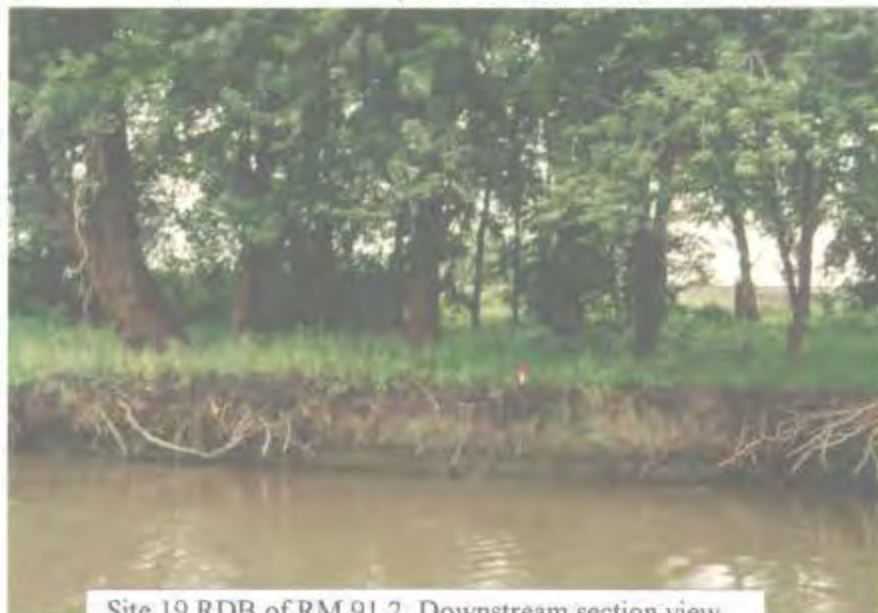
Site 19, RDB of RM 91.2, A closer view of bank conditions

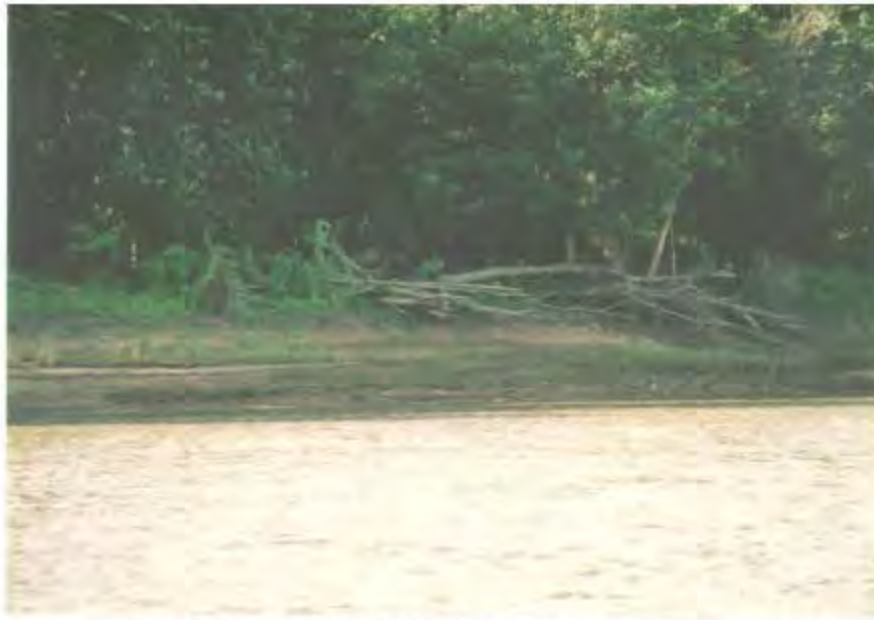
Site 20. RDB of RM 79.4, Sampling location of the bench where ground water showed up at the sampling hole
