UPPER MISSISSIPPI RIVER SYSTEM  
ENVIRONMENTAL MANAGEMENT PROGRAM  
POST-CONSTRUCTION PERFORMANCE  
EVALUATION REPORT (PER5F)

**BIG TIMBER REFUGE  
REHABILITATION  
AND ENHANCEMENT**

POOL 17  
UPPER MISSISSIPPI RIVER  
MILE 443-445  
LOUISA COUNTY, IOWA

**POOL 17, MISSISSIPPI RIVER MILES 443.5 - 445.0  
LOUISA COUNTY, IOWA**

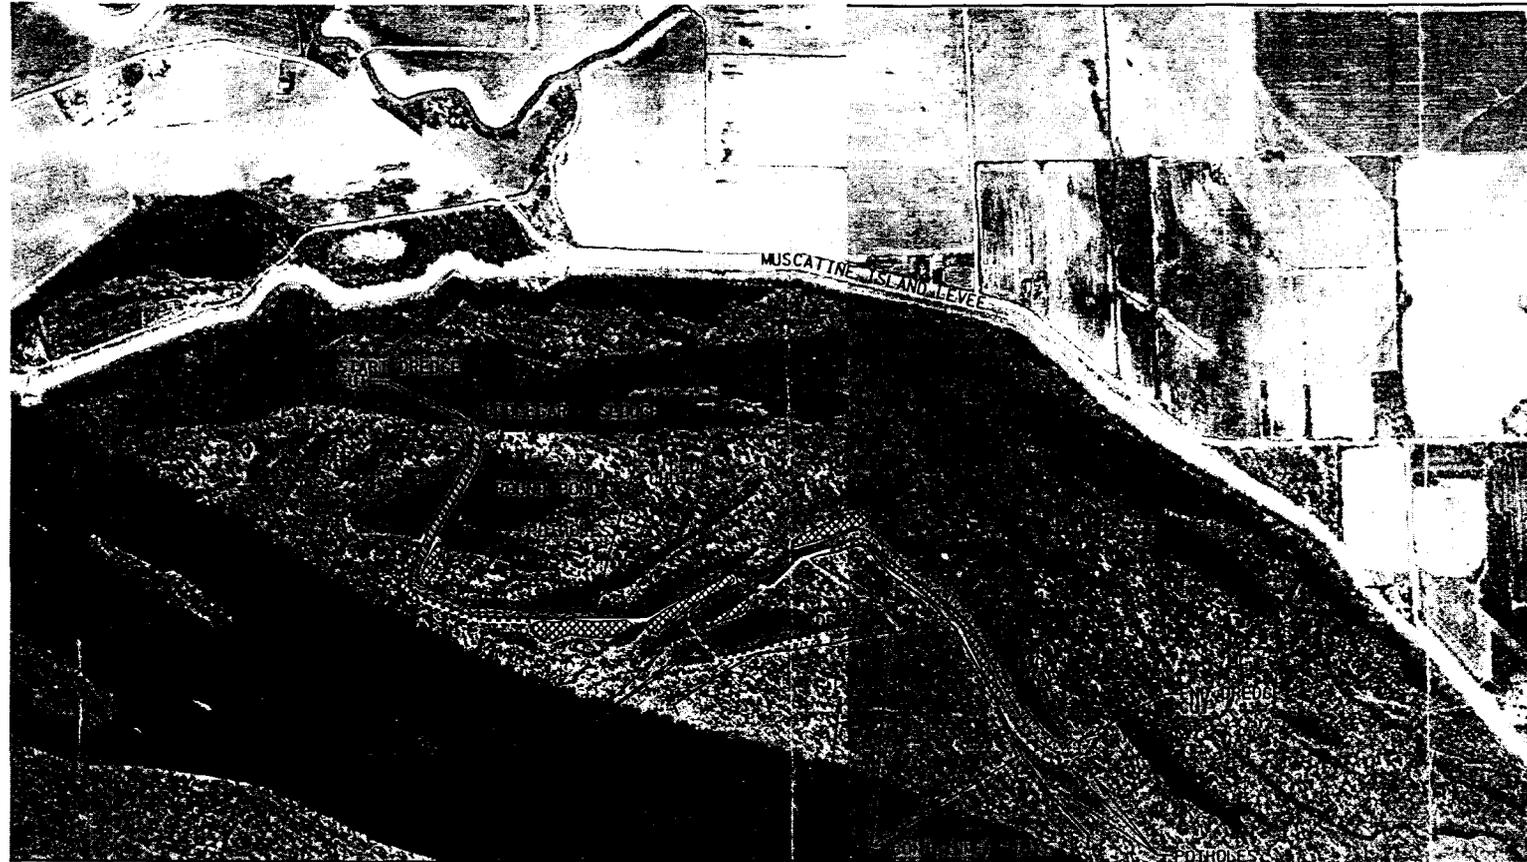
NOTES:

1. MAST TREES PLANTED ON THE CONTAINMENT DIKE.
2. DATE OF AERIAL PHOTOGRAPHY: 4-17-94
