**HAZARDOUS, TOXIC, AND RADIOACTIVE WASTE  
DOCUMENTATION REPORT**

**SECTION 206  
WATER RESOURCES ACT OF 1986, AS AMENDED  
LAKE BELLE VIEW  
AQUATIC ECOSYSTEM RESTORATION PROJECT  
BELLEVILLE, WISCONSIN**

**December 2000**

**Revised October 2002**

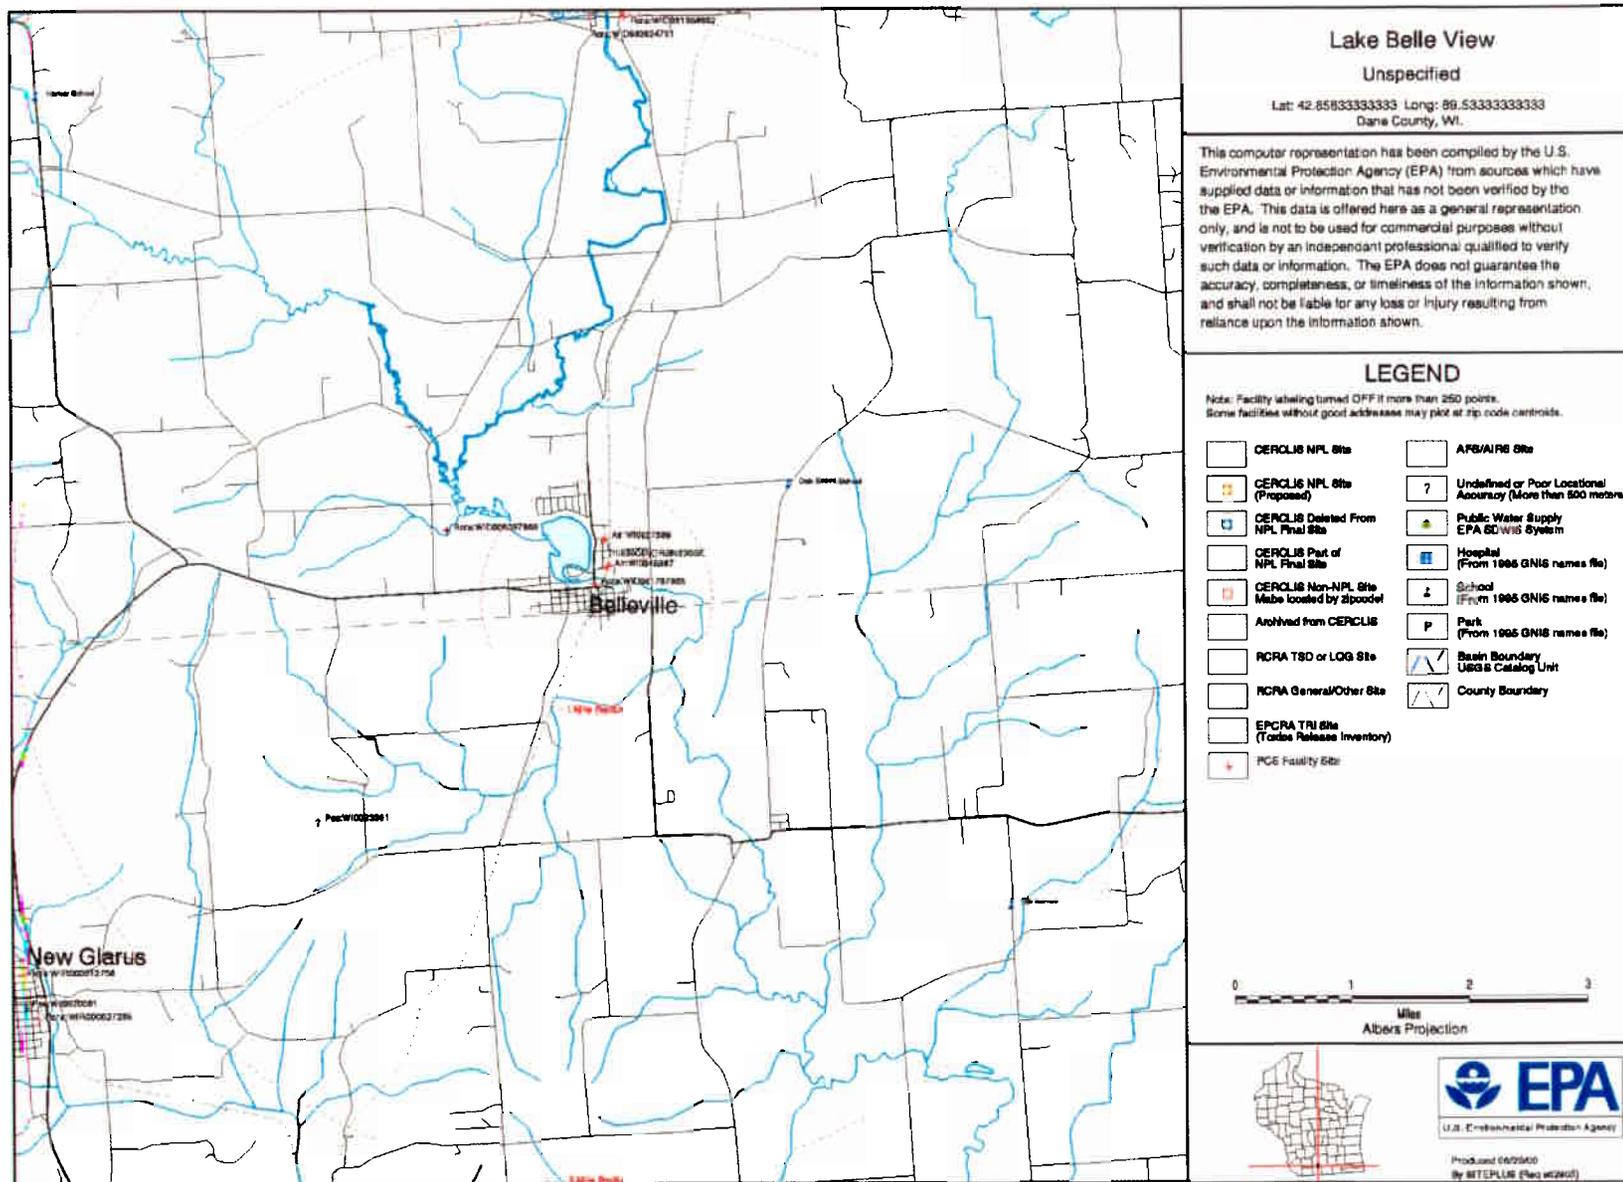
Figure 1. Site Results

When an Envirofacts database query was conducted using the City of Belleville (Wisconsin), evaluating a five and two-mile radius around. There were 11 facilities identified. 2 facilities were permitted discharges to water, 1 had toxic releases reported, 6 were hazardous waste handlers, and 2 had air releases reported. None of the facilities were BRS 1995 reporters and or had an active or archived Superfund report. See the following figure for detail.

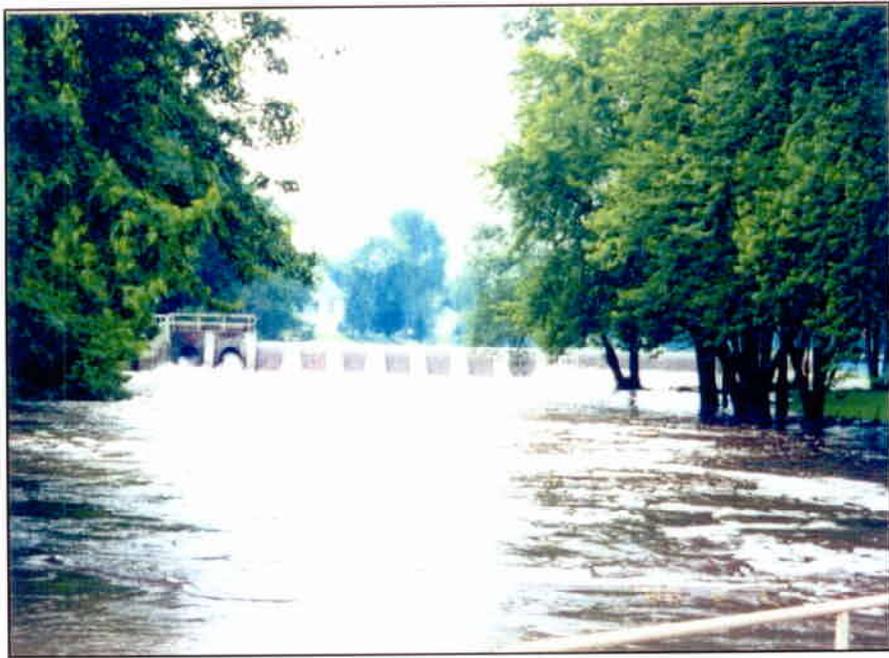
**Photo 1. During high water; taken from the pedestrian bridge, looking upstream at the Belleville dam.**

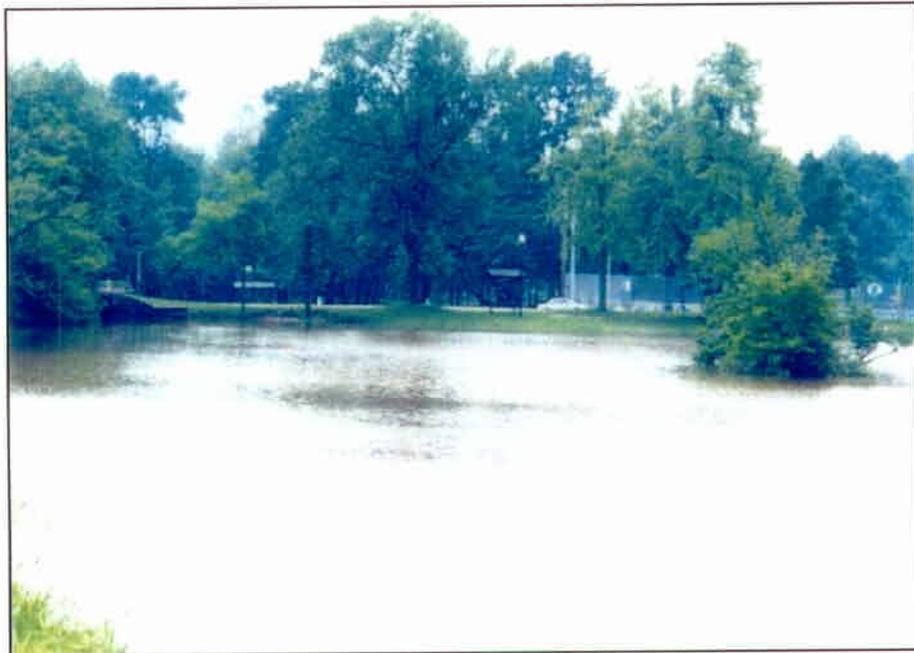
**Photo 2. Bross Circle Bridge and park entrance, during high water.**
