**DEFINITE PROJECT REPORT
WITH INTEGRATED ENVIRONMENTAL ASSESSMENT**

**SECTION 206
LAKE BELLE VIEW
AQUATIC ECOSYSTEM RESTORATION PROJECT**

**APPENDIX H
HYDROLOGY AND HYDRAULICS**

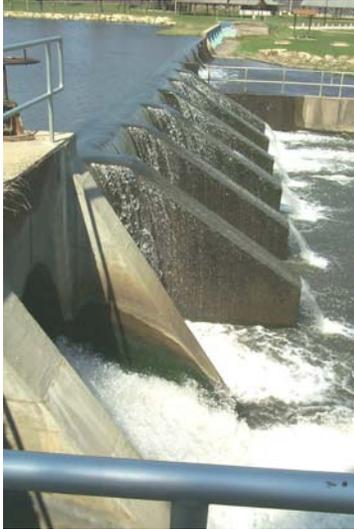
**Belleville Dam
typical flow condition**

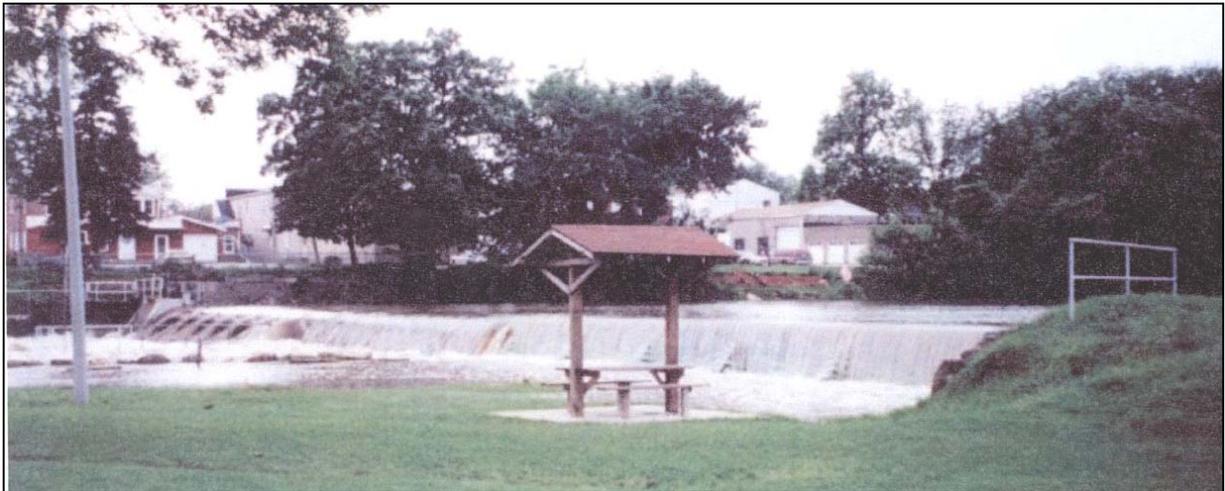
**Belleville Dam: June 2, 2000 flood flow conditions
Approximate Flow: 1,800 cfs (33% exceedance probability)**

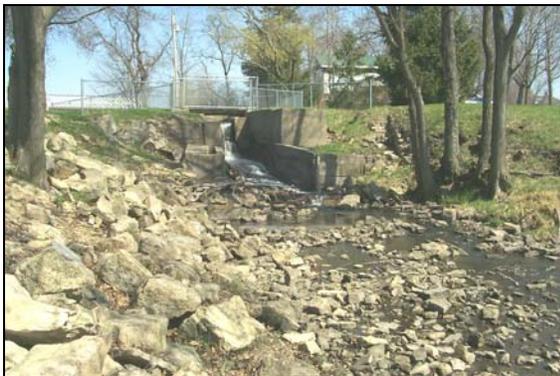
Belleville millrace: typical flow condition

Located approximately 600 feet northeast of Belleville Dam, at the southeast corner of Lake Belle View, the Millrace Chute allows minimal flow to pass from the lake into the Sugar River. Of historical significance, this location was the former location of the Belleville Mill. In the “eastern diversion” alternatives of this 206 project, this location would be excavated to allow the Sugar River to bypass Lake Belle View. The bottom width of the new channel would be 65 feet, requiring a new bridge to be constructed that would allow access to the island park. In the “western diversion” alternatives, this location would serve as an outlet channel for lake level management and would remain unaltered.

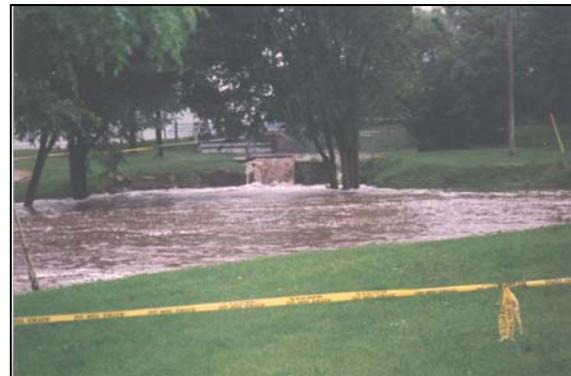
Belleville millrace: 1997 flood flow

If the stoplogs at the canal gate are removed, a maximum discharge of 153 cfs could be released during flood conditions. If the stoplogs are not removed during a flood, the lake level would rise slightly and

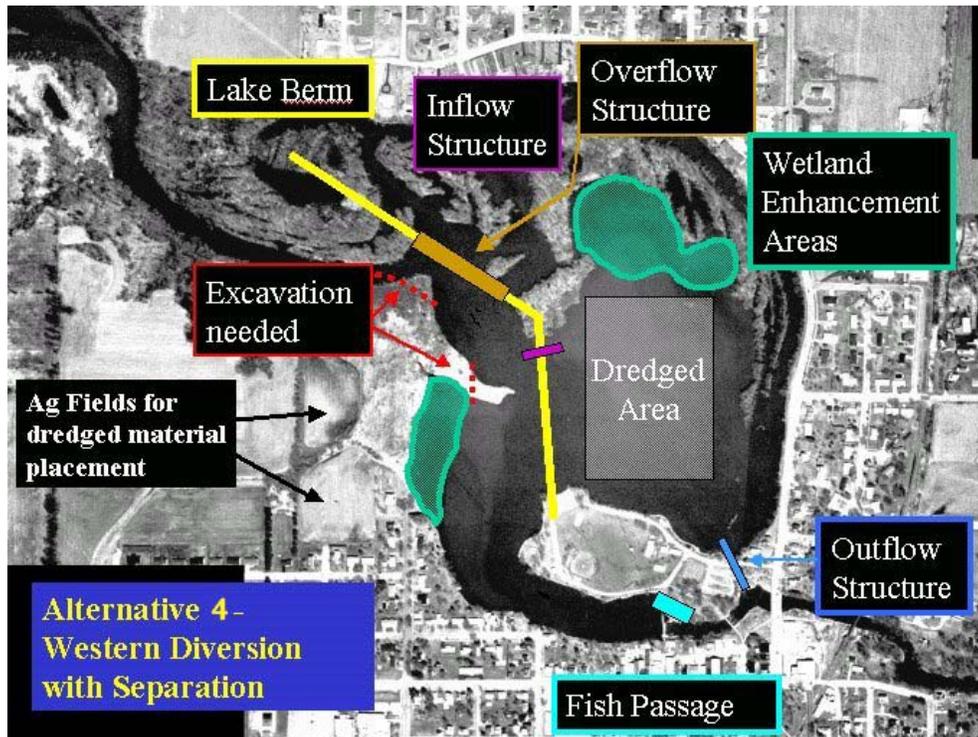
Figure H.6. Alternative 4 - Western diversion with separation.

This alternative includes sediment removal, river diversion, wetland enhancement and periodic drawdown. A berm with an approximate 50-year crest elevation (862 ft NGVD) separates the lake from the river. An overtopping spillway is located in the berm at the northern portion of the lake to help equalize lake levels during a large flood. This spillway must be a minimum of 300 feet long with a crest elevation of 861 ft NGVD, which corresponds to the 25-year crest elevation. Wetland enhancement measures would be implemented primarily in the northern and western portions of the lake (see green shaded areas in Figure H.6). Inflow and outflow control structures also would be included to assist in management of water level within the lake, as well as providing the opportunity for periodic lake drawdown. The current millrace would serve as an outlet structure. The inlet structure would be a “carp gate” installed in the separation berm. This gate would provide boat access between the river and the lake, would supply dissolved oxygen to the lake, and would help restrict rough fish access to the lake. Much less shoreline protection is needed in this alternative than the three eastern diversion alternatives. This alternative will need to implement a form of fish passage at the dam. Several types of fish passageways were studied, but only three were found to be economically feasible. Details of fish passage options appear in the “Fish Passage” section of this appendix.

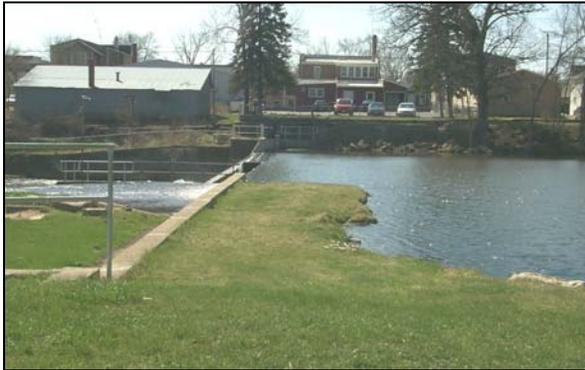
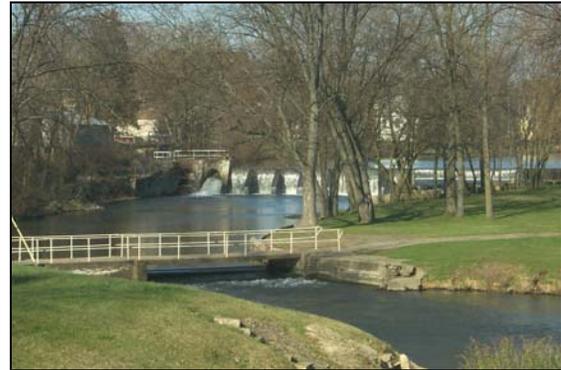
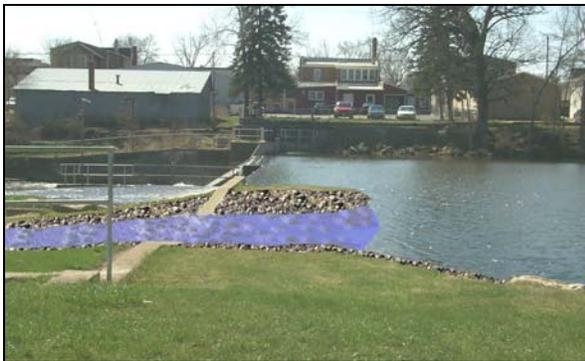
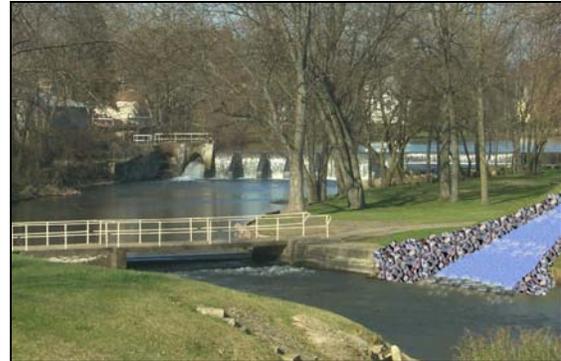
Belleville Dam

Sugar River downstream of footbridge

Belleville Dam with fish bypass Option 1

Exiting flow of fish bypass Option 1

Figure H.11. Conceptual photo of fish bypass Option 1.

Below is a conceptual photo of how the Belleville Dam would look if the Option 1 fish passage bypass channel were constructed:

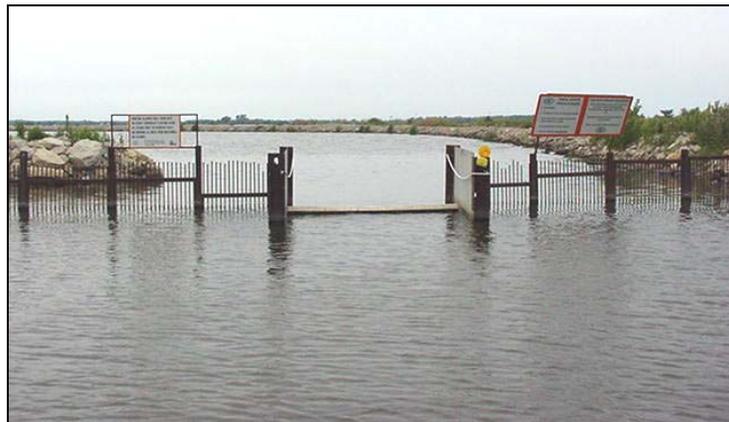
Figure H.12. Photo of carp gate at Lake Butte des Morts, Wisconsin.

Restricting the number of carp that enter can be accomplished by completely separating the lake from the river or by using a carp gate. Complete separation may lead to low dissolved oxygen in the lake and resulting fish kills. Separation also makes management of the lake level possible only through the use of a pump. Carp gates limit adult carp from entering the lake and can also function for boat passage between the lake and the river (assuming a separation berm is constructed). The gate is buoyant and is hinged at the bottom so that boats may pass over the gate. Since carp are vertical jumpers, the gate is positioned at an angle underwater, so that adult carp are prevented from entering the lake. The carp gate concept was originated from Art Techlow III, et al., WDNR, at Lake Butte des Morts, Wisconsin. A photo of a carp gate appears in Figure H.12 below.

The wetland enhancement benefits of the Lake Butte des Morts breakwater and carp gate are impressive. The success of the carp gate relies upon the migratory habits of carp. Before winter, the gate is pinned to the bottom of the channel so that carp may exit the protected area as they search for deeper, warmer portions of Lake Butte des Morts. In early spring, the gate is raised to prevent larger carp from entering the protected area.
